Home Inspection Report

11900 11920 sw Iron Horse Lane
Beaverton, Oregon
Inspection date 08/11/2011
(section one of three)

Prepared by: The Home Tester
10555 SW Tigard St. #57
Tigard, OR 97223
Ben Tester
503-515-1833 CCB# 164921 OCHI # 912

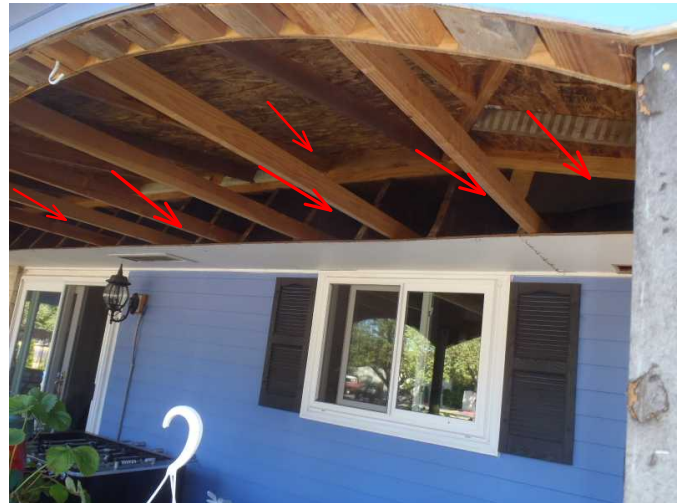
front patio is noted with added covered area...close off all open areas and add gutter and downspout to end...

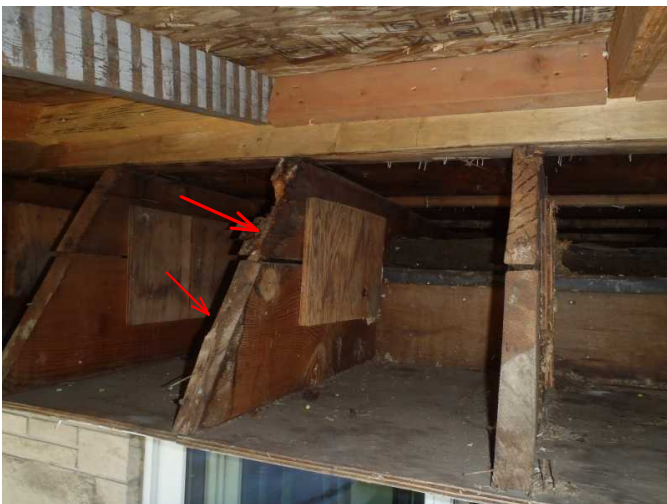
main attic at same patio covered area is noted wide open for bats and birds and critter entry..close up ASAP

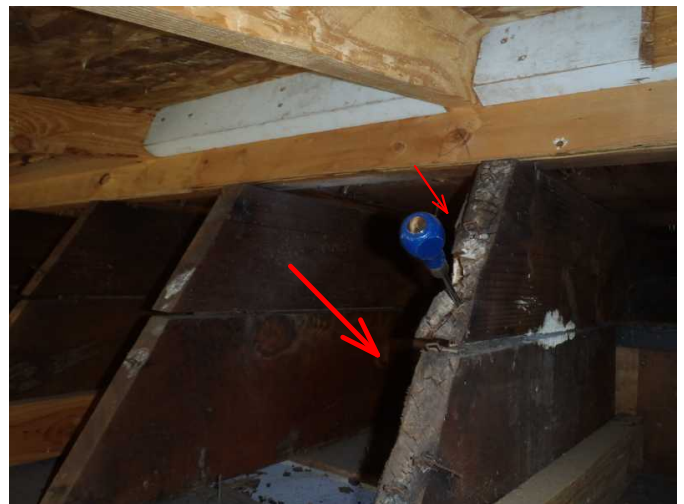
open area is also noted with random dry rot from past damage...expect added repairs at mansard roof areas...

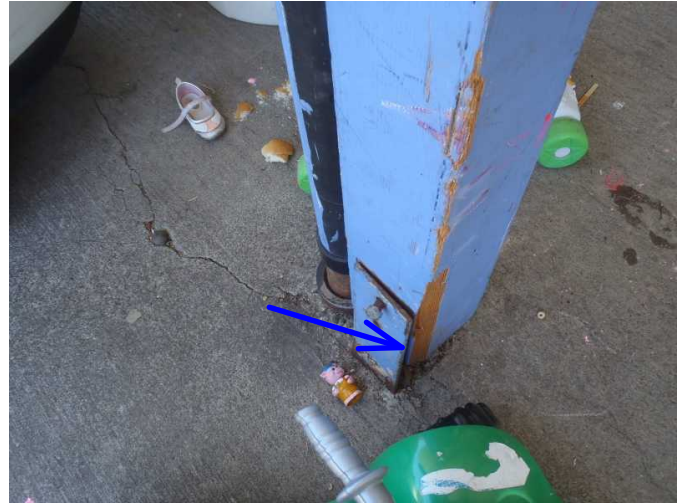
overall condition of carport area is noted solid...no lights noted at carport area for night safety...posts are solid...

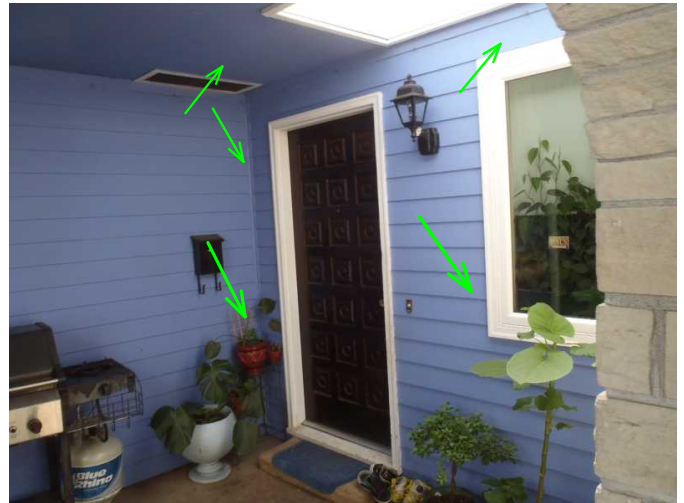
11900 front covered area is noted with fiber cement siding and wood trim...needs paint and caulked...venting noted...

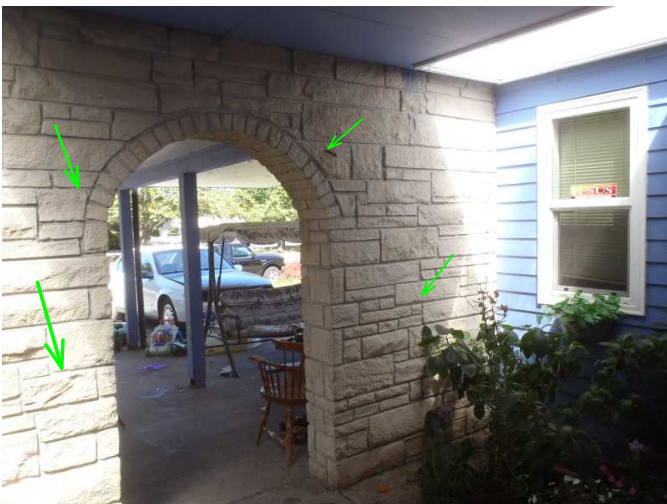
noted 11920 entry and trim are also fiber cement and will also need paint and caulking..

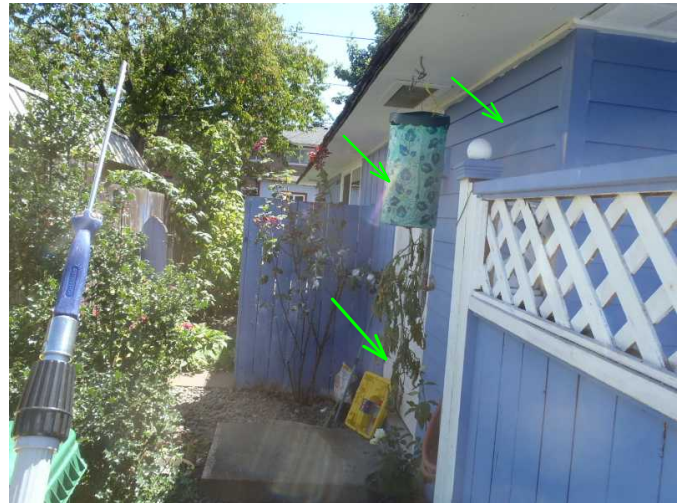
open gaps noted at hose bib and hose bib was noted not operable...some PVC tapped water lines broken...

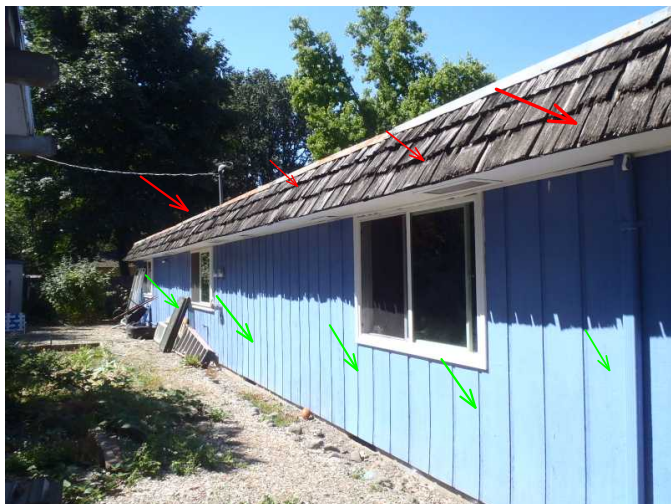
back view of T 1-11 siding is noted solid...mansard roof is noted rotted shakes...replace...

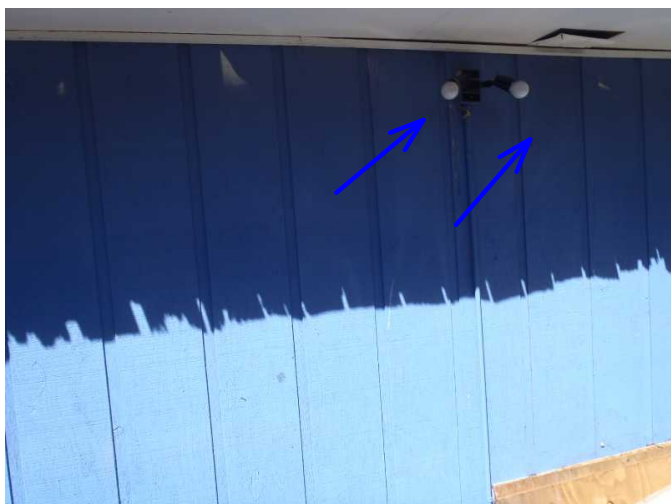
light fixture is noted mounted , but not operable...back center area of home...

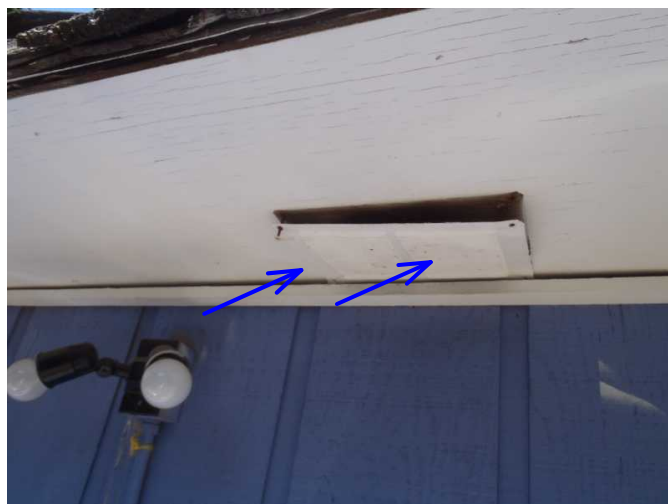
many vents are noted loose to soffits and will need secured...

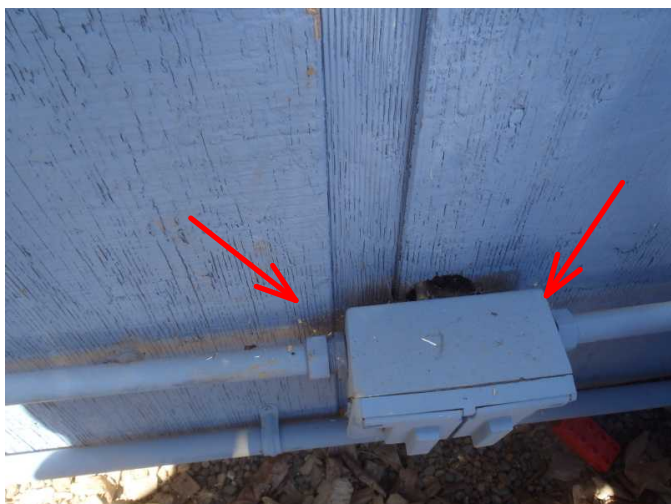
loose and open junction box is noted at back area by 11920 bedroom area...outlet is operable..secure to siding..

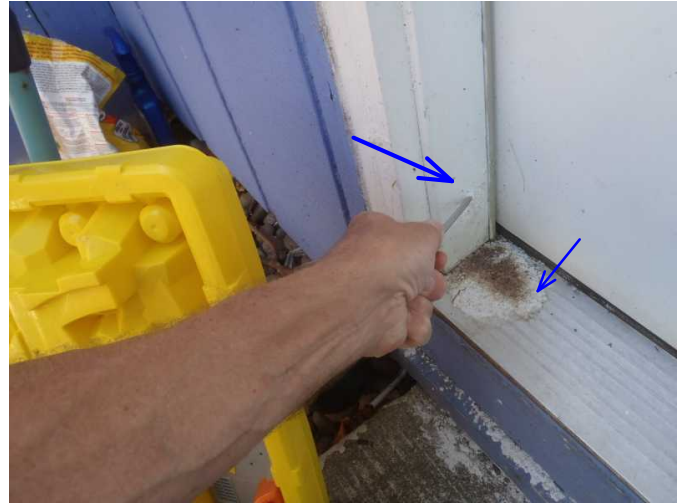
siding divided at side doors...fiber cement at front and T1-11 at back...all of mansard roof shakes are rotten, replace

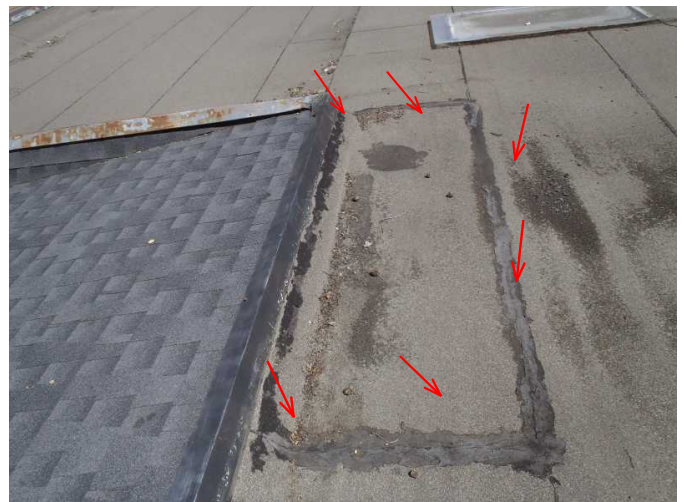
front area roofing is noted patched and no exit drains noted where should be...debris standing at flat roof is not good

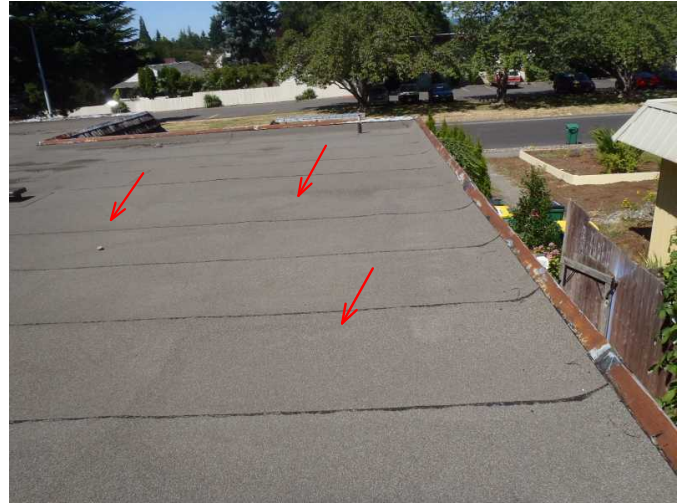
when walking the roof...the sheathing under roof is noted uneven and soft in many places...

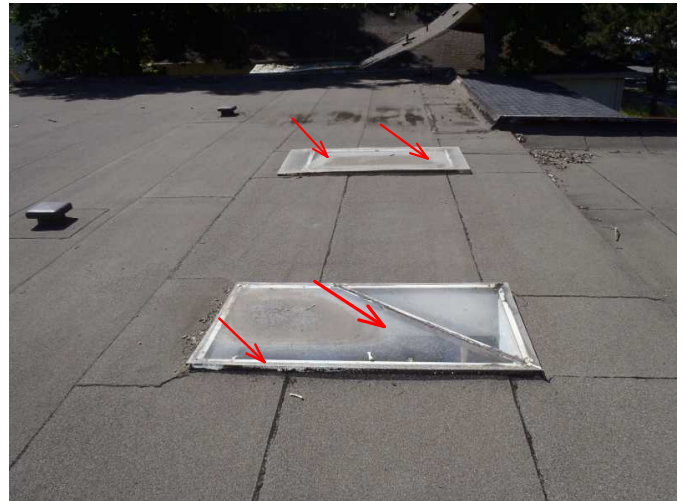
wherever seeing the dark areas is where the granules are now bare....this means potential leaks...

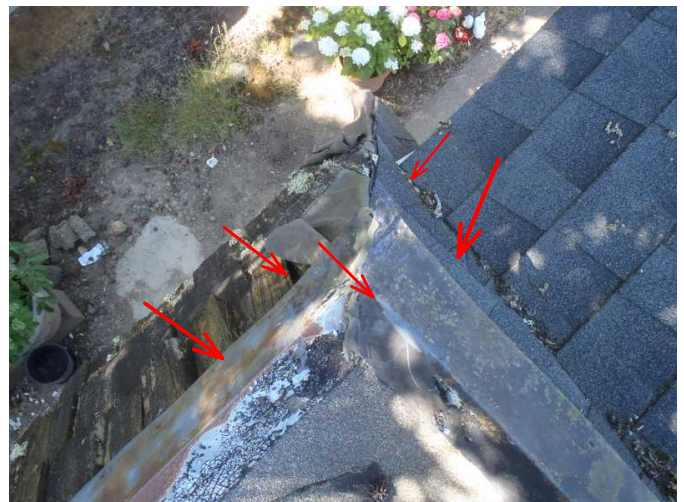
front patio awning covering is not sloped well enough for shingles...can wick water up and under ...use rolled roofing

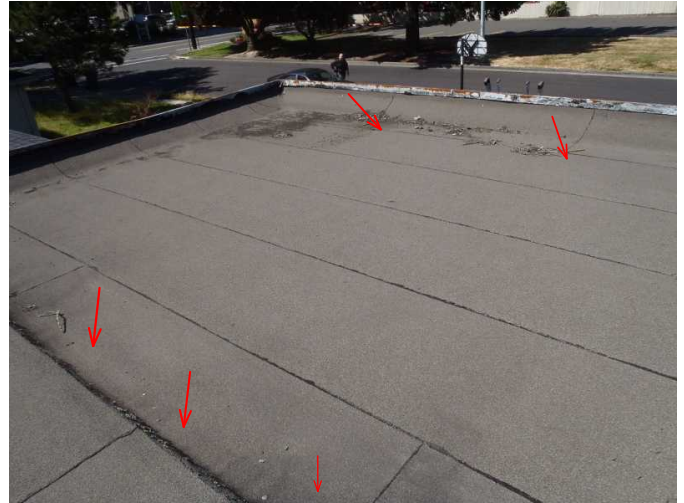
all sewer vents are noted not flashed and are tarred and noted open cracks at all intersections..will required repairs...

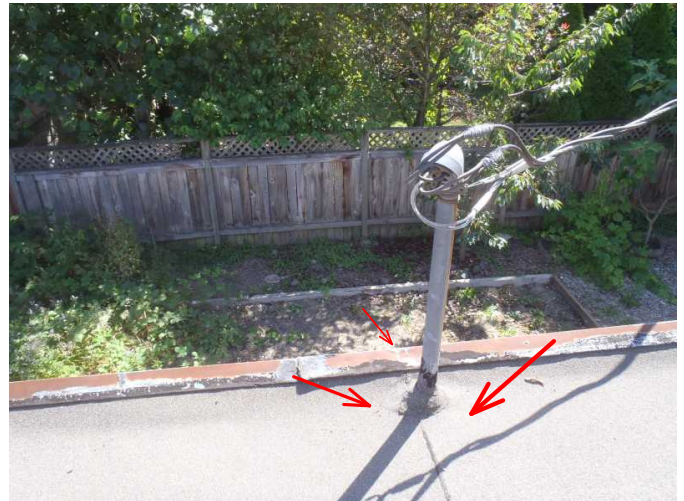
the main drop from carport to roof is noted with cracked roofing and will leak if not tarred...

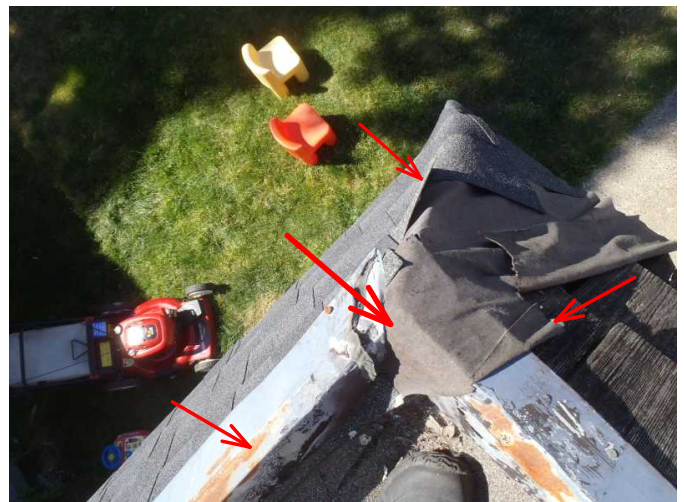
put my awl into open cracks that will be leaking this fall...assess and correct...or replace roof...

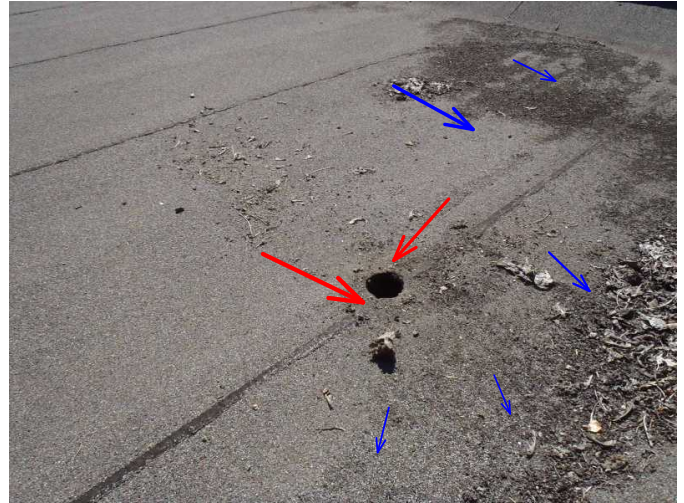
the main sewer exit vent in center of structure is also noted with open cracks at roof line and will need tarred/sealed

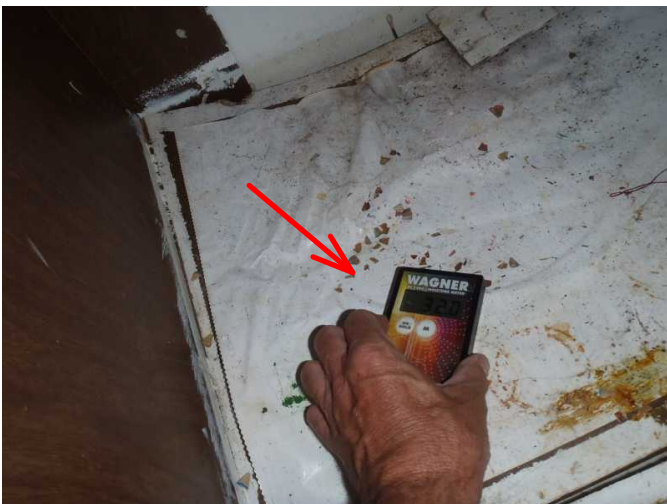
cabinet area floor is noted high in moisture..expect damage to under layment...

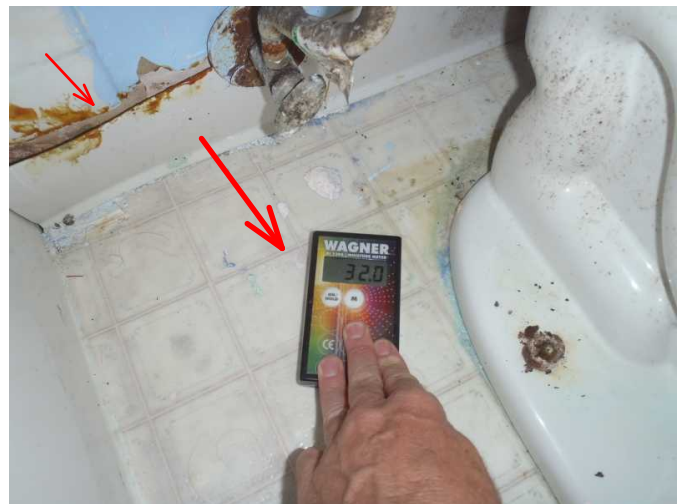
floor of cabinet is also noted high in moisture...expect floor under cabinet to be damaged..

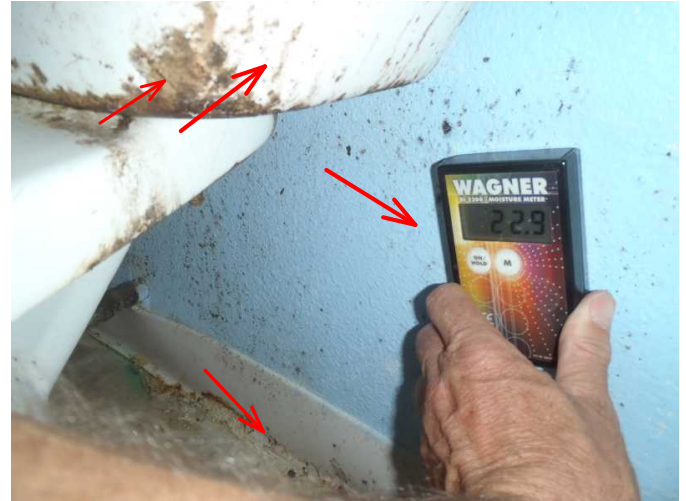
floor at toilet in main bath at 11900 is noted saturated again...as is in master...

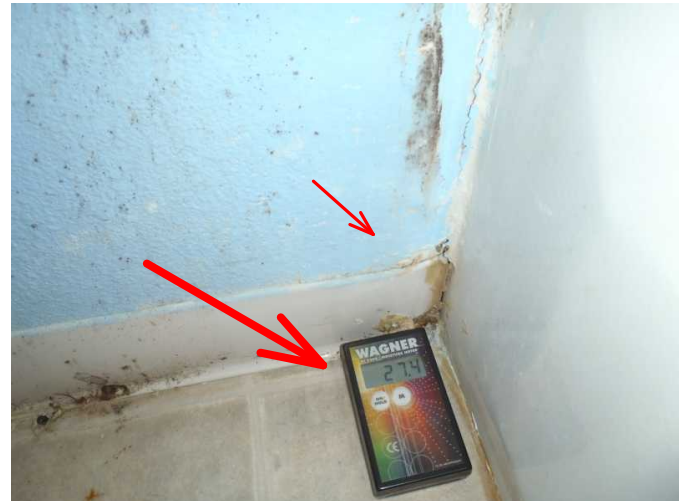
floor behind toilet is noted saturated as well...expect damages...

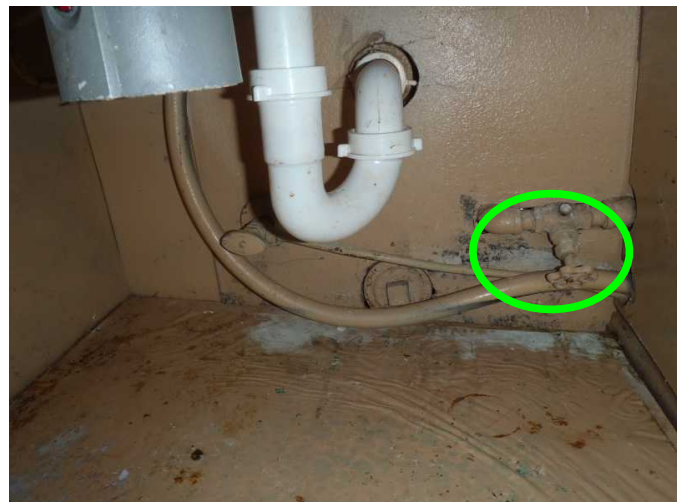
garbage disposal is noted operable..but needs armoured cable electric line...dishwasher needs high loop...

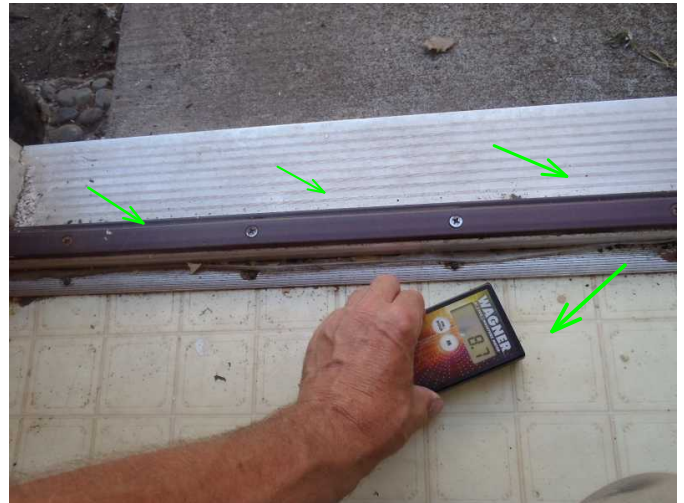
back metal door is noted operable...but door does not latch when closed...and weather stripping is damaged...

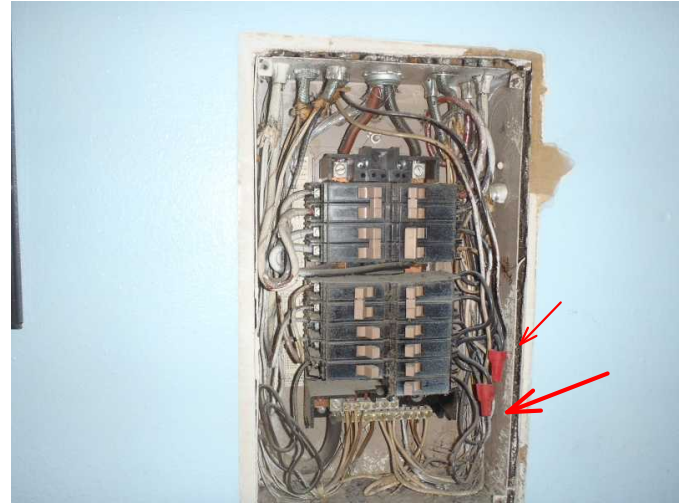
main breaker panel is noted full and no room for expansion for any major changes...is 125 amps...

the breaker panel has some spliced wiring that is indication that the panel is full and no room for any added items...
