Home Inspection Report

11900 11920 sw Iron Horse Lane
Beaverton, Oregon
Inspection date 08/11/2011
(Section two of three)

Prepared by: The Home Tester
10555 SW Tigard St. #57
Tigard, OR 97223
Ben Tester
503-515-1833 CCB# 164921 OCHI # 912

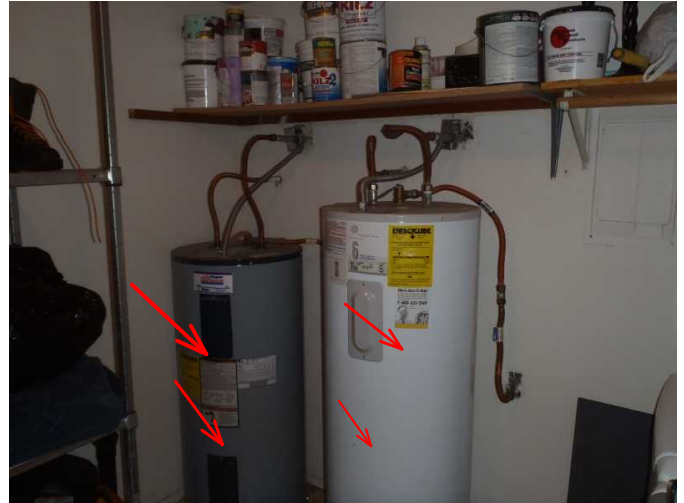
both water heaters are aged and will need earth quake strapping...is required...monitor for leaks...

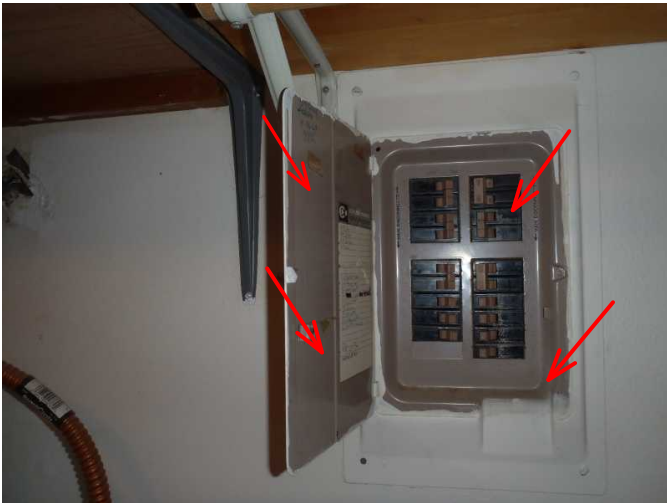
breaker panel for 11920 is noted next to water heaters...and is at capacity...125 amps and full..

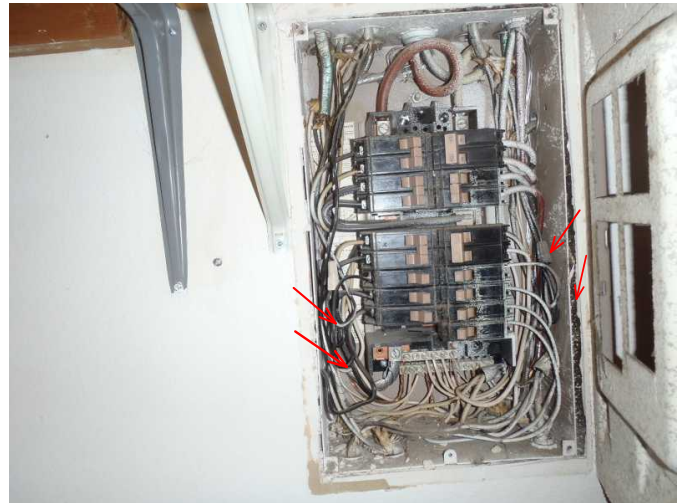
in this breaker panel is noted several spliced wires...appears the panel is at capacity and may need upsized...

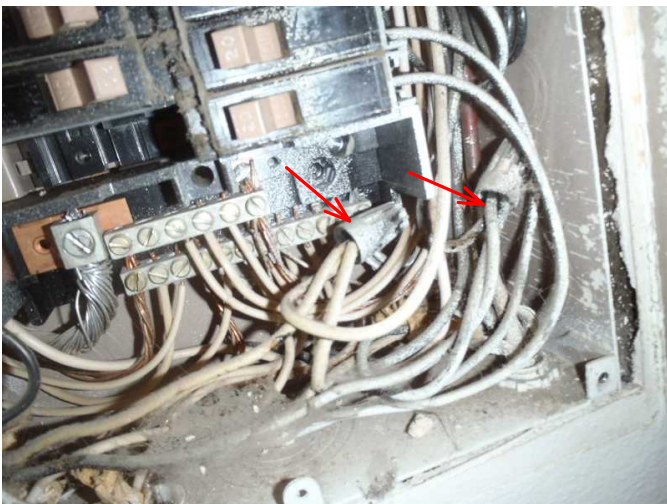
two of four spliced wiring noted..this is where two circuits are powered by one breaker and wired away from breaker

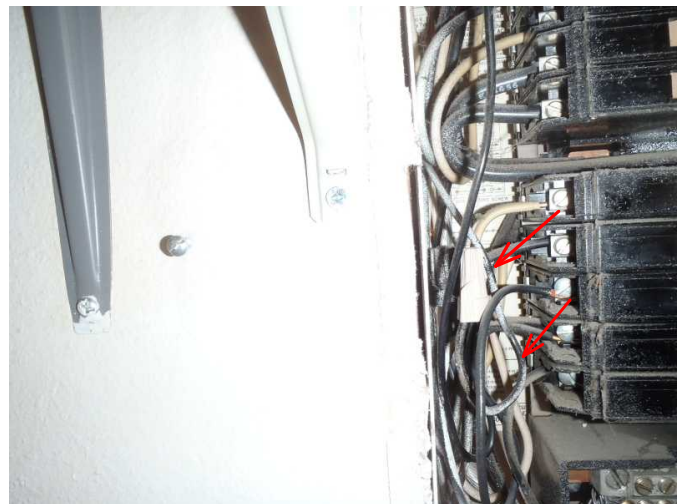
the idea can be fine at low use circuits..but can pop breakers alot if overused.....expect breakers to "pop"

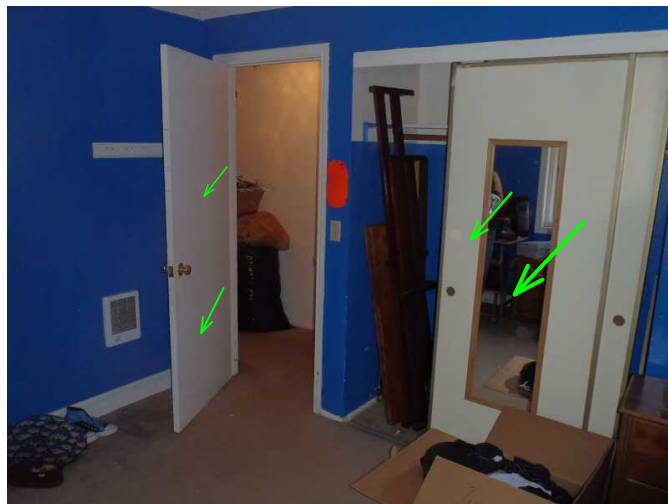
entry and closet doors are noted operable...door hinge at base is bad....

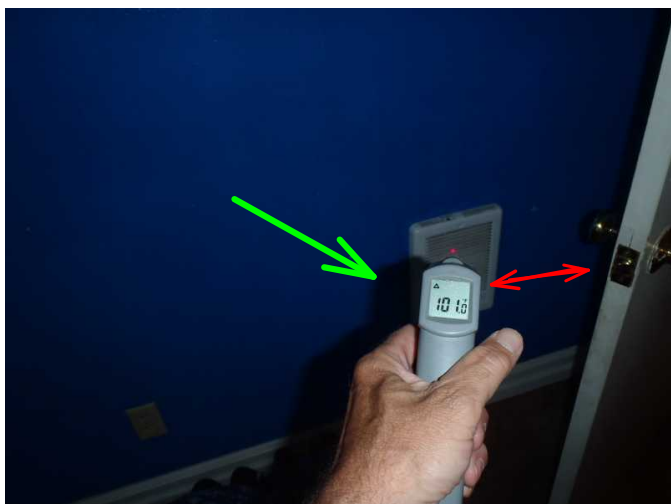
while Cadet wall heater is noted operable...it is too close to entry door and can be fire hazard...

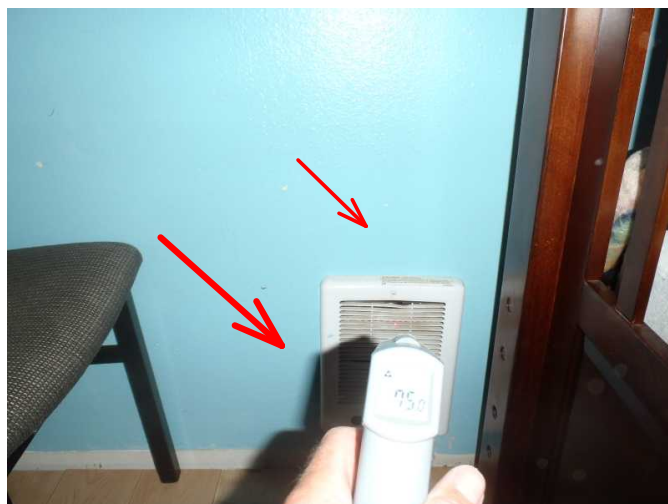
Cadet wall heater in this room is noted not operable...replace...

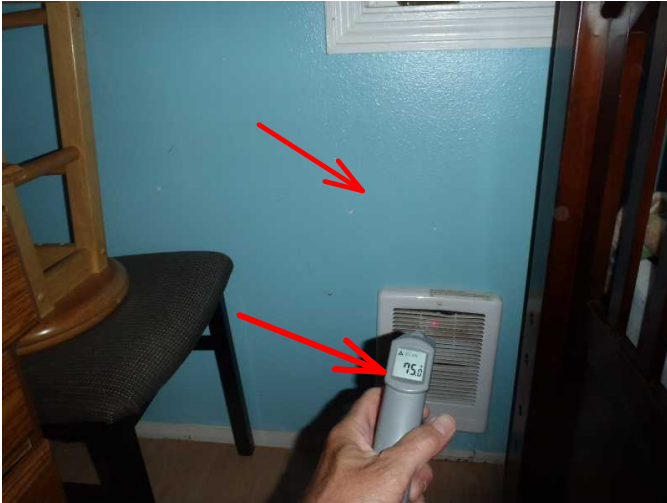
tried again with use of plyers to try to get switch to respond...replace...

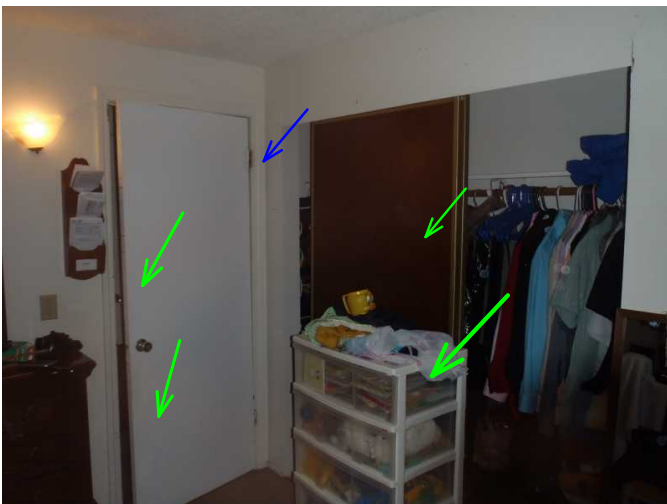
entry and closet doors are noted operable...lupper hinge at door is noted damaged...

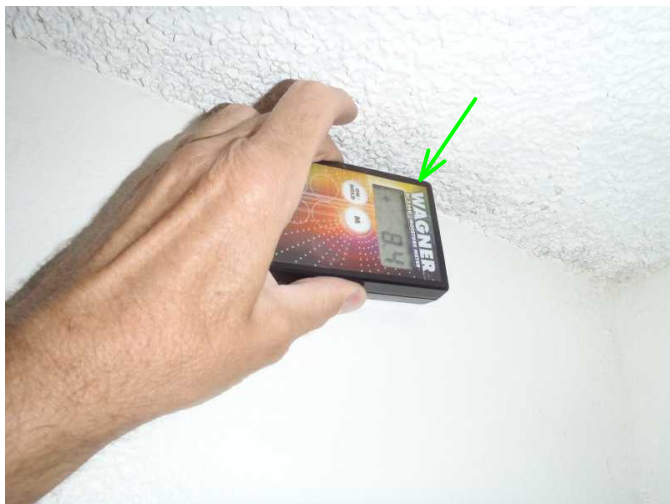
areas at ceiling and wall where stained and dark are noted low in moisture at this time...

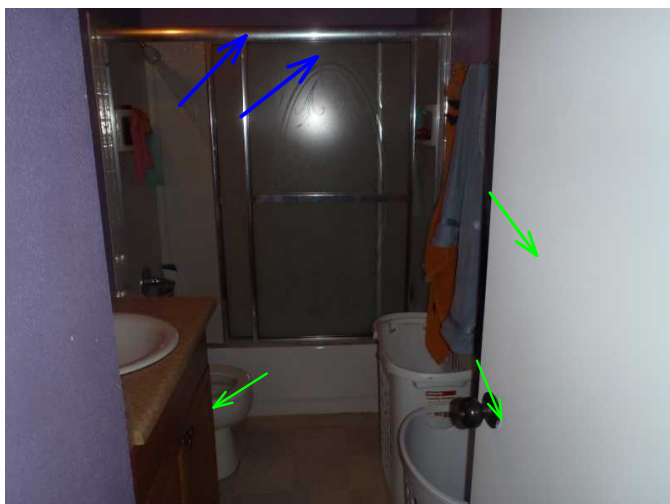
master bath entry door and cabinets are noted operable...ceiling fan / cover is noted missing...replace...

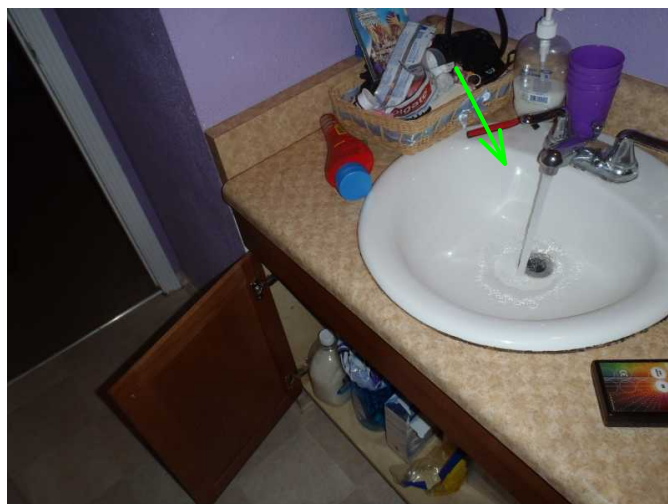
sink faucet is noted operable..no drain stop noted...

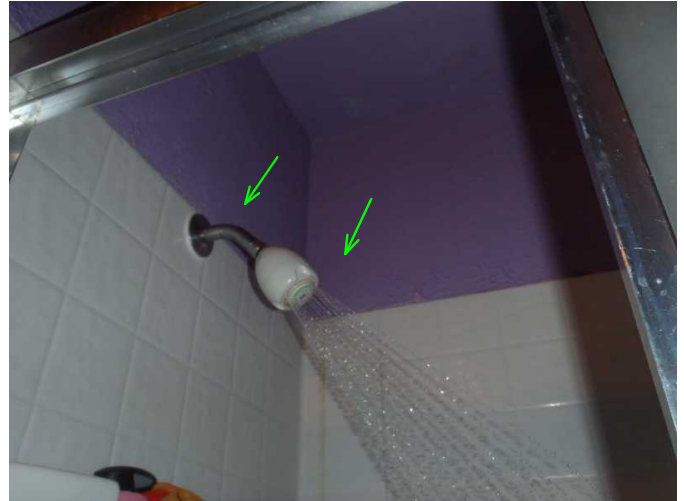
shower head is noted operable...shower doors need towel bar and door handle...

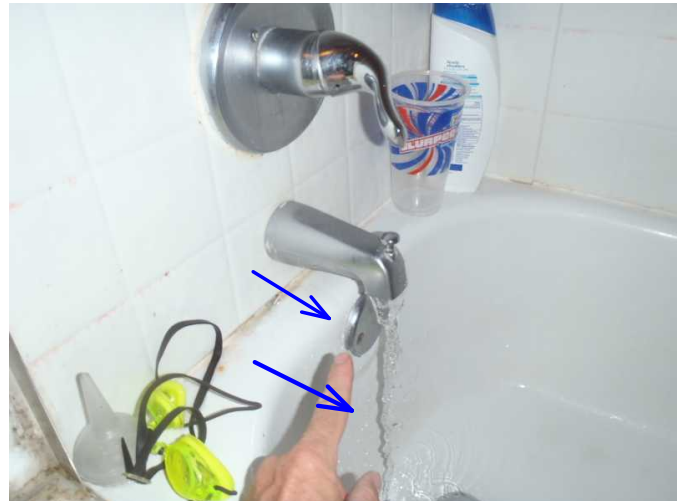
hot water is noted slow flow at master tub area...

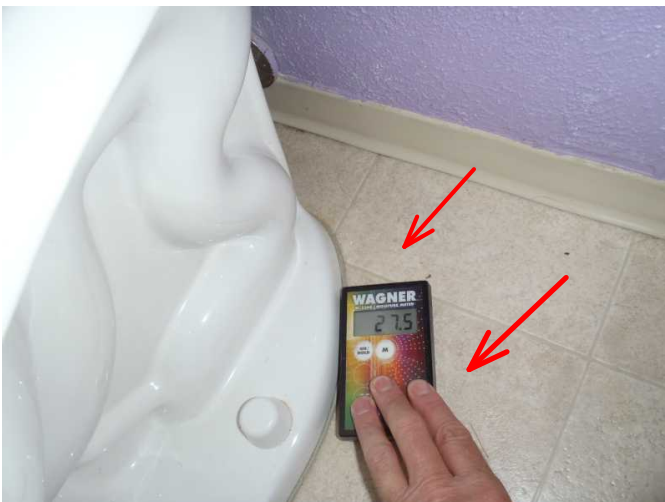
one area of master bath is noted with high moisture at floor...back corner of floor at right side...

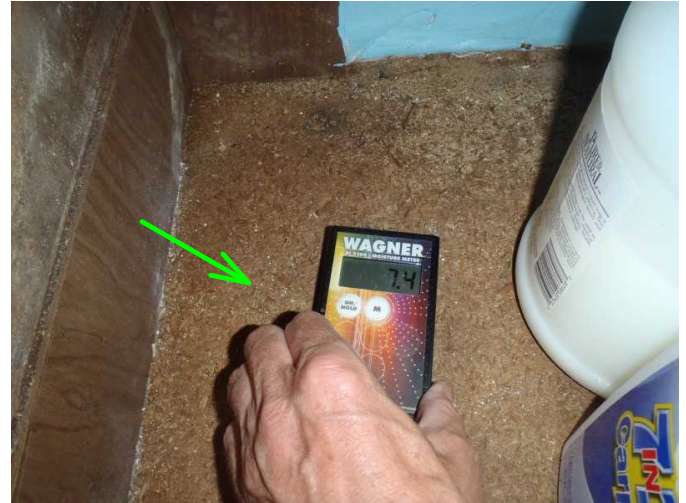
cabinet floor area is noted damaged...and appears to be past issue...low moisture noted now...

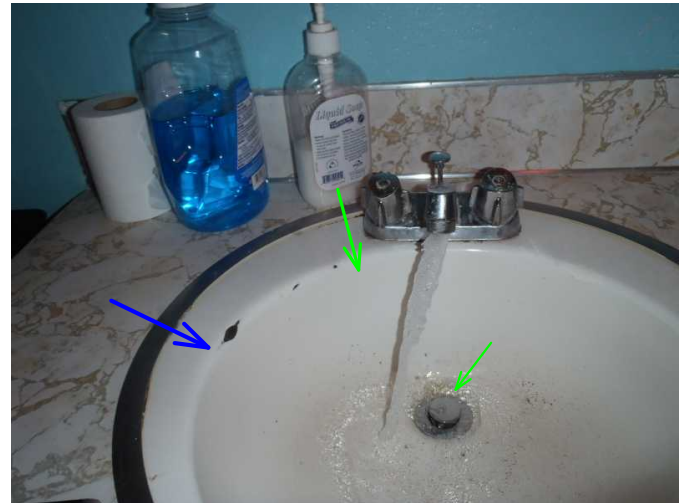
faucet needs repairs and sink has surface damage...drain is operable...but drain stop is noted not operable..

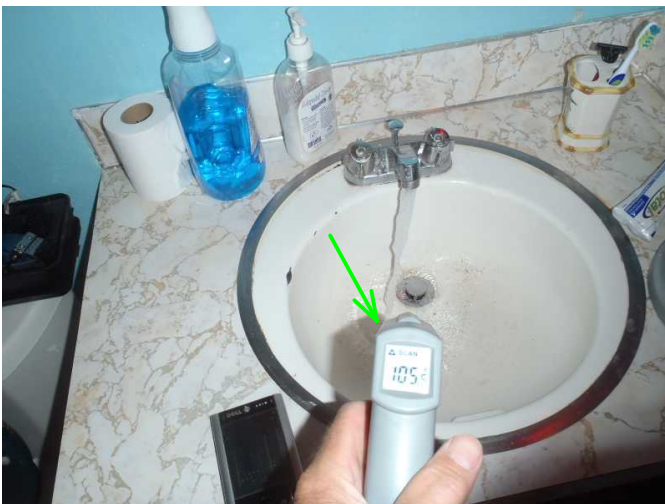
hot water is noted at faucet and flows to side...appears is aerator...

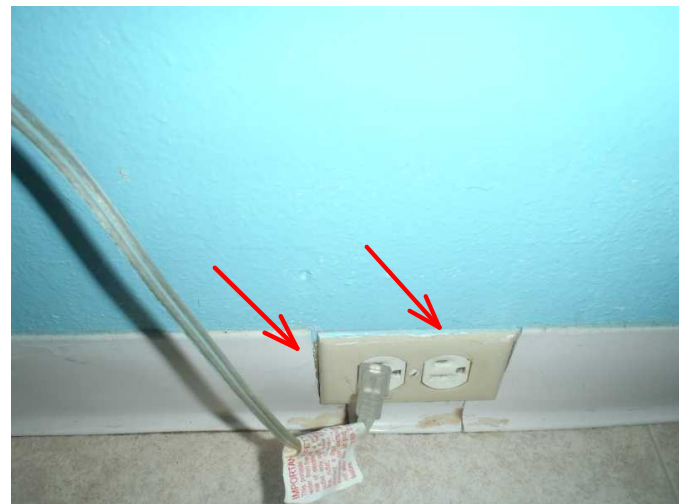
plug in main bath is at floor and not GFCI...correct...

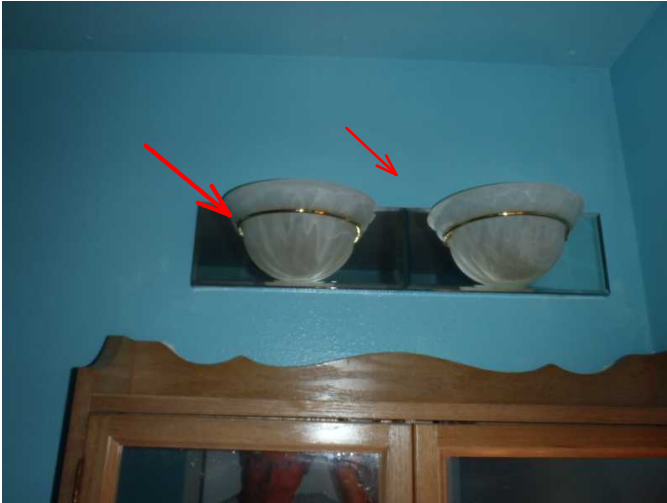
fixtures noted not operable...

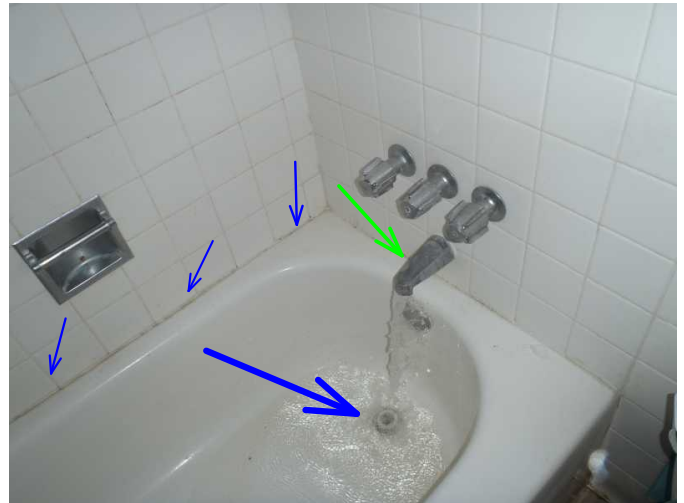
tub faucet is noted operable..drain stop not operable...monitor grout at tile walls...

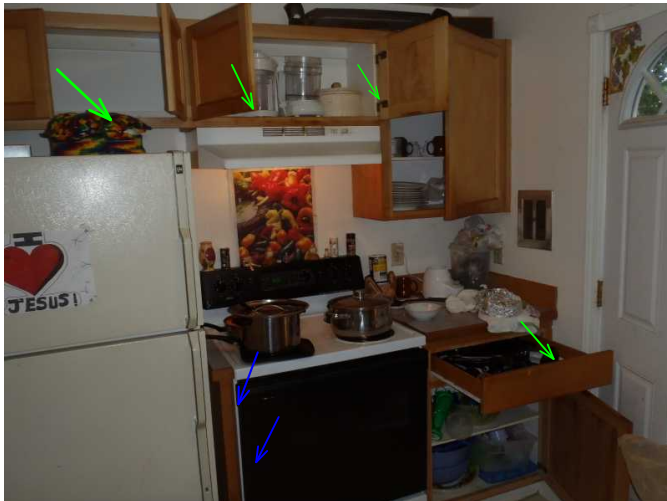
upper center wall cabinets and counter to side are noted solid and operable..side cabinet to left is noted loose...

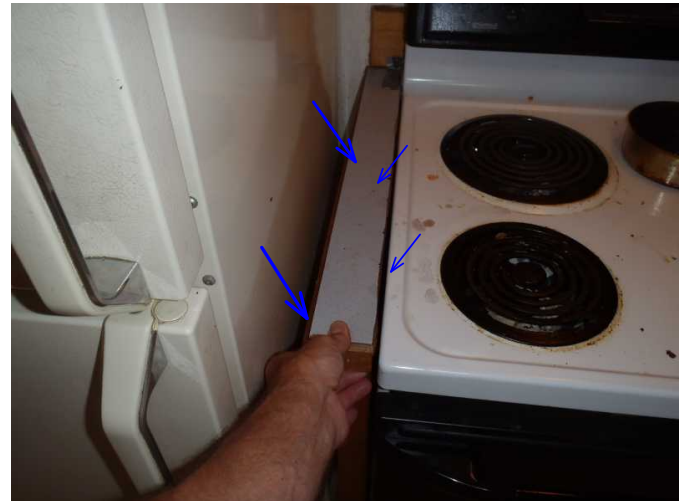
not sure why...loose and cut open at formica...

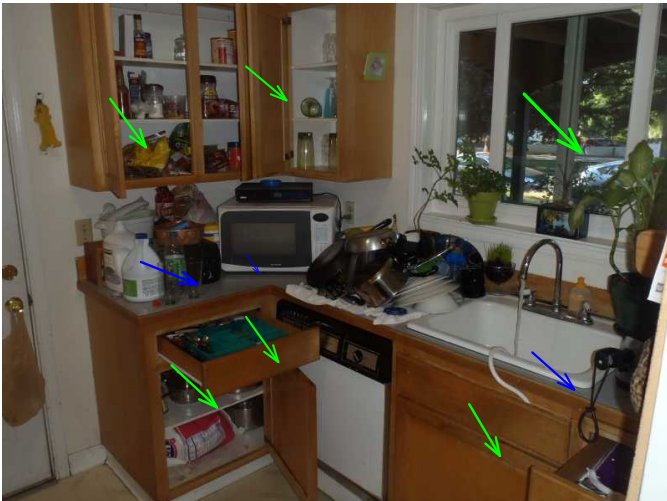
main cabinets and counter are noted operable..counter has surface damage...window is noted operable..

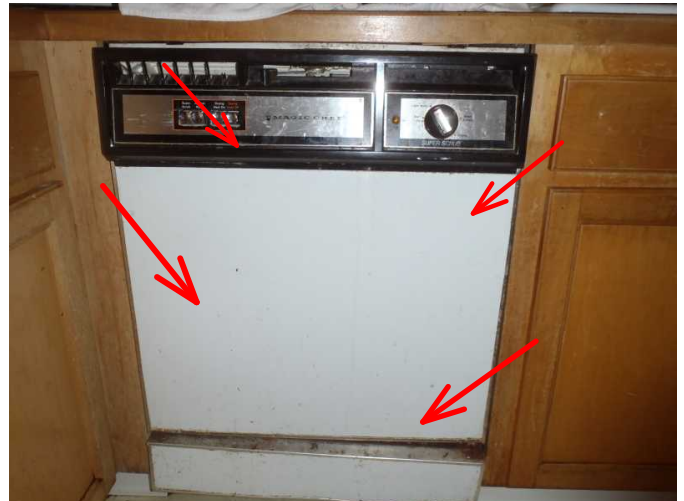
dishwasher is noted not operable....will need replaced...

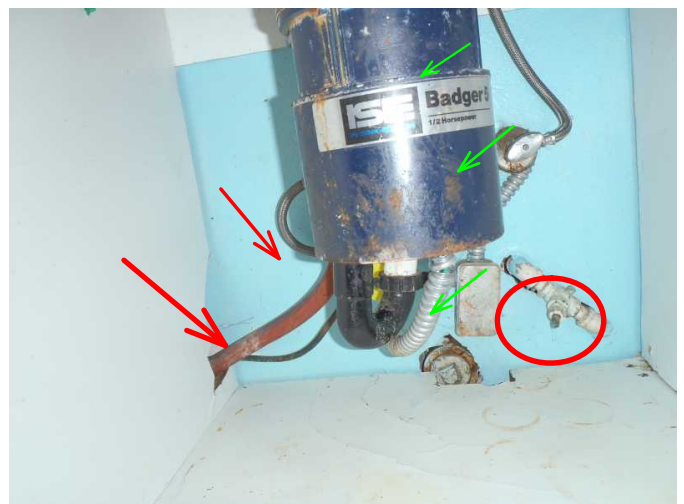
garbage disposal is operable..hose bib shut off needs handle..armoured cable good..high loop needed for drain...

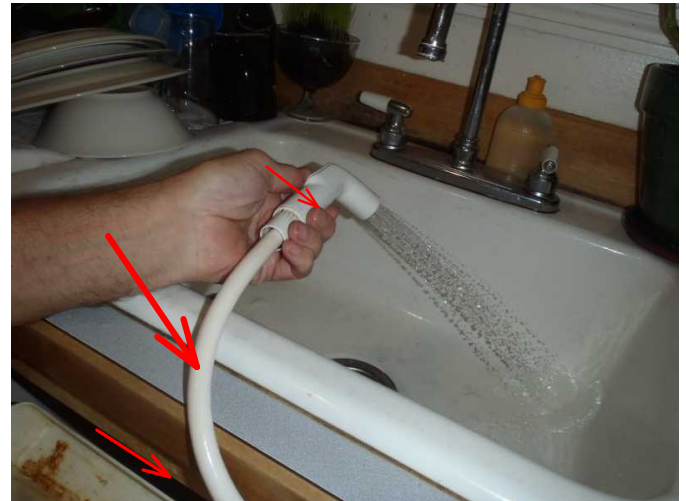
NO...the sprayer arm is not allowed to be set up as noted...will leak and cause damage..remove...

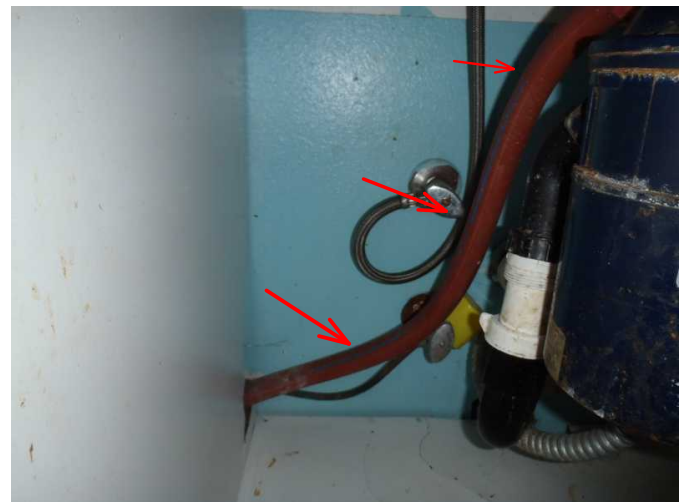
high loop is when the dishwasher drain is secured to under cabinet to not allow back flow of garbage disposal...add

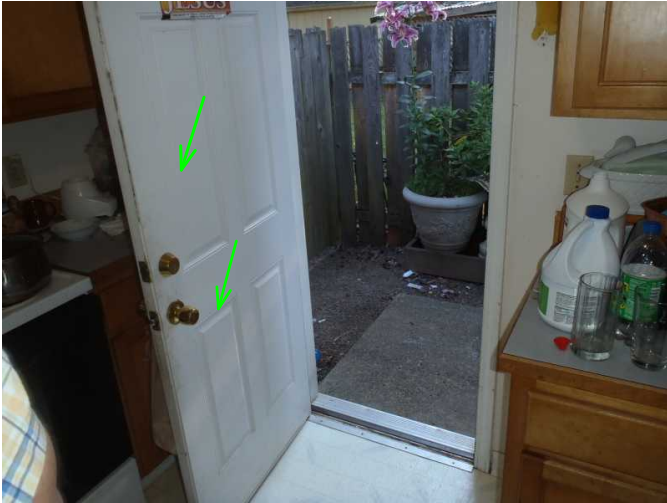
back door is noted operable...but does not latch secure...closes very loose...

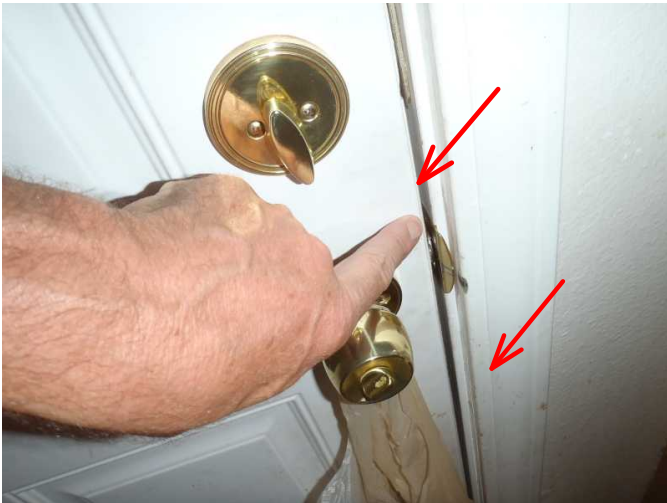
door does not latch secure and can leak cold winter air..correct...
