Home Inspection Report

11900 11920 sw Iron Horse Lane
Beaverton, Oregon
Inspection date 08/11/2011
(Section three of three)

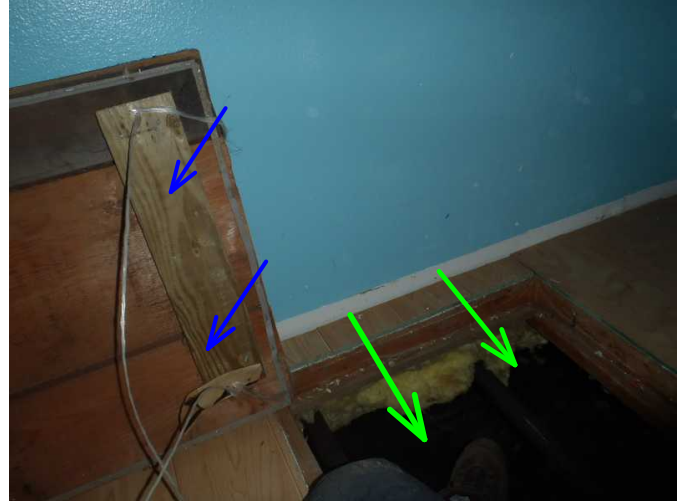
access to crawl is noted in bedroom closet floor and hatch needs insulation and weather stripping to seal...

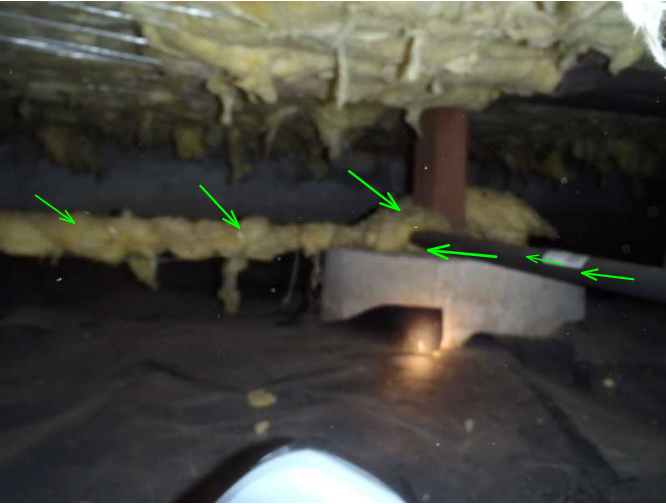
main copper water entry line is noted here and is insulated...good...ABS sewer exit is noted at right center...

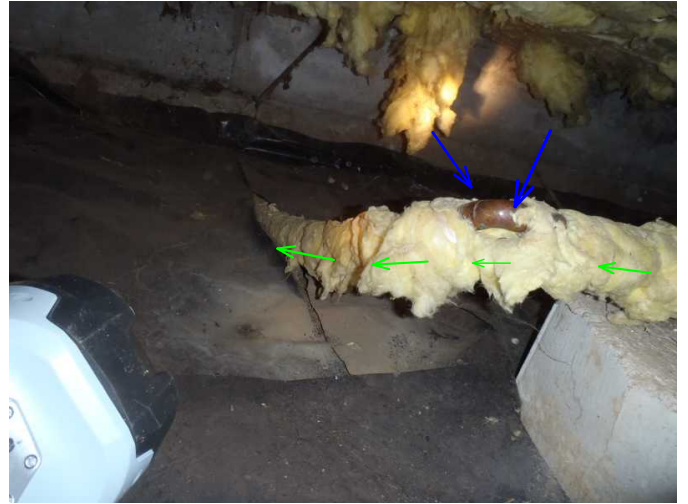
most of water feed lines are noted insulated...but will need random new insulation where pulled back...

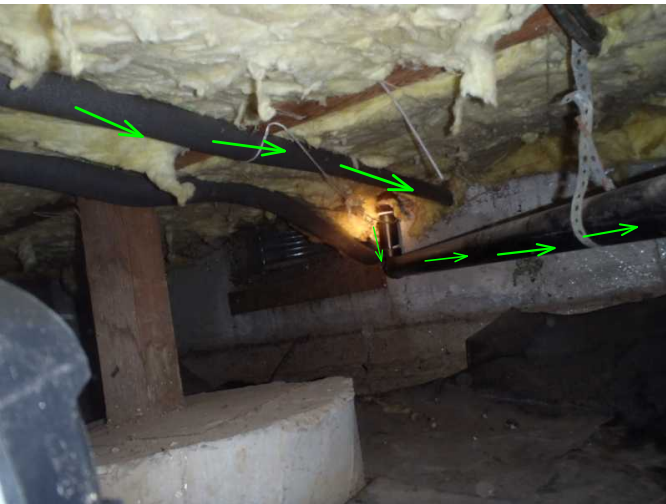
most water lines are noted insulated with insulation or foam...ABS sewer exit lines are noted from both kitchens..newer

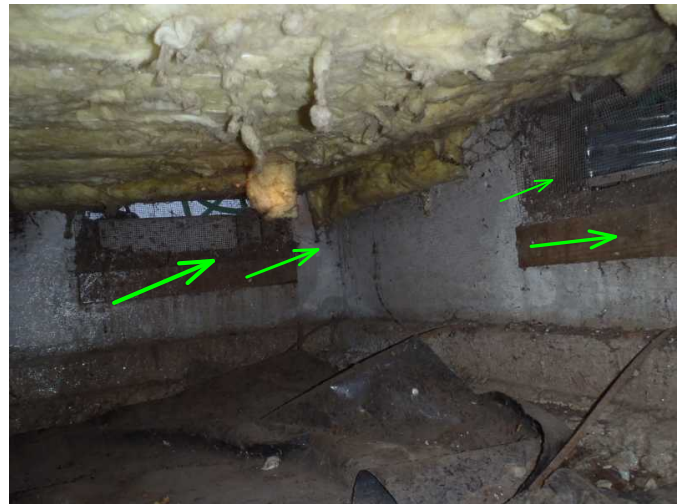
most all the vents are noted screened....monitor all vents to be sure screens are in tact to not allow in critters...

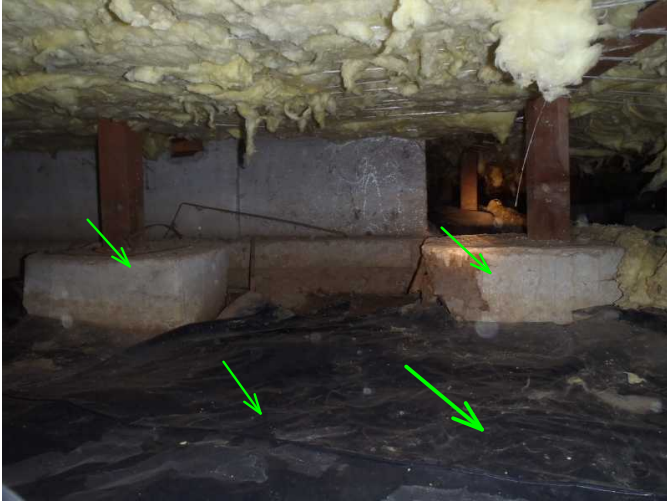
all of crawl is noted with vapor barrier and posts are raised and dry...and solid on piers....

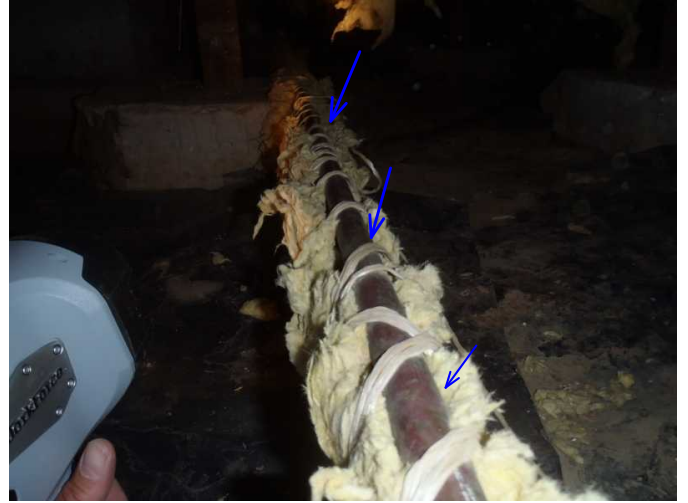
more areas noted that need insulation...main copper water feed lines...

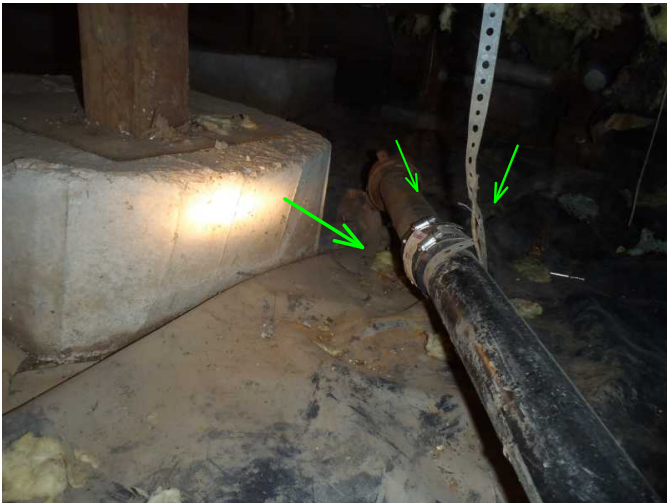
ABS meets original sewer exit drain and is noted clamped as needed...good...no drips or leaks...

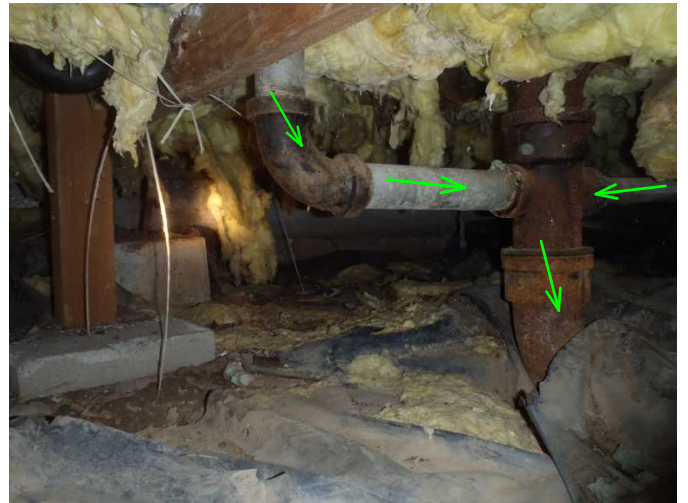
11920 bath exit drains are original and noted no drips or leaks below as well as in area...

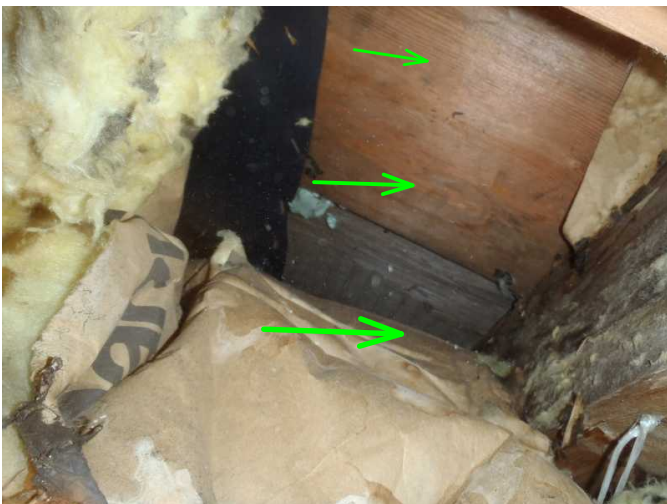
some areas are noted with flooring replaced with plywood under bath areas in 11920 sub floor area where insulation down...

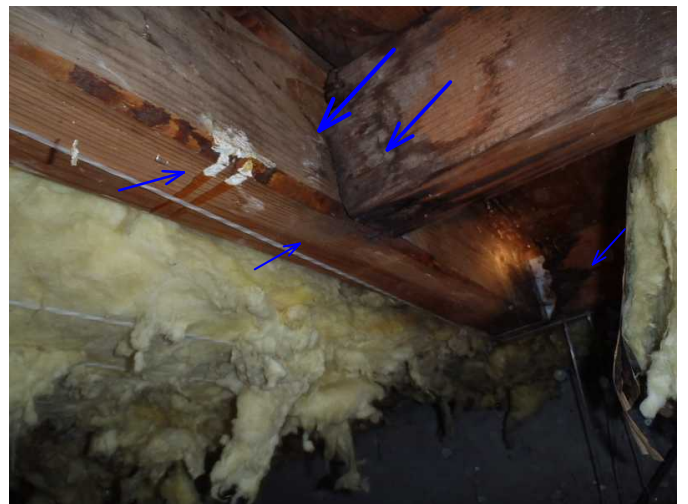
some beams are noted with staining and are noted solid...repairs were performed...

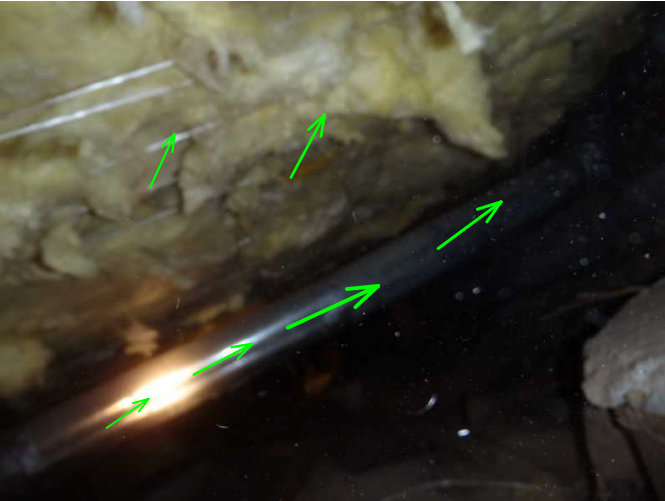
insulation is noted secured to under floor areas and not able to remove...11920 dryer vent is noted solid and secure...

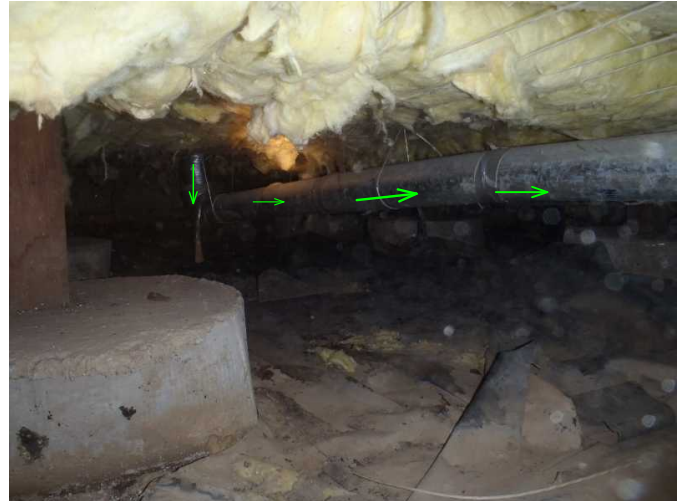
dryer vent is noted with no lint leaks and solid from laundry to exiting area at back of home...

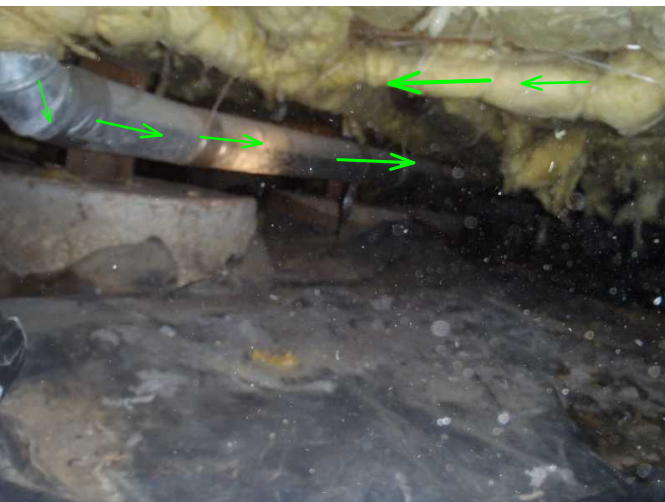
most all water pipes are noted here insulated...and 11900 dryer vent duct is noted solid to exit as well..

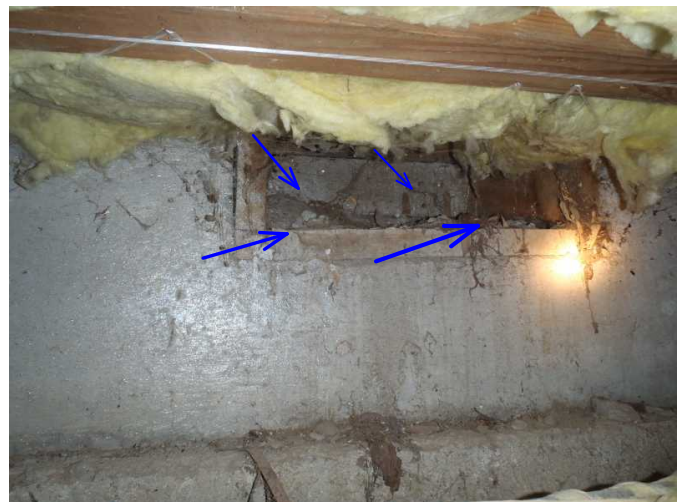
here is vent in front of home that needs screen...is covered with wood..but is recommended to be kept open to vent air...

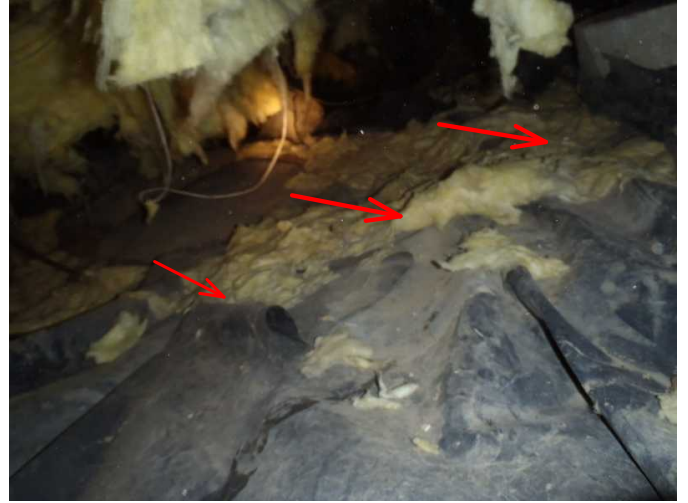
many small areas under structure noted with insulation down on vapor barrier and old critter nesting noted..remove...

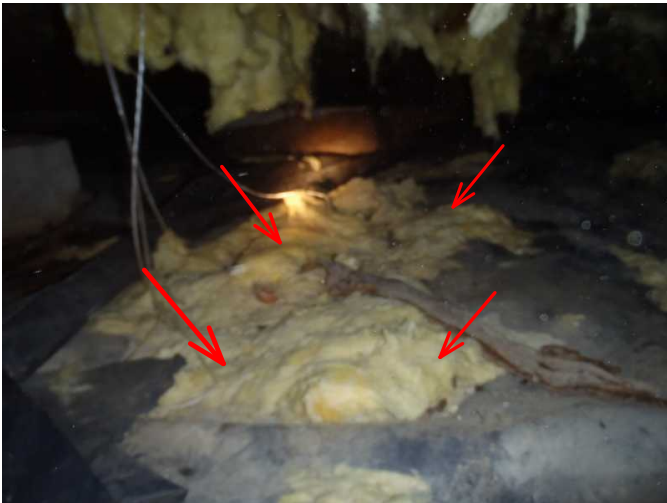
critter nesting is also area where fecal matter and urine is in the insulation..contaminated...remove...

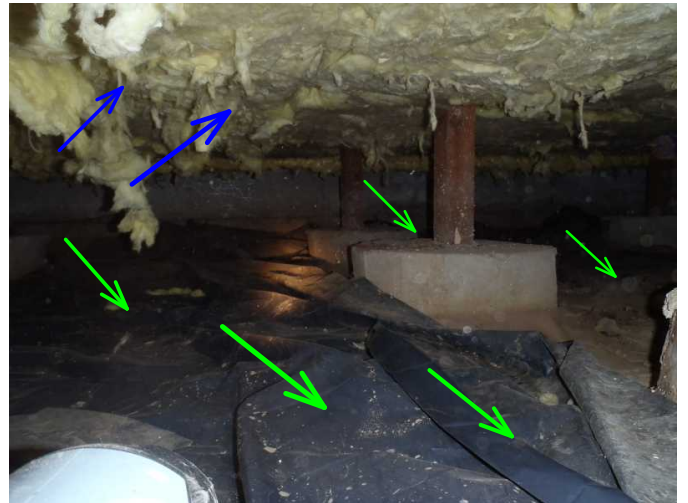
most crawl is noted in very clean and dry condition...posts are raised and vapor barrier in place...insulation shredded

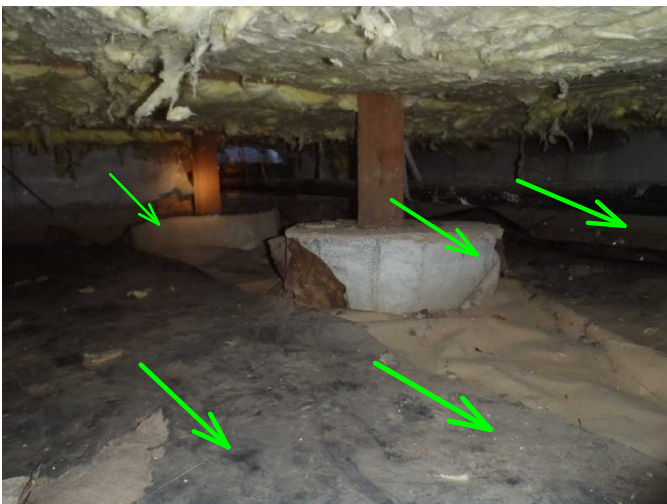
another view of crawl and most areas are noted fine...dry and posts raised...

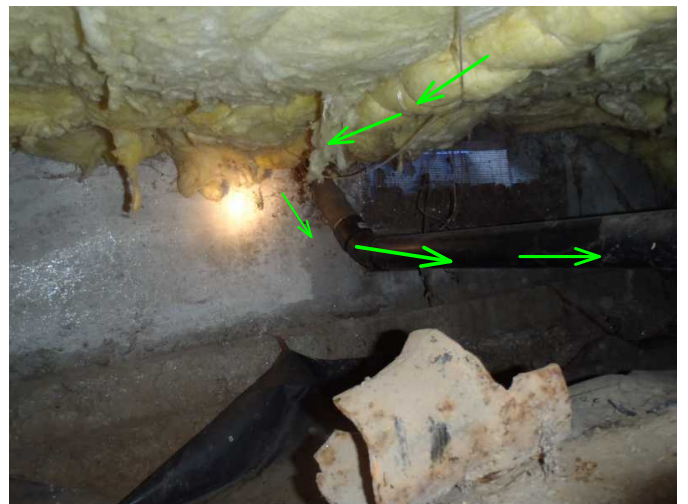
this is area under 11900 kitchen and sewer exit drain is also ABS and is solid and no leaks noted...

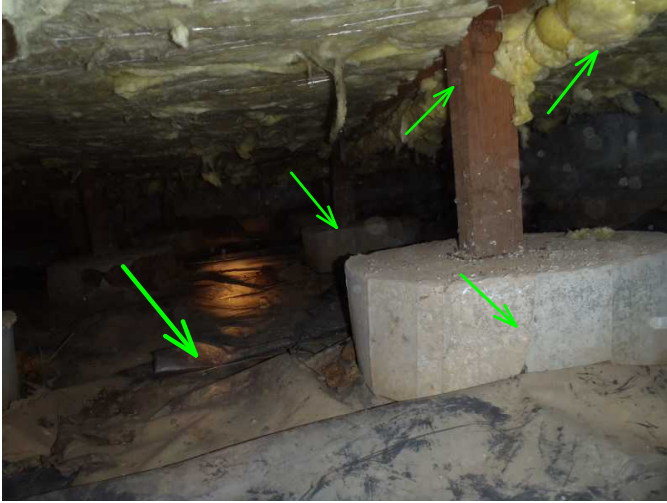
can see the under floor insulation is strapped with string and is secured to structure...damage will occur to access

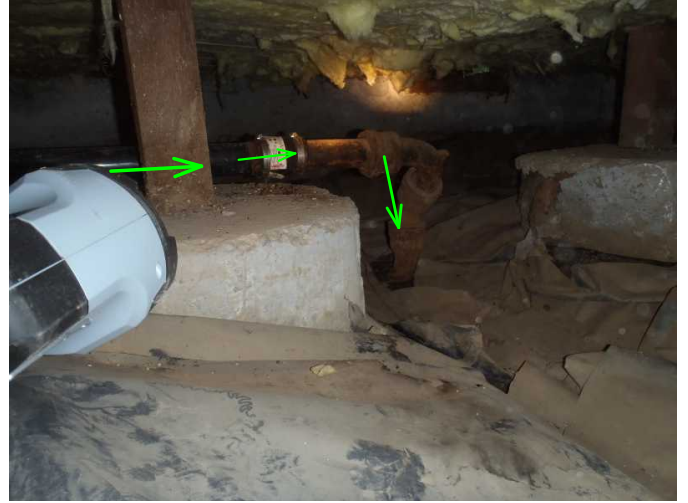
here is the kitchen exit drain and is connected to original galvanized exit drain...clamped well...

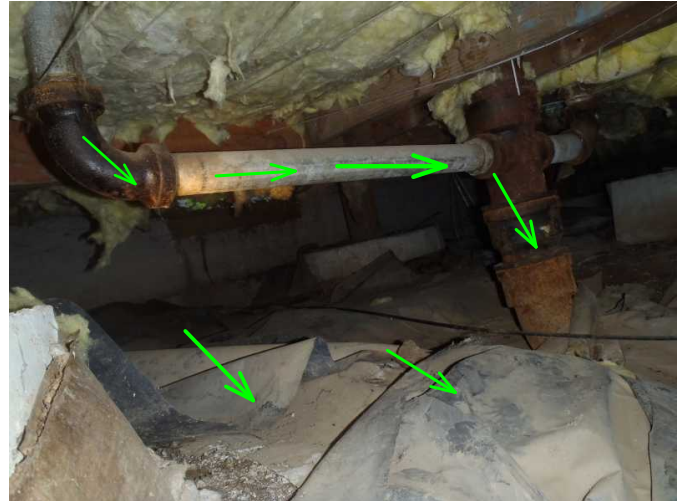
this is under 11900 bath areas at sewer exit drains and no leaks noted at drains or area around and no wet insulation...

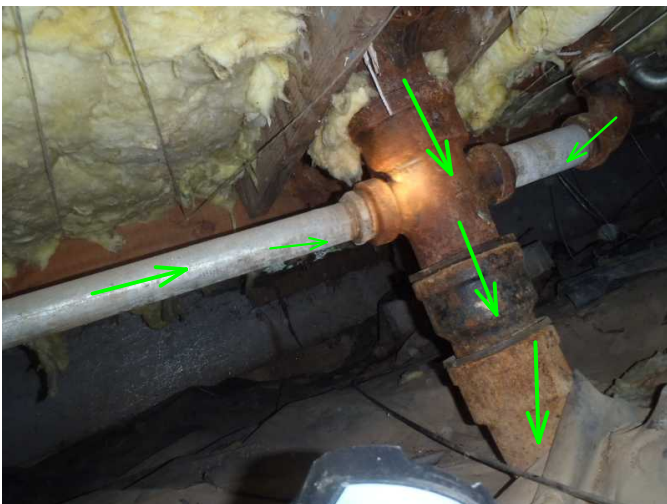
under bath area is close up and all connections are dry...galvanized and cast original exit drains noted...

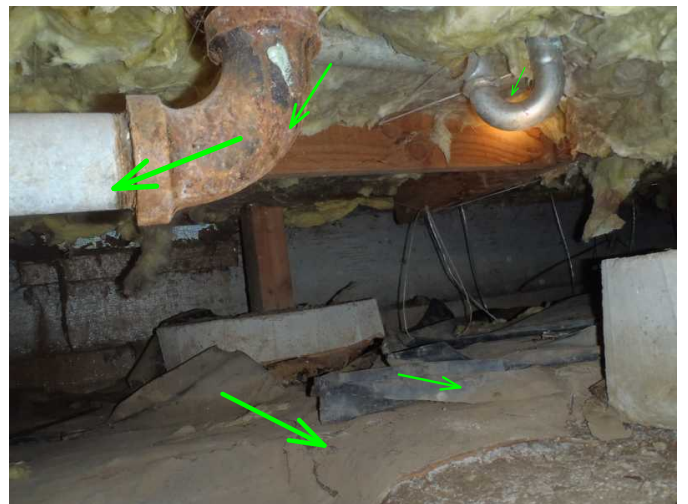
some rust is noted at exterior of cast exit drain, but no leaks noted...good...dry at all areas of crawl vapor barrier..

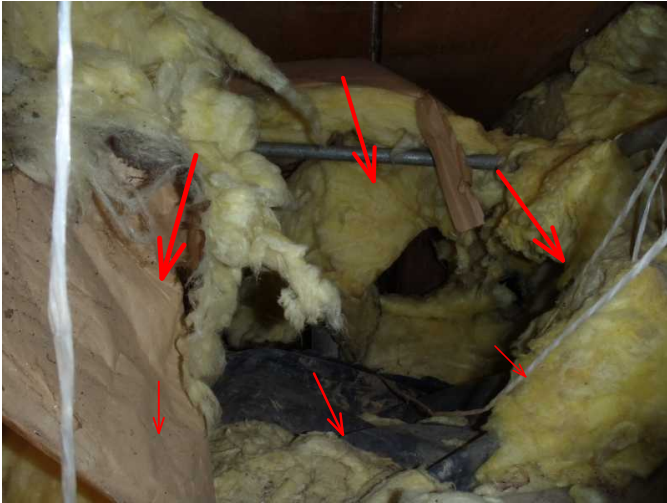
here is area between baths of both units and noted insulation is down and nesting has occurred...remove all contaminated

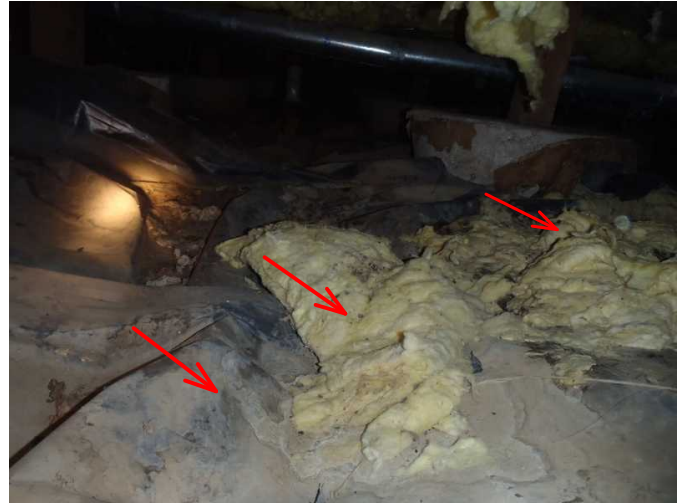
the vapor barrier is noted here with contaminated insulation with critter fecal and urine matter and needs removal..

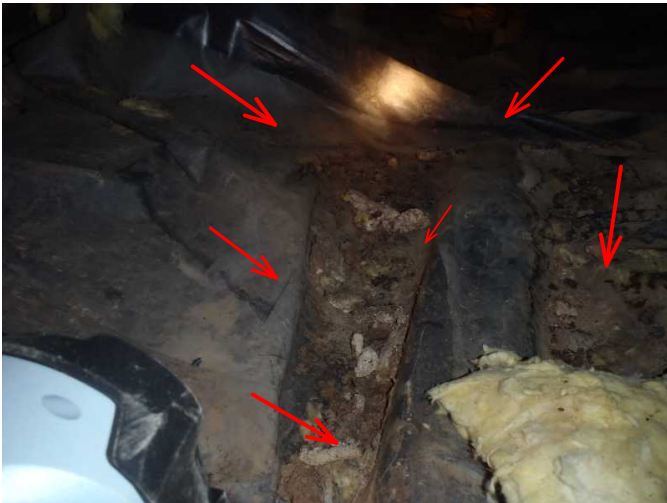
there is also an area where appears is critter toilet area...fecal matter and urine are noted on vapor barrier...remove

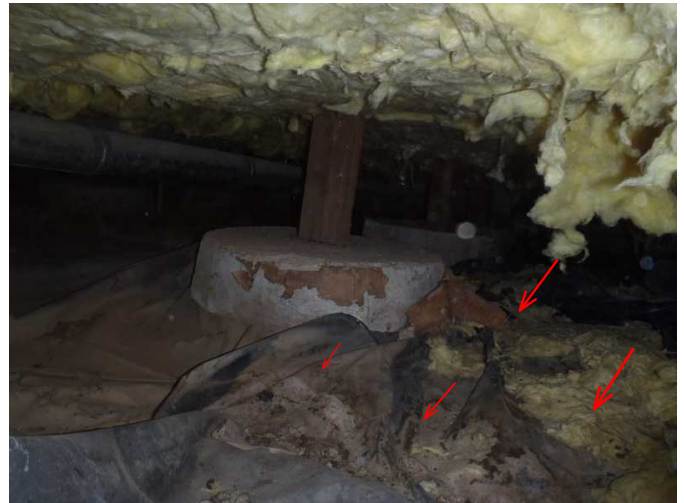
more downed insulation noted...appears was past issue...and vents were closed up, but repairs not performed...

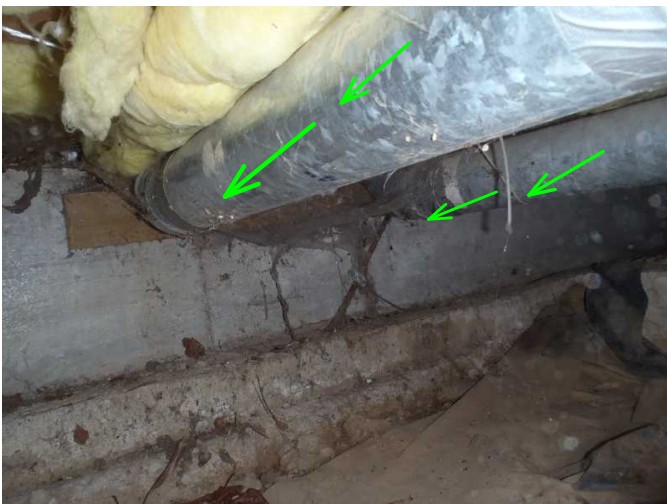
here is back area of home where dryer vents exit and are noted solid and no lint or leaks noted...

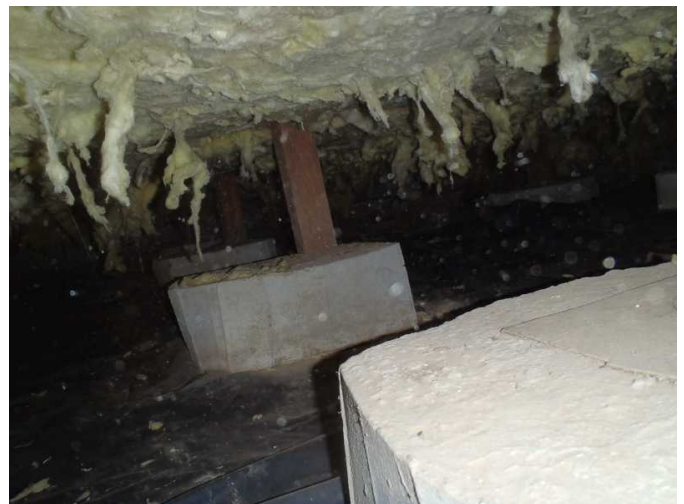
11900 11920 sw Iron Horse ln Beaverton. Or..alb

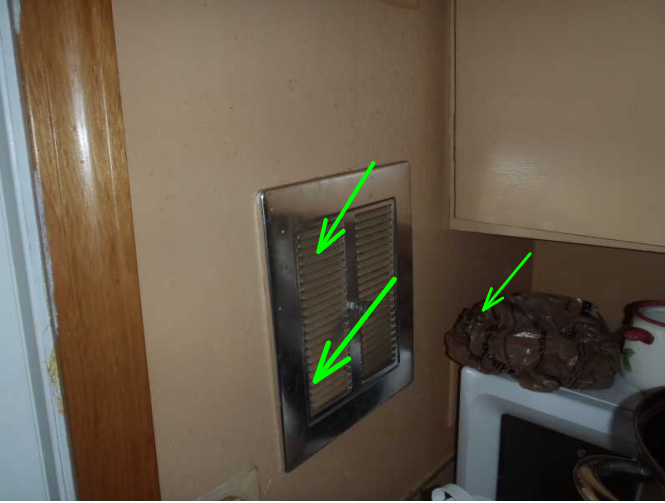
both side wall kitchen exit fan vents by stove are
noted operable..found switches for both and both ran
fine...
