Home Inspection Report

27192 East Welches Road

Inspection date 11/09/2010

Photo Attachments

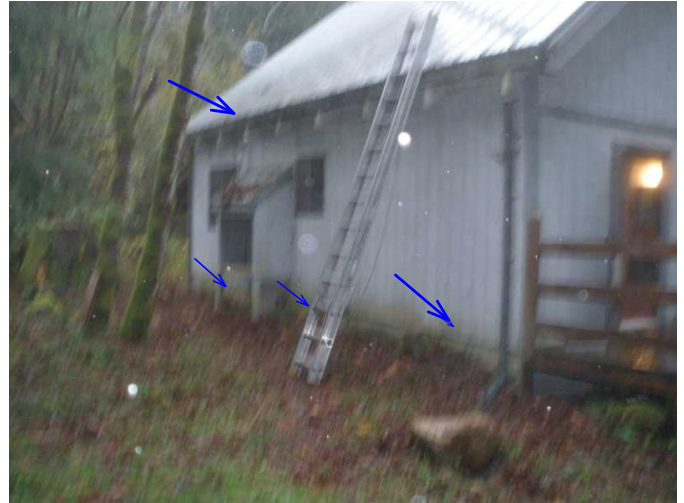
front view of home on 11/09/2010...driveway noted uneven and can use some added gravel and grading...

lower area at north side noted stained, but no rot noted at this time..add gutters and then paint

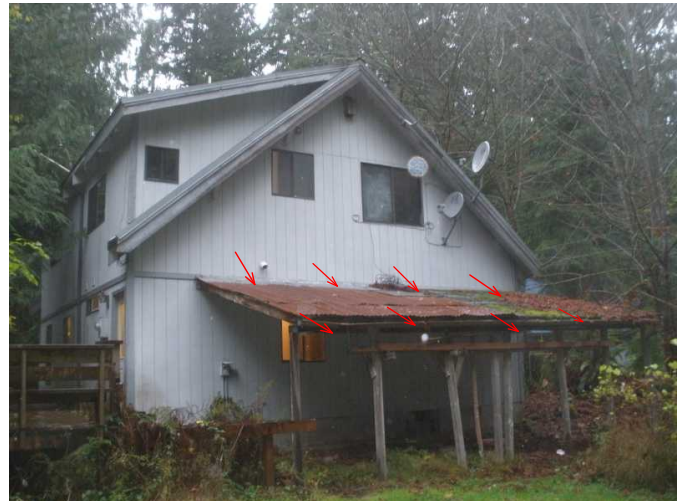
back roof extension is noted not flashed and needs lags to secure to structure...has roof rafter hangers...

roof and gutters at back are noted damaged and recommend replacement...add flashing to roof to siding area...

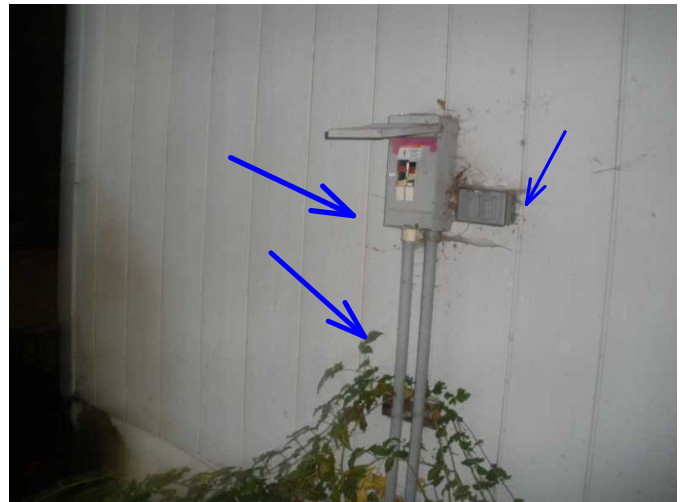
replace gutters and downspouts and pull back all earth to wood contact at base poles...

spa tub disconnect is noted here and outlet noted not operable...

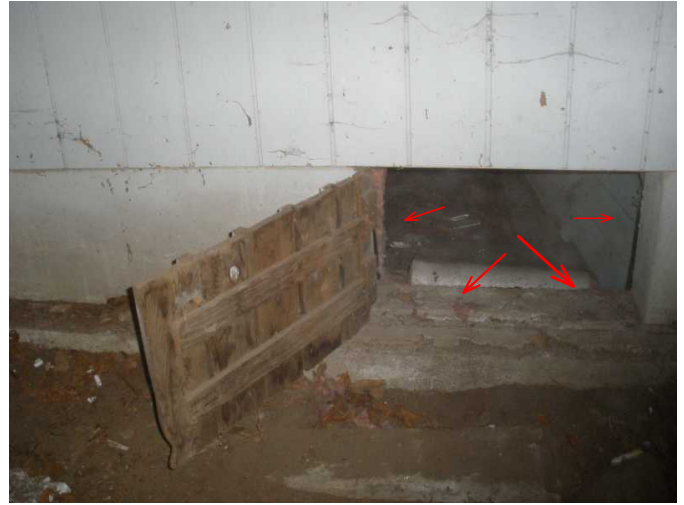
recommend all exposed wiring be removed or encased in junction box...never leave exposed wiring out...

re-build outside crawl access to have frame and secured access hatch to be able to lock and keep sealed...

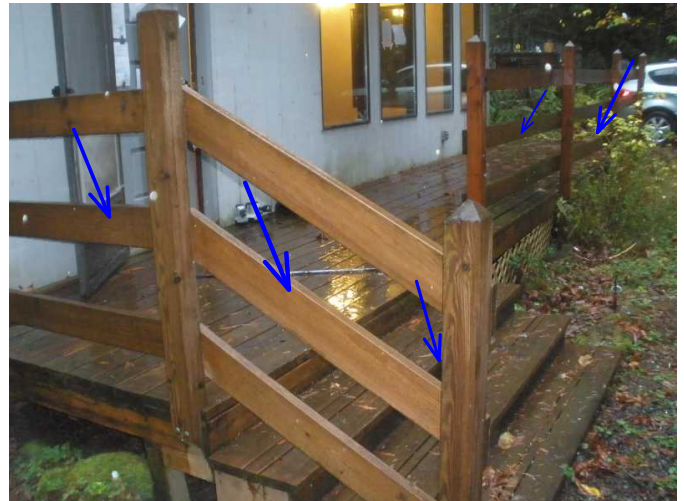
propane tank entry gas line and shut off noted here...good...

deck handrails are noted loose and will need complete deck assessment for strength...

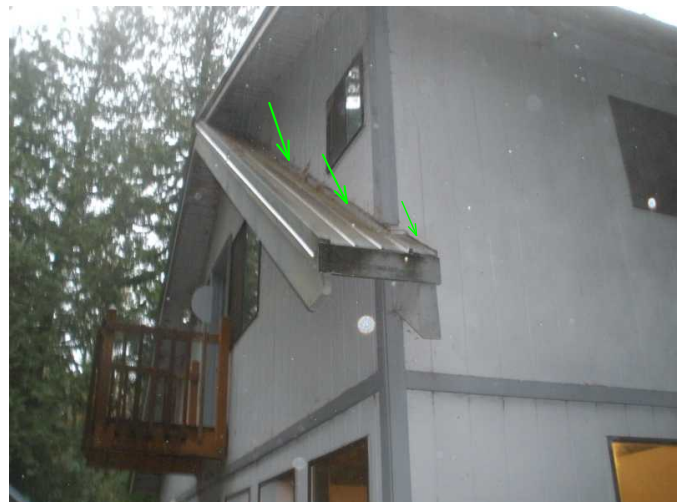
staining at base of siding at front west area noted needing paint..no rot noted at this time...assess all deck planks..

flashing and roof noted fine here at front right area...

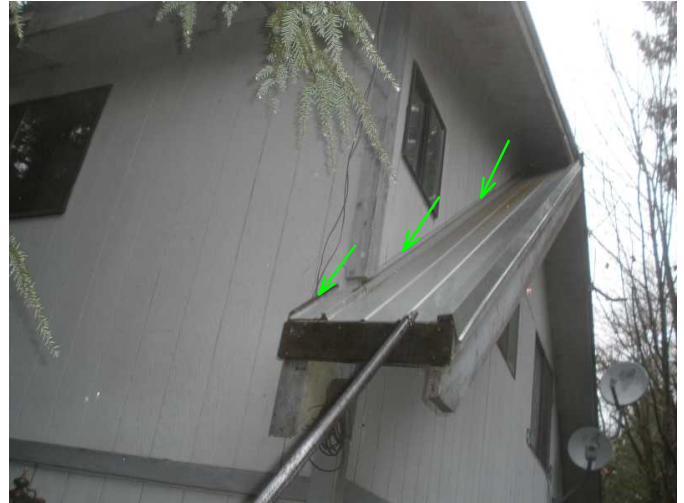
missing fascia boards at upper roof area...and cut back tree branches 6- 8 feet from structure to monitor home...

back roof and flashing to home noted fine...

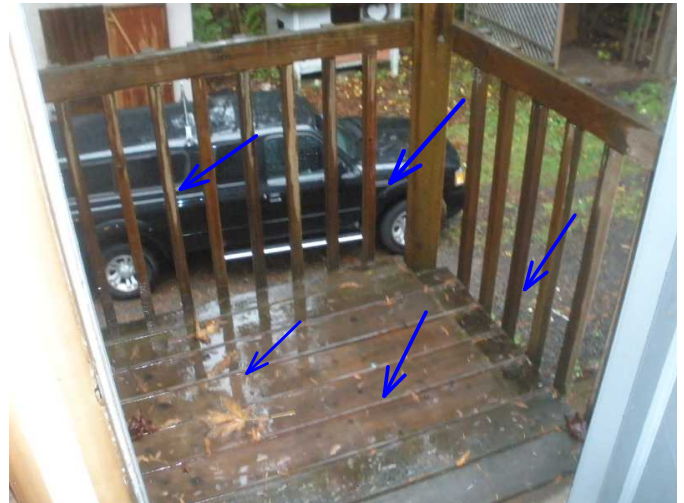
back roof area needs replaced and recommend adding flashing at roof to siding to avoid added rot...

mini balcony appears solid. but needs cleaned and sealed...monitor at all cantalevered beams

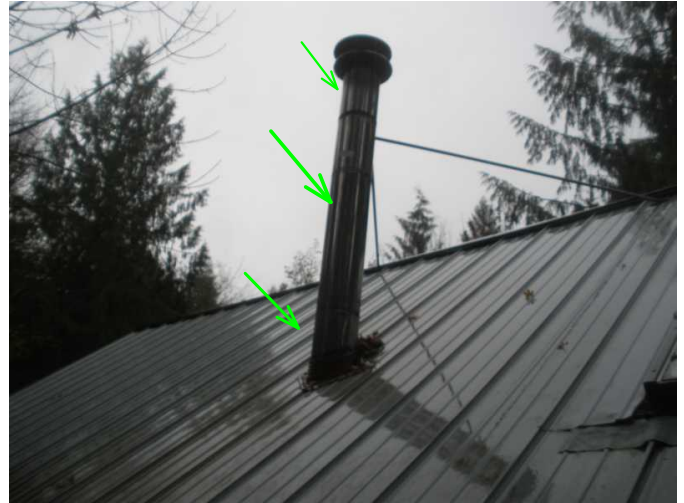
no flashing noted at back roof area...add...

chimney at roof at north side is noted fine...monitor and assess flashing every fall before winter...appears fine

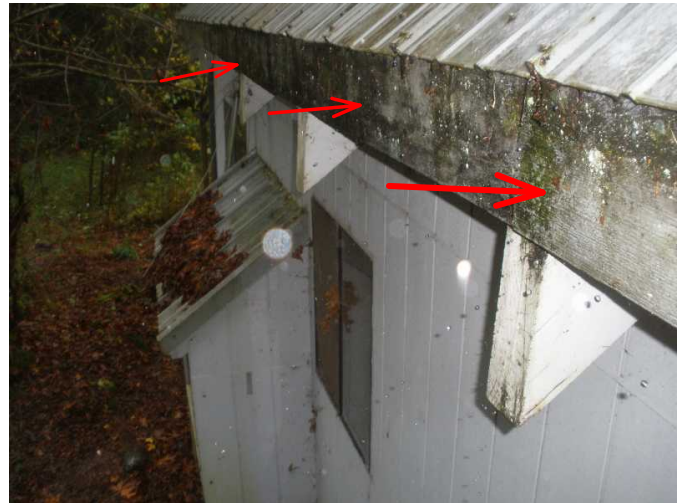
skylight noted flashed fine

fascia board noted rotted and will need gutters installed...north side...

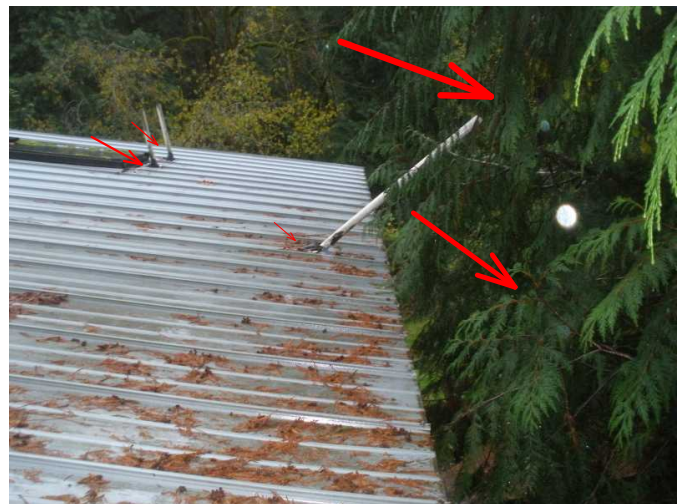
skylight flashing appears fine at south roof area over bath..and upper sewer flashing need assessed with lower damaged..

assess flashing at all sewer vents...appears damaged...cut back tree branches 6- 8 feet from structure...

Plumbing Vents: PVC - broken vent due to ice and snow and will need replaced...

Vent Pipes: PVC - broken at roof line...will need replaced, A licensed plumber is recommended to evaluate and estimate repairs

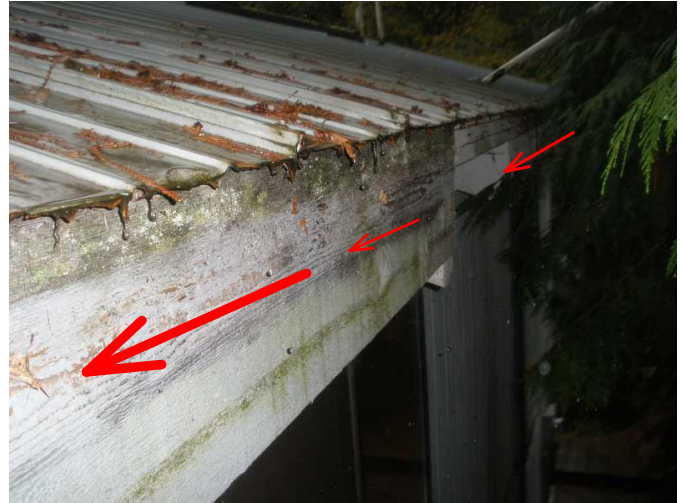
overall roof appears fine...recommend cleaning roof and paint where any areas of paint are found failing...

sout upper roof fascia board noted missing and sections appear rotted..replace and add gutters...

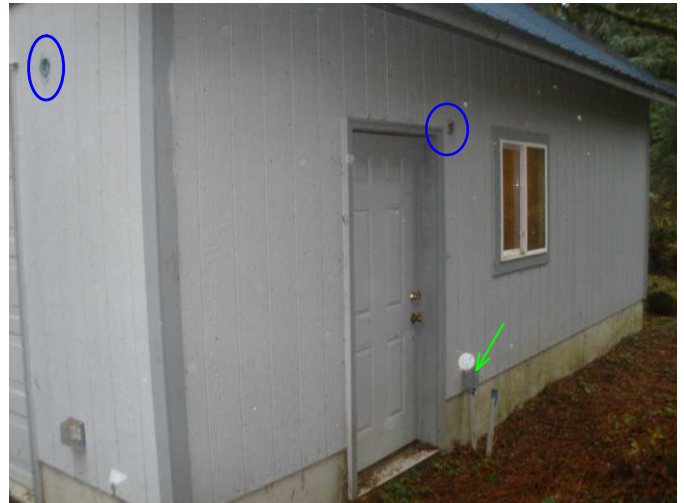
garage is noted fine...solid and sound...add covers to open junction box areas for fixtures...

agdd covers to open junction box areas...main electric service entry is noted in conduit...good..

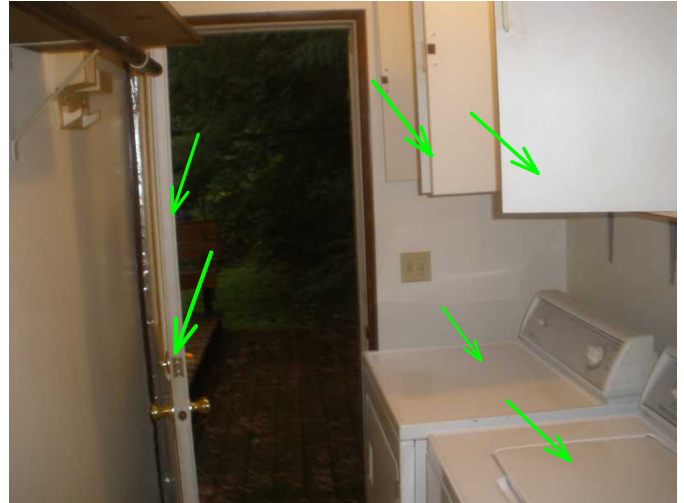
window is noted operable in laundry..patch hole in wall at blue arrow....

back metal door is noted operable...cabinets are solid to walls....both machines noted operable, did not run completely

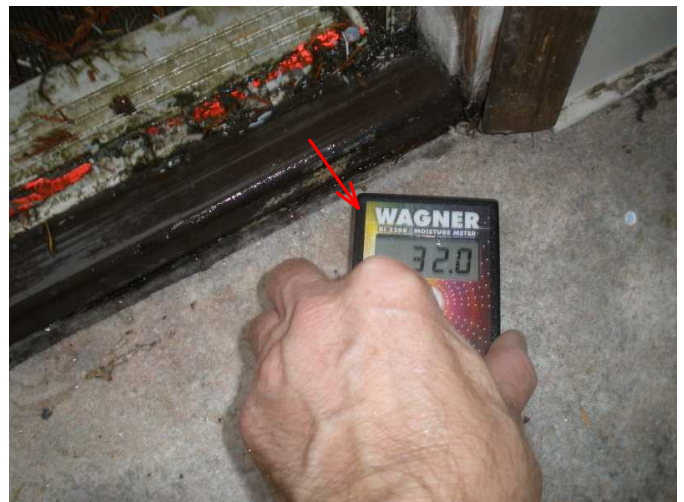
back door threshold is leaking water into area..floor is noted warped and discolored...remove all and assess...

high moisture is noted here at floor by dryer...

this is reading that means is saturated..is highest moisture meter can read...damage is noted here...

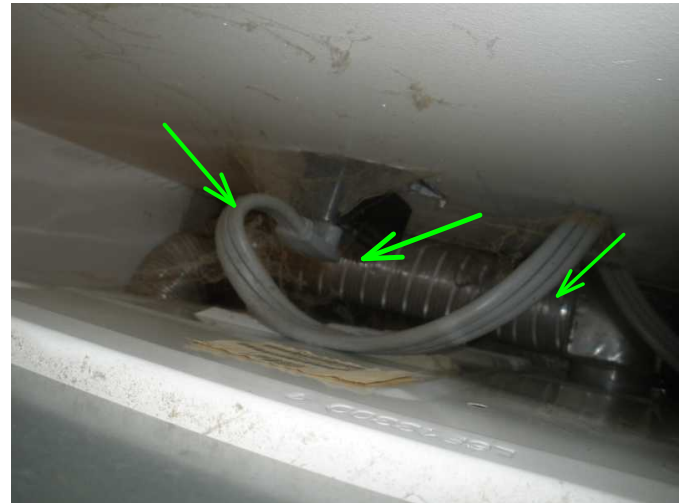
and at front of dryer area...moisture meter can read up to 4 inches into floors and walls...

and noted standing water behind washer are...and noted saturated moisture meter reading...

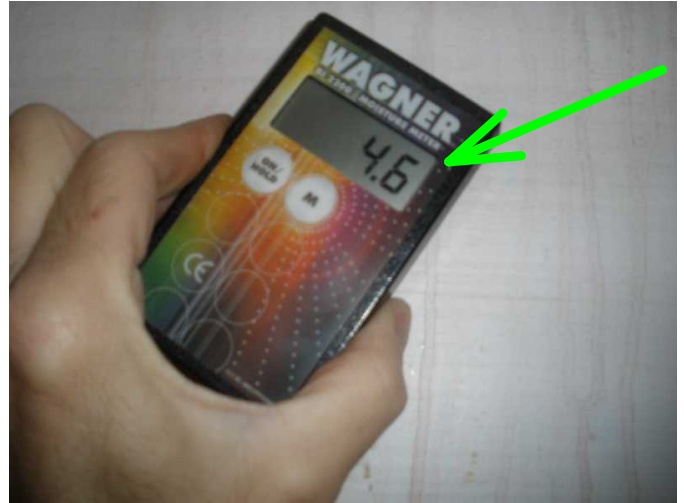
up at upper beams where noted stained condensation..expect is from shower at bath and to low exit fan vent...

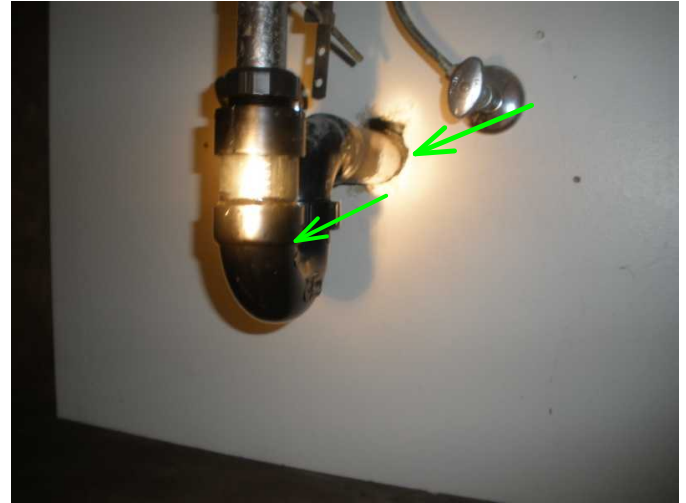
low flow noted at faucet and drain and overflow are noted operable..and surface damage noted at sink...

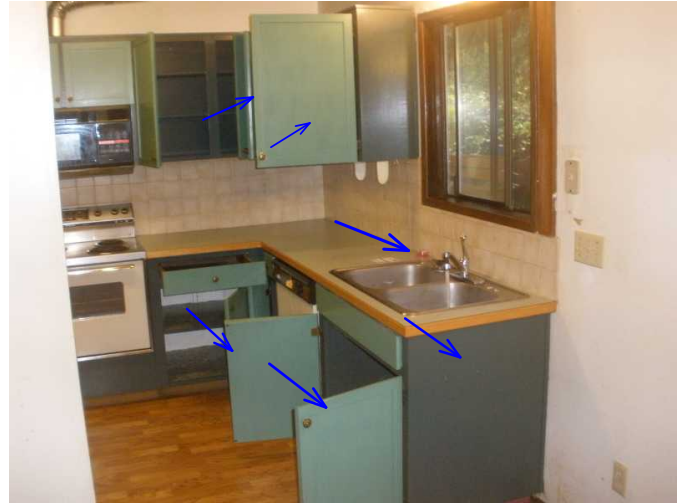
cabinets will need repairs and drawer tracks repaired as well...kitchen area...

cabinets will need to be removed to assess damaged wall from moisture...

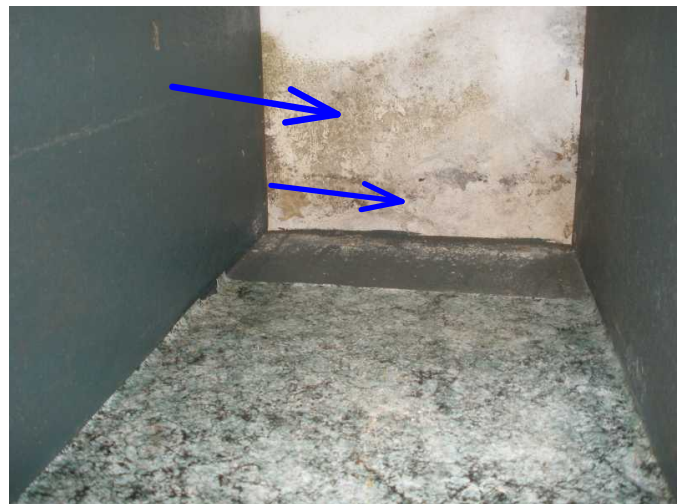
no leaks noted under sink...garbage disposal not recommended with septic system...

black mold noted at lower walls inside outer wall cabinets..

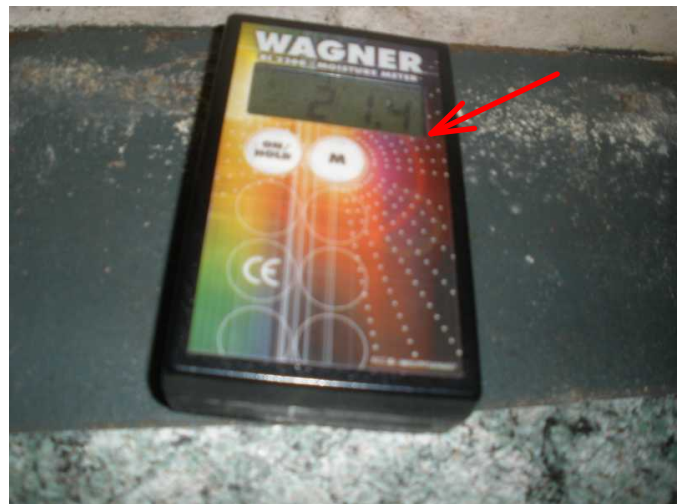
noted black mold at lower walls under cabinets...and moisture reading of 32 %

noted more black mold and moisture reading at 32% at lower drywall walls of kitchen area...

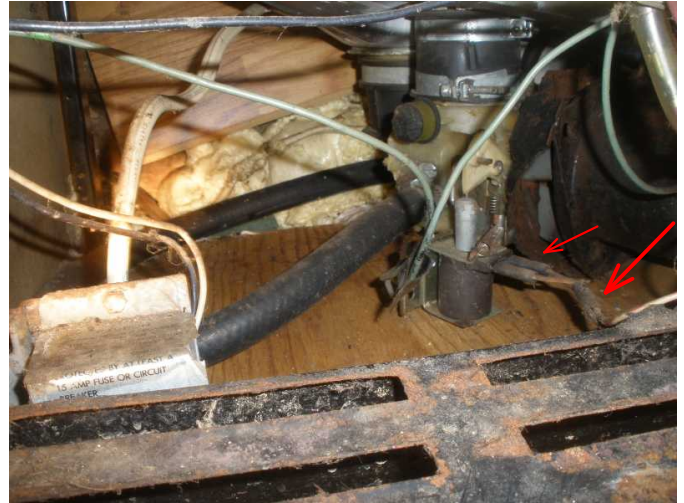
back in lower cabinet walls all noted saturated and reading as wet as can get at 32 %...is drenched...

no leaks from dishwasher noted at floor under dishwasher...but did find nest of vermin fecal matter..indicates nests..

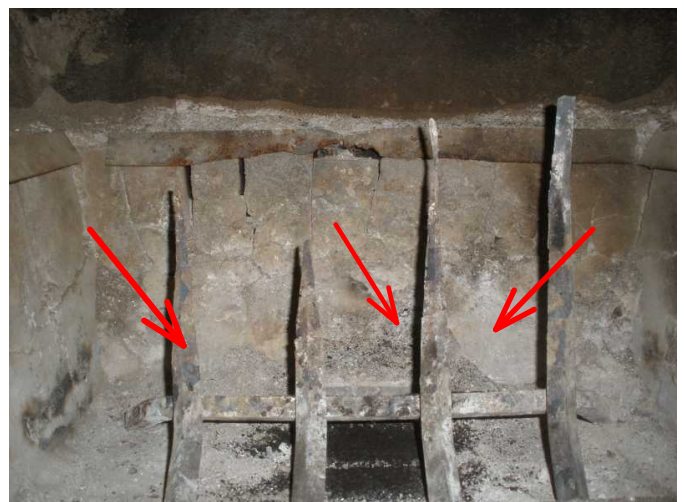
no EPA tag noted and is required...remove and replace with EPA approved wood stove is required

damaged fire brick noted...can not sell this unit....must be scrapped and fine is involved if sold....

Living Room - Fireplace - Fireplace Insert: wood stove - Oregon Senate Rule # 102 requires all non EPA certified wood burning stove and insert units to be removed from homes/shops and barns in real estate transactions on and after August First of 2010

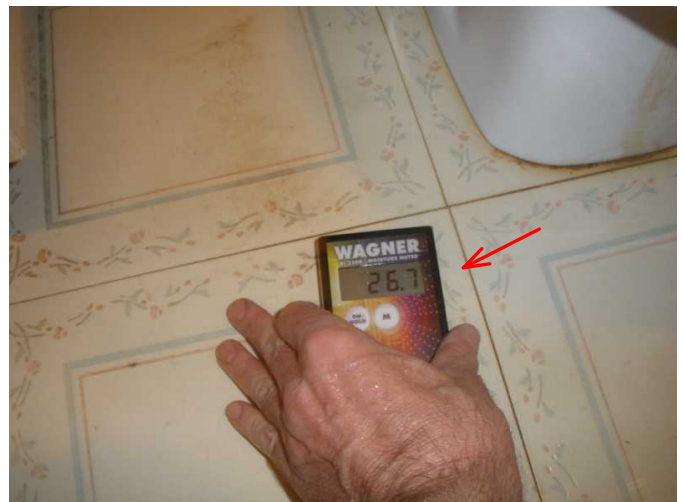
high moisture noted at tub floor...may be from tub or from siding issues...

high moisture is noted at toilet area of floor as well..appears to flow from tub area...

1st Floor Hall - Bathroom - Floor: Vinyl floor covering - Water damage noted around toilet and tub area...moisture readings were high....

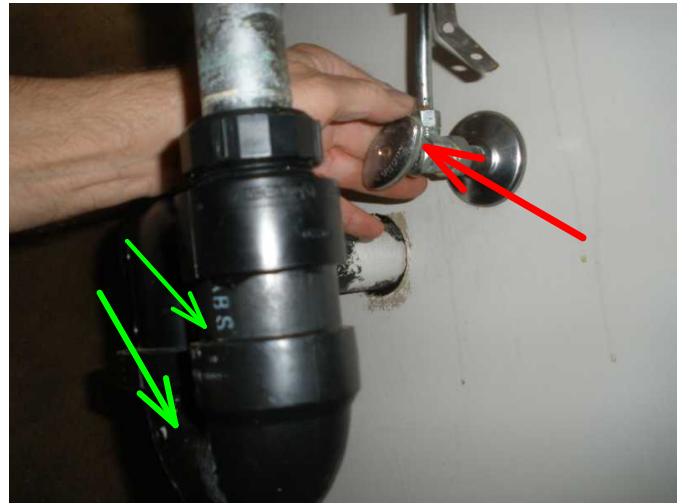
faucet leaks at base..correct or replace...

leaking noted at connections under sink
area...correct...trap appears fine...

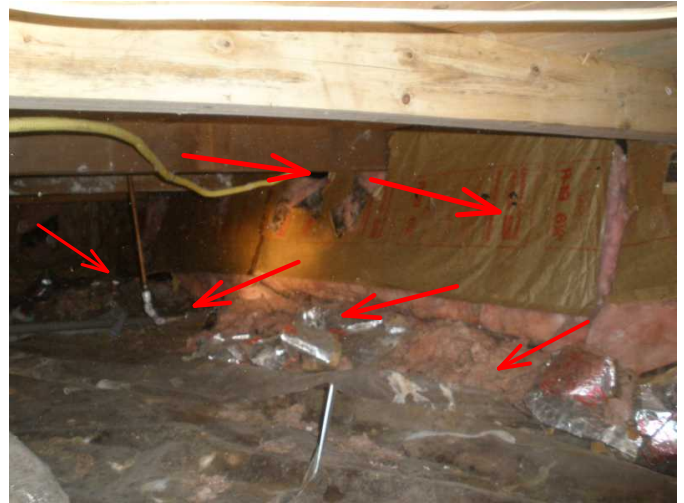
this is north side of home and noted all perimeter insulation is acting as nesting critters..most likely rats...remove

perimeter insulation around all foundation...and is at best poor for energy conservation..recommend complete removal

Main - Crawl Space - Insulation: Batting - remove all perimeter insulation around foundation and install under floor insulation for best energy savings and reduced heated areas...perimeter insulation is damaged and contaminated and needs complete removal...

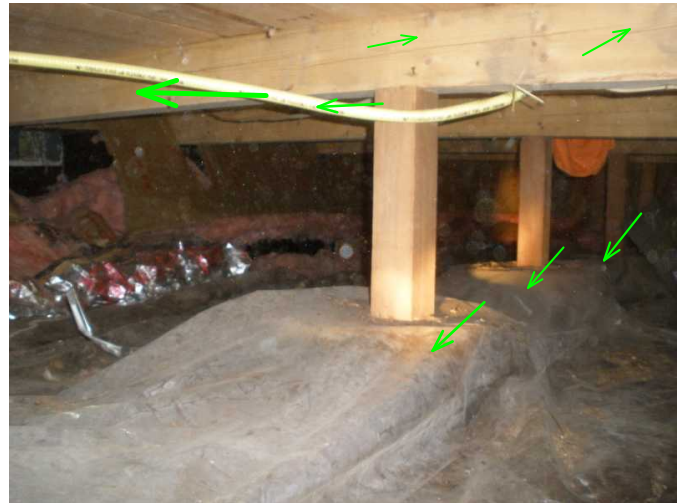
you can see nesting all around perimeter of base of insulation...appears vermin live under corners...

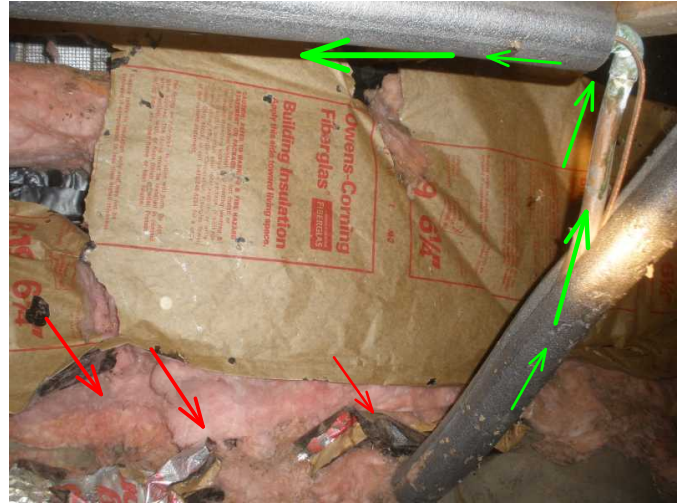
the bunched up insulation acts as nesting for rats and mice...remove and keep off the floor...

all insulation is noted contaminated...remove...here is main water entry to home..is insulated..good..no shut off noted...

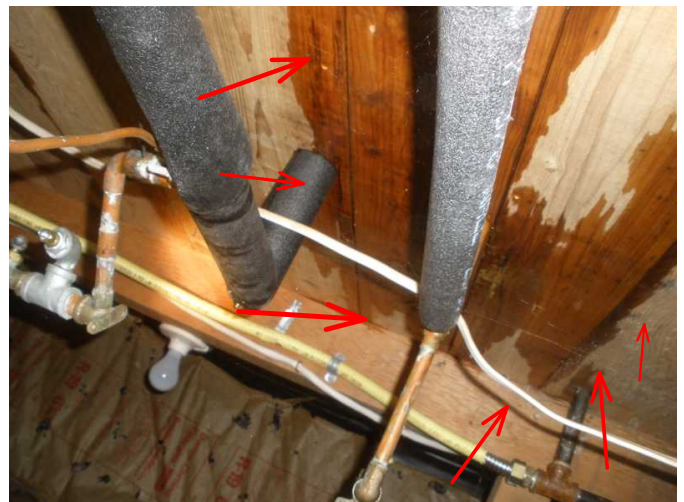
the foundation around kitchen sink drain at wood is noted wet...and foundation is stained...noted water damage...

this is under main bath area floor planks..see water active areas?....at tub area and toilet...

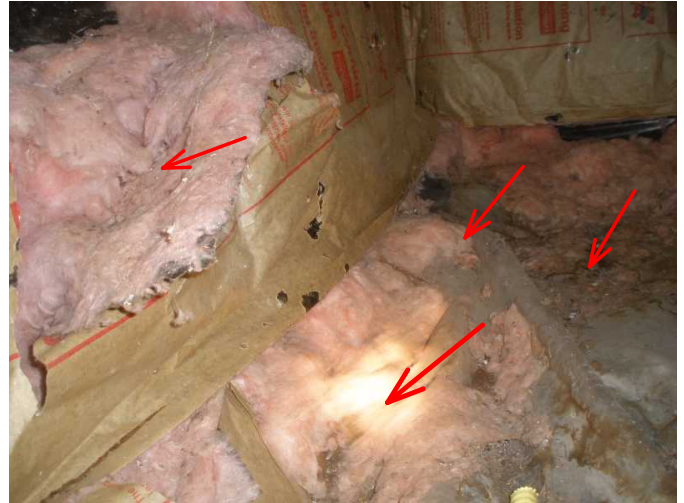
vapor barrier is noted wet....

downed insulation is noted under corner area and has nesting noted as well...rats most likely...

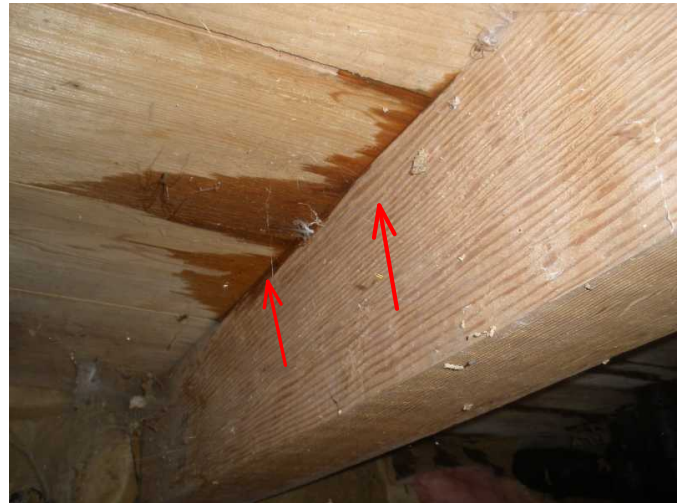
soaked insulation is breeding ground here for vermin and contamination...fecal droppings noted around flooring...

beam and sub floor are noted wet here under laundry area...

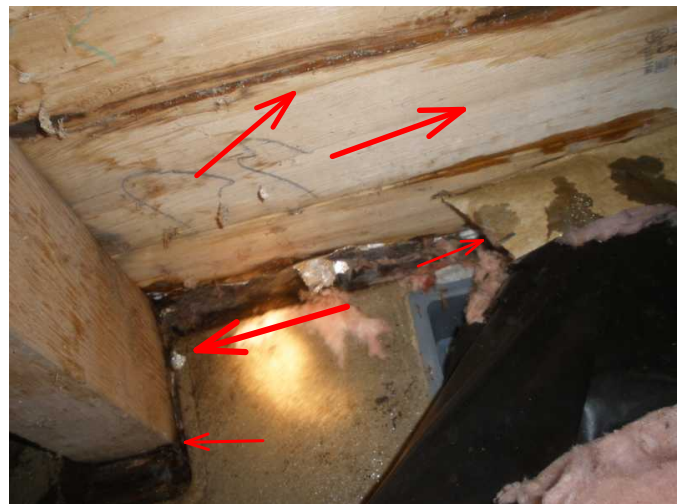
this took some work to pry off the foundation...but here is the wood plank flooring along foundation rotted and soaked...

main beam into foundation here is wet and may need replaced...floor at foundation is soaked and rotted..

Beams: Solid wood - noted main floor beams under south wall affected area are wet and may have rot at areas not visible..remove affected sub floor and assess and replace if needed...have assessed and corrected by licensed professional contractor...

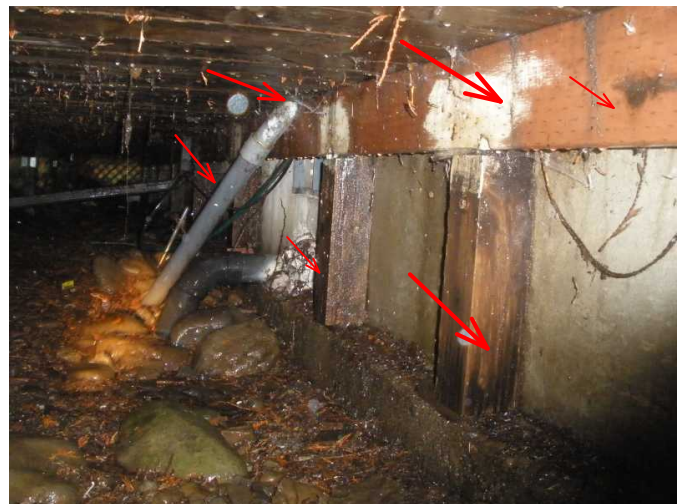
most of deck is noted rotted...assess and replace as needed...may need complete replacement...

most posts along deck are found rotted..may be easiest to sreplace entire deck...

Deck: wood - rotted main beams noted at south area under structure...and random planks need replaced...have complete assessment by licensed professional for bids and repairs...

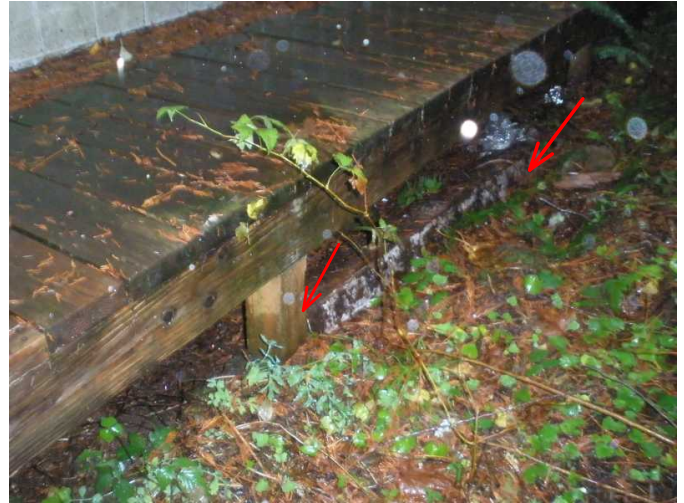
stairs at side to yard are rotted..replace...

most posts at deck are noted rotted and have earth to wood contact...

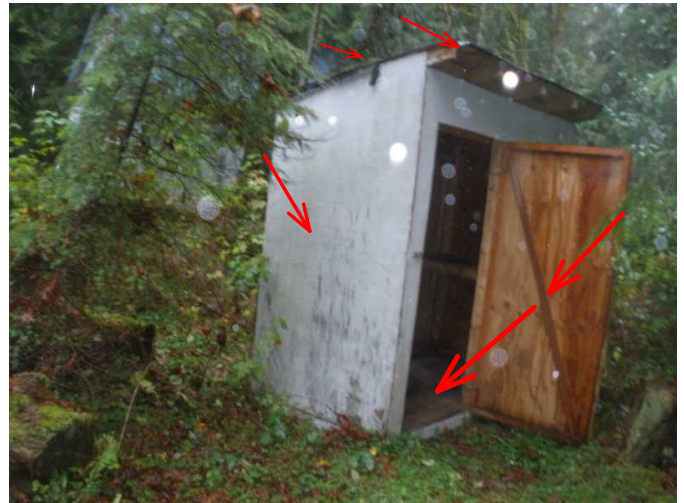
random outbuildings are noted with roof issues and will need regular repairs..is common to find in disrepair...

backout buidling is noted with random rot as well..repair as needed...roof needs replace on all outbuildings...
