Home Inspection Report

4587 se Bethesda Drive
Gresham, Oregon

Prepared by: The Home Tester

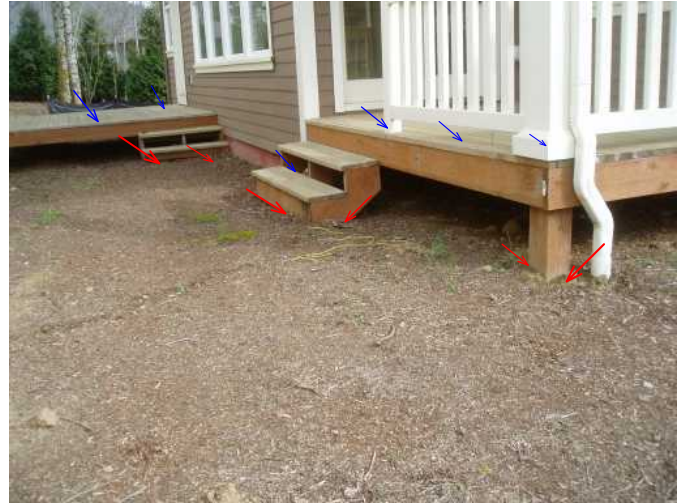
noting earth to wood contact at back deck lower grade to keep wood from rot..also clean and reseal decking...

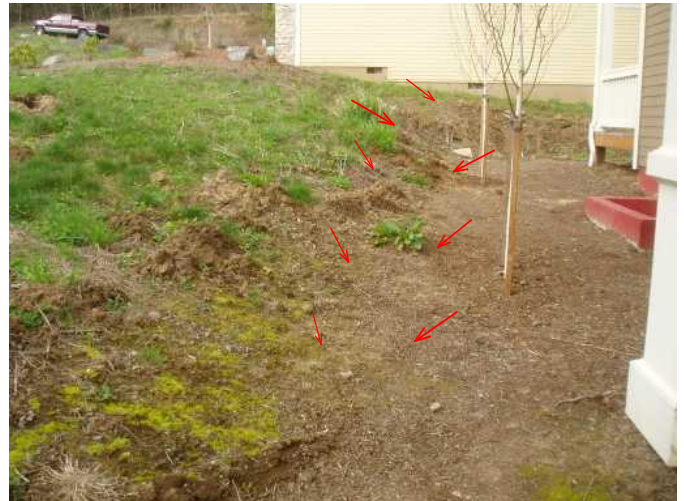
steep slope here needs retaining wall for erosion control...

Retaining Walls: missing - no retaining walls noted at back areas and may cause erosion and leaking into basement...

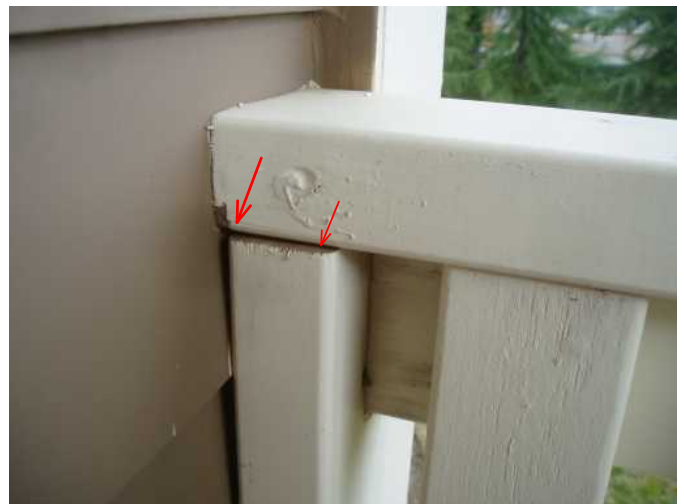
any gaps found at intersections will allow water to stand and rot wood...caulk all open gaps...cracks to extend life

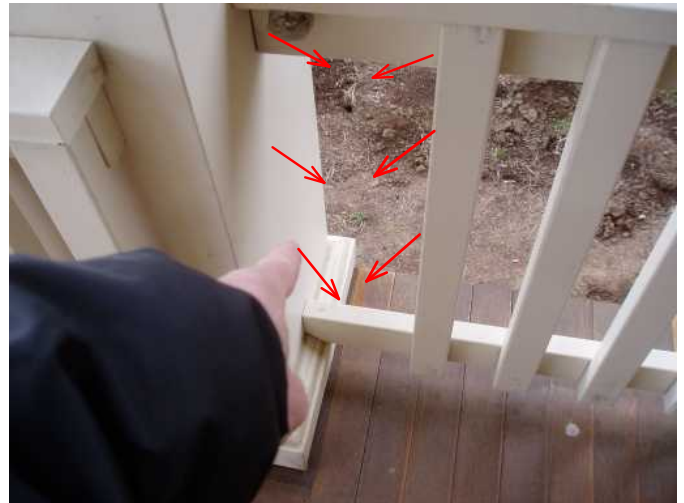
noted several areas that need spindles, max of 4 inches allowed between spindles...coorect where needed...both porches

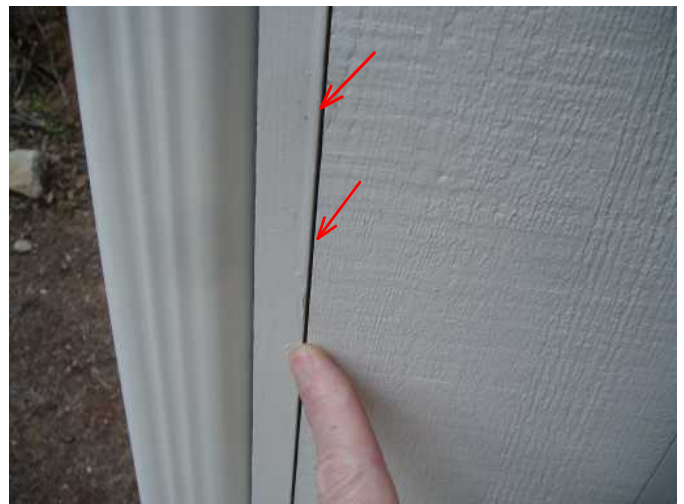
these seemingly innocent little cracks are suseptable to rot...correct with caulk...and then paint

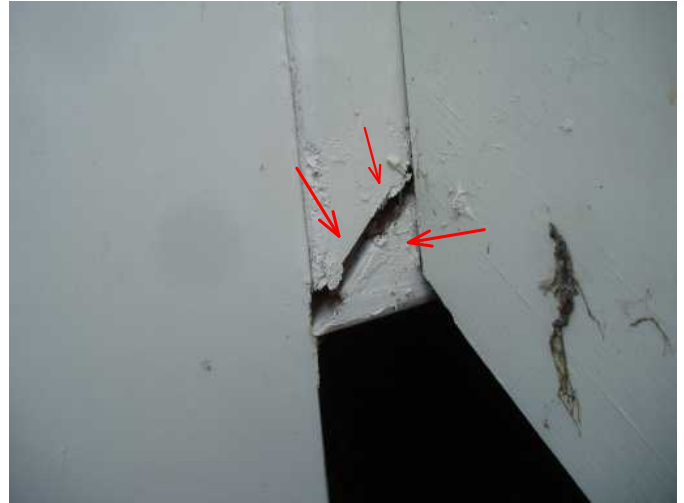
all open gaps like this one will promote rot quickly...a few years will be rotted...caulk all gaps...

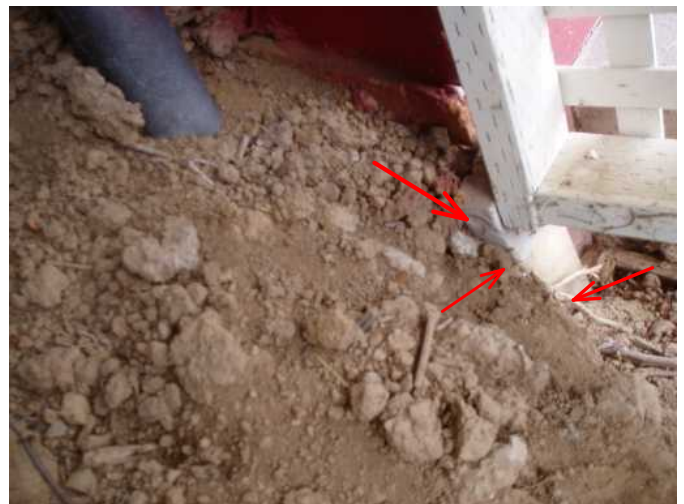
remove this 2 x 4 at garage area wall to skirting..is buried in earth...will draw termites and rot...remove asap...

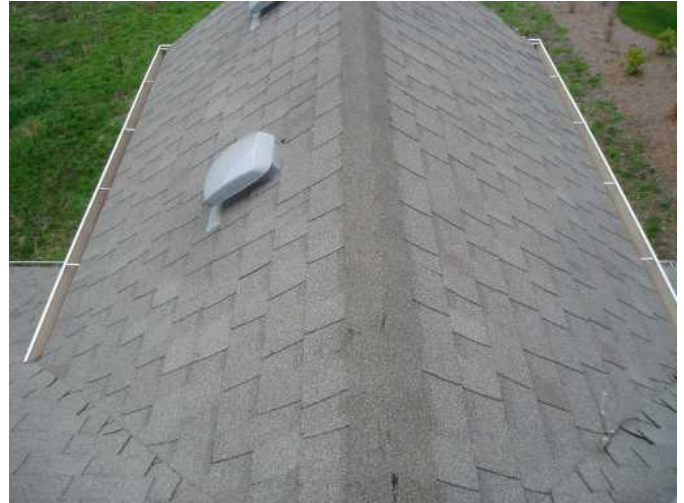
up on roof at back of home over west gable area....remove metal bracket noted here for roofer left behind....patch...

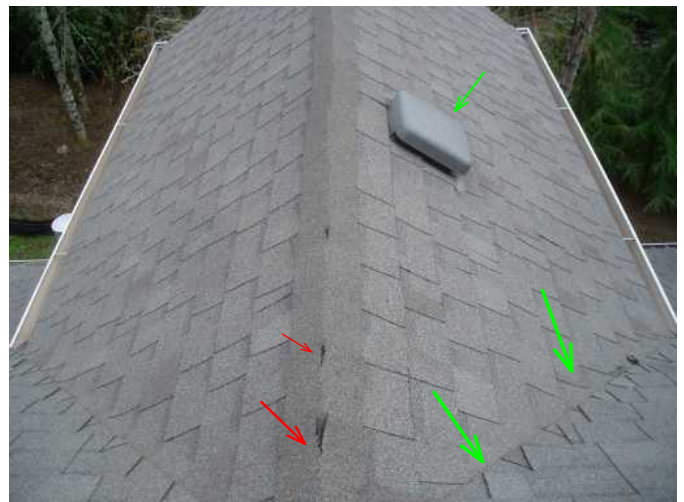
random ridge shingles noted split at many areas of several peaks...replace all damaged like this...example of many...

Main - Roof Surface - Material: Architectural comp - Loose or damaged shingles at ridge caps noted at random need replaced, remove 2 brackets noted in photos and patch/seal nailed gaps...see photos of random examples

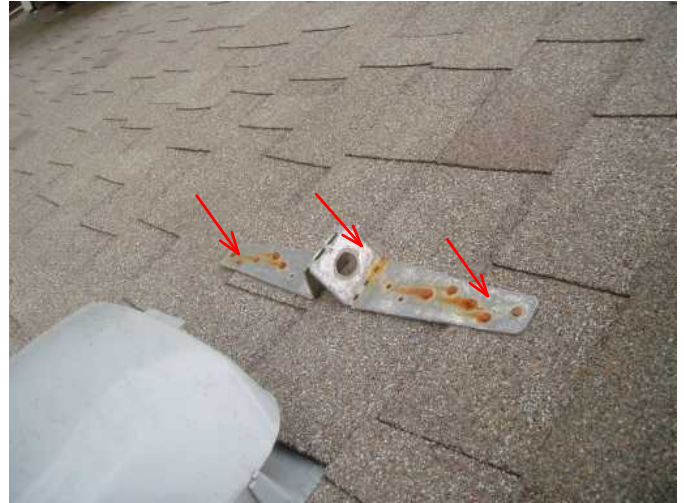
second bracket needing removed as well..then patch nail holes in shingles...see rust...was not intended to be left...

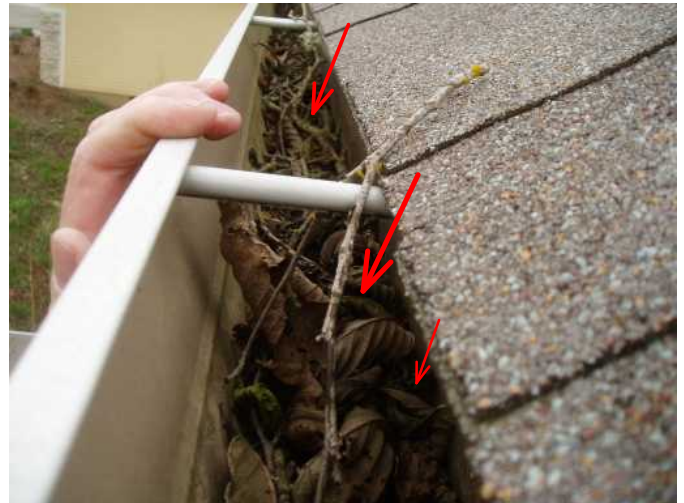
upper gutters around home are noted here with need to be cleaned...will overflow and cause erosion...clean...

Gutters: Galvanized - Need cleaning, always control water exiting around structures...is not cleaned, will overflow and potentially cause leaking into basement areas...

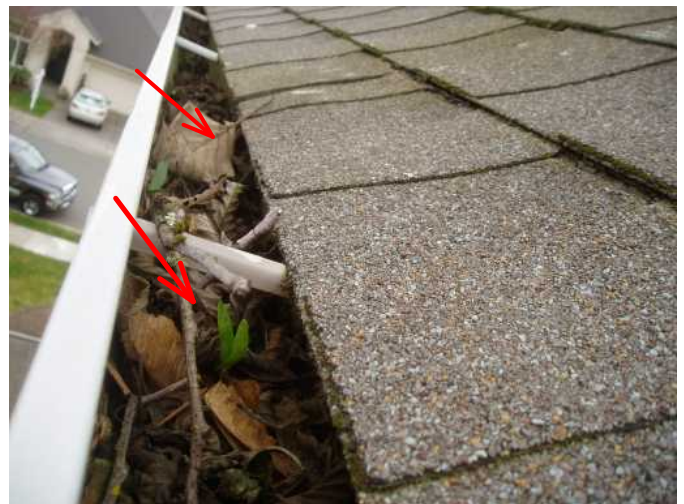
more full gutters...clean and try to clean often to avoid overflow and potential leaks into basement areas...

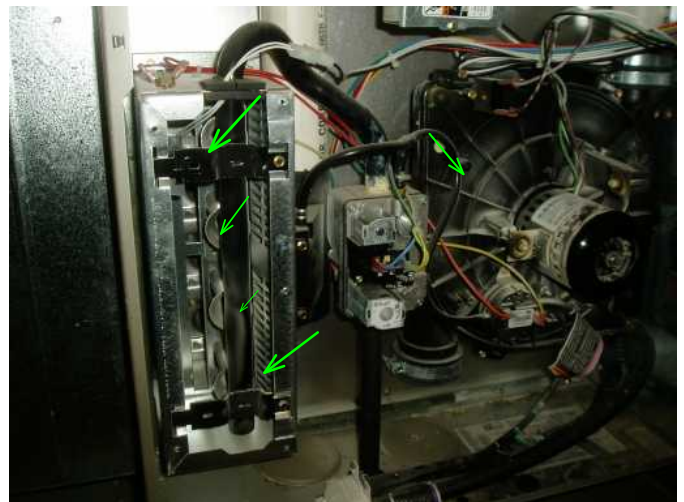
this little fuse is the culprit that appears to have failed and there is a second one on furnace as well..repair unit

Attic - Heating System - Heating System Operation: not operable - secondary fuse signal reading needs replaced at direct drive fan area according to listed trouble shooting guide on cover inside, have serviced by licensed H-VAC specialist and ask for delivery assessment of ducts for temperature differential...

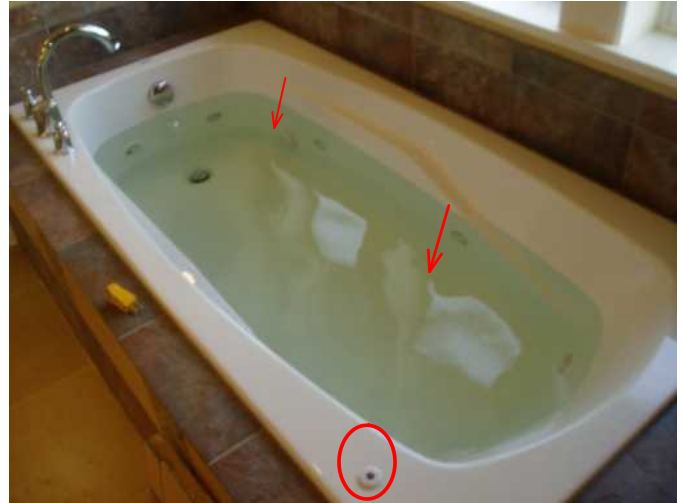
this is master bath spa tub and noted leaks at fittings under tub in enclosed area...correct....

Master - Bathroom - Spa Tub/Surround: fiberglass tub and tile surround - not able to operate...did not respond to controls...also, noted leaking at fittings at under area of tub...have assessed and corrected by licensed professional...

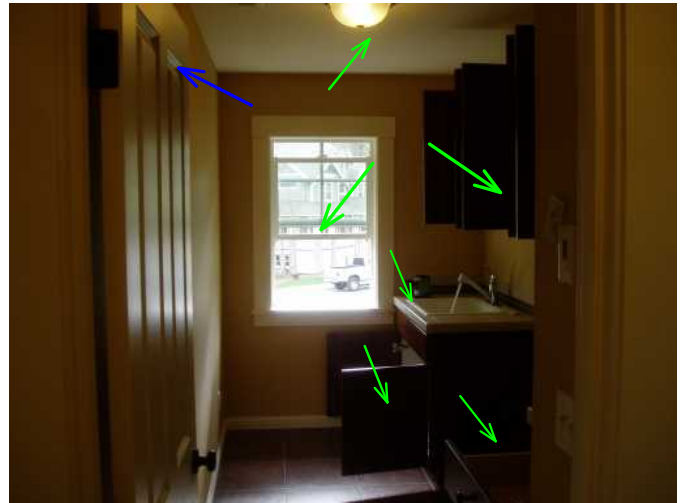
laundry room cabinets and window and fixture are noted operable..entry door is noted sticking at top..correct...

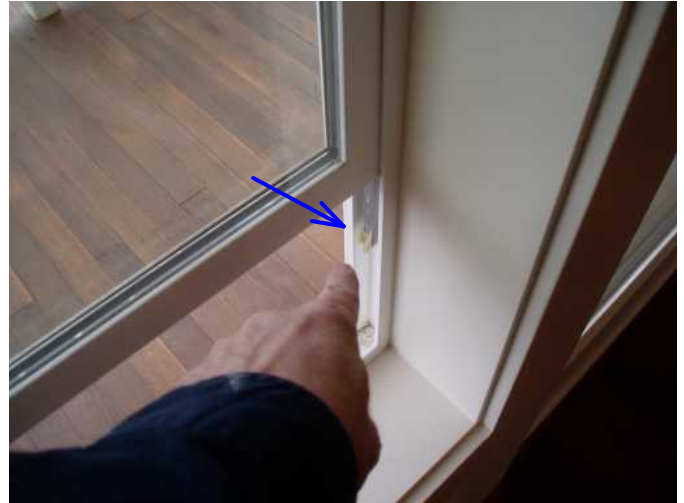
door handle latch is noted here to not latch...correct...

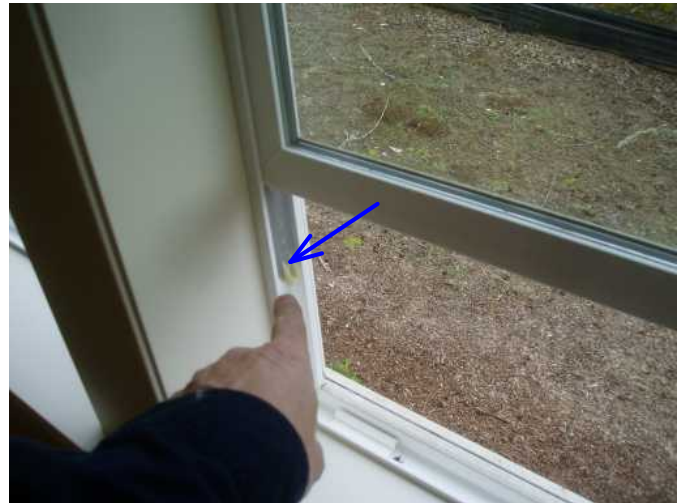
window track noted here at sun room window needs adjusted to flow easily...

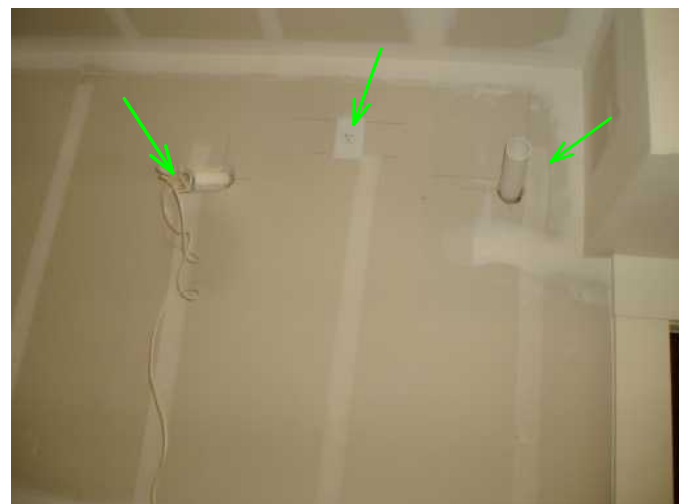
main water entry and shut off noted here, suggest insulation added to protect from freeze in winter....

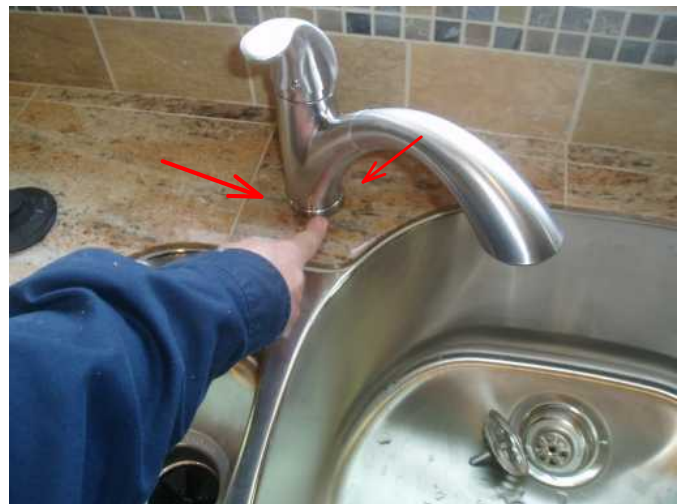
faucet at base here was leaking heavily and needs to be corrected..shut off at supply lines under sink....

1st Floor - Kitchen - Plumbing/Fixtures: Brand not known with PVC trap - Leaking heavily at faucet at base...shut off at supply lines under sink area...
