# Home Inspection Report

6603 se 31st ave  
Portland, Oregon

Prepared by: The Home Tester  
10555 SW Tigard St. #57  
Tigard, OR 97223  
Ben Tester  
503-515-1833 CCB# 164921 OCHI # 912

## Photo Attachments

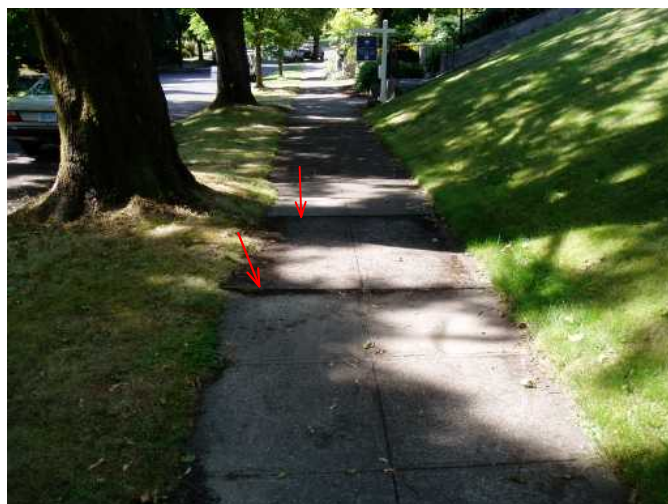
sidewalk..street level...has two noted uneven possible trip factors...suggest leveling...

**Walks:** Flagstone/concrete - all walks are good at home level/at street level, sidewalks have some unequal heights, can be solved by grinding or leveling with more concrete...sidewalk specialists..Pat Crowell...503-515-1611

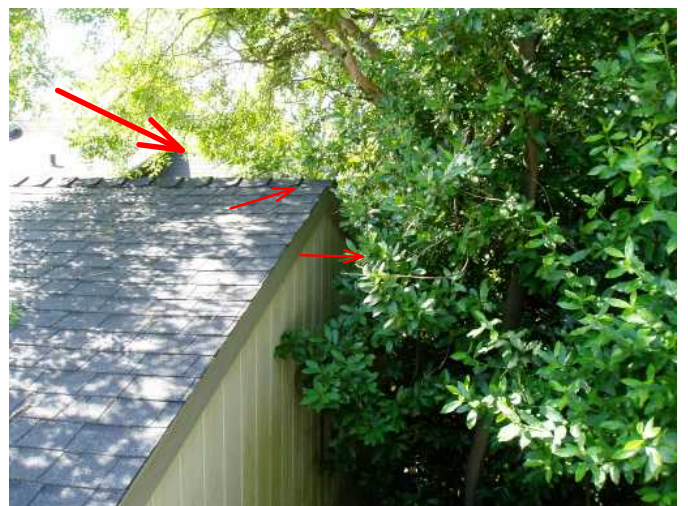
tree above garage needs to be trimmed back as well...

**Vegetation:** Tree/shrubs - trim back shrubs around home where to close..see photos...also trim back trees and shrubs at back and side of garage...roof and siding..see photos...

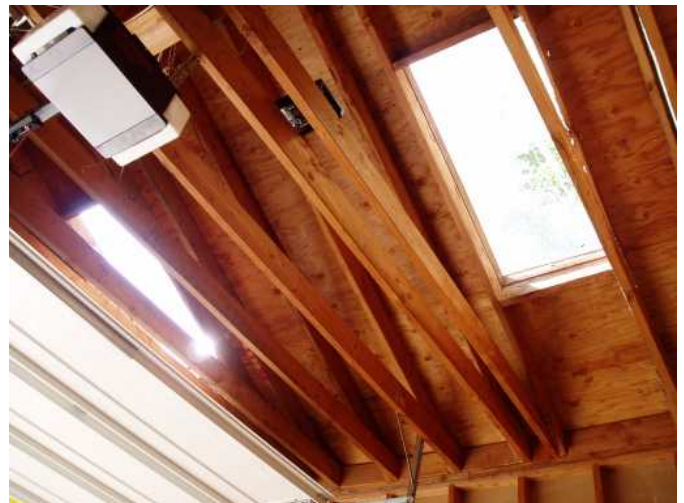
garage window appears to need new caulk around base of window...

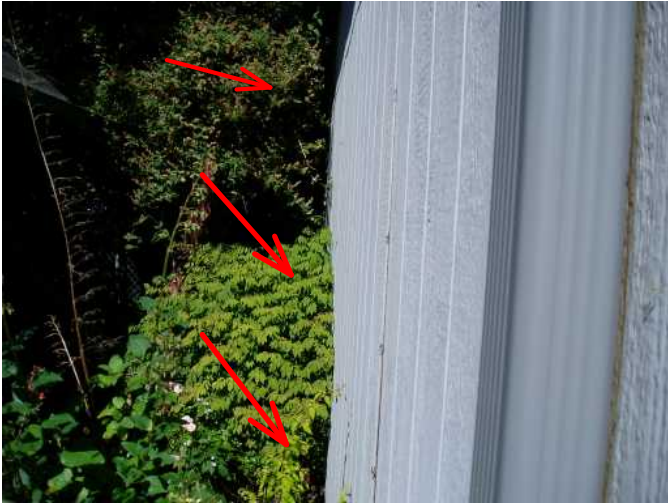
left side of garage needs trim back of vegetation to keep siding from moisture intrusion...

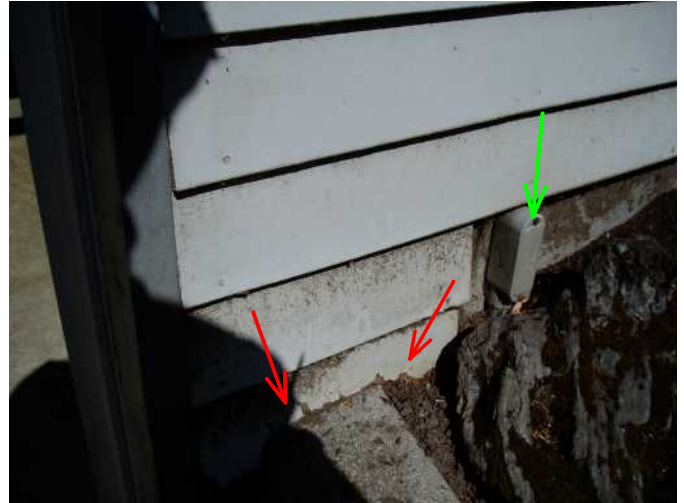
small arewa of siding show rot...at dirt level...replace this one piece...easy fix...electrical entry done well...

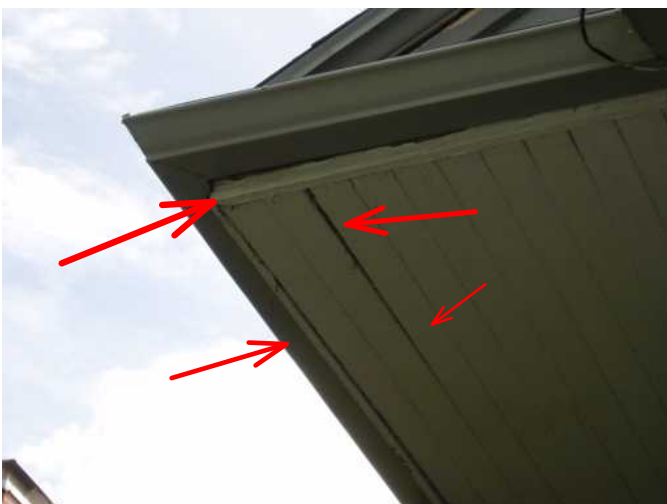
monitor this corner at rear of home...is a bit loose ...maintain paint to keep from getting any worse....

**Trim:** Wood - all in good shape/ one corner rear of home needs to be monitored...is loose..see photos..

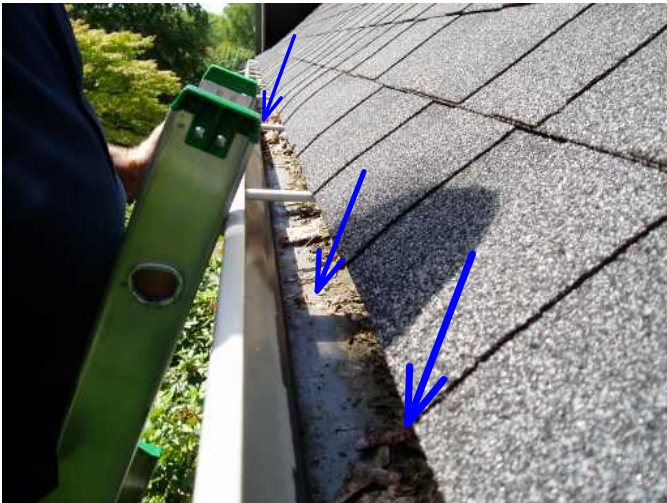
front section of gutters missing cover...odd...

**Gutters:** Galvanized/with gutter helmets - front section of home is missing gutter helmets....see photos...

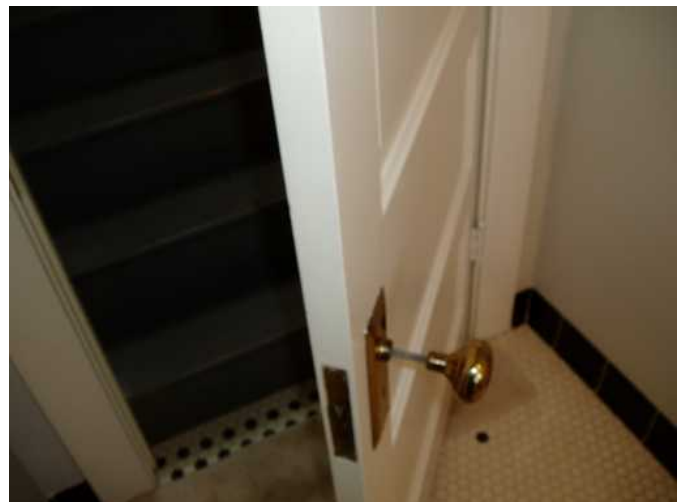
door knob to attic needs to be installed...exit hazard...

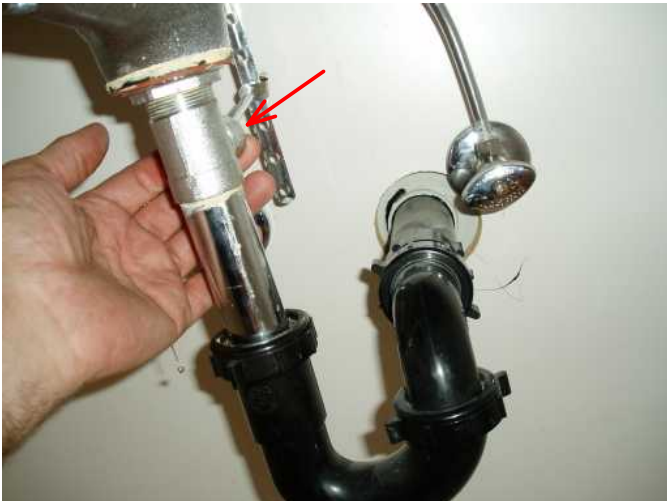
drip noted here at stop connector...small now/ will get worse...please fix...

**2nd Floor Hall/shared master - Bathroom - Faucets/Traps:** Brand not known - master sink is good/main sink has leak at connector for stop..see photo

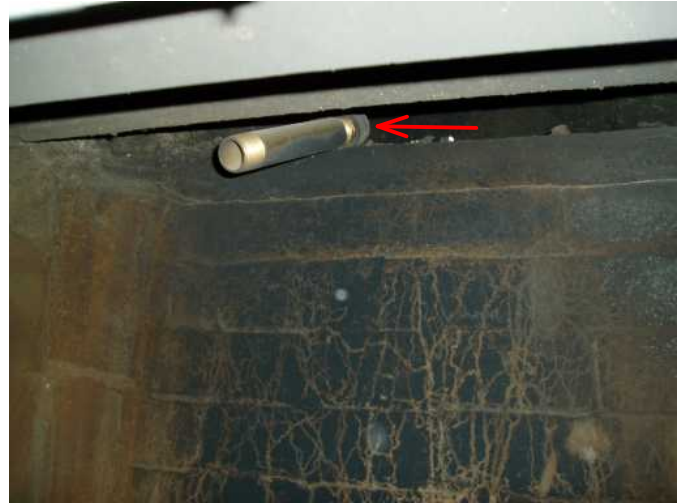
replace pipe with attached clip...easy fix...damper fireplace...

**Living Room - Fireplace - Damper:** Metal - needs real clip installed to hold open damper, not pipe...see photo

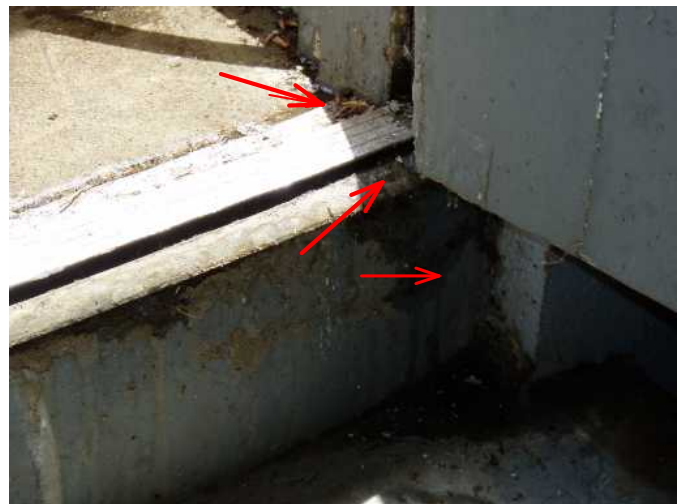
area noted with stains...

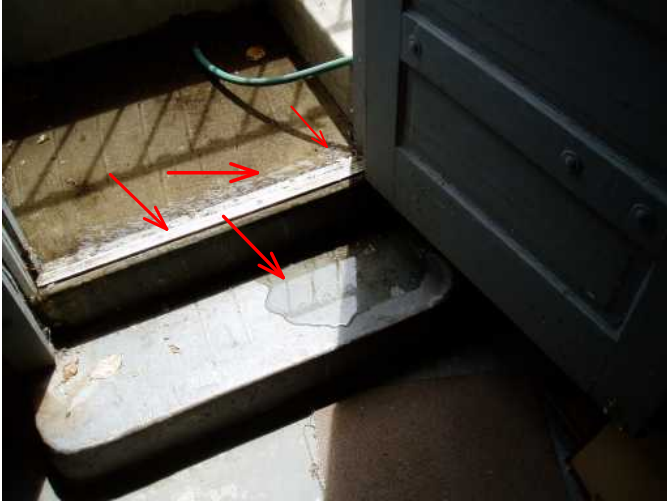
basement door threshold needs to be removed and sealed  
up well to eliminate leaks...

**Main - Basement - Moisture Location:** at entry door to stairway at base of door - thresh hold plate will need to be re-sealed...is letting in water...
