# Home Inspection Report

72310 E Faubion Loop-Road 9 lot 11  
Rhododendron, Oregon  
Inspection date 12/24/2010  
Broker/ Sandi Strader @ Oregon Realty

Prepared by: The Home Tester  
10555 SW Tigard St. #57  
Tigard, OR 97223  
Ben Tester  
503-515-1833 CCB# 164921 OCHI # 912

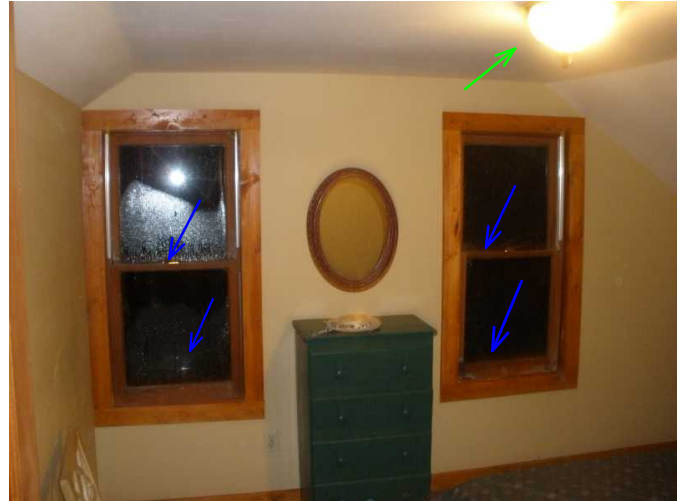
bed 3 entry door and wall heater...wall heater needs cover plate and entry door needs door stop...operable...but swollen

bed 3 ceiling fixture is noted operable..all outlets noted operable..windows not operable..and single pane....

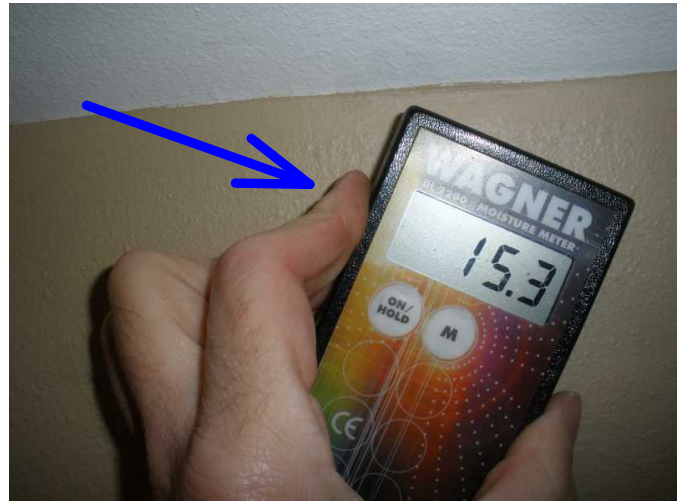
wall moisture is noted fine at right window wall area...bed 2 area..entry door operable...window painted shut...

am noting wall to bed 2 ceiling is fine...but is higher than normal...home has no heat on and can get damp...

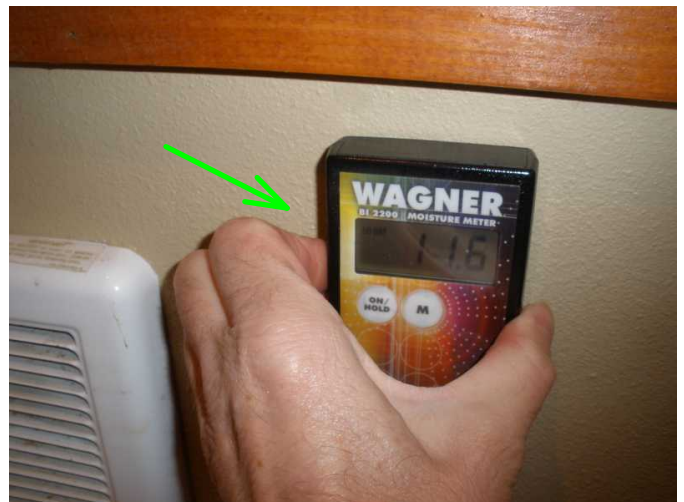
second floor entry to bath door is noted operable..but swollen as noted all doors...heater and window noted operable...

wall moisture is noted fine....

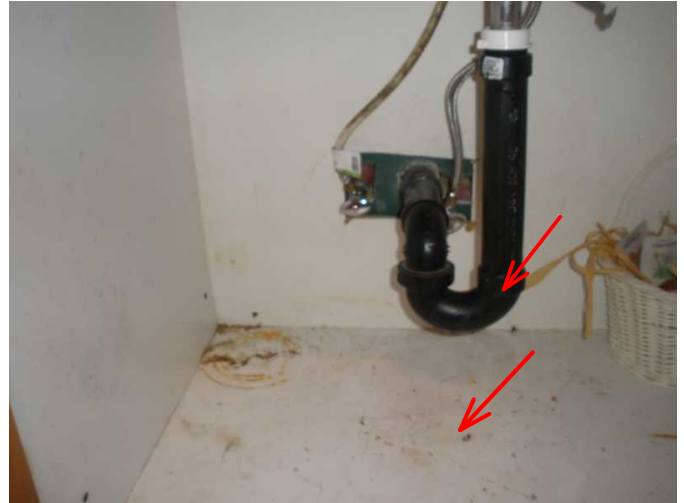
cabinets noted operable...sink is fine...counter is damaged and will need replaced...

drain trap under sink is noted leaking...correct...

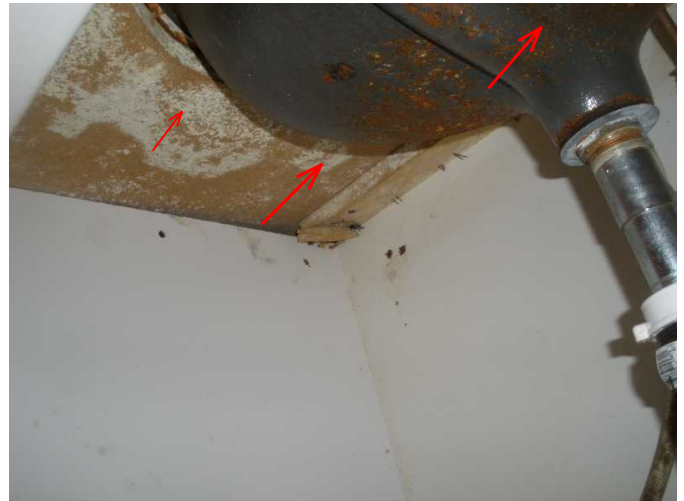
faucet is noted operable..drain is noted operable...no drain trap noted...correct...

underside of sink counter area is noted damaged from water...is sinking in center...replace...

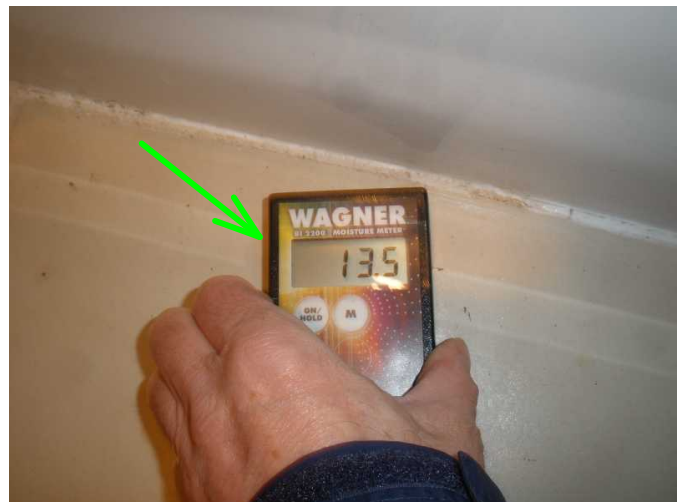
toilet is noted solid to floor and operable...does run after flushed...correct...floor moisture is fine...

floor moisture at tub is noted fine...

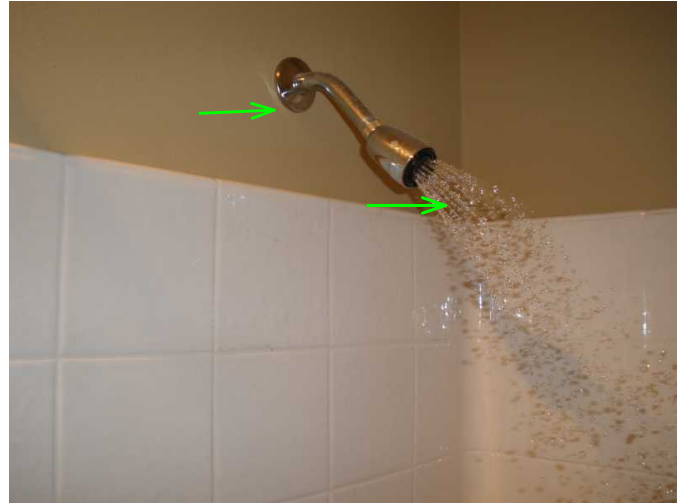
tub faucet is noted loose...operates....drain and drain stop noted operable...

shower head is noted solid to wall and operable..

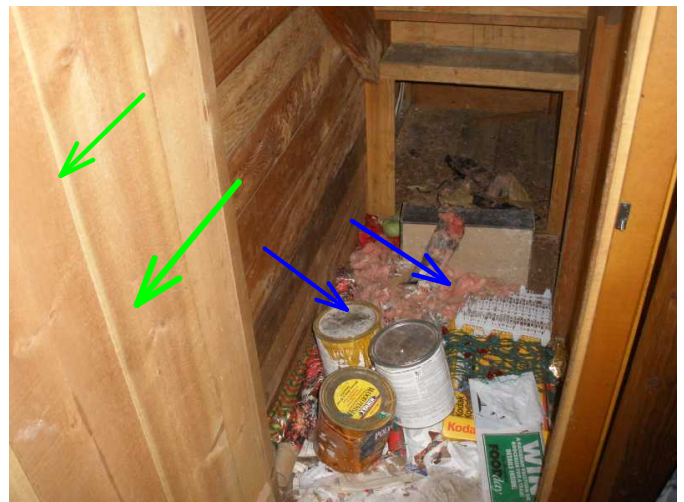
stairway is noted here and handrail is missing spindles and can be issue for small children...add for safety...

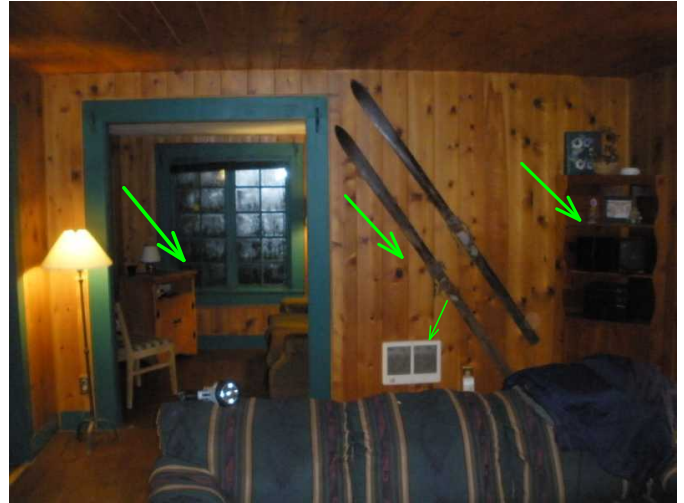
general view of living room and noting windows are painted shut and walls and ceiling are fine...

cadet heater is noted fine as well...walls are solid wood and are fine...some higher moisture detected...leave heat on...

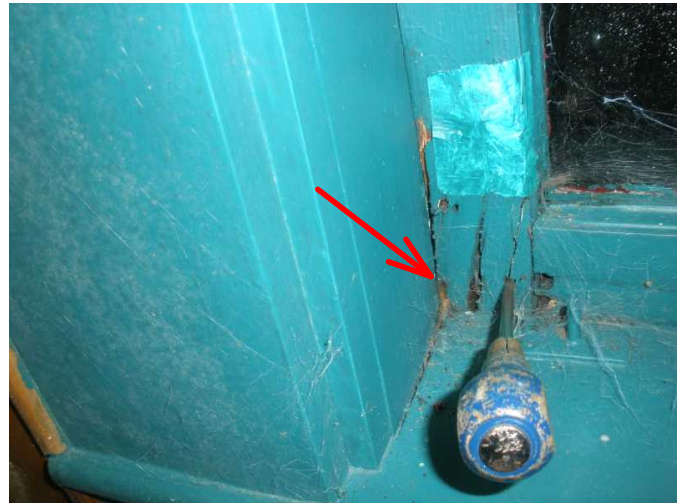
high moisture noted at exterior window sills at main level of home...appears to be too damp...leave heat on...

rot noted at window to right of fireplace in living room...correct...

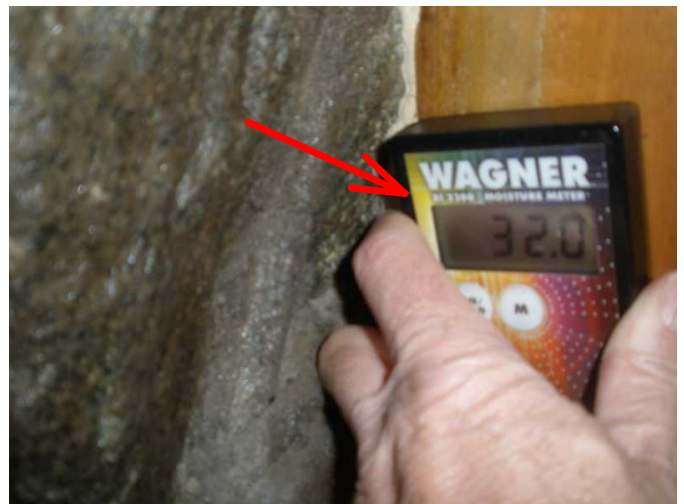
all throughout home is noted with higher moisture content of exterior wood trim...is due to no heat and damp areas..

high moisture is noted at side walls of fireplace areas...

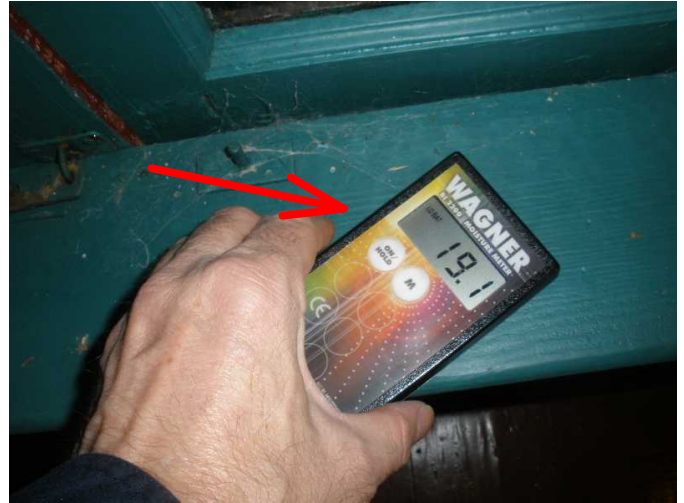
study area noted here with windows not operable...condensation noted...

high moisture noted at window sills in study area...

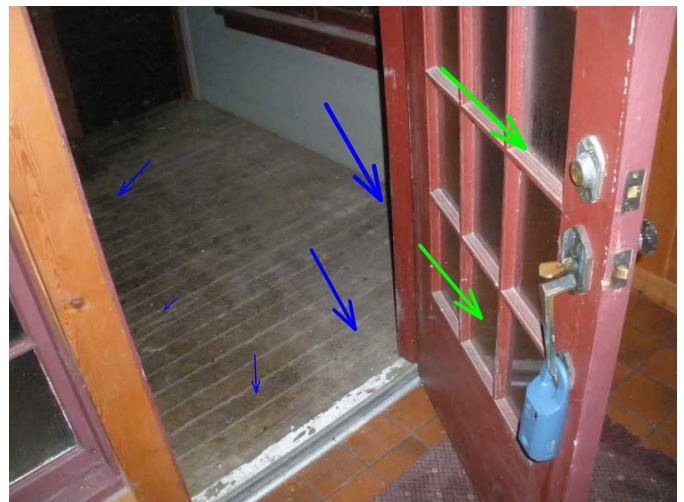
higher moisture noted at window areas...at sills...noted at all exterior wall sills...run all heaters to keep home dry...

main entry door is noted operable...recommend adding weather stripping around entry door...

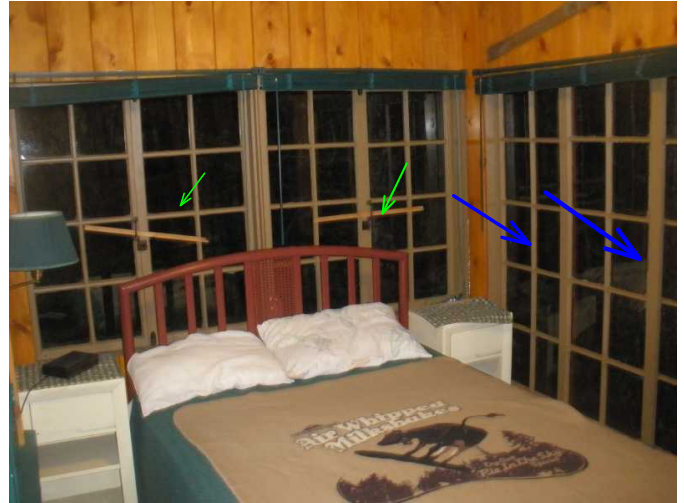
door to master first floor bedroom area is noted operable...swollen as is all interior doors...to much moisture...

bedroom west windows are noted operable...north windows are painted shut...all windows in home are single pane...

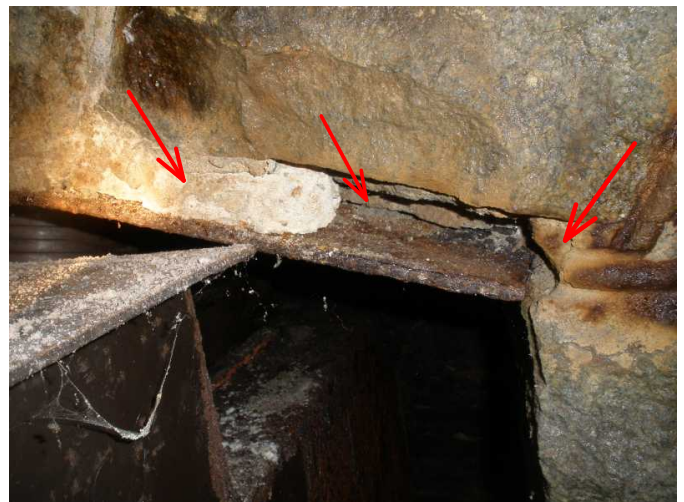
fireplace has a obsolete wood insert...is noted with spalling and efflorescence at mortar joints...high moisture

open gaps noted at lintel and efflorescence noted at many areas...is sign of wet entry around fireplace...

**Living Room - Fireplace - Fireplace Construction:** Stone - noted efflorescence at many areas of fireplace structure in home...will need assessed and corrected by licensed professional mason...see photos

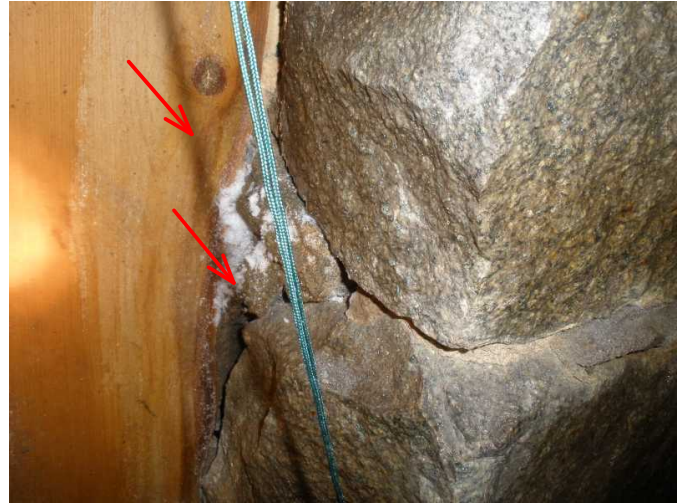
the wood stove insert is noted with single wall flue installed up the original chimney... no damper noted...

efflorescence is noted at many areas of fireplace...have assessed by lisenced mason...will need repairs/replaced

**Living Room - Fireplace - Fireplace Insert:** cast wood stove - Oregon Senate Rule # 102 requires all non EPA certified wood burning stove and insert units to be removed from homes/shops and barns in real estate transactions on and after August First of 2010

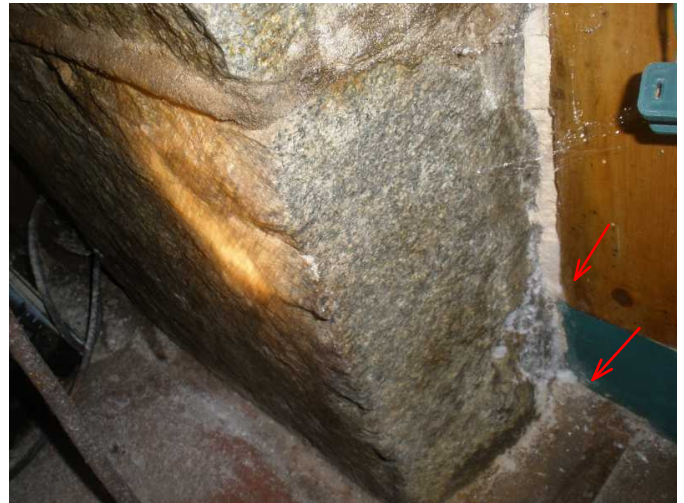
this is the mantle of the fireplace with salts...(efflorescence) appears the fireplace may need replaced...very wet...

efflorescence noted at both sides of lower area of fireplace...

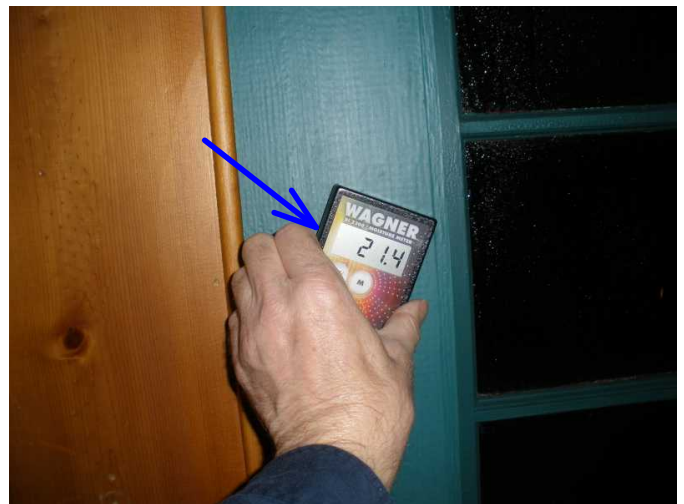
hearth is noted cracked...

high mositure noted at window trim in dining area...is noted that the exterior is not sealed well...

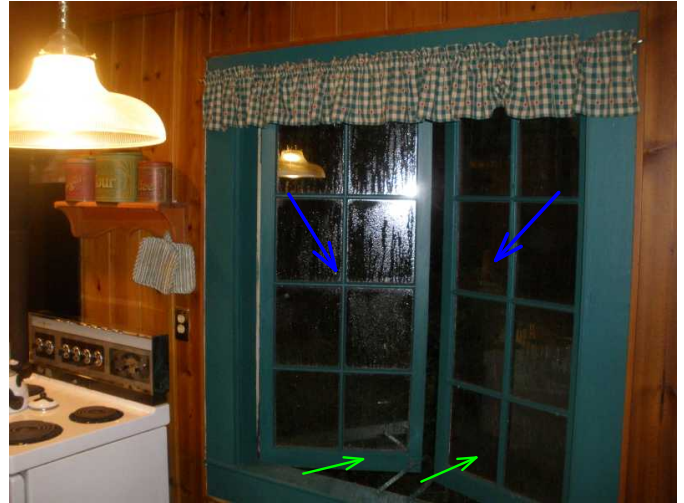
dining area is noted here with fixture operable...west windows are noted not operable...and have condensation...

east windows are noted with condensation as well...and are found operable...dining area...

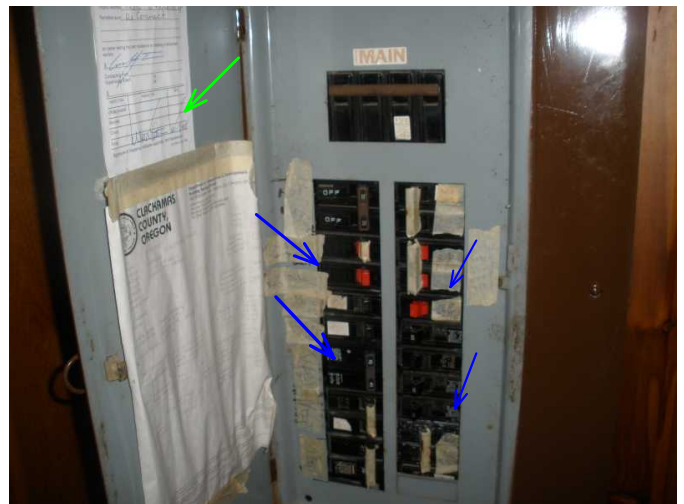
dining area has main breaker panel noted in dining area...

open view of panel is noted here...remove all tape and install new grid with details...

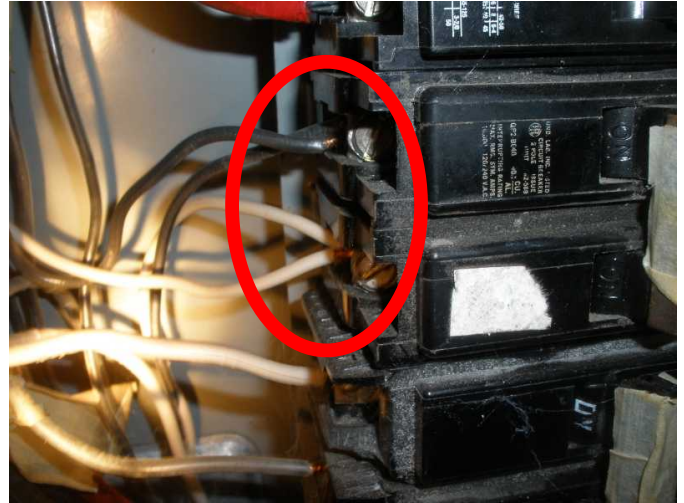
200 amp service is very good for this size home...is updated and 200 amps is enough...

double taps noted here at 240 breaker and not acceptable...have assessed and corrected by electrician...

**Kitchen - Electric Panel - Breakers:** CU/AL - Double tap wiring noted...correction needed.... have assessed and corrected by licensed electrical professional...

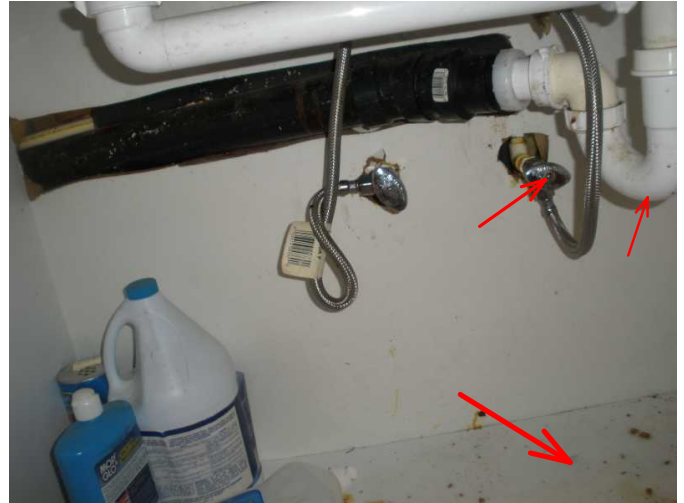
under sink is noted with leaking at connection to right...and trap to right sink as well...

leaks noted and will need repaired...may need to assess water lines in wall..did note leaks at exterior siding as well....

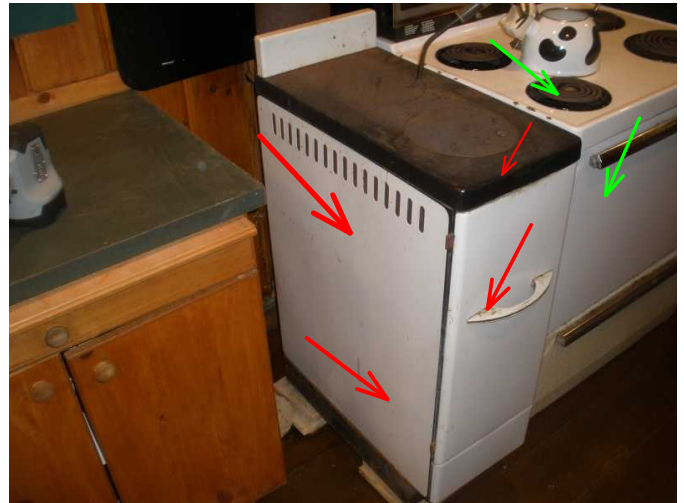
the single wall flue is noted here and is noted to close to wall...has simple wall protection,. but needs secure brick..

the wood burning cook stove is not acceptable and will need to be removed...is not DEQ approved...main stove is operable

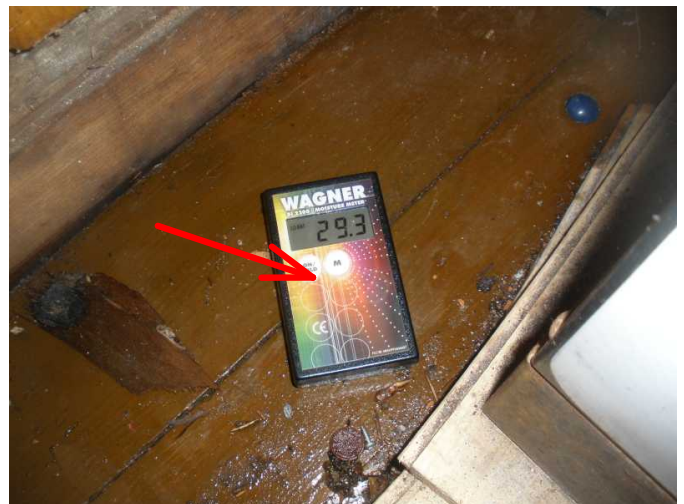
noted high moisture at floor area by wood stove..appears is coming from wall of sink area...

high moisture readings noted here at wood stove area behind wood stove in kitchen....

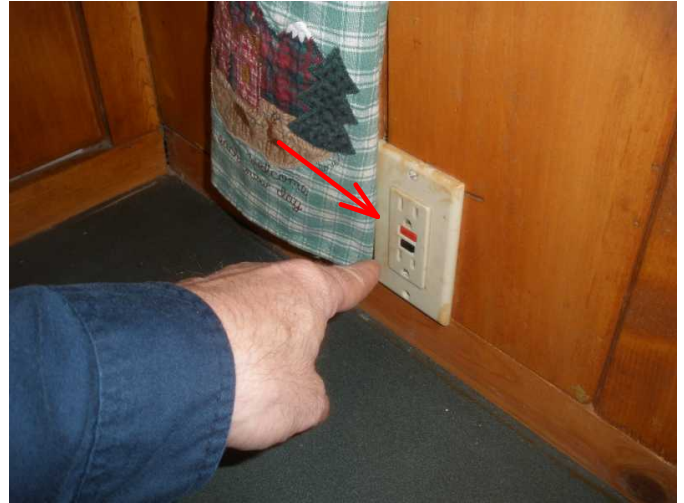
appears may be leaking from wall area at sink? but can not determine....just can see wet and staining at trim...

left GFCI outlet at outer counter area is noted not operable..and needs replaced...

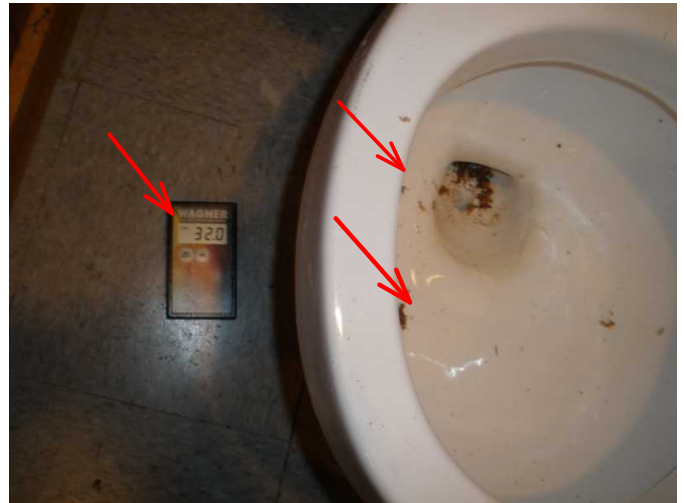
first floor bath entry door is noted operable..but sticks to door frame and cabinet at sink is noted operable...

first floor bath toilet is noted with water disconnected...and floor is reading saturated..is from leaks of broken pipes

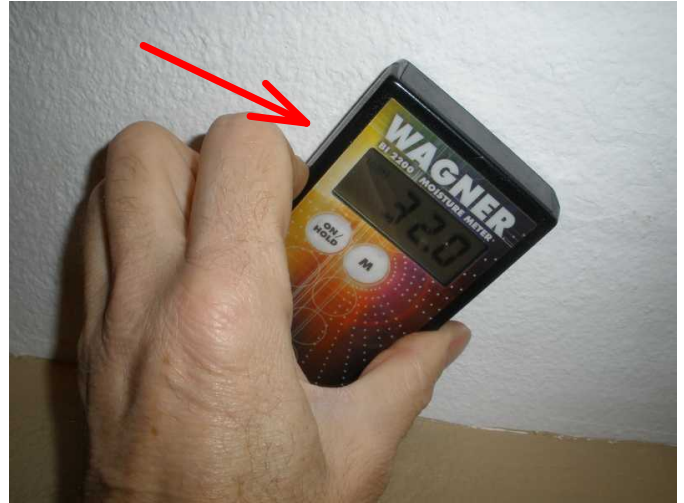
ceiling at main bath is noted with high moisture...at wall by entry door...appears the roof to siding is not sealed well...

the ceiling over wall at entry door is noted at saturated...the attic area is noted not accessible...

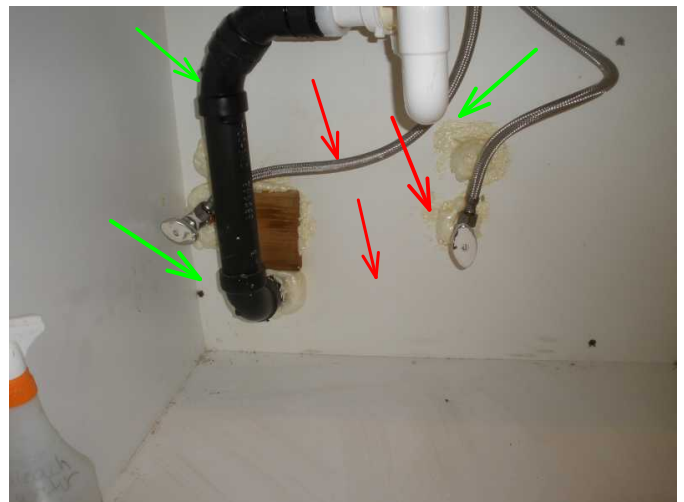
shower head is noted solid to wall and operable...

the drain trap and connections under sink are noted not leaking at this time...wall is reading 32% moisture from break...

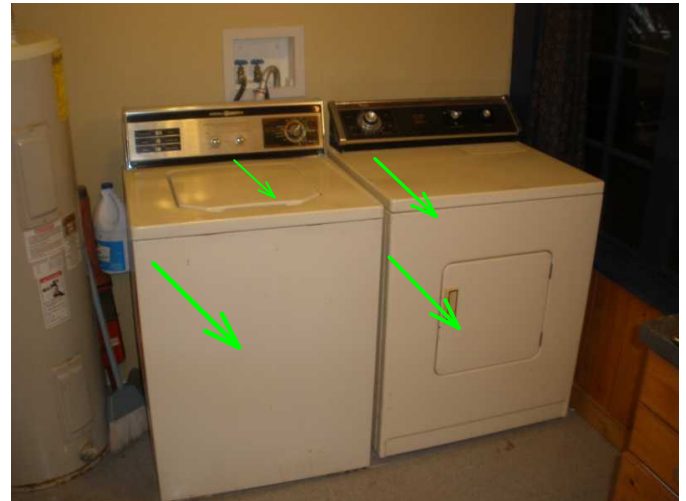
overall view of bath is noted here...the floor is high in moisture...from past water line break...

ran both washer and dryer and both are operable...

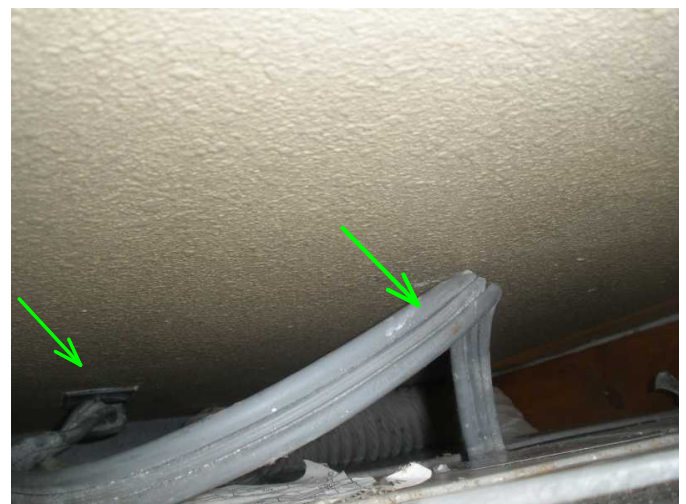
main hook ups for washer are noted here and are operable...left valve is noted leaking...correct...

dryer is noted with 240 amp outlet and is operable..

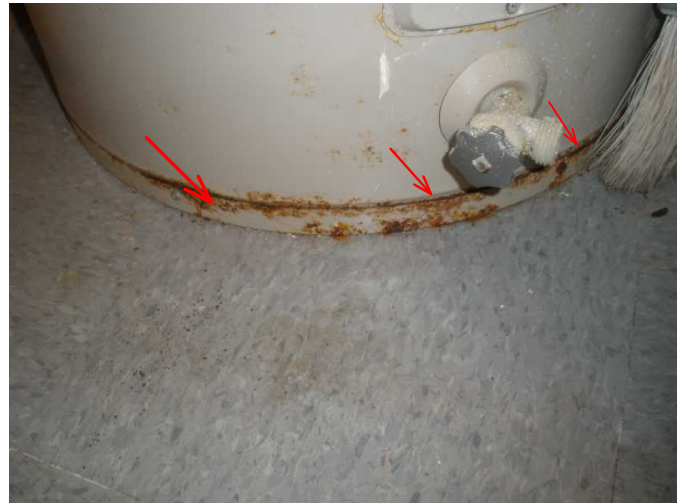
noted rusting at upper tank areas...

as well as along the base...recommend a new water heater....

**laundry room - Water Heater - Water Heater Operation:** Inadequate - Earthquake support straps missing or not properly installed, Water heater has exceeded design life/noted rust paint over/recommend replacement now, did get somewhat warm, but not hot in 1 hour....is at end of useful life...

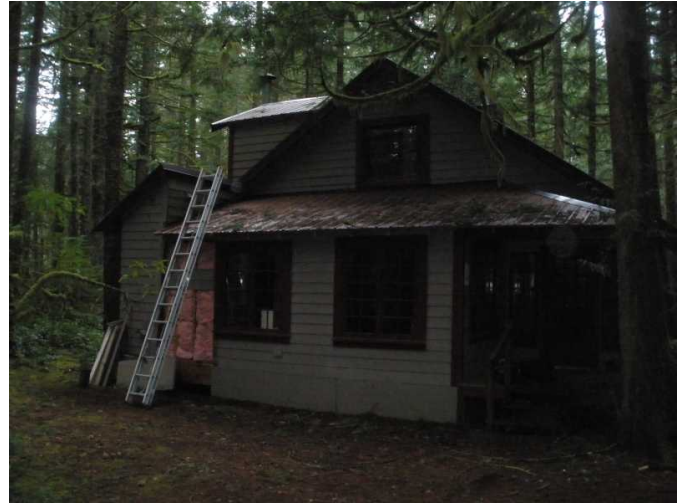
both ceiling fans in first and second floor baths are noted not operable...replace...first floor is noted rusted...

front view of home is noted here ....

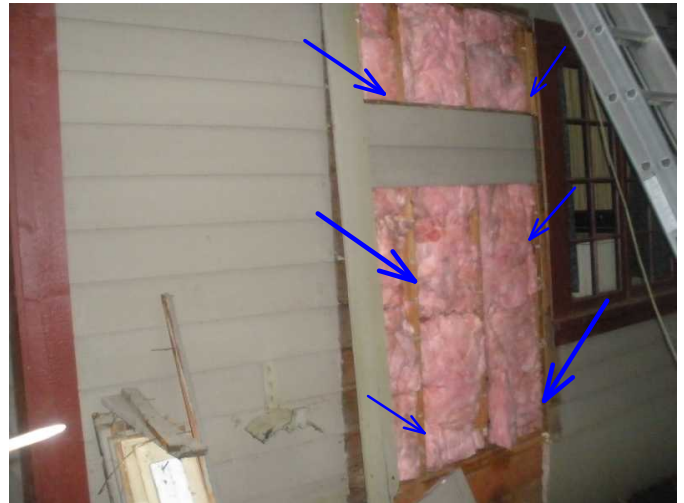
rake has some minor rot noted...at front of structure...

area where the water pipe was noted broken...the siding needs replaced...and any wet insulation needs replaced...

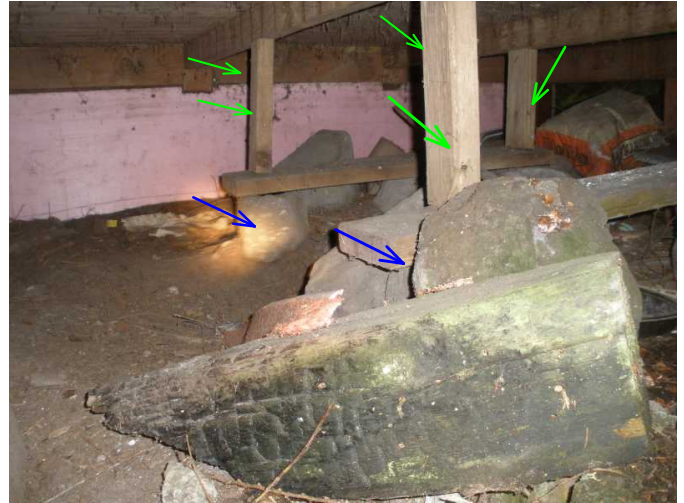
handrail and steps need repairs...wood touching earth and handrails are loose...

all supports under porch are noted dry and solid...on rocks and pads...raised...recommend adding pads..not rocks...

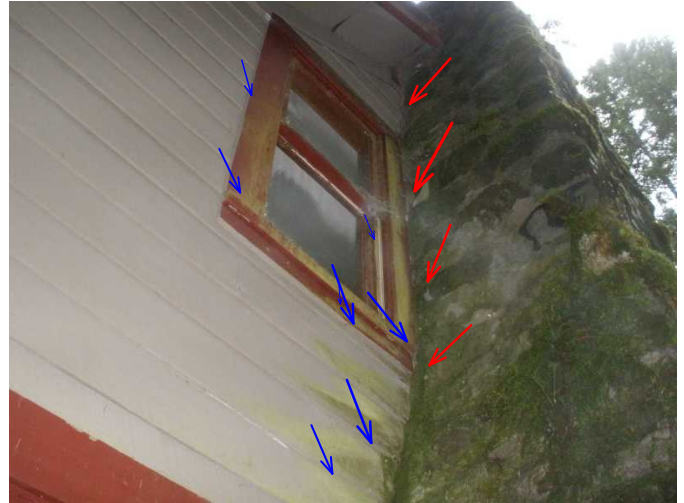
fireplace is old and has issues with seal to siding..is letting in water to home...have assessed and repaired/replaced

siding and trim are noted here with algae and fireplace is noted gapped away from siding..allowing in rain water...

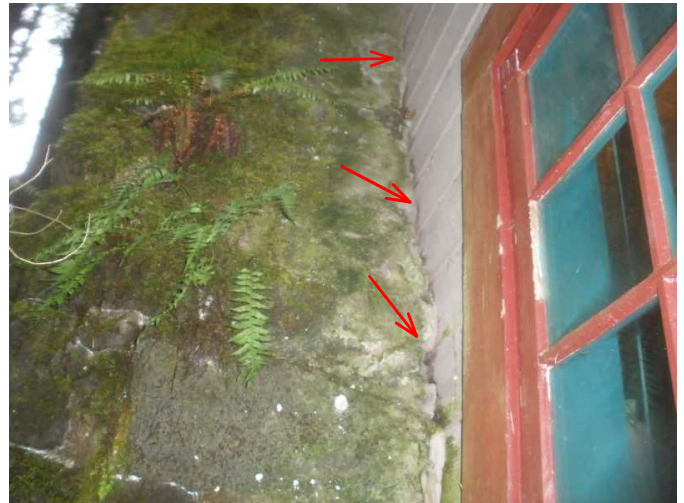
many gaps noted in fireplace to allow in water and leaks...correct...may need re-build...

both sides of fireplace are noted with open gaps to siding at west side of home...and trim needs paint...correct..

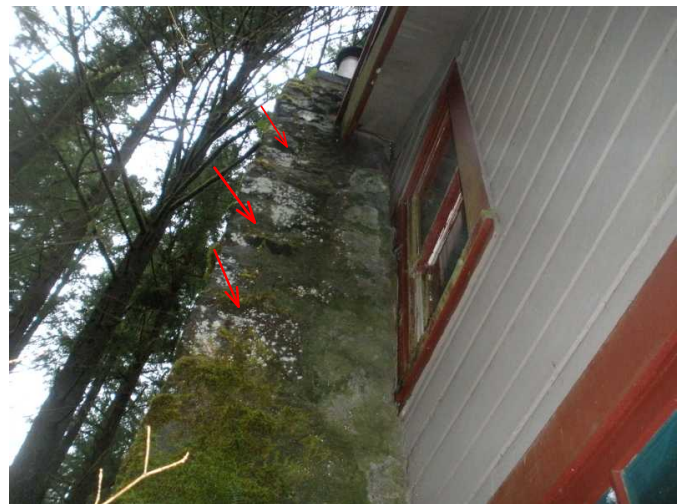
large open gaps are not good...have assessed and corrected by licensed mason...

efflorescence noted at exterior of fireplace...is letting in dampness and getting wood wet...correct...

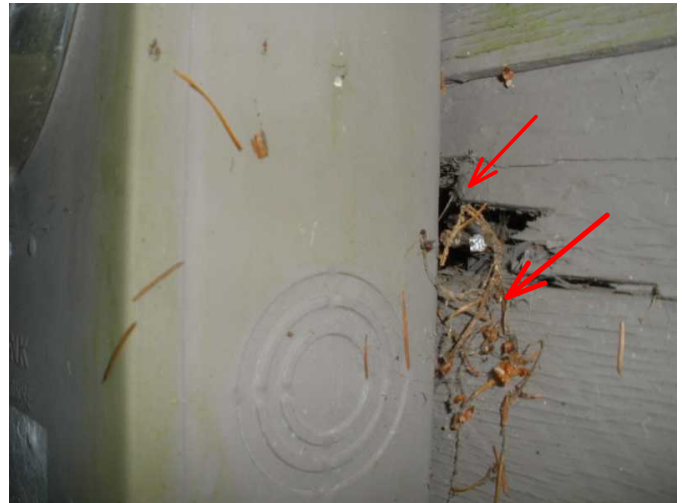
grounding wire is noted here at earth below meter at corner of home...

open gap is noted at electric meter area...close up...and seal...

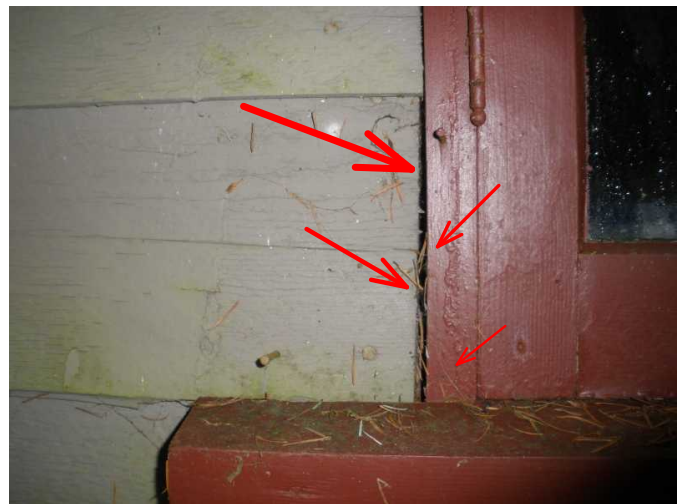
open gaps noted at dining area window at west side...seal with caulk...

any and all open gaps need sealed to close off the exterior of home and avoid water entry...is issue with this area..

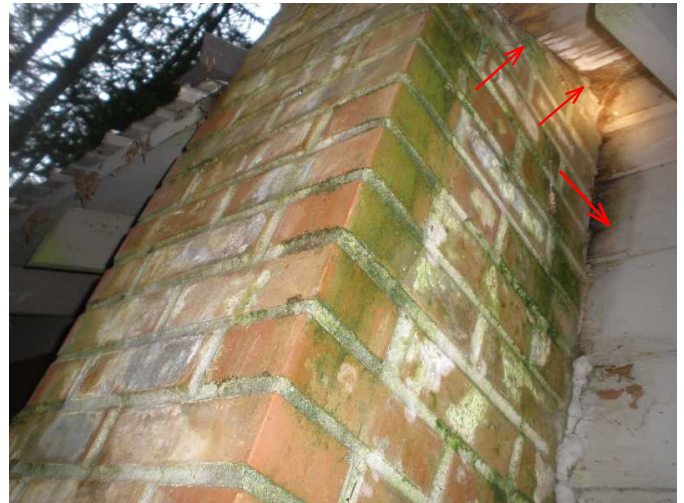
wood area here at old window does not appear to be exterior grade and will need replaced...warping from wet...

the eaves at chimney are noted wet and stained...appears to be from flashing at roof area...correct flashing and wood..

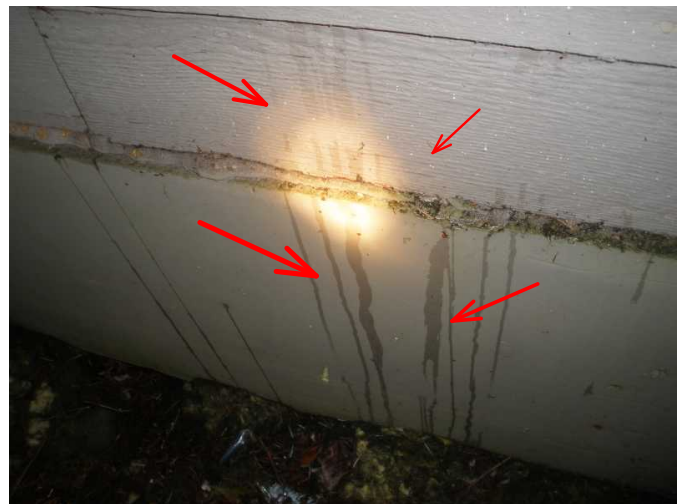
same issue noted at other side of chimney and open gaps noted at chimney to siding..seal off and correct flashing...

there appears to be leaks in wall at kitchen area exterior wall..appears water lines are broken and leaking..

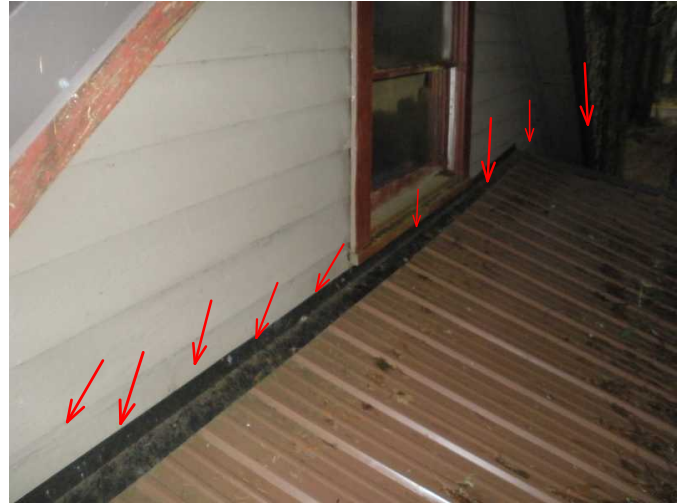
cut back tree overhangs at roof area...east side upper gable...

metal roof flashing to siding is noted over siding and should be under it...did note high moisture at wall area in bath

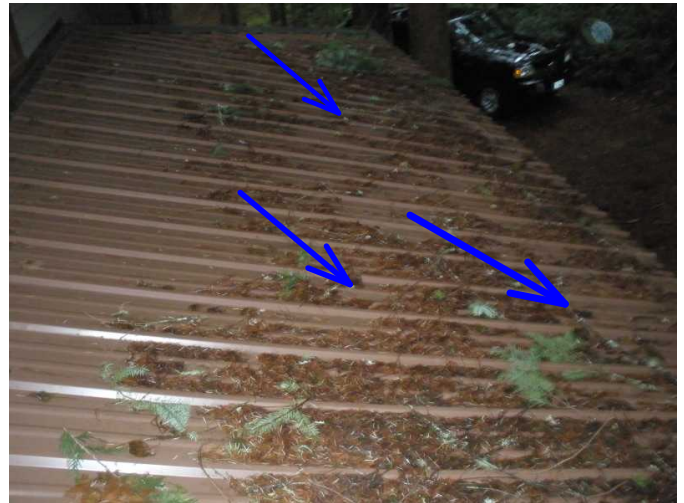
this flashing at roof to siding will need repaired to have counter flashing or plenty of caulk to seal...appears leaking

all roof areas are needing cleaned and de mossed...

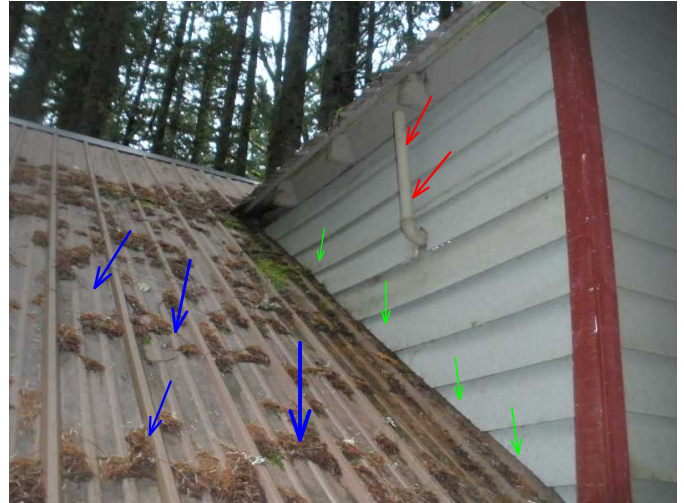
sewer vent noted here needs to be above upper roof line..is required...and appears step flashing is fine...clean roof...

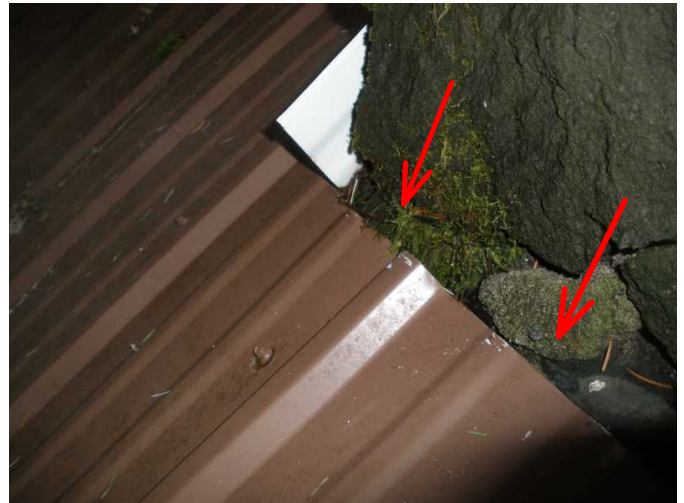
more open gaps noted at siding by master bedroom area...close all noted gaps at siding around home...

no flashing noted at main fireplace chimney areas...can allow lots of water entry into attic and home areas...correct..

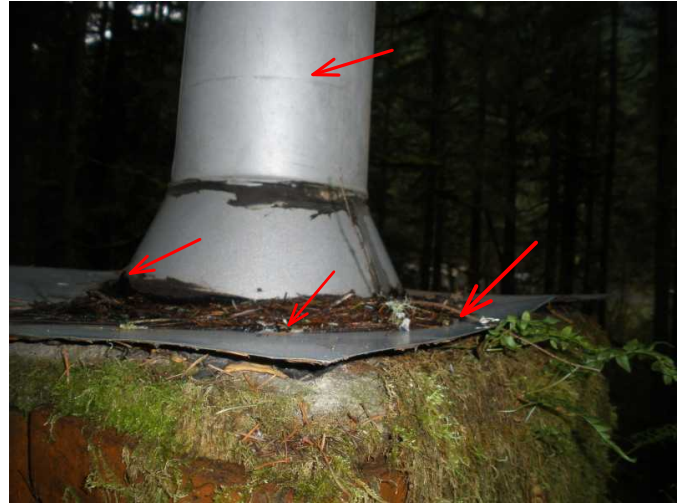
no flashing noted all around fireplace at all sides...correct...may be reason for high moisture in home as well...

single wall flue extension is not allowed in fireplace flues...replace...

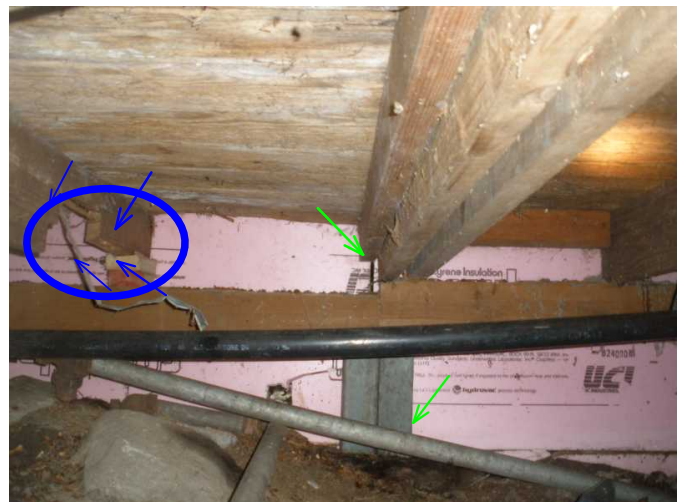
also noted leak area at sewer exit under kitchen drain area...posts are all noted raised and solid...

recomemnd marriing the blue arrow area...joists are cut and not enough support noted...correct...

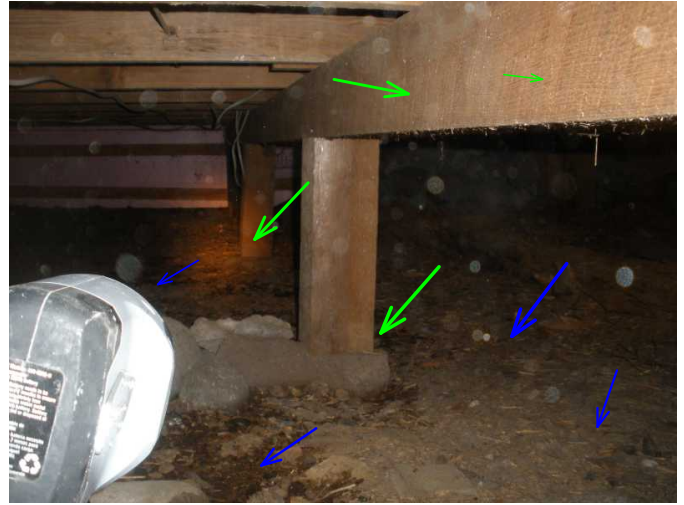
all post under dining area are noted raised on rocks/recommend pads...no vapor barrier noted for most of crawl..correct...

all wood under home is noted solid and raised..remove all rotted wood on earth and add vapor barrier...

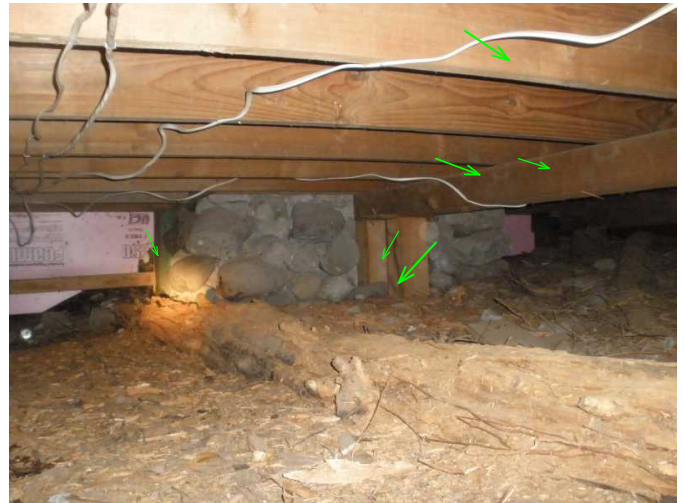
remove rotted wood...add vapor barrier and noted the base of fireplace is here...assess mortar joints...posts are solid...

joists and posts are noted solid...but rotted wood needs removed...recommend adding under floor insulation...

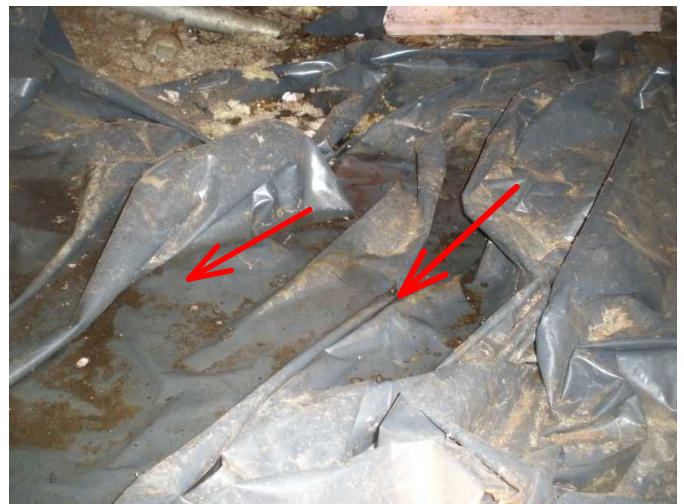
the area under kitchen is noted with leaks...and can be same issue as found outdoors at siding under sink area...

ponding water noted under kitchen area....appears to be a part of leaks...
