Home Inspection Report

1503 #52 Hayden Island Drive
Portland, Oregon

Prepared for: Manufactured Home Sample / Actual Report

Prepared by: The Home Tester

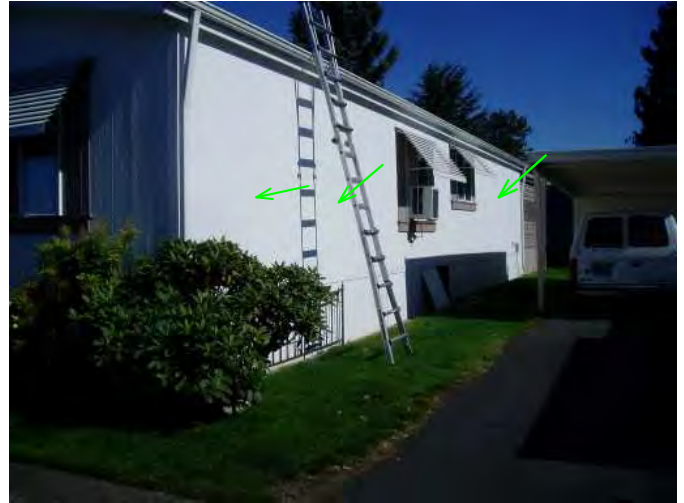
south side of home...all of home is painted/sealed well...good..

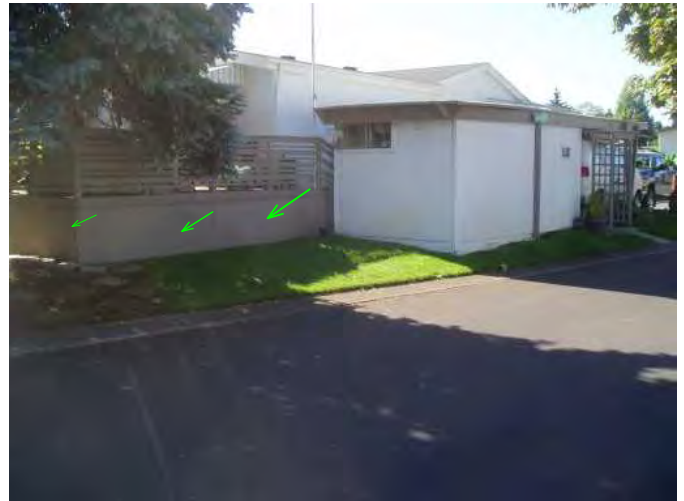
all skt=rting around home is weather resitant product ...deck is solid and sound...good...

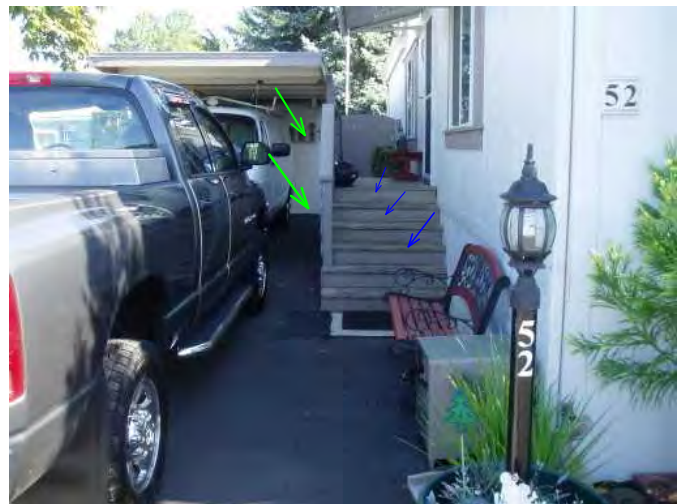
porch and steps and handrails are solid...will need to be cleaned and treated to extend useful life...

Porch: Wood - clean and reseal wood

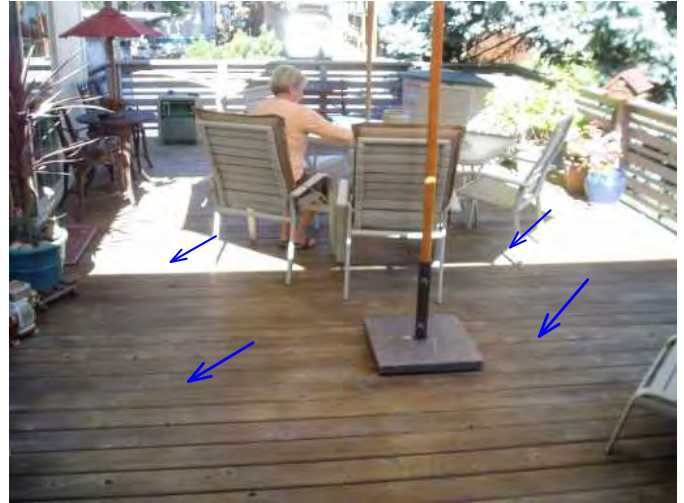
main deck and handrails are solid and sound...deck surface should be cleaned and treated/sealed

Deck: wood - Clean and reseal wood

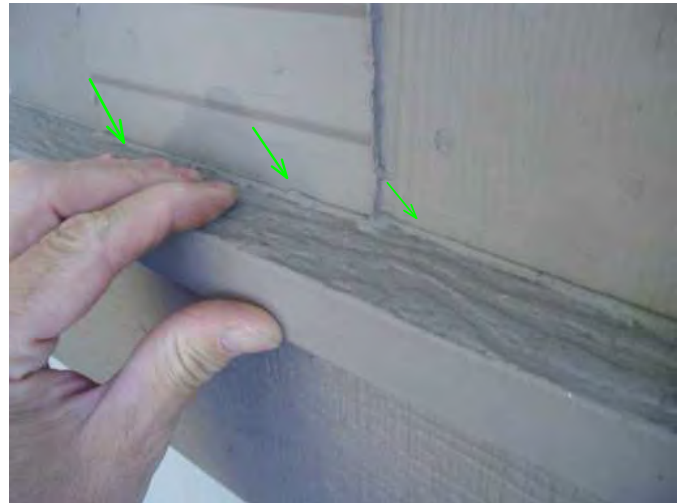
minor issues here at south side with need for caulk to seal at window trim....

Trim: Wood - caulk at open gaps at trim/noted at south side lower windows...

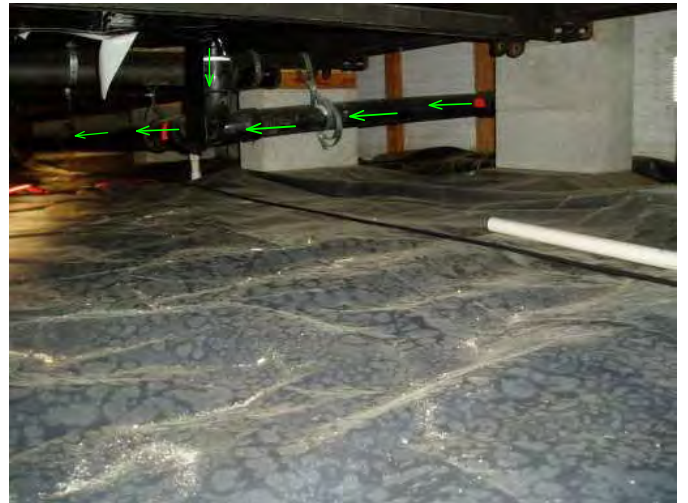
main water entry and main shut off is noted here and all water entry pipes are insulated....very good...

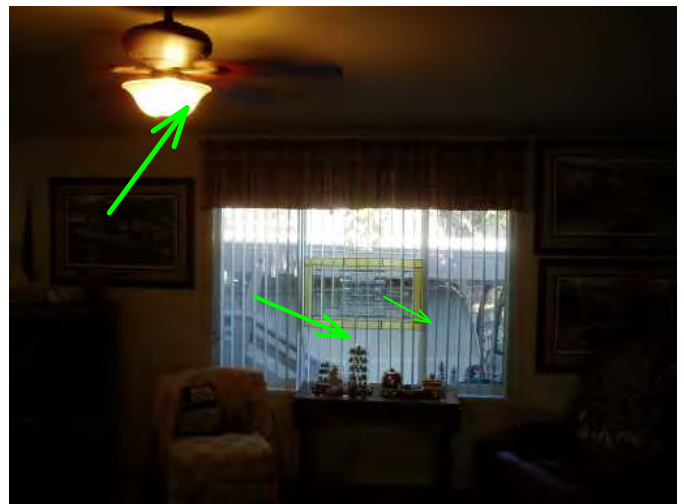
fixture and entry and closet doors are operable...good...add door stop discs wherever needed....

entry - Living Space - Doors: painted wood - needs door stop

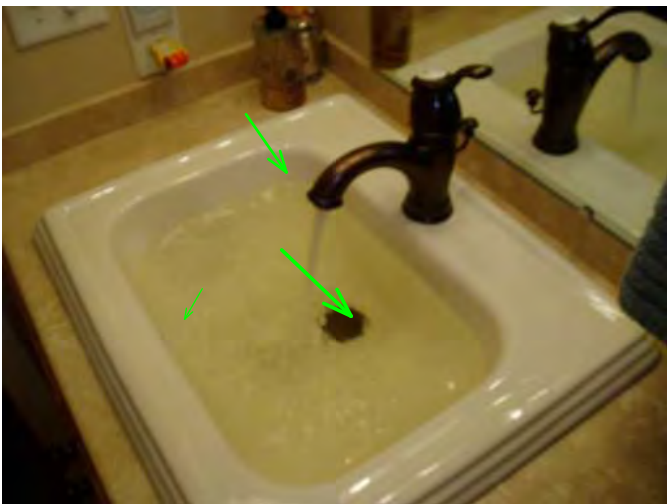
minor issue here needs to be caulked.....

1st Floor Hall - Bathroom - Counter/Cabinet: ceramic tile and wood - add clear sealant/caulk and back splash area at counter

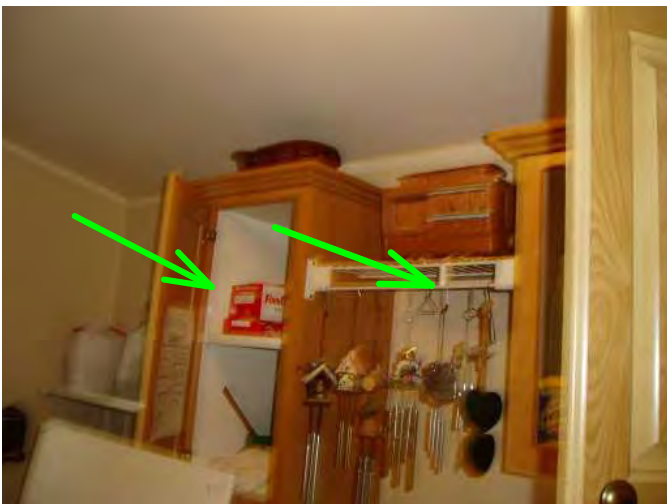
add door stop where ever not found...easy fix....

1st Floor Master - Bedroom - Doors: painted wood - needs door stop

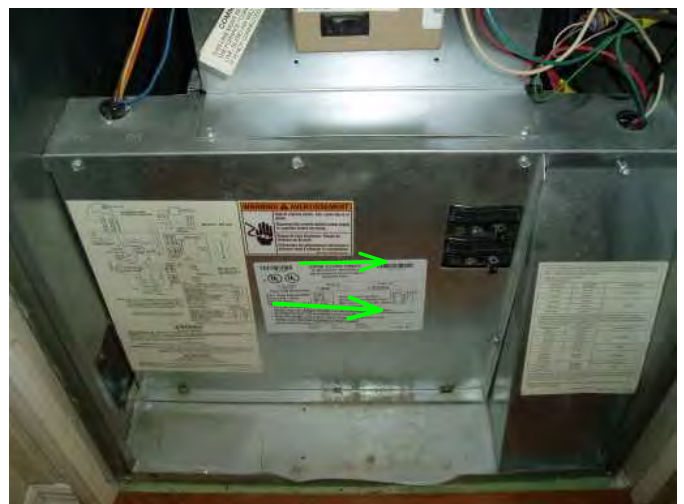
open view of electric furnace is noted here and has two filters....fine....
