Home Inspection Report

18623 NW Reeder Road
Sauvies Island, Oregon

Prepared for: Sample Report

Prepared by: The Home Tester
10555 SW Tigard St. #57
Tigard, OR 97223

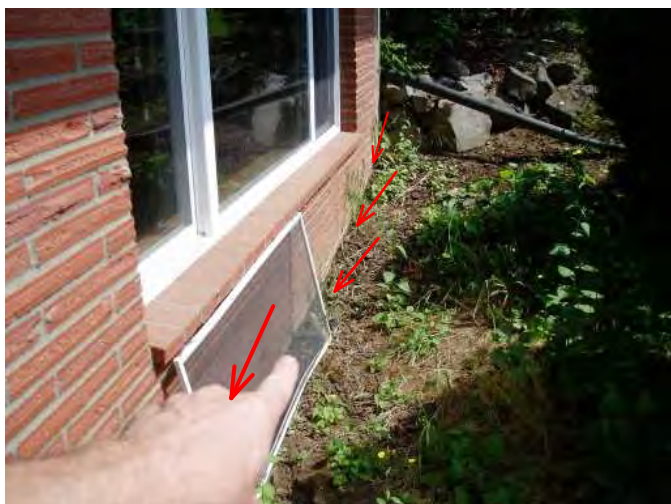
earth to brick is not good, no weep holes noted at base..not good...vapor has no way to exit

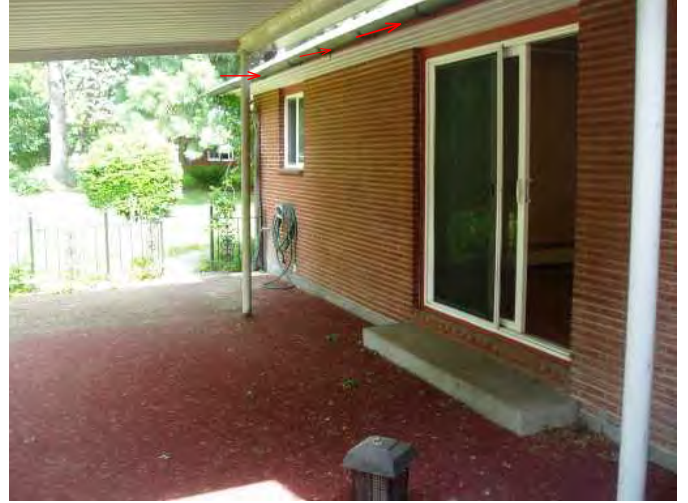
gutter here appears to be negative sloped...reslope for best drainage control...

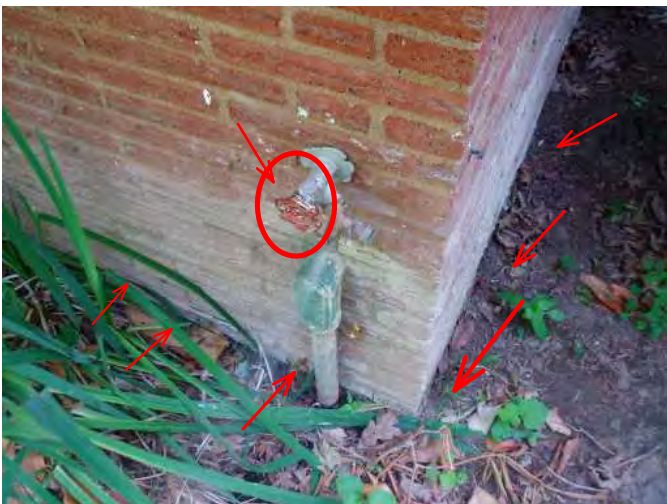
hose bib need repair...see spalling at brick to earth contact?

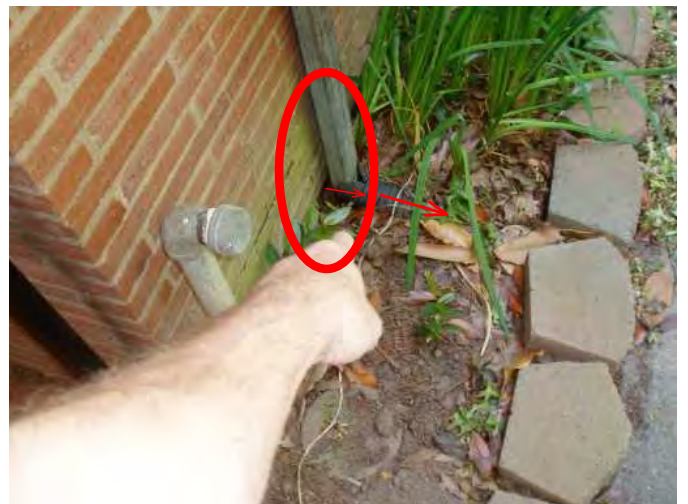
appears this is not working here...does not appear to feed into pipe..and wet at earth area...re-think at back patio

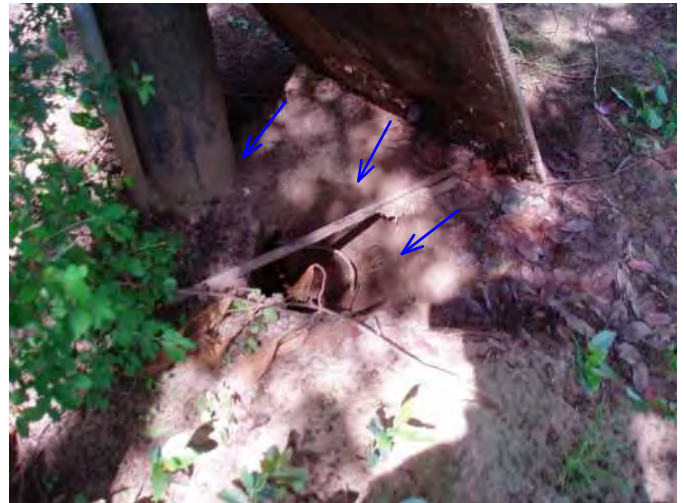
appears newer hole is here..pole is full of rot...will need replacement...

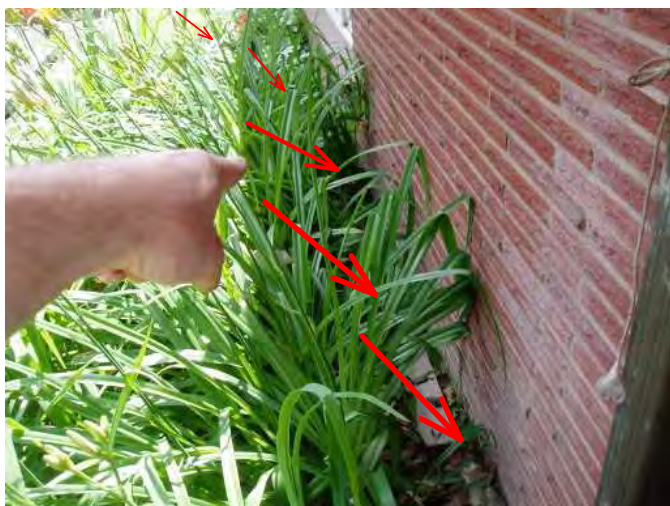
lower earth to brick contact here around planter in front of home...spalling noted...(wet brick)

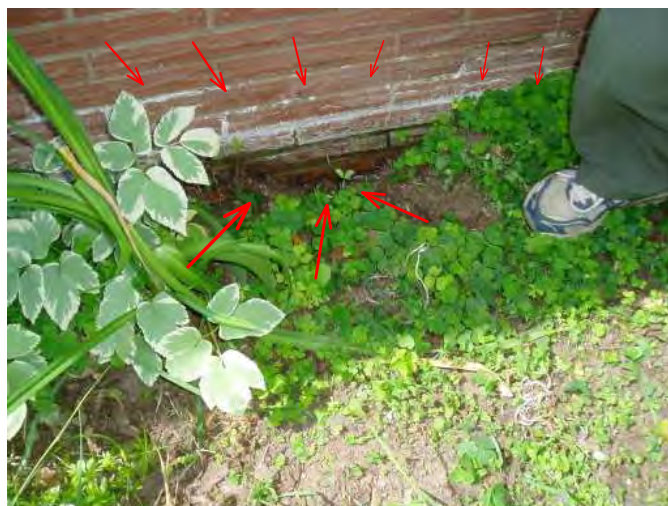
pulled back earth to show wet brick and white substance is spalling(salt from wet brick mortar) pull back earth...

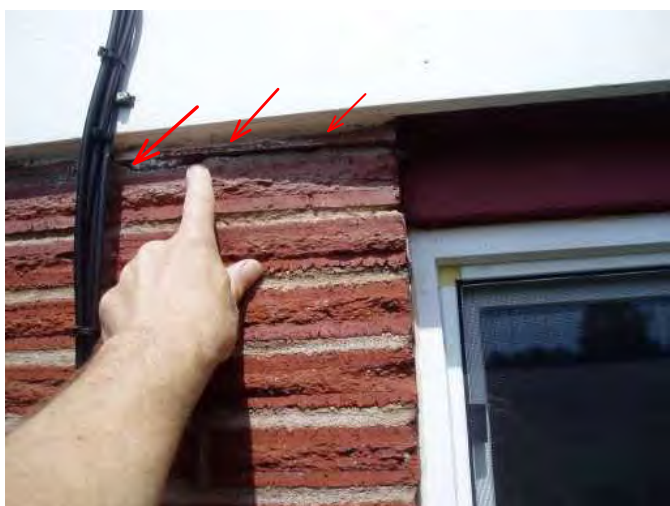
noted upper area of brick around window that has high moisture under window area is open here...re-seal...

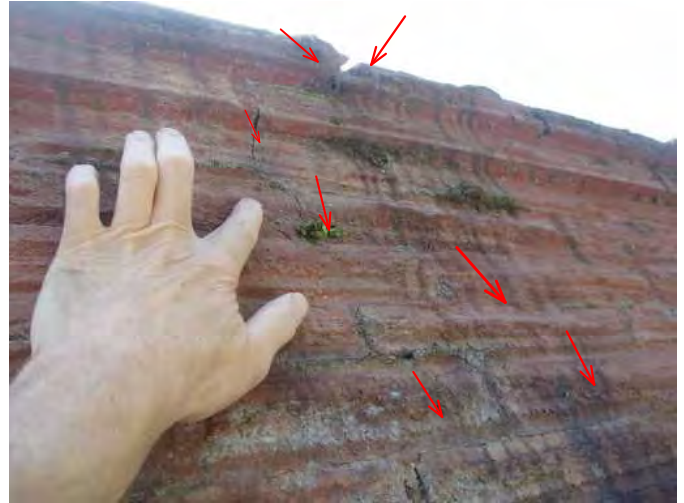
old crown is showing leaks that are staining chimney here at back over patio fireplace...

add solid rain cap with screen to keep out rain and critters...circle..arrows are pointing to needed new crown...

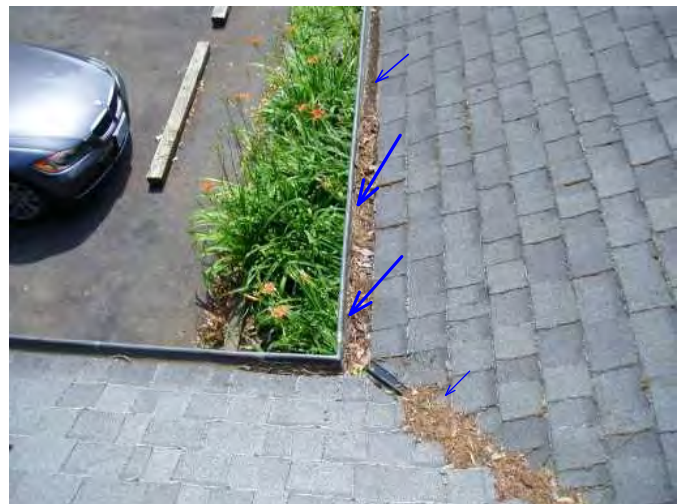
more full gutters mean leaks into home....clean gutters often...

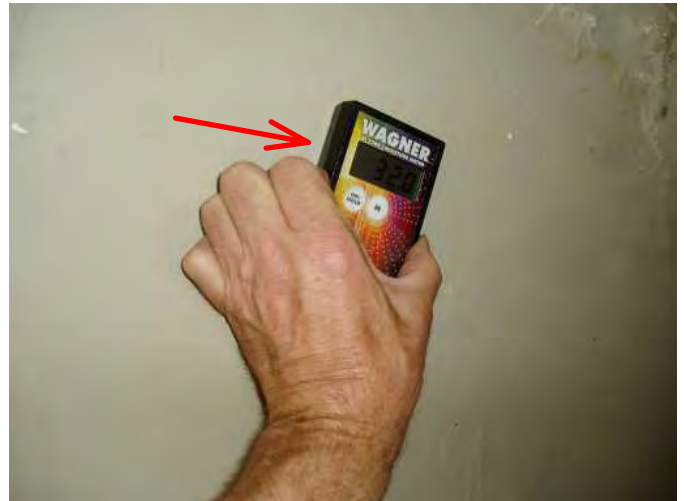
here is issue with family room walls...lower area and at corner is noted with very high moisture content, will need work

really high here at lower areas...32% is very high...

Leader/Extension: Aluminum/plastic - area at family room was just recently connected to extensions...has been dumping in area all winter..is reason for wall damage...repair or replace affected wall areas shown in photos...

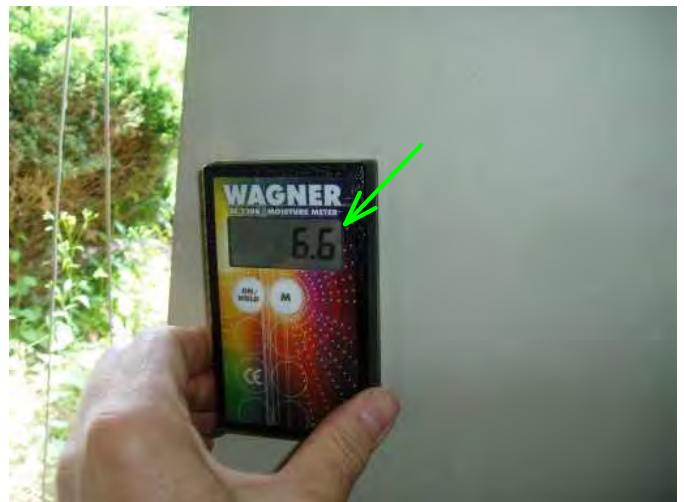
again in lower area under downout area outside that should have been connected to exit extensions.....

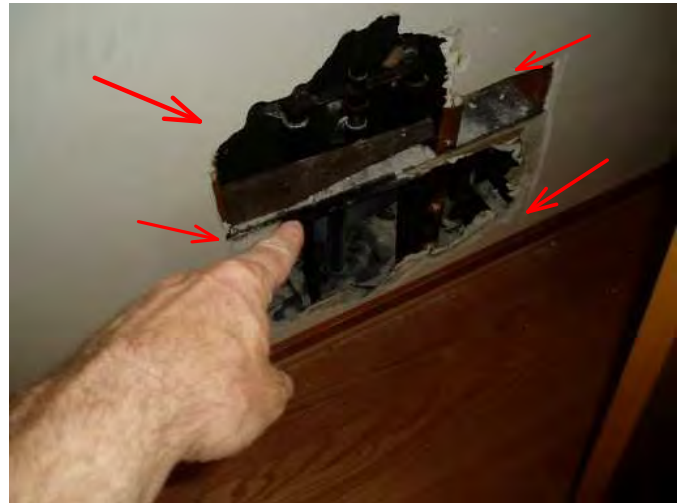
large hole in closet was found..not in home before...not sure why..no leaks noted...

2nd Floor Hall - Living Space - Walls: drywall - open holes noted...repair..mostly cosmetic in closet to left of master...

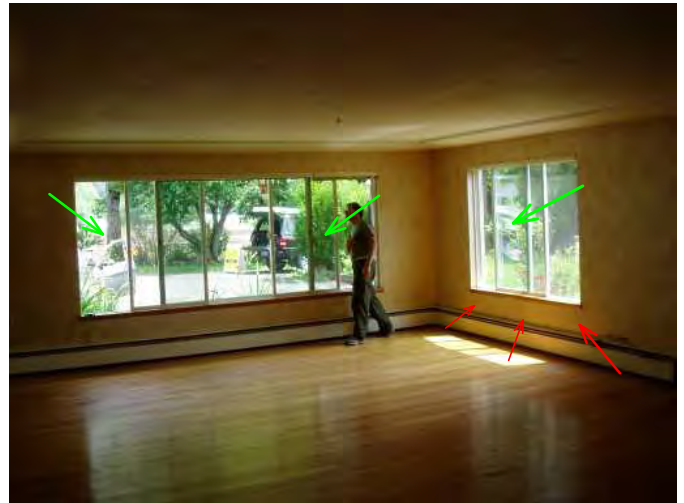
living room windows are operable...found high moisture in lower area of right window...

Living Room - Living Space - Walls: drywall/wood - Water present, under right window at porch area...see photos...repair or replace affected areas...

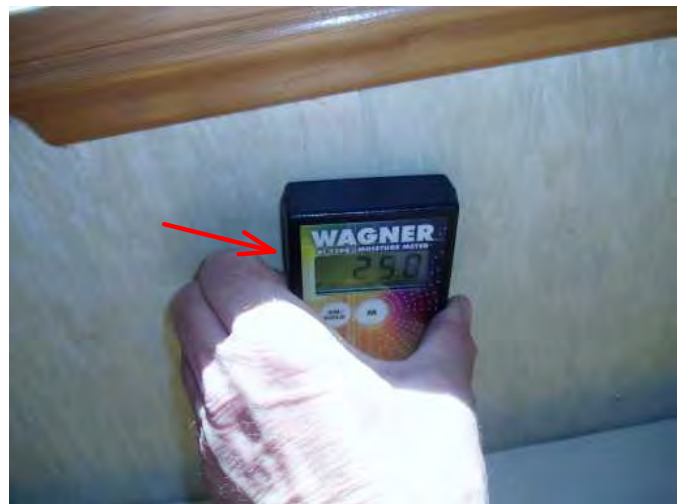
area udner window is noted here as high and needs assessed....

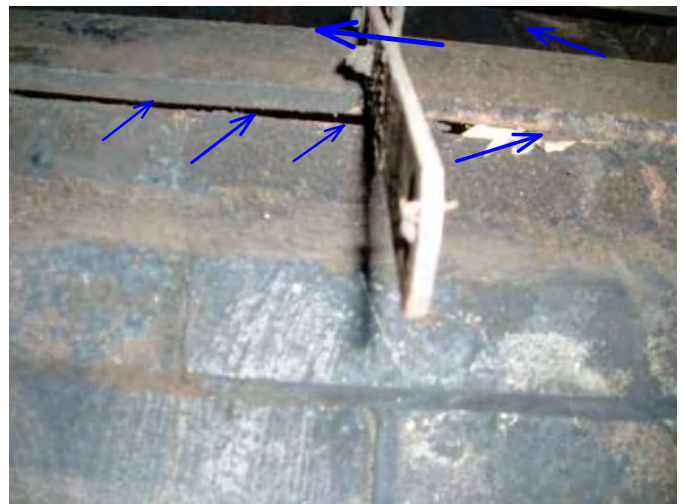
damper is needing cleaned, and will need sealed at base....

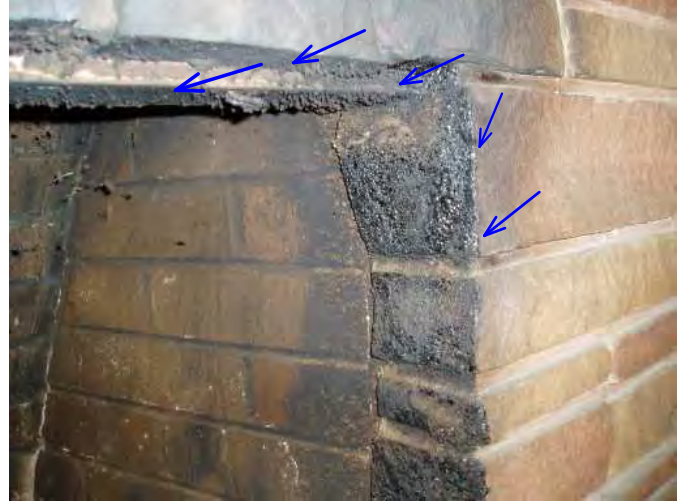
lots of soot noted here and in chimey flu and smoke chamber..have cleaned...

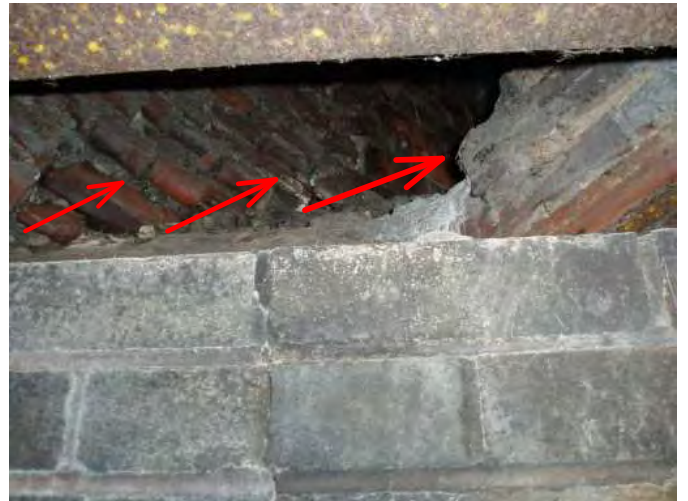
no damper noted...add top cap damper for best results...

- Patio - Fireplace - Damper:** none noted - add top cap damper to avoid water, critter and bird entry...

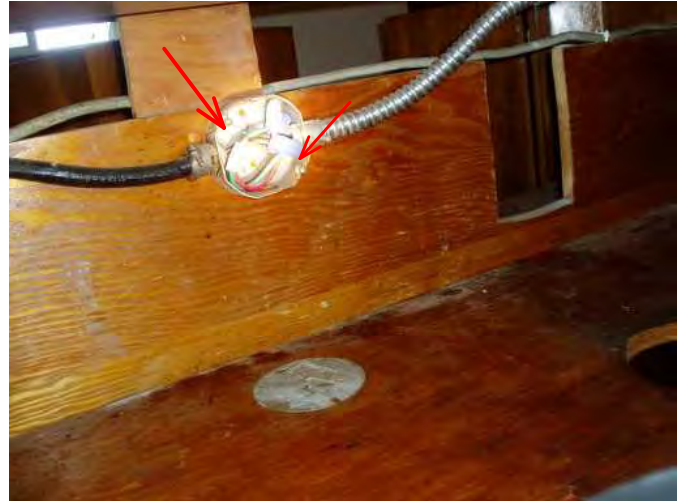
add cover plate to junction box under stove...shock hazard...

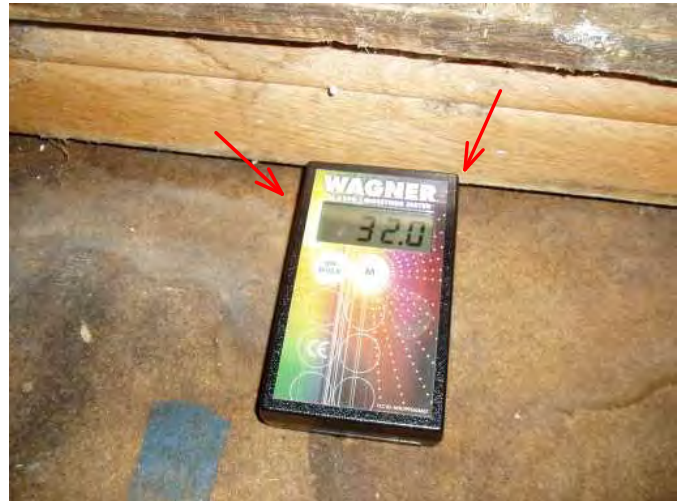
all area at cabinets at area under sink are very high moisture content...most likely wet under wood floor area at joists...

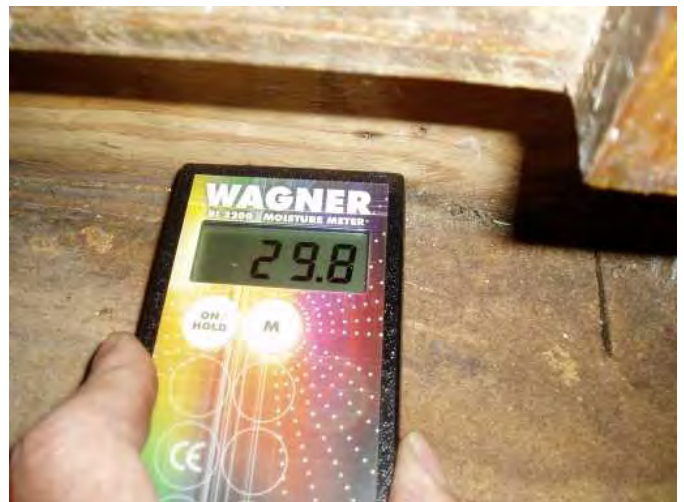
close to under dishwasher area...very high content noted....

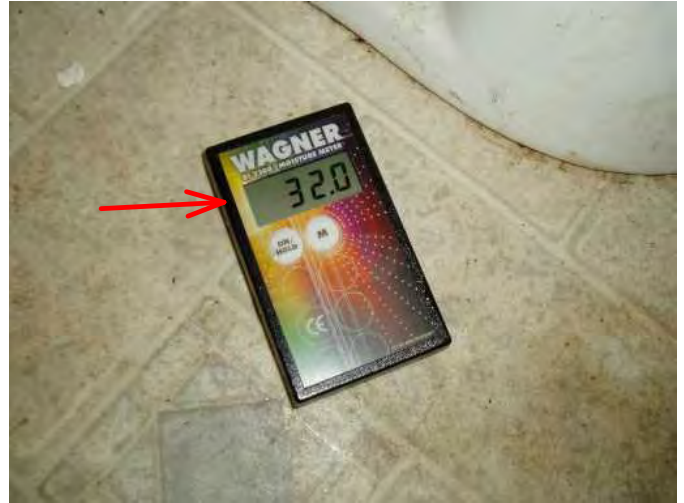
here at front of toilet is same...very high content noted....repair or replace flooring...

- first floor rear of home - Bathroom - Floor:** Vinyl floor covering - high moisture noted around toilet, assess and repair...
- 2nd Floor Hall - Bathroom - Tub/Surround:** Porcelain tub and ceramic tile surround - drains slow...or not at all...repair...
- Basement - Bathroom - Walls:** drywall - exterior lower wall is showing high moisture and will need to be repaired or replaced...
- Basement - Bathroom - Faucets/Traps:** Brand not known with PVC trap - no drain stop noted...toilet not draining...
- Basement - Bathroom - Toilets:** American Standard - does not flush/drain well

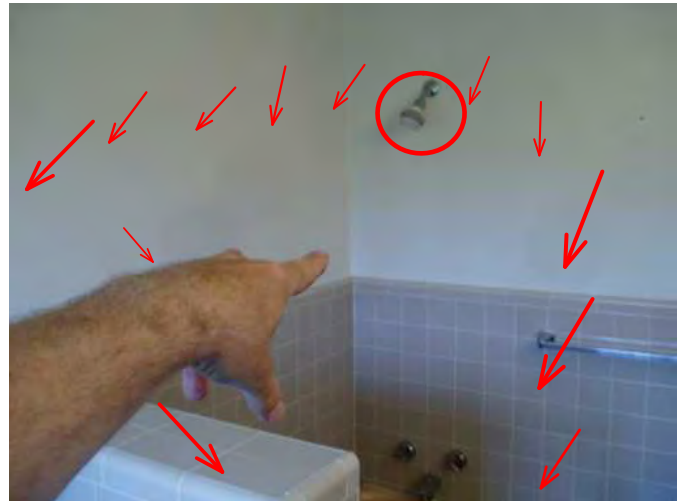
this is all wrong for wall wetness protection...needs tile to area at shower nozzle and enclosed to contain spray....

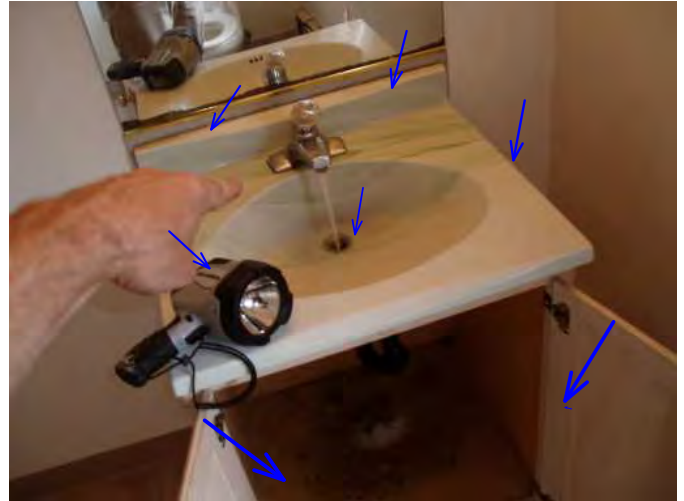
this counter is installed over old counter..and cabinet is showing lots of moisture issues...replace...

Basement - Bathroom - Counter/Cabinet: formed marble/wood - Peeling laminate, Moisture damage, replace

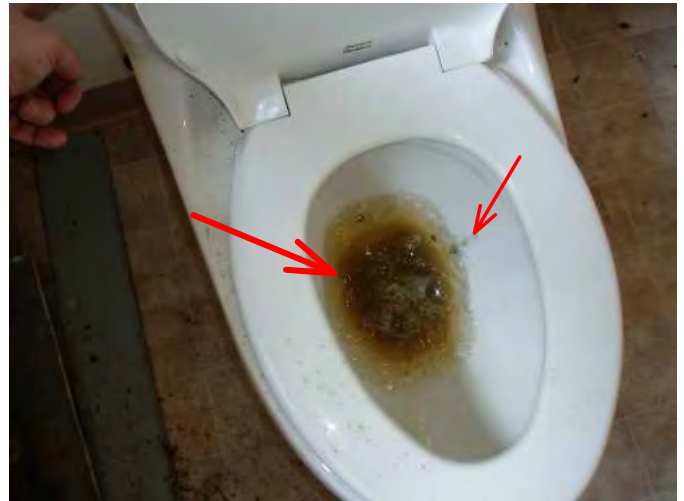
toilet is not flushing properly....repair or replace...

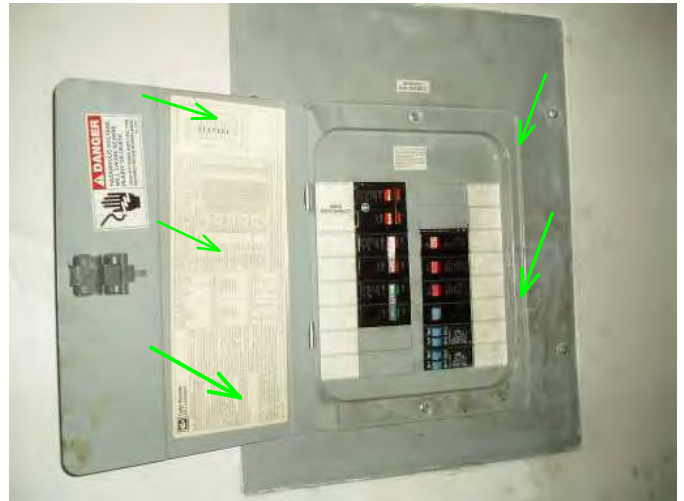
open view of panel shows a conflict of breaker sizes..this one is 60 amp...and breaker in main panel is 50 amp...assess...

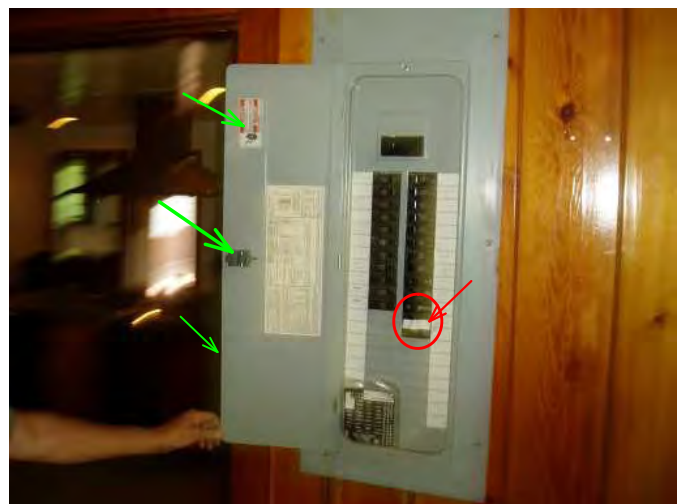
here is main service panel in back mud room area....noted well marked...any breakers taped off should be removed...

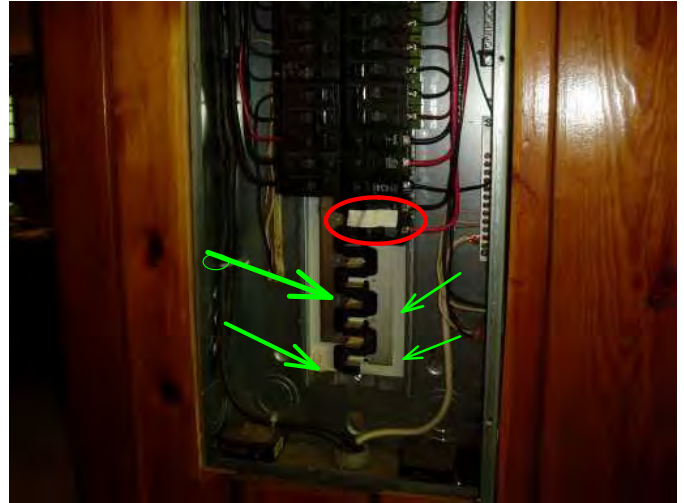
125 amp service entry wires noted with 200 amp breaker ...needs attention now...upsizing service is best answer...

remove tape and identify breaker or remove breaker...after upsizing service, you will have lots of room for growth...

- Service:** Aluminum - copper service entrance conductors are undersized for main breaker, Evaluation by a licensed electrician is recommended
- in utility room - Electric Panel - Main Breaker Size:** 200 Amps - undersized entry wires are noted...
- in utility room - Electric Panel - Breakers:** CU - other breakers are noted as undersized for wires, have licensed electrician assess and correct...

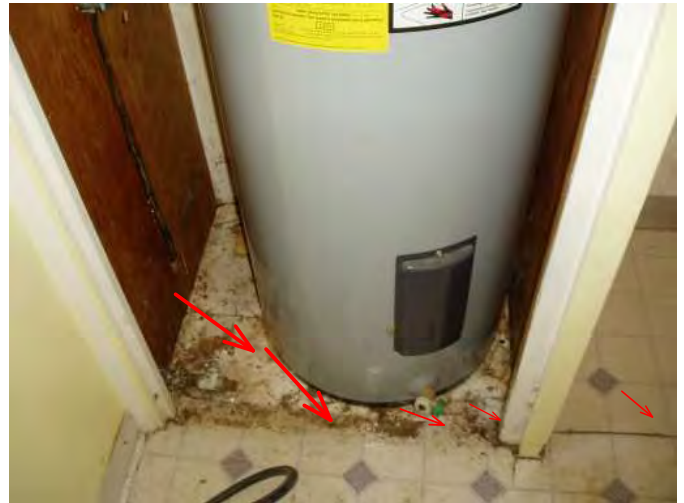
appears to be old wet area from old water heater...strap water heater...

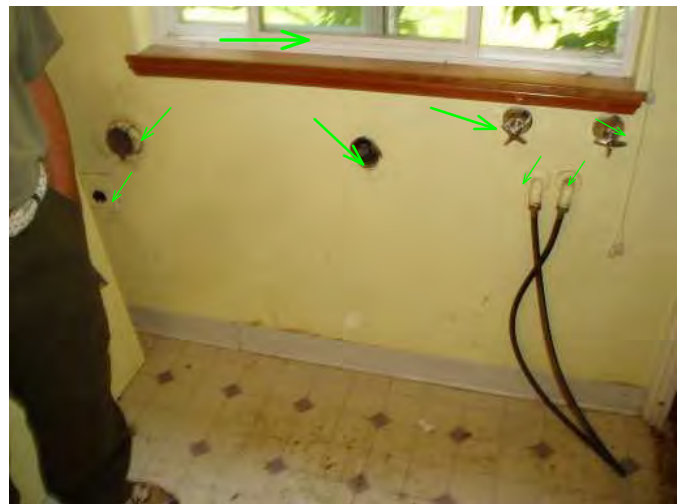
open wires like this need to be in junction box....repair for shock safety...

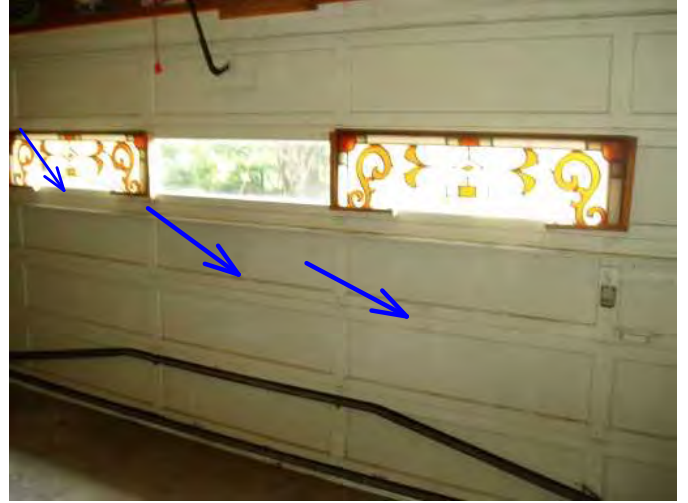
garage door is operable...but is not attached to opener...and is very heavy to operate, have repaired by door specialist

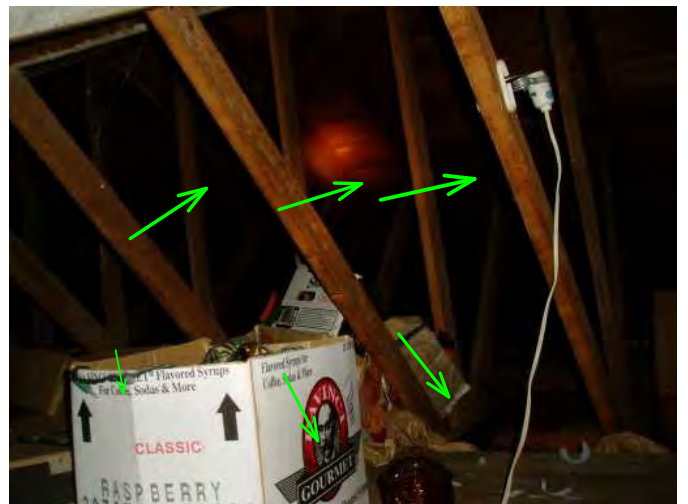
noting cloth wrapped wiring in attic over breazeway....not grounded...

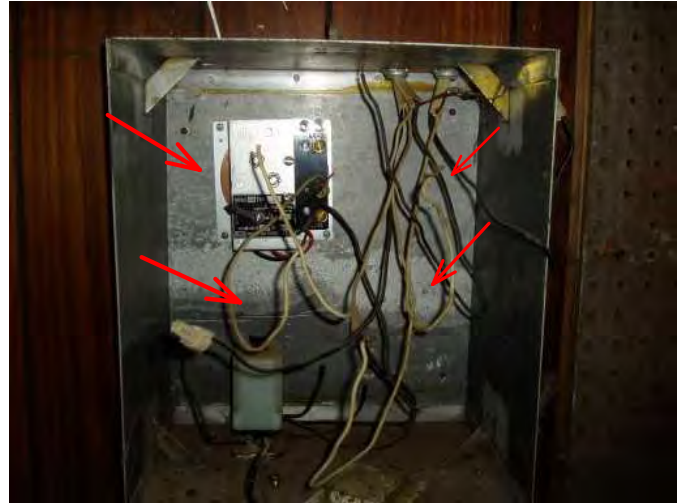
old service box is noted here in garage..not sure what to make of it..have assessed by electrician...

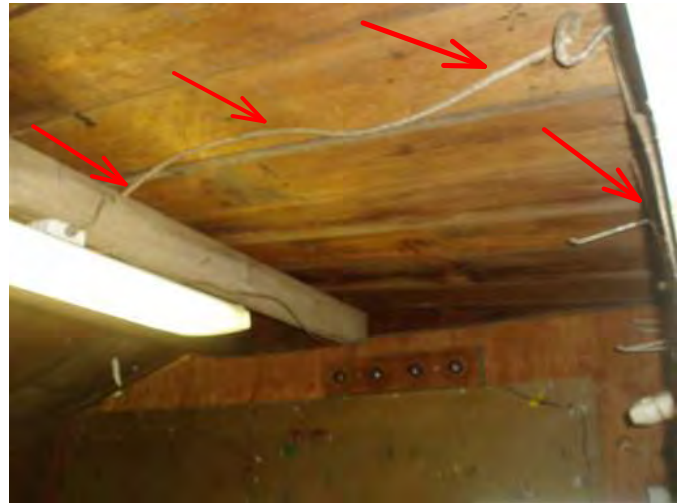
add any wiring into conduit...for shock safety...

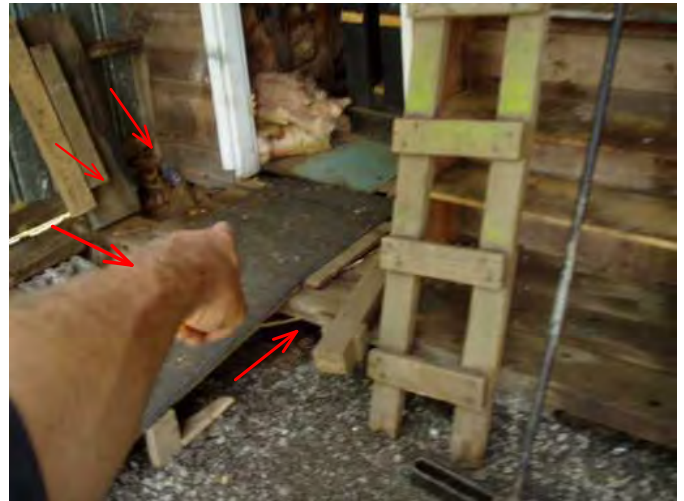
enclosed area flooring is noted here as rotting and needs repair at random....

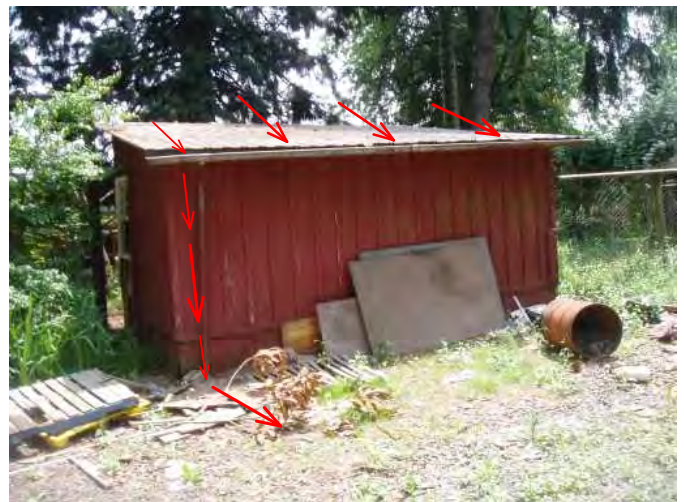
back of chicken coop needs gutter re-attached and downpout added adn extension as well...
