Home Inspection Report

8170 SouthWest Maxine Lane #65
Wilsonville, Oregon

Prepared for: Sample Report/ Actual Report / Condo

Prepared by: The Home Tester

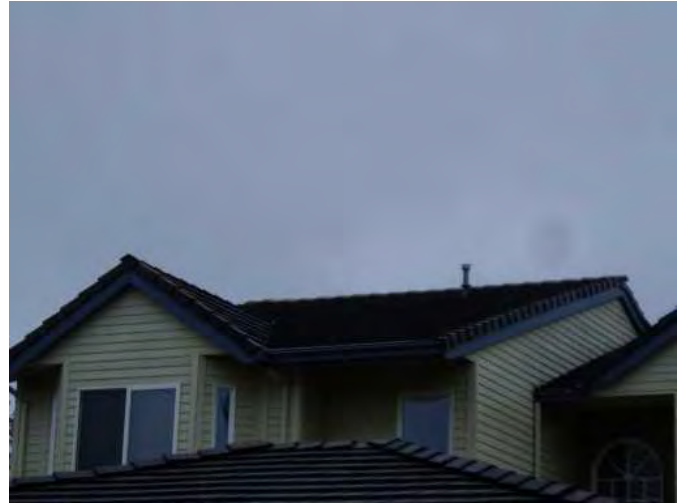
front view of unit and garage....

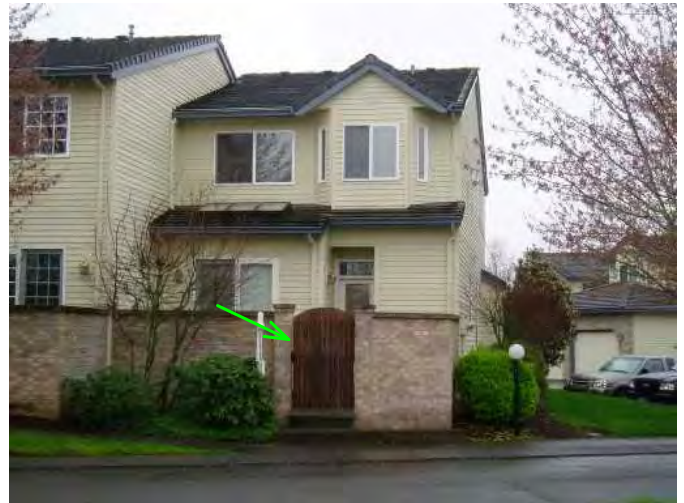
side of unit...entire outside of unit appears well maintained...as does complex...

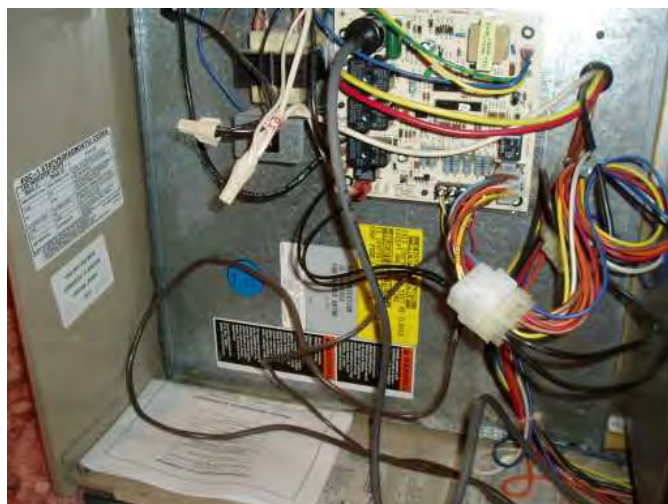
4 burner system is operational...in furnace...good...has draft inducer...good..

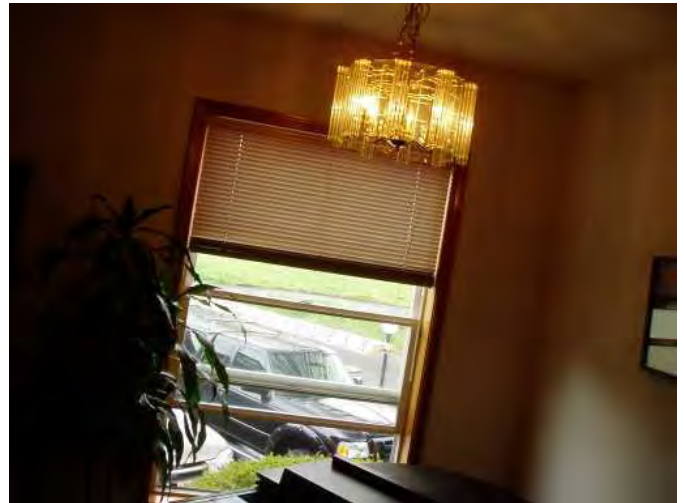
living room windows are operable..but need screens...may be screens in garage...

Living Room - Living Space - Windows: all vinyl - missing screens...noted screens in garage...may be the ones...

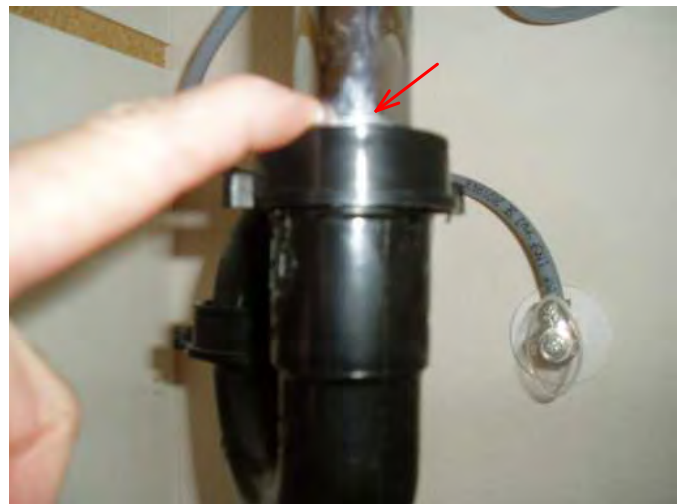
smal leak noted at trap...run all faucets for 2 hours to detect any future issues..here is one...

Master/front - Bathroom - Faucets/Traps: Brand not known with PVC trap - Leaking trap, minor leak, repair...

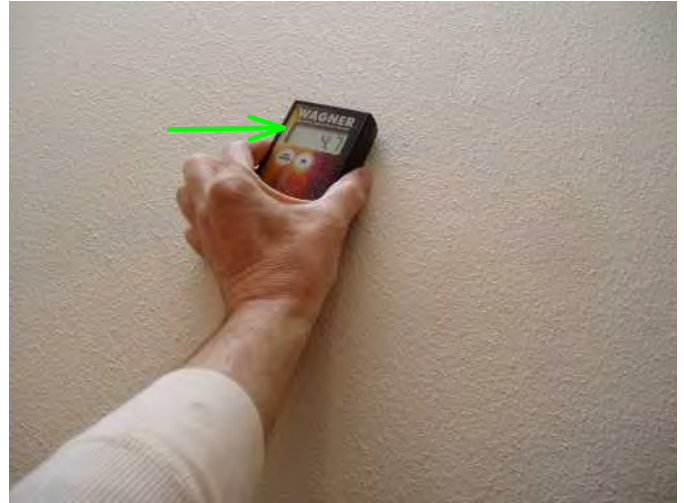
moisture meter at walls shows all good...

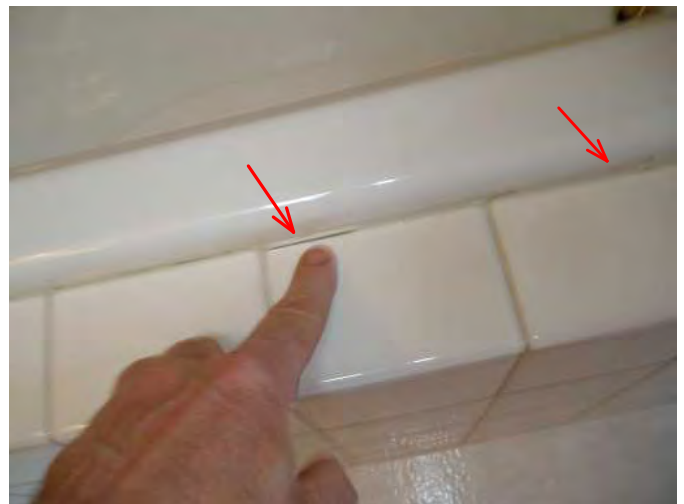
minor grout repairs needed to keep out water at joints noted...

Master/back - Bathroom - Tub/Surround: Fiberglass tub and ceramic tile surround - Loose grout at tube to tile area in front...seal up
