Home Inspection Report

Actual Inspection

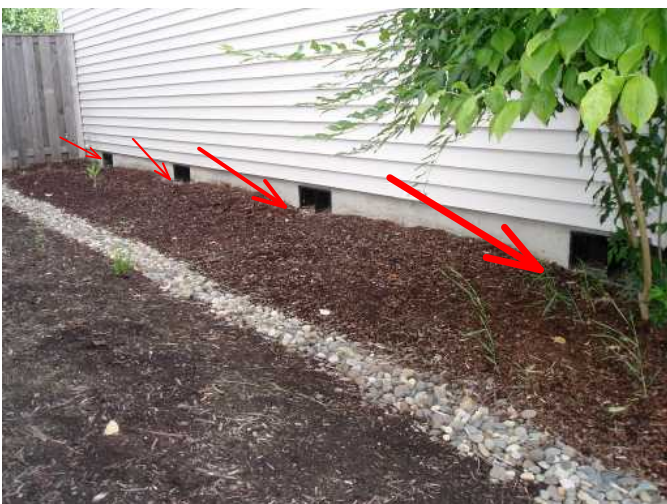
vents to crawl...do not add any more barkdust...will cause water entry to crawl...keep even or below...

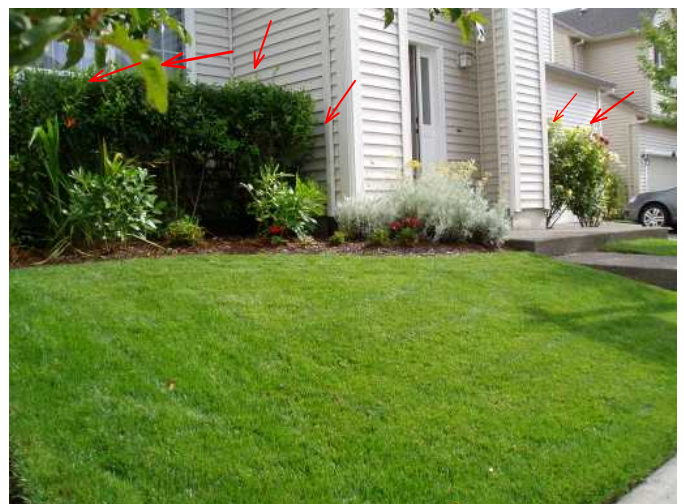
as noted in report..keep shrubs away from home 12-16 inches..these are a bit to close...

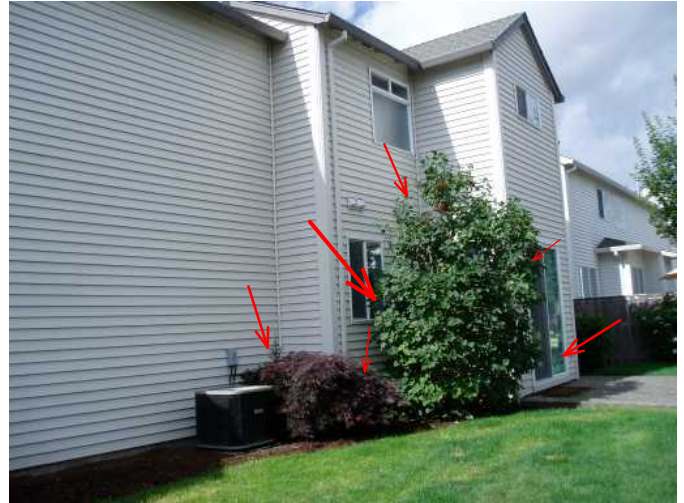
backside of home looks good..air conditioner is on level pad..good...again..trim back shrubs..to close...

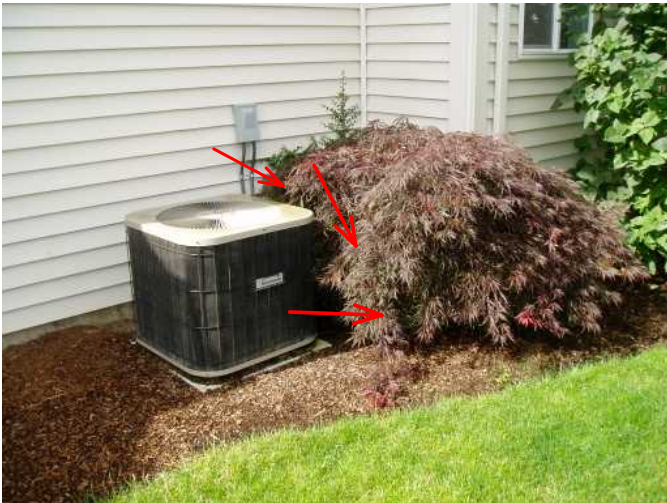
a/c unit was installed after home was built..runs fine..trim back shrub here is to close to unit to make it work harder.

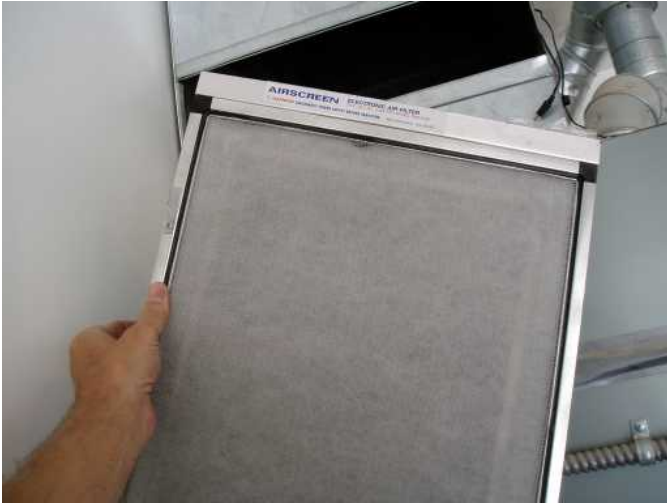
furnace filter is electronic and is replaceable insul fiber ..see directions on side of furnace....

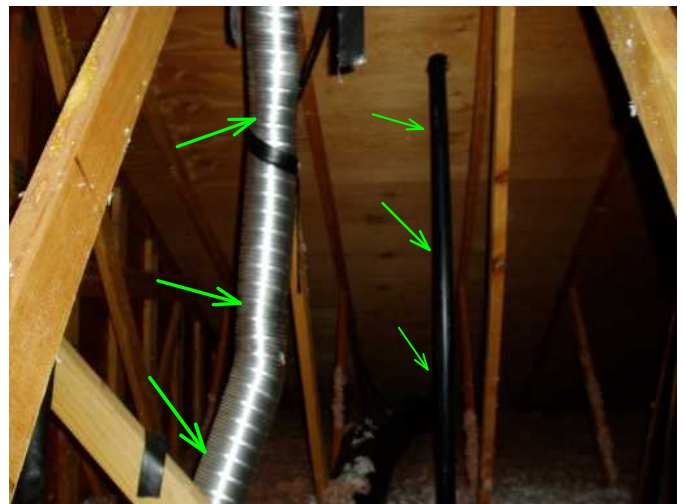
attic is plywood sheathing and 2x4 truss system...bath venting is good from both baths...one sewer vent pipe noted here.

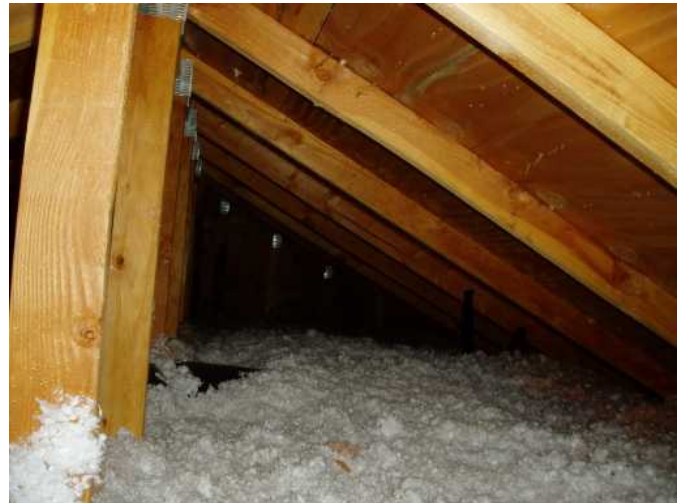
lower attic area above great room on right side of home..lower attic area...good insulation here too...

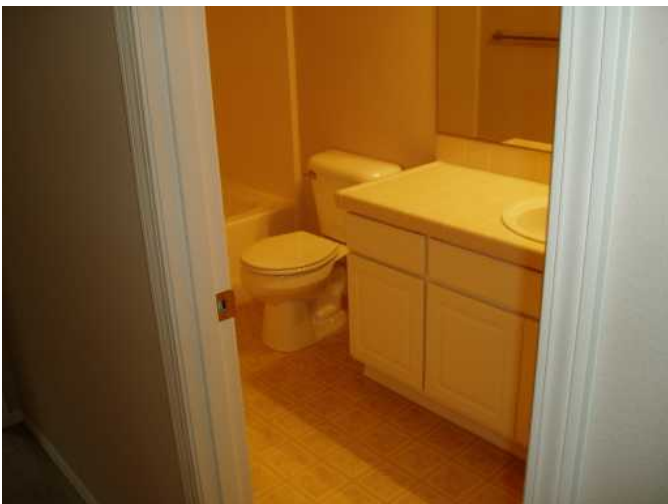
main bath door works fine...no moisture noted in floor around toilet and shower areas...

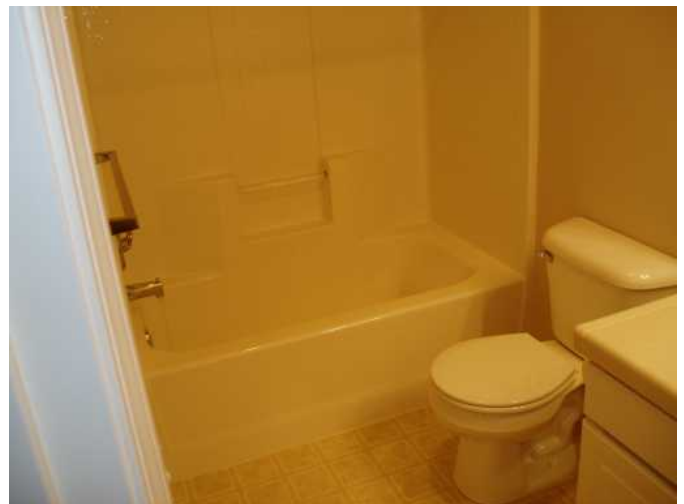
ran shower and sink and toilet and did rate of flow test..all good...no variation in water temp or flow noted...

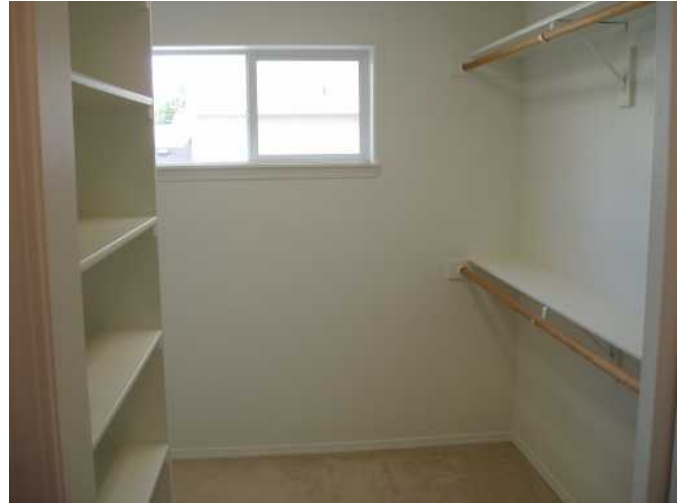
master closet is in very good condition...

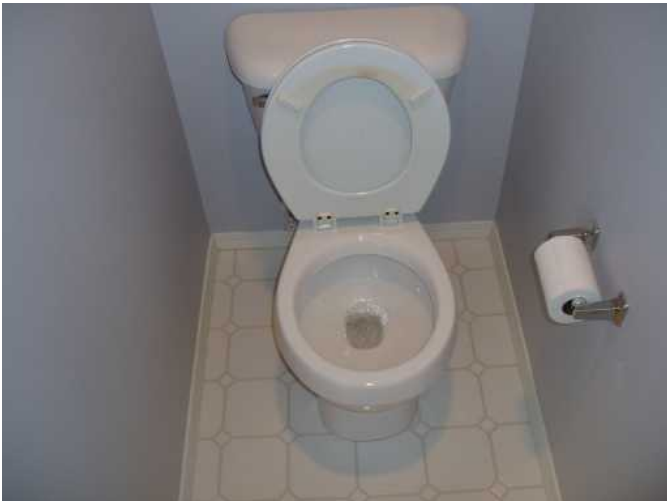
did rate of flow test...when all utilities were in operation..noticed a bit of slowing of flow..use only tub or shower...

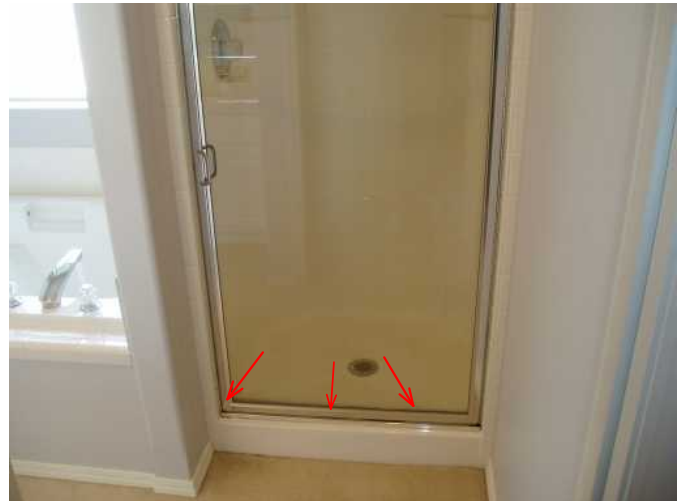
shower showed no leaking at door seal..good..

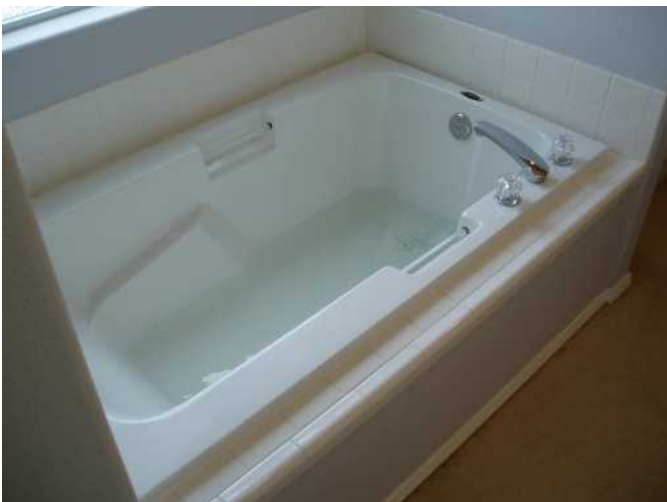
tub filled and drained well...ran slower with shower and both sinks ..only run tub or shower, not together....

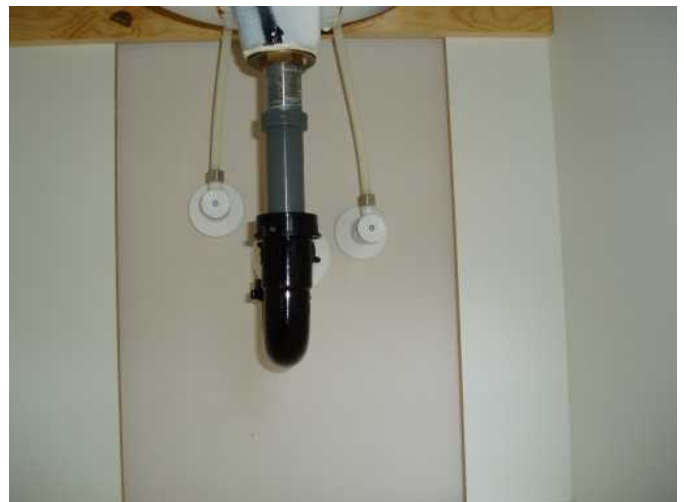
under sink had no leaks ...left master

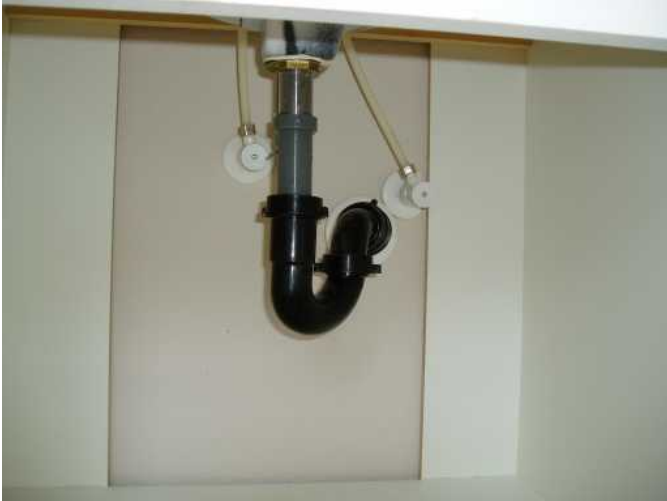
under sink had no leaks ...right master

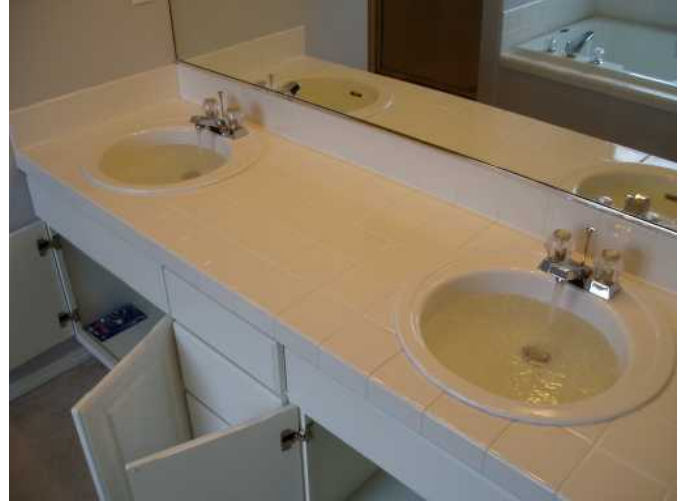
did overflow test on both sinks..did fine...

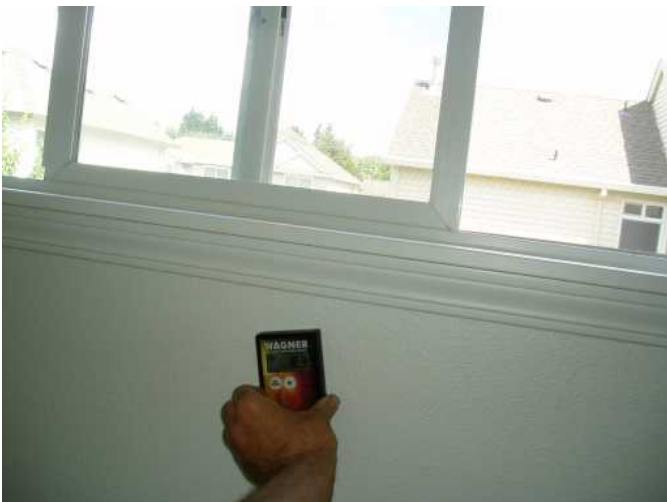
master closet window worked fine...did moisture check of walls around windows and at random, 5.5% - 7.7% good...

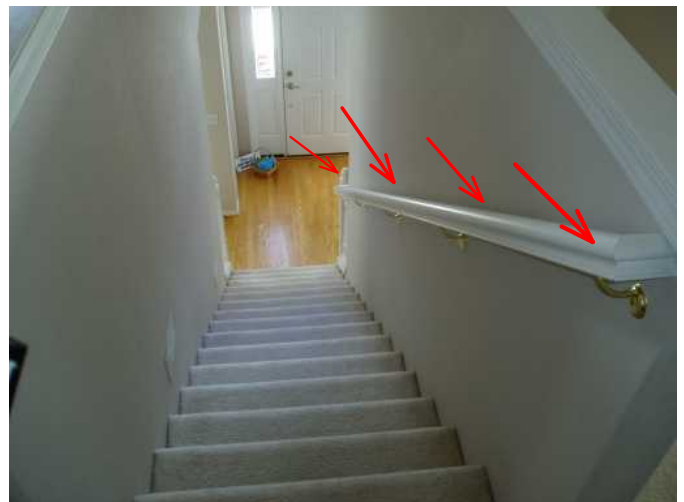
handrails to first floor are solid and sound...

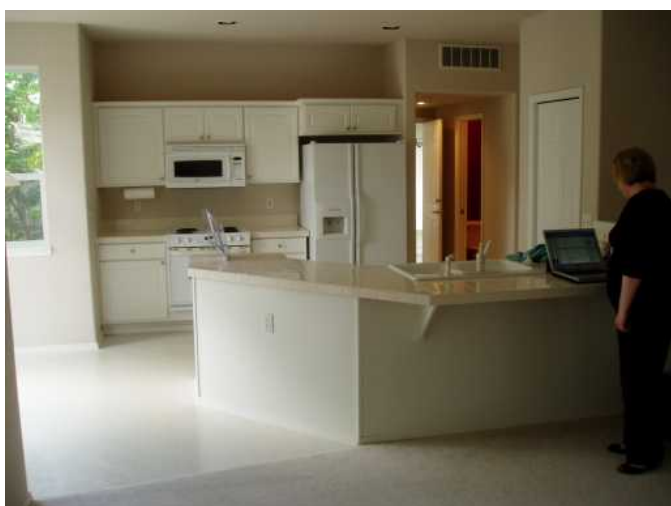
overall view of kitchen...cabinets are in very good condition...counter tops are well maintained...

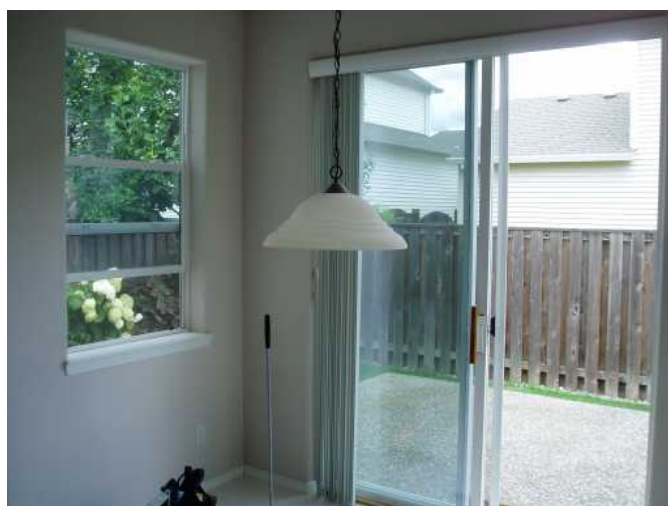
dining area windows (2) and slider are operable....

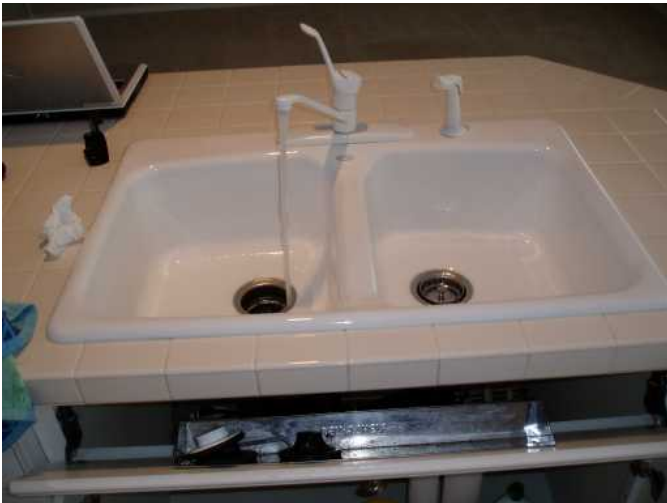
did flow test at kitchen sink and ran dishwasher through complete long cycle..all good no leaks noted...faucet is good.

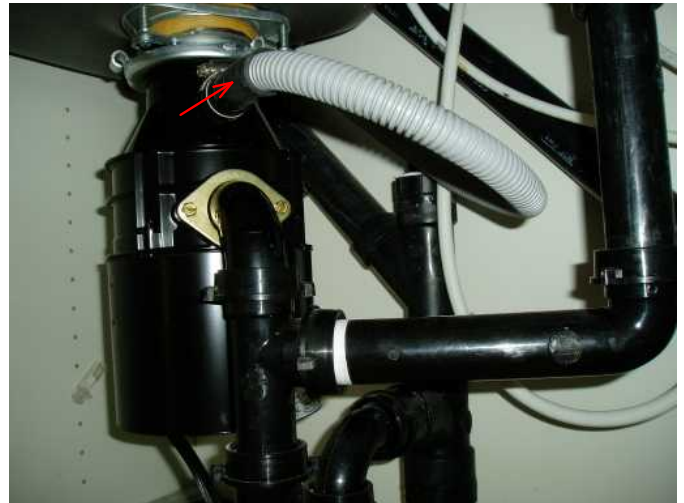
air gap for dishwasher..good...no drips here...

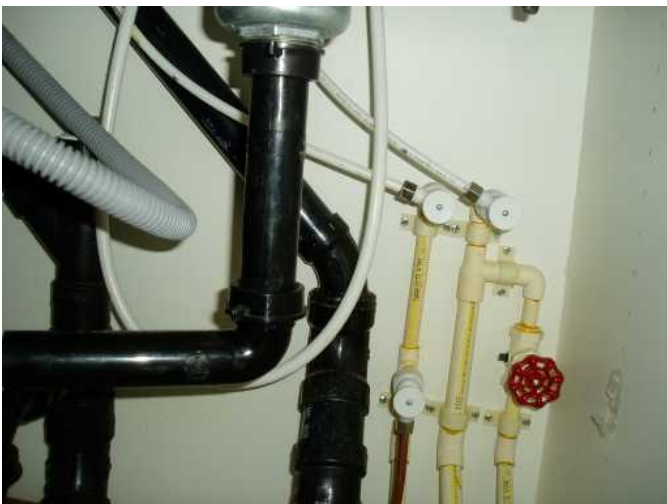
water connedtions are all solid and no drips noted...

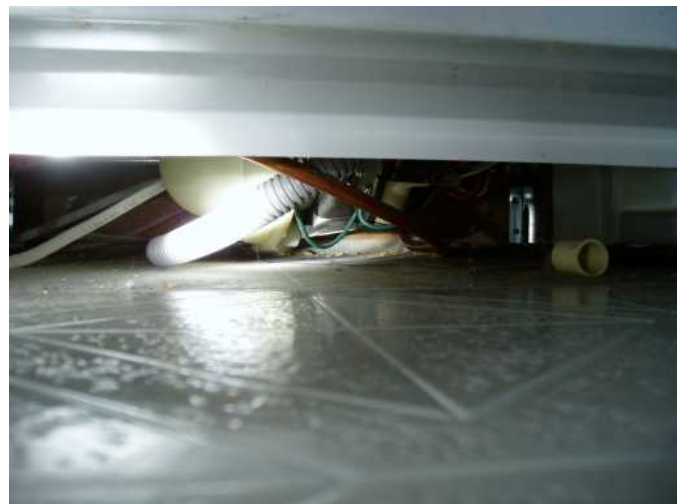
under dishwasher is dry and tight...

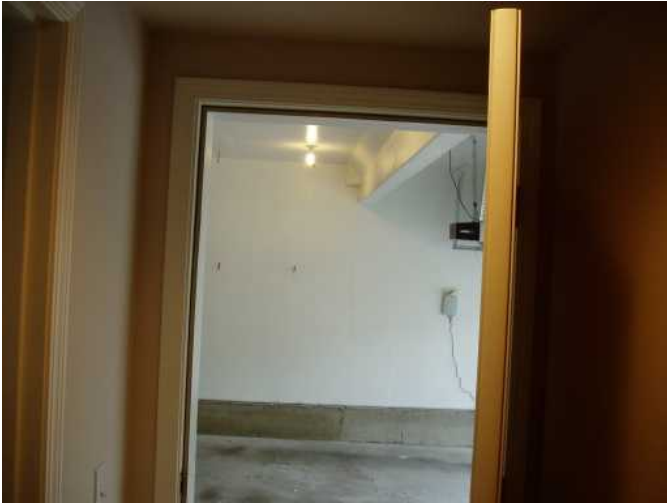
weather seal around garage door is in good condition...

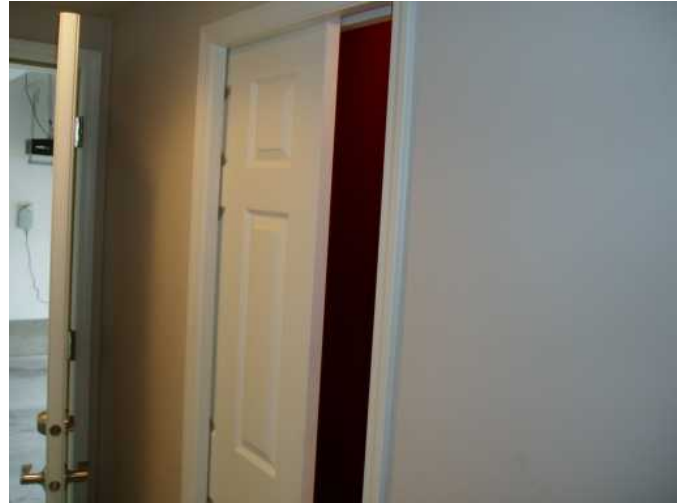
pocket door to powder room works great....

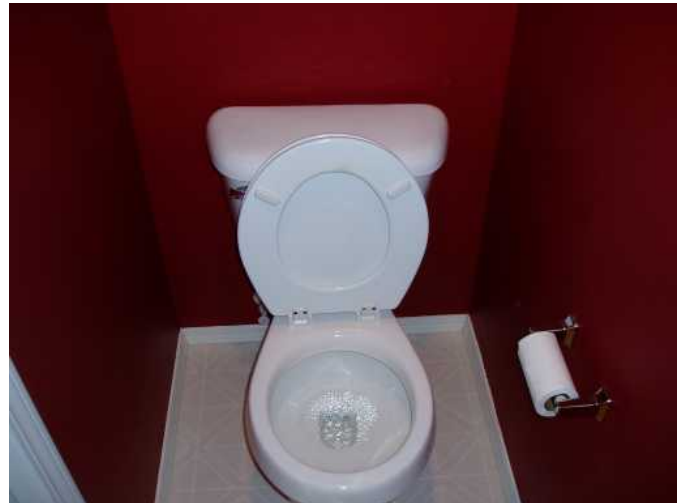
checked around toilet base for high moisture...no signs noted...power...

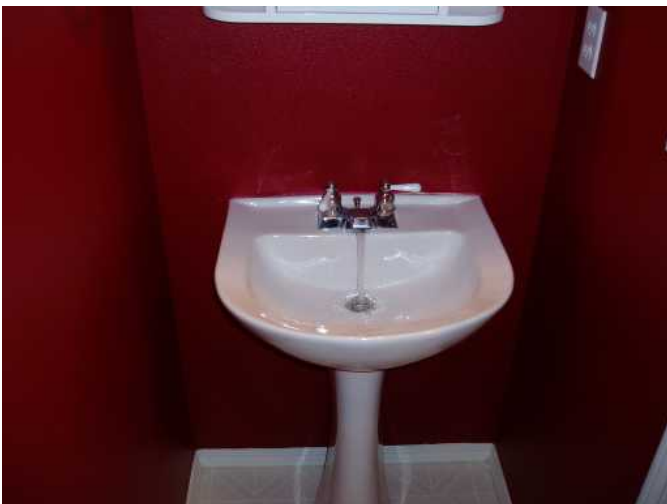
pedestal sink has no drips noted...faucet works fine..overflow works as well...

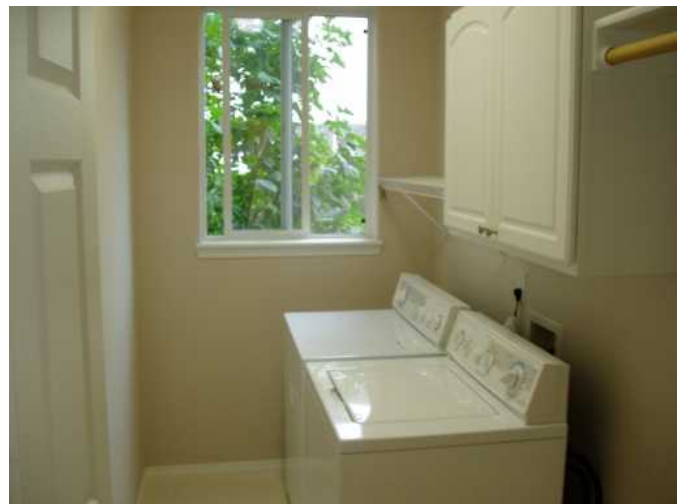
laundry window works fine..ran both machines through complete cycles..all good...no leaks at connections....

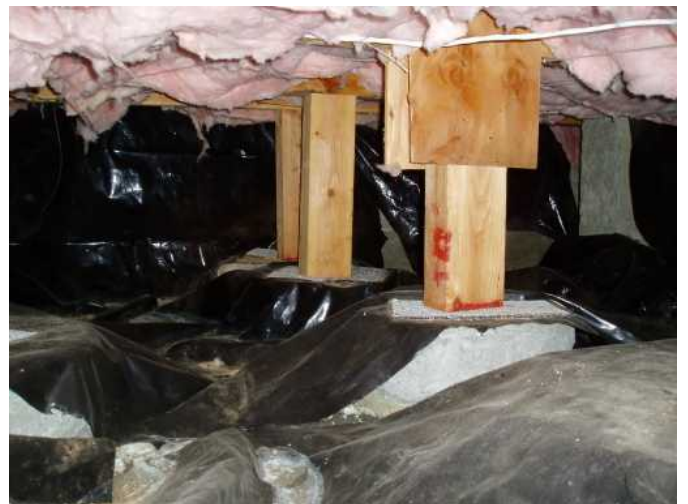
more post and beam and insulation and moisture barrier over earth to keep dampness out of your home...very good

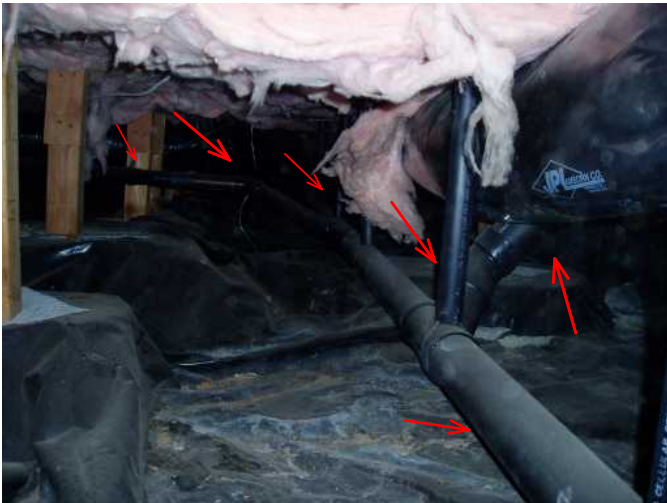
main sewer exit pipe is solid and sound with no leaks noted....

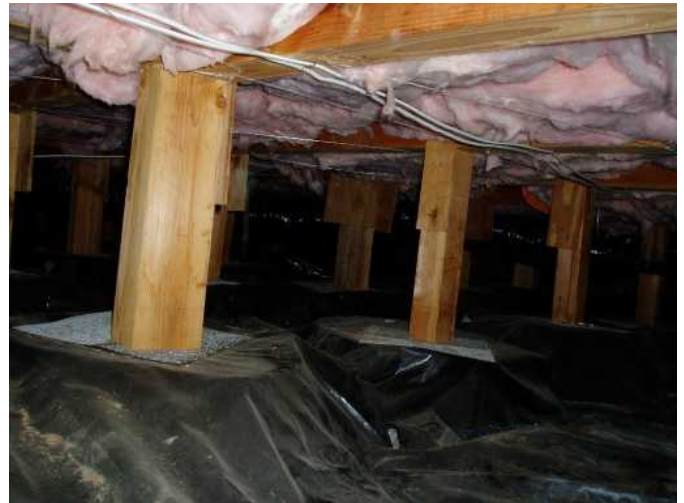
another great view of lots of post and beam under your home...

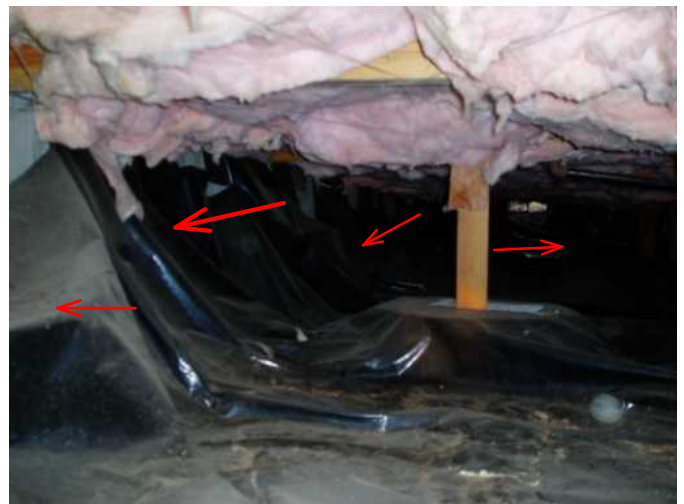
moisture barrier goes up the side walls...this is by the book..I love that!!
