Home Inspection Report

Actual Inspection

Prepared by: The Home Tester
10555 SW Tigard St. #57
Tigard, OR 97223
Ben Tester
503-515-1833

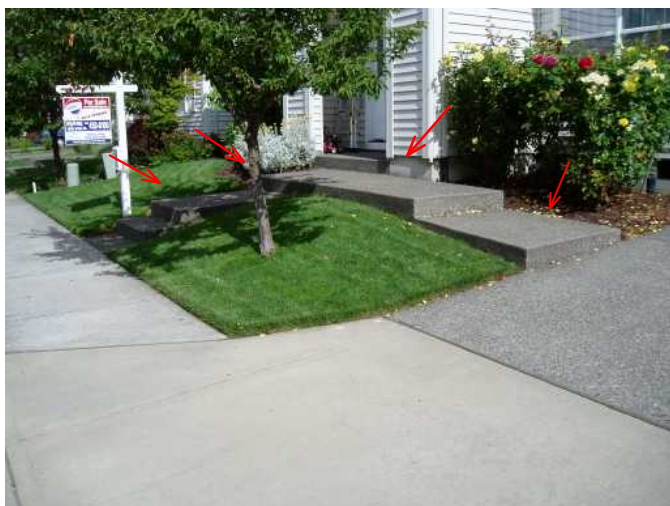
main sewer cleanout..good..

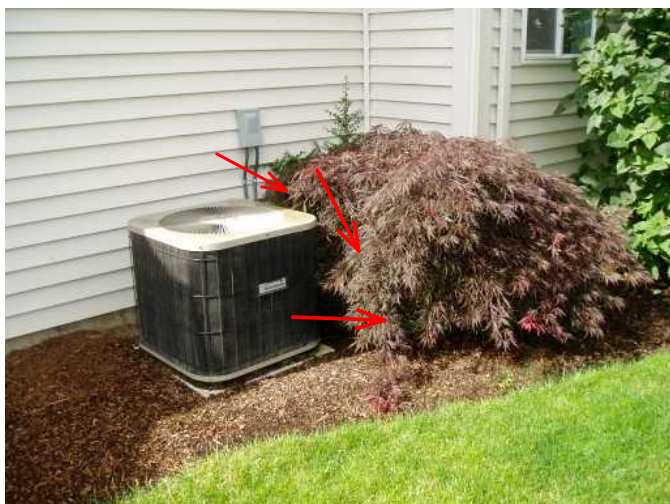
backside of home looks good..air conditioner is on level pad..good...again..trim back shrubs..to close...

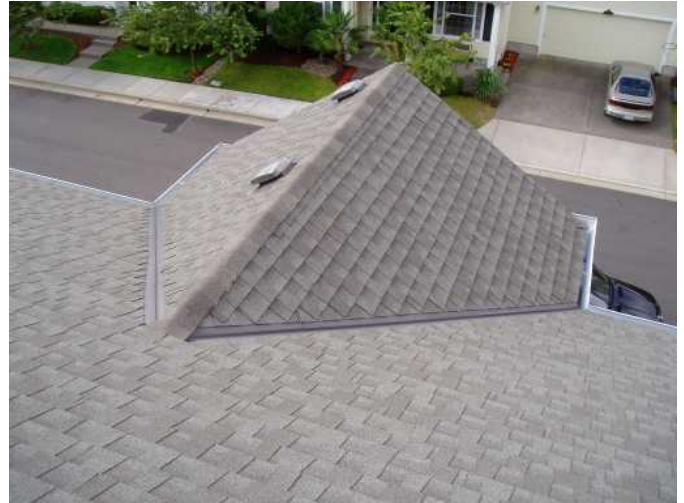
back of roof is vented well...valleys are good...

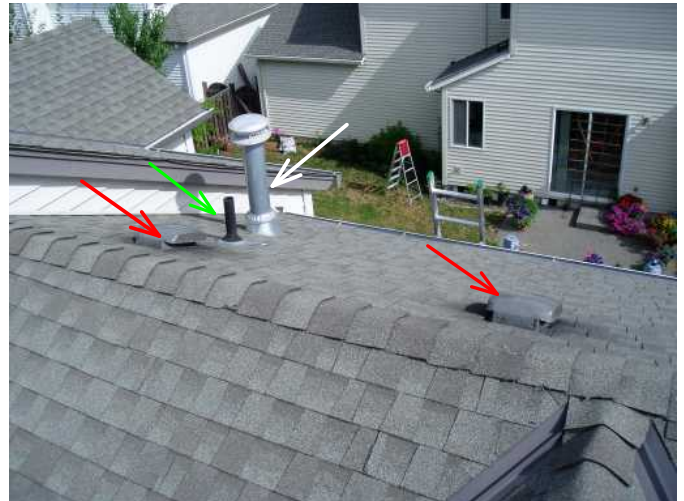
peak of main roof is well ventilated...one of three sewer exit vents to keep sewer pipes flowing...good...

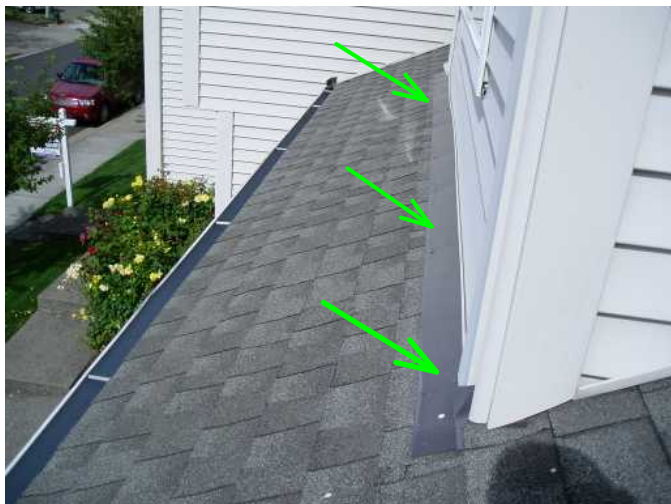
very good flashing in front of home upper area by great room...

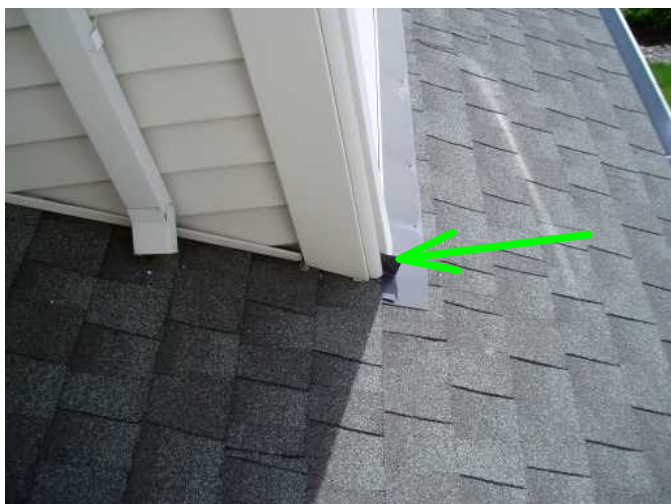
good kickout to keep water from entering under shingles in this area....

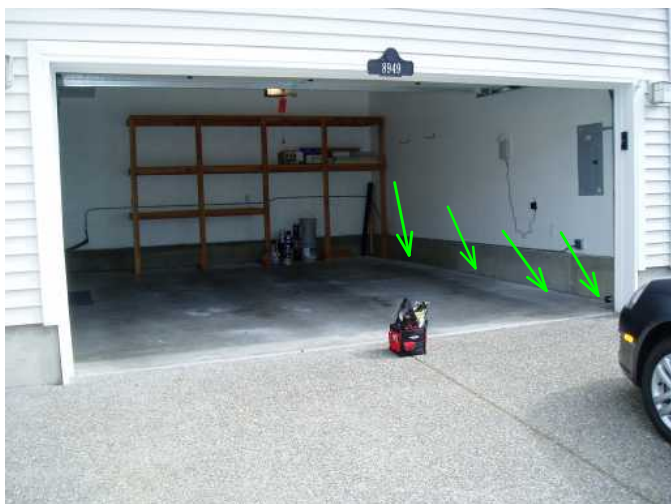
garage entry is good..see slope of floor towards front..very good...

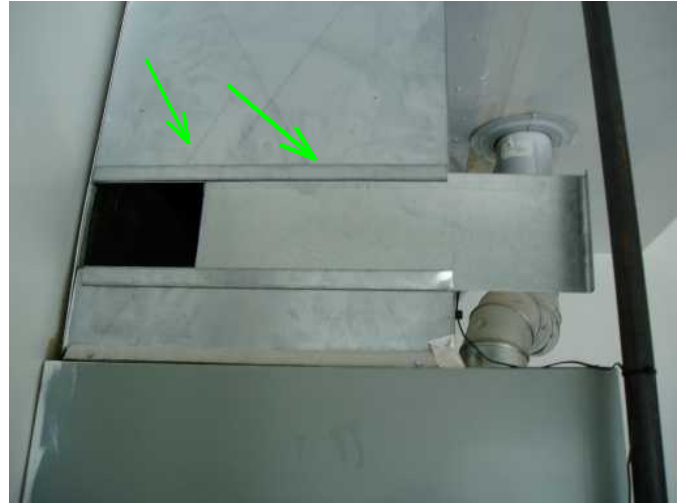
furnace filter is accessible on upper side access slider cover....

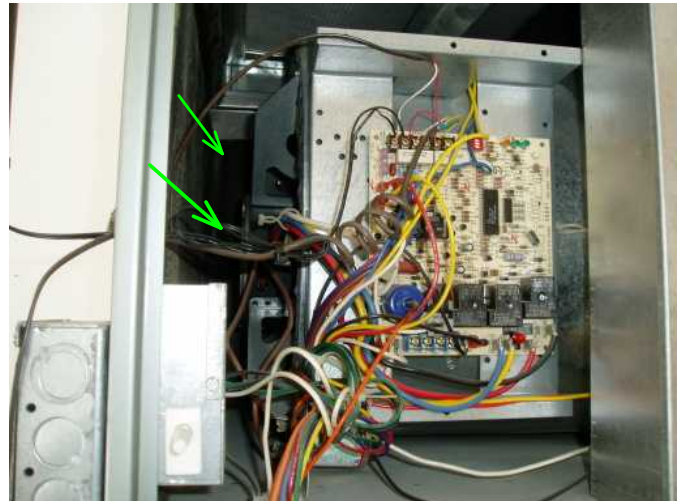
direct drive fan and the electronics attached...good...

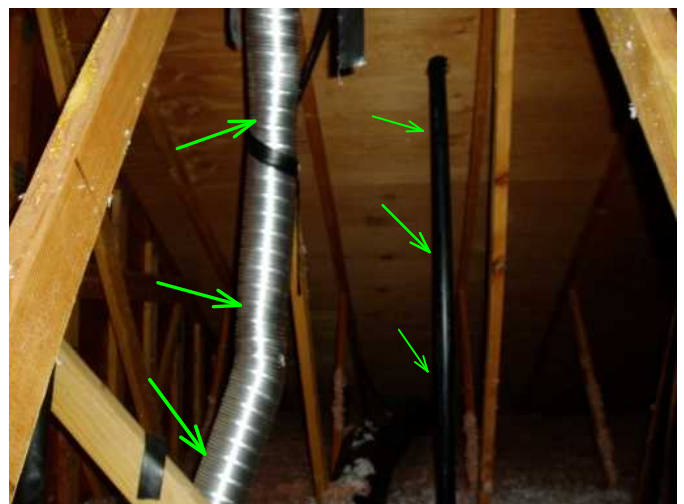
attic is plywood sheathing and 2x4 truss system...bath venting is good from both baths...one sewer vent pipe noted here.

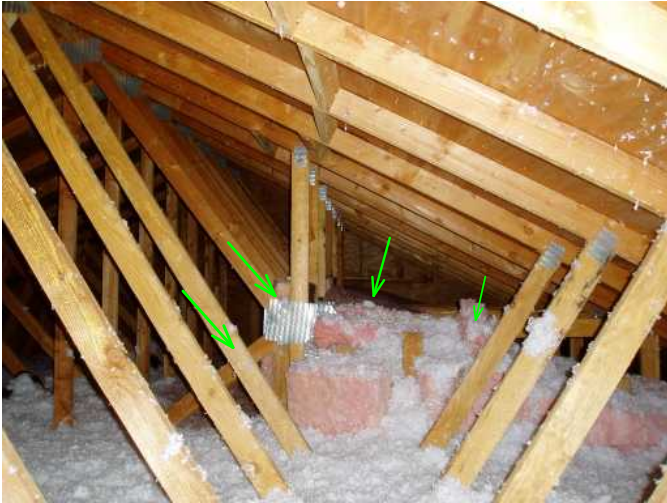
vaulted ceiling above master bedroom has batt insulation...rest of attic is blown..very good job...

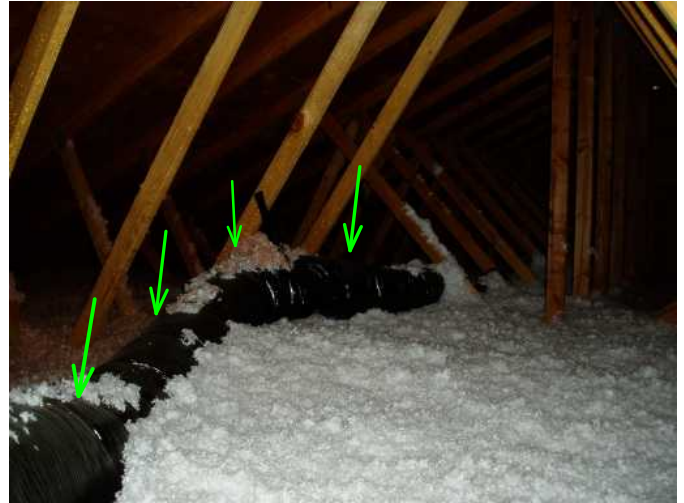
one of several insulducts to various rooms on second floor..good...

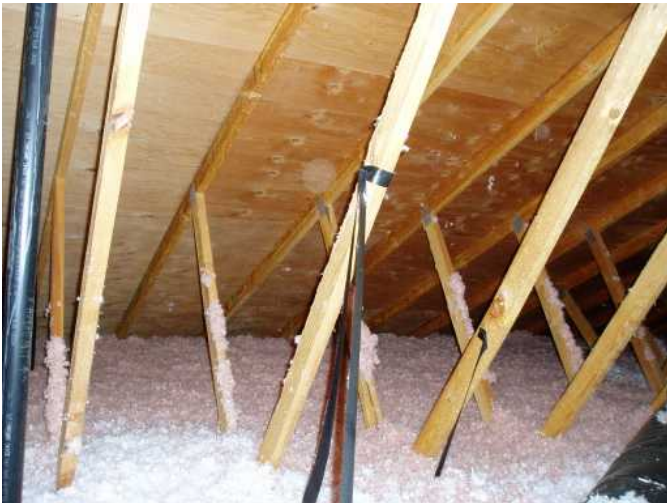
no moisture stains noted in any areas of attic...

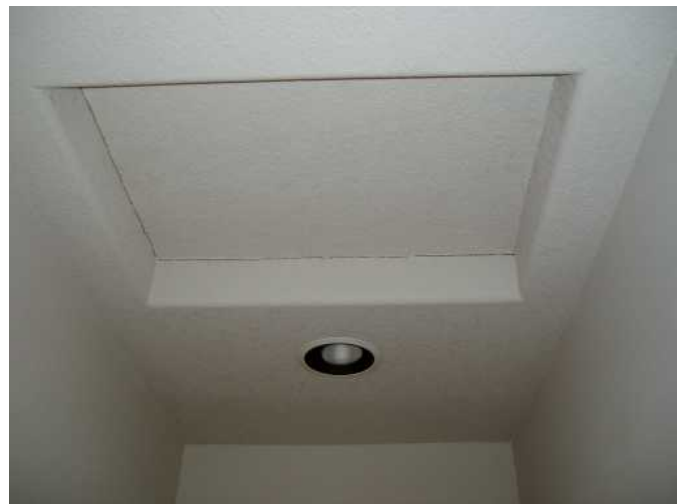
scuttlehole to attic ..you may never go there....

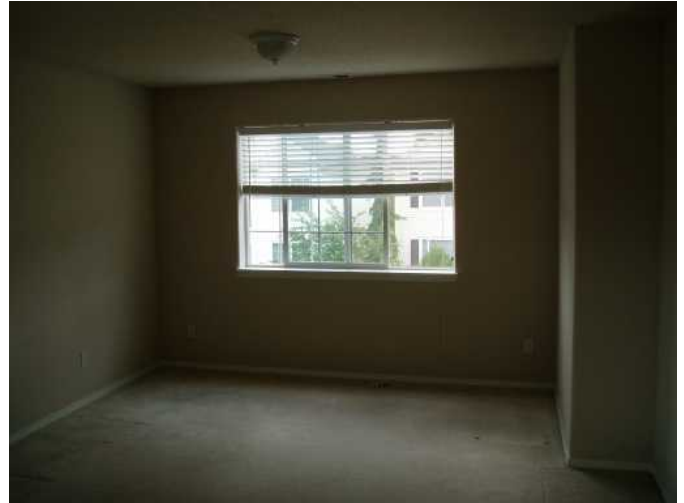
front window of great room works fine...

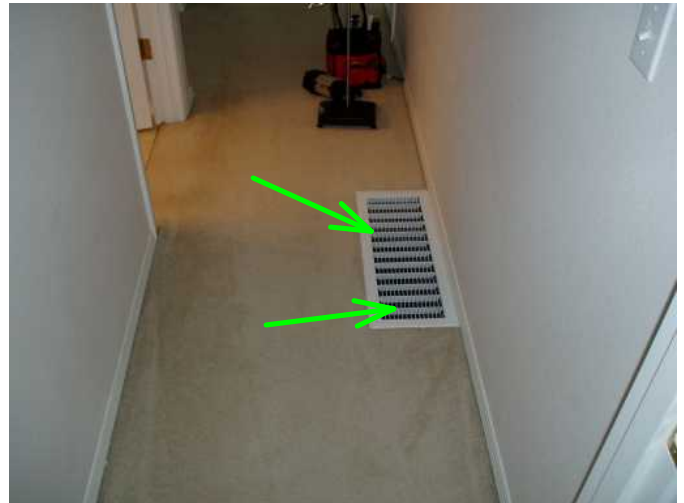
one of two return air ducts for furnace..do not cover with rug..will affect your furnace greatly...

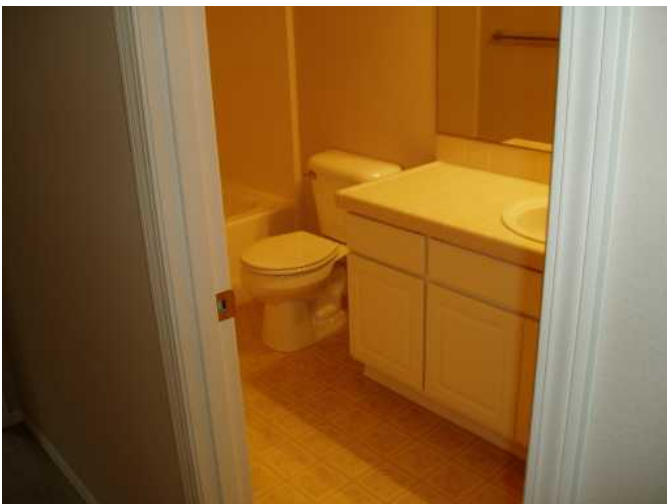
main bath door works fine...no moisture noted in floor around toilet and shower areas...

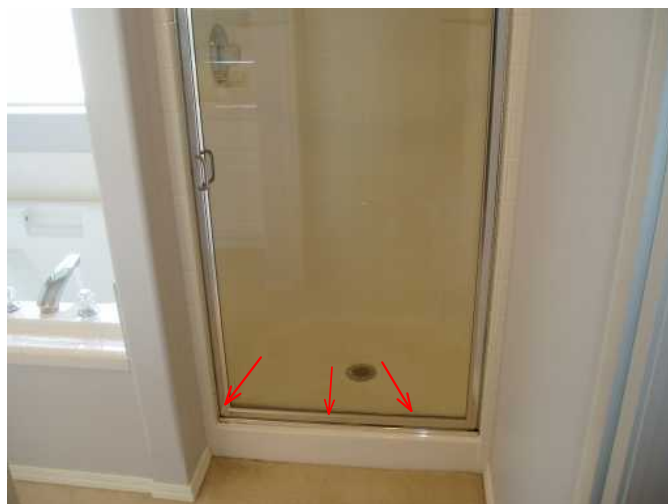
did rate of flow test...when all utilities were in
operation..noticed a bit of slowing of flow..use only
tub or shower...

Master - Bathroom - Tub/Surround: Fiberglass tub and ceramic tile surround - not big deal/ noticed that if tub, shower, and sinks run, its taxing the system/but how often will you run all four at the same time?...just note to run tub or shower only...

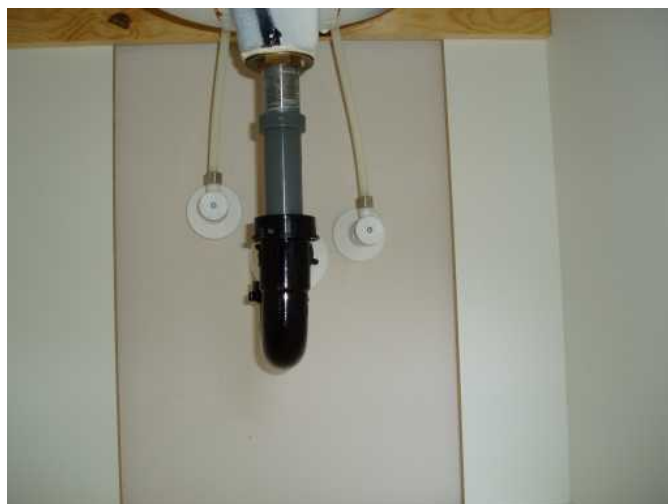
tub filled and drained well...ran slower with shower
and both sinks ..only run tub or shower, not
together....

| 22. Maintenance | Tub/Surround: Fiberglass tub and ceramic tile surround - not big deal/ noticed that if tub, shower, and sinks run, its taxing the system/but how often will you run all four at the same time?...just note to run tub or shower only... |

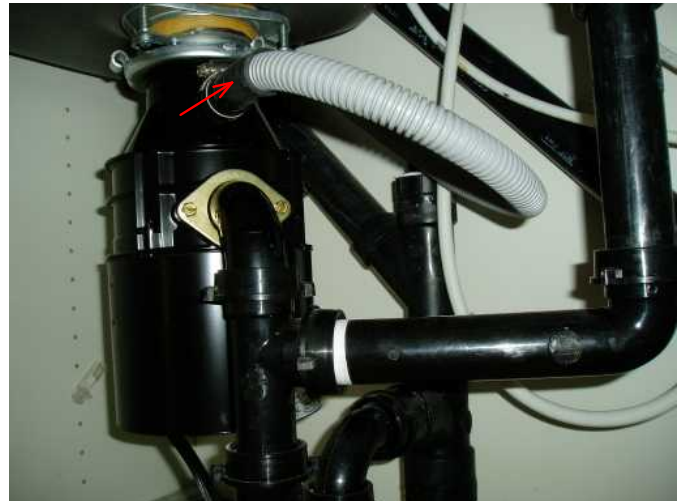
did flow test at kitchen sink and ran dishwasher through complete long cycle..all good no leaks noted...faucet is good.

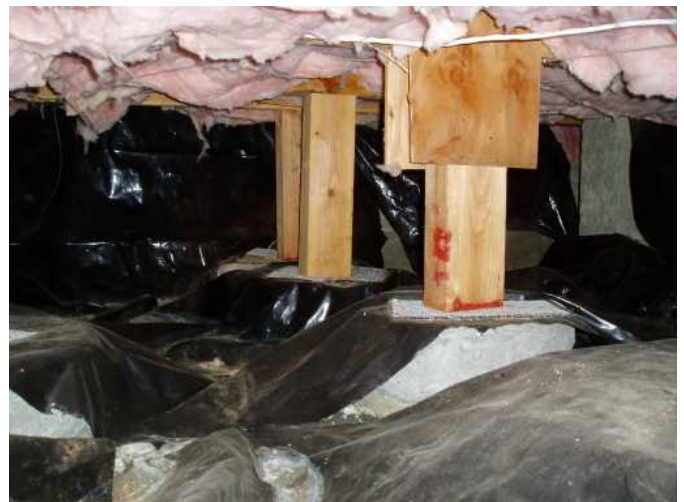
post and beam system in crawl space means a very well built home...sub floors are plank diagonal tongue and groove...
