Home Inspection Report

1936 Sunburst Terrace
West Linn, Oregon

Prepared by: The Home Tester

18:09PM March 14, 2010

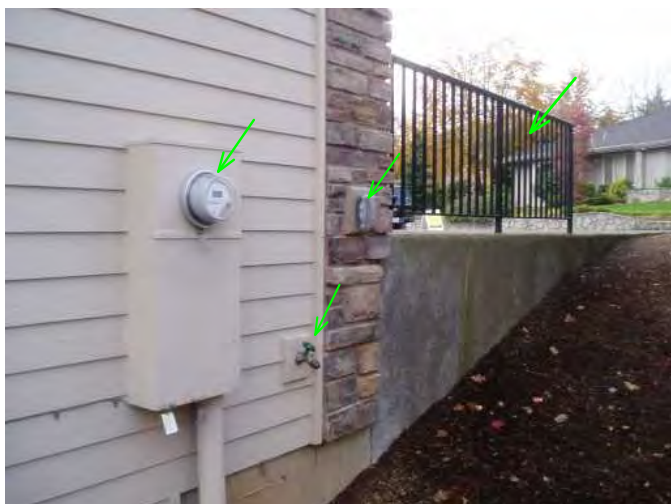
main gas meter is solid to home...PVC flues are noted for both furnaces and water heater...one needs to be re-sealed...

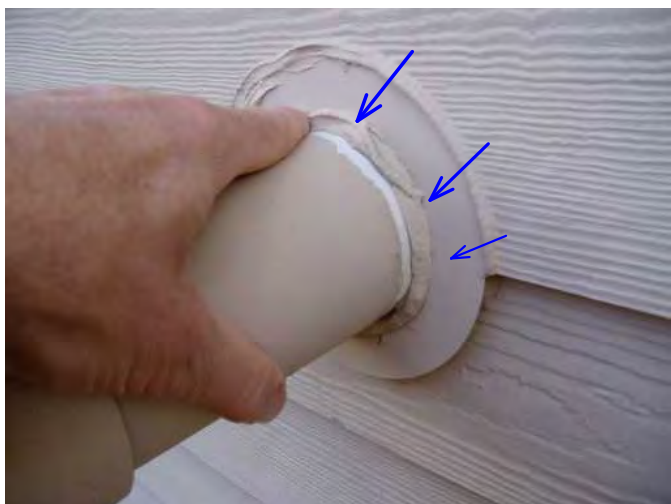
close up of affected flue that needs to be re-sealed to keepout water entry...

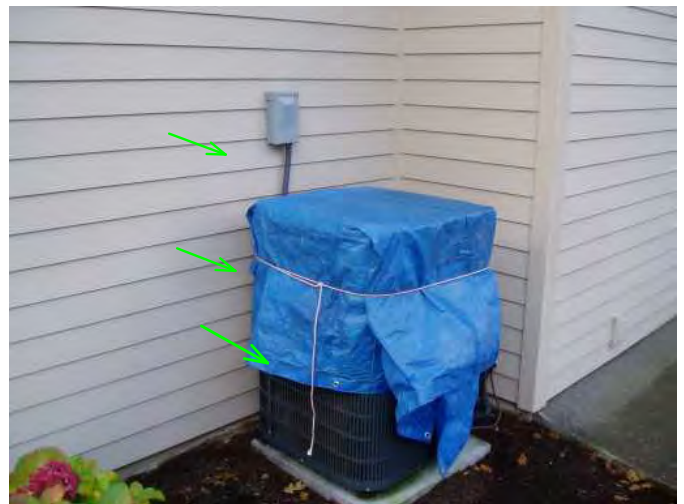
any gaps in caulking around siding to trim is noted and needs to be re-caulked to avoid water entry...

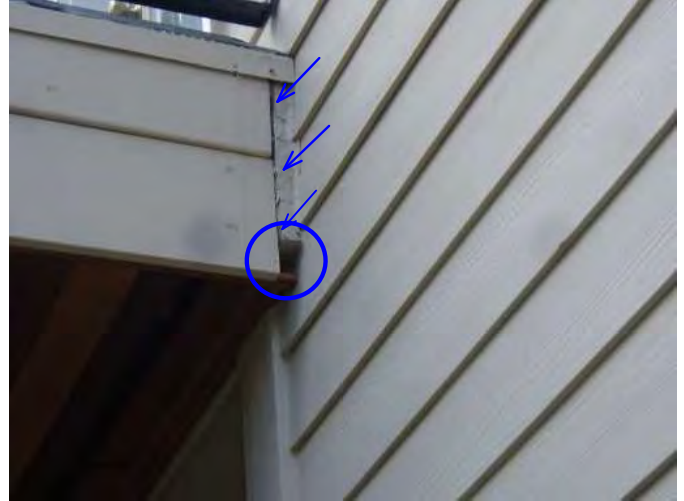
fill gaps here at lower balcony area that can allow water in in time and affect deck wood here...

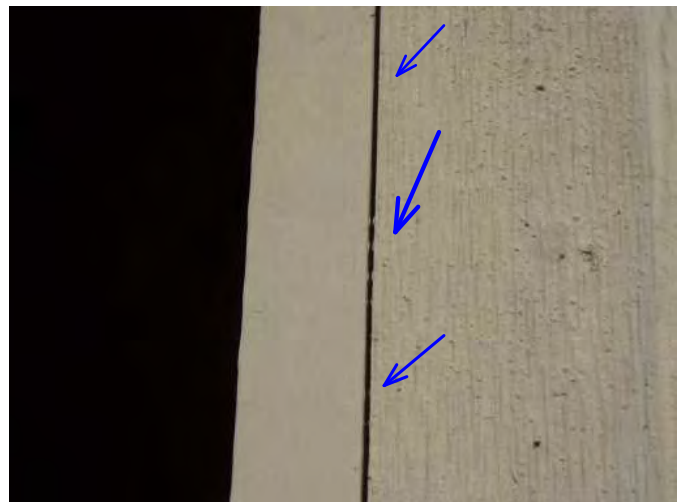
other trim at different areas are not caulked...correct to extend useful life...

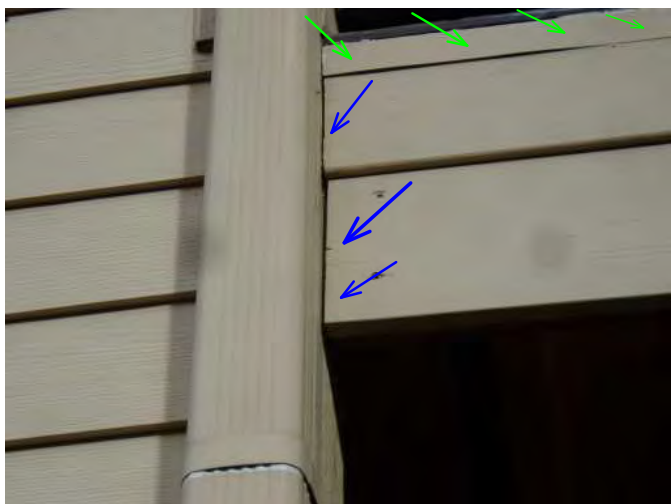
blue needs sealed at gaps...green is flashing at balcony edging and is good...

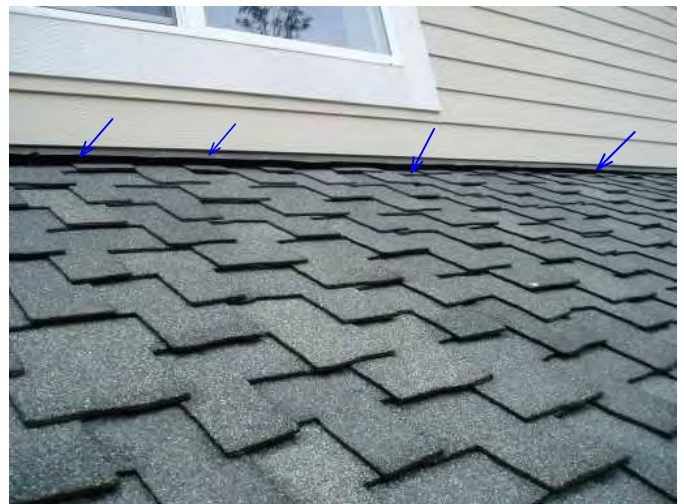
flashing at the back of home below bedroom s 3 and 4 is noted coming loose and needs re-attached...

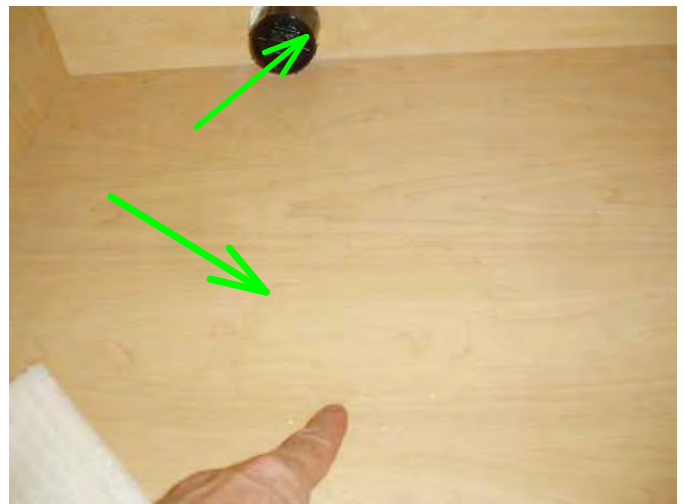
noted leak under sink in butlers pantry...will need repairs....

1st Floor - Kitchen - Plumbing/Fixtures: Brand not known with PVC trap - Leaking trap at butlers pantry sink...correct...

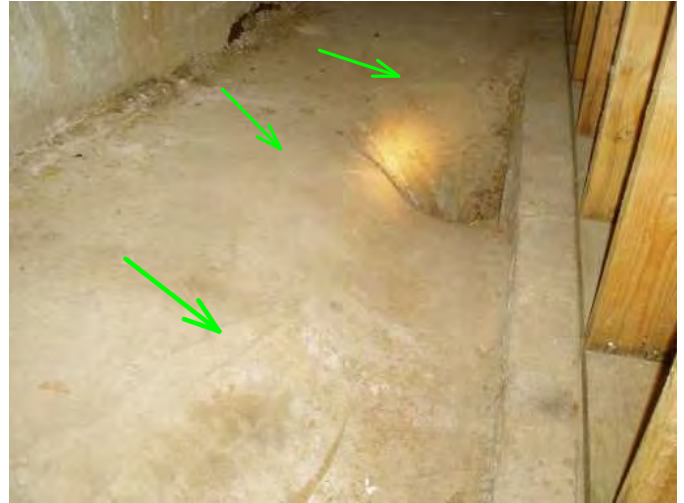
small area here needs vapor barrier over it..install to control moist air issues...and open all crawl vents....

front of home - Crawl Space - Vapor Barrier: plastic over earth... - Missing, pull vapor barrier over all earthen areas not covered...see photos...
