# Home Inspection Report

6603 se 31st ave  
Portland, Oregon

Prepared by: The Home Tester  
10555 SW Tigard St. #57  
Tigard, OR 97223  
Ben Tester  
503-515-1833 CCB# 164921 OCHI # 912

## Photo Attachments

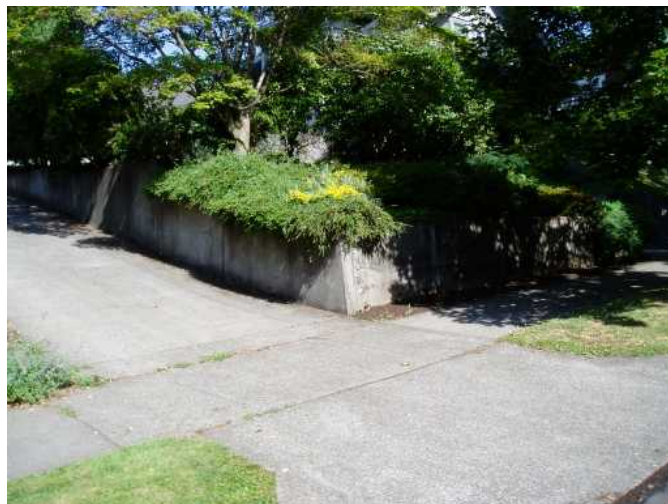
concrete retaining wall front lower area of home...good

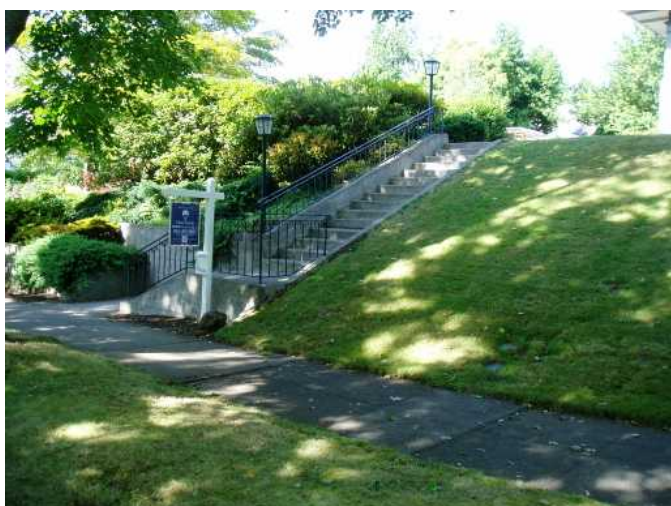
stairs and handrails are great...

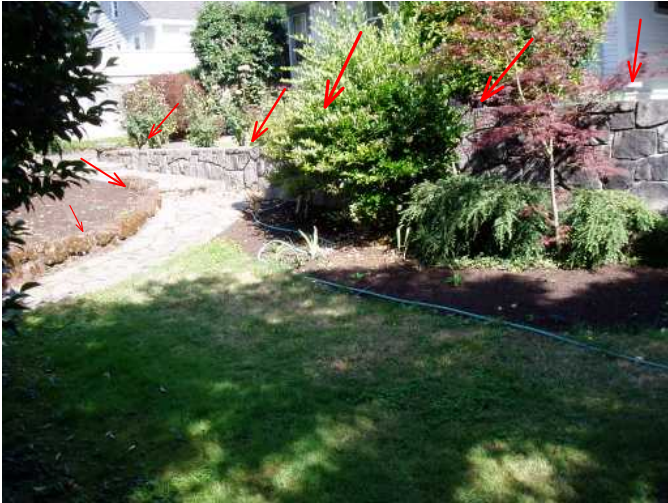
rock retaining wall and walk upper level appear solid...

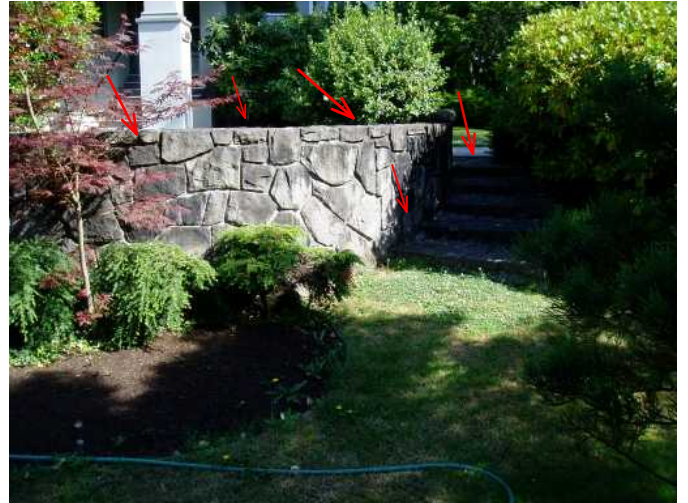
stairs and wall are solid...

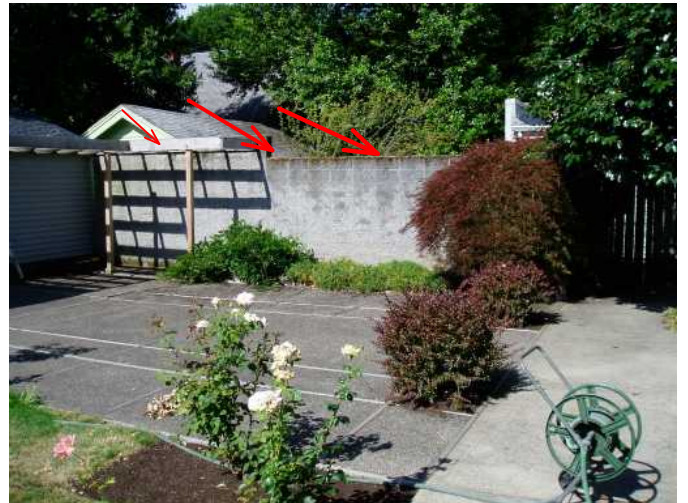
parapet wall is solid and secure...

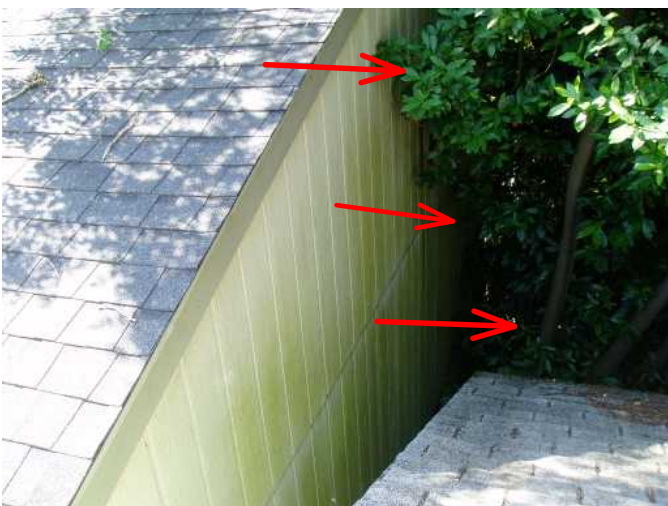
backside of garage will need trimmed back for vegetation...

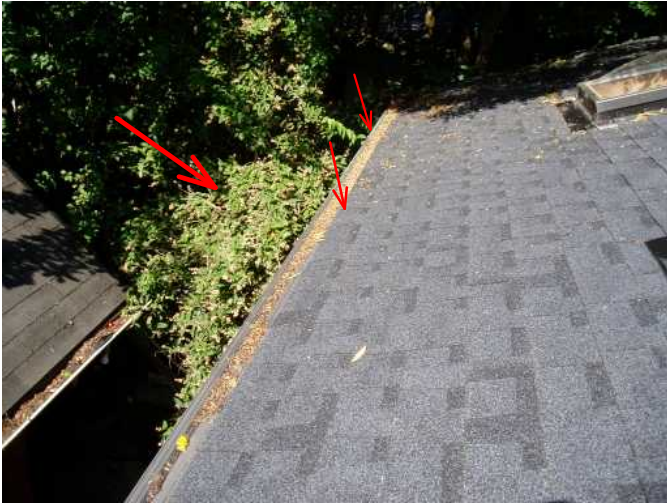
gutter cover is engulfed in debris/trim shrubs touching side wall of garage...

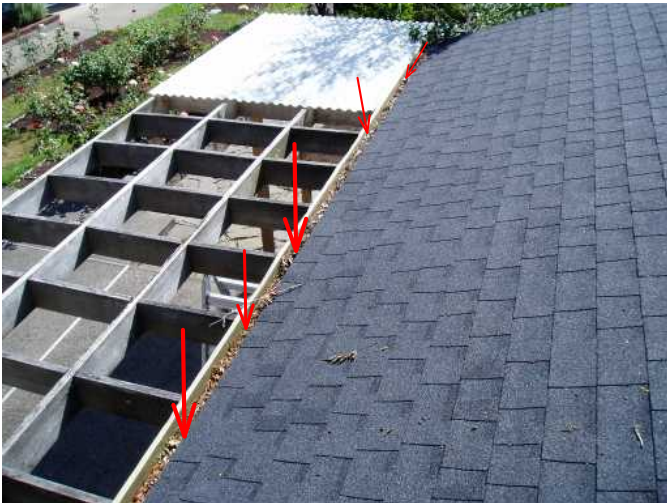
no gutter cover here and very full of debris..needs to be cleaned...

**Gutters:** Galvanized/with gutter helmets - front section of home is missing gutter helmets....see photos...

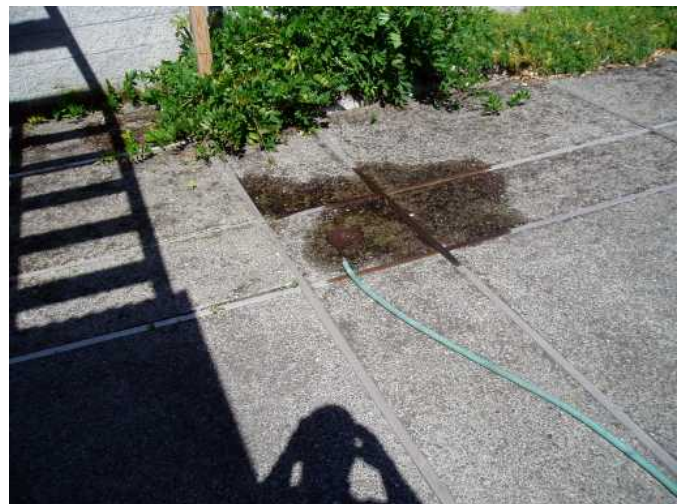
surface drain works well...patio...

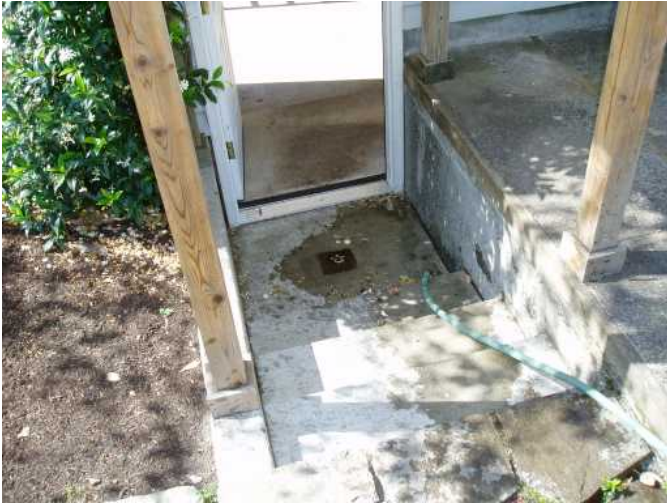
garage entry drain works fine...

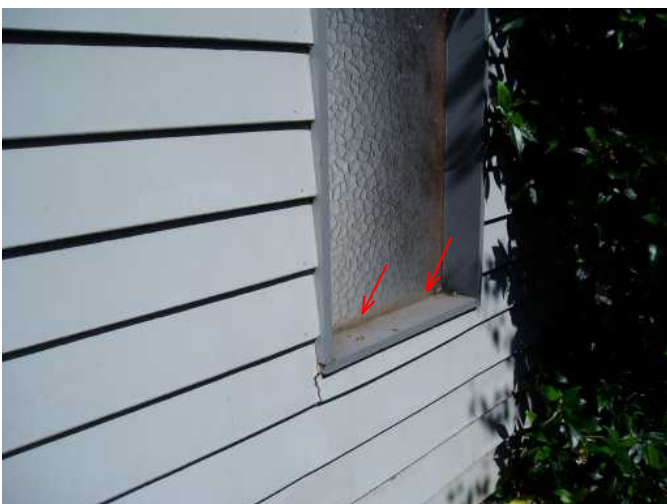
garage window appears to need new caulk around base of window...

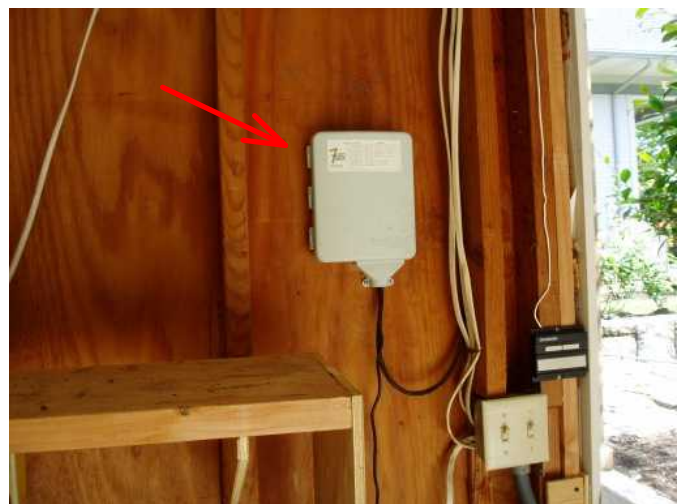
water sprinkler control box in garage...fine...

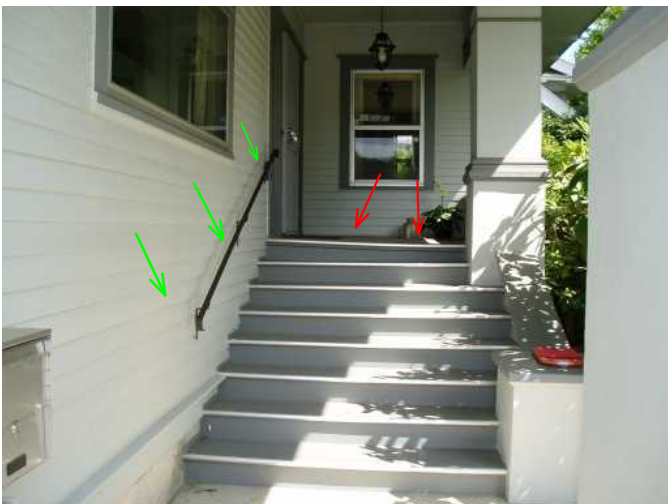
front porch has good slope/ stairs are solid and sound...handrail is solid as well

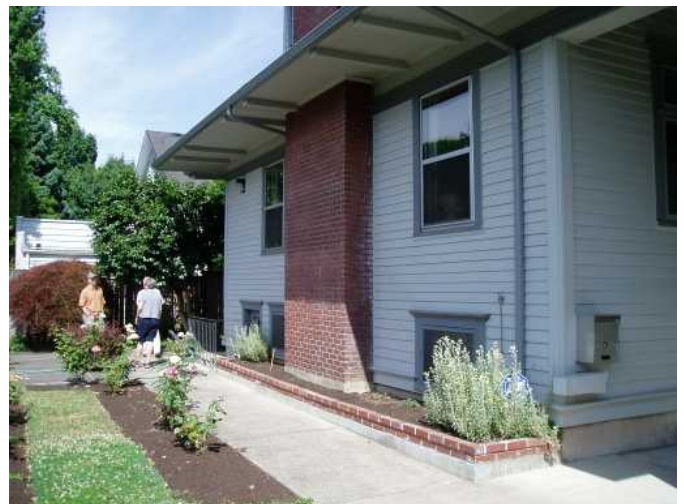
side of home siding is in great shape...trim is well maintained...

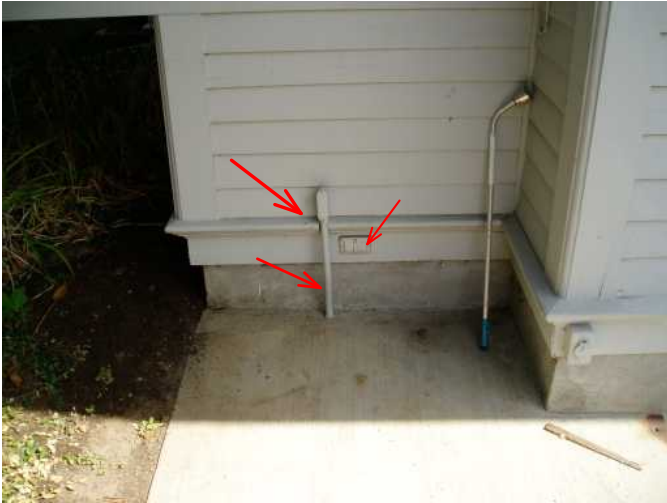
electrical exit to garage..and exterior outlets are grounded...fine...

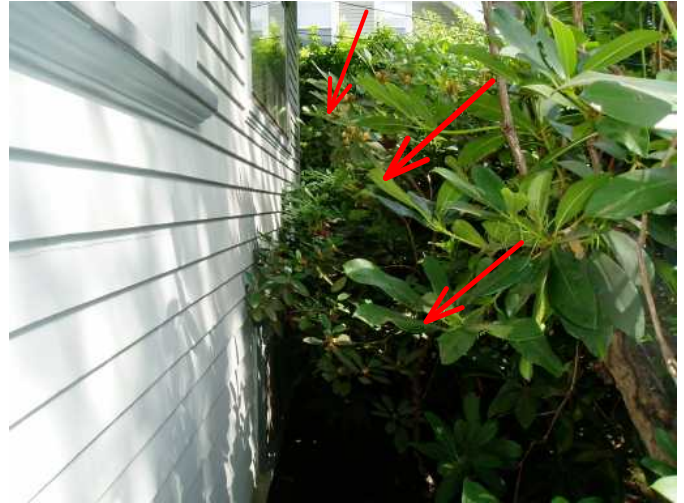
front of home has need for trimming back vegetation to keep 12-18 inches from home...

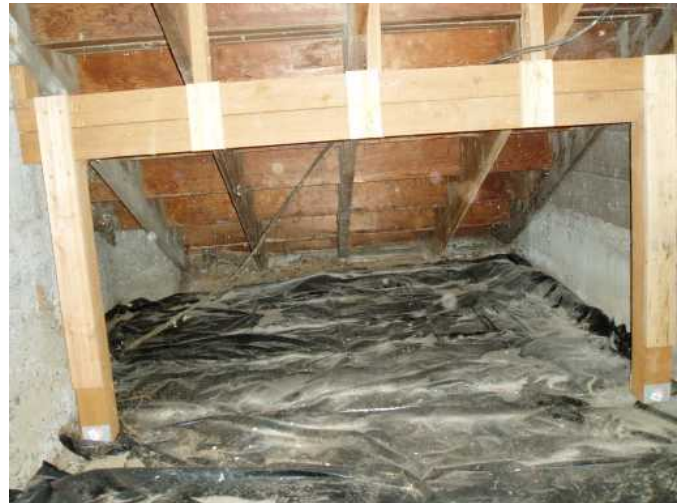
new stair support beam...moisture barrier..good...

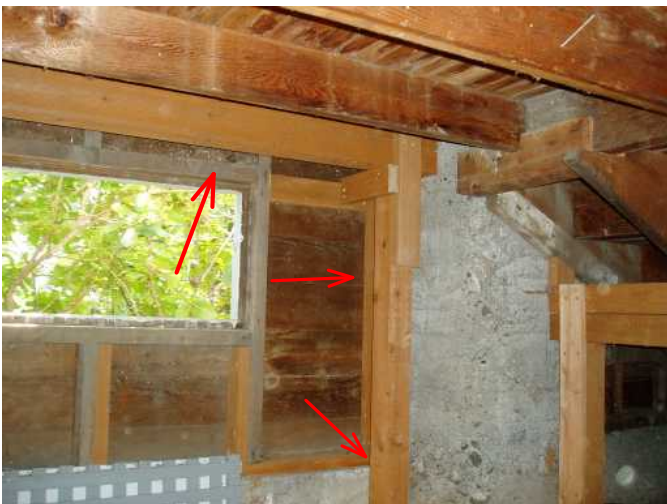
new support at front of porch/done by the book...great...

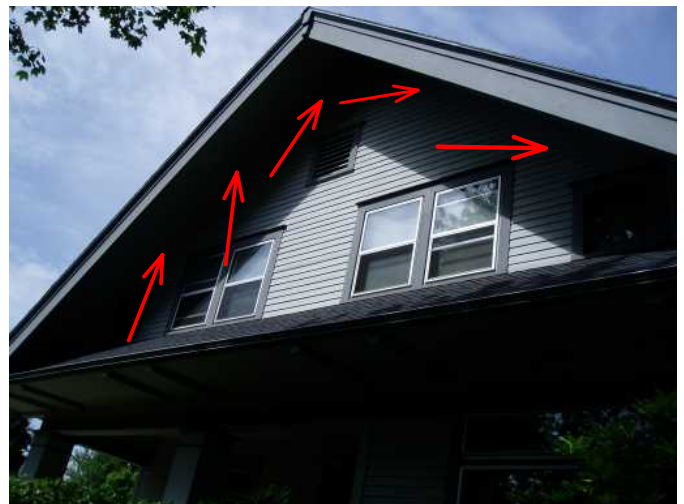
all trim under soffits around home is well maintained...

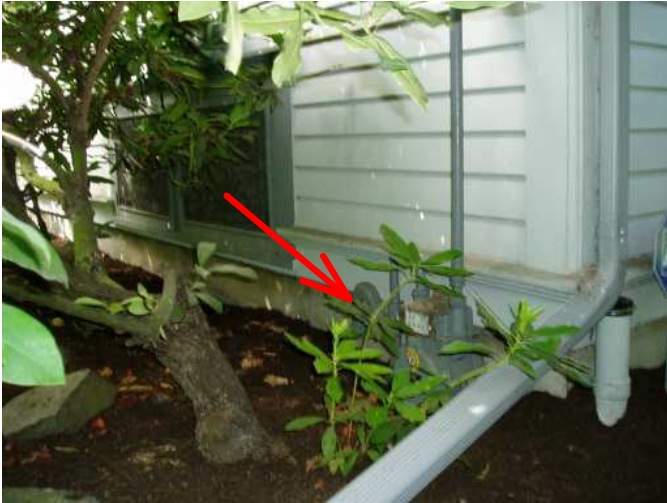
gas entry and main gas shutoff front off home...

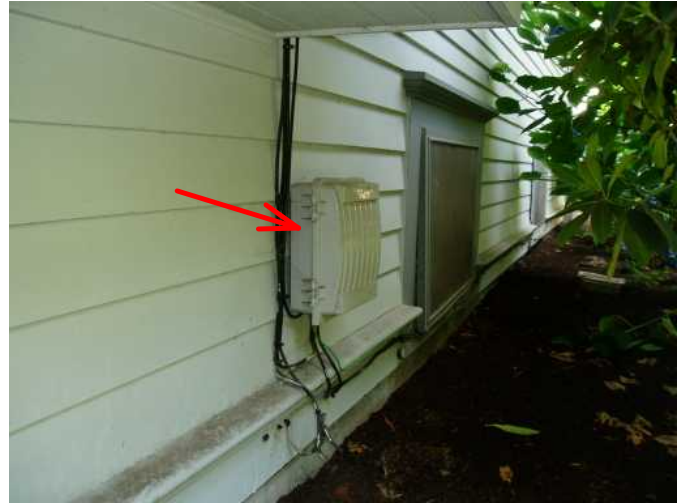
cable box and entry to home under dining room...fine...

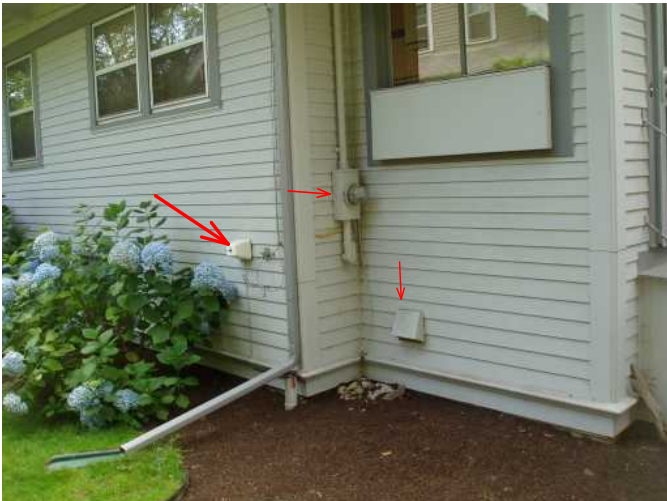
electric meter, good...exit vent for stove, kitchen...good...hose bib is covered...

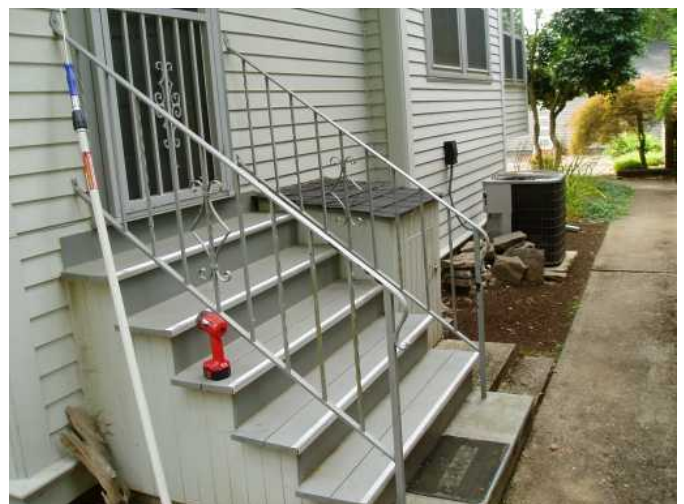
rear entry stairs are solid and sound...hand rails are solid as well...

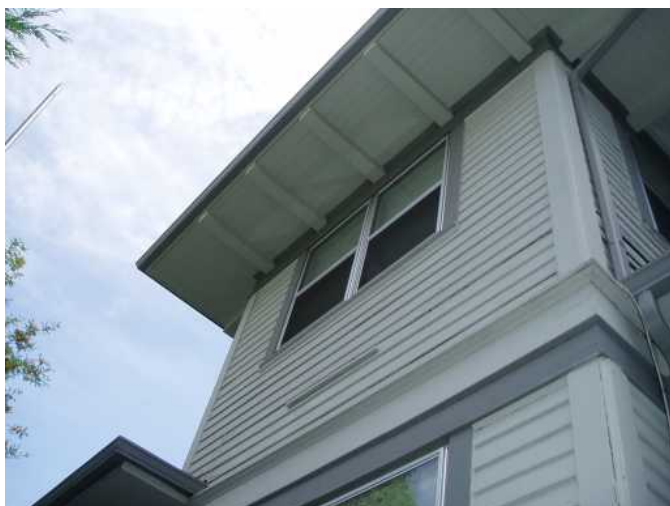
siding and trim are overall maintained well...

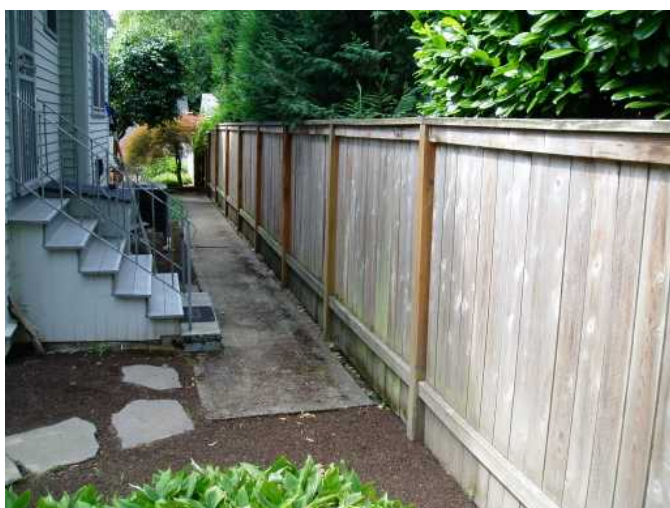
rear fence appears to be newer...

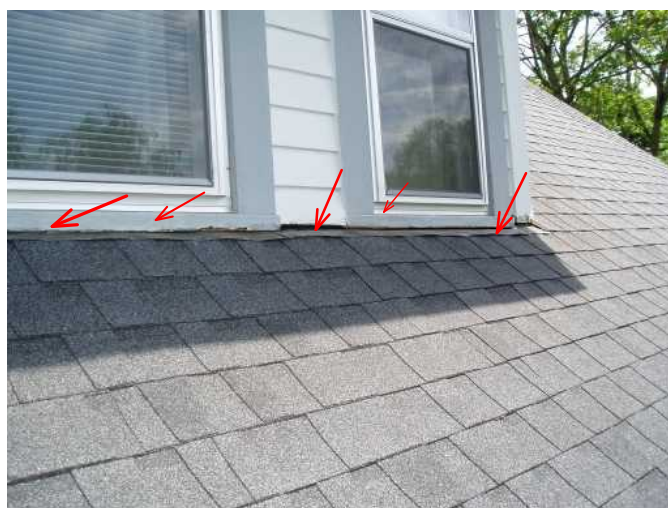
great flashing..will need trim paint...

**whole house - Exterior Surface - Type:** Wood - generally in good condition, will need paint around areas where old flashing were removed when new roof was installed..see photos...

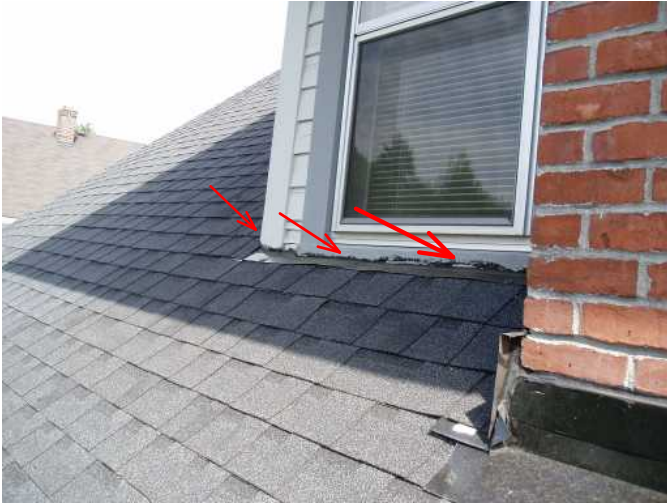
great new flashing..will need trim paint...

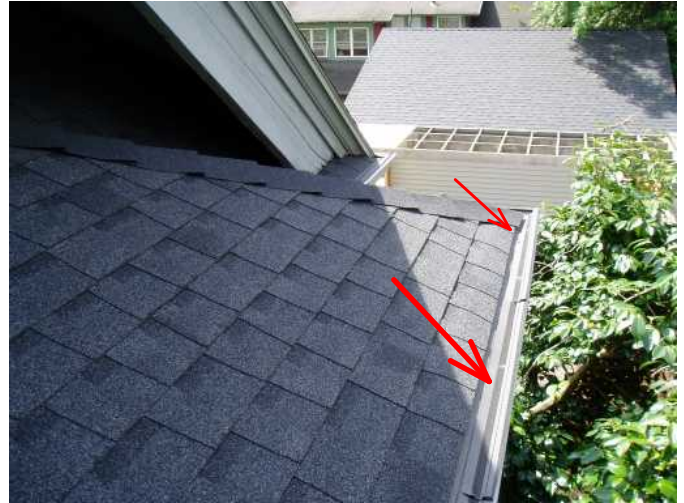
gutter covers are good at rear of home...

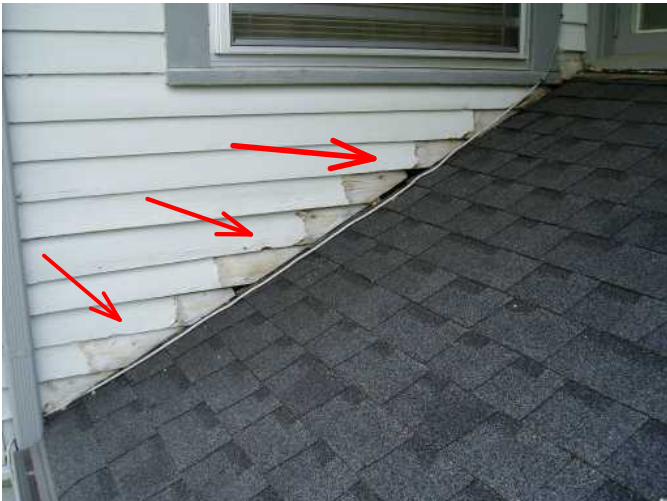
here is great new flash job/will need a bit of paint..see old step flashing marks?

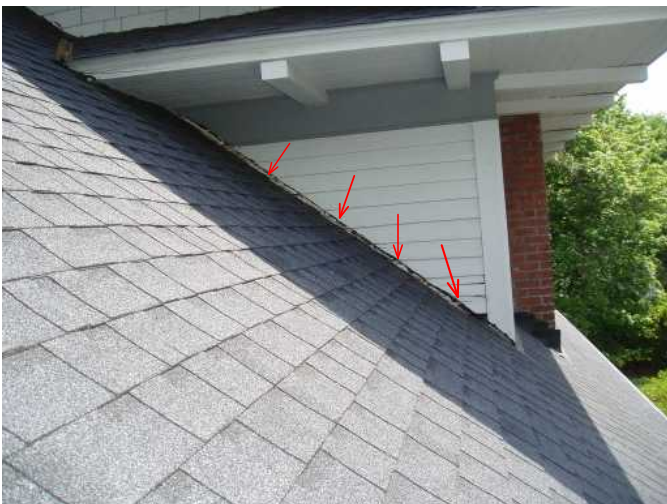
great flashing...trim paint needed...

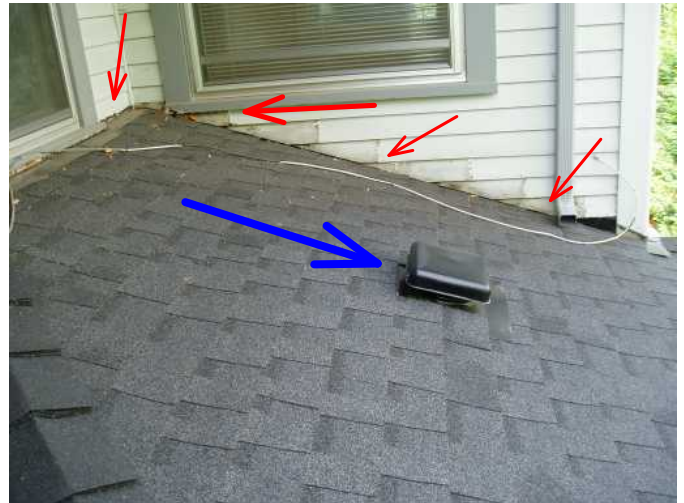
great flashing/needs paint...1st floor bath vent....good...

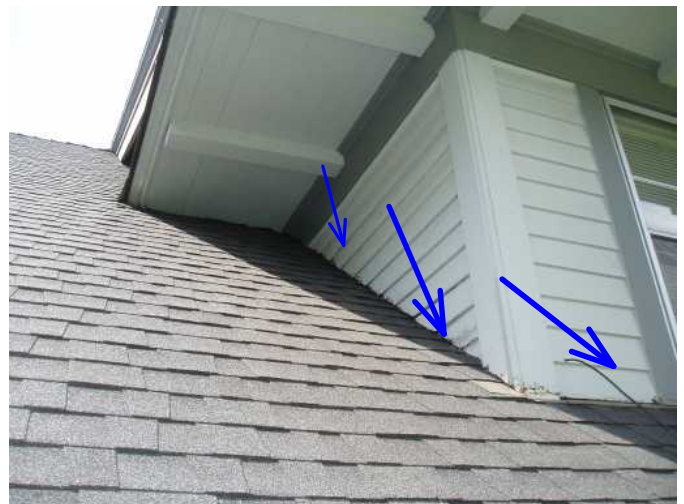
trim paint around dormer siding...

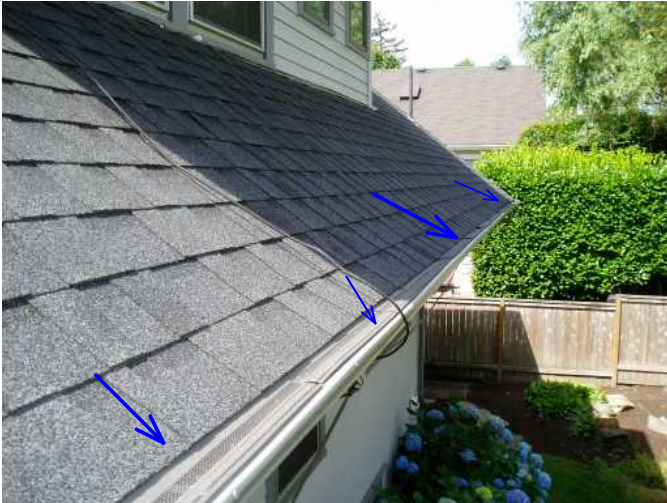
gutter covers are good this side of home...

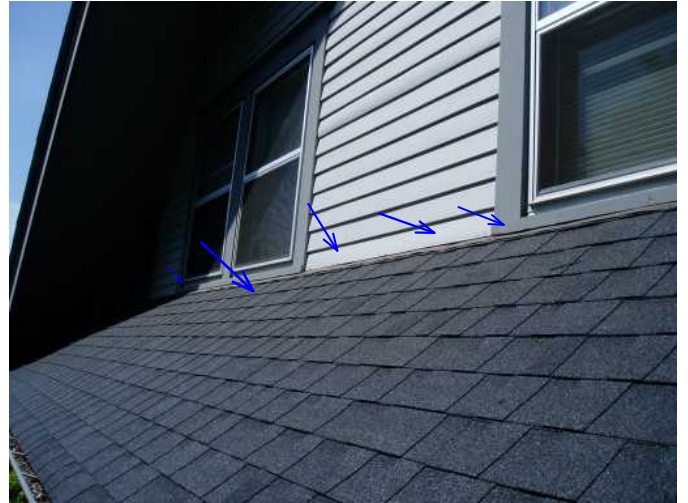
great flashing front of home...trim aint looks good here...

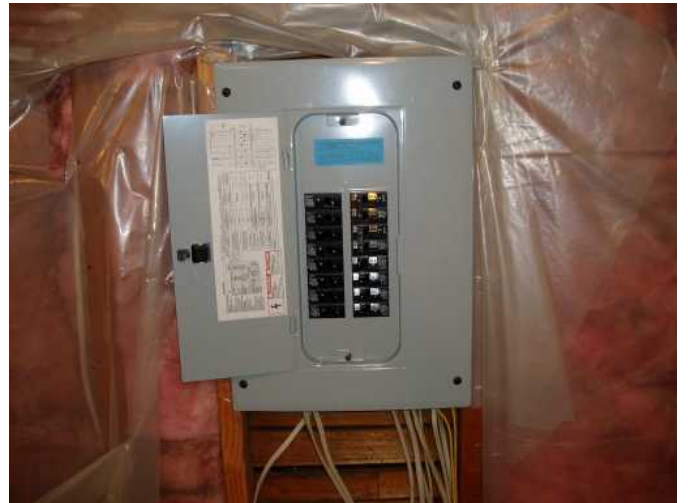
attic sub panel..installed in 97/signed off by inspector...

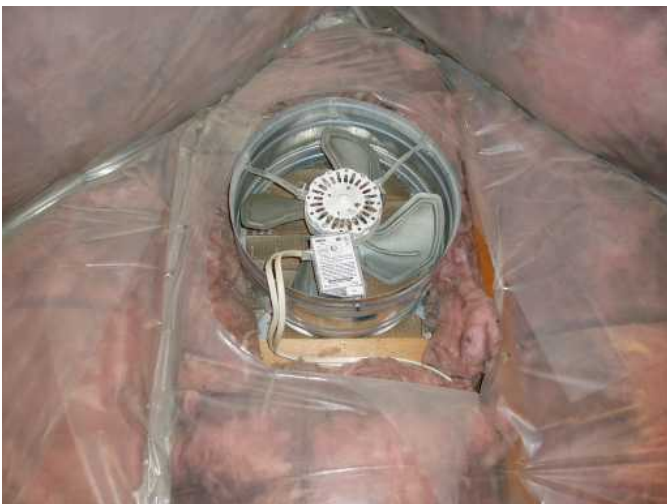
thermal switched attic fan woks great....

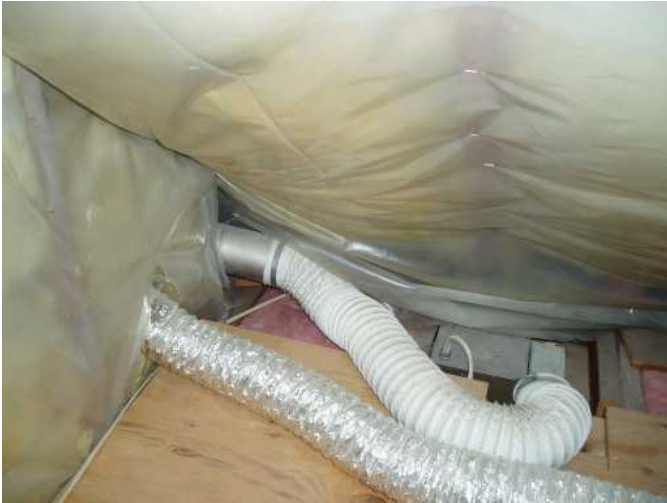
both bath vents are vented to outdoors..good...

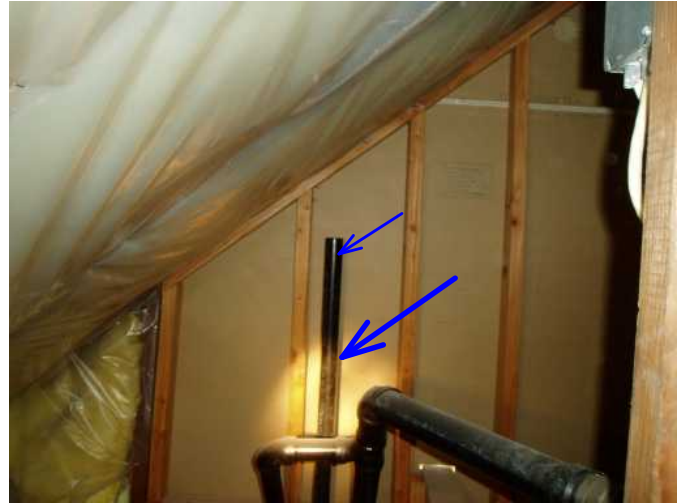
this is sewer vent pie in question..should be capped...

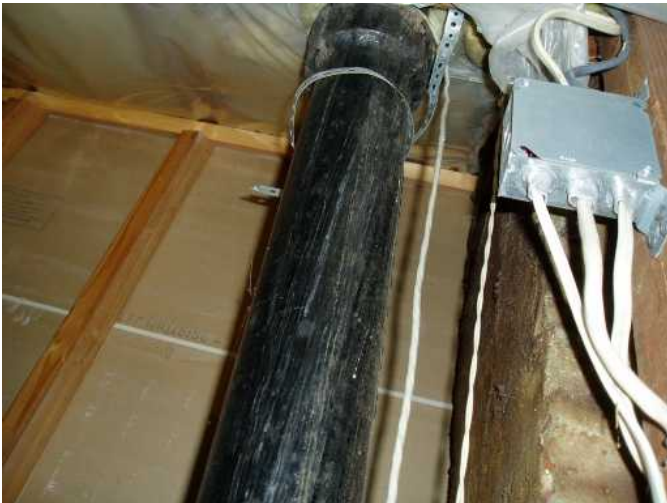
main sewer vent is installed fine...

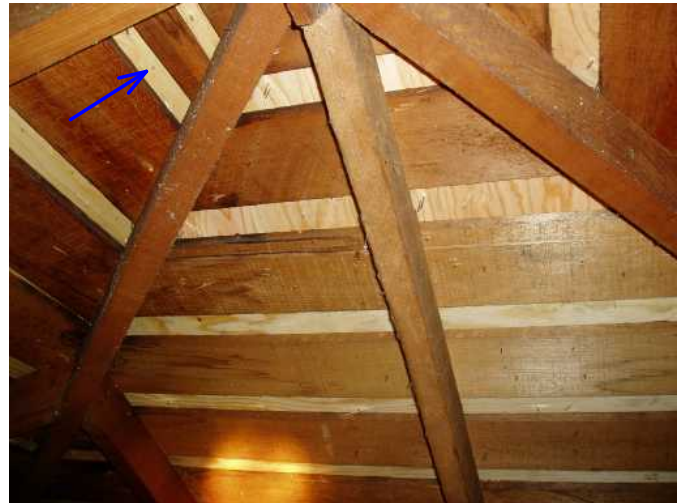
this is in rear attic area showing old plank and new plywood roof sheathing..very good...dry...

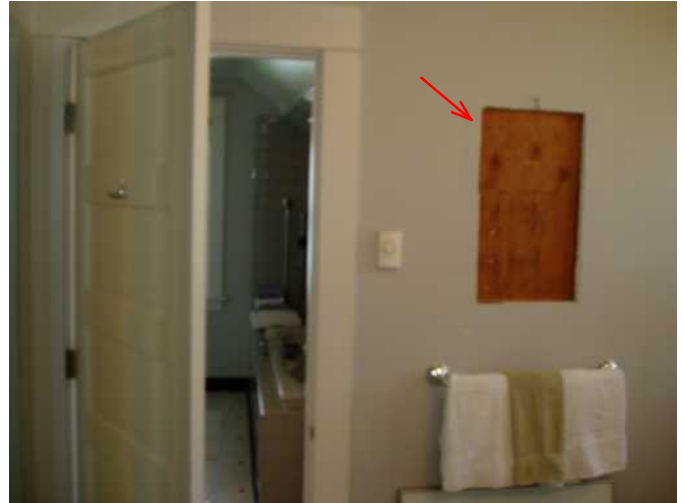
wall needs patch or cabinatt installed/had picture over it...

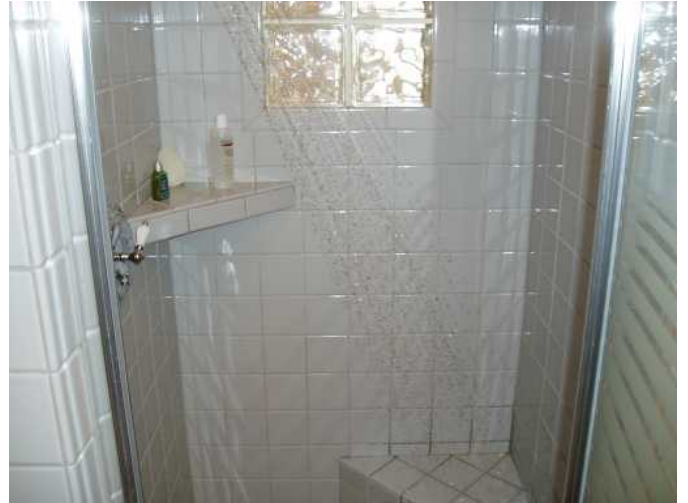
main shower works fine..no leaks apparent at this time...monitor grouting...around base mostly...

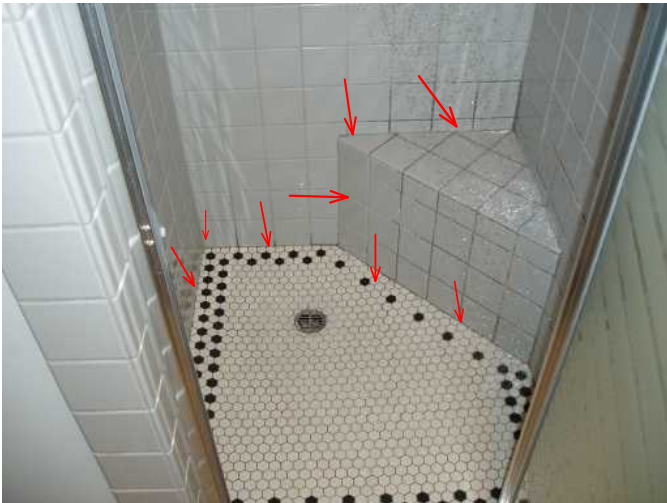
these areas are the most prime for cracks and leaks...

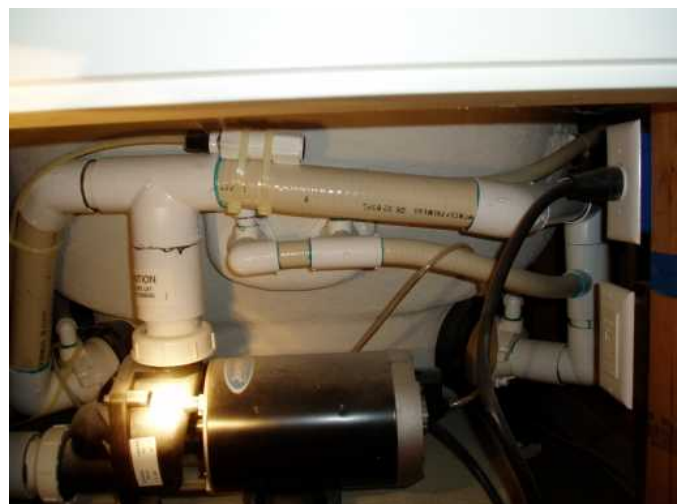
plumbing for bath appears leak free....

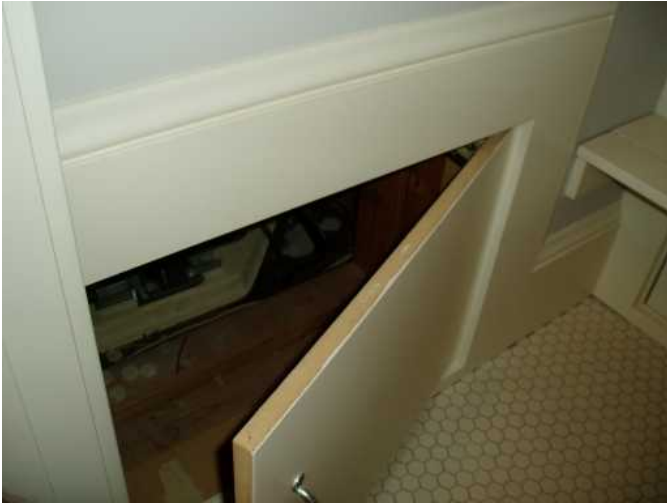
access to pump...bath...

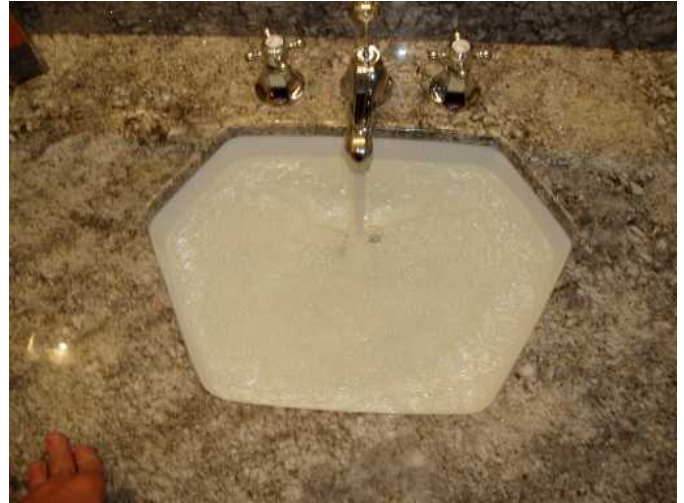
main bath sink drain well...

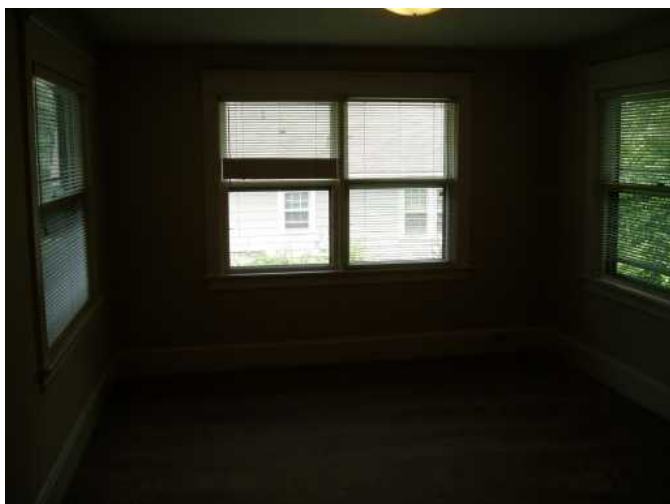
all windows are in working order...ths room has all grounded outlets...

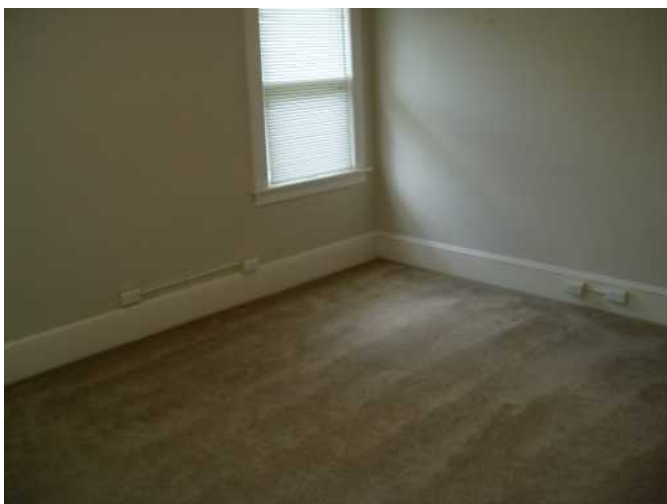
outlets in thsi room are all not grounded...windows work fine...

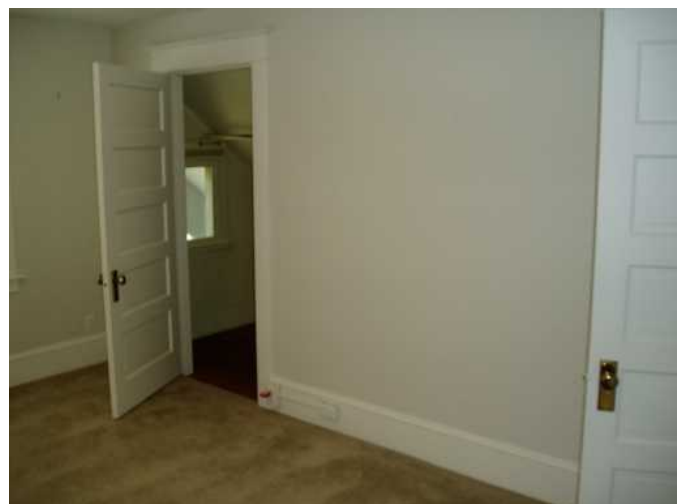
bed 2 doors work fine..only one grounded outlet here...

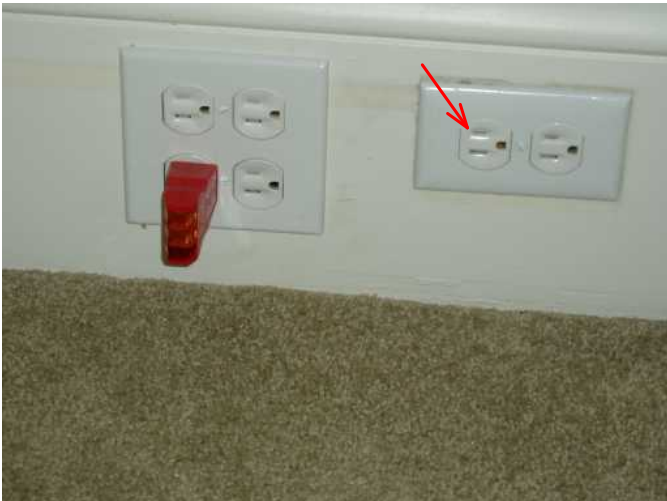
master bed outlets on left are grounded/on right tare not...go figure...

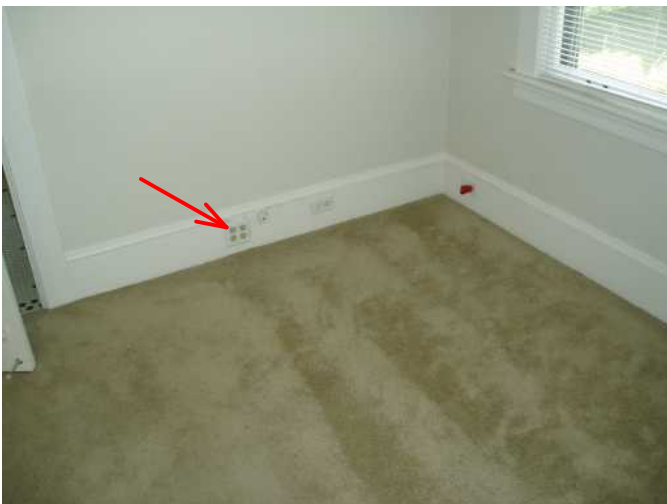
outlets here are grounded...

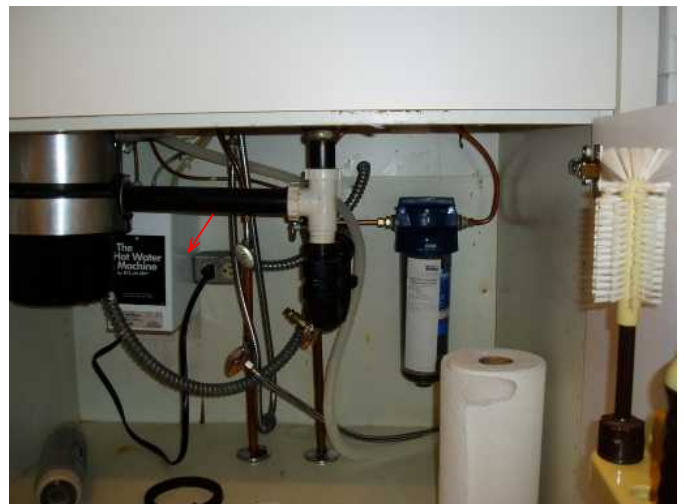
under sink no drips here...hot water dispenser should be monitored/known for leaks often(high maintenance)

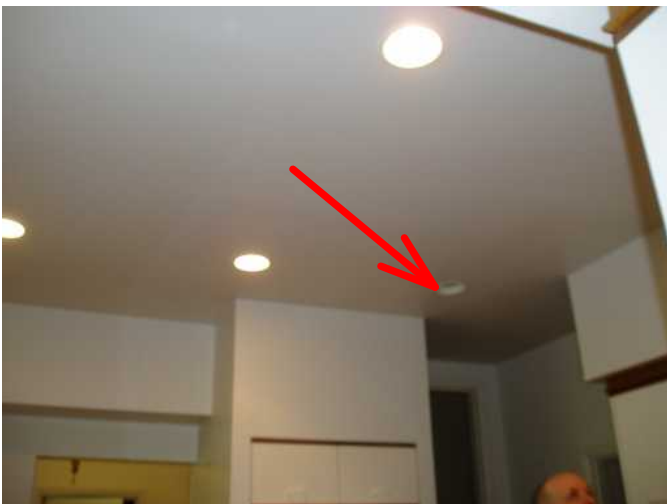
one kitchen light is not operable..please make operable..is probably bulb...but lets be sure...

9. Acceptable **Sink:** Stainless double
10. Needs Attention **Electrical:** 120 VAC - suggest adding GFCI outlets for safety ...one overhead recessed light inoperable/please make operable...

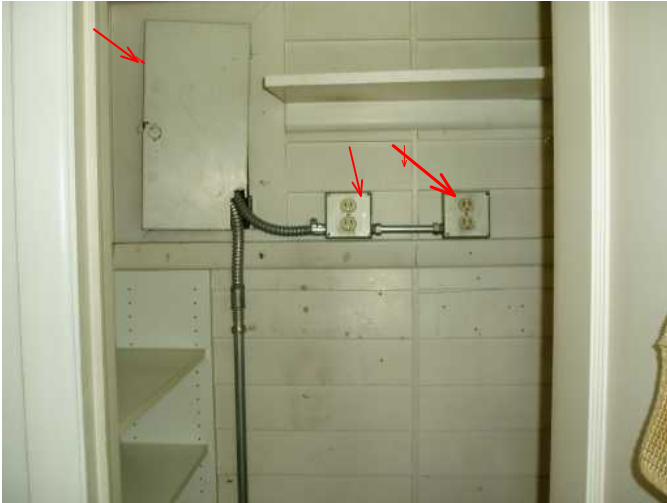
old panel...outlets are grounded....

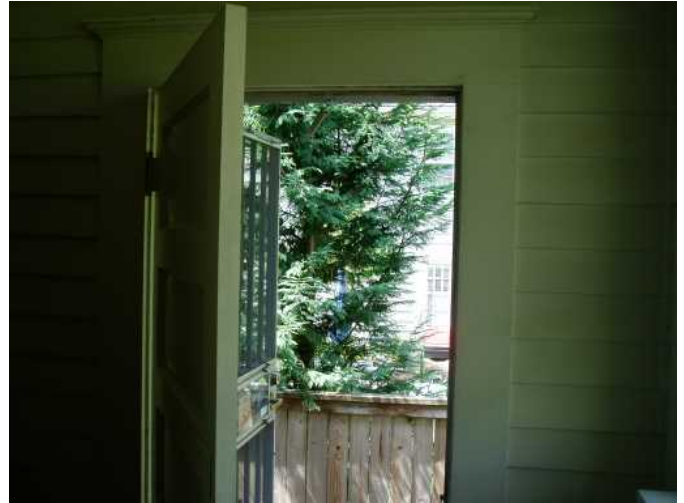
rear exit door is good and solid..weather stripping is good...

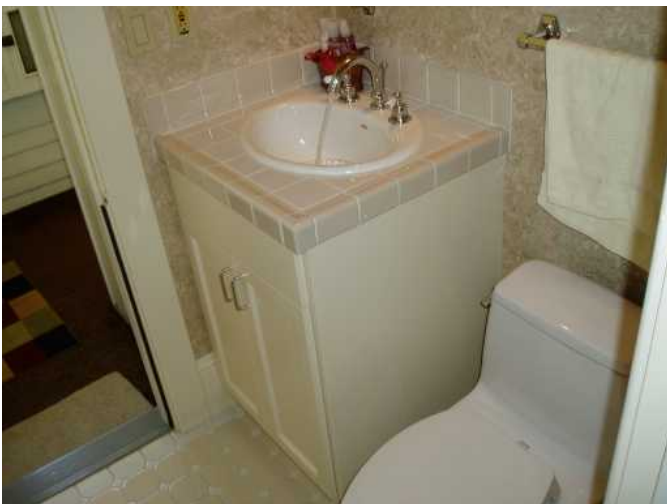
first floor powder..sink is good...

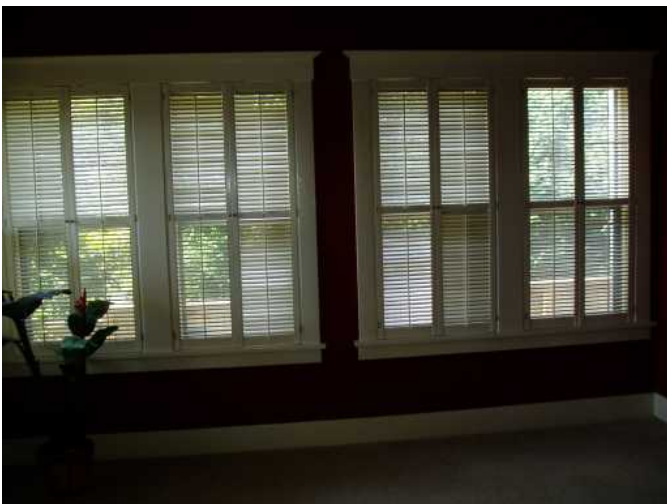
sun room windows all work...

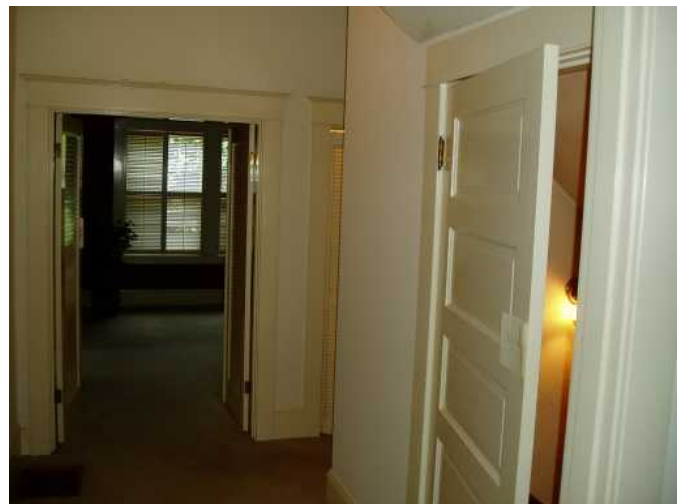
hall way first floor....doors work fine to base ment and to library...

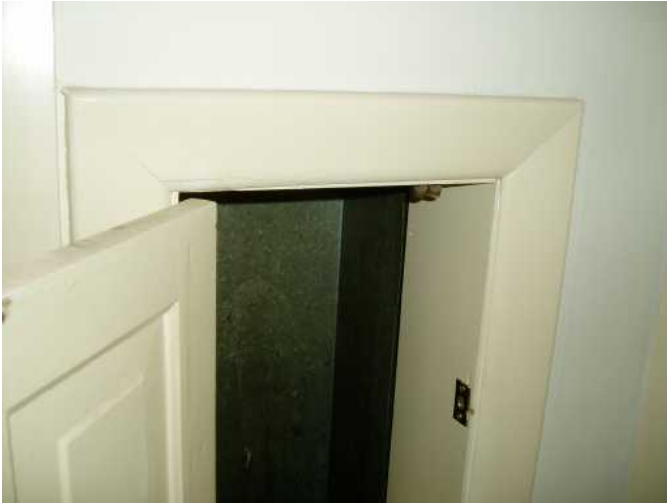
laundry chute in hallway behind kitchen door...

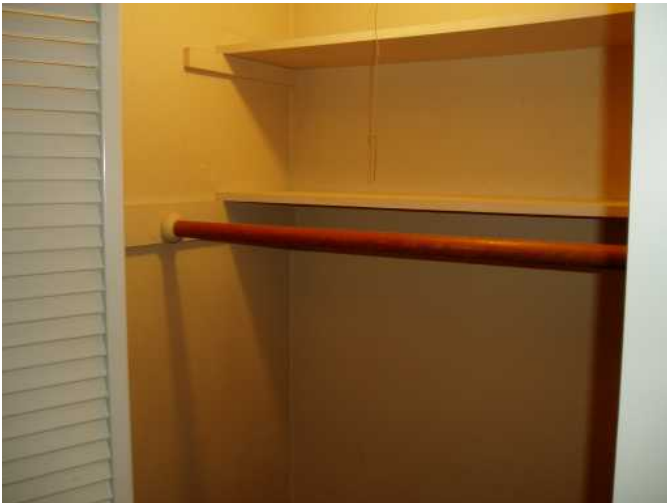
closet 2 hallway door move hard..a little to tight to carpet...use caution....

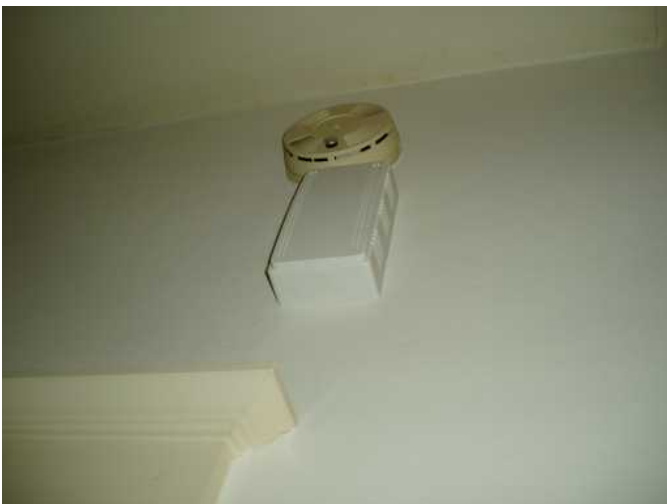
door bell and smoke detector...

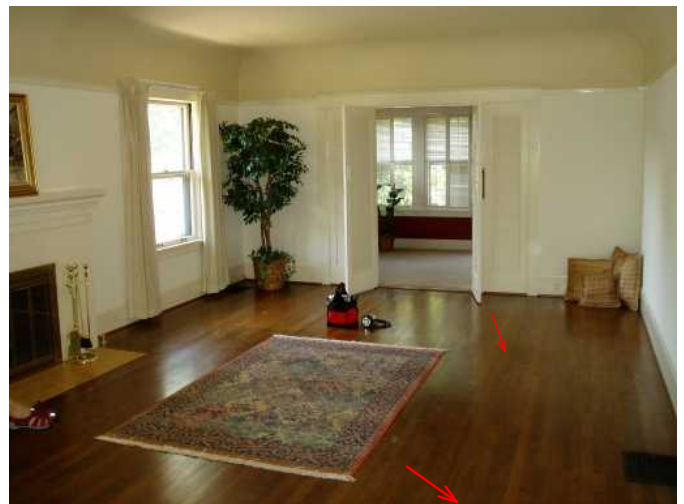
living room/wall outlets are mixed..grounded and ungrounded.floor outlets were not operable...

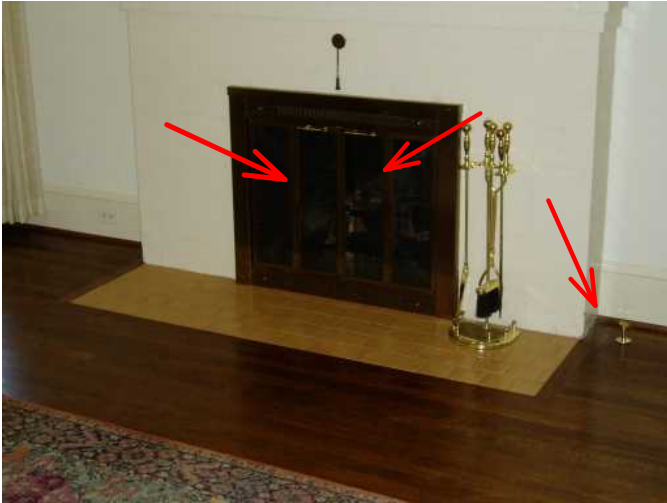
fireplace has gas log inside..good..control by key use lighter to ignite...confirm glass is tempered or ceramic...

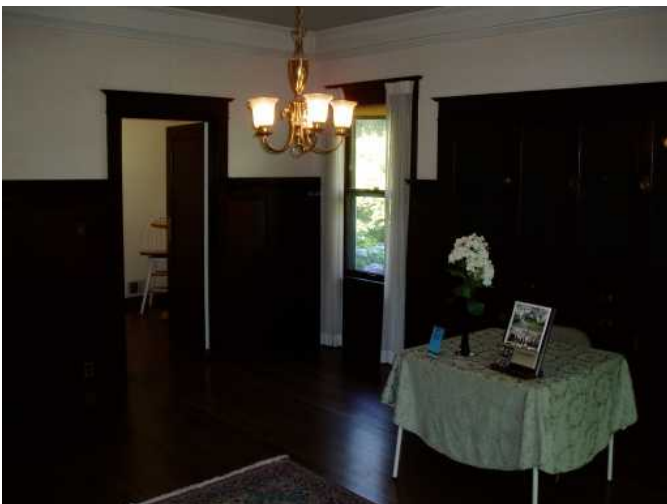
door to butlers pantry is good...dining room...

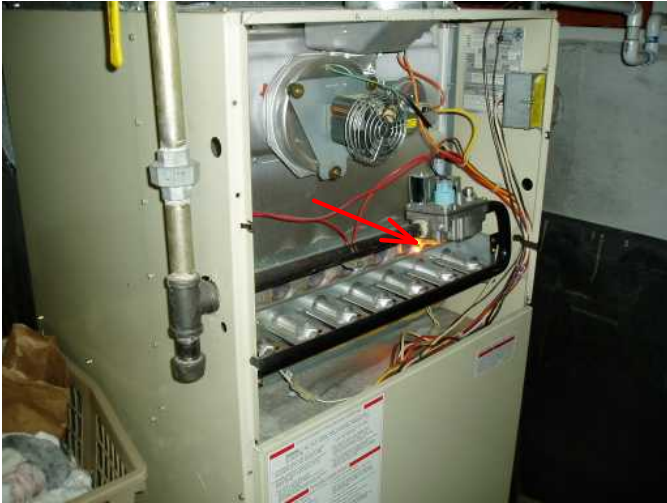
furnace in basement...showing electronic ignition..not standing pilpt...good...
