# Home Inspection Report

6603 se 31st ave  
Portland, Oregon

Prepared by: The Home Tester  
10555 SW Tigard St. #57  
Tigard, OR 97223  
Ben Tester  
503-515-1833 CCB# 164921 OCHI # 912

## Photo Attachments

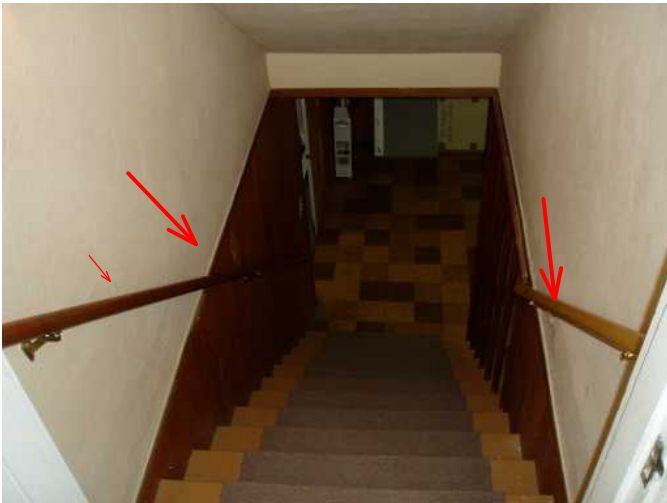
handrails to basement are solid and sound....

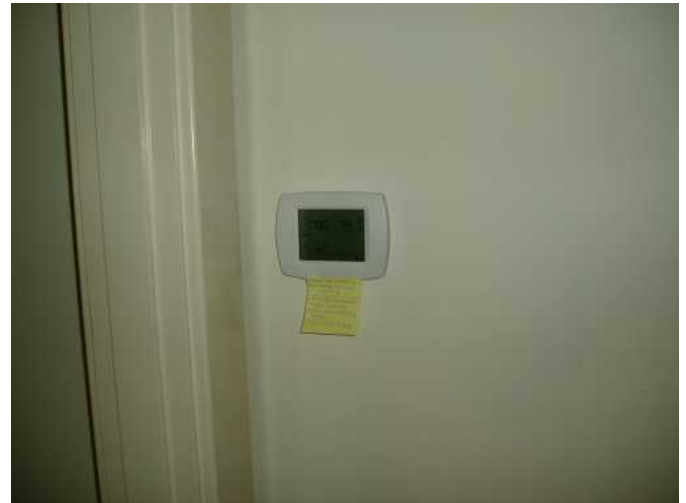
first floor thermostat control is programmable...ask for owners manual...

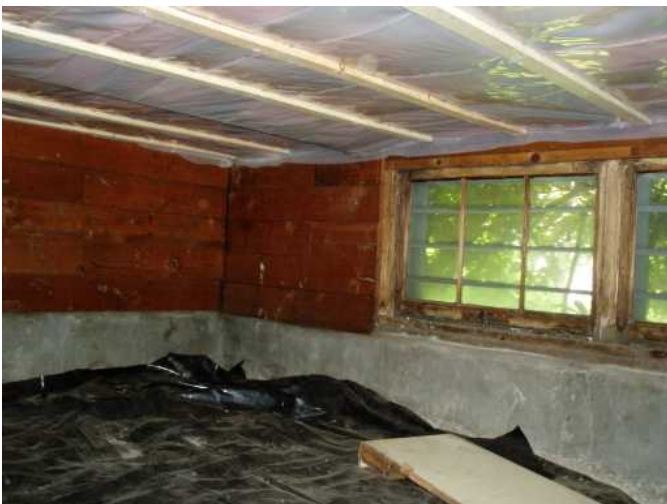
crawl space under dining room is awesome...insulated and moisture barrier is installed great....

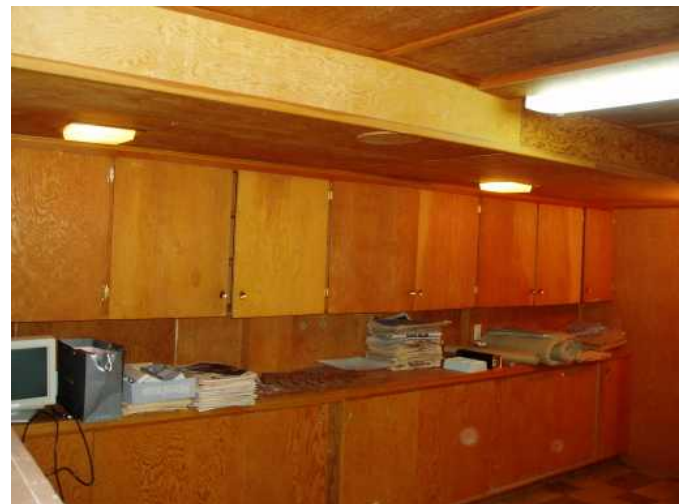
cabinetts in basement room at bottom of stairs has ungrounded outlets....

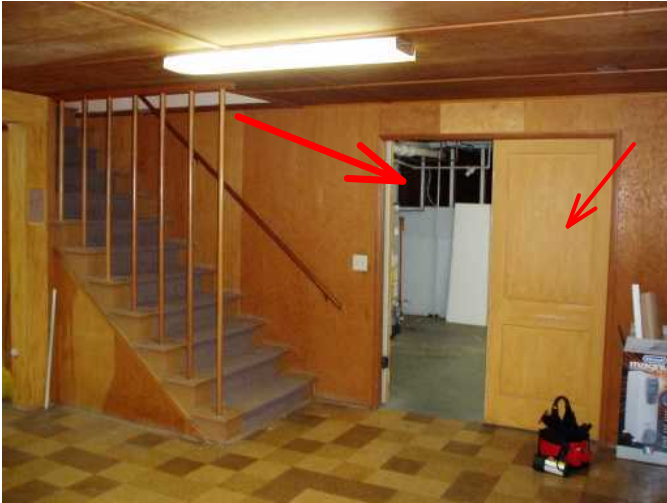
doors are solid to utility are....

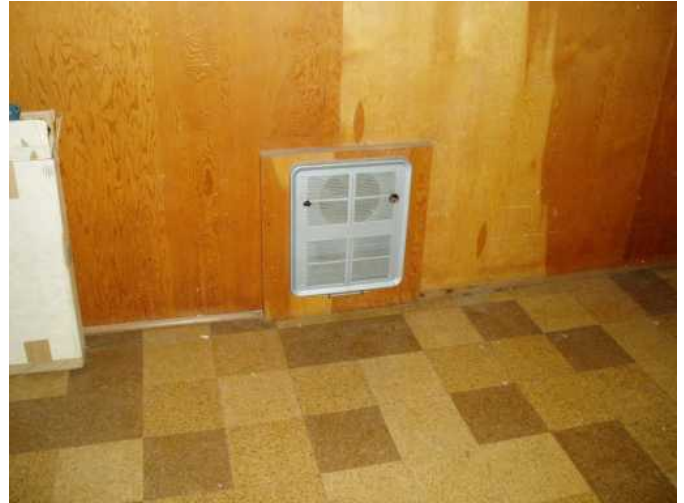
wall heater in basement room works fine...zonal...

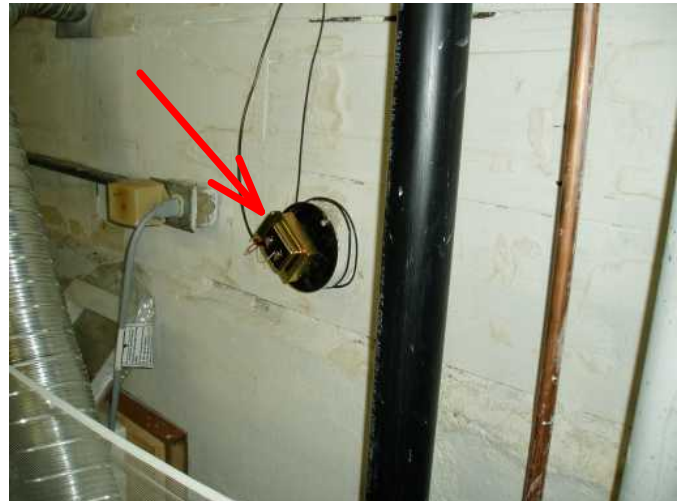
doorbell converter keeps low voltage to door bell button...

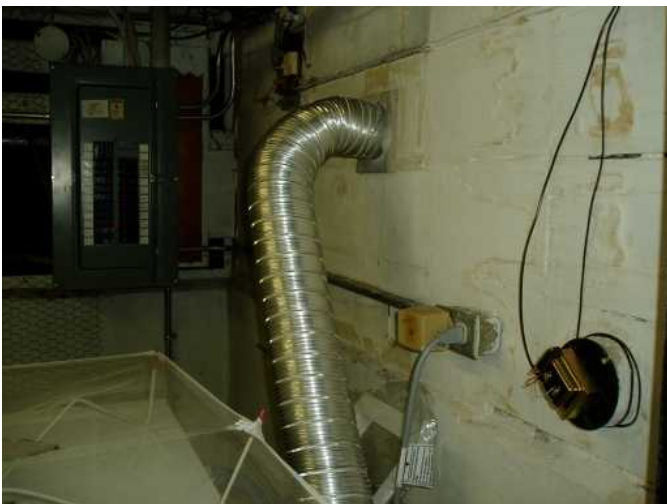
dryer exit vent to outdoors is good...

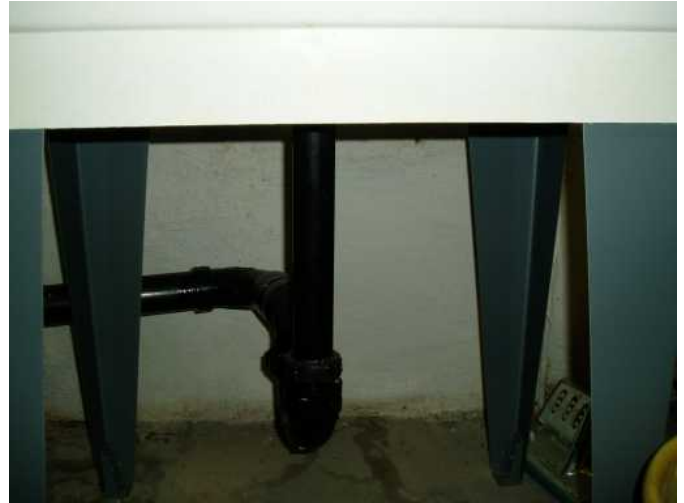
under laundry tub is drip free....

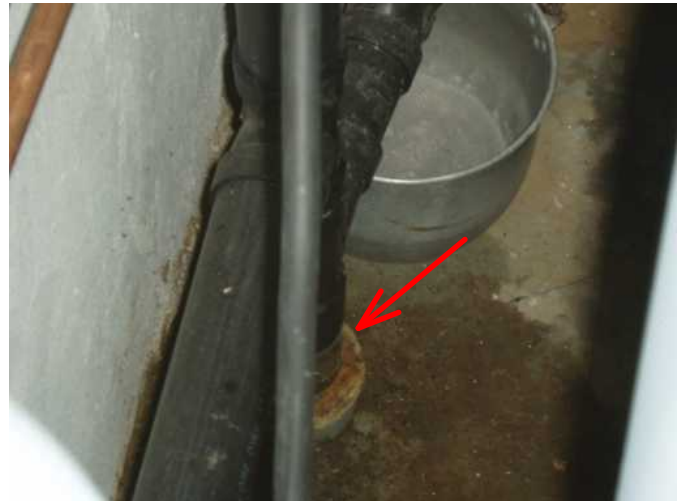
exit pipe to sewer exit is sound....

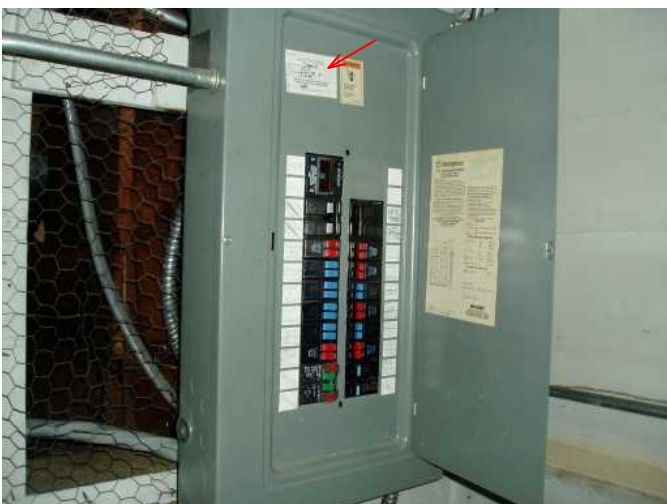
electric panel is 1985 installed and signed off...good...

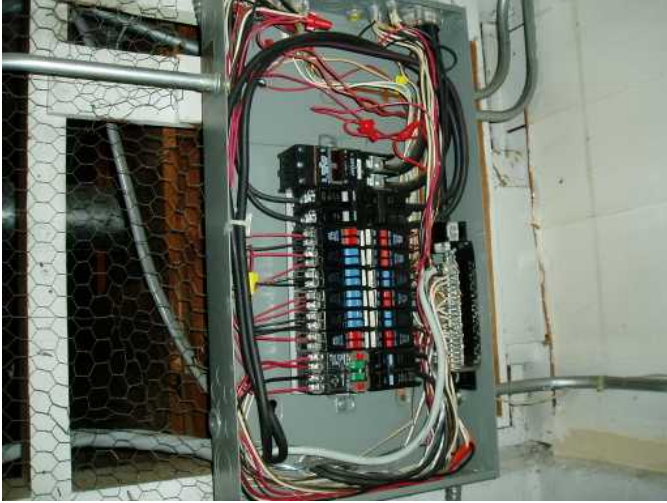
inside panel looks fine...200 amps and 100 amps to sub-panel in attic...

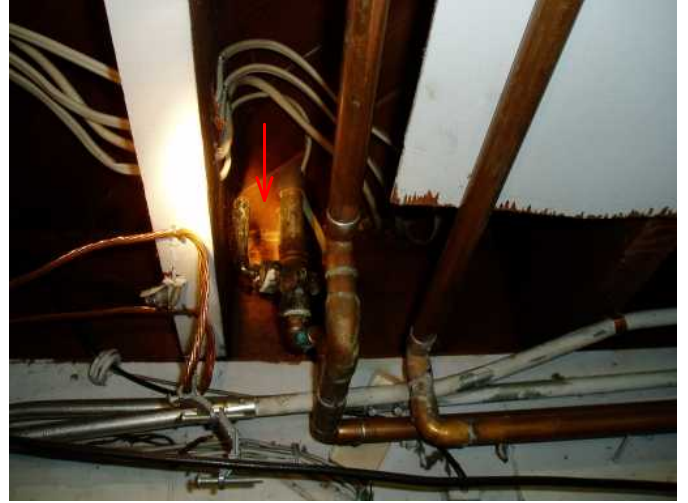
hose bib shutoff to outdoors above laundry..good...all copper pipes..very good...

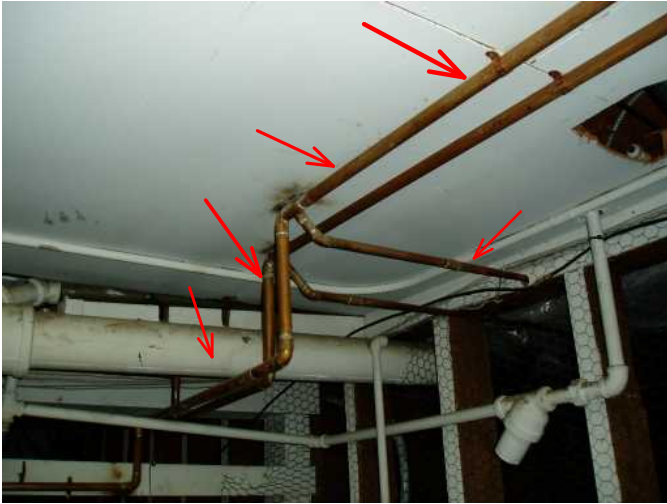
more copper pipes...

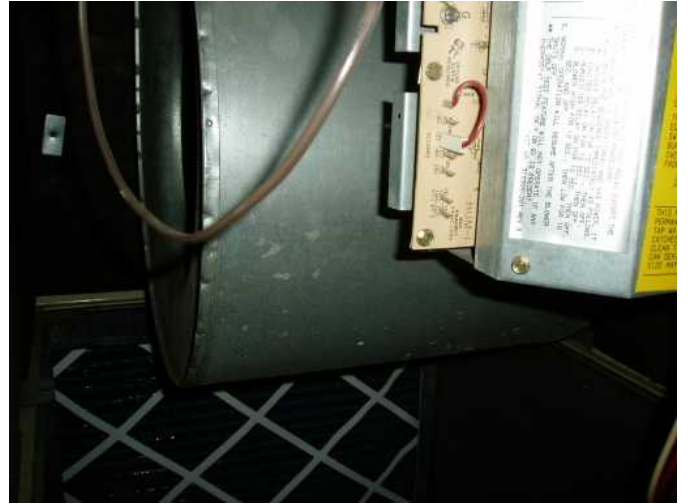
furnace fan and filter ....

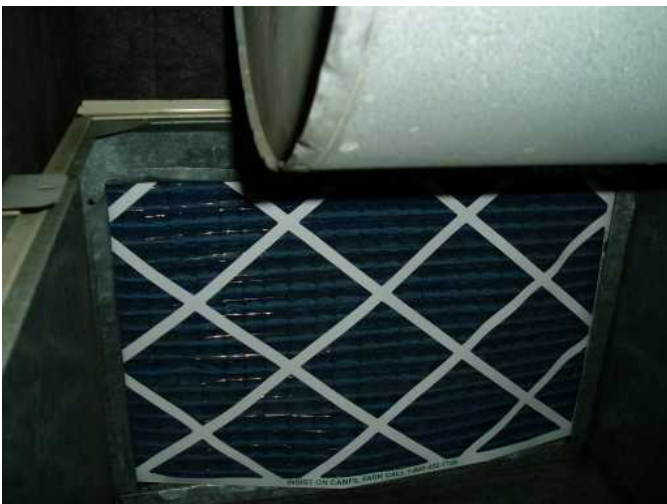
second view of filter/fan box...

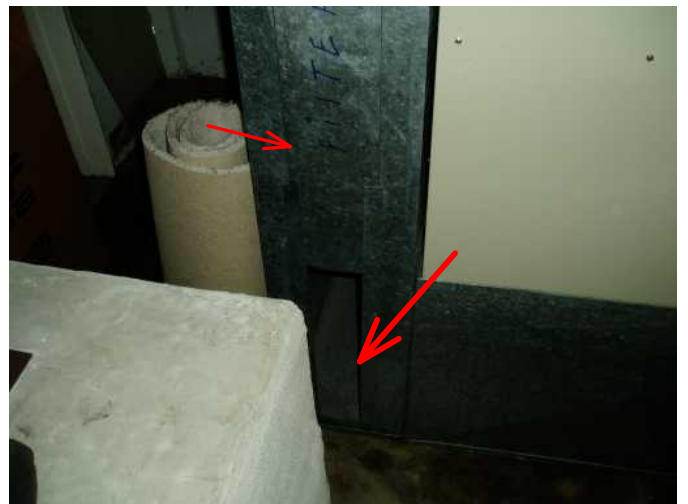
filter access on outside of furnace...

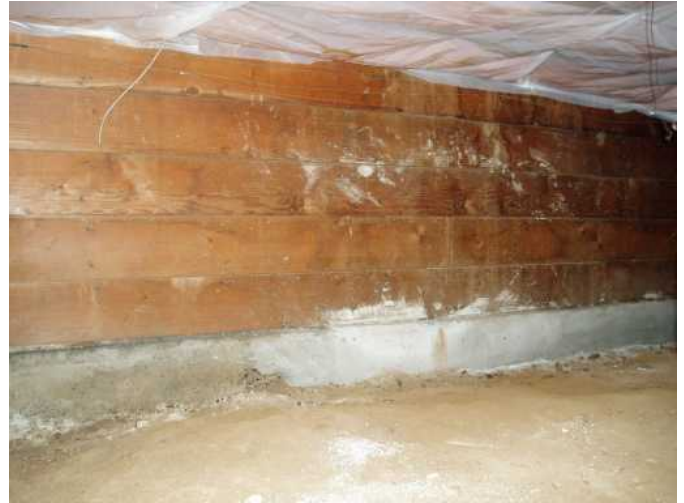
crawl space in back area of home..good...

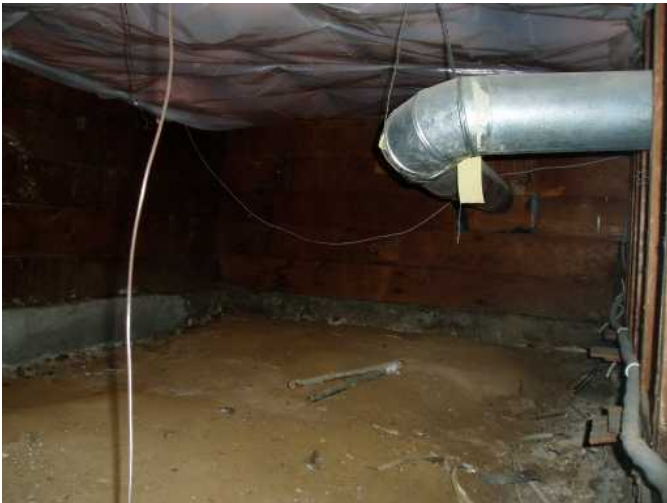
second view of same crawl space...

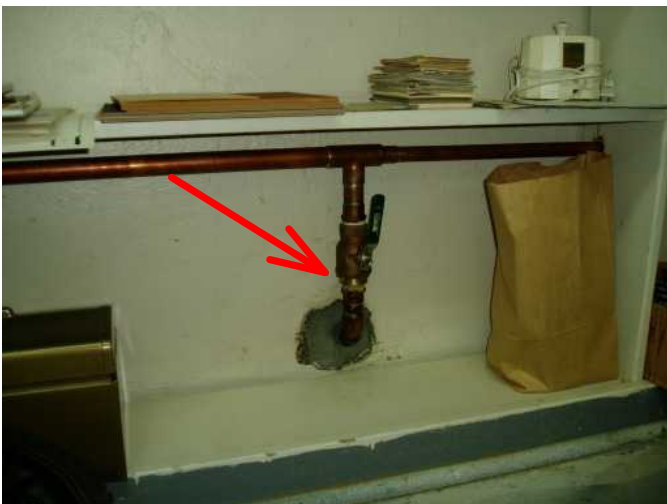
main water entry and shutoff in front of home basement under living room...

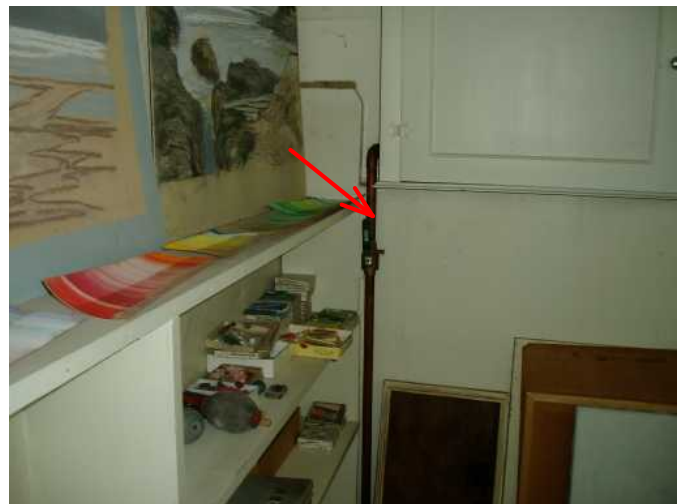
hose bib shutoff to outdoors ...

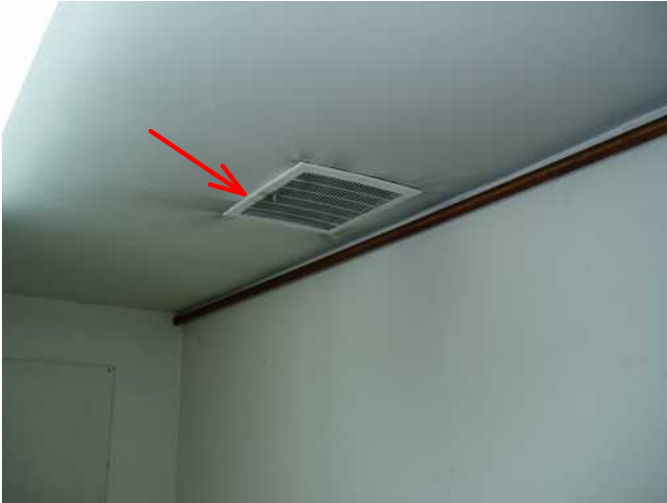
work room in basement has furnace/a.c access....good...

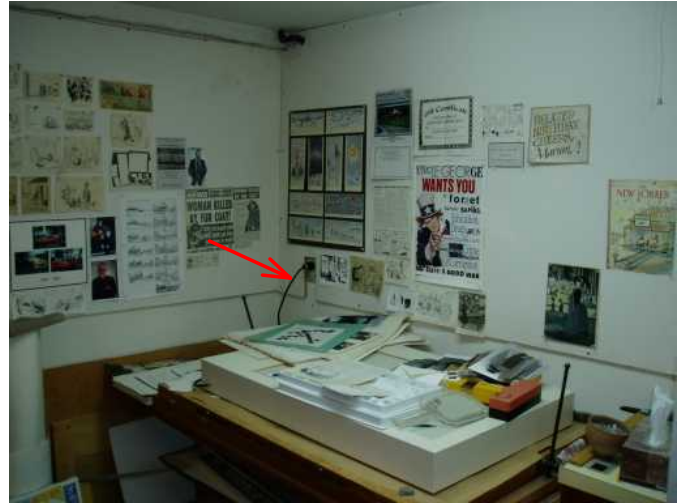
only found one outlet in this room is grounded....

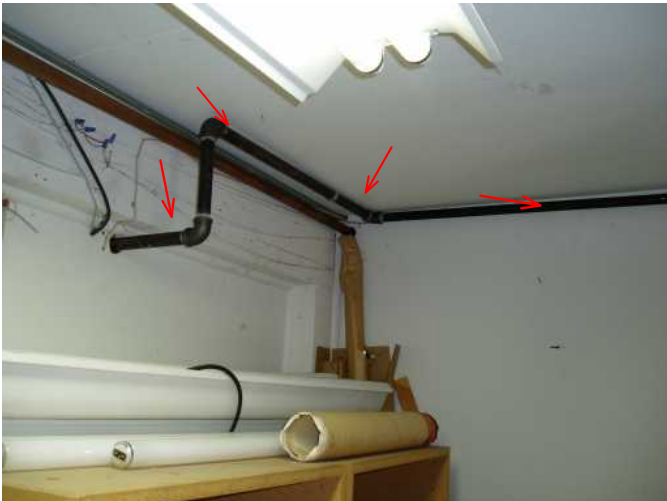
gas pipe to fireplace for gas logs....from furnace and water heater access...

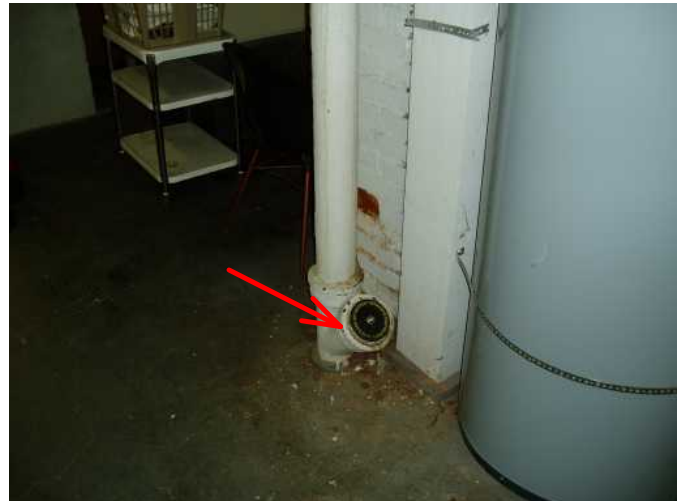
sewer cleanout access basement by water heater...good..

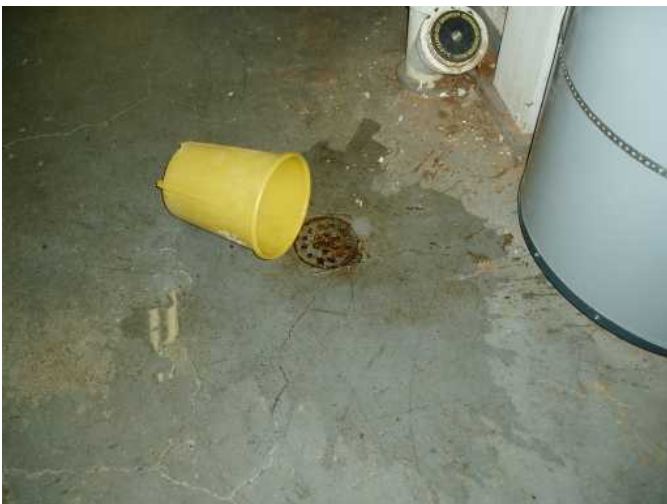
basement drain checked and operable...
