Home Inspection Report

1503 #52 Hayden Island Drive
Portland, Oregon

Prepared for: Manufactured Home Sample / Actual Report

Prepared by: The Home Tester

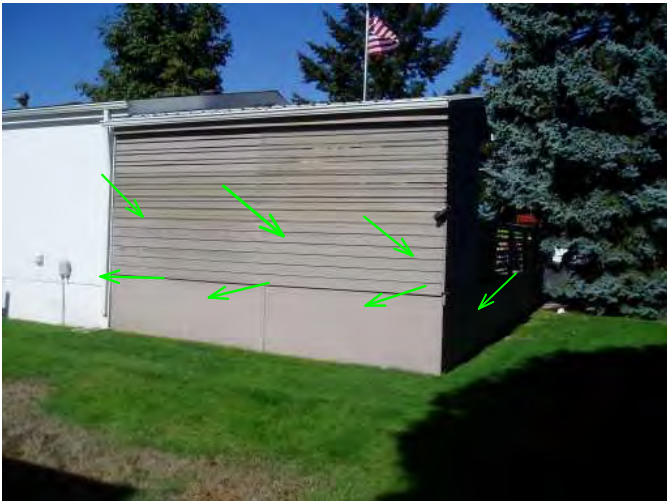
back area of small covered deck area...good...has plastic baffled sections to cover in winter to keep out rain...good..

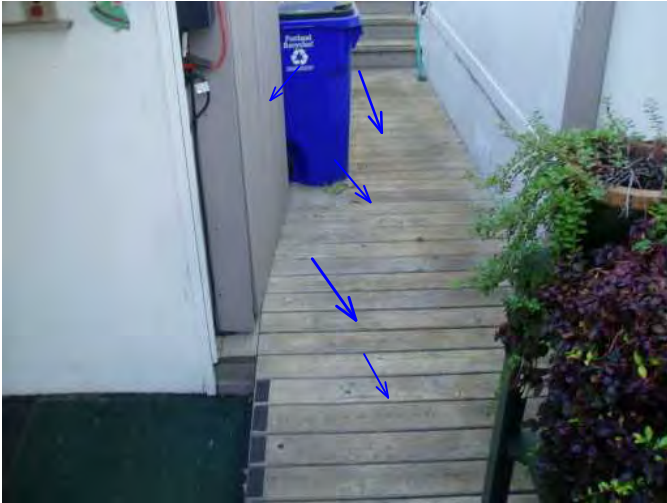
wood is solid and sound...will need to be cleaned and sealed to extend useful life...gate is solid...good...

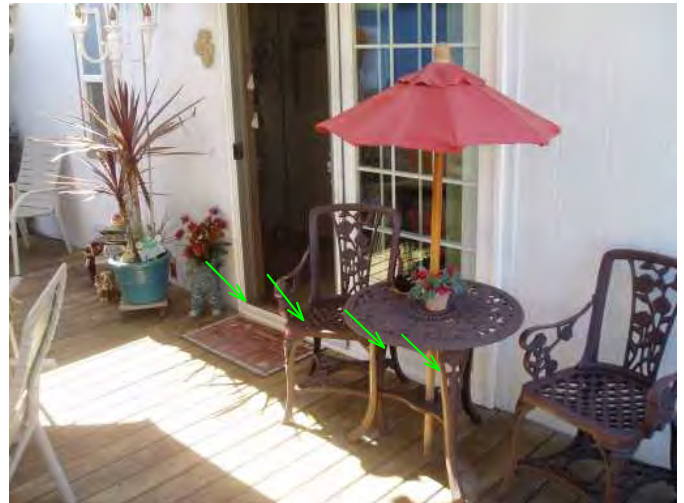
patio slider door is higher than deck...good...raised to keep out rain water...good..

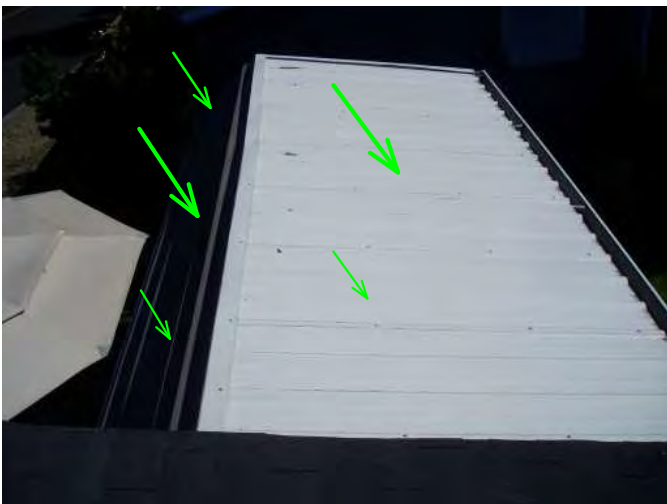
deck metal roof over covered deck area and wood siding at front area noted as decorative finish...keep painted...good

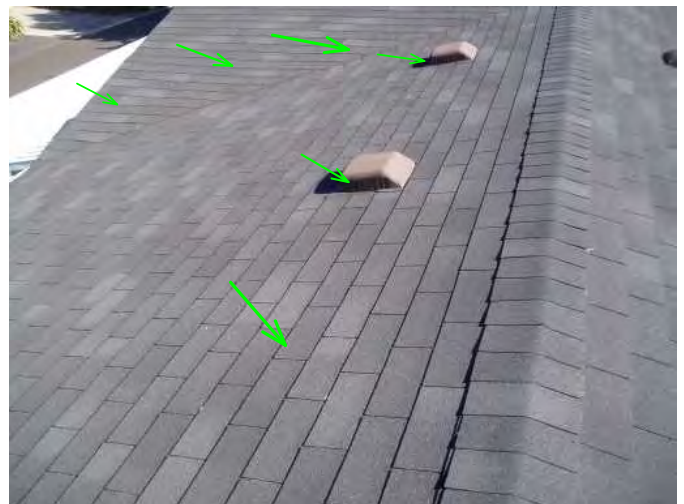
facing back of home on roof and noting clean and solid. ...shingles are fine...vents are fine as well...

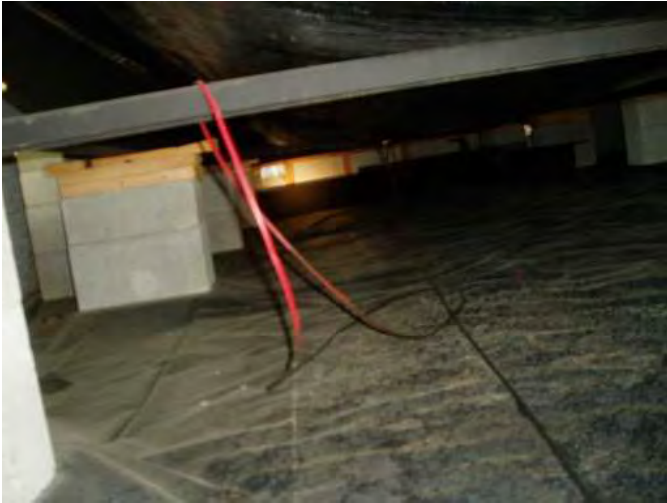
under home is clean and dry and appears to be checked regular....good...

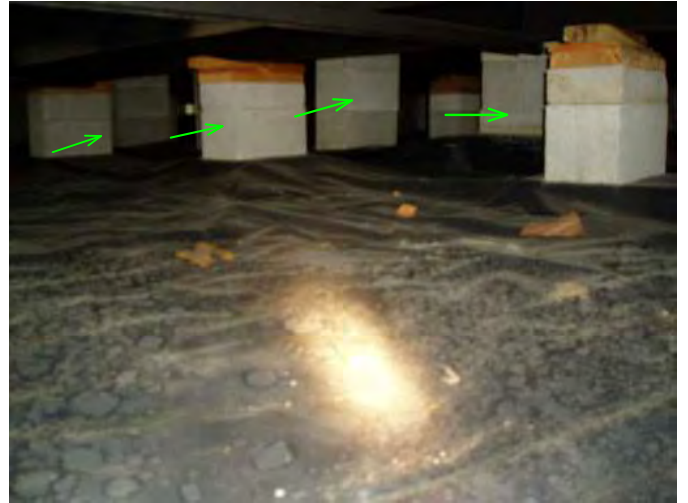
all of home is on blocks and wood levels...solid and sound...all of under home is clean and dry and insulated...good...

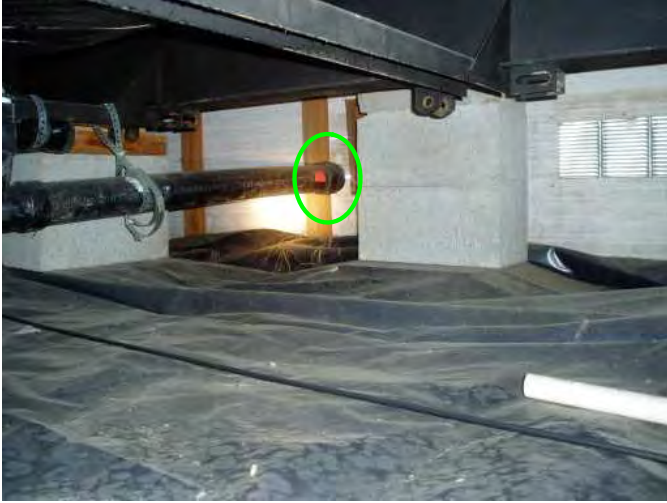
main sewer access has outdoor access clean out hatch for easy access when/if needed....

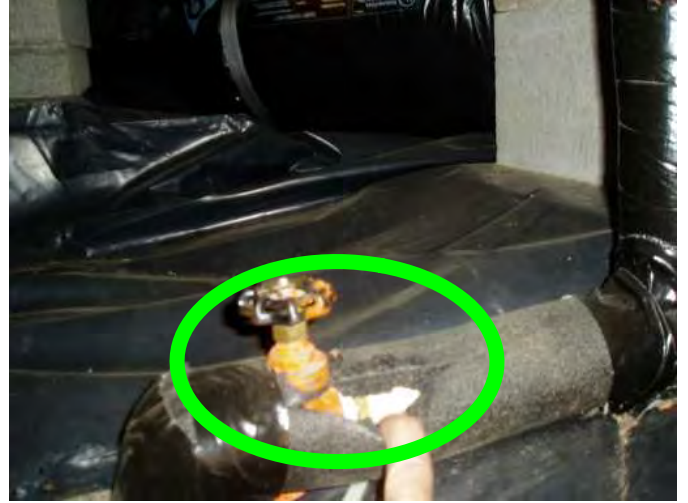
main water entry shut off and pipes are C-PVC and are fine..insulated as well...good..

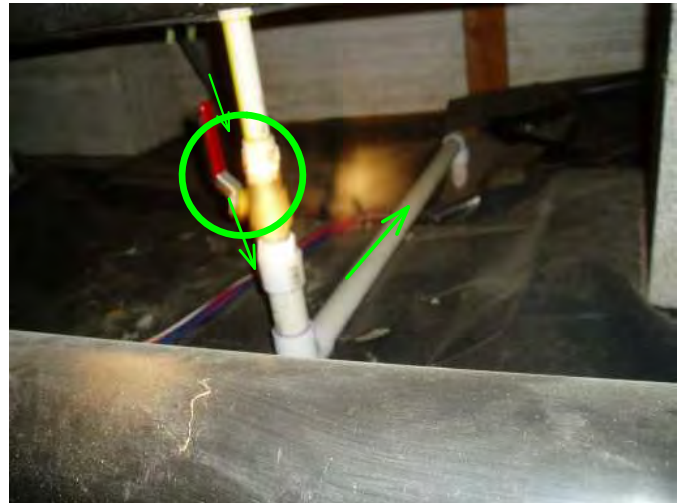
this is pipe to supply to irrigation system for lawn...has shut off for winter...use to keep from freezing pipes...

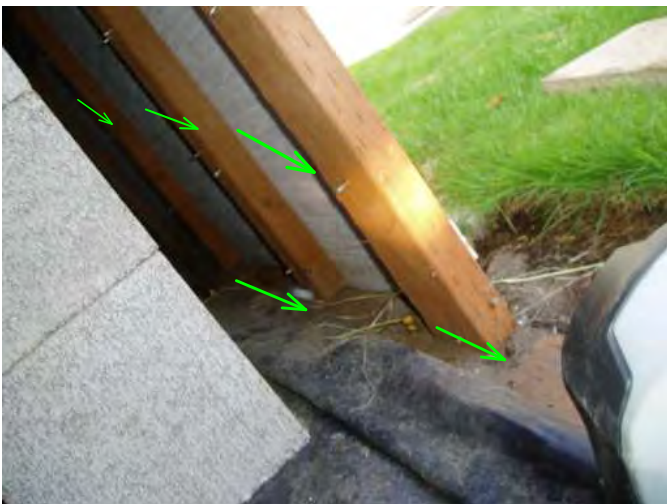
all skirting framing is treated wood...all of this home is proving to be better quality than I normally find

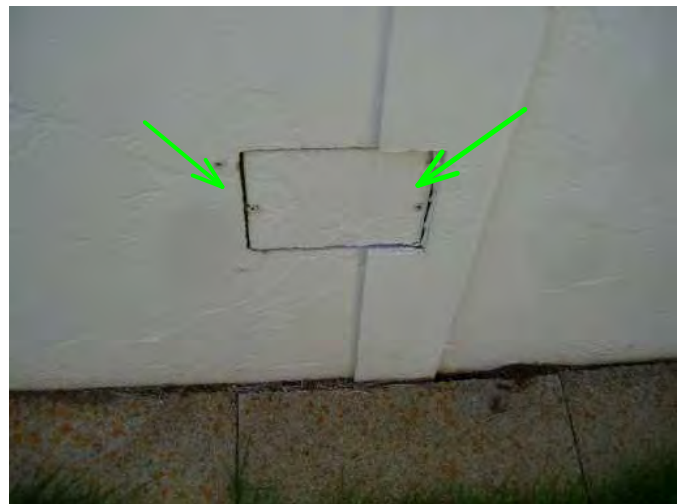
sewer clean out access hatch...good...

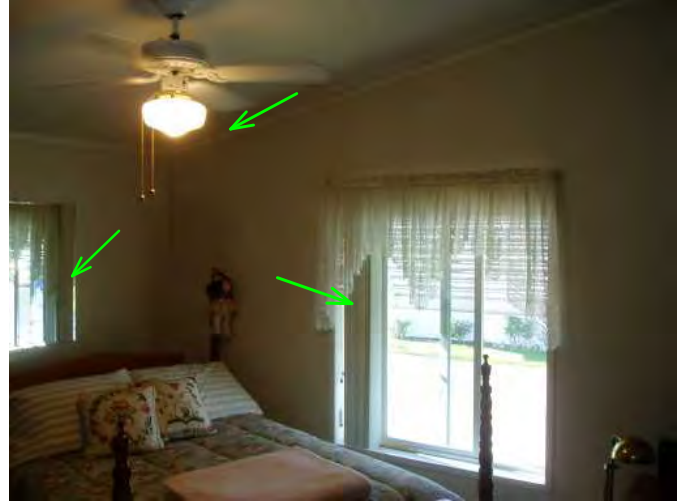
bed 3 windows and fixture and fan are operable..good...

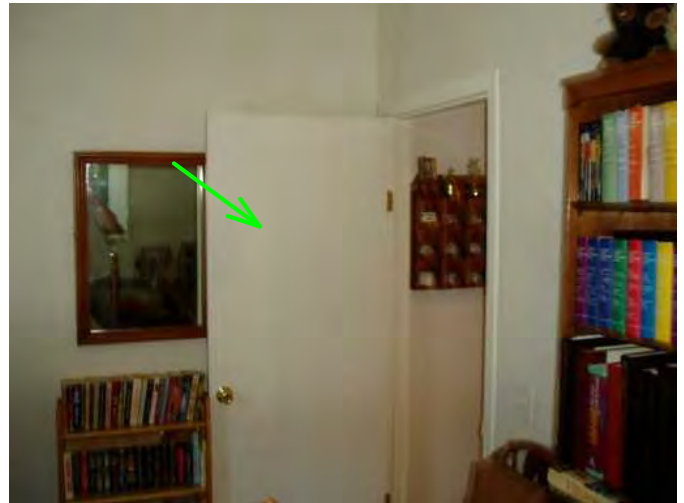
bed 3 entry door is operable...good...check all doors for door stops and add disc to wall if missing ...

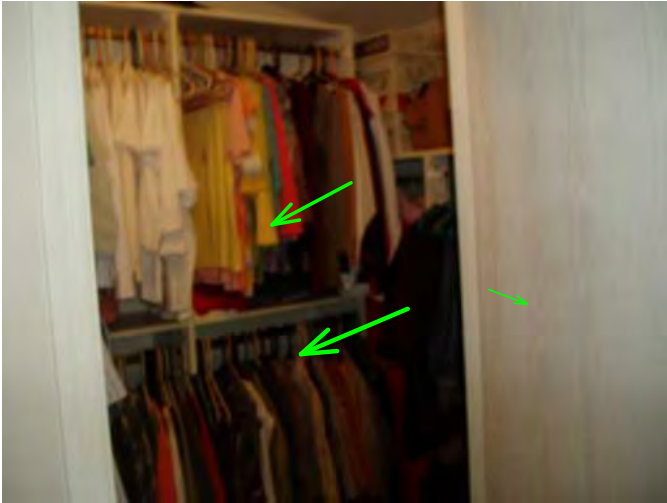
bed 2 walk in closet entry door and shelves and fixture are operable....good...

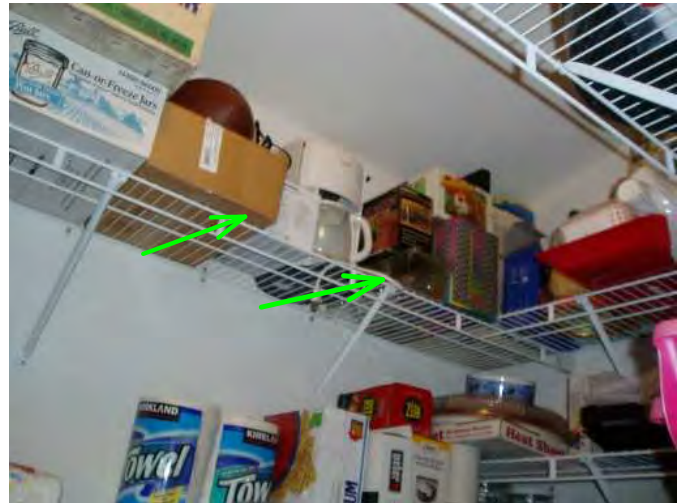
master closet is being used as pantry type storage....

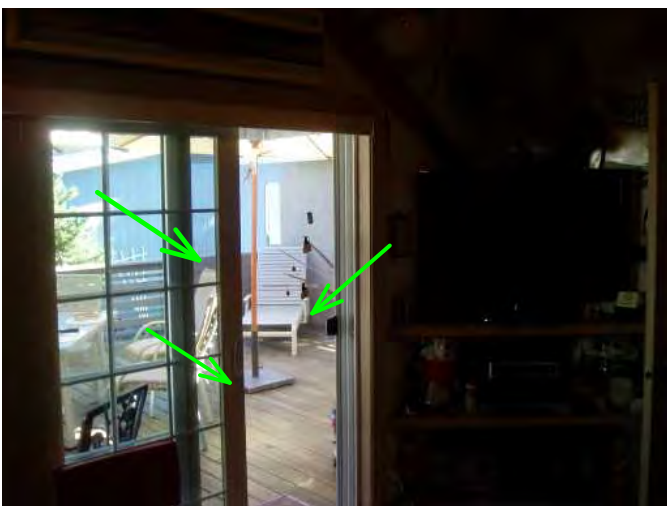
patio slider in master is operable..good...

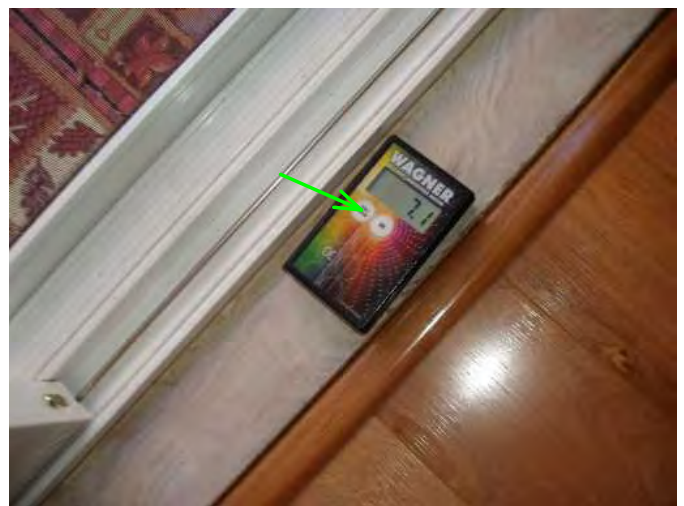
no high moisture noted at slider door area....good...

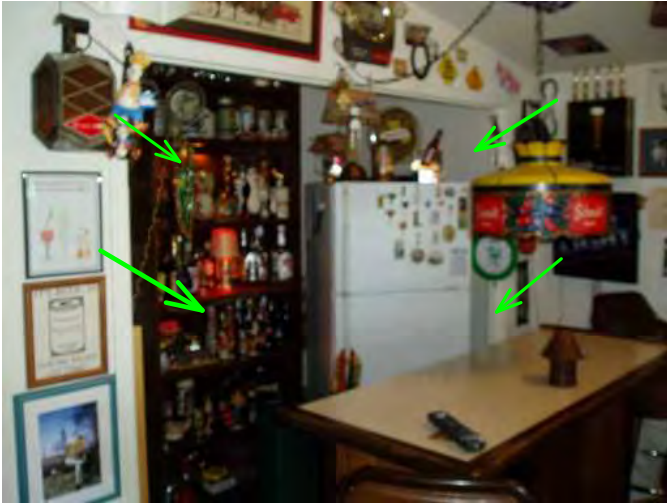
master closet is now being used for bar area...and doors are removed....

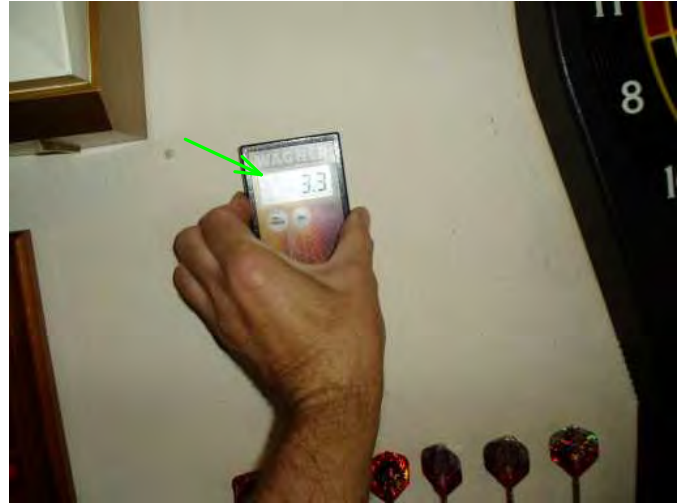
again, at random, checked for moisture in exterior walls and all is fine...good...

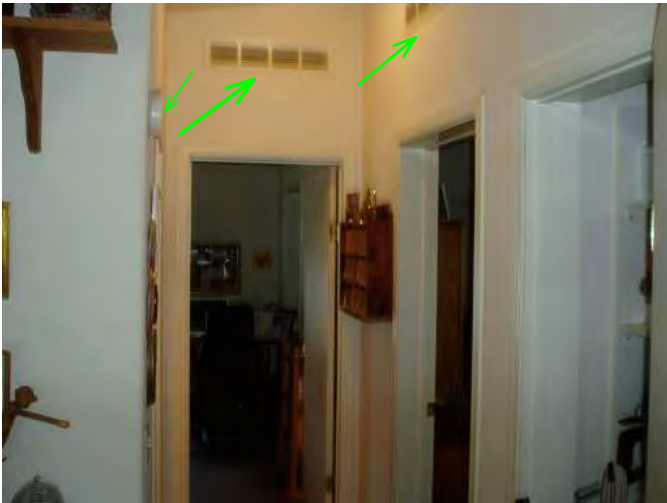
small hallway area has vents above doors to allow air flow around home...and noted smoke detector in hall...

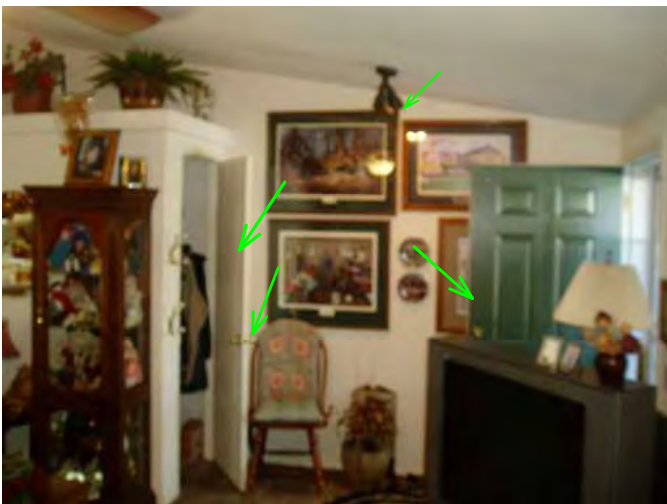
fixture and entry and closet doors are operable...good...add door stop discs wherever needed....

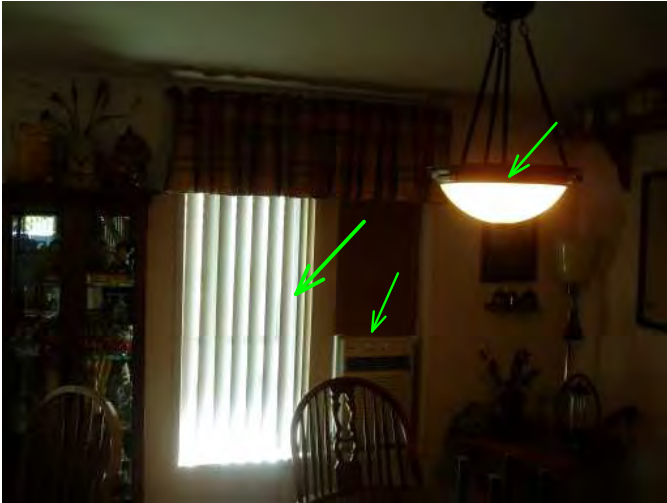
window in dining room and fixture are operable....good....

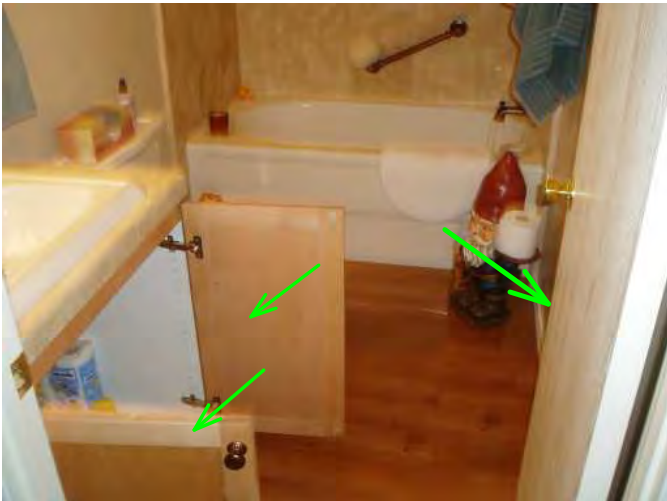
entry door to front bath and cabinet doors are operable...good...

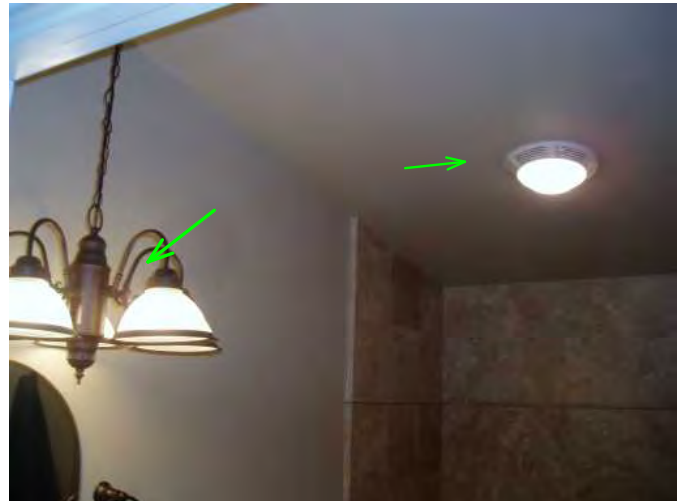
fixtures and exit fan are operable in bath as well....good...

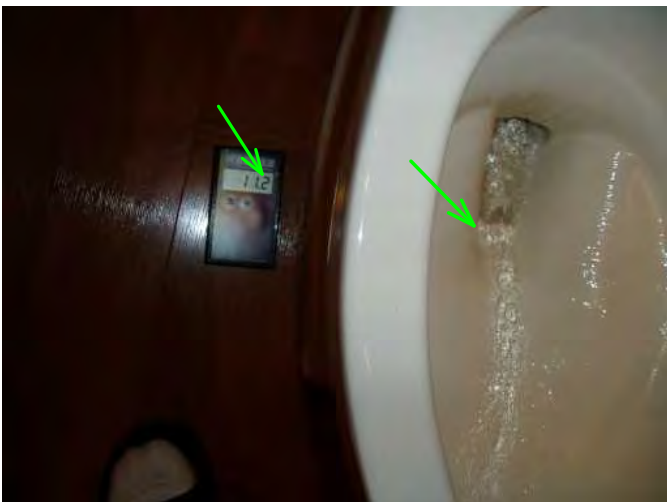
toilet is operable and no high moisture at floor is noted...good...

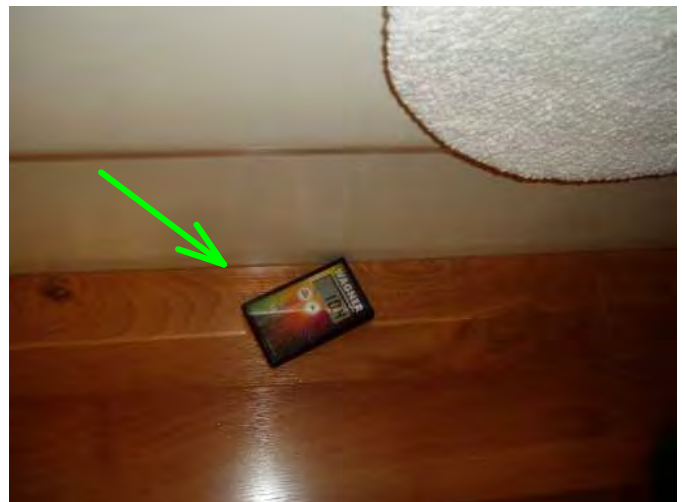
no high moisture noted at floor area as well....good...

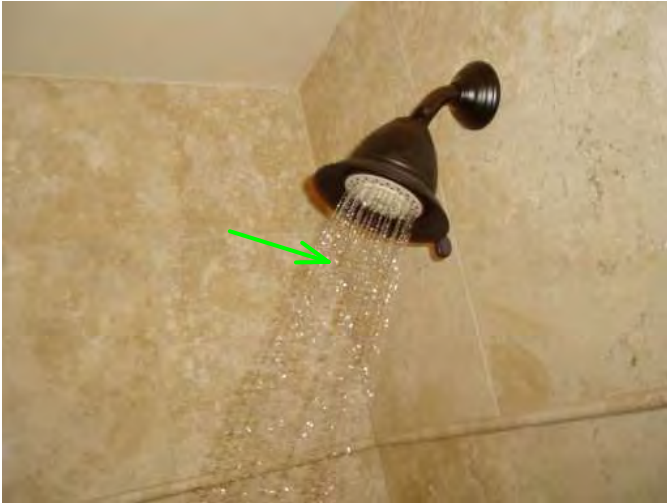
shower head and shower walls are operable...walls are awesome! not noted in any other home in area!!

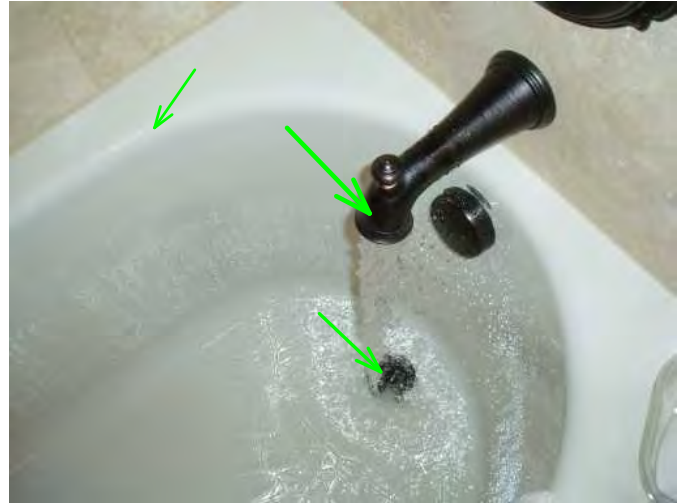
tub fixture and drain are operable...is better quality fixtures as well...good.....

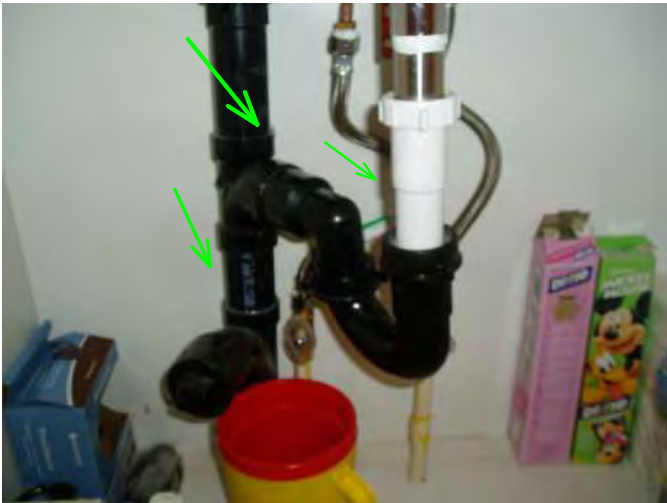
no drips or leaks noted under sink area....good...

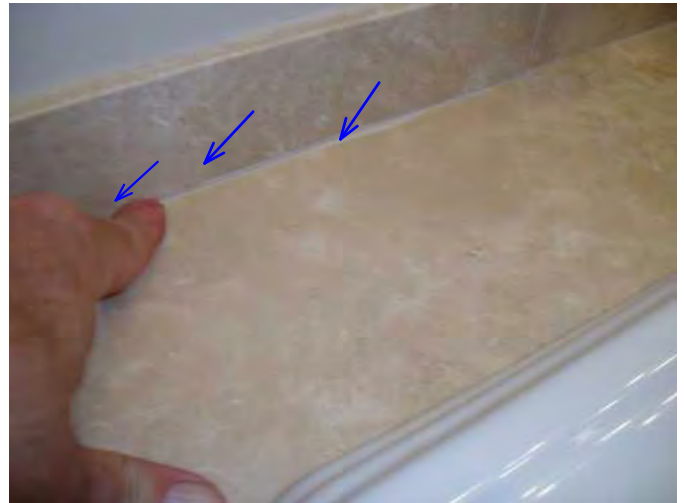
minor issue here needs to be caulked.....

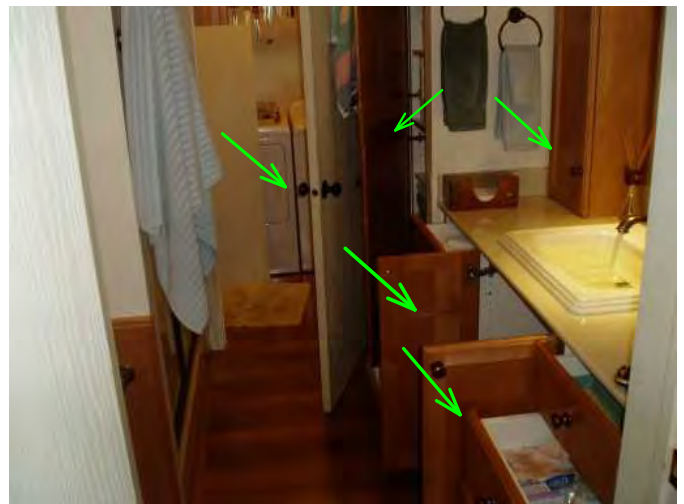
cabinets and entry doors to master bath area are operable..good...

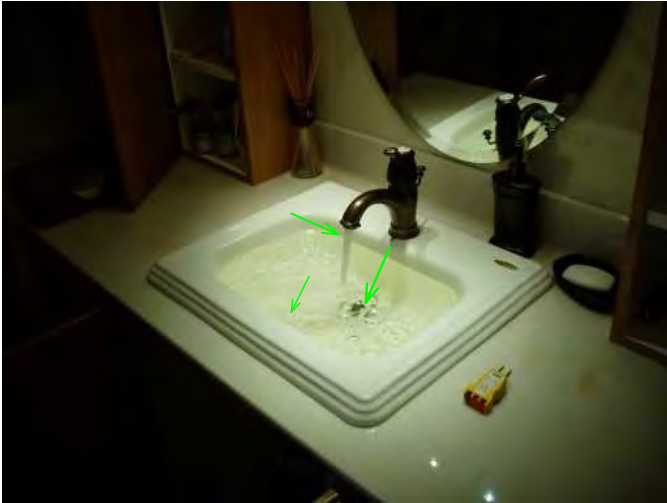
master bath sink faucet and drain and overflow are operable..good...

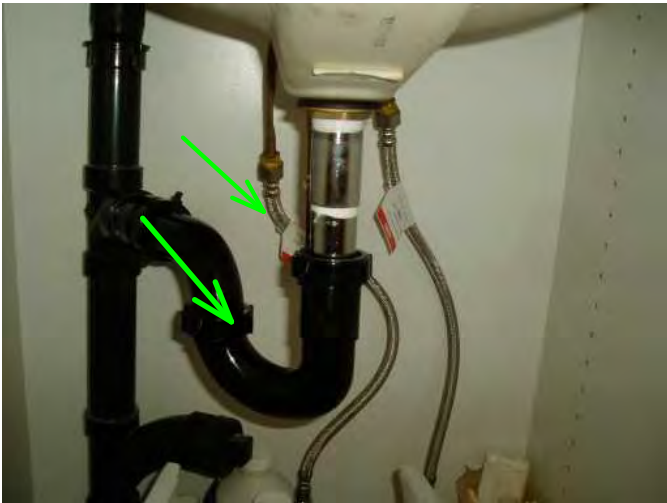
again, better quality found here under sink and no drips or leaks noted....very good...

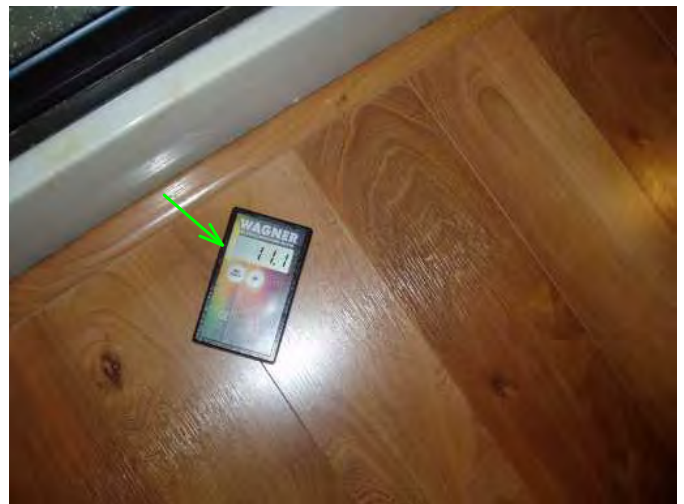
no high moisture noted at floor area....good...

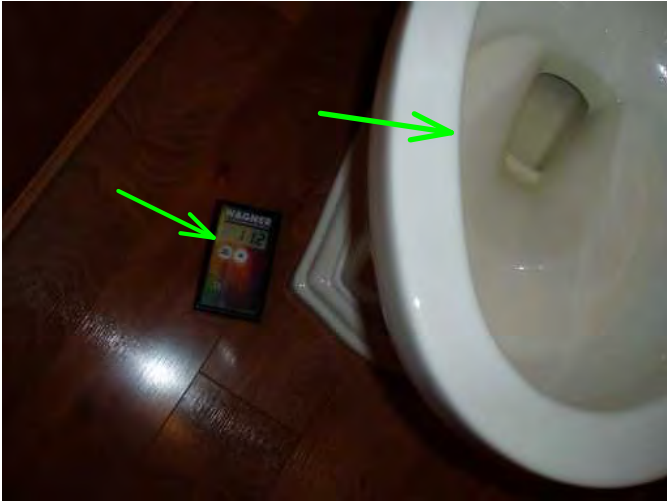
toilet is operable...and no high moisture noted at floor area....good...

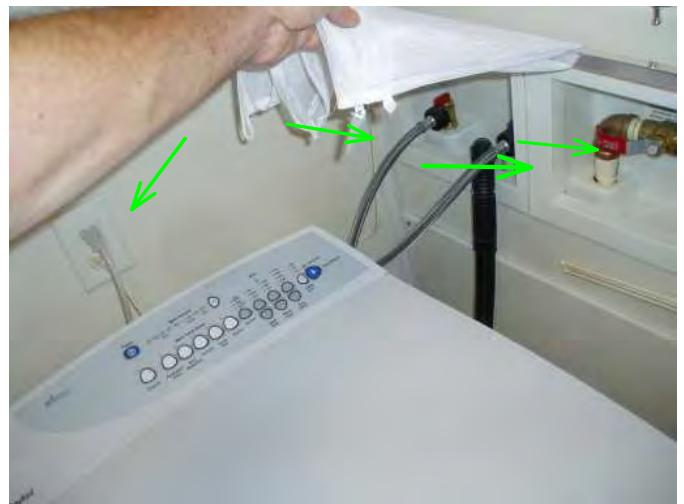
washer hook ups are fine..noted hot water heater has shut off in wall area....good....

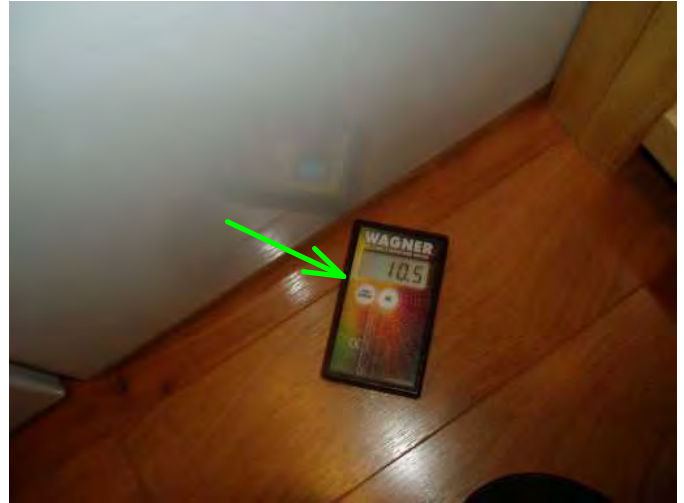
no high moisture noted at washer area....good...

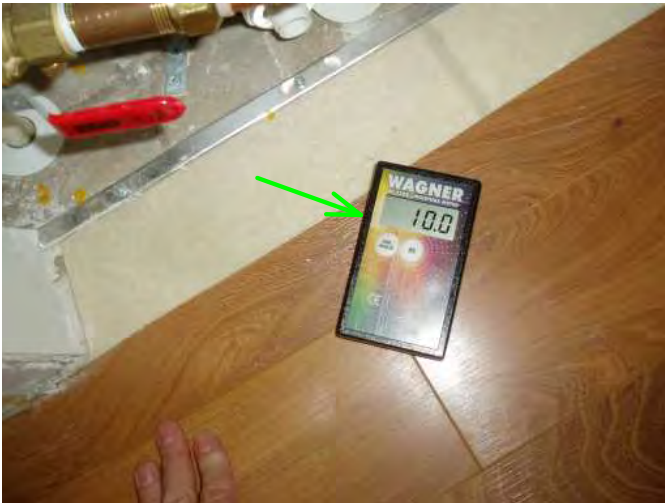
no high moisture noted at floor area at water heater area...and noting old flooring was not as nice as wood new....

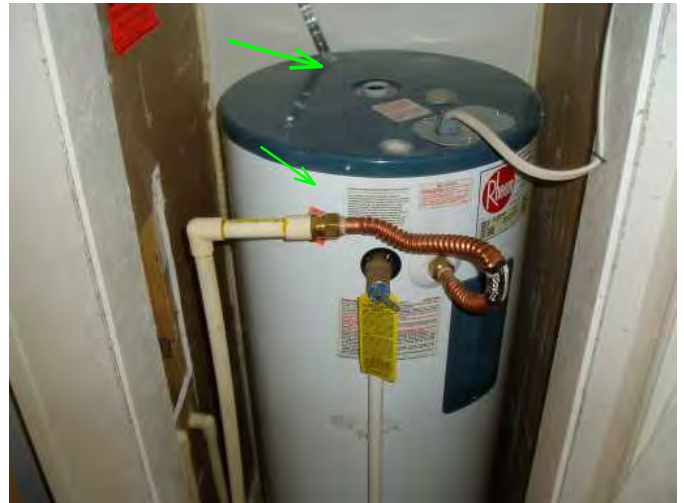
water heater is fine and is strapped in its own odd way...fine...

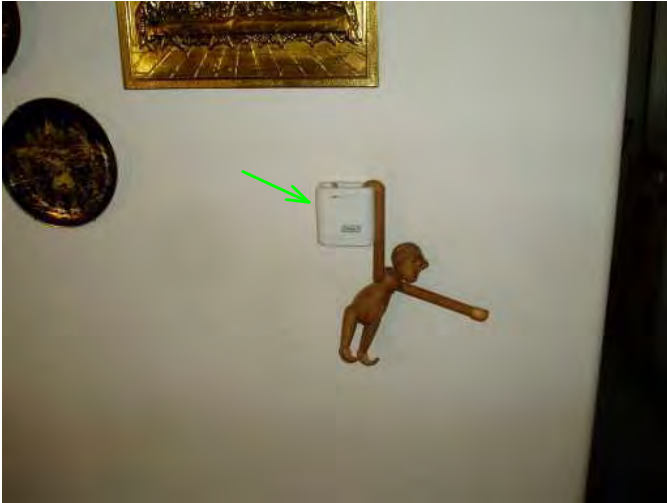
thermostat is noted in center of home in dining area....change filters every 30-60 days when in use....

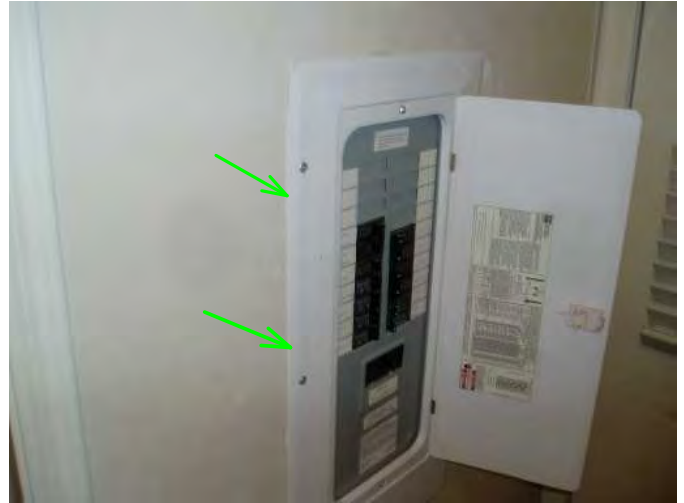
main breaker panel is noted behind back door area....

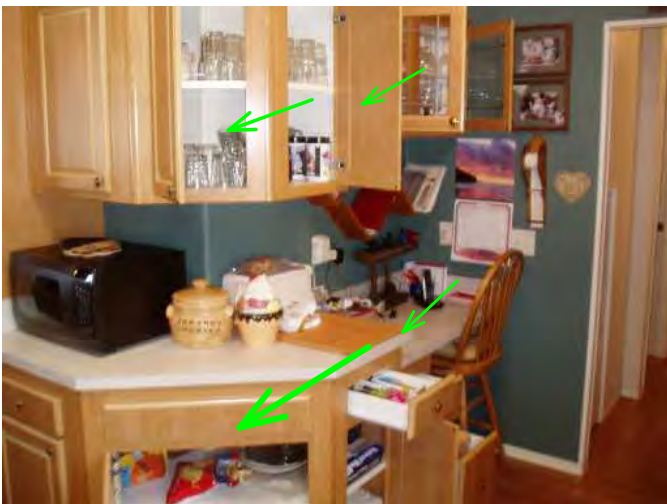
second view of same...all good here...operable..and solid to walls....

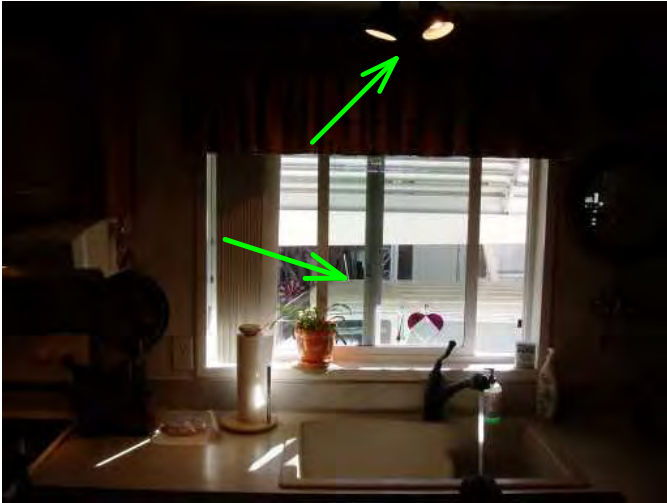
kitchen window and fixture and faucet are operable...good...

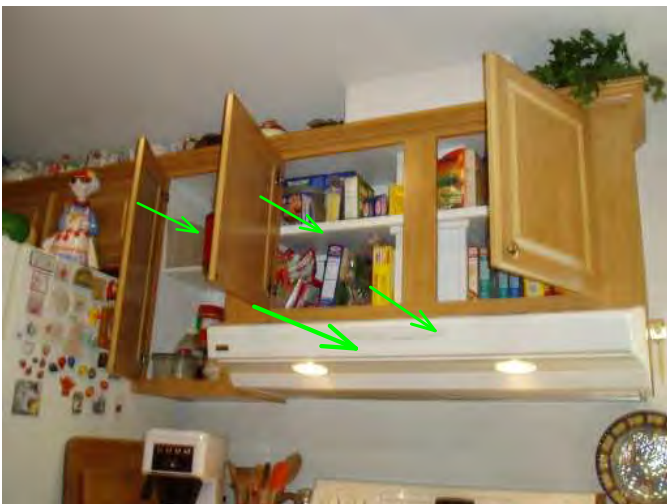
over stove cabinets and exit fan are operable...good...
