Home Inspection Report

18623 NW Reeder Road
Sauvies Island, Oregon

Prepared for: Sample Report

Prepared by: The Home Tester
10555 SW Tigard St. #57
Tigard, OR 97223

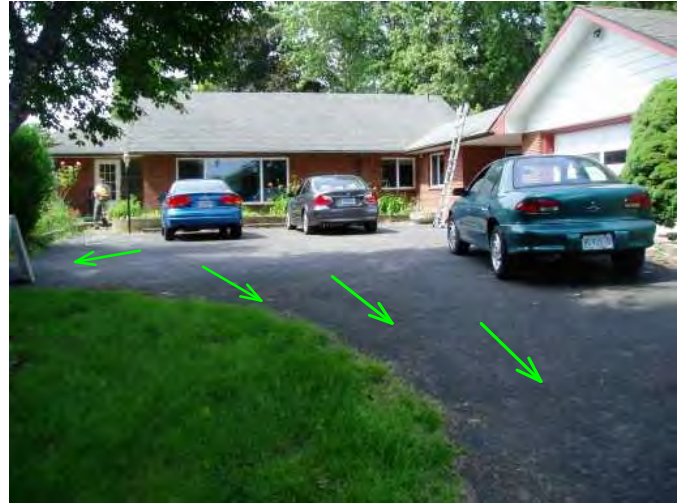
front of home has driveway that is sloped well for drainage....

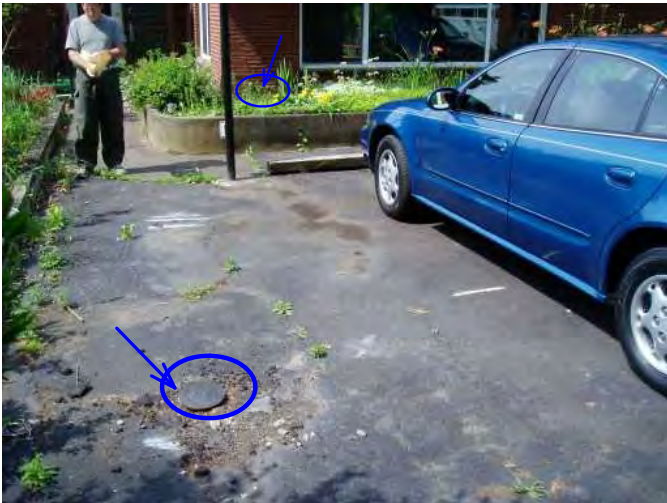
oil tank and vent noted here at driveway...

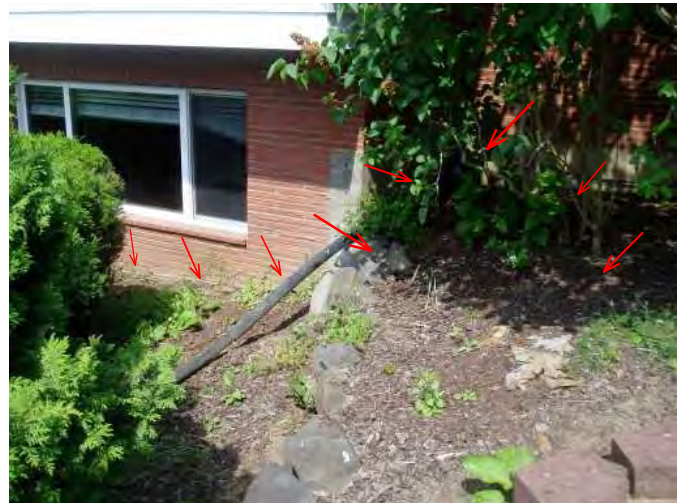
red arrows signify issues to address...this is area of great concern for family room walls and drainage at outside....

Leader/Extension: Aluminum/plastic - area at family room was just recently connected to extensions...has been dumping in area all winter..is reason for wall damage...repair or replace affected wall areas shown in photos...

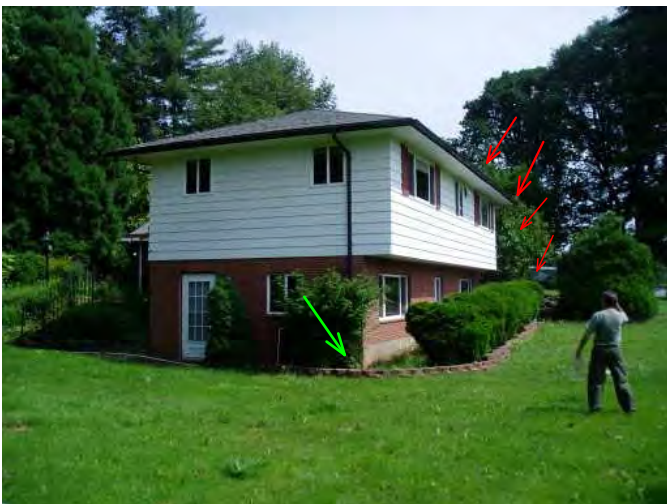
all other downspouts are connected to exits...good..upper siding needs to be painted..trim back all vegetation from home

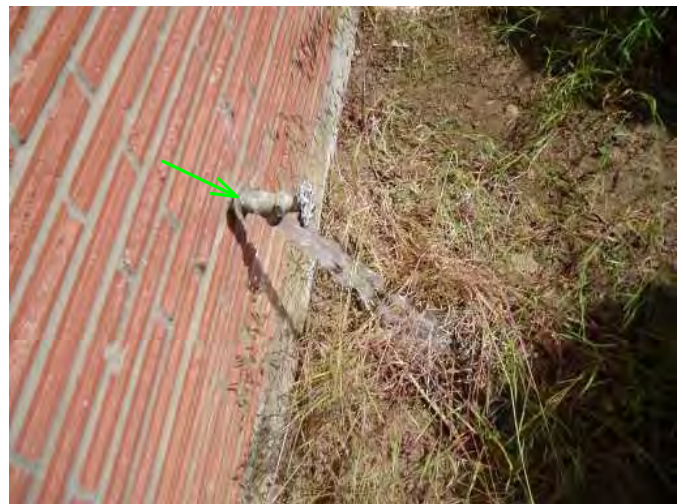
hose bib here at area works....good..

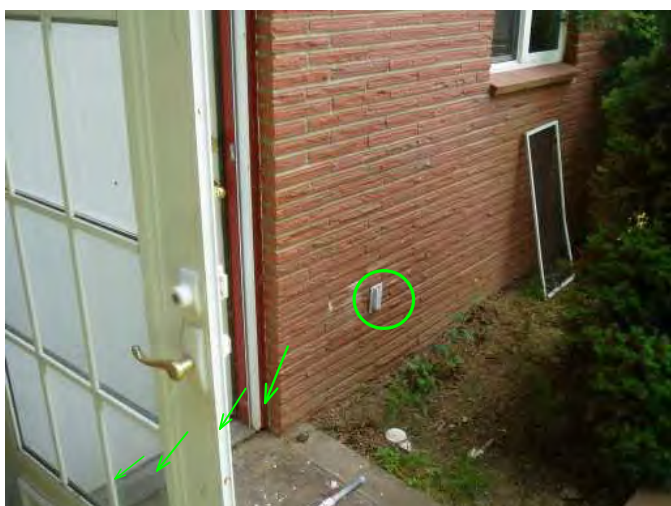
outlet at door by bed 3 exit is GFCI and is operable...porch area is sloped well and door threshold is raised...good..

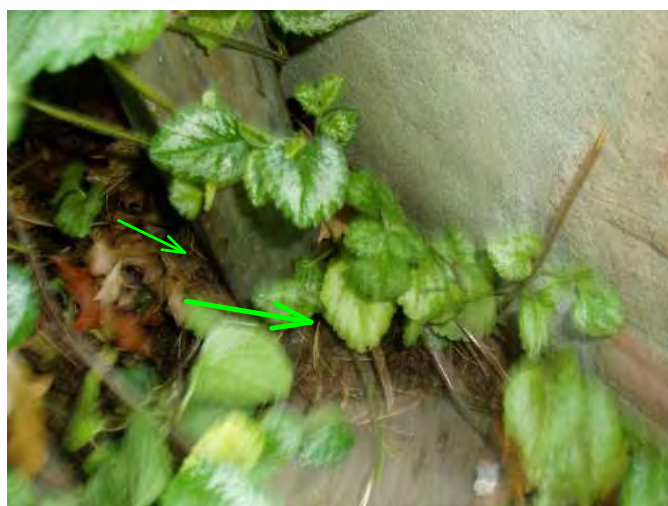
downspout at left of door to bed 3 is connected and draining....good..

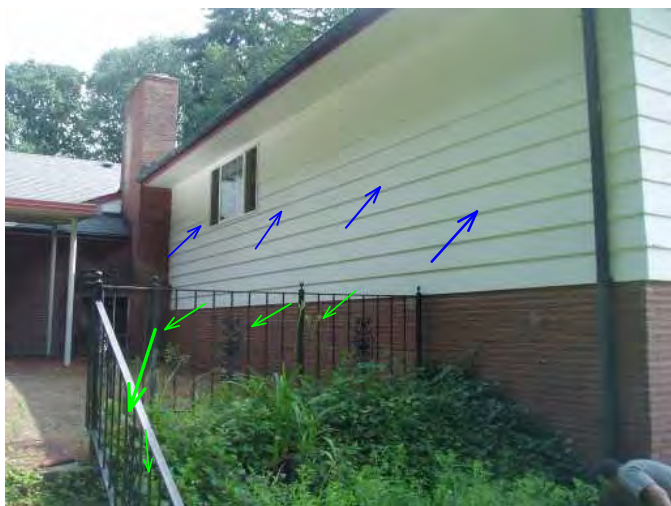
upper area is appearing solid...just needs some paint...handrails are solid....good..

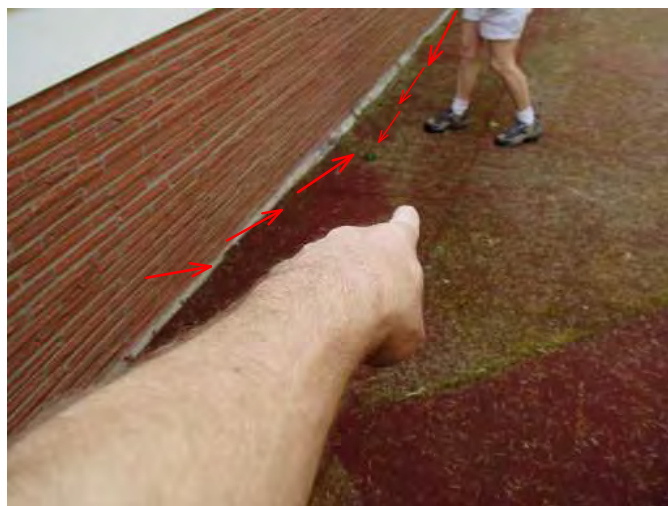
slope at patio is not good for lower area in basement room...suggest adding surface drain or curb to exit water...

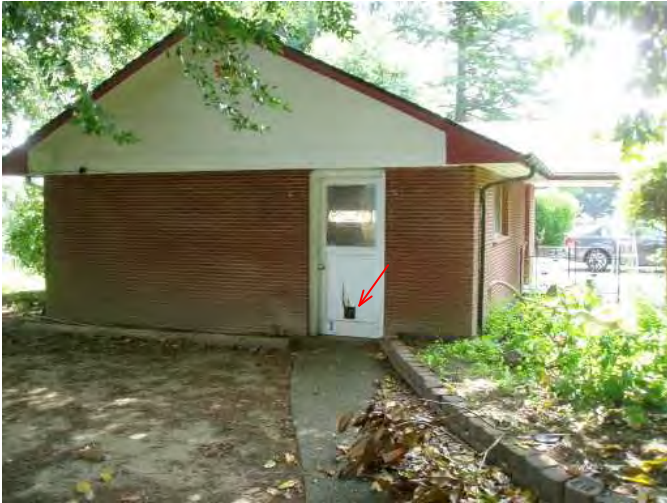
both garage doors are in poor condition...may need replaced....rest of structure is in pretty good shape...

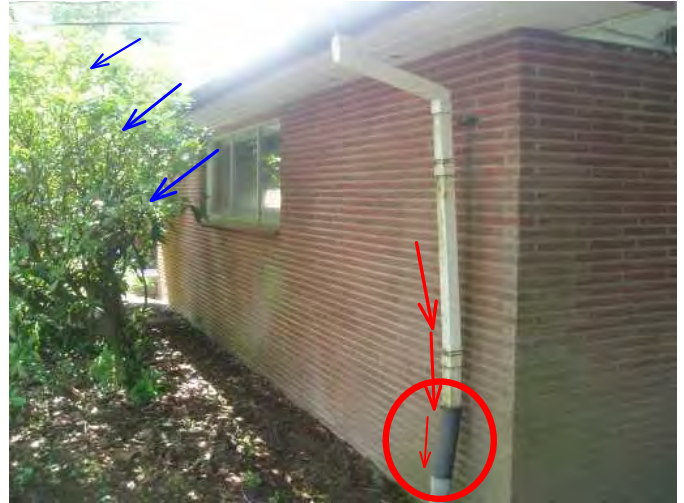
remove or pull back vegetation and not sure where this exit drain exits to...

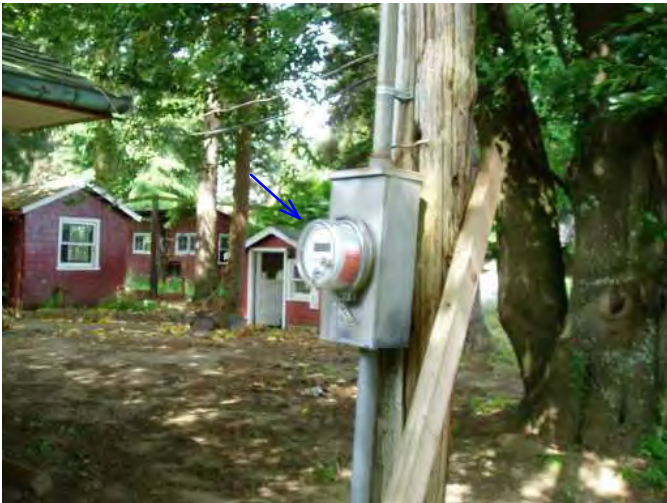
main electric is overhead and then enters into lateral service...appears to be newer meter...

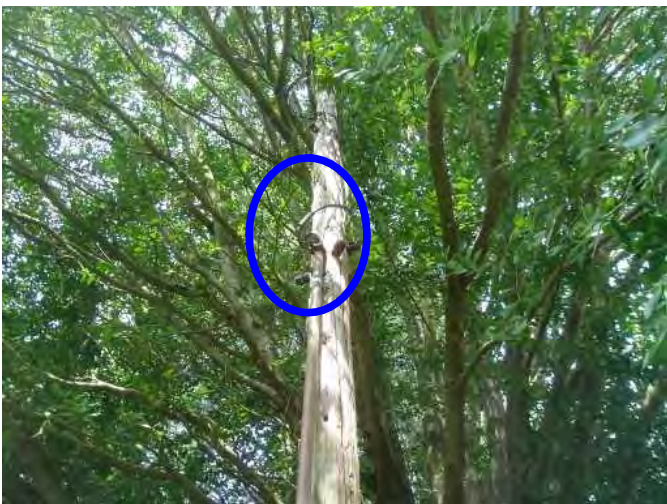
drip loops are fine...but service from street is impeded by tre branches....

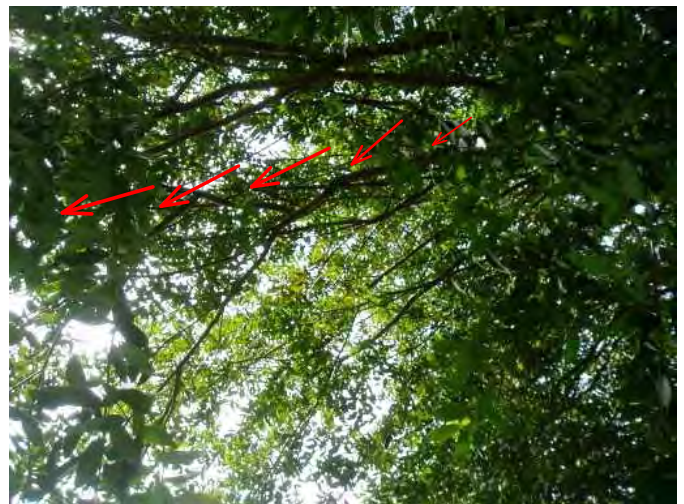
many tree branches will need to be removed to make safe to use

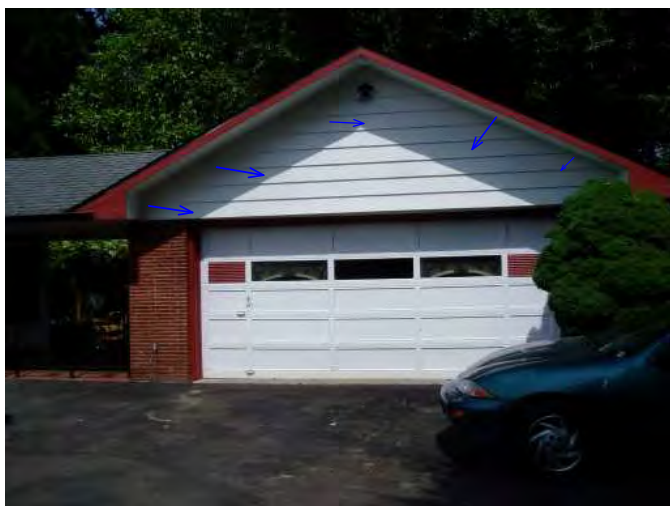
front of garage is noted here and lights are operable...siding just needs a paint job...garage door is not operable yet...

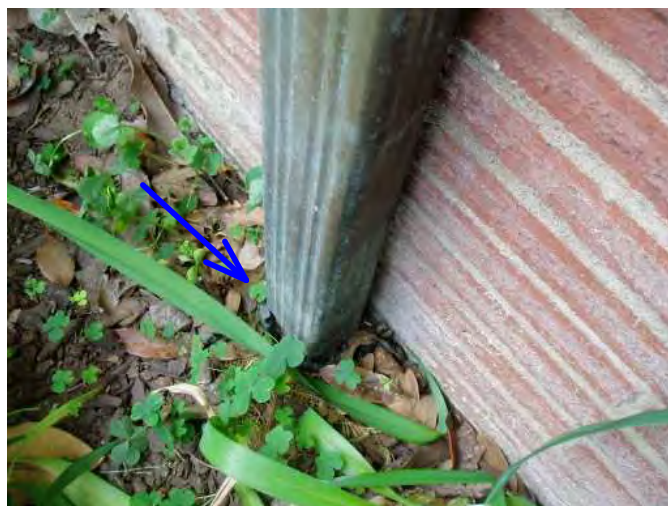
downspout at front of home under living room main window has exit to driveway...

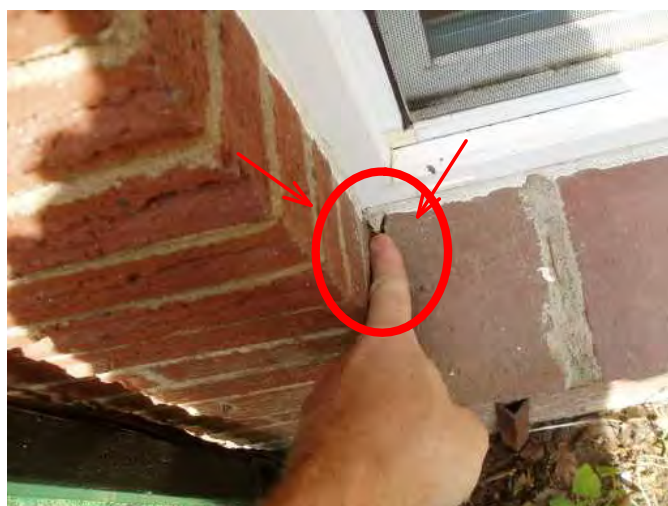
any open gaps may be added cause for high moisture in window walls noted....

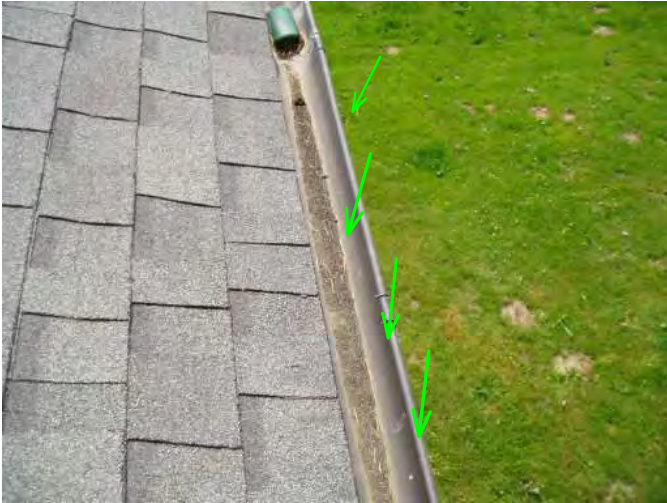
up on roof showing that not all gutters are full of debris...but this is about the only one like this...

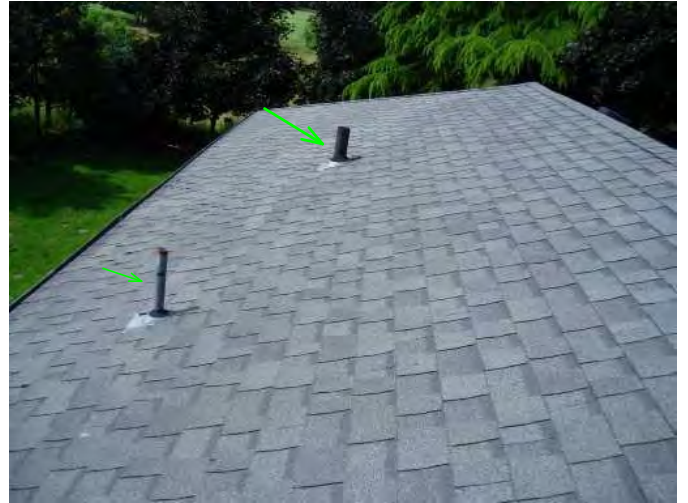
back area over upper bedrooms showing sewer vents in roof are solid...sleeves are good...roof fairly clean here...good..

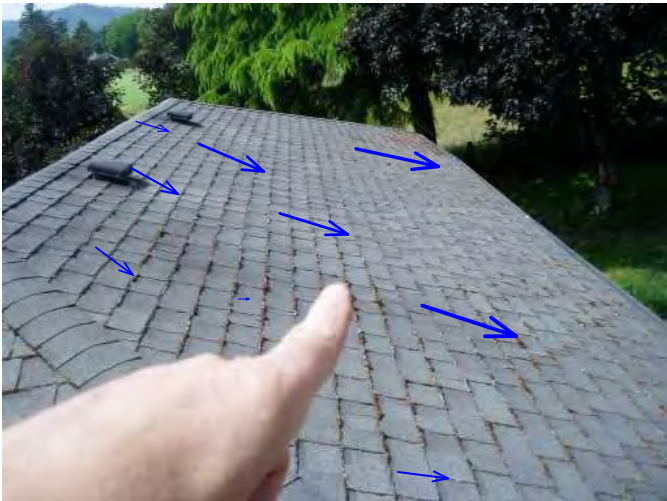
other side (back) of roof needs cleaned and de mossed...

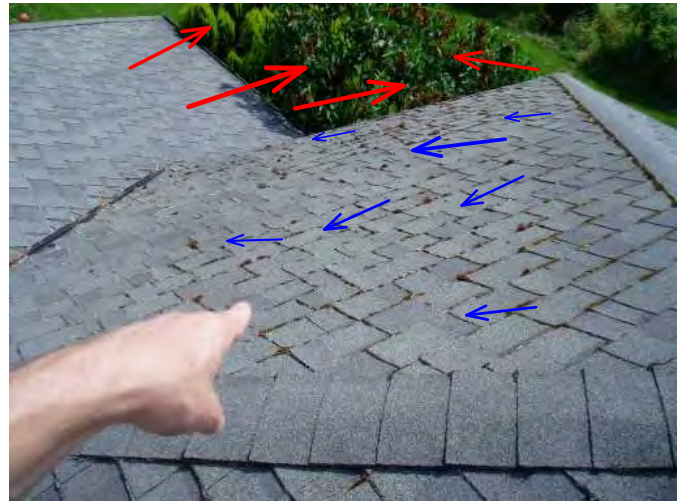
ditto here over front porch area...also noted heavy vegetation needs to be cut back to see home...(maintain)

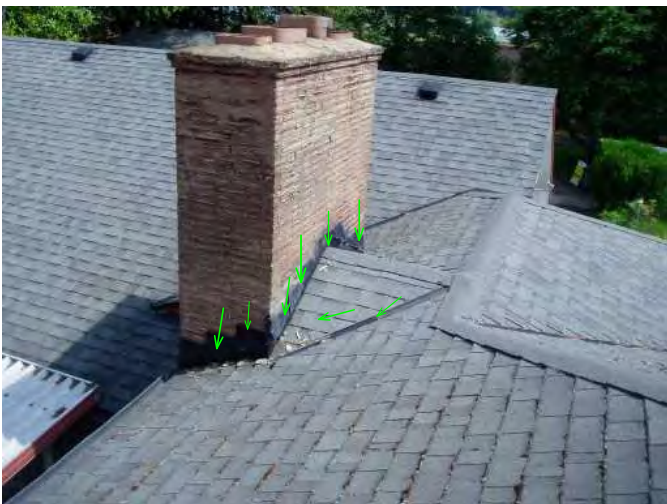
cricket and valleys around chimney are good...

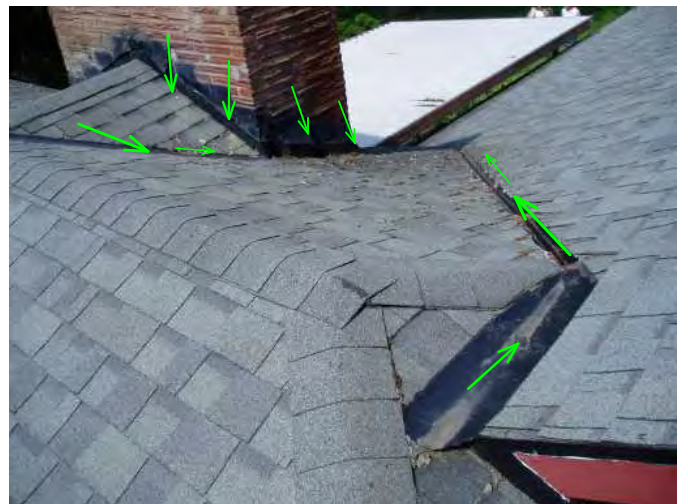
valleys and cricket here on other side of chimney are good as well...

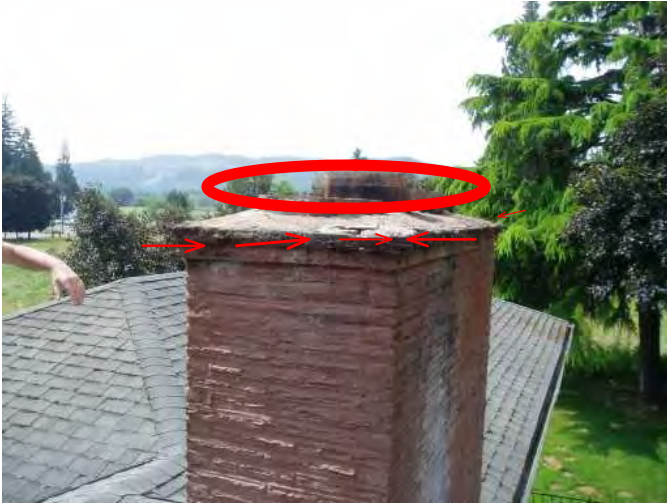
add solid rain cap with screen to keep out rain and critters...circle..arrows are pointing to needed new crown...

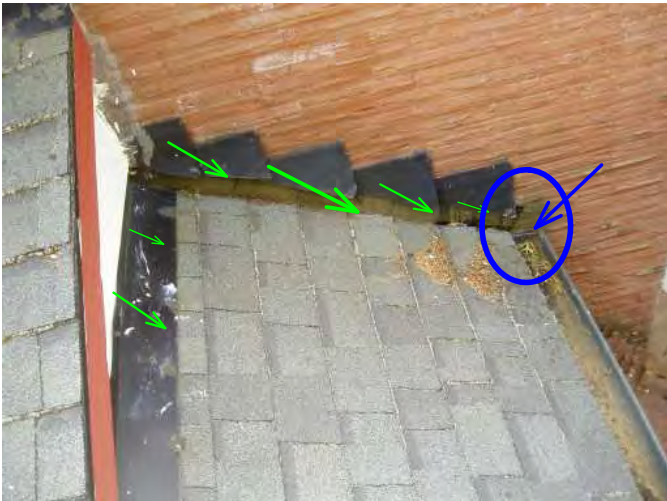
green is good step and counter flashing that are working well, blue is area that needs kickout to direct water to gutter

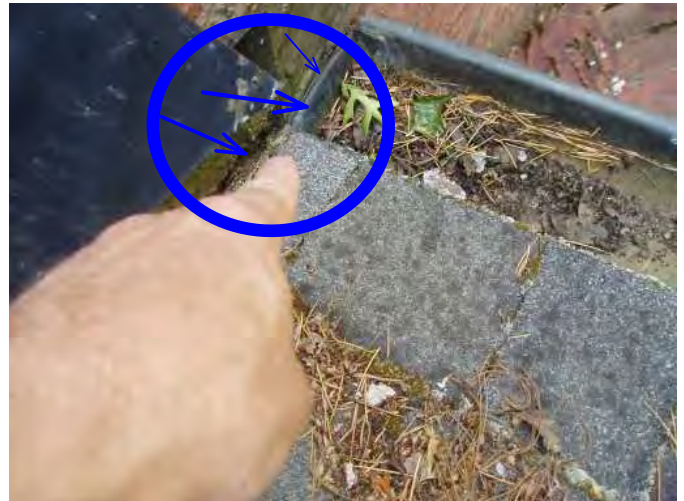
kickouts go over gutter area and deliver water into gutter and not behind siding...

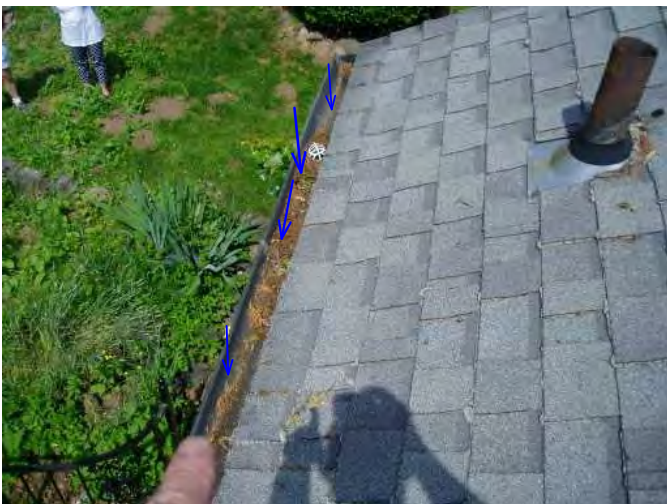
back area over patio shows full gutters and they are reversed flow as well...not good..re-hang...

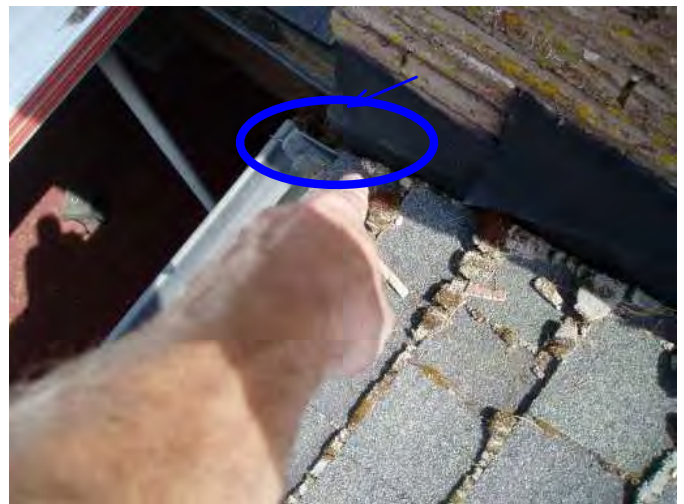
needs better kick out here as well...just stops and does not direct water into gutters...

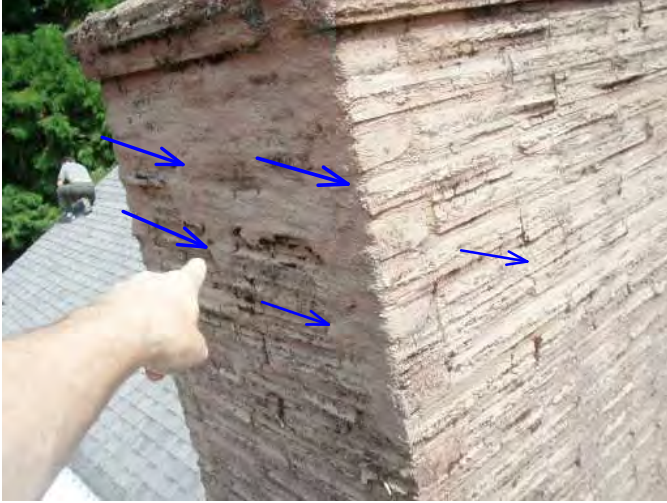
random tuck pointing needed at chimney area..not huge issue , but needs work,,,

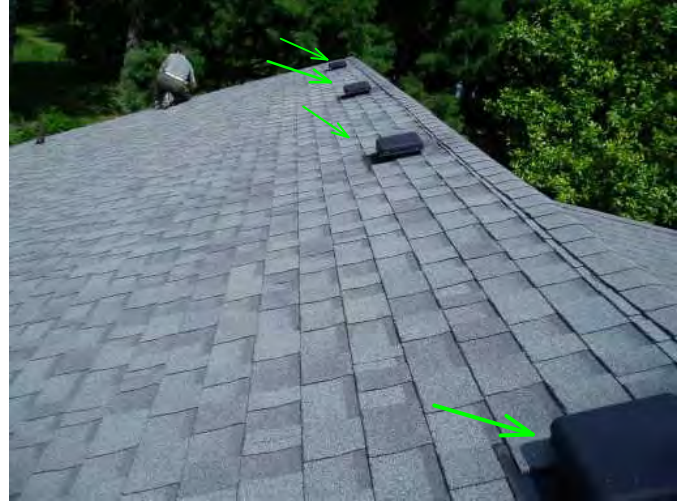
main attic roof looks good here...areas that have no moss look pretty new...areas that have moss look older...

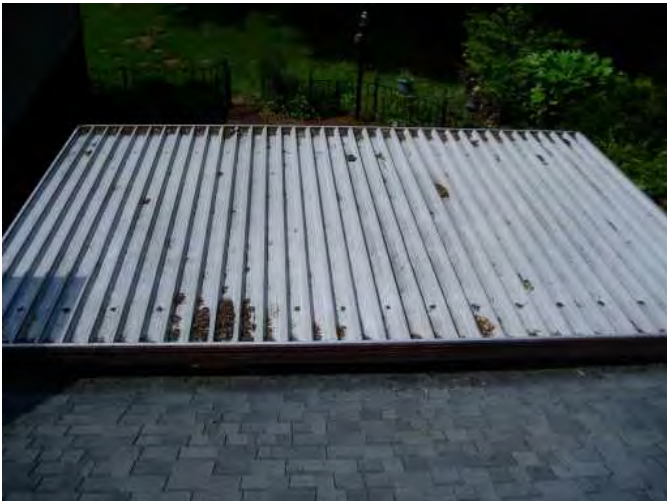
metal awning roof over patio needs cleaning..and is in good condition....good..

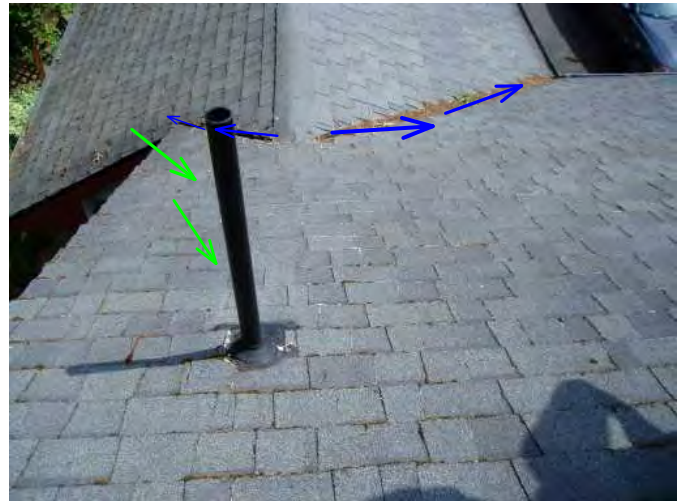
looks like abs, but is painted galvanized pipe...fine...over kitchen area....clean valleys...

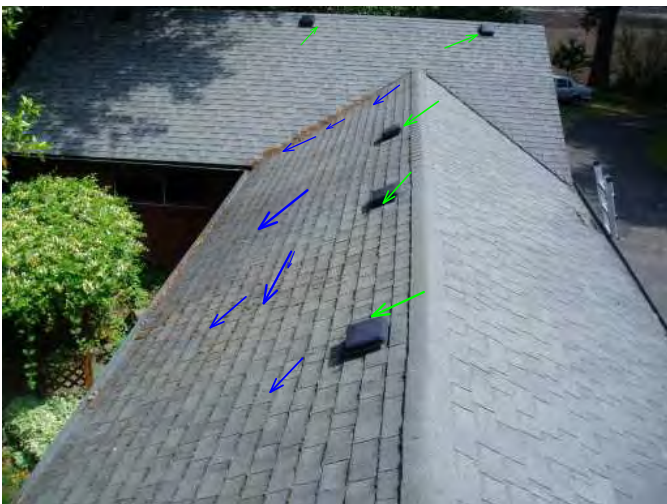
over back area and breezeway to garage roof at back, just needs cleaned valley and some moss removal...

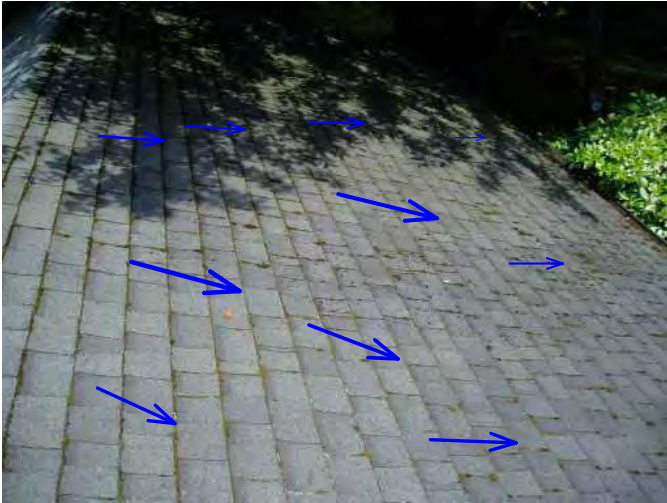
area over garage to right of front upper roof...trim back tree branches 6-12 feet above roof line...clean and de moss....

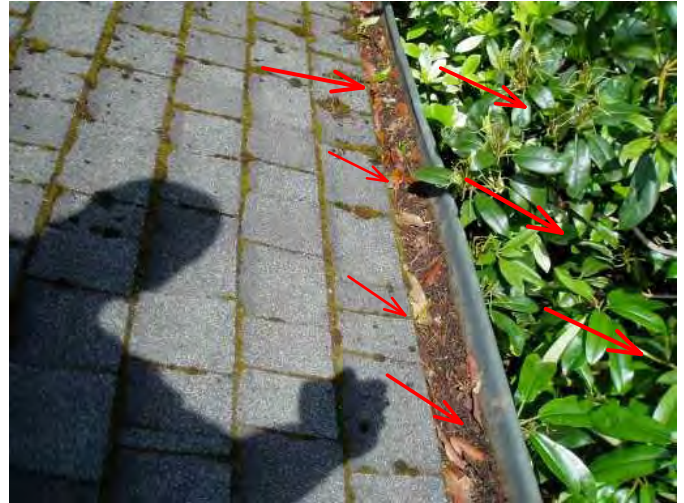
realy full gutters and trim back shrubs 12 18 inches from structure...

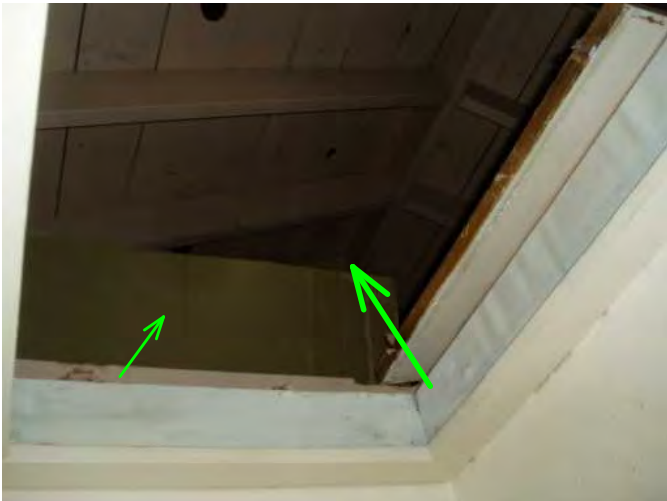
going up into attic in upper home area above bedrooms....in hall closet access...

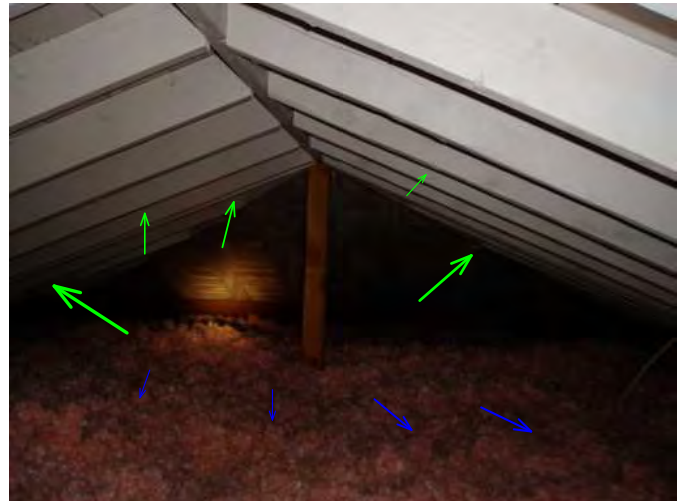
upper rafters are fine..painted from old fire some time ago...insulation could be 8 inches deeper for best efficiency...

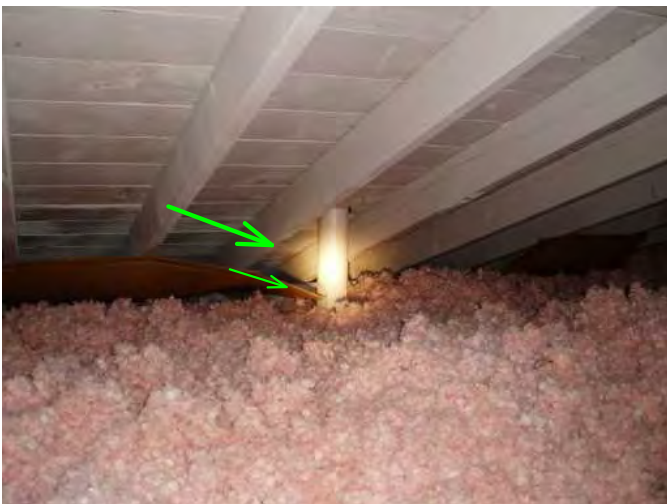
sewer vent and sheathing are good here...

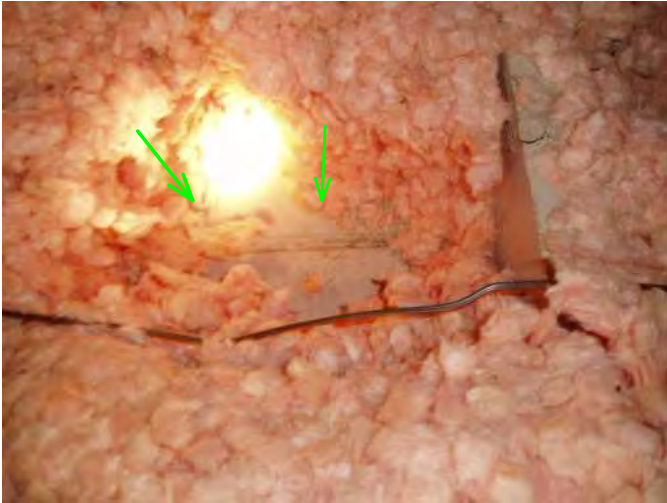
drywall under insulation noted here....good..

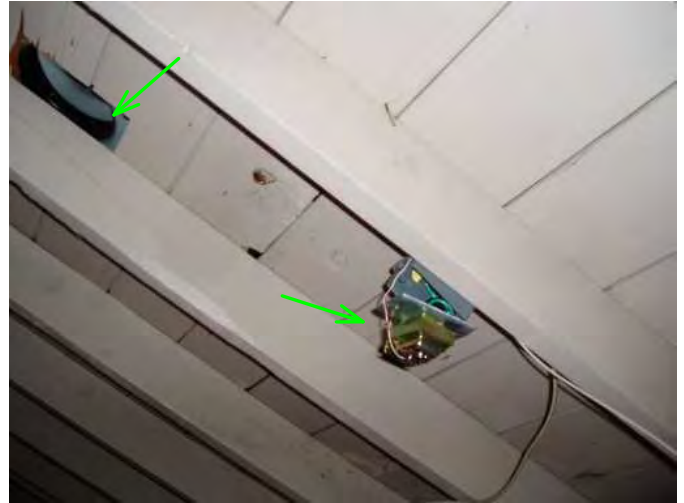
attic is well vented and low voltage door bell converter is noted here in attic for front door...

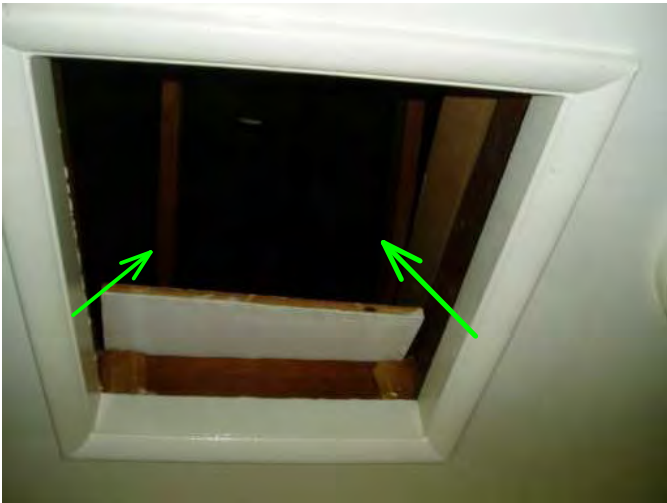
attic access to lower attic over main home area....access in laundry room area....

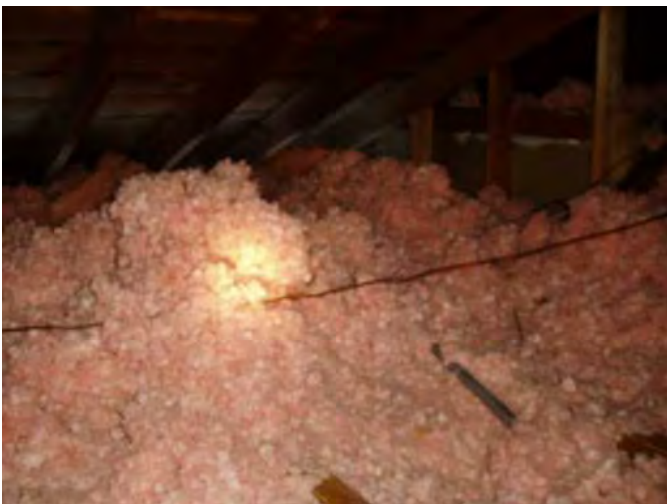
insulation is 12 inches deep...suggest adding 8 inches more for bes efficiency....

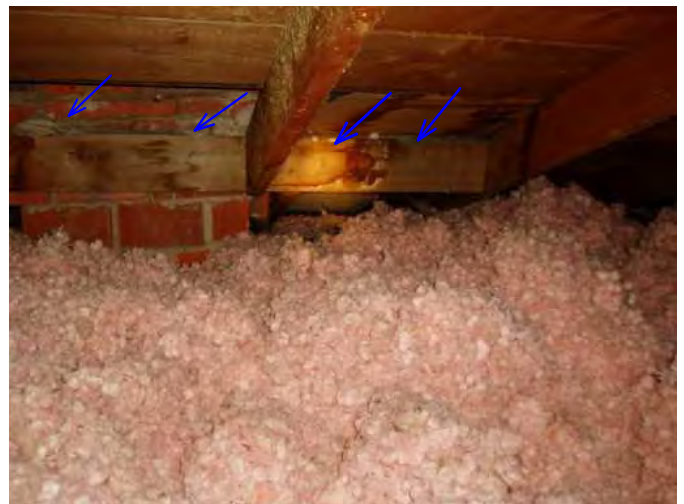
old inactive staining noted here over chimney in main attic from past...most likley why newer roof is on now...

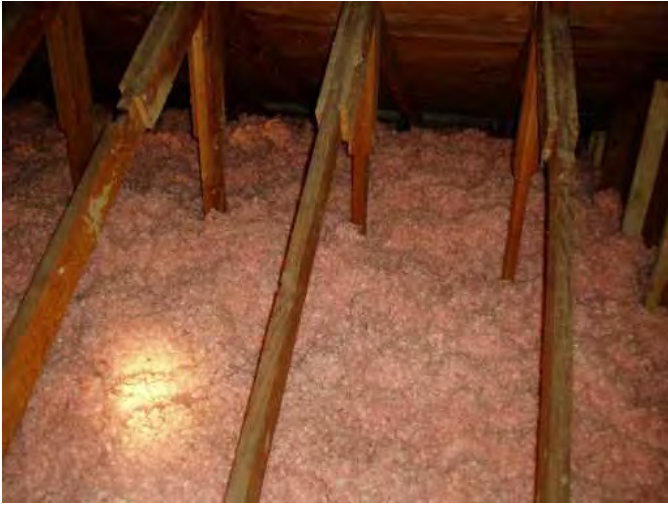
strength is noted all through out attic area...good..

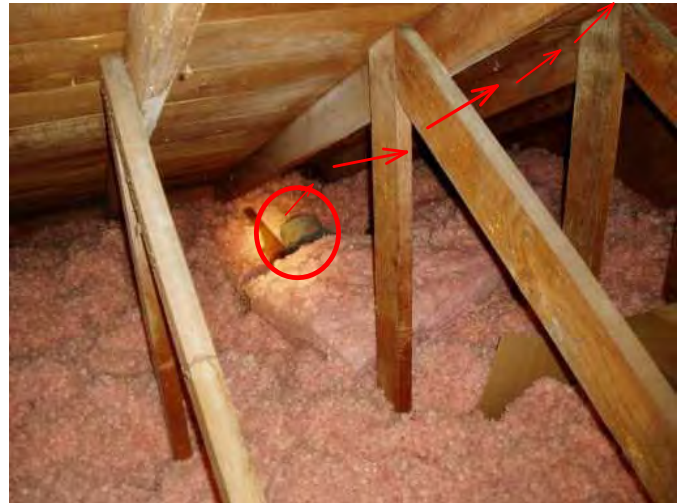
bath vent needs to be ducted to attic vent to get hot damp air out...

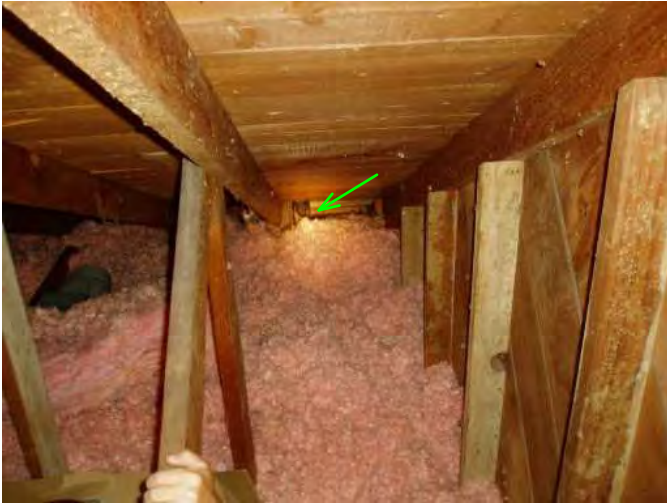
sewer vent is noted here over bath at back of home....

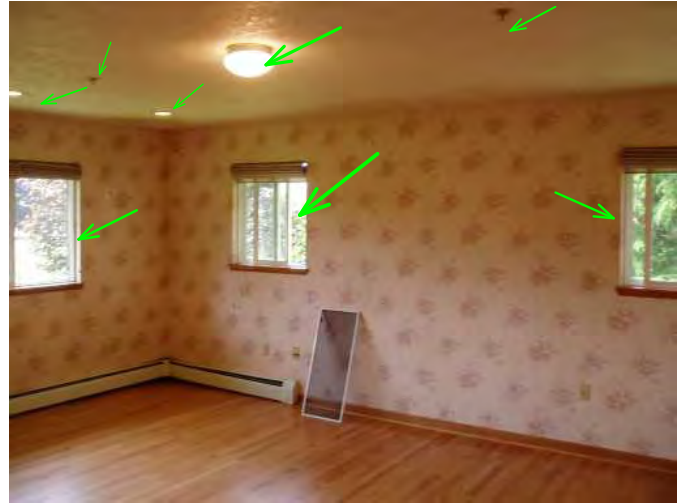
master bedroom windows and fixtures are operable..all of home has sprinkler system installedgood..

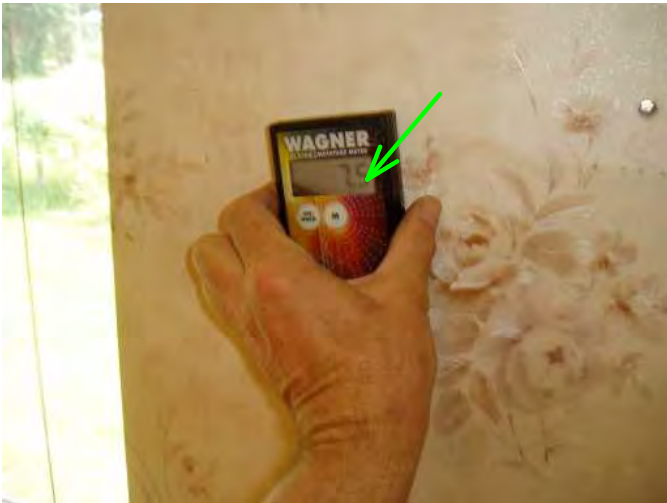
checking all exterior walls for moisture...good here in master...

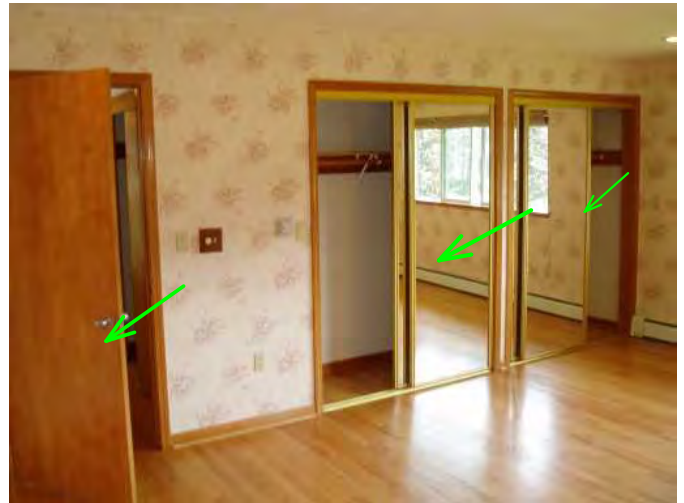
master entry and closet doors are operable...good...

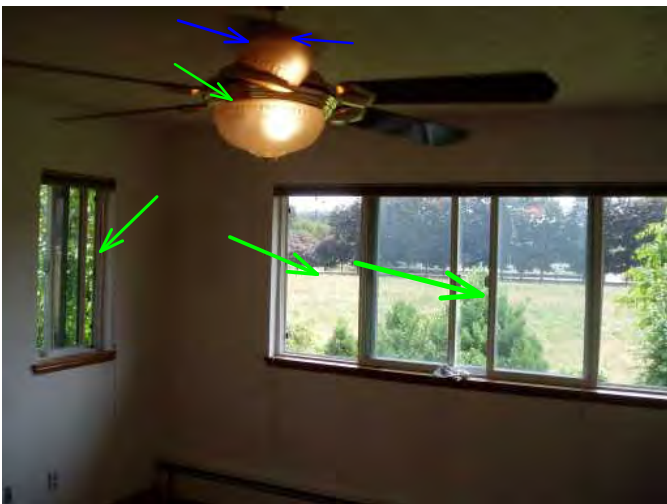
bed 2 windows and fixture and fan are operable needs trim at ceiling area..

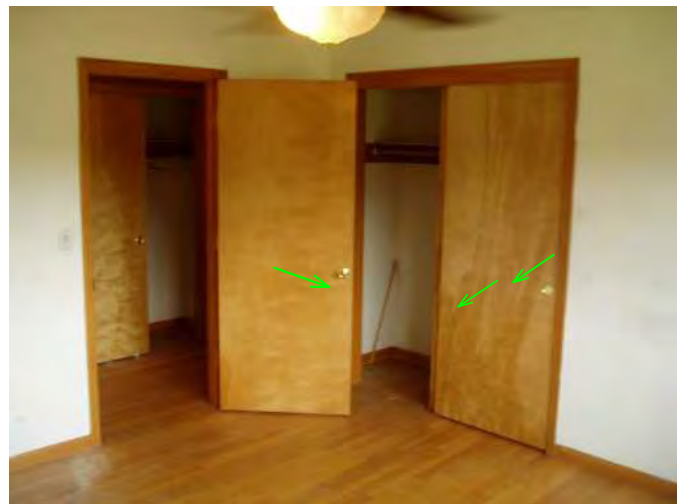
bed 2 entry and closet doors are operable...good..

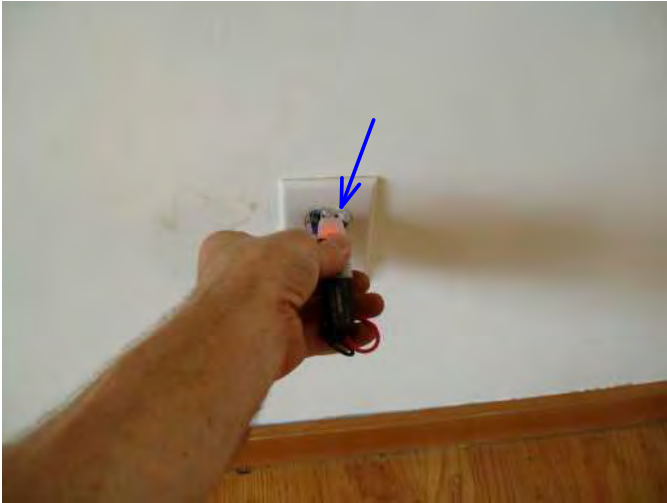
bed 2 outlets are not grounded....is common find in older homes...

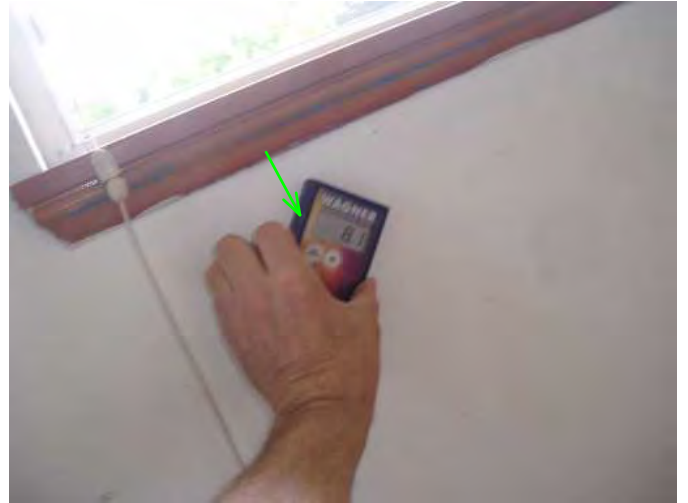
noted low moisture at bed 2 under windows....good...

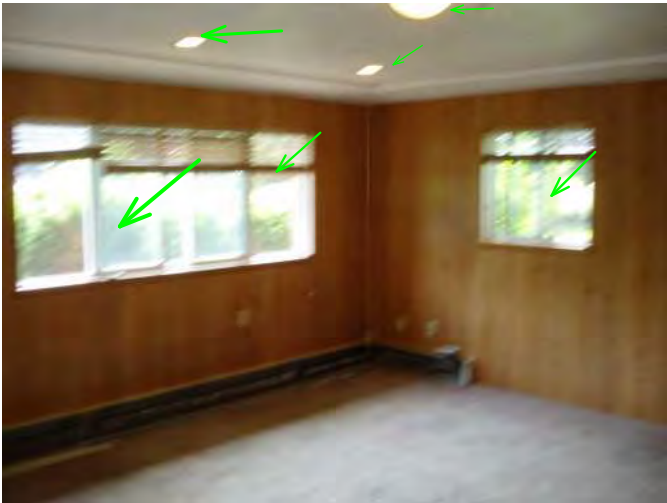
basement bedroom windows and fixtures are operable...noted random missing screens needed....

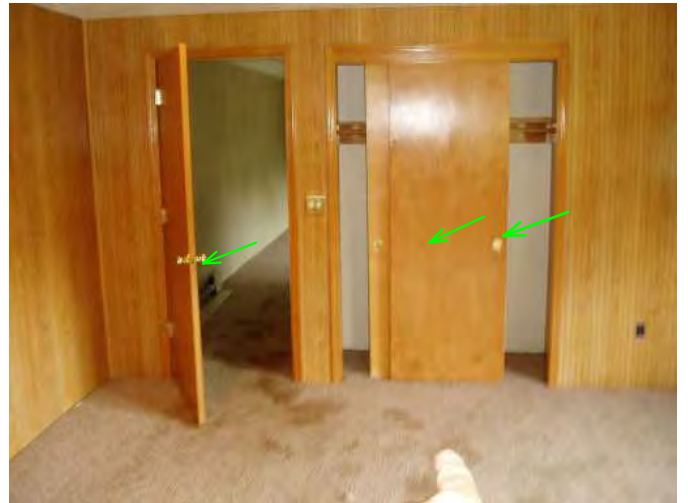
bed 3 in basement entry and closet doors are operable...good..

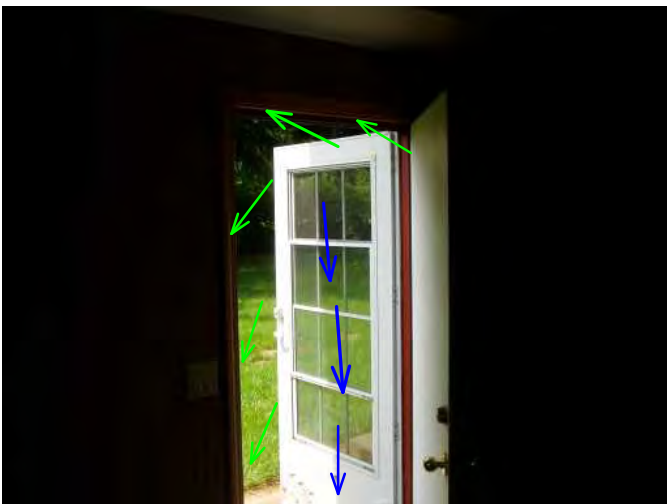
exit door is operable..weather stripping is good...storm door needs work...

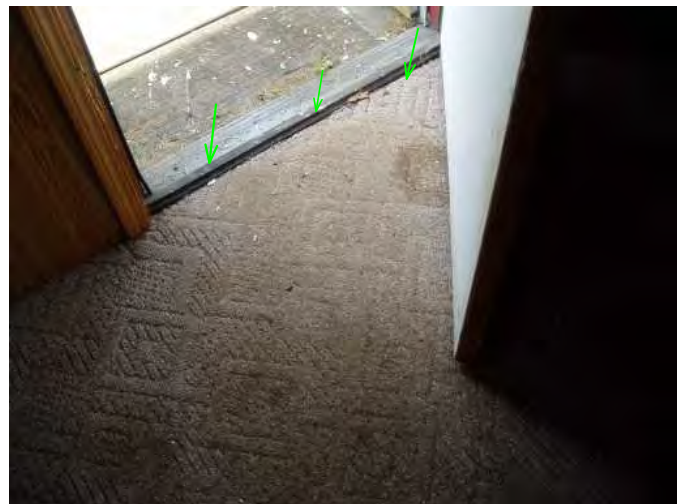
threshold is solid and sound...exit door at bed 3.....good..

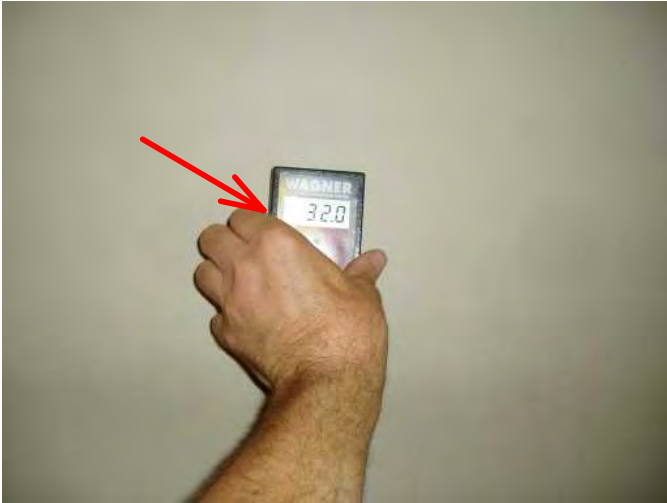
this is area at center of wall on opposite side of room where patio slopes into center..and drains into wall...

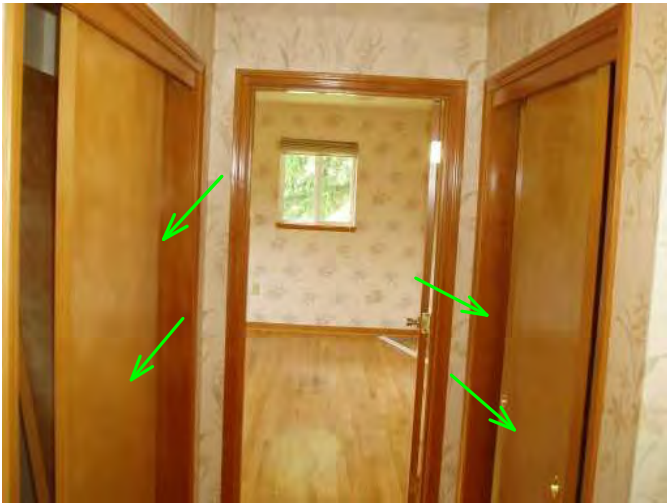
upper hallway closet doors are operable...just needs some lower tracks installed....

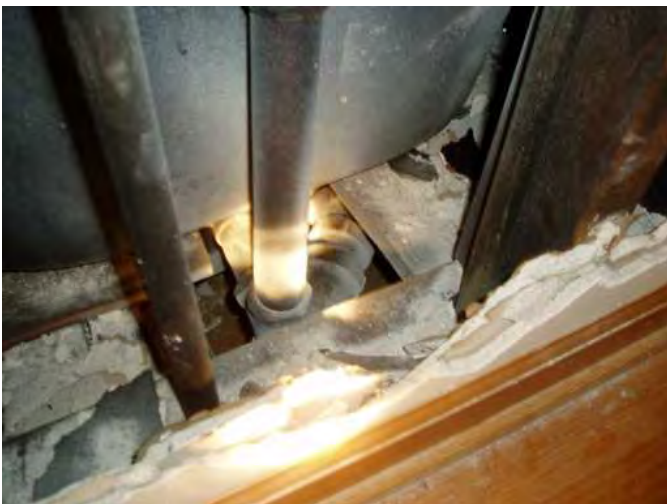
did acces into area to see if any leaks were noted...none found..but also tub drain was blocked

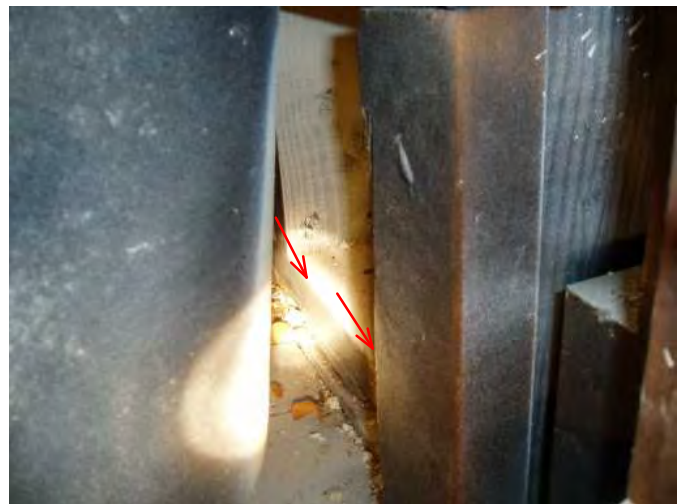
all dry....tub drain was blocked, so I did not run tub 2 hours like all other fixtures in bath and kitchen areas...

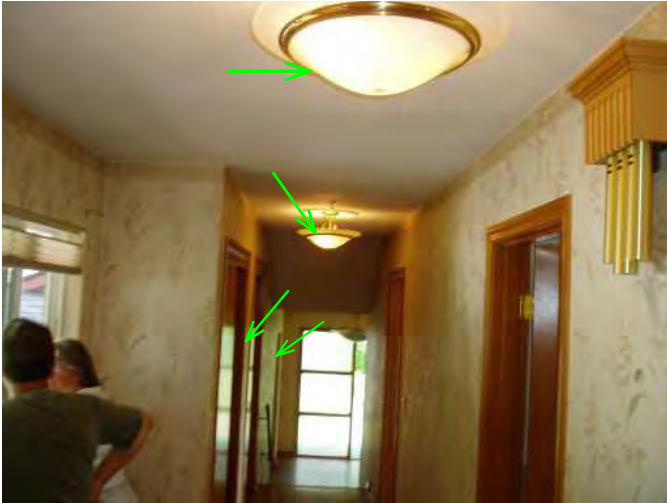
upper hall windows and fixtures and closet doors are operable...good..

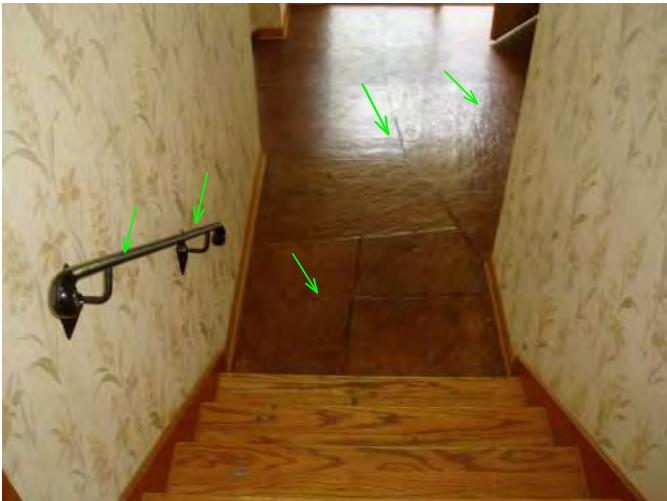
handrails are solid and entry floor is solid as well...
