Home Inspection Report

18623 NW Reeder Road
Sauvies Island, Oregon

Prepared for: Sample Report

Prepared by: The Home Tester
10555 SW Tigard St. #57
Tigard, OR 97223

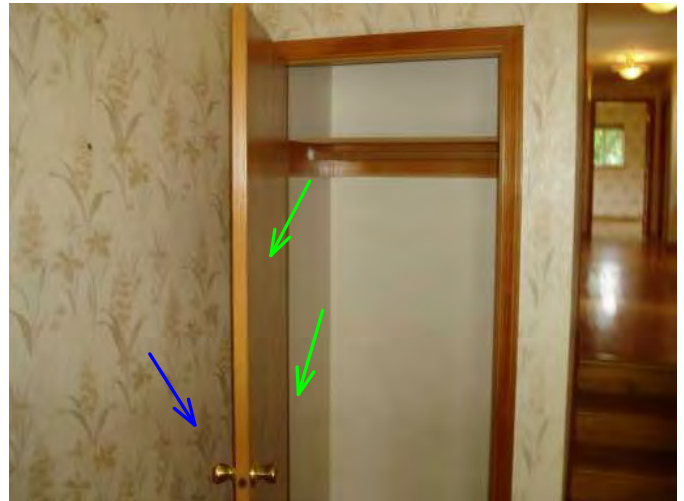
entry hall closet door is operable..but needs door stop...

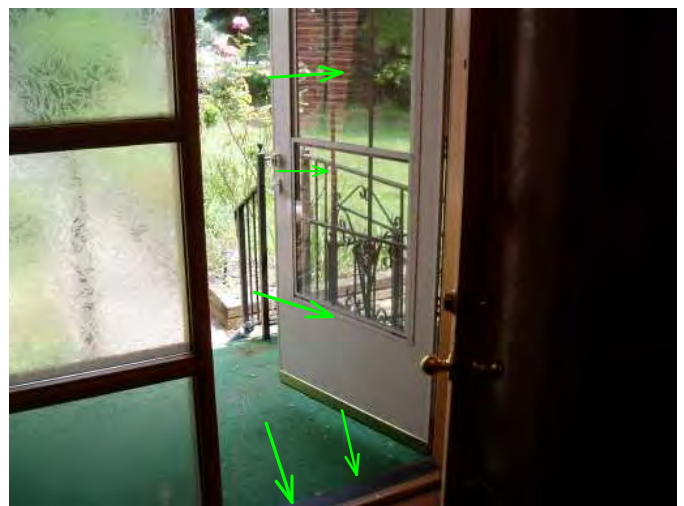
storm is operable, and threshold is solid...good..entry door area....good..

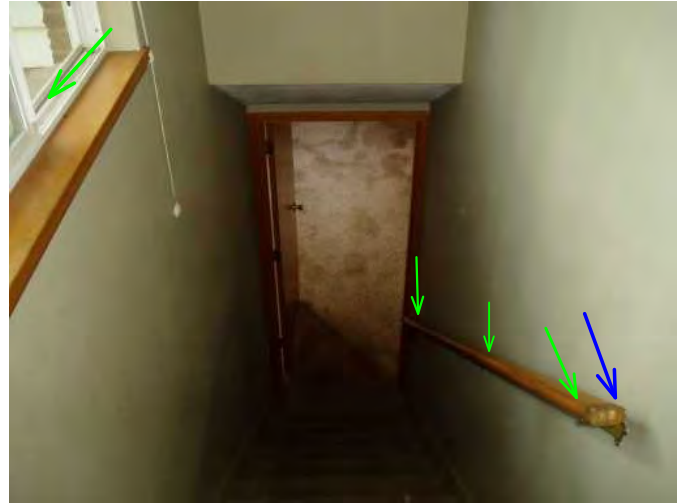
window in staiway is operable...handrail is solid...but needs repair...missing end piece...

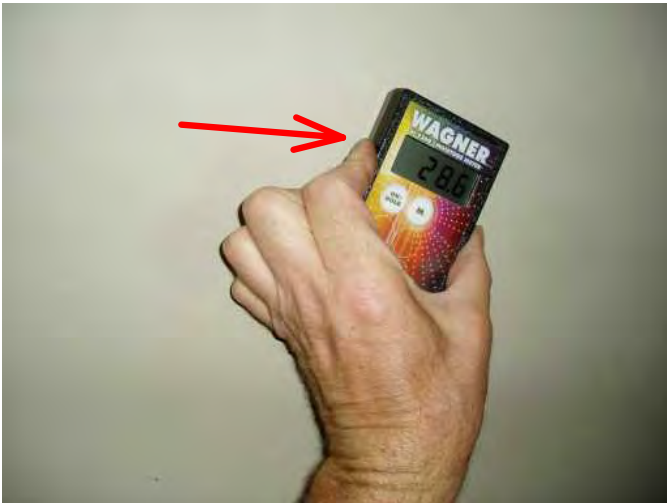
under window area in stairway is high in moisture content...will ned repairs...

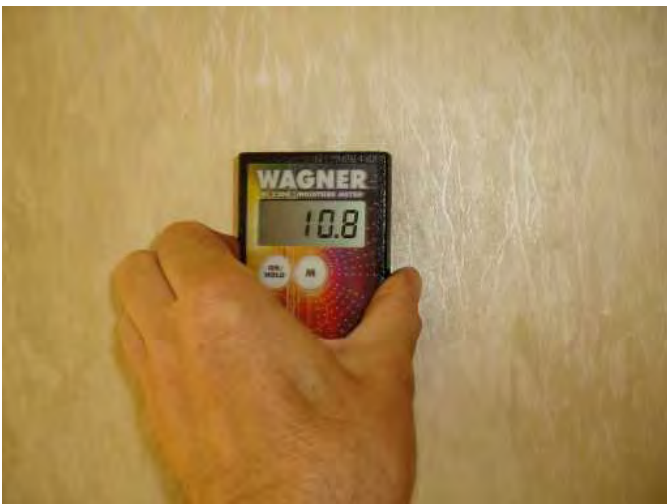
upper walls are fine....

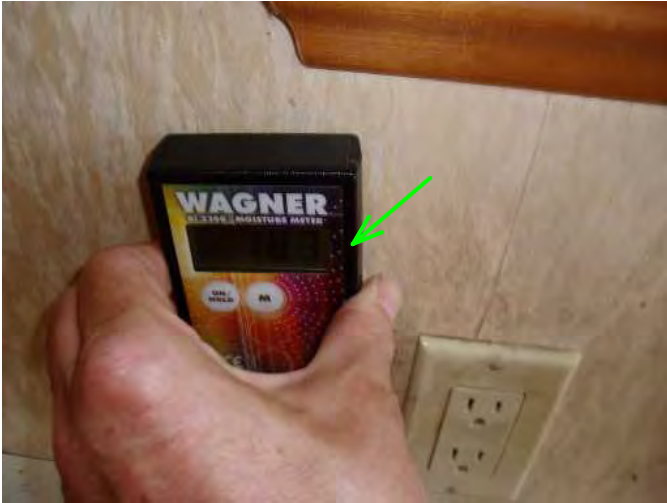
area under left main window is fine....good..

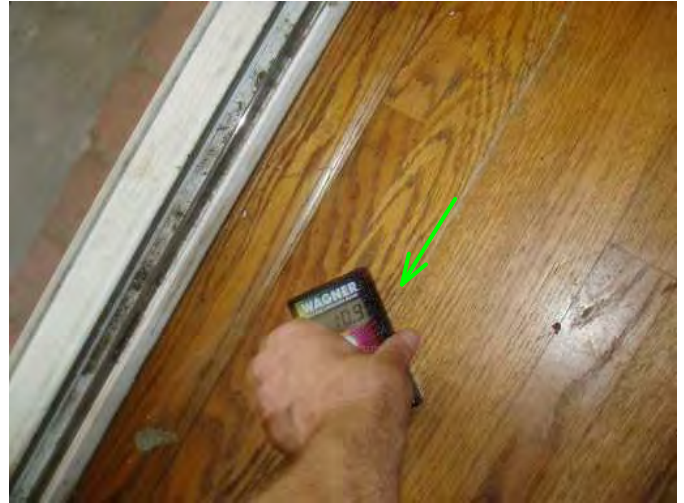
floor area at dining room slider to patio is fine...no high moisture noted....good..

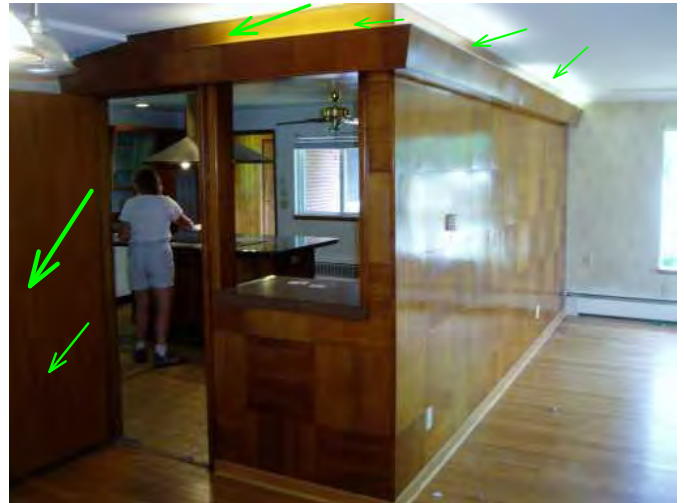
upper lights in dining room and living room are operable..as is door to kitchen area....

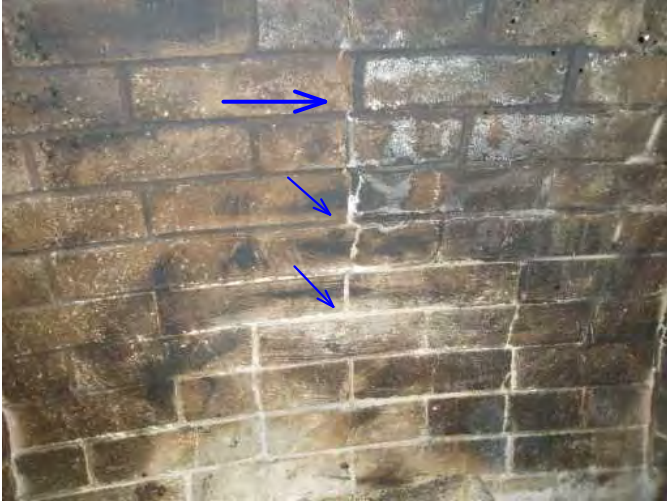
cracks in fire brick are needing sealed, but are not fire threat...repair...

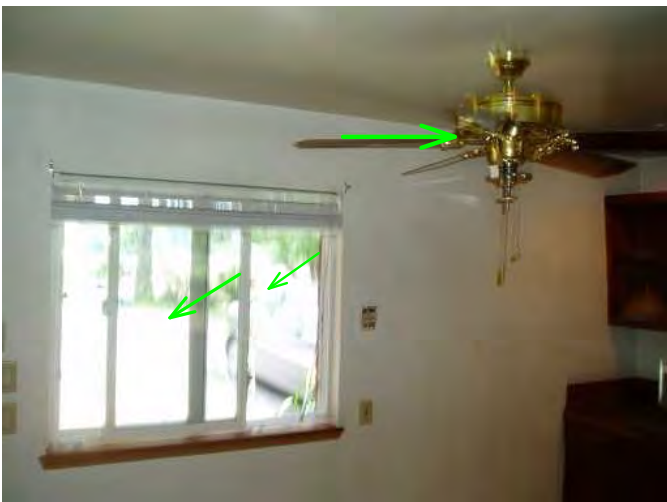
fixture and window in dining area in kitchen are operable...

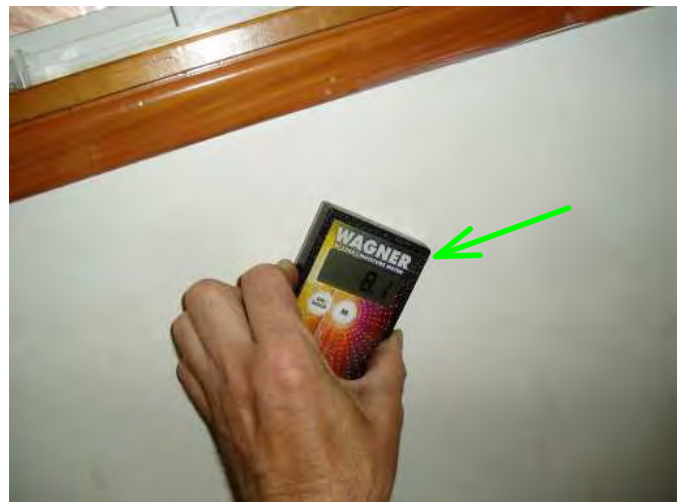
no high moisture is noted in area under dining area window...good..

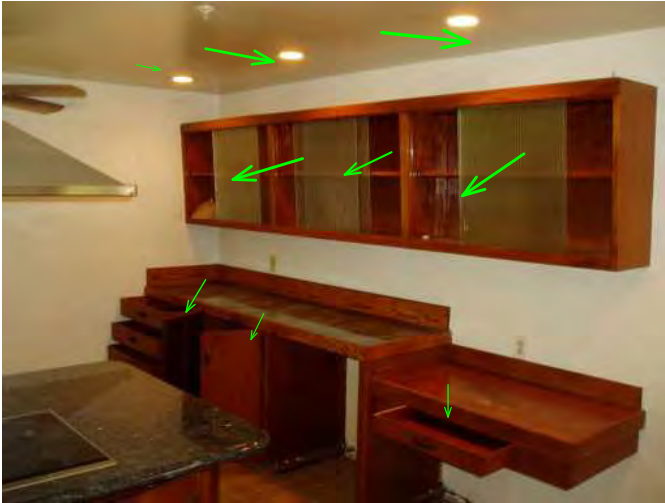
fixtures and cabinets are operable in area...good..

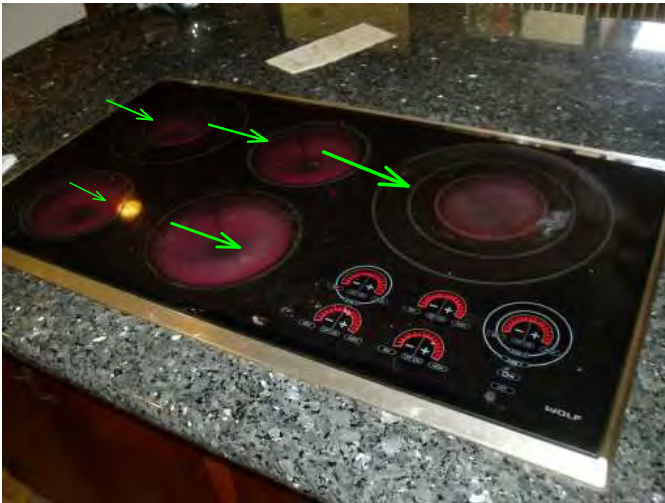
stove top is operable...good..

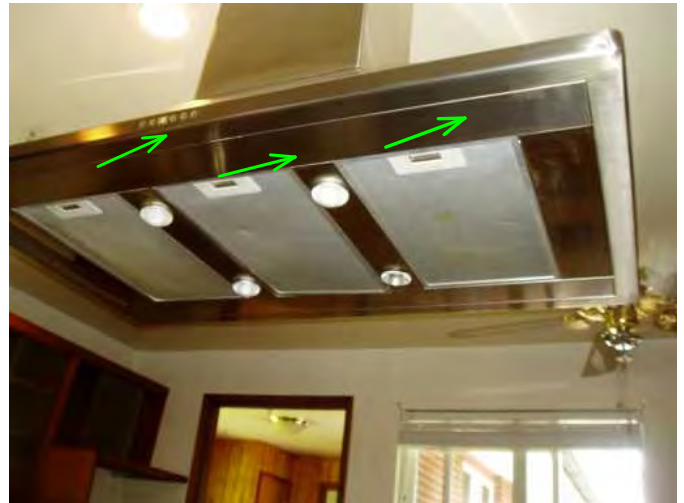
over stove hood is operable and is solid to ceiling...good..

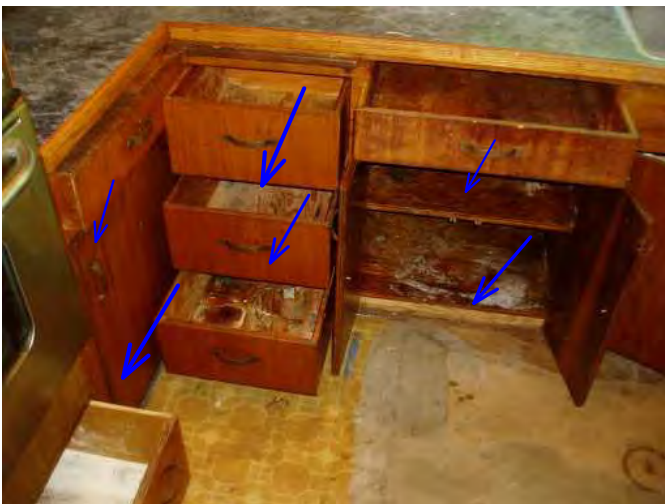
lower cabinets in kitchen area are full of debris and hoted vermin droppings...

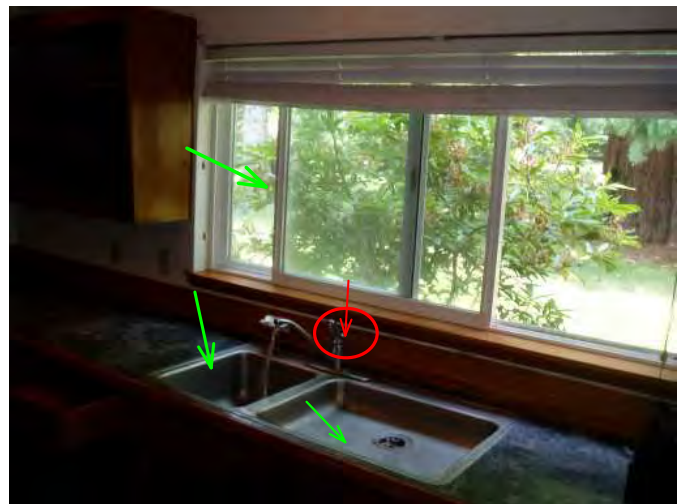
window over sink is operable...sink is operable..but faucet is reversed and on is down and off is up...really odd...

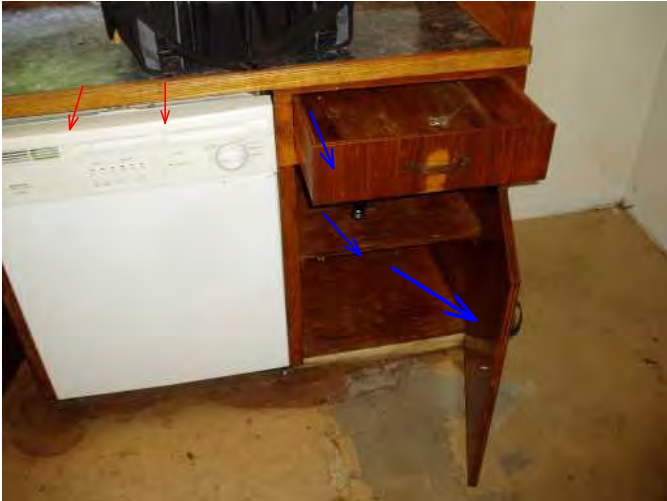
dishwasher is operable...but needs to be attached to counter...cabinets are operable..but need work...

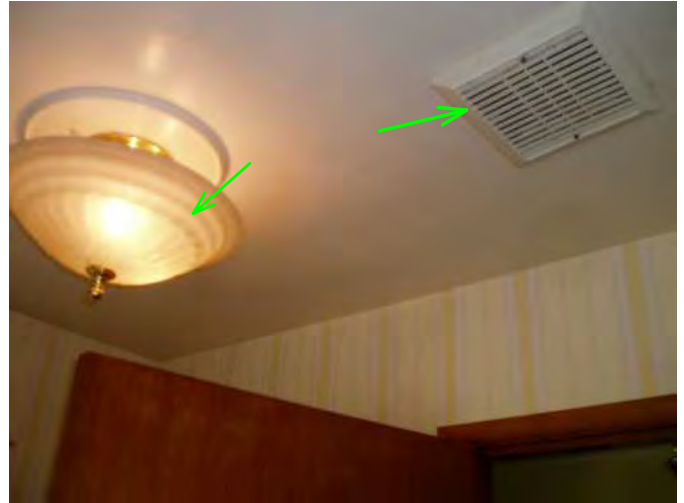
back bathrom fixture and exit vent are operable...

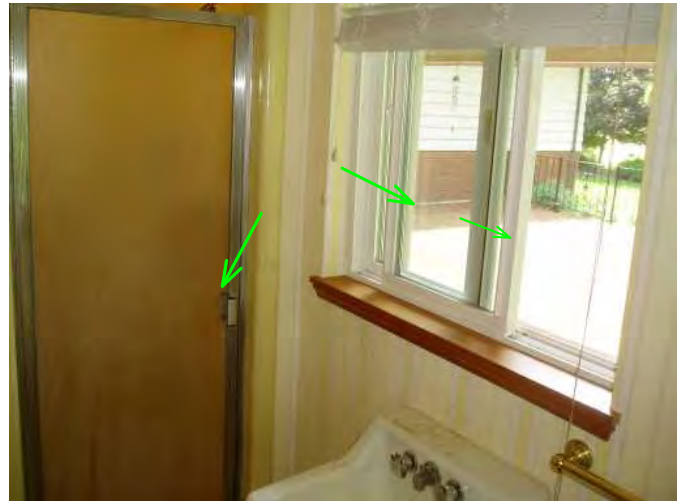
shower door and window at side of bath are operable...

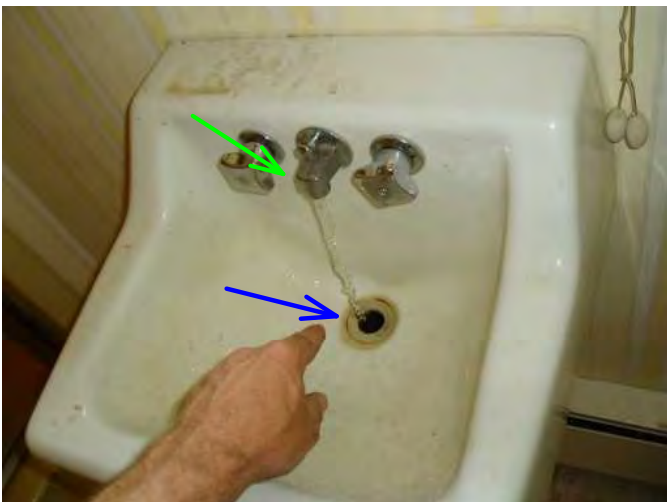
wall hung sink is operable..but needs drain stop....

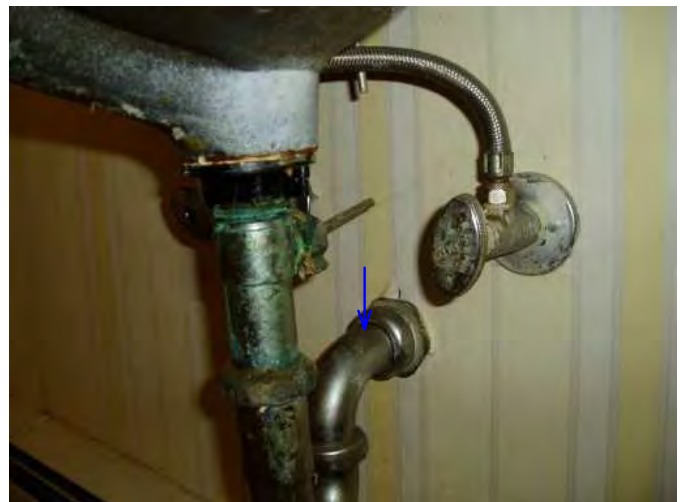
dripping at trap area under sink...

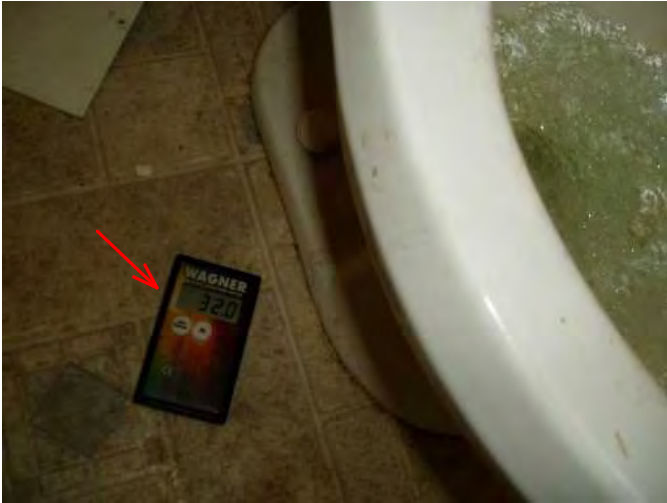
toilet is operable...but floor around toilet is very high moisture content noted....

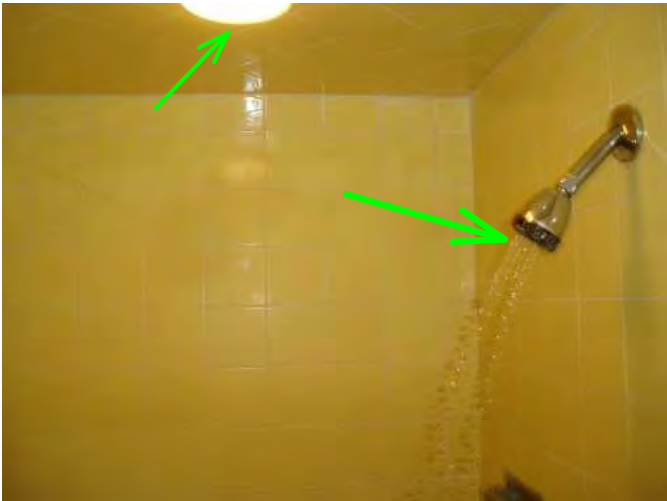
shower fixture and shower head are operable...

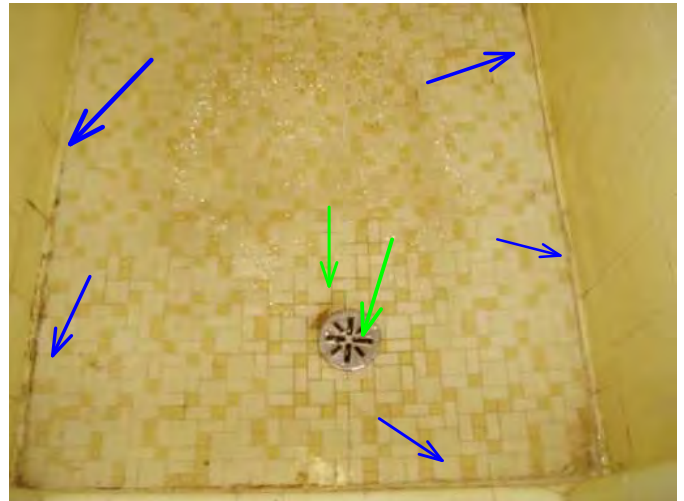
drain is operable...but ceramic tile needs grout work....

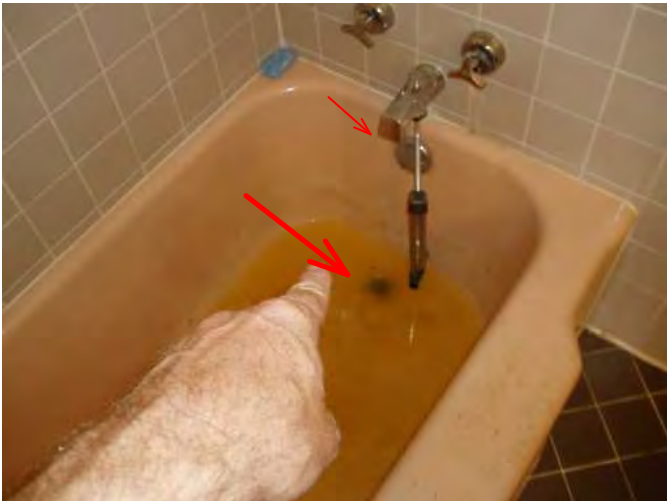
did acces into area to see if any leaks were noted...none found..but also tub drain was blocked

tub is blocked at drain..did not run like all others....may leak as well..not sure....

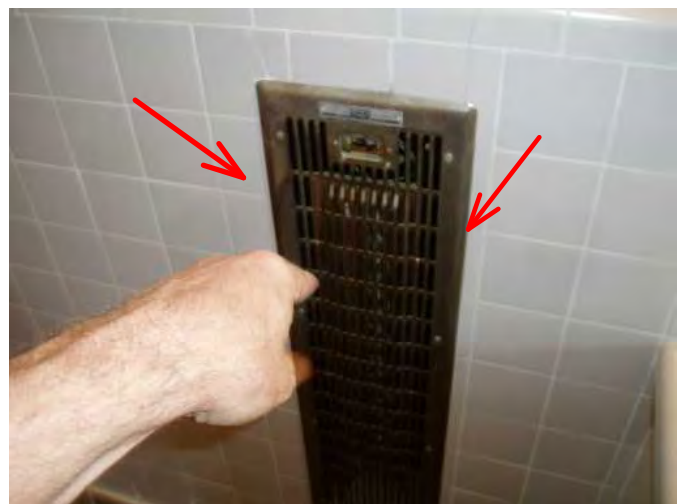
main breaker was shut off for this unit...did not turn on...may be a reason...

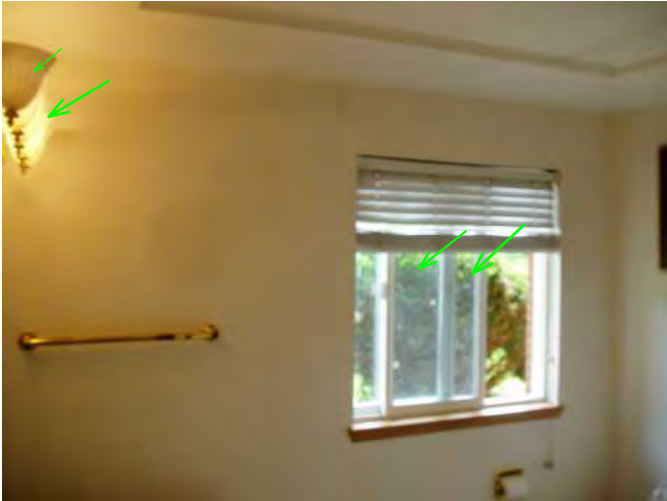
windows, fixture and entry door are operable in basement bath....good..

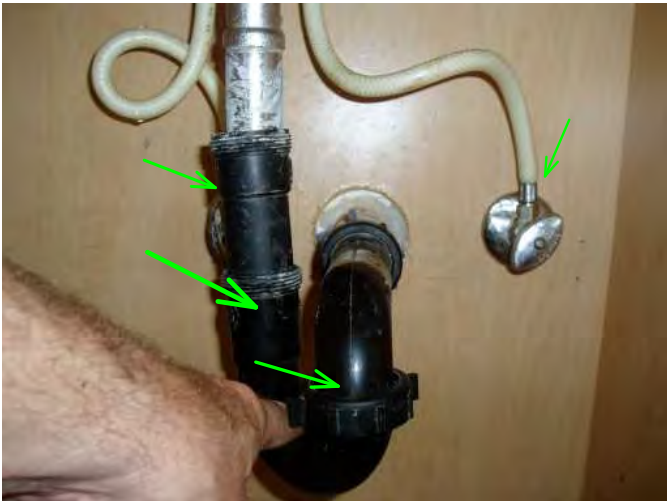
no drip sor leaks noted here under sink....good..

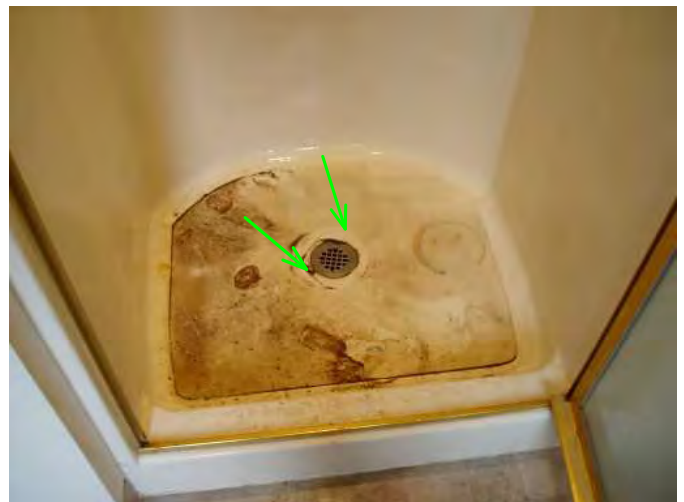
drain works, as does door...just needs a gallon of bleach to clean up....

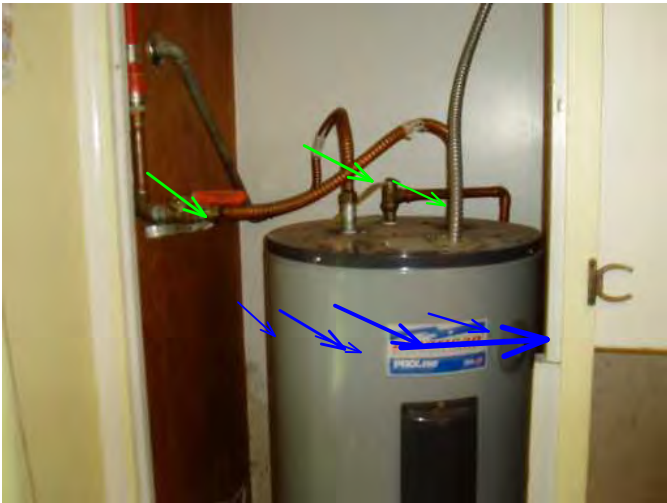
upper area of water heater in laundry room is noted as fine ..but needs strapped to wall...

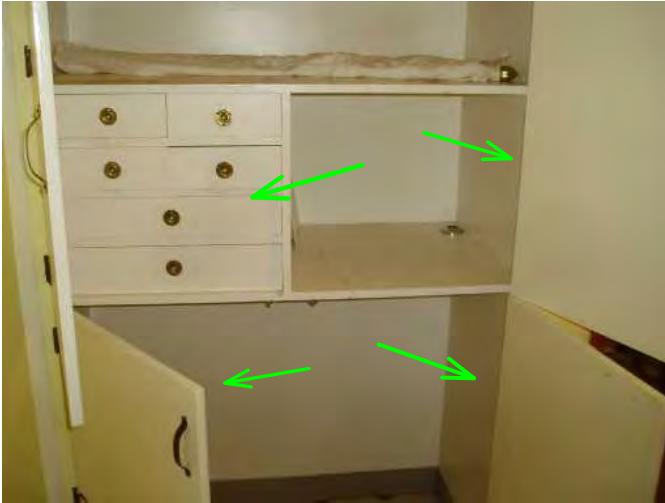
cabinets in laudnry room are operable...

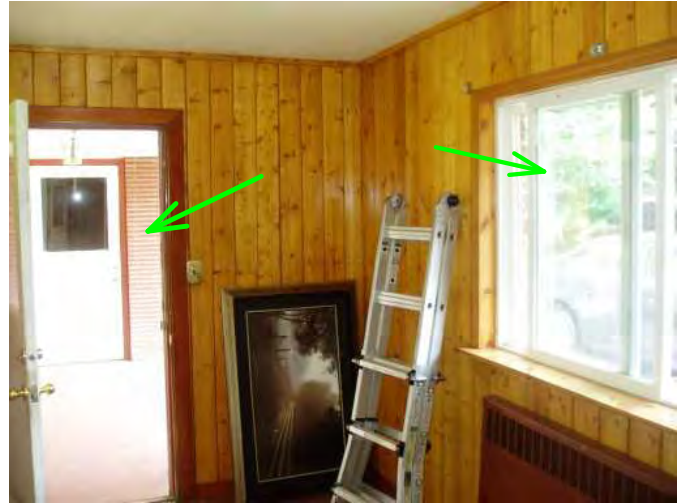
window and door in muc room are operable...

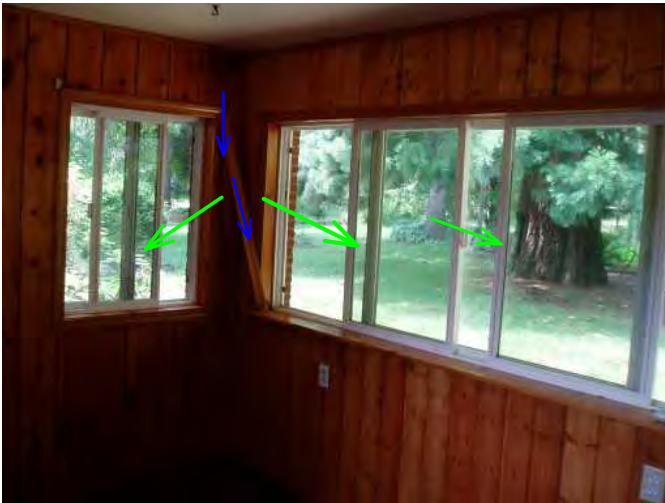
windows are operable in mud room here as well....needs trim repair...

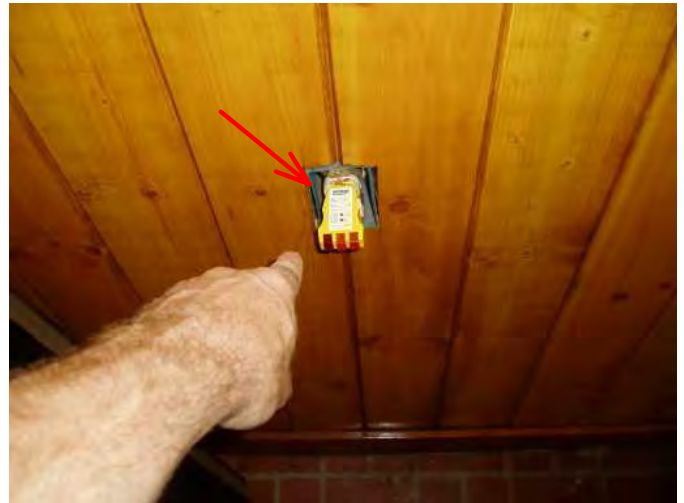
outlet in mud room is not operable...

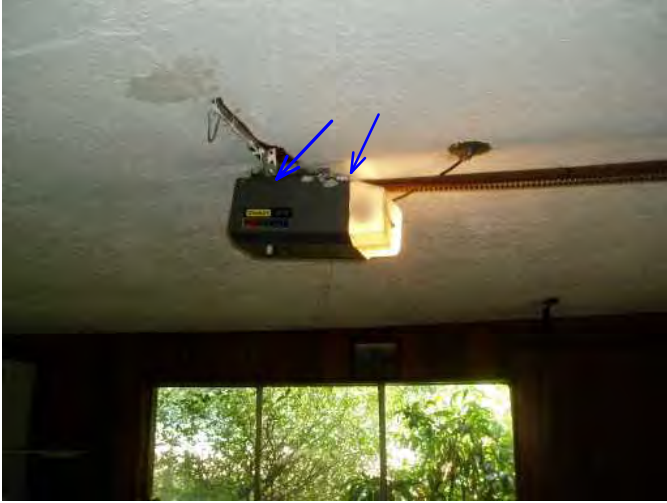
garage door is operable...but needs new wall switch and needs repair to attach to door...

Side - Garage - Door Operation: Mechanized - A qualified contractor is recommended to evaluate and estimate repairs

Side - Garage - Door Opener: stanley - A qualified contractor is recommended to evaluate and estimate repairs

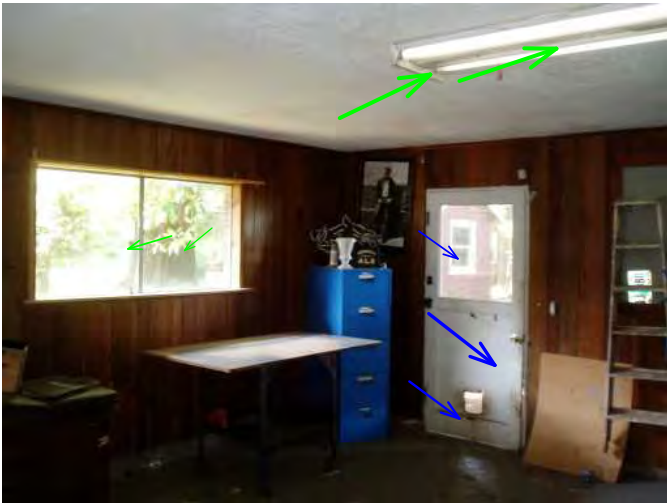
window and fixture are operable...door needs work...

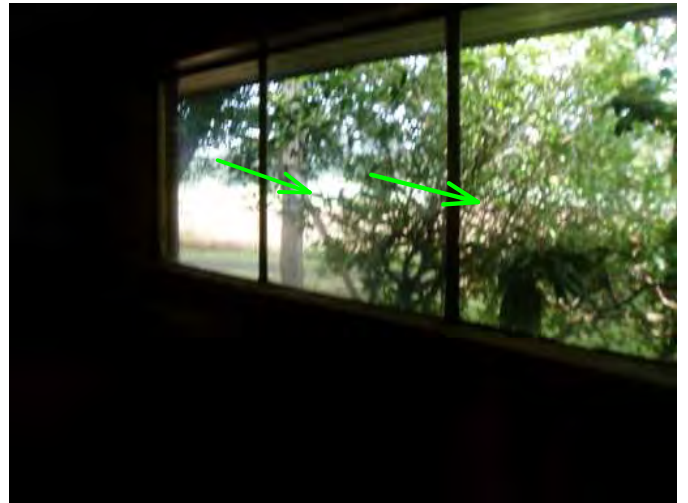
other window is operable...aluminum windows in garage noted....

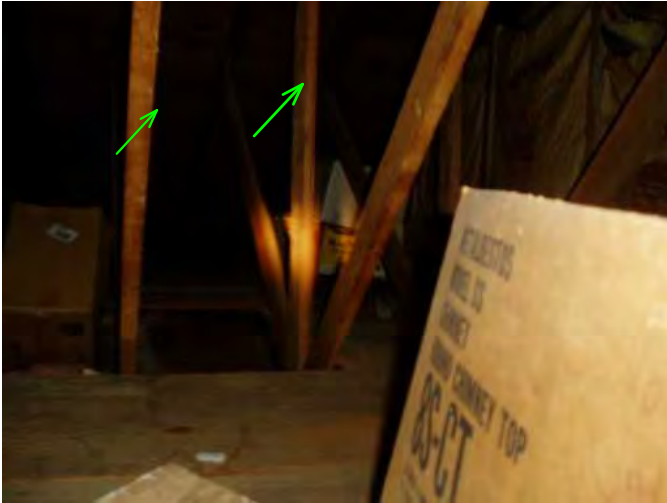
2 x 6 rafters and 2 x 4 truss supports noted in attic...good..no staining on sheathing noted...good..

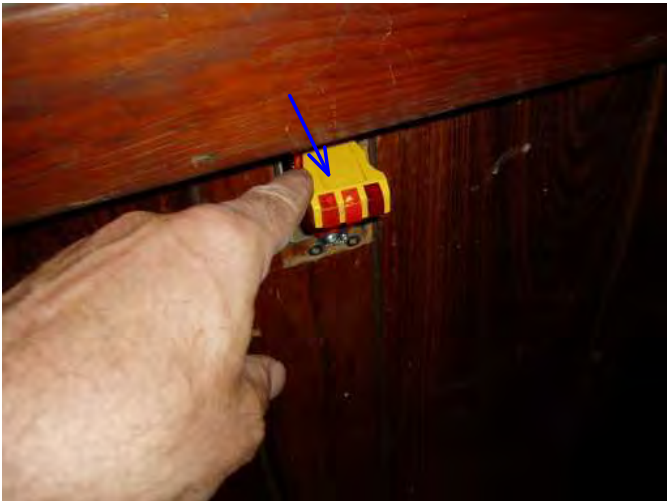
just noting that outlets in garage have 3 prong outlets, but are not grounded....

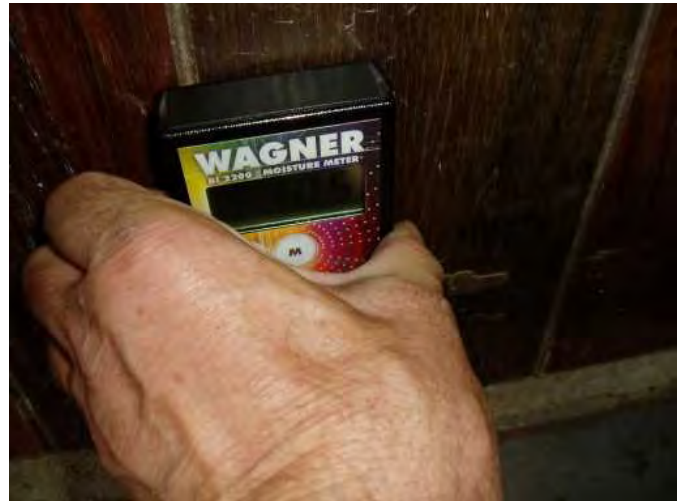
no high moisture in garage walls noted....good,..

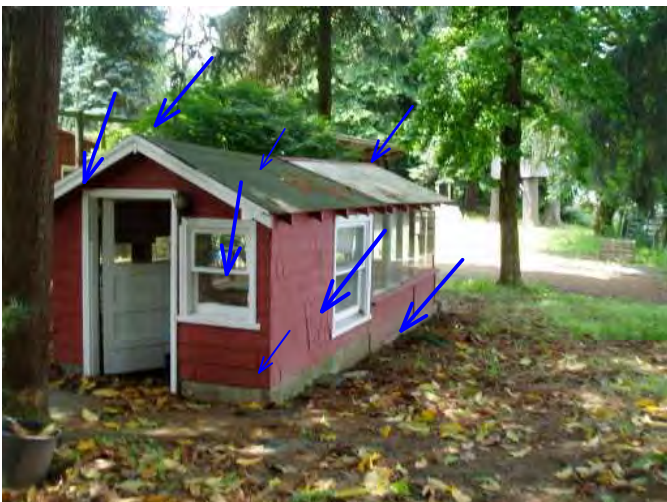
note that all outbuildings need paint and roofs cleaned and gutters and general regular maintenance....

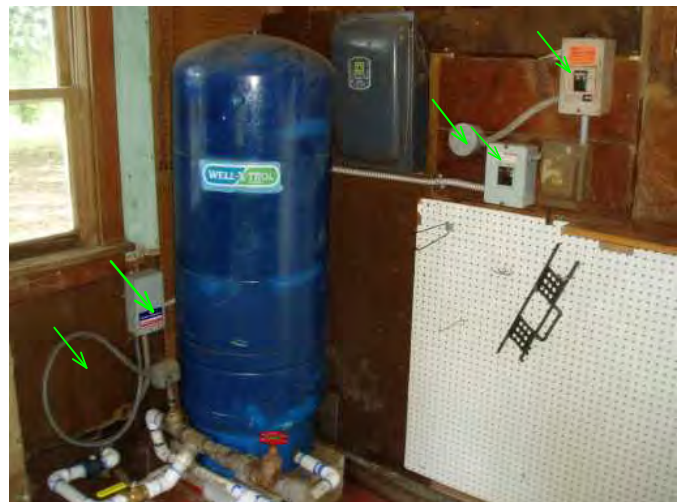
noted major cleanup of breaker boxes in pump house...very good...all cleaned out for specific use now...very good..

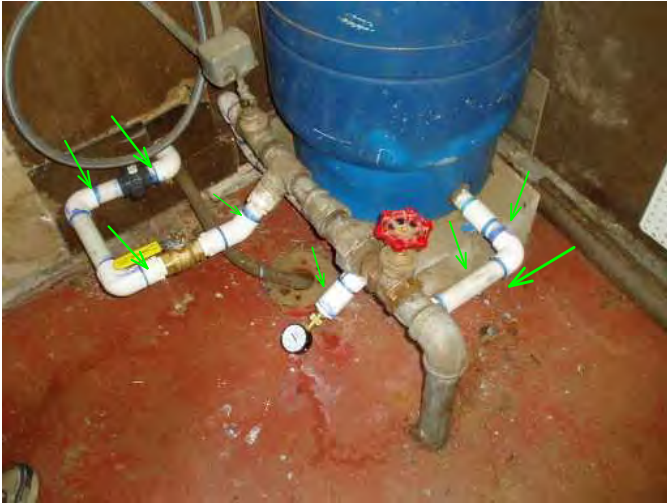
noted many new parts here in plumbing..very nice....

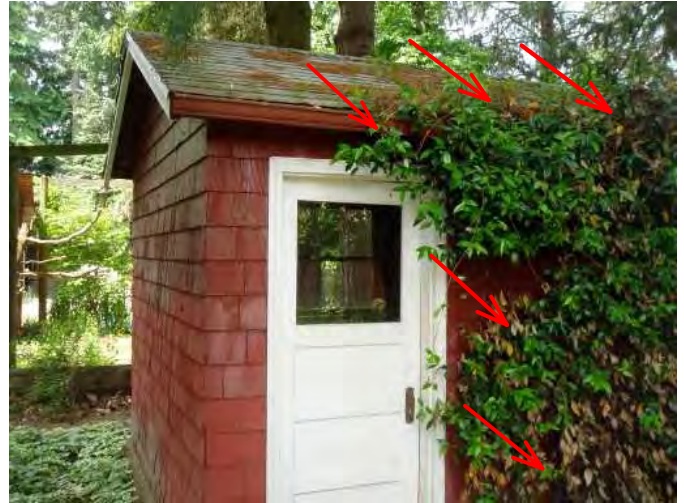
remove all vegetation that creeps onto structures..can not maintain and see what is going on with structure...

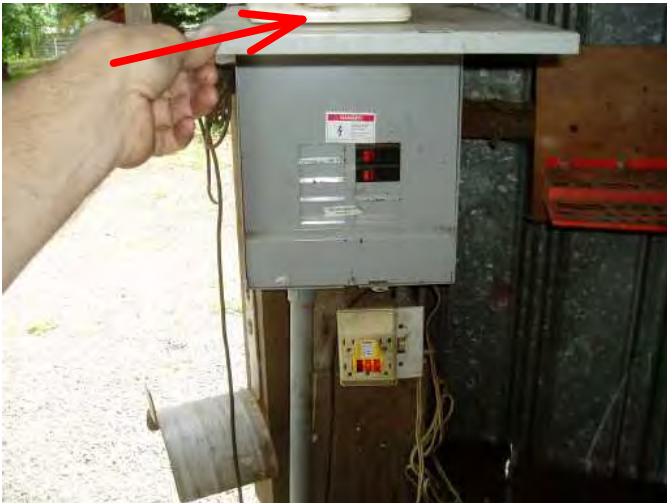
mini breaker panel at pole shed is noted here....sugest removing hand sanitizer from cover....

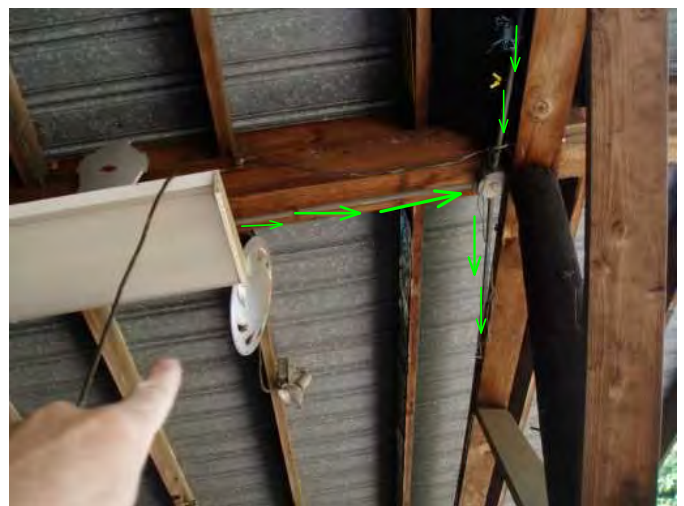
conduit is noted here...good..

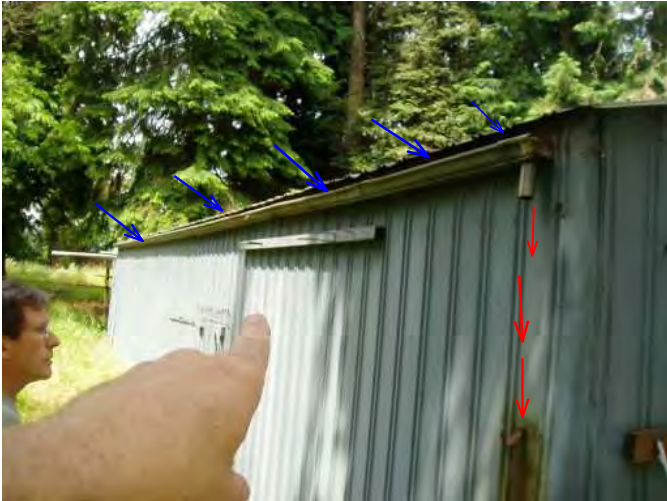
gutter at back of pole shed needs to be operable and cleaned regular...add downspout and extension...

pole shed - Outbuilding - Gutters: Galvanized - Leaking, Loose, Need cleaning

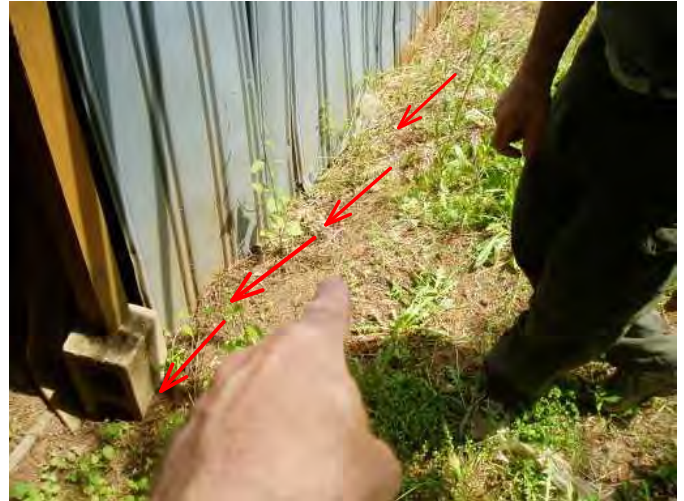
pull back earth from back of structure..this is at pole shed...

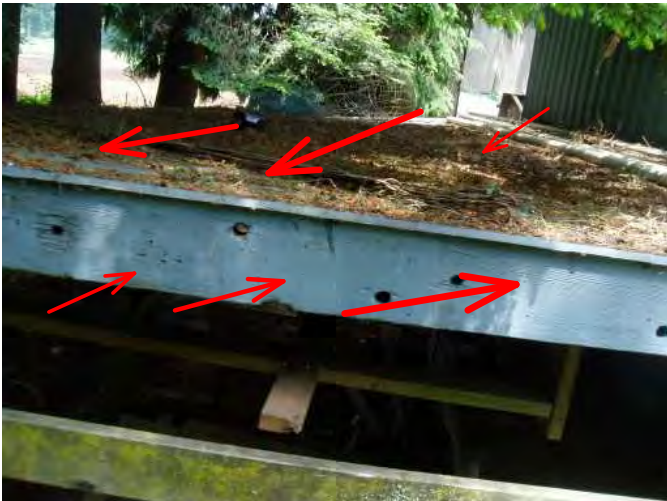
clean all roofs of outbuildings often...keep al wood trim painted to extend useful life....

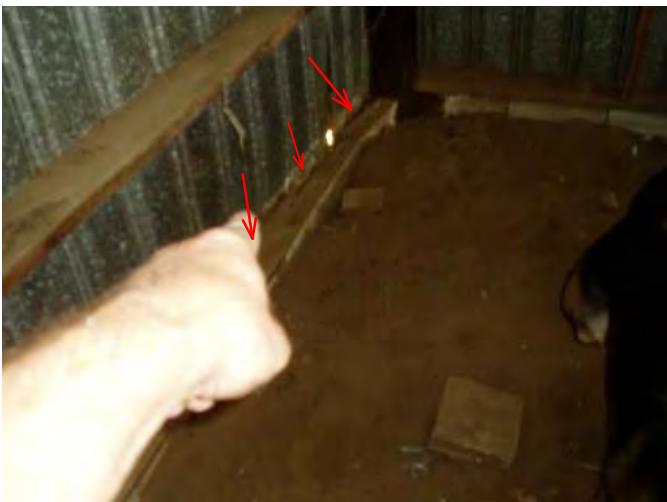
mud sills need to be kept from earth..or will need repalcement as this area is noted at back of pole shed....

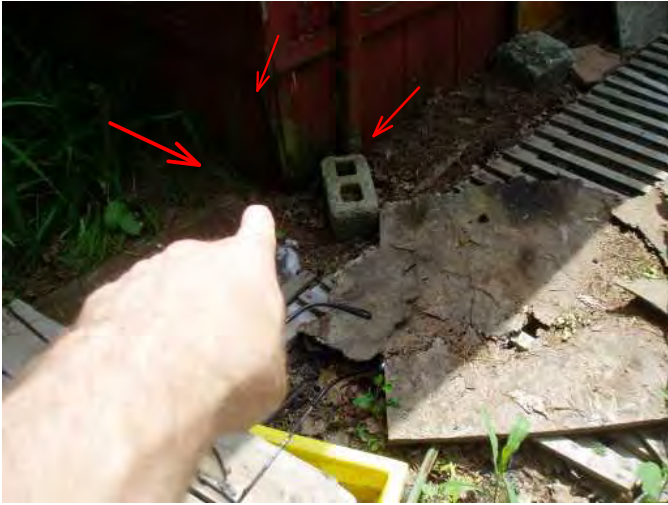
this is where downspout was and now is rotted wood area....chicken coop back area....maintain roofs...

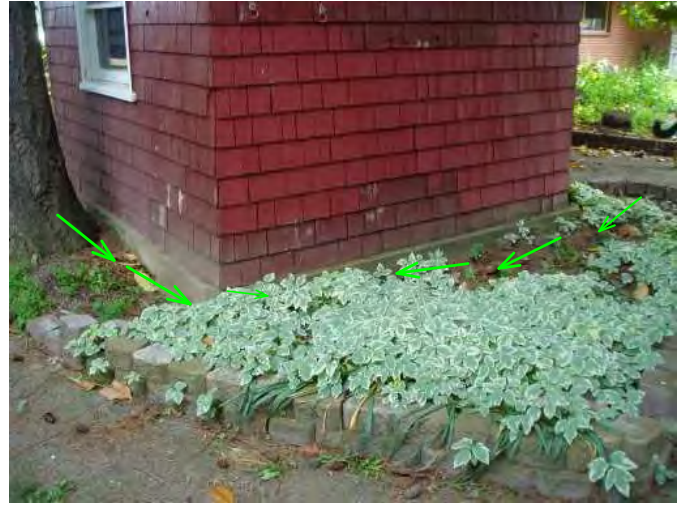
good foundation note here at pump house...

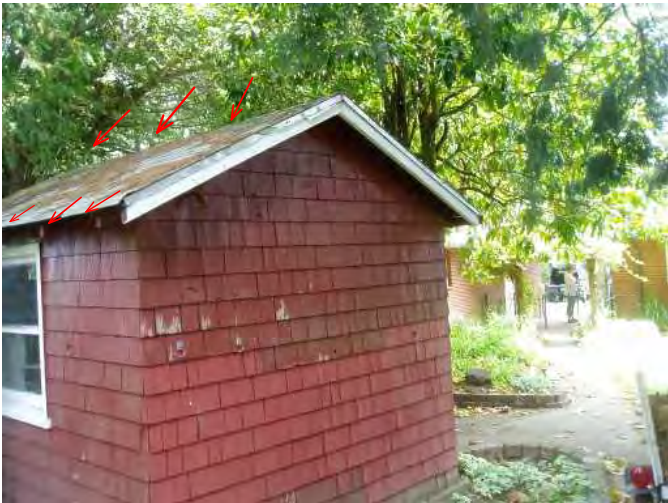
clean pump house roof and add gutters to back of roof...

- pump house... - Outbuilding - Gutters:** Galvanized - needs added to back
- pump house... - Outbuilding - Downspouts:** Galvanized - needs added to back
- pump house... - Outbuilding - Leader/Extension:** none - Extend runoff drains to move water away from foundation
- pole shed - Outbuilding - Floor:** wood - Loose or damaged wood flooring, Surface deterioration
- pole shed - Outbuilding - Electrical:** 120 vac - needs cover plates, Non-GFCI circuit, add conduit for safety
