Home Inspection Report

11900 11920 sw Iron Horse Lane
Beaverton, Oregon
Inspection date 08/11/2011
(section one of three)

Prepared by: The Home Tester
10555 SW Tigard St. #57
Tigard, OR 97223
Ben Tester
503-515-1833 CCB# 164921 OCHI # 912

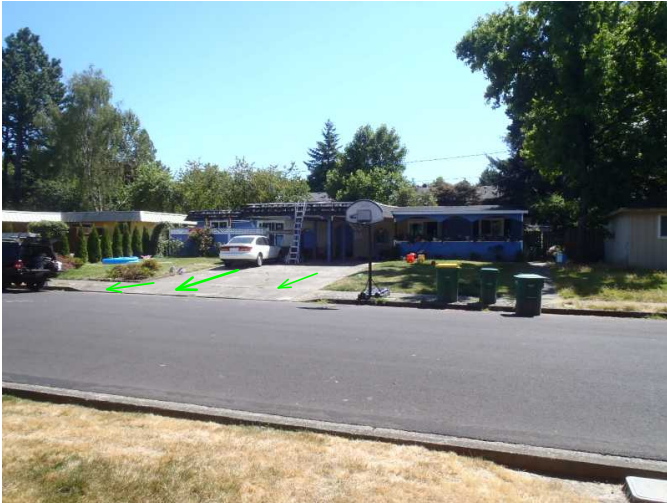
street view of duplex on 08/11/2011 at 2:00pm driveway is noted sloped well for drainage...

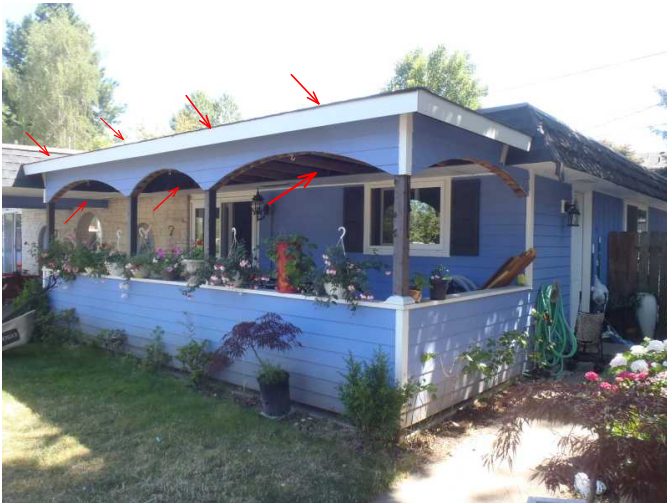
front patio is noted with added covered area...close off all open areas and add gutter and downspout to end...

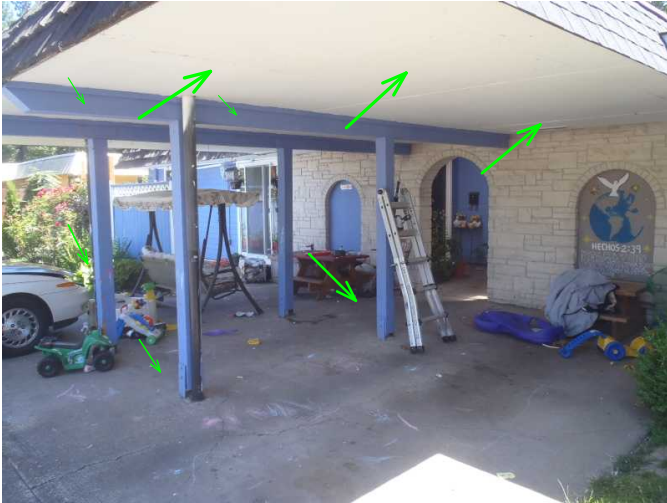
overall condition of carport area is noted solid...no lights noted at carport area for night safety...posts are solid...

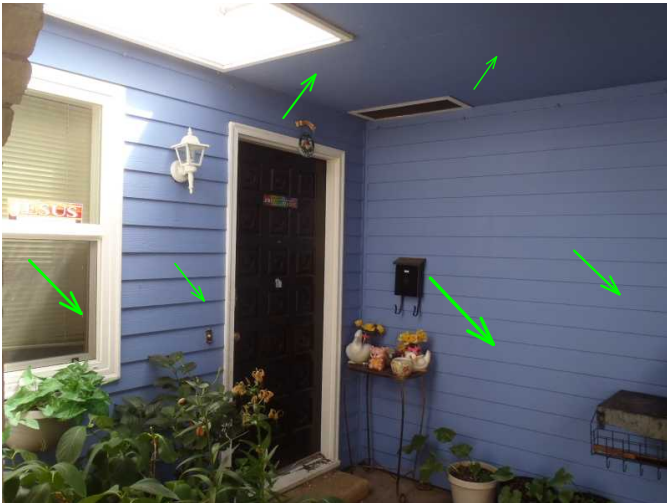
11900 front covered area is noted with fiber cement siding and wood trim...needs paint and caulked...venting noted...

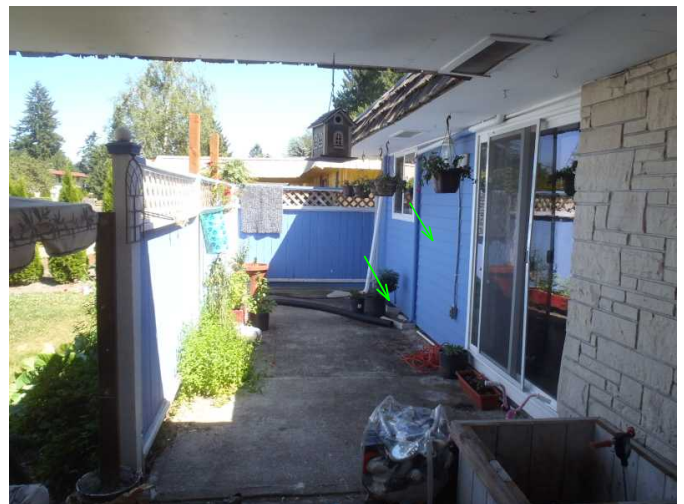
fiber cement siding is noted needing paint and caulk at random open gaps...

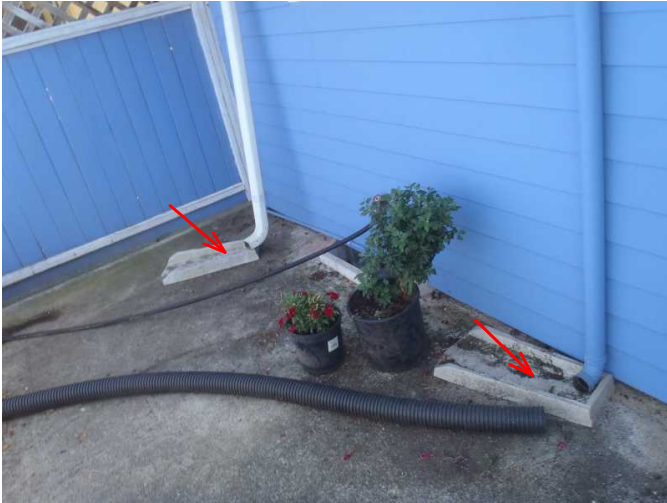
water exits are noted to close to structure..extend away from foundation....

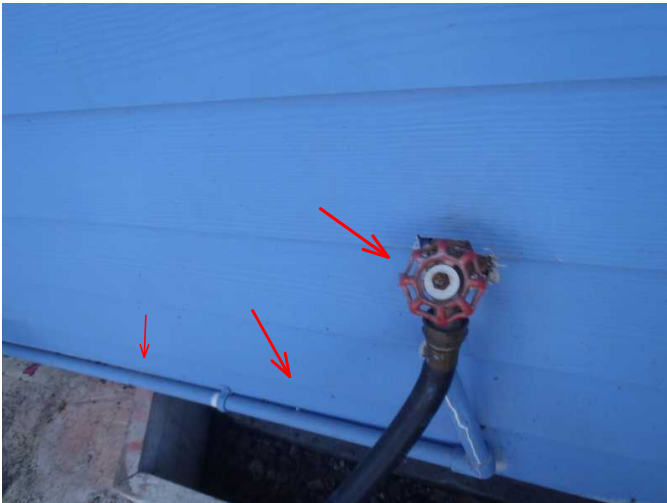
open gaps noted at hose bib and hose bib was noted not operable...some PVC tapped water lines broken...

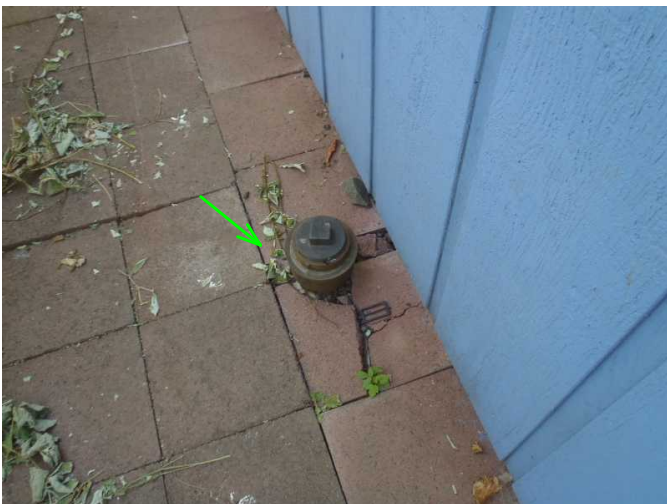
main sewer clean out for entire structure is noted at back center area by bedrooms..

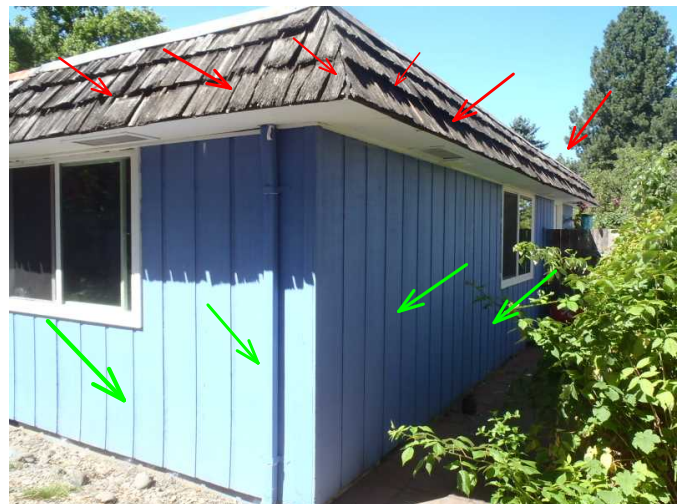
T 1-11 siding is overall solid...just needs paint...all the mansard roof shakes are noted rotted...replace, expect rot

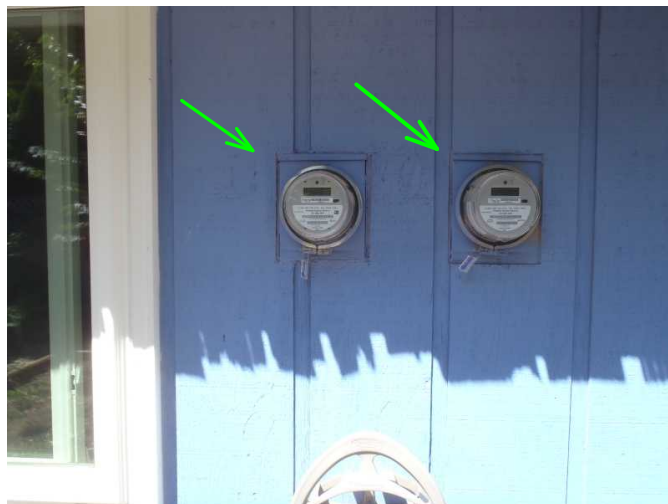
main electric meters are noted solid to siding...

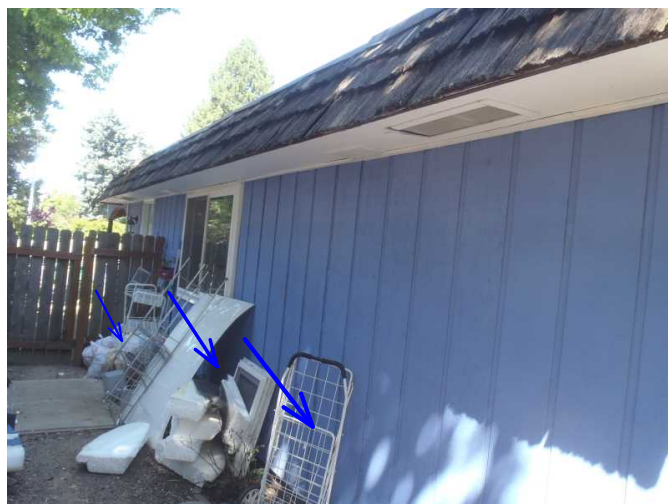
recommend all debris be stored at another area...allways keep al siding and home in view for maintenance...

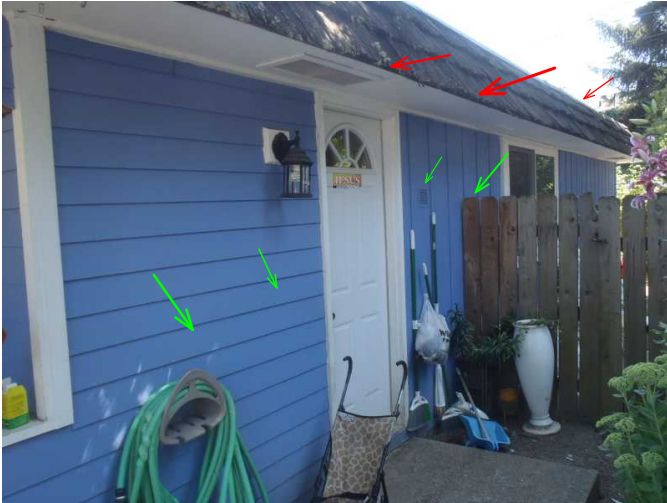
siding divided at side doors...fiber cement at front and T1-11 at back...all of mansard roof shakes are rotten, replace

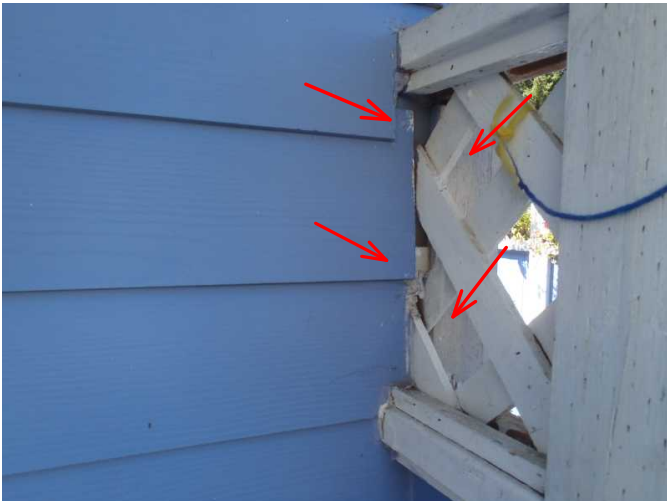
side fence area at 11990 where siding and fencing connect is noted open gaps and will need closed up...

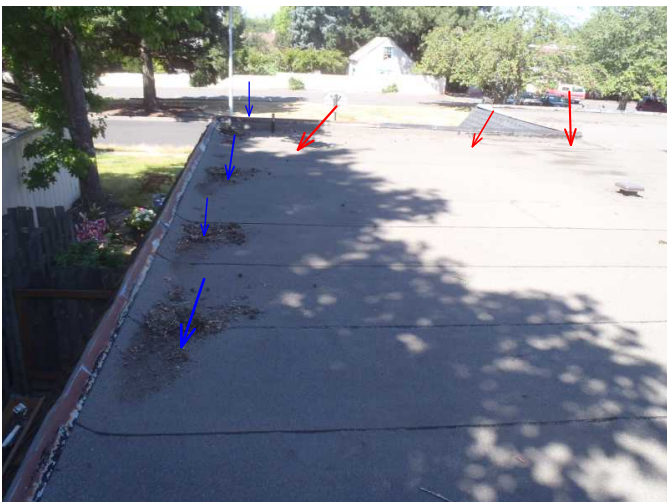
front area roofing is noted patched and no exit drains noted where should be...debris standing at flat roof is not good

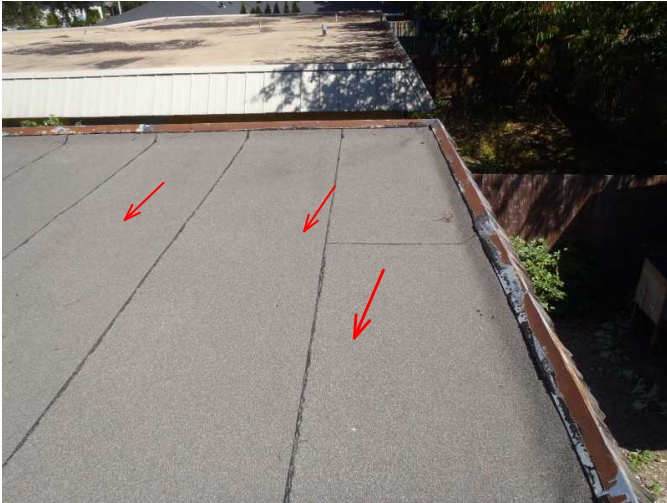
when walking the roof...the sheathing under roof is noted uneven and soft in many places...

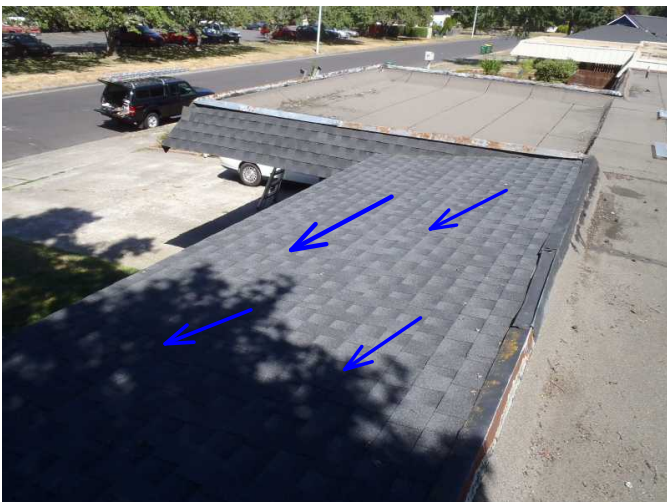
front patio awning covering is not sloped well enough for shingles...can wick water up and under ...use rolled roofing

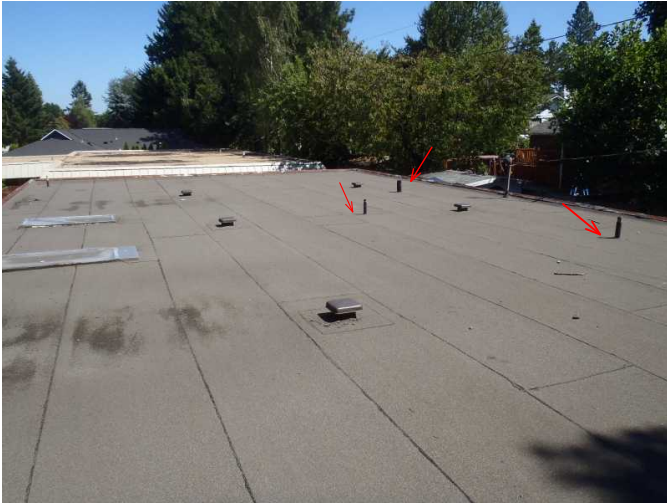
all sewer vents are noted not flashed and are tarred and noted open cracks at all intersections..will required repairs...

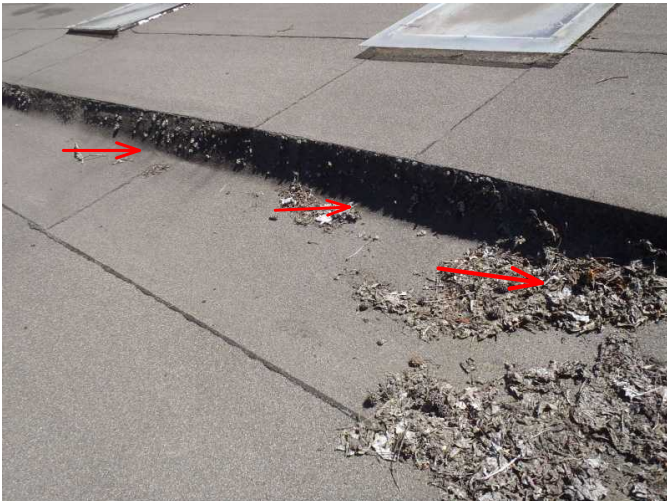
the main drop from carport to roof is noted with cracked roofing and will leak if not tarred...

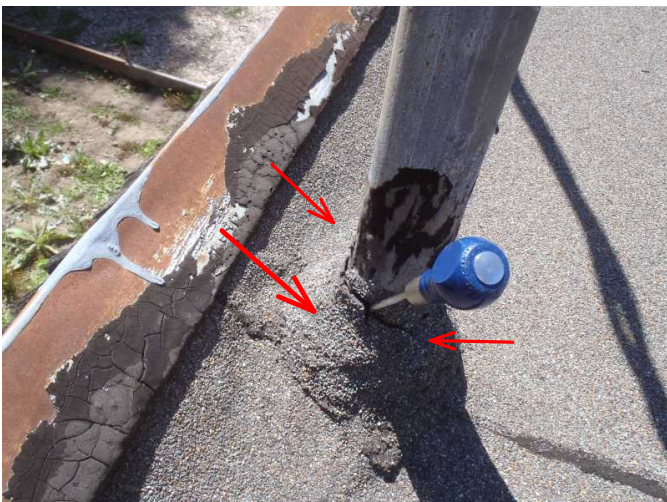
put my awl into open cracks that will be leaking this fall...assess and correct...or replace roof...

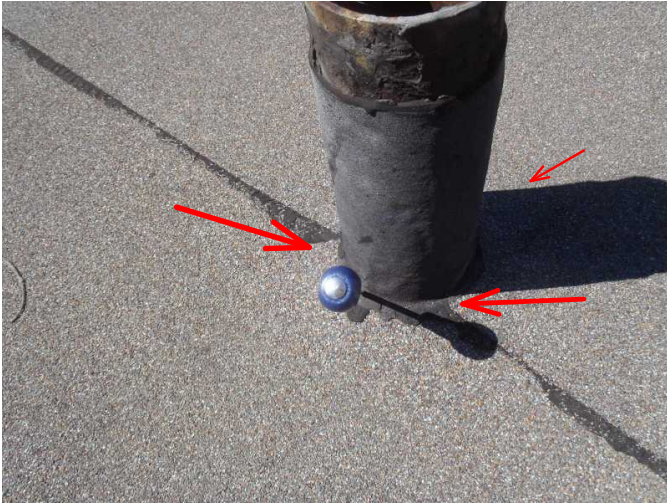
the main sewer exit vent in center of structure is also noted with open cracks at roof line and will need tarred/sealed

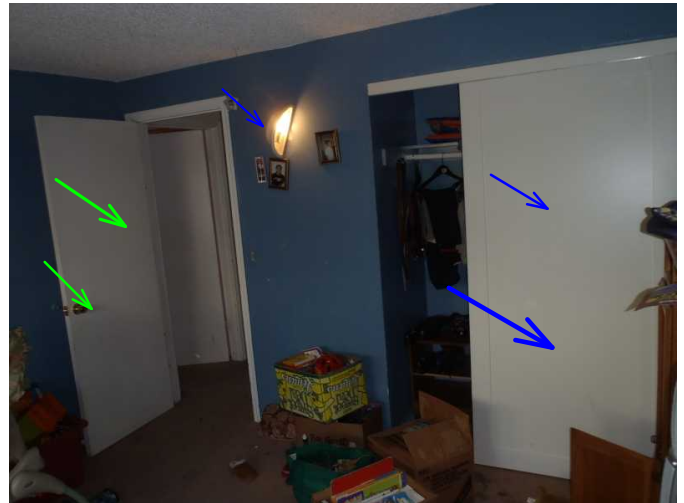
entry door is operable...closet doors off tracks...fixture is off center...

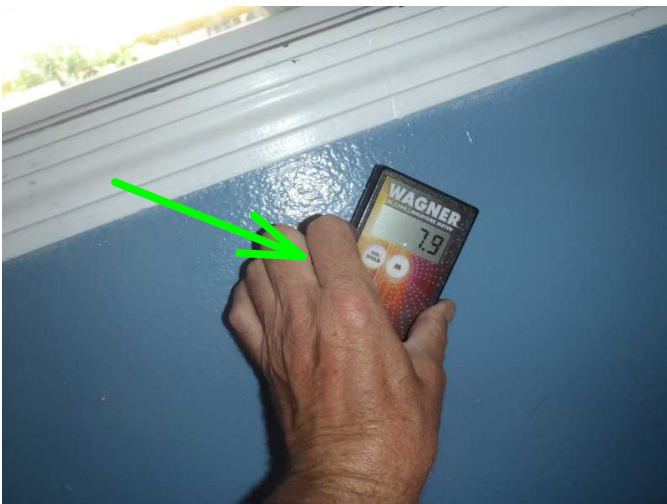
low moisture is noted under exterior wall areas of window in bed 2

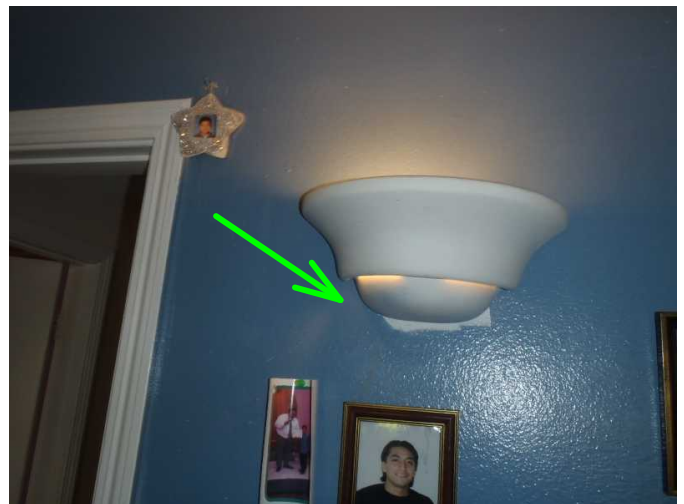
corrected fixture...

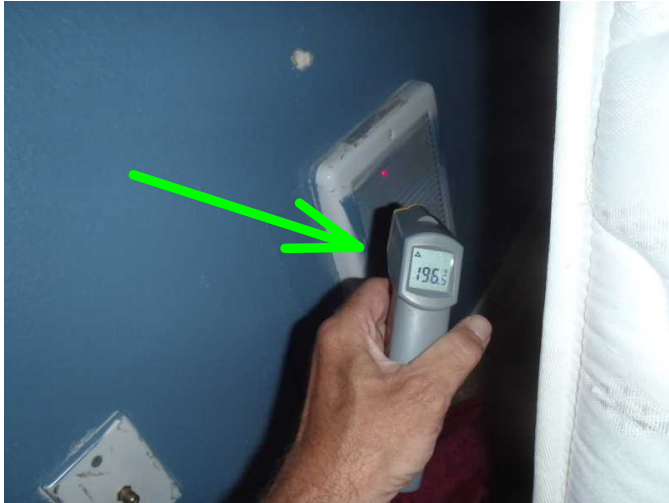
Cadet wall heater needs cleaned and is operable...bed
2

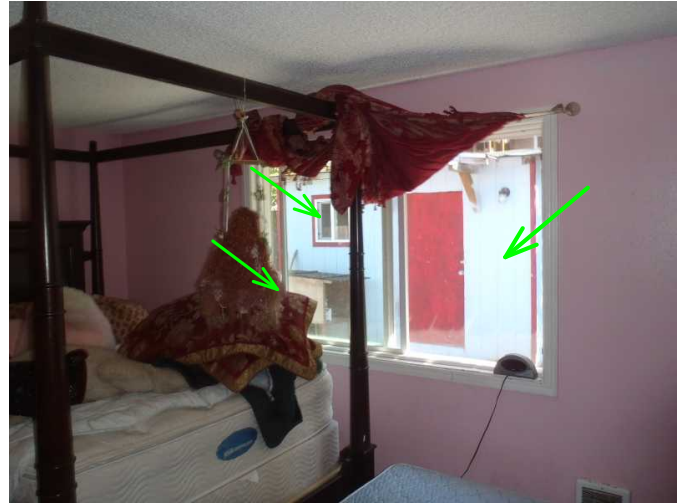
window in master bedroom of 11900 is noted operable...

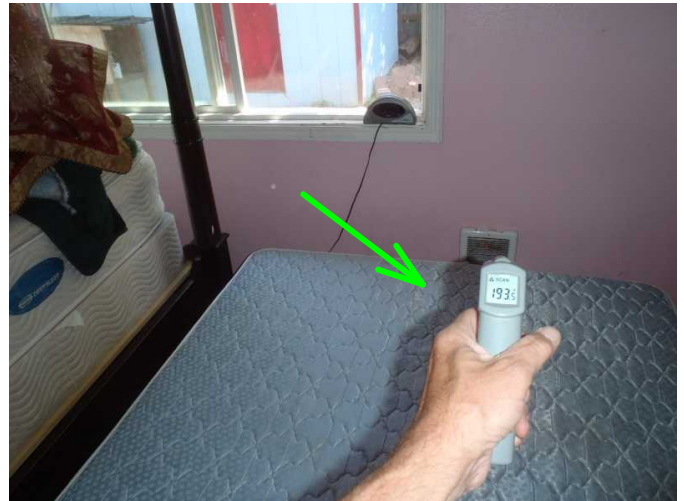
Cadet wall heater is noted operable..breaker was shut
off due to bed to close to heater...

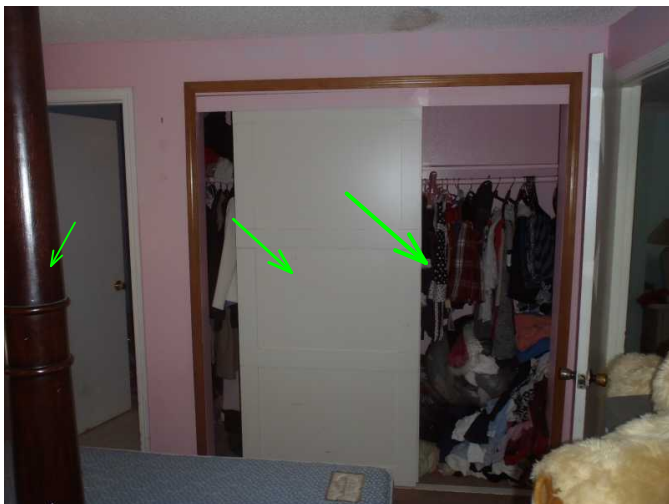
master bedroom and closet doors are noted operable..

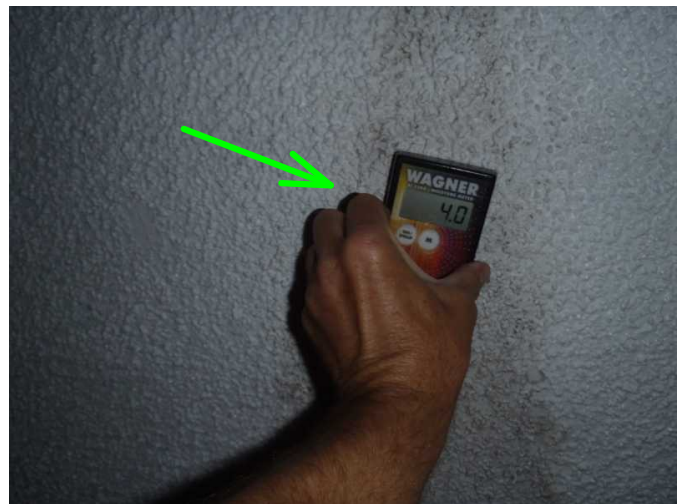
staining at ceiling area is noted low
moisture...appears was past issue...

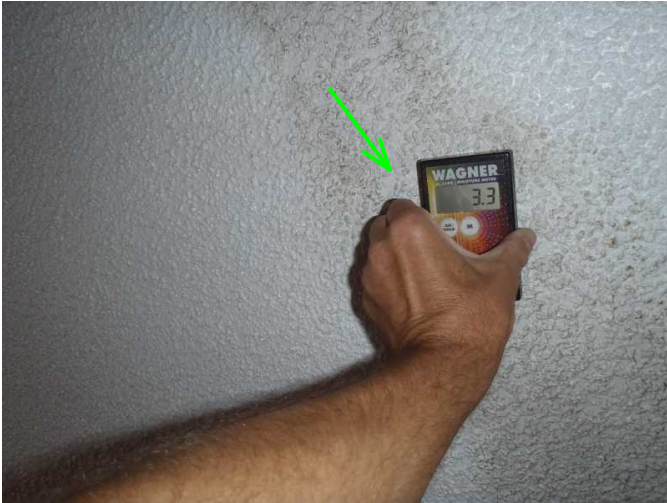
second reading of moisture at another area is noted low in moisture as well...

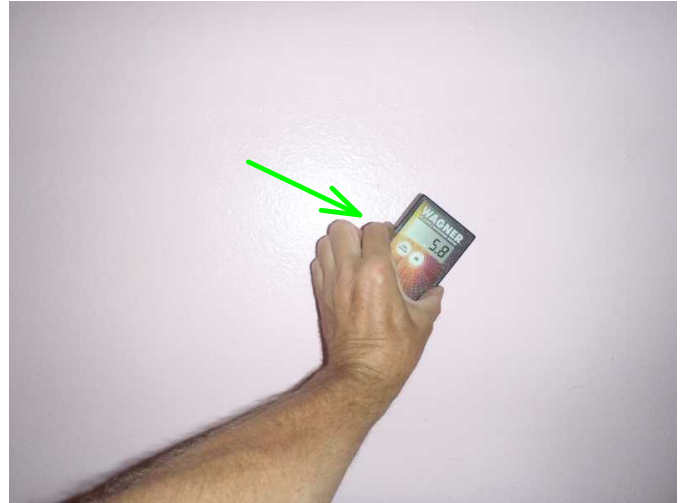
outer wall at back of master bed is noted low in moisture..

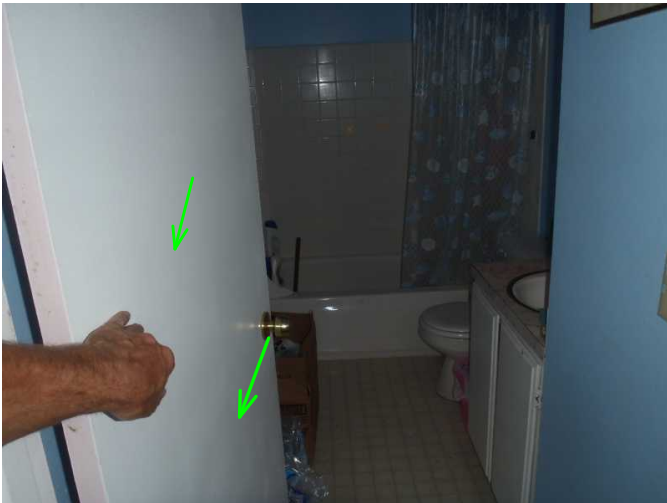
door to master bath is noted operable..

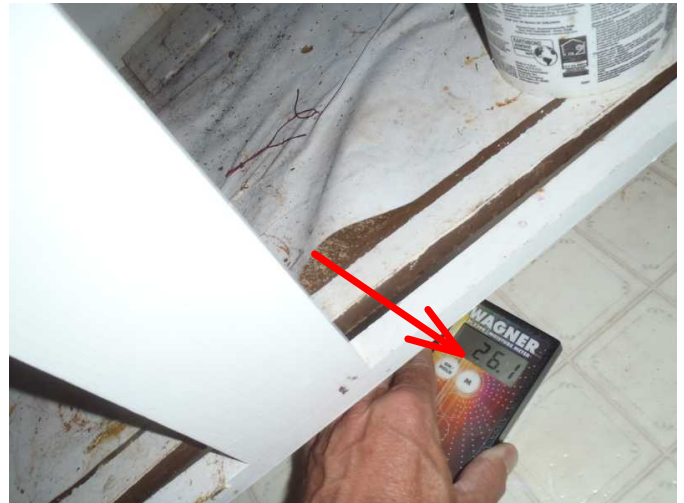
cabinet area floor is noted high in moisture..expect damage to under layment...

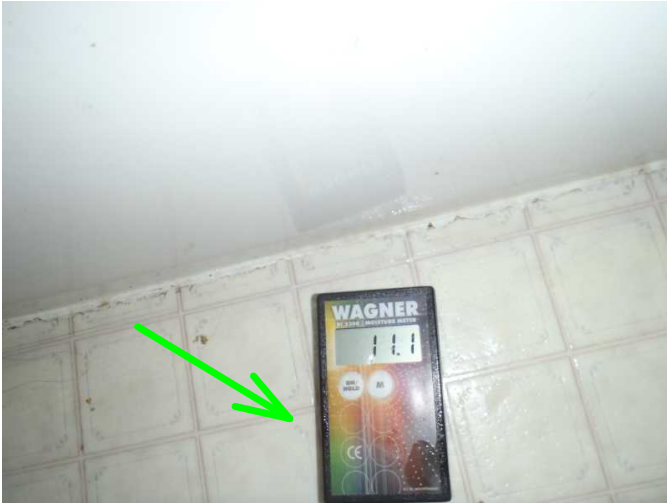
front and center area of tub floor is noted fine...

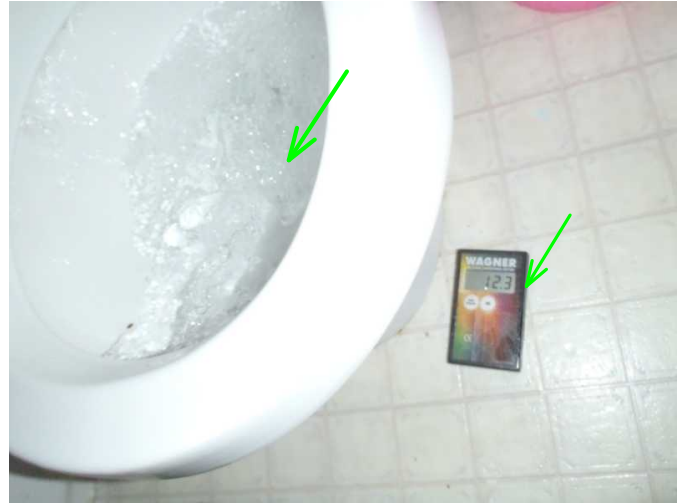
toilet is noted operable..and right area of floor is noted fine...

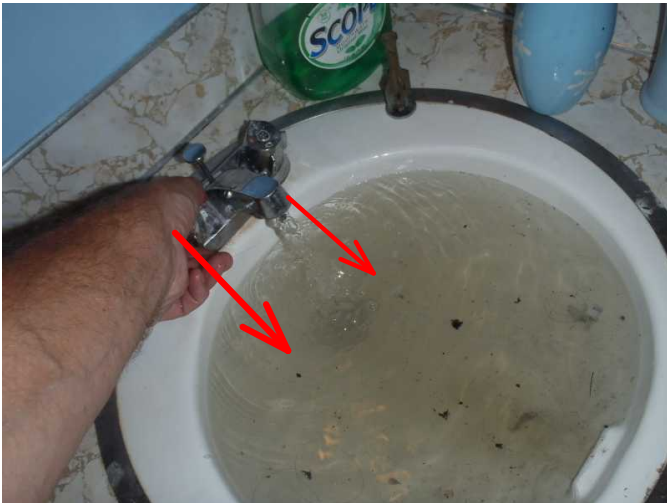
sink drain and drain stop are noted not operable..

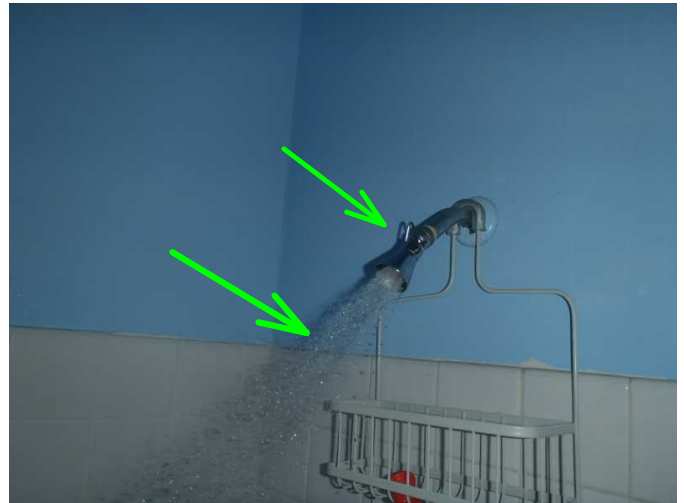
shower head is noted operable and solid to wall..

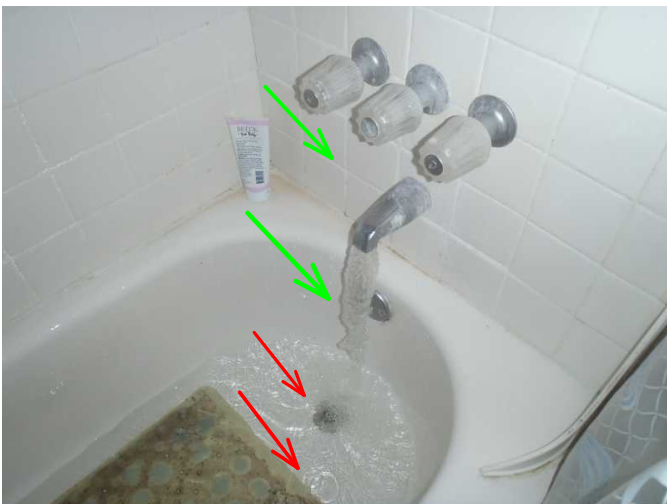
tub faucet and shower control are noted operable...but drain and drain stop are noted not operable..

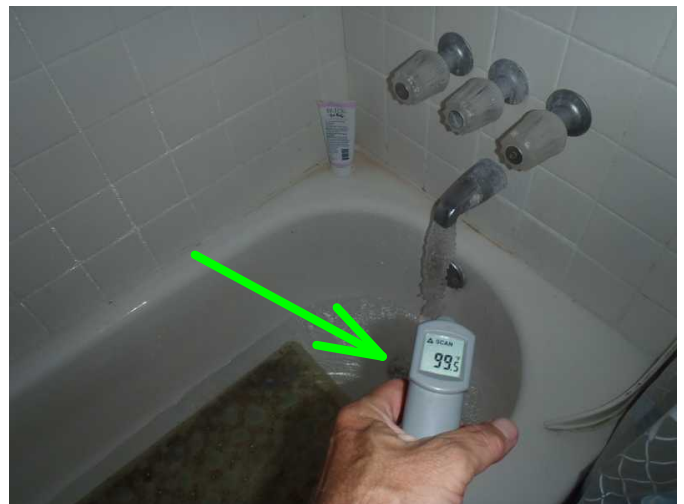
hot water is noted to both faucets...

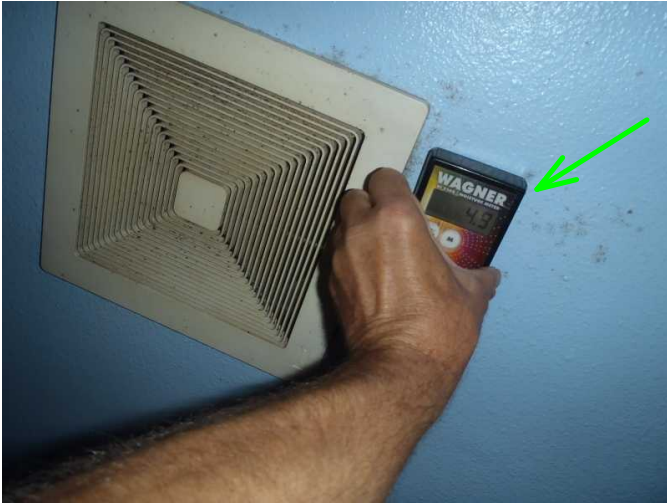
ceiling is noted low in moisture...appears is surface issues and needs a good bleach treatment and paint...

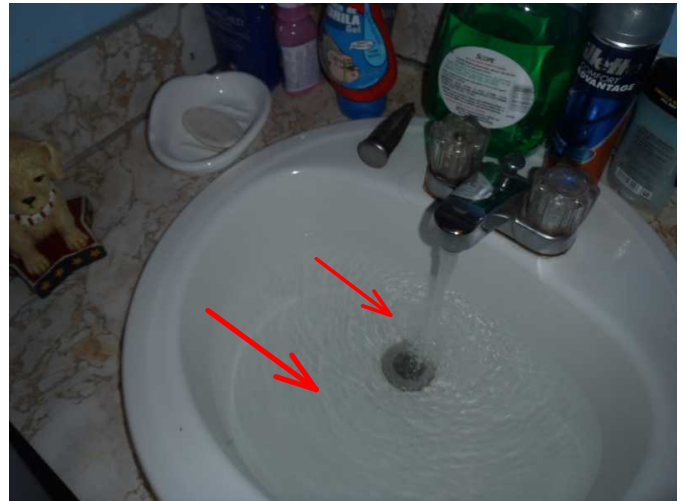
again , slow drain noted and no drain stop...

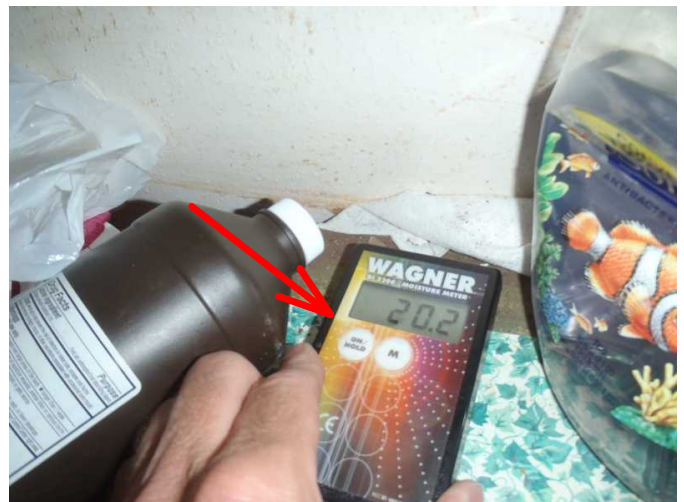
high mositure is noted at back center area of cabinet....rest is fine..

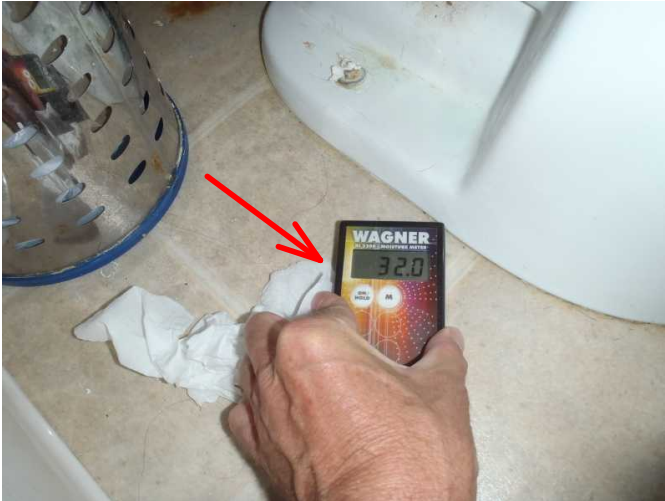
floor at toilet in main bath at 11900 is noted saturated again...as is in master...

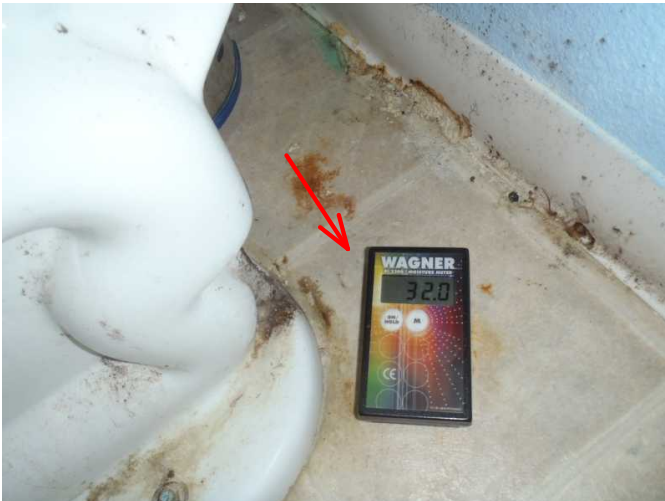
floor behind toilet is noted saturated as well...expect damages...

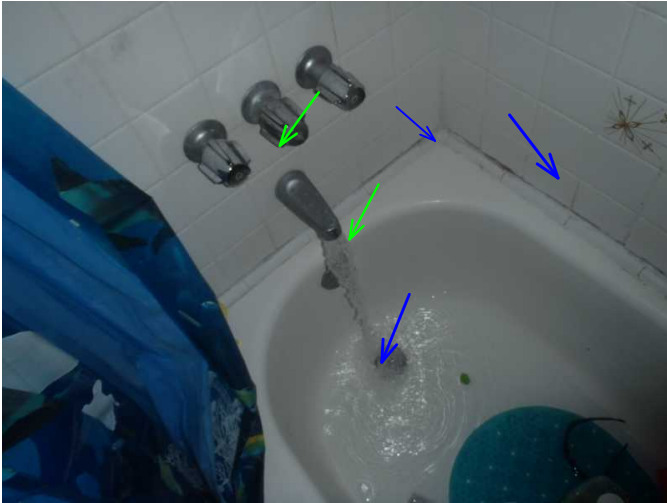
monitor grout at tiles and seal as needed...faucet is noted operable...drain is noted slow and no drain stop...

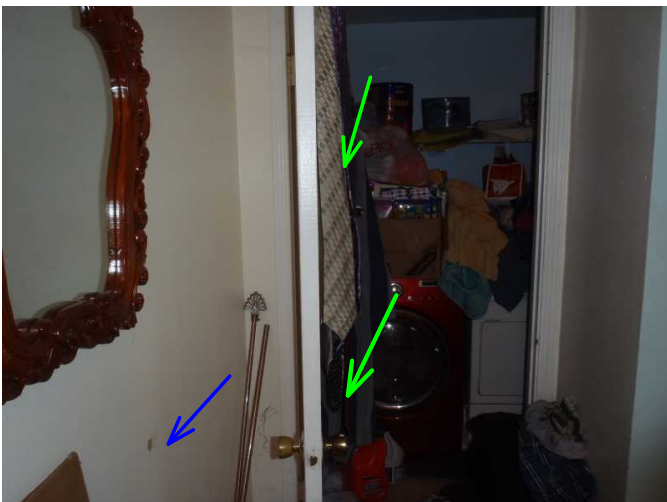
door to laundry is noted operable...needs door stop...

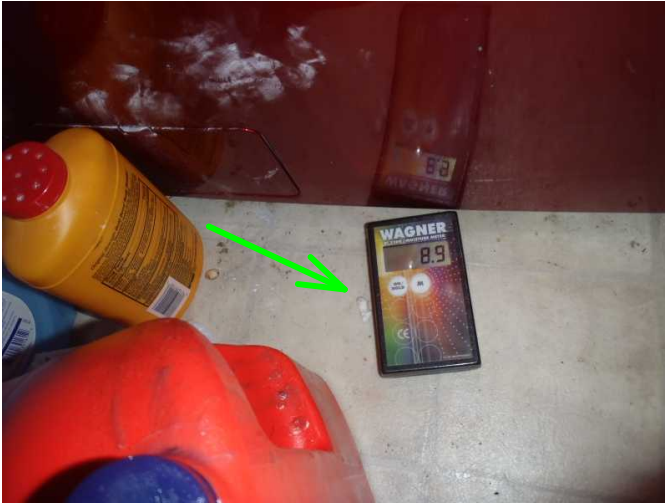
low moisture noted at washer floor area...

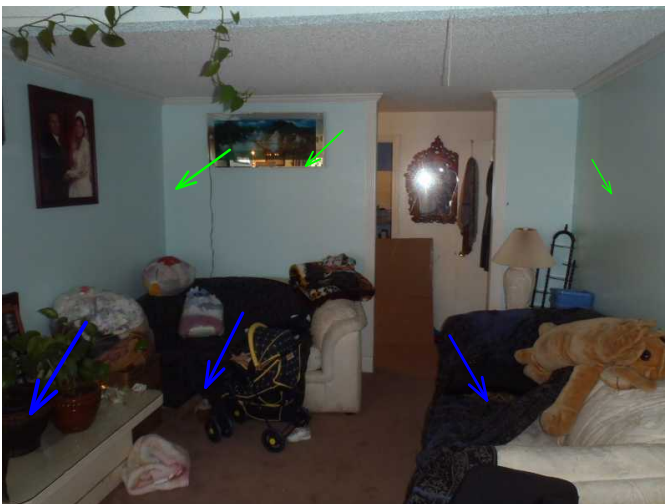
walls in living room of 11900 are covered with storage...tried to find second Cadet heater...not successful...

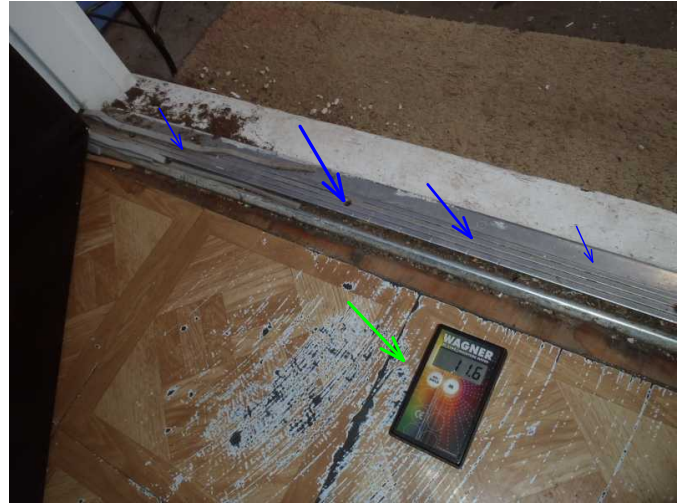
front door is noted operable..floor is noted low in moisture...appears threshold is damaged with weather stripping

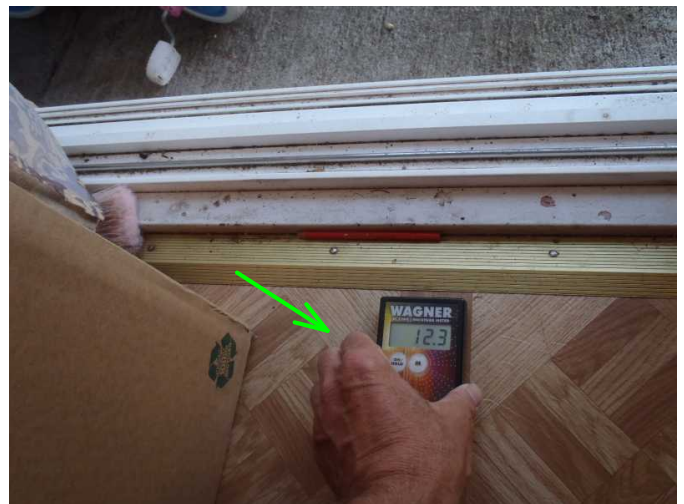
floor moisture is noted low at entry area of patio vinyl slider...

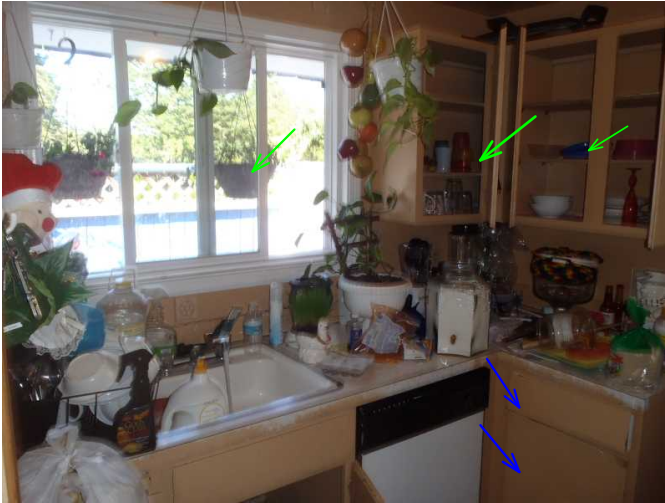
window in kitchen and upper cabinets noted operable...lower cabinets noted damaged....

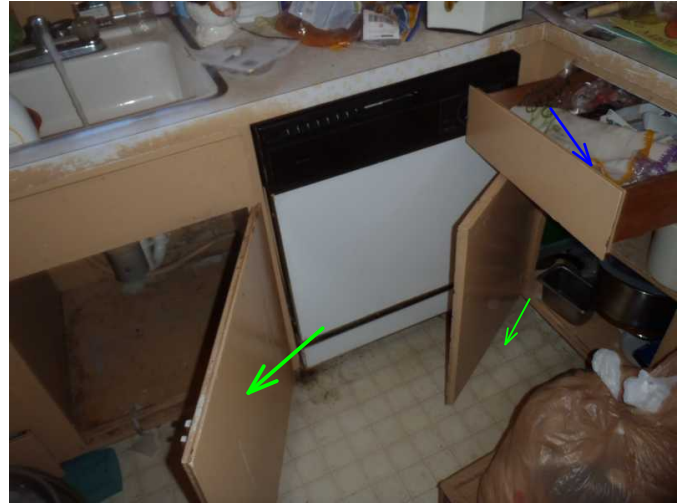
lower cabinet doors are noted operable..drawers are noted damaged...

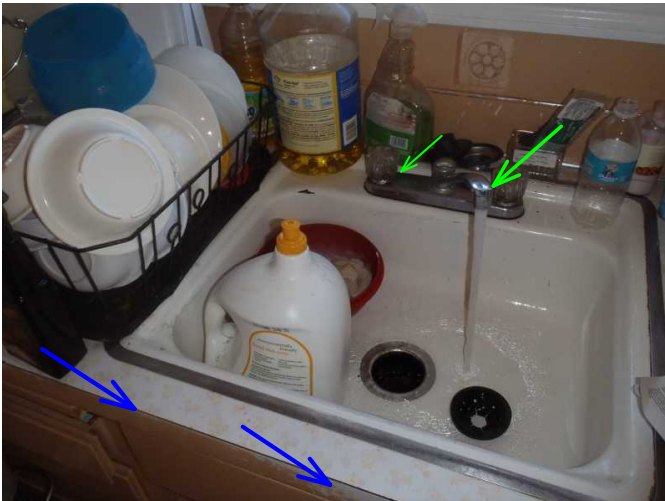
faucet is noted operable....counter appears damaged..from what can be seen...

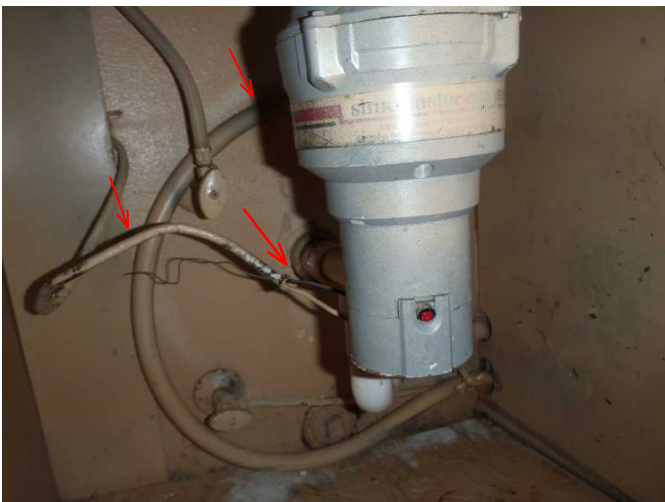
garbage disposal is noted operable..but needs armoured cable electric line...dishwasher needs high loop...

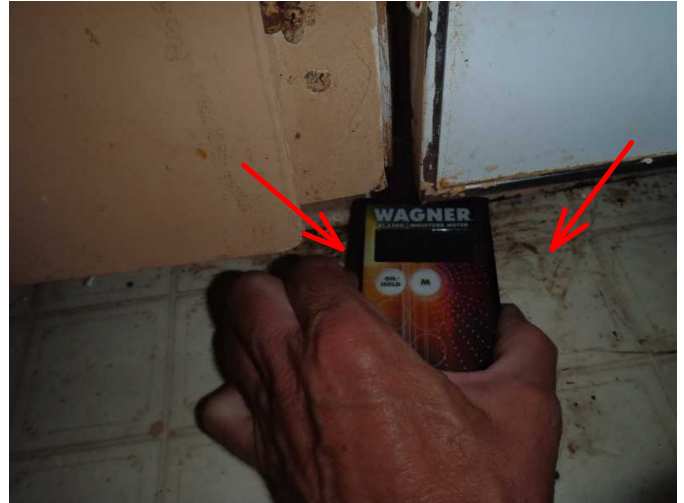
base area of dishwasher is noted with high moisture readings....expect floor damage here...

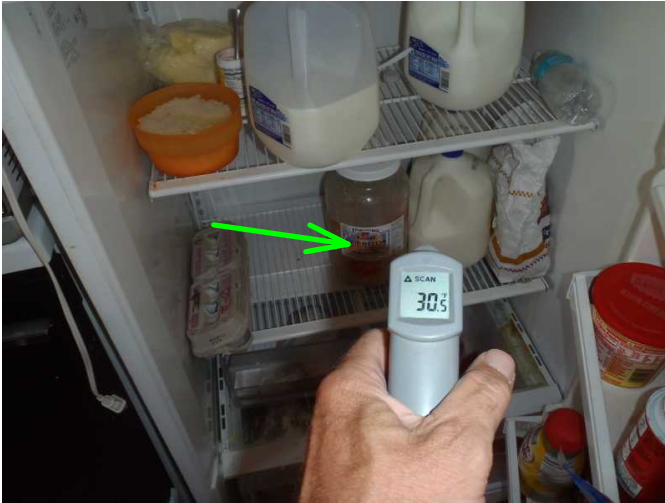
refrigerator is noted operable...

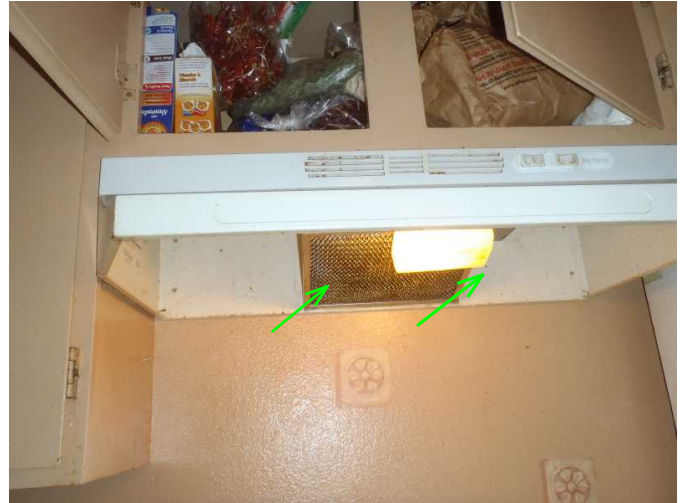
opver stove fan is recylcing...fine..exit fan is to left at wall and is operable...use both...

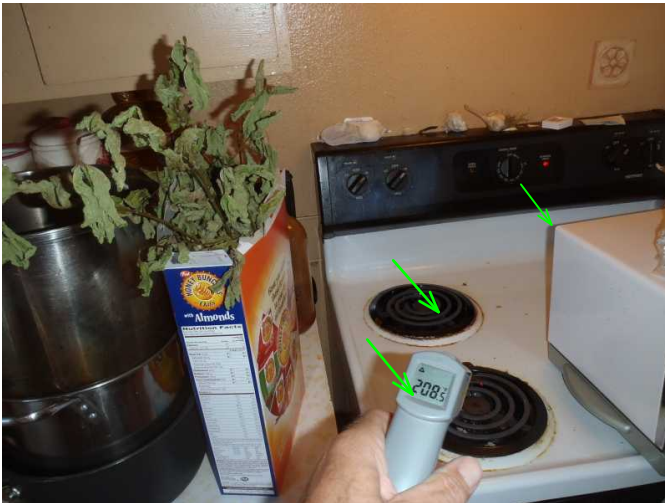
stove top burners are noted operable...oven was not tested due to storage in oven...

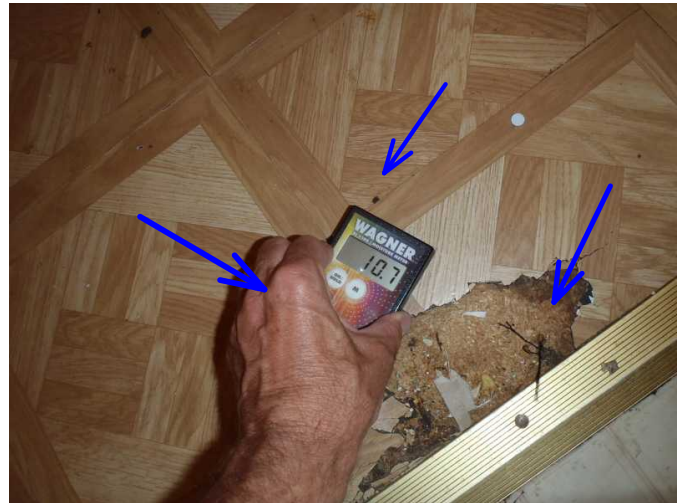
floor in dining room area is noted damaged...appears to be cosmetic...no high moisture at this time...

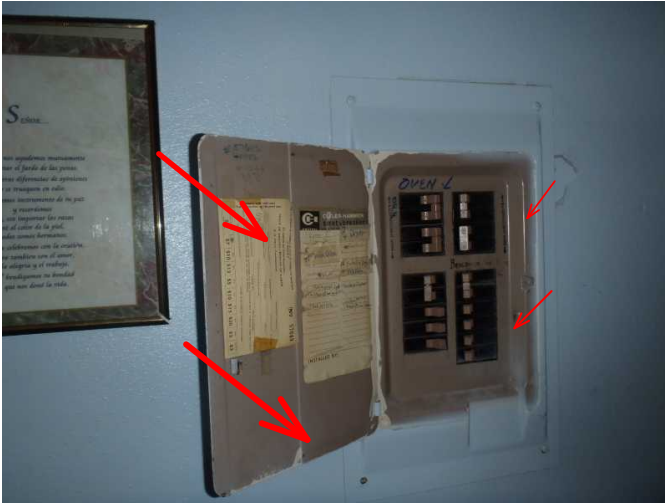
main breaker panel is noted full and no room for expansion for any major changes...is 125 amps...
