Home Inspection Report

11900 11920 sw Iron Horse Lane
Beaverton, Oregon
Inspection date 08/11/2011
(Section two of three)

Prepared by: The Home Tester
10555 SW Tigard St. #57
Tigard, OR 97223
Ben Tester
503-515-1833 CCB# 164921 OCHI # 912

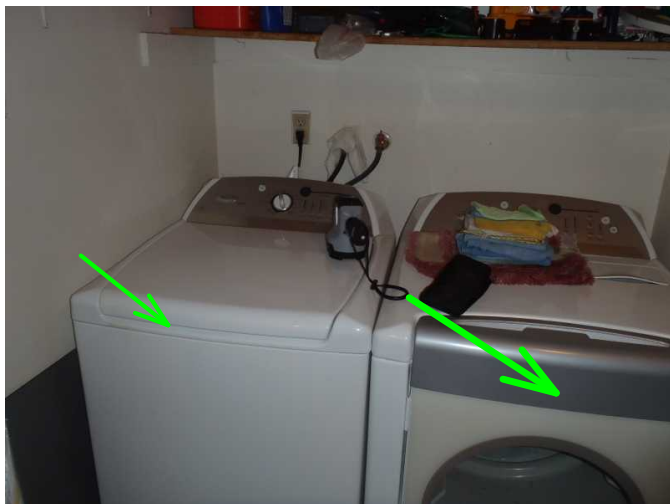
laundry area is noted visible...floor moisture is noted low..

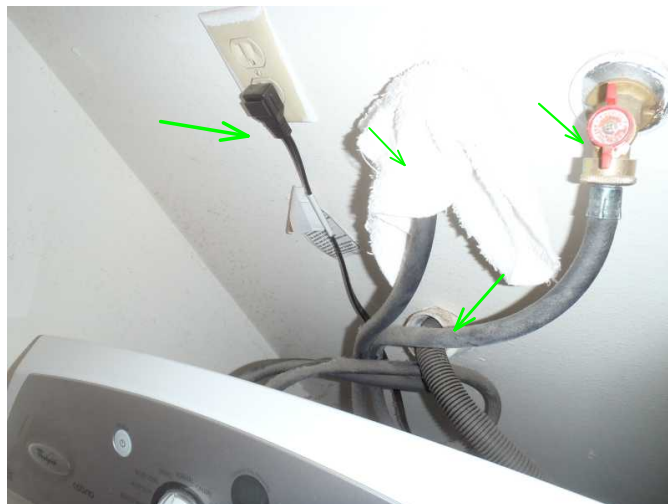
washer connections are noted drip free...

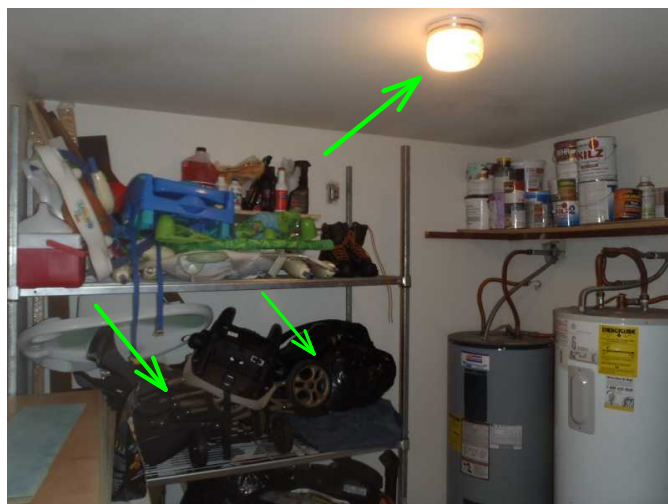
laundry room walls appear fine..can see around stored items pretty well...fixture is noted operable...

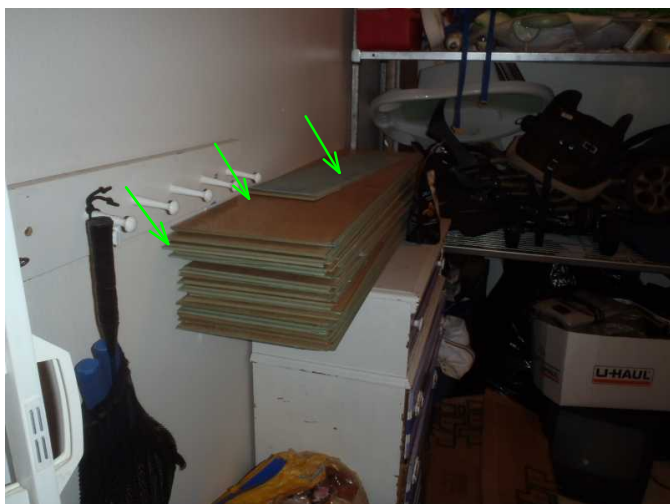
appears extra flooring is noted at laundry room and may be from side bedroom area...

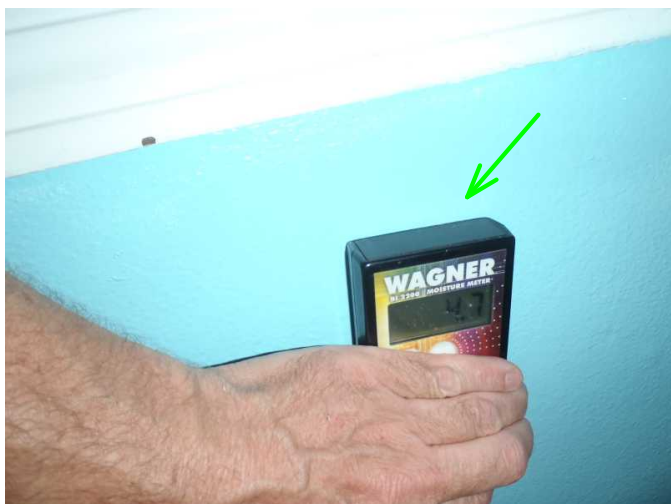
low moisture is noted at all areas of exterior wall ...

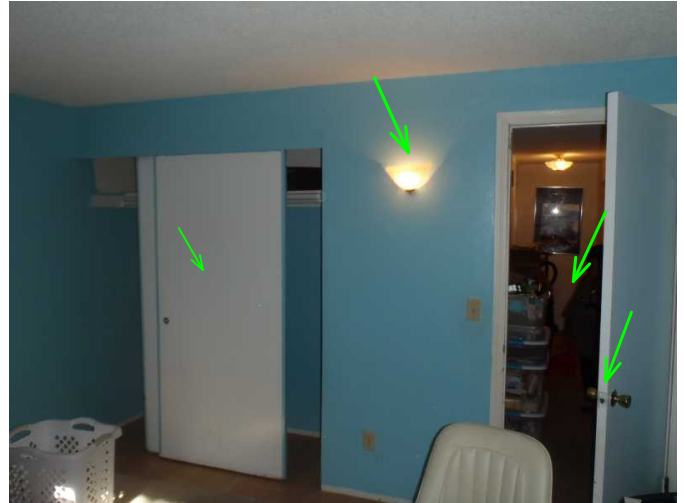
entry and closet doors and fixture are noted operable...

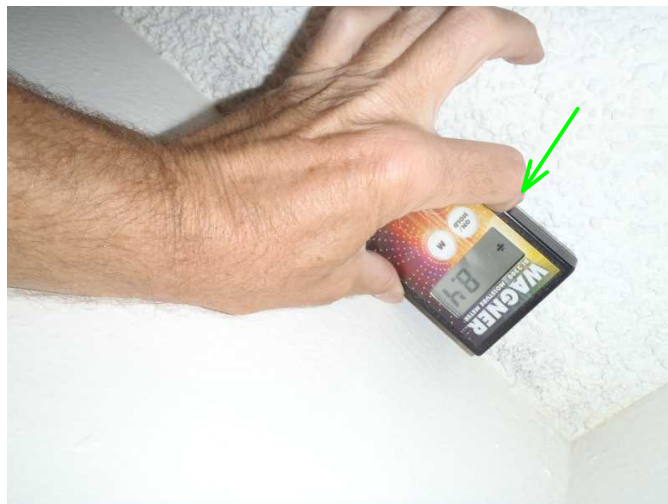
low moisture is noted at ceiling area at corner as well...

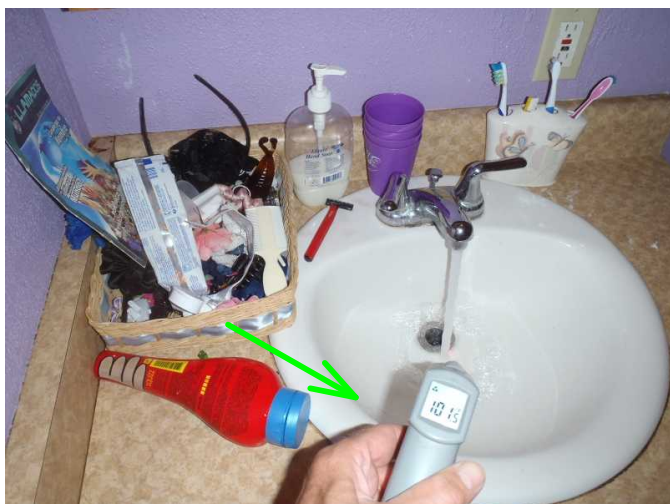
hot water is noted fine...

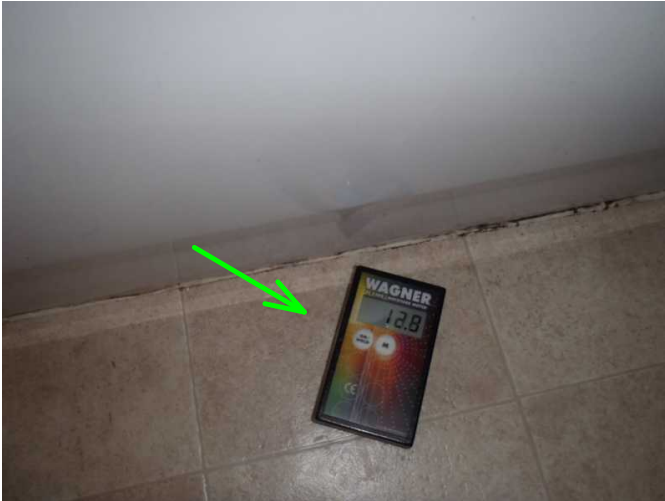
floor at tub area center at master is noted low...caulk is needed at rim areas of flooring..

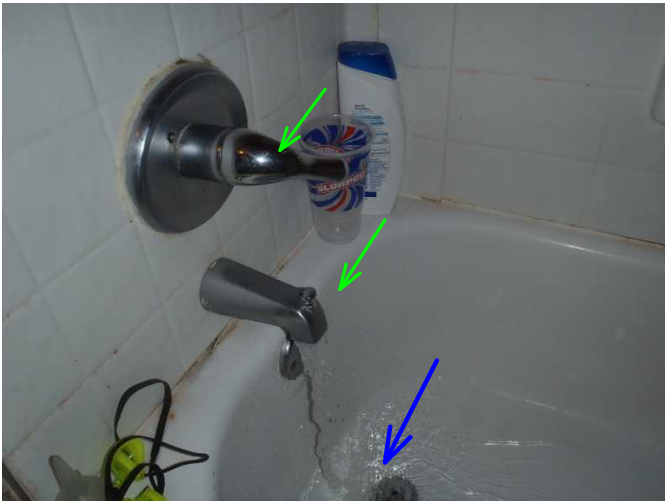
faucet is noted operable...but drain stop not operable...

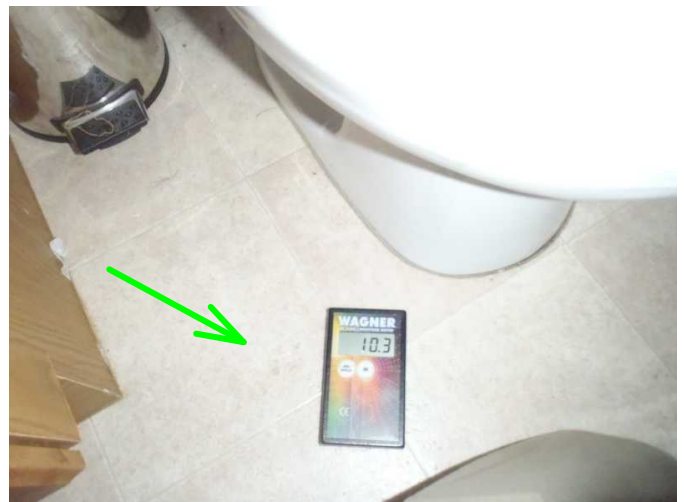
toilet is noted solid to floor and operable...floor is noted low in moisture at rest of areas...

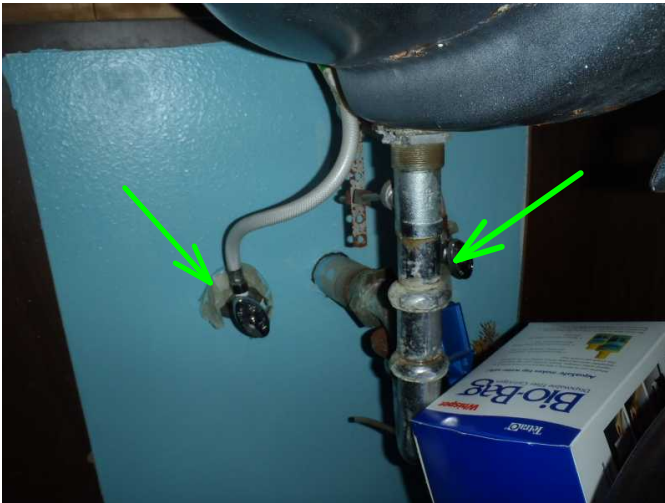
trap and connections under sink area are noted drip free...

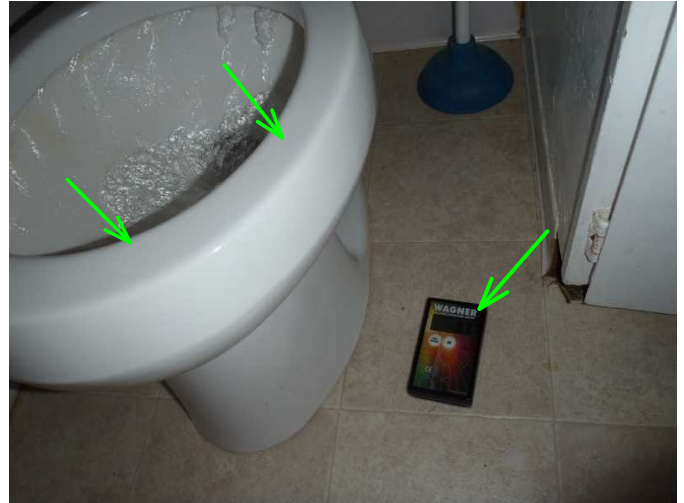
toilet is noted operable...and floor moisture is noted low...

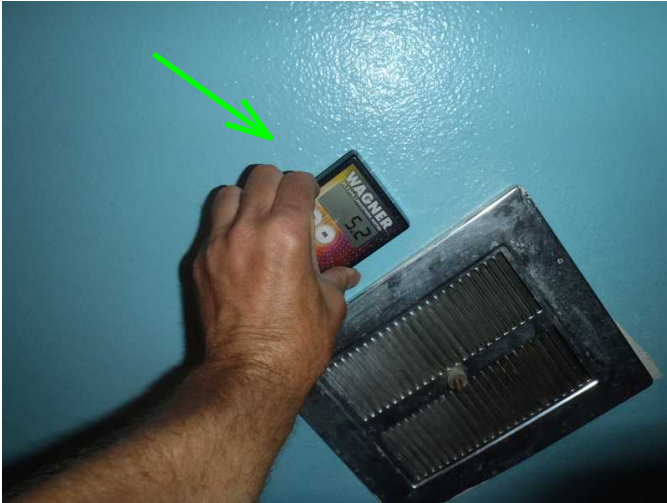
ceiling fan is noted operable...and low moisture at ceiling area...

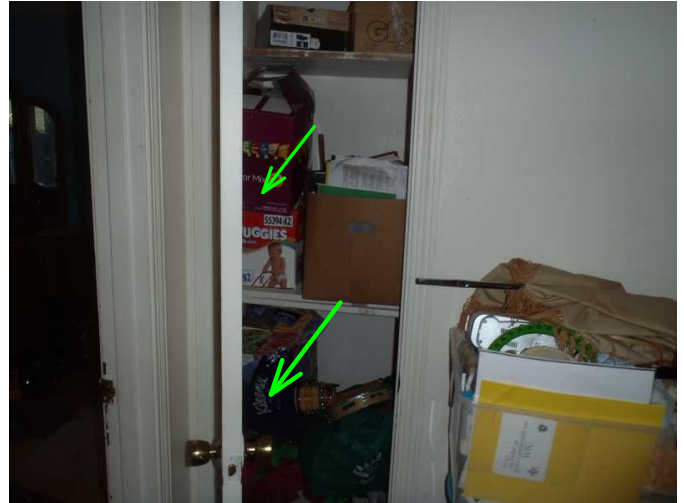
hall closet door and shelves noted operable..

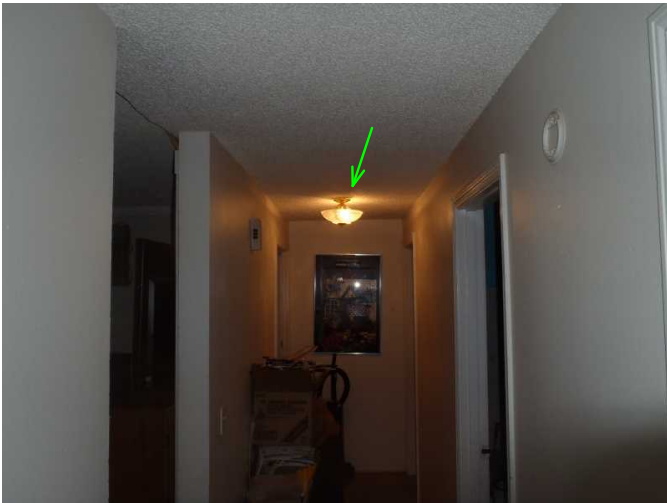
ceiling fixture and door bell noted operable...

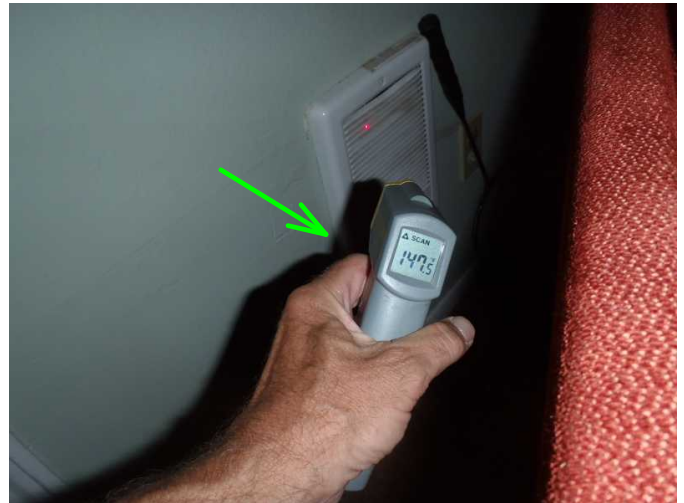
living room Cadet wall heater is noted operable..

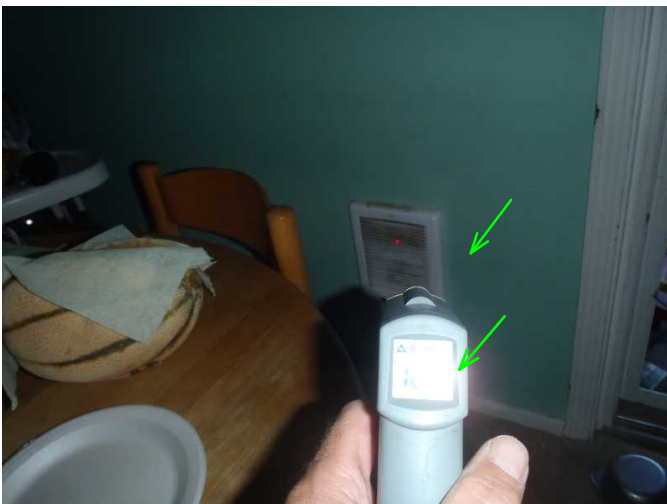
Cadet wall heater in dining area is noted operable..

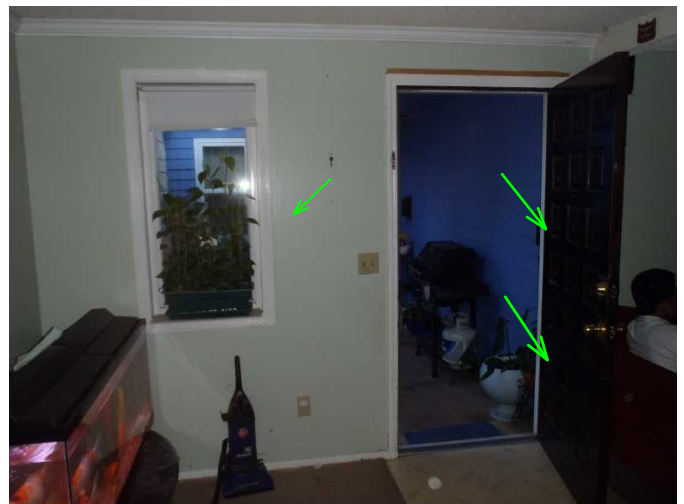
front entry door and window are noted operable..

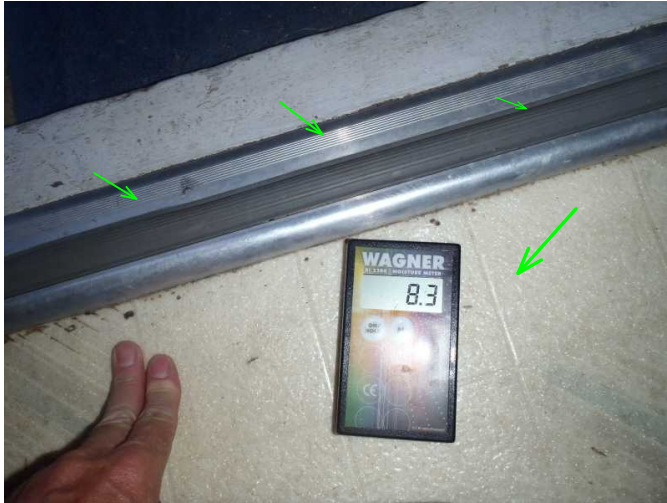
threshold is noted solid to floor and floor moisture is noted low..at front door area...

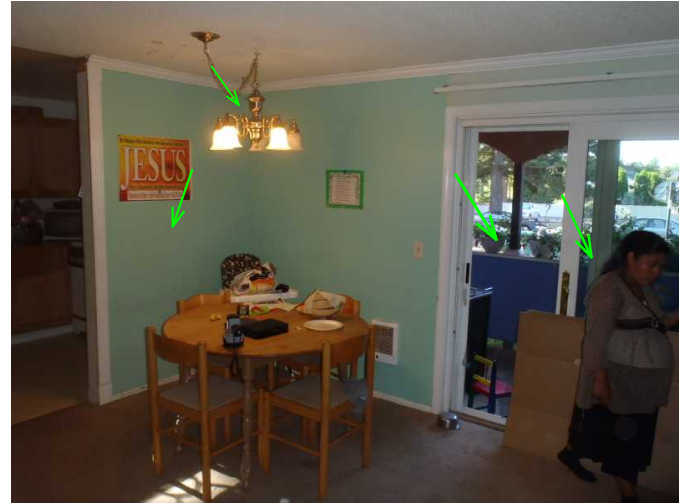
dining room fixture and slider to patio are noted operable..

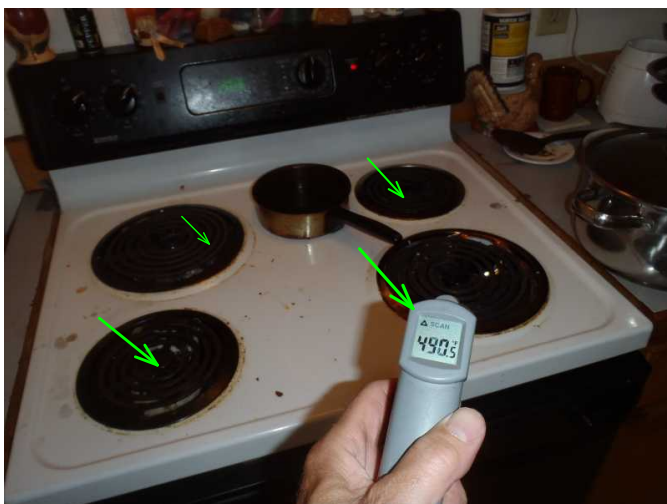
all burners are noted operable...oven is not tested...stored items in oven

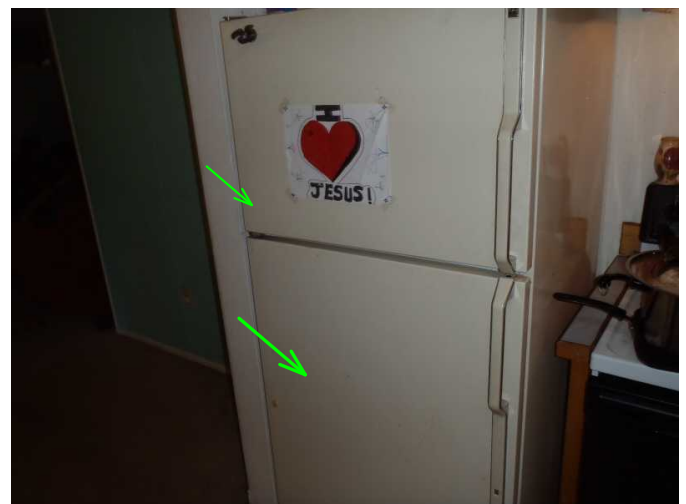
refrigerator is noted operable..

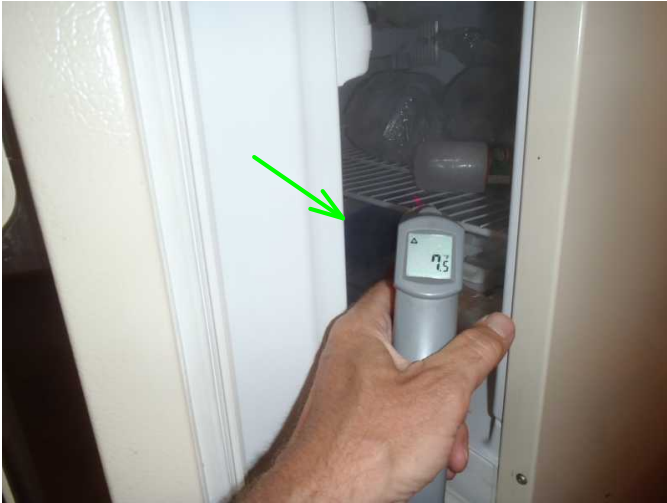
freezer is noted cold enough to keep ice cream hard...

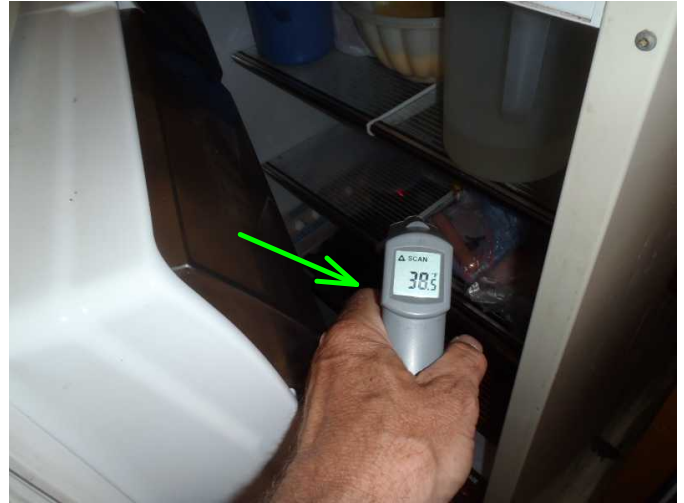
refrigerator is noted operable...

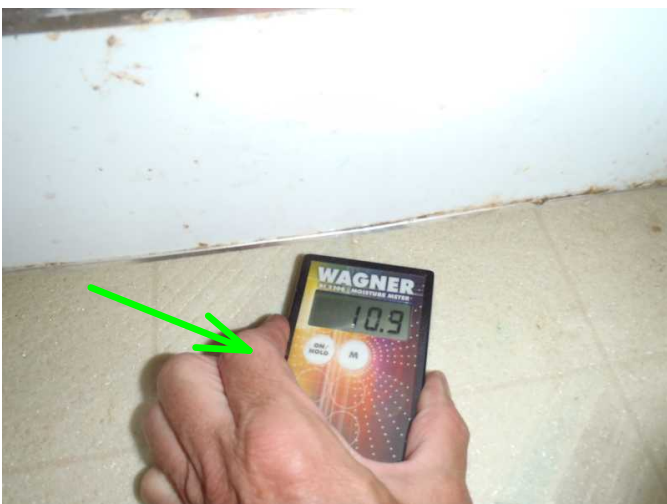
floor moisture is noted low at dishwasher area...good..

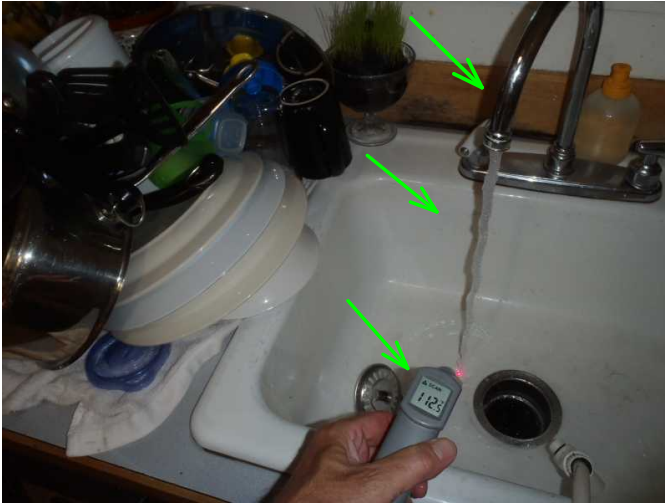
kitchen sink faucet is noted operable...and hot water delivery is noted fine..

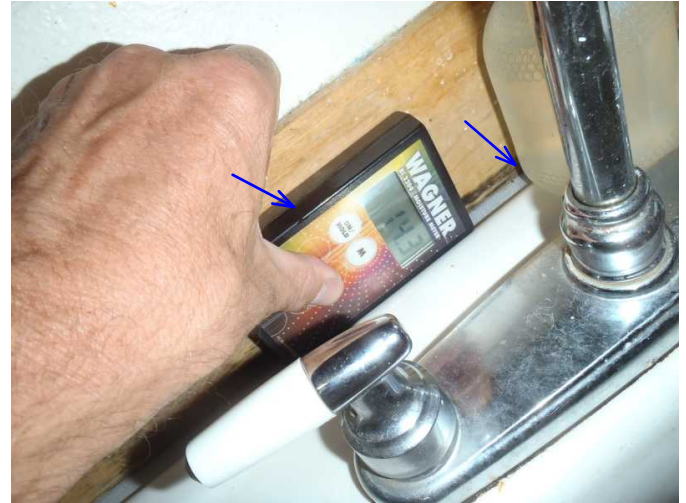
low moisture is noted at wood back splash...is stained...not mold...

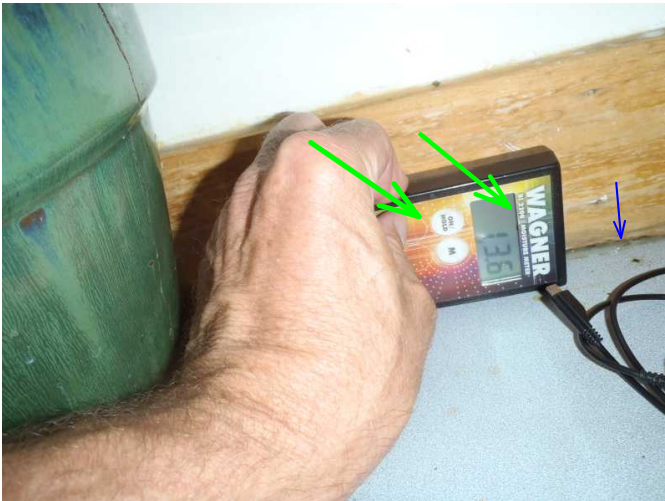
second area is also noted fine..low moisture and wood staining..

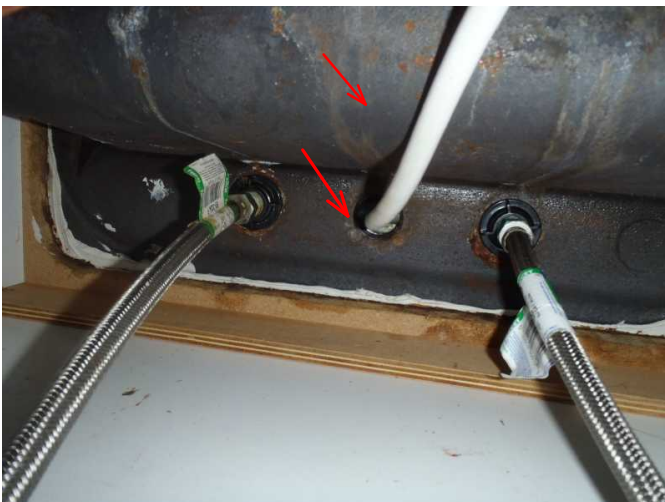
feeds off the main faucet and can at any time burst and cause massive water damage...remove...

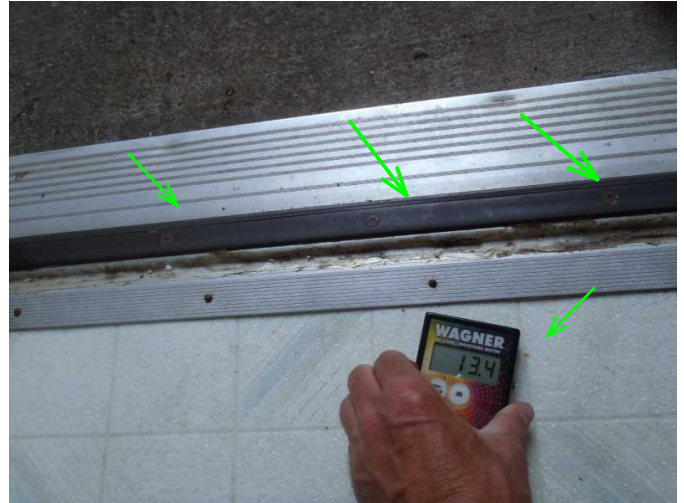
threshold is noted solid...moisture at floor is noted low...good..
