Home Inspection Report

27192 East Welches Road

Inspection date 11/09/2010

Photo Attachments

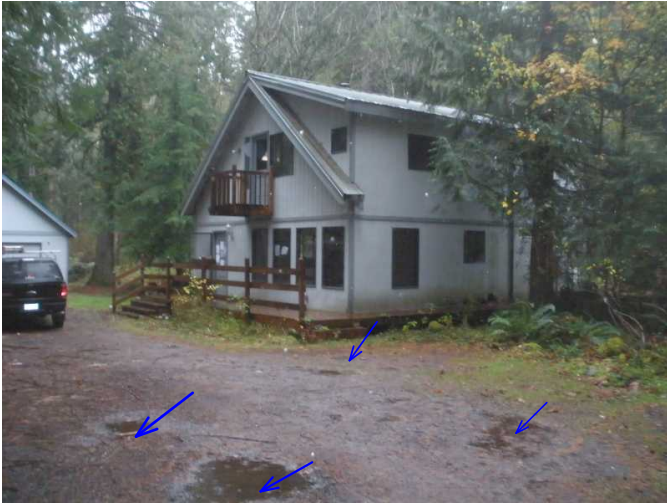
front view of home on 11/09/2010...driveway noted uneven and can use some added gravel and grading...

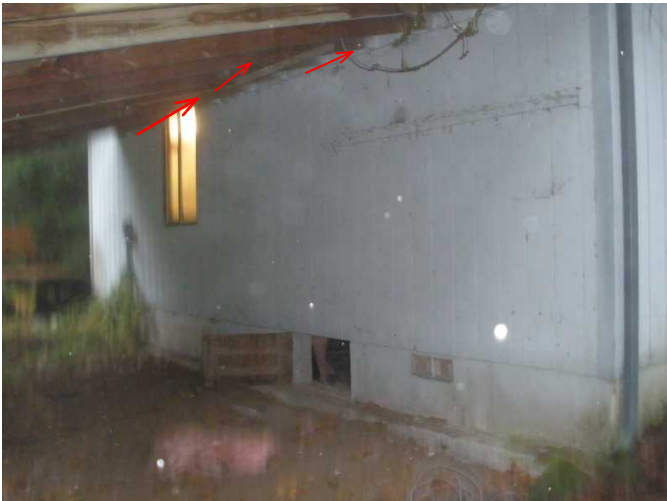
back roof extension is noted not flashed and needs lags to secure to structure...has roof rafter hangers...

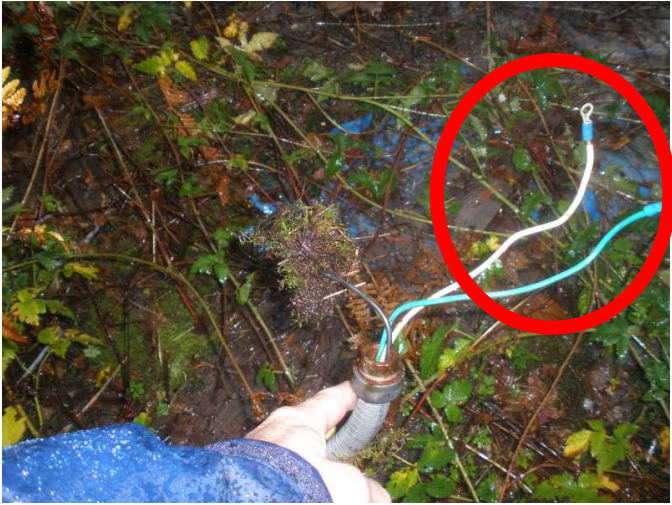
recommend all exposed wiring be removed or encased in junction box...never leave exposed wiring out...

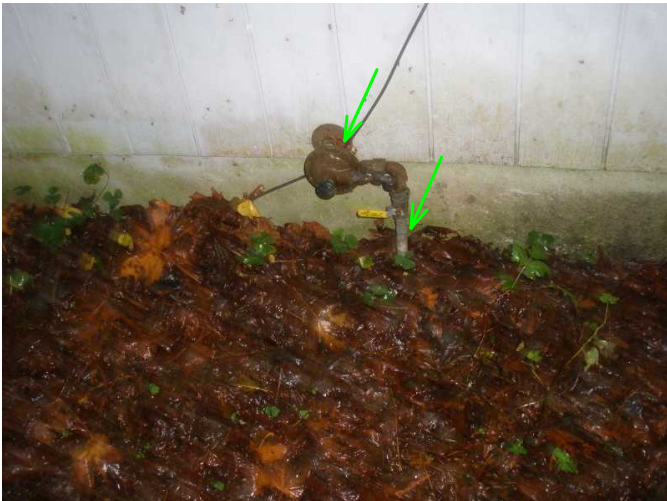
propane tank entry gas line and shut off noted here...good...

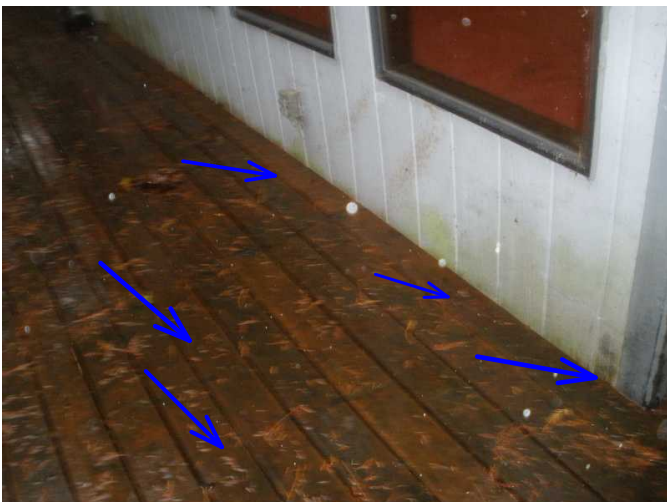
staining at base of siding at front west area noted needing paint..no rot noted at this time...assess all deck planks..

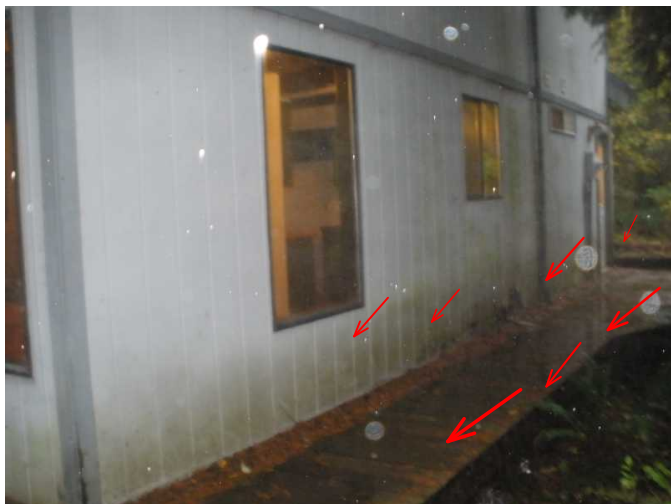
south deck and siding noted rotted and will need extensive assessment and repairs...

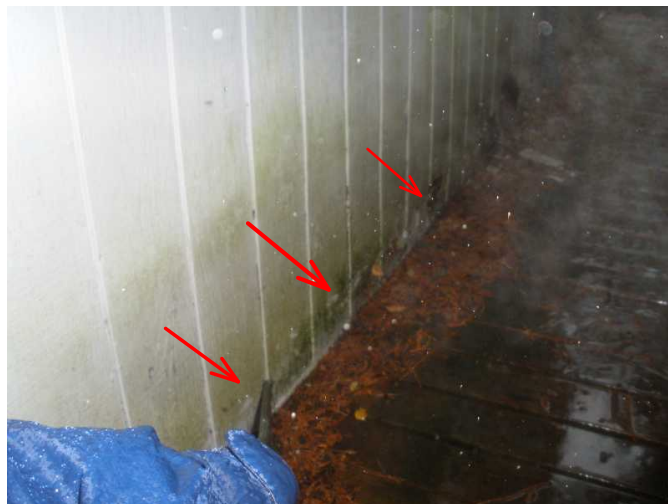
rot starts at area under dining room window and will need all of siding removed and assess damage to framing and floors

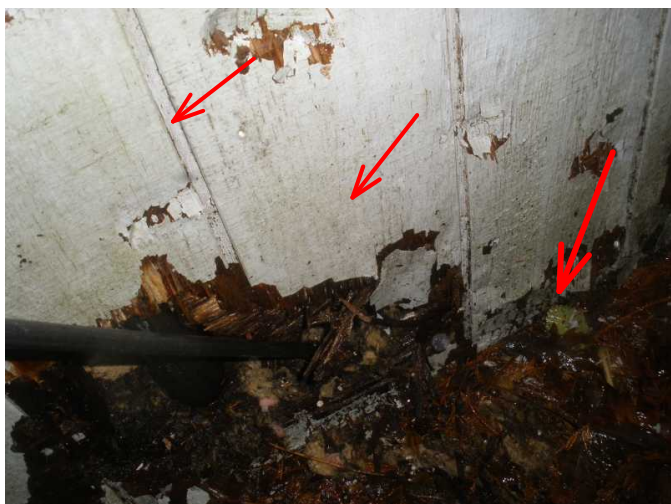
open gaps are allowing water entry and the gutters missing at upper eaves appears to be the cause....massive water falls

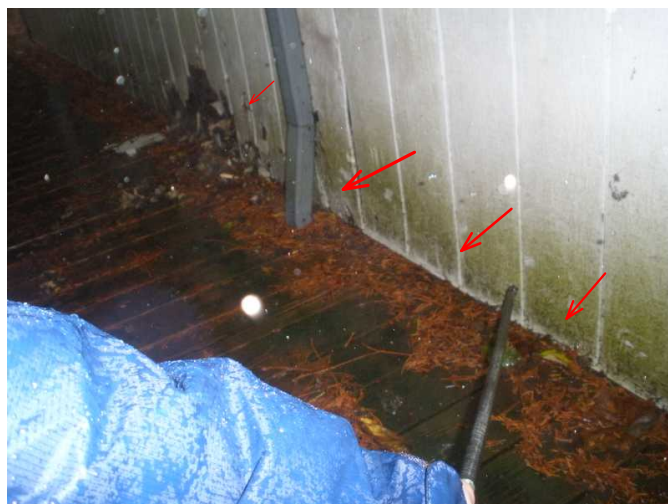
the lower areas where not even seen open are found rotted...

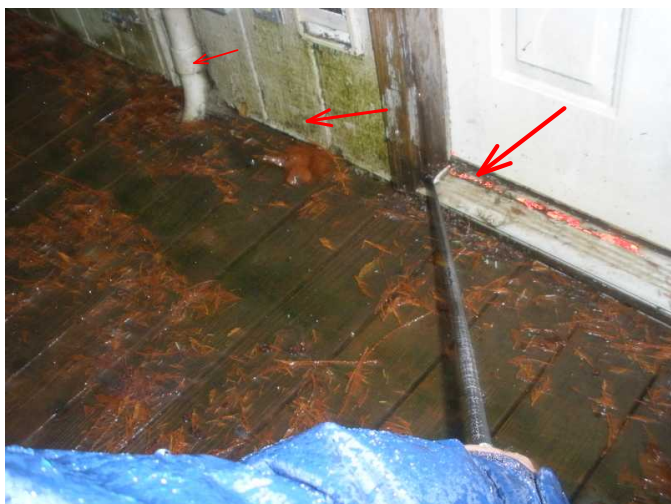
rot noted at base of back laundry door frame is noted...

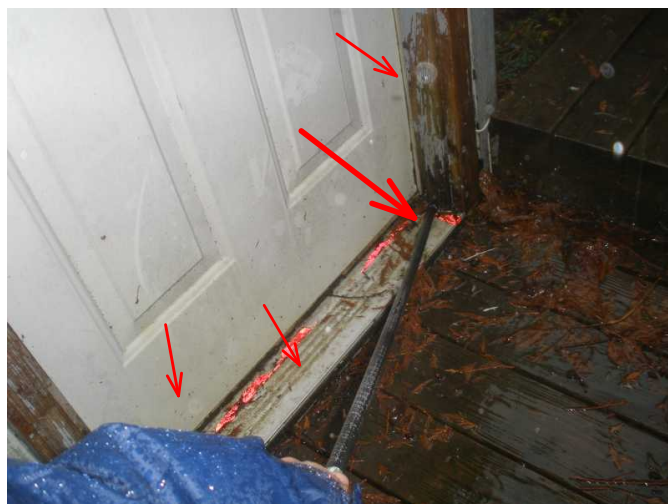
both sides of door frame are noted rotted..also noted water flowing into laundry room at door threshold...

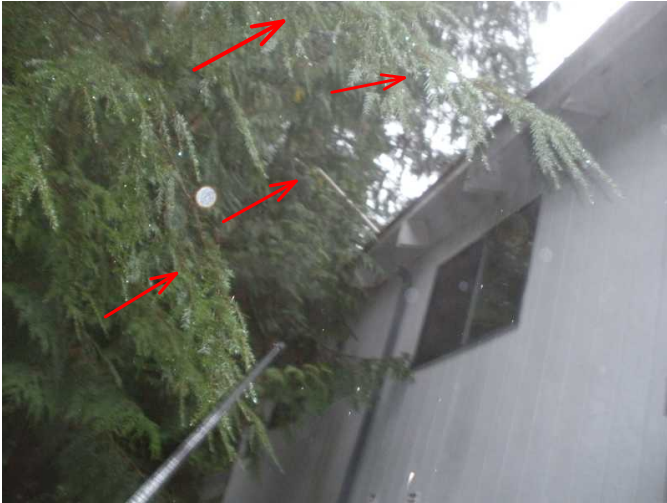
missing fascia boards at upper roof area...and cut back tree branches 6- 8 feet from structure to monitor home...

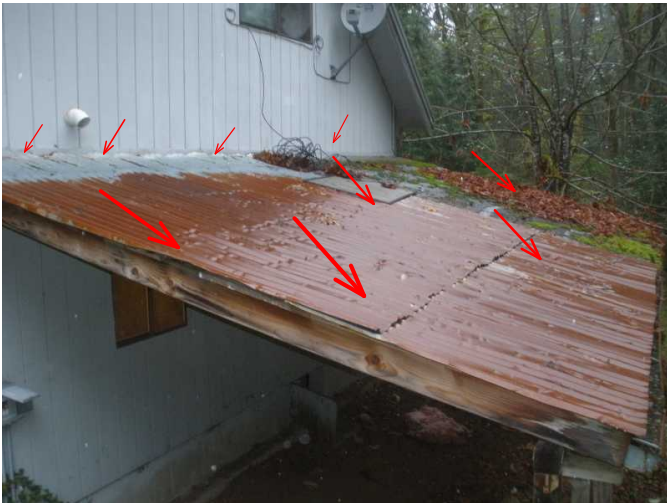
back roof area needs replaced and recommend adding flashing at roof to siding to avoid added rot...

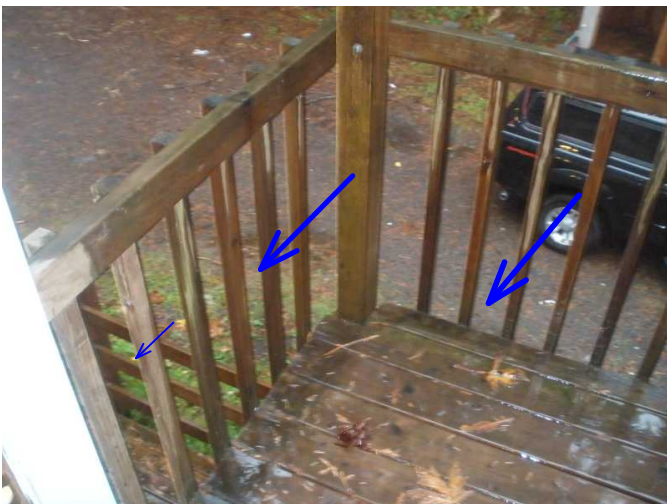
clean and seal and monitor balcony...

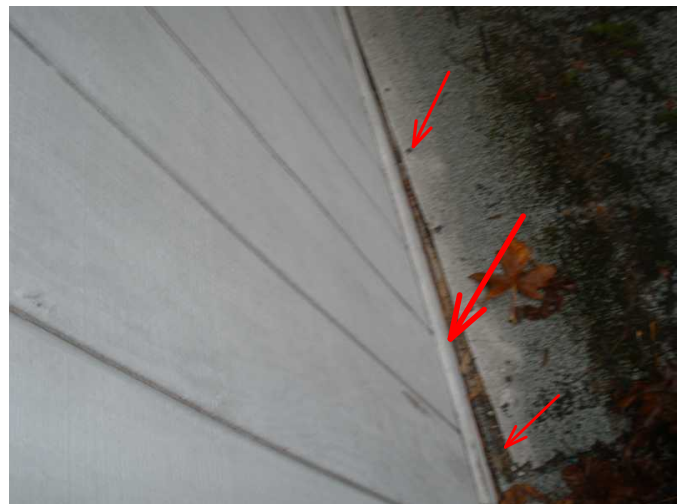
this is looking out window at back roof...add flashing and new roof...

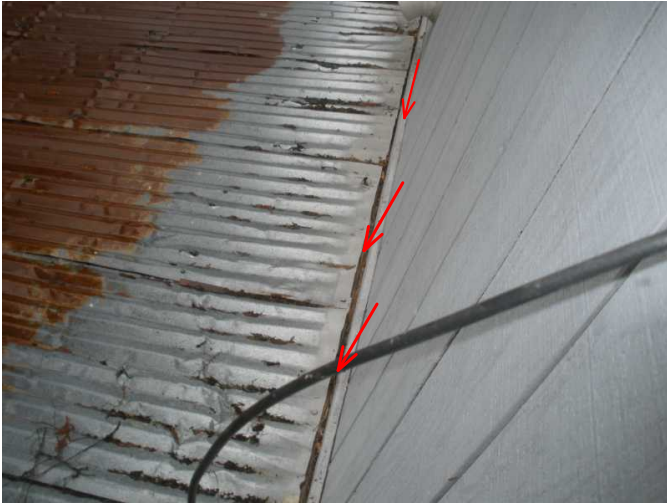
no flashing noted at back roof area...add...

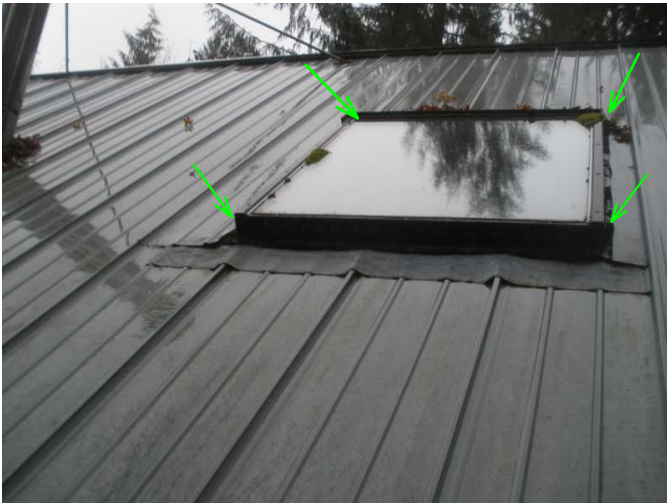
skylight noted flashed fine

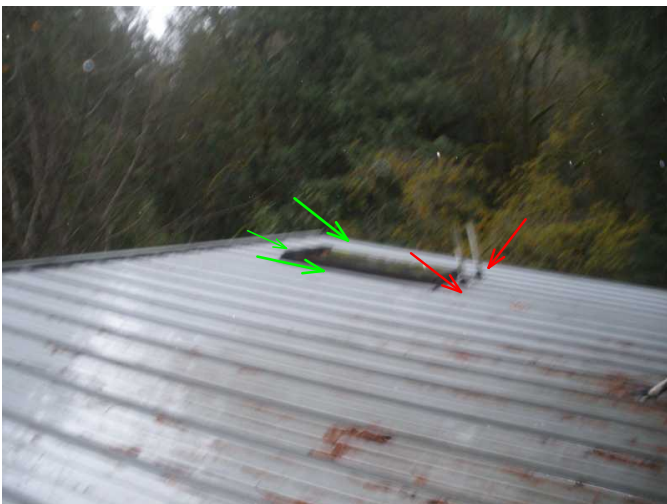
skylight flashing appears fine at south roof area over bath..and upper sewer flashing need assessed with lower damaged..

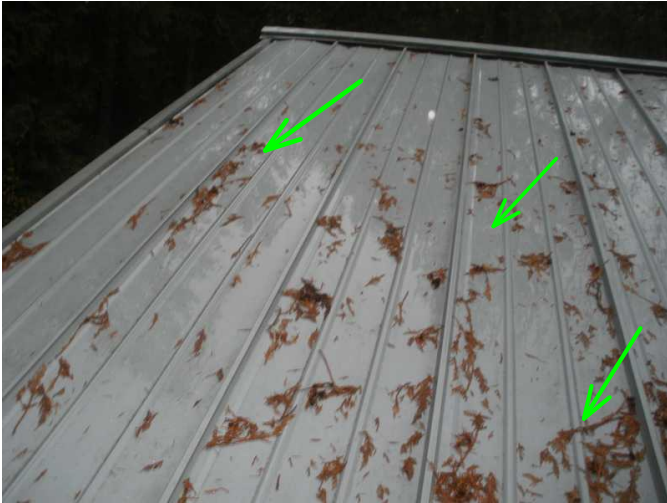
overall roof appears fine...recommend cleaning roof and paint where any areas of paint are found failing...

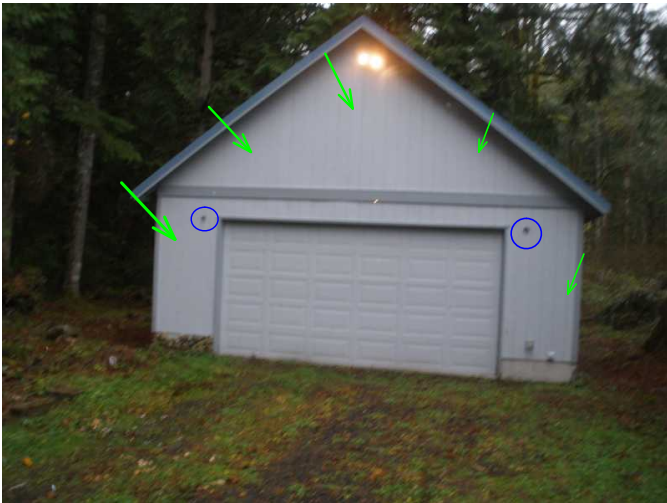
garage is noted fine...solid and sound...add covers to open junction box areas for fixtures...

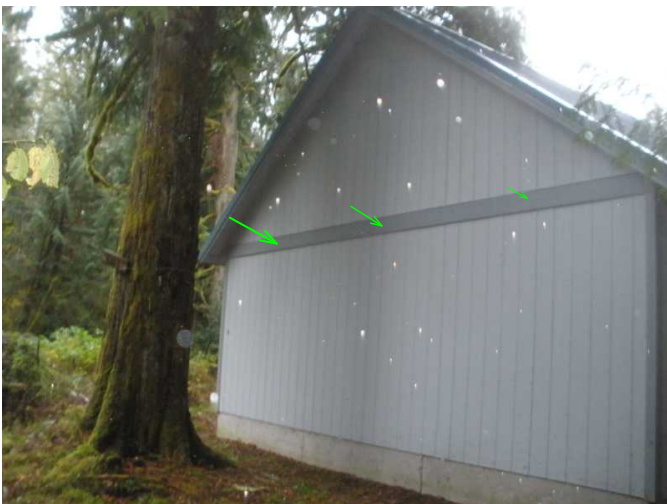
back belly band is noted flashed...good..

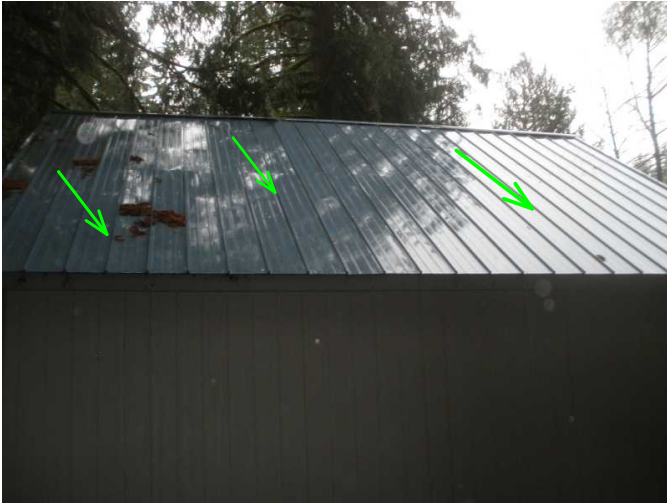
garage roofs are noted fine..

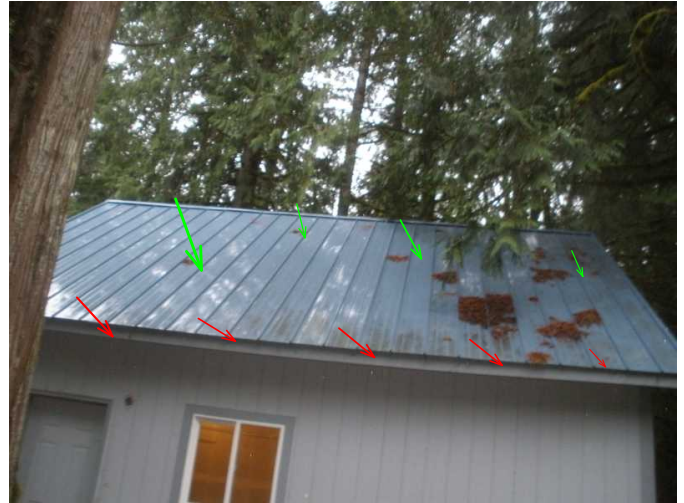
both sides of roof are noted fine, recommend cleaning.....add gutters for best water control at any structure...

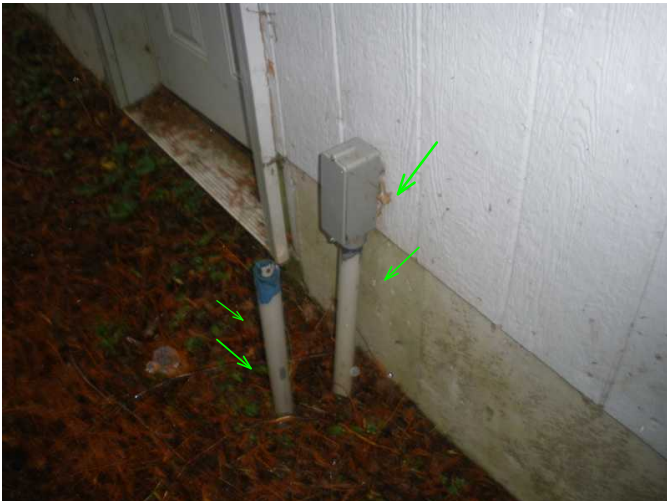
appears electric entry is fine..second conduit is noted, not know what for..

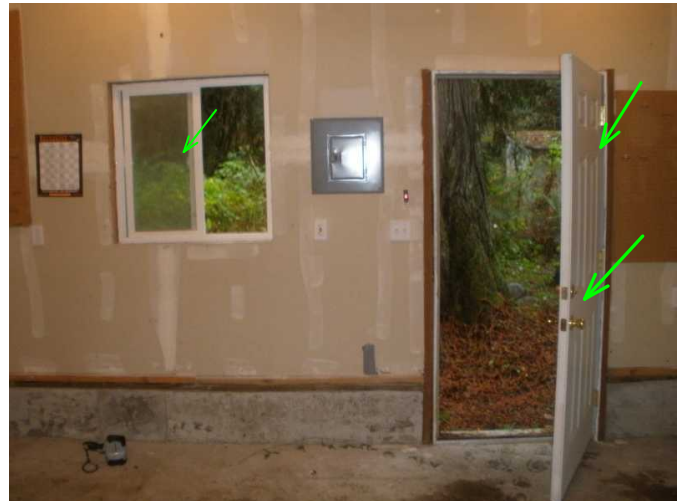
garage entry door and window are noted fine...operable...add screen to window..

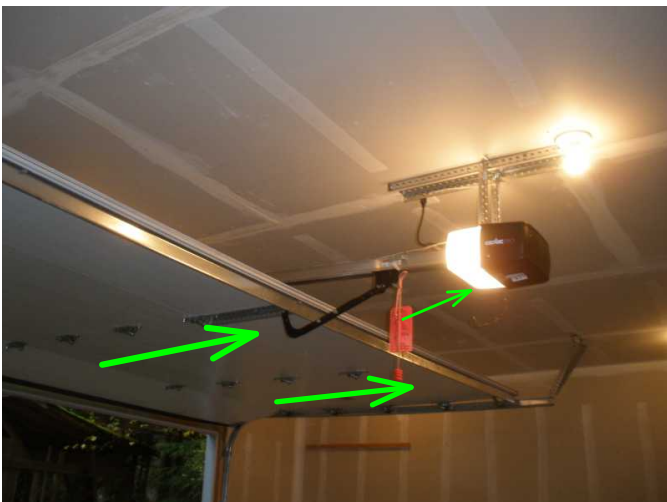
overhead door opener and overhead door are noted fine...operable...and auto reverse is fine...

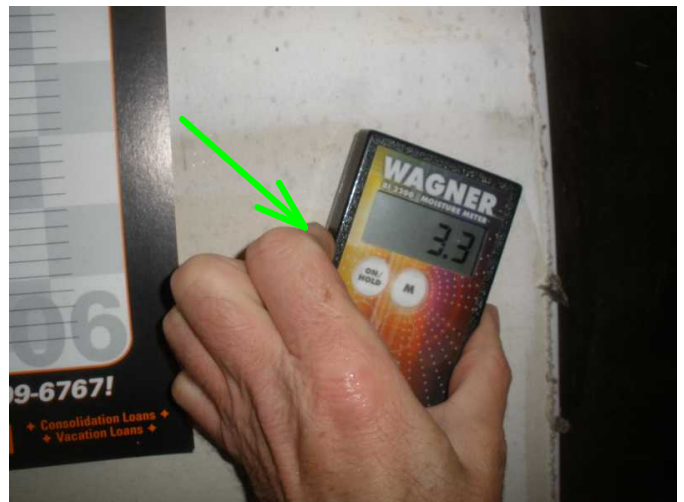
low moisture is noted at all exterior walls...good...

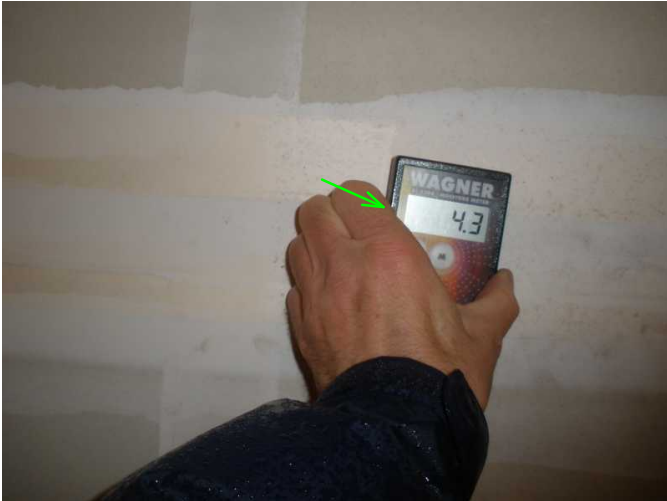
here is moisture reading of north wall...good..

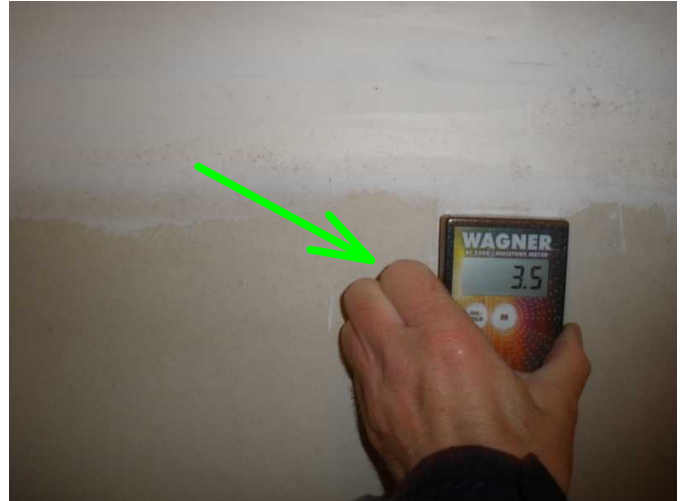
here is reading of west exterior walls...good..

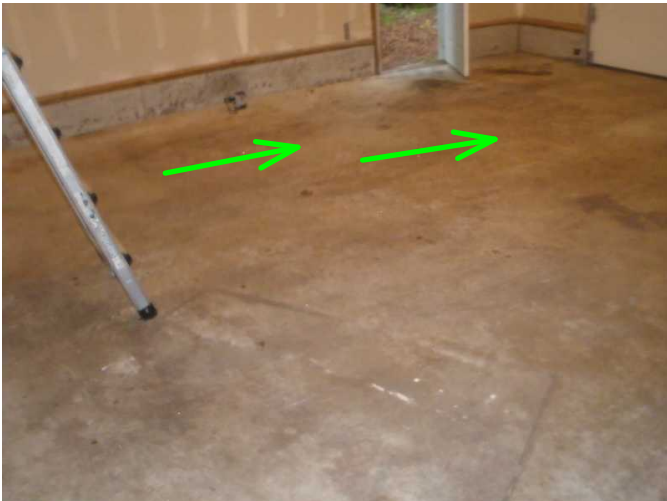
poured garage floor is noted sloped well for drainage toward overhead door area...

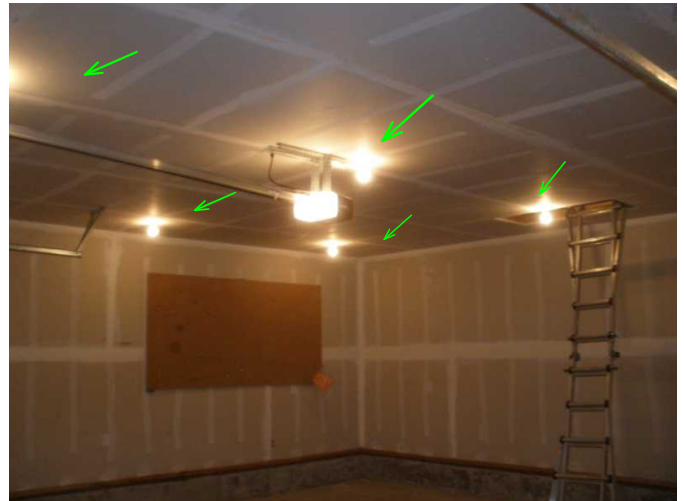
fixtures in garage are all noted operable...

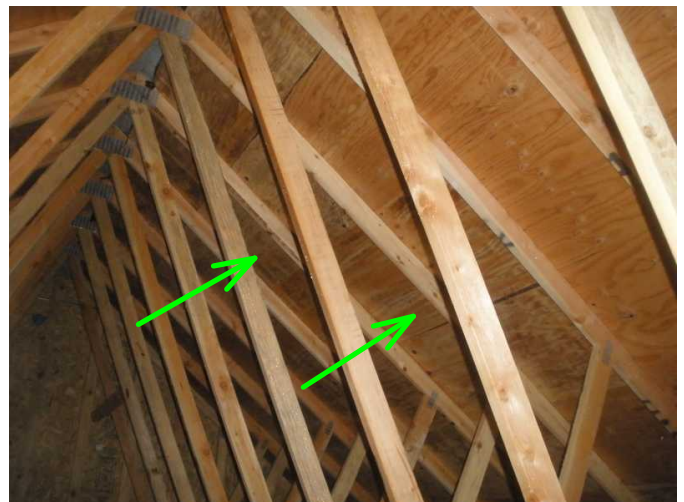
here is noted upper area of garage attic truss system...good...

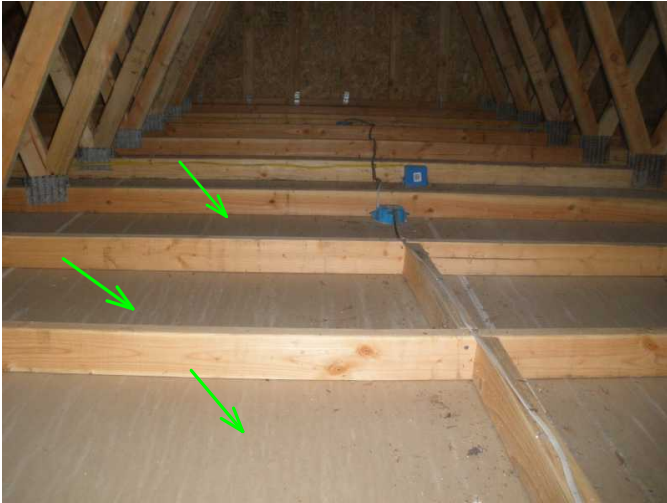
garage ceiling is noted fine....

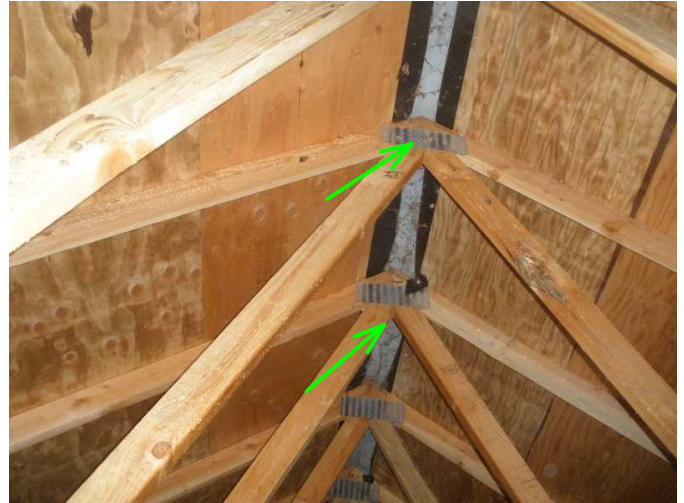
roof has ridge vent system..and is screened...good...

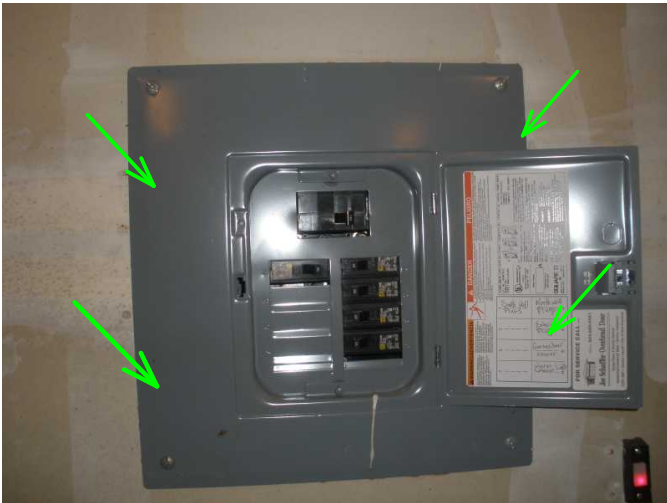
here is sub panel at garage exterior wall by exit door,,, noted with no permits..but appears professionally installed..

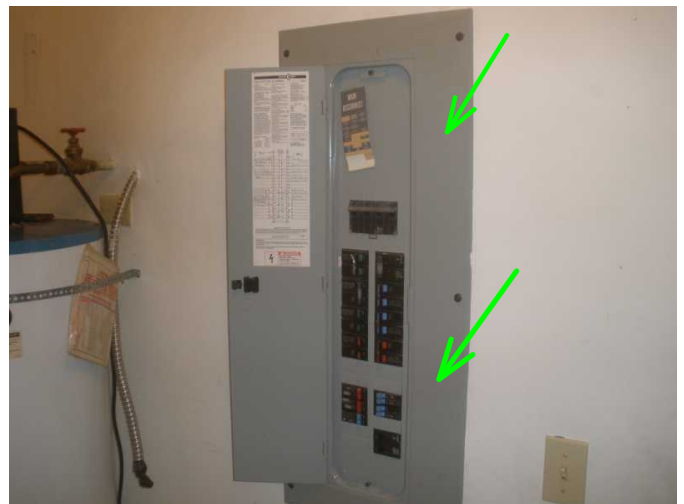
here is main breaker panel in main structure of home...is noted in laundry area...

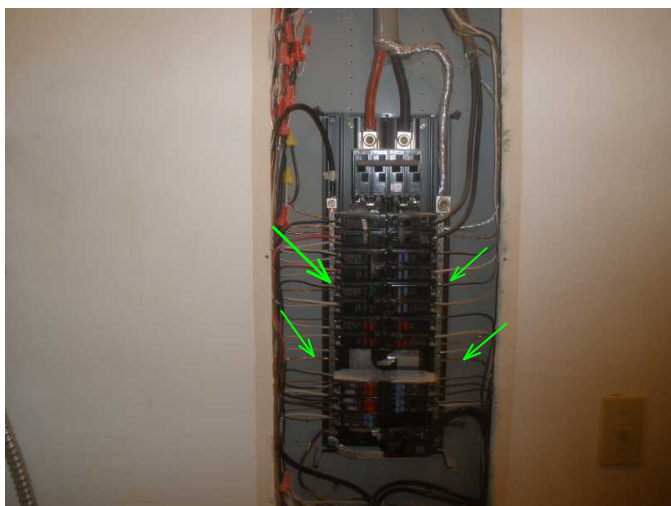
open view of panel is noted with 200 amp aluminum service and is original panel...

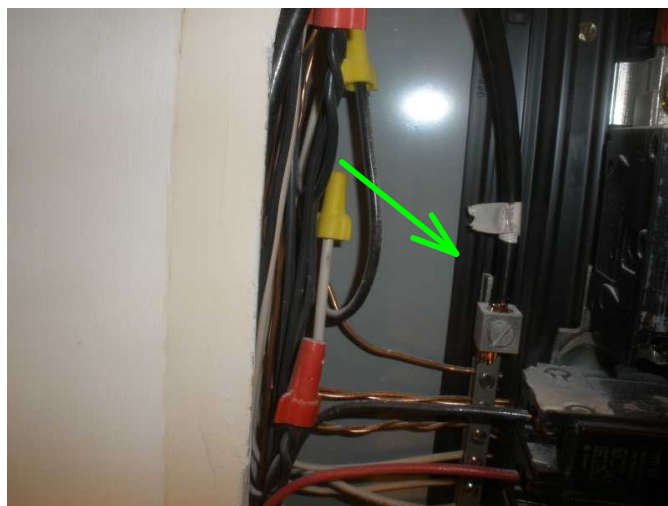
noted the ground to sub panel in neutral bar area...good..

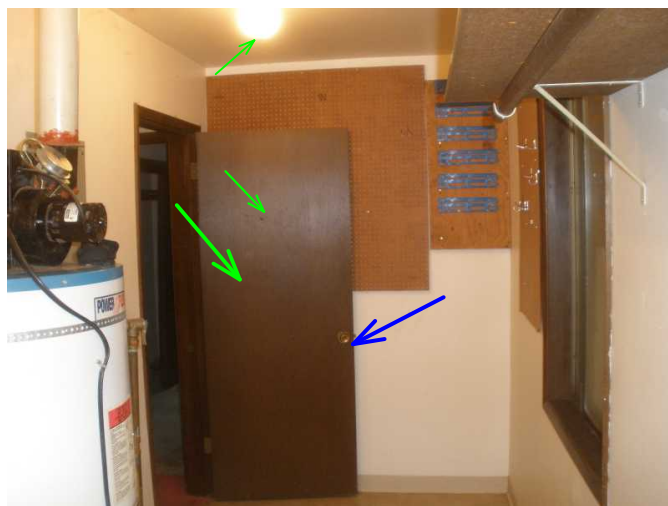
laundry room entry door is noted operable..but will need door stop to avoid punch holes in wall...

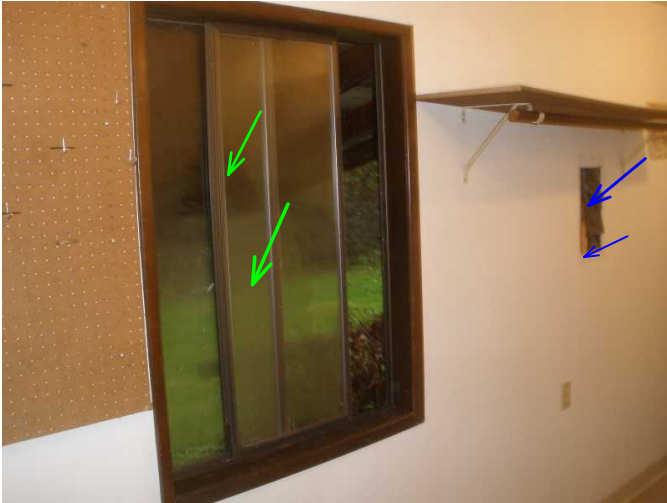
window is noted operable in laundry..patch hole in wall at blue arrow....

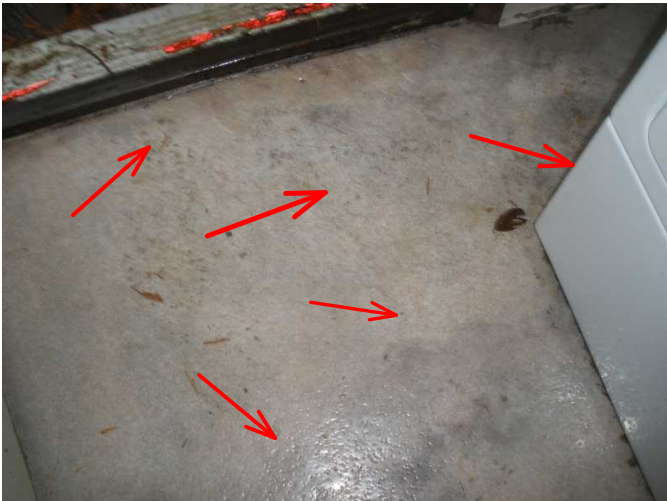
back door threshold is leaking water into area..floor is noted warped and discolored...remove all and assess...

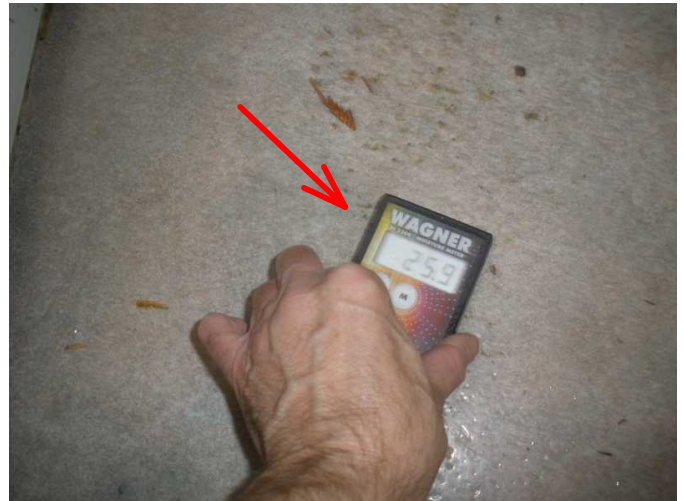
high moisture is noted here at floor by dryer...

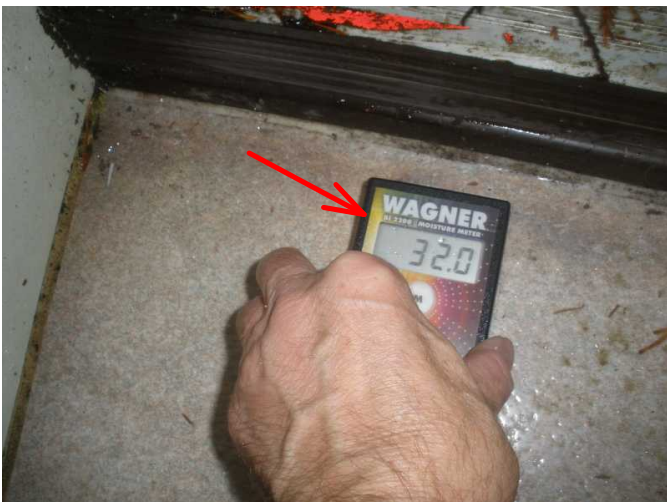
this is reading that means is saturated..is highest moisture meter can read...damage is noted here...

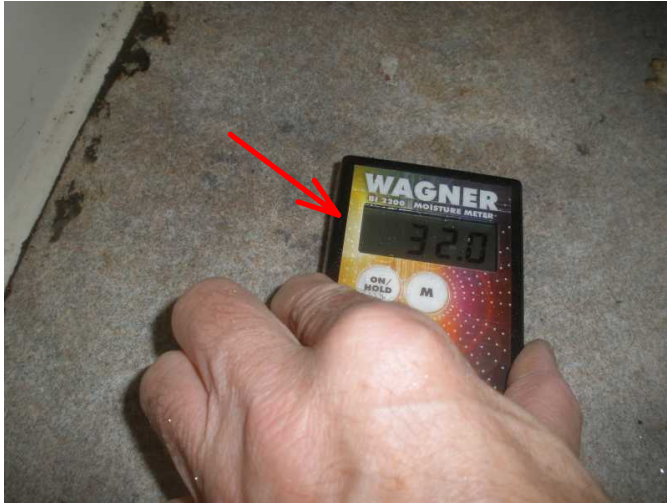
and at back wall by side of dryer....

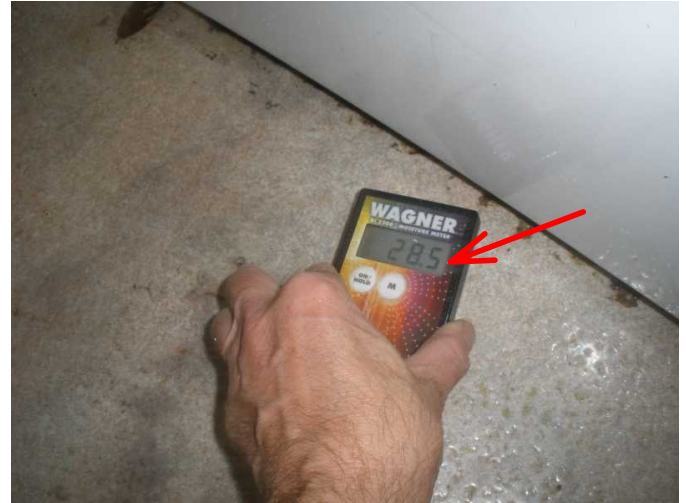
and at front of dryer area...moisture meter can read up to 4 inches into floors and walls...

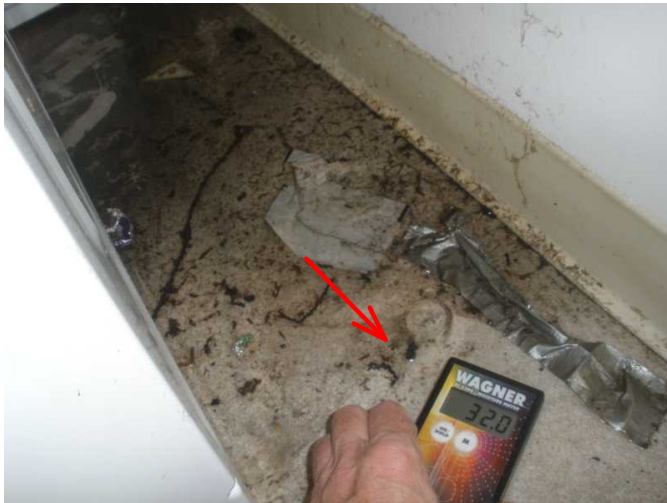
and noted standing water behind washer are...and noted saturated moisture meter reading...

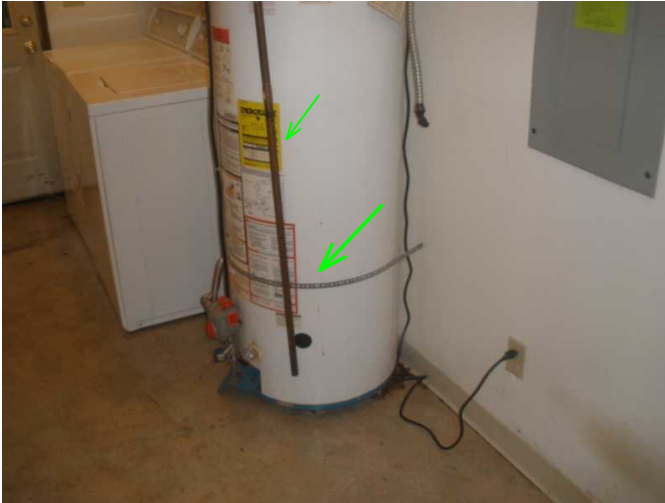
unit is strapped to wall and solid...

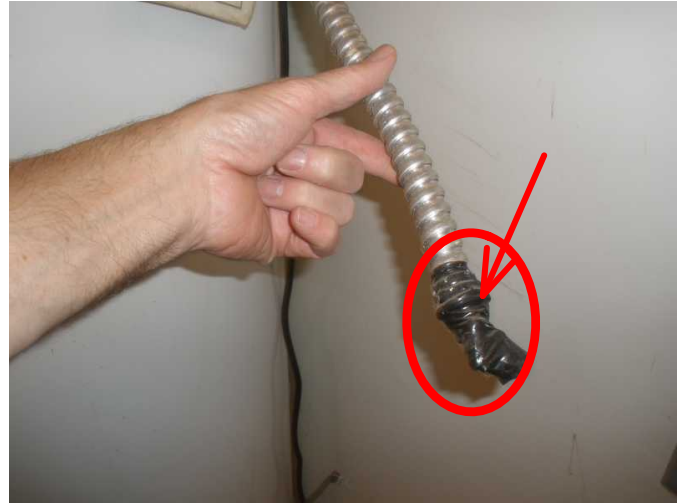
loose wiring from old electric water heater must be removed..is standard practice and is not allowed to have any loose

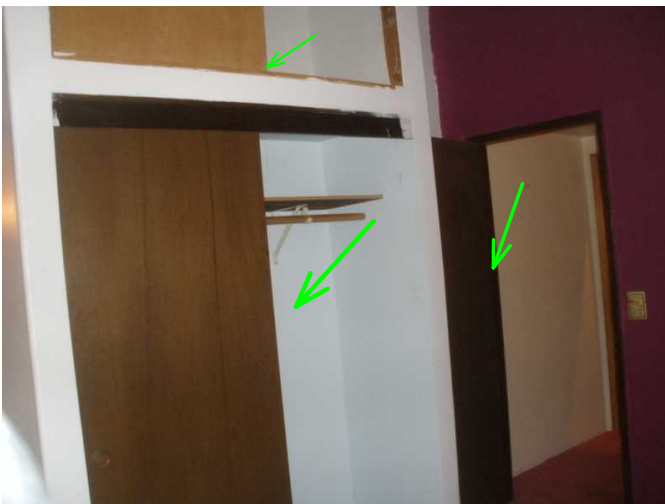
closet and entry doors are noted operable...

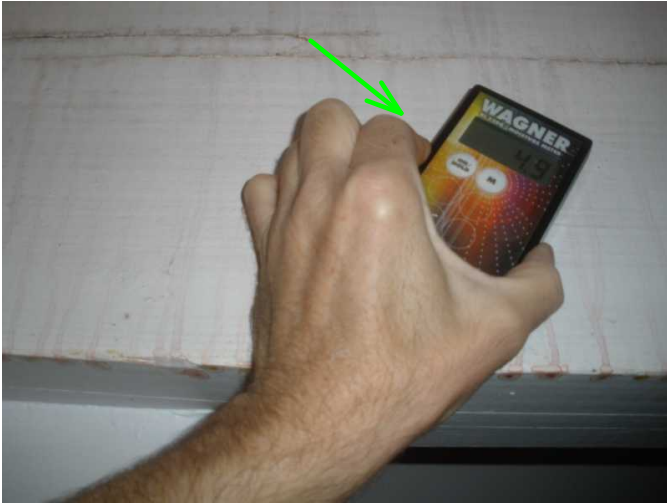
up at upper beams where noted stained condensation..expect is from shower at bath and to low exit fan vent...

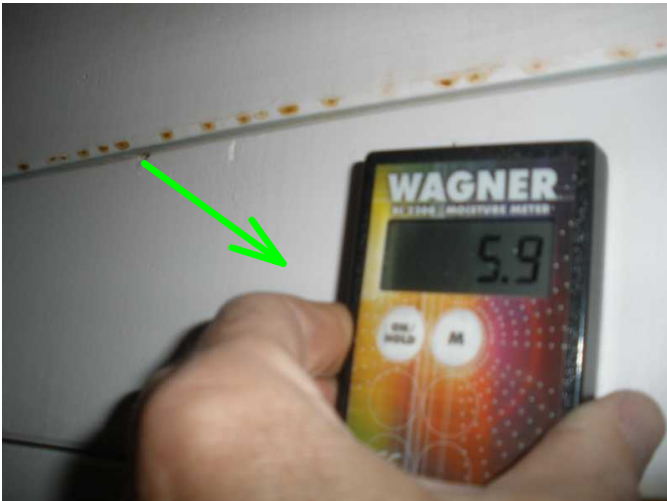
here at ceiling areas as well..condensation is most likely issue here...add vent at higher area at bath room...

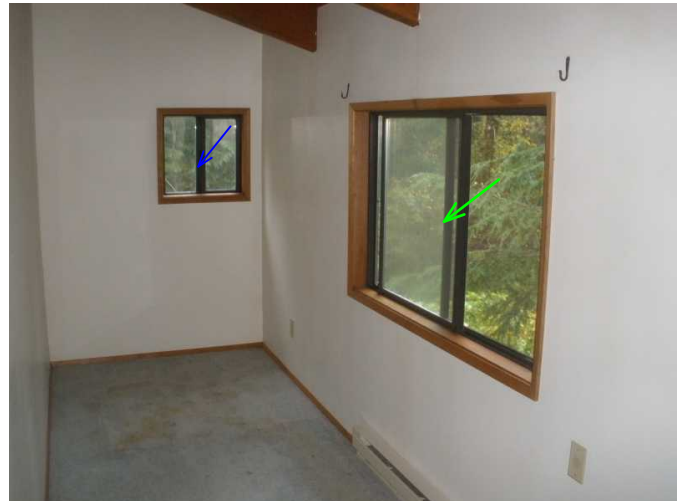
front main bedroom is noted with back window not operable..side window operable...

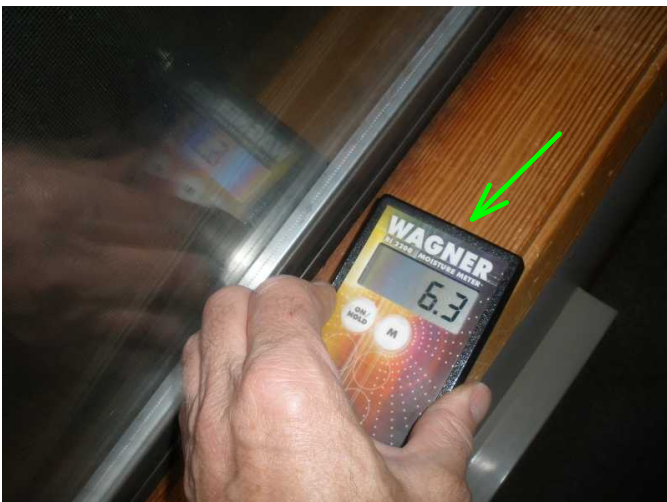
low moisture noted at window sills...

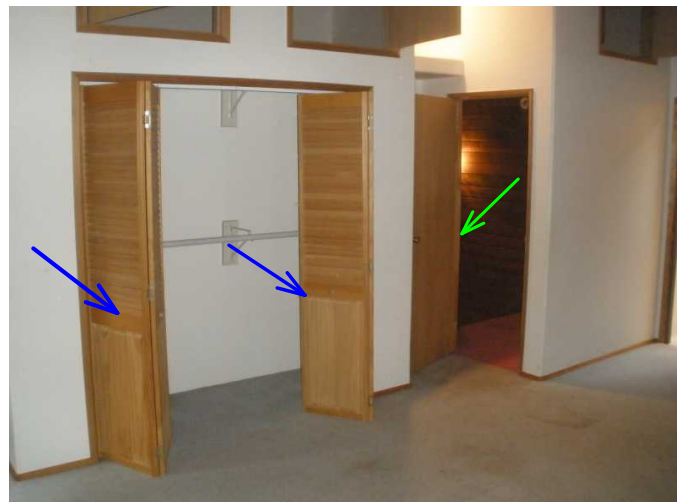
entry door is noted operable..closet doors need adjusted...

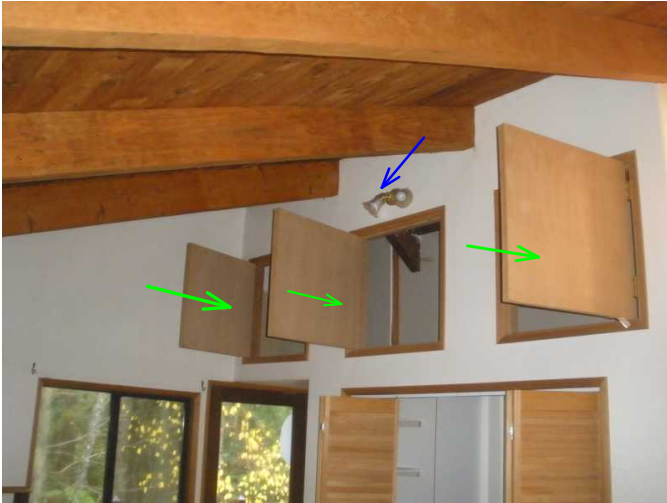
upper closet doors are noted operable..fixture appears operable..may need bulbs...

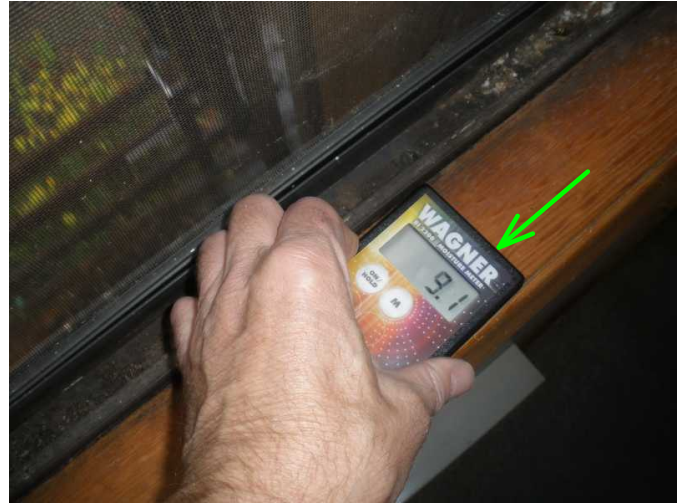
front window sills noted low in moisture...good..

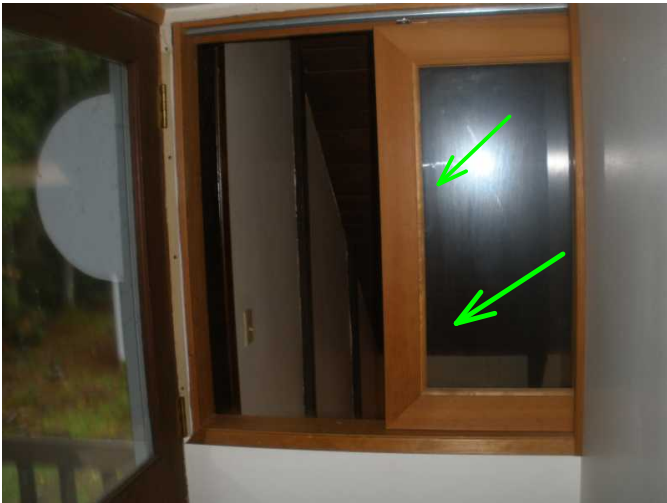
pocket window over living room area is noted operable...

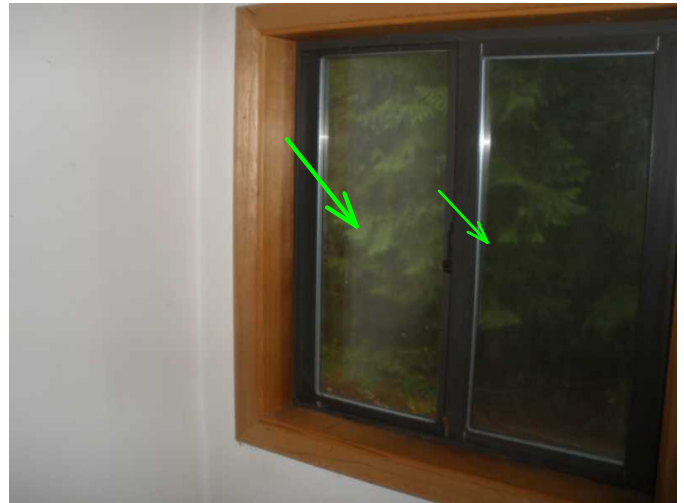
windows in upper front bedroom are noted operable...

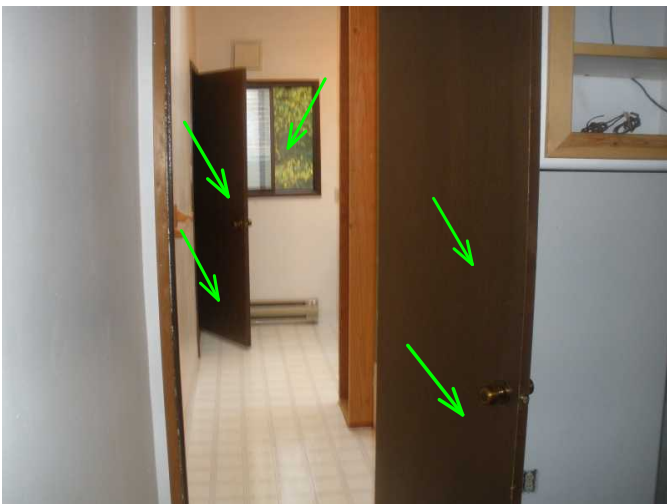
both doors to bath and window are noted operable..

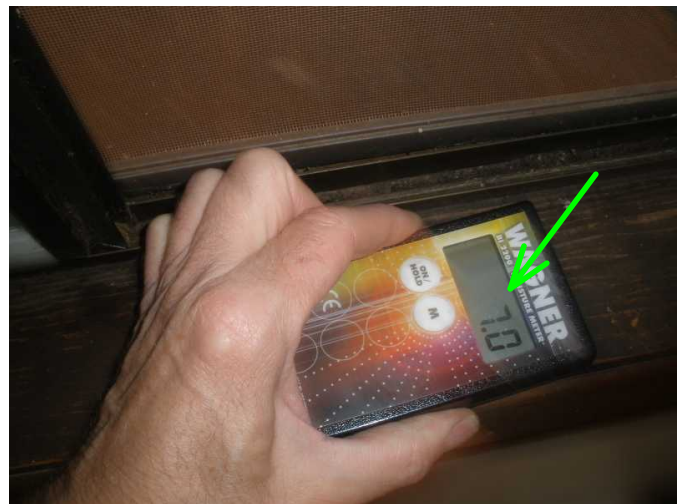
low moisture noted at window sill in upper bath...good..

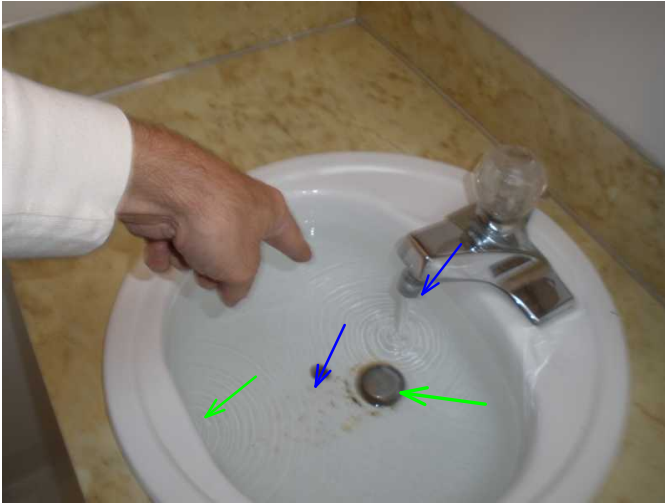
low flow noted at faucet and drain and overflow are noted operable..and surface damage noted at sink...

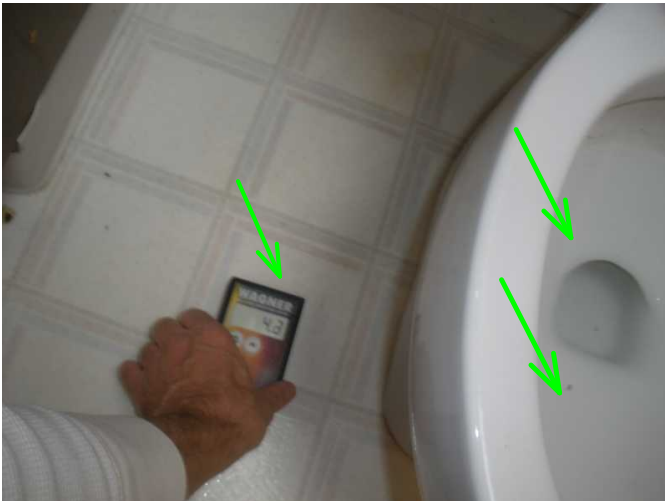
toilet is noted solid to floor and moisture is noted low...toilet was shut off at feed and turned on and tested...

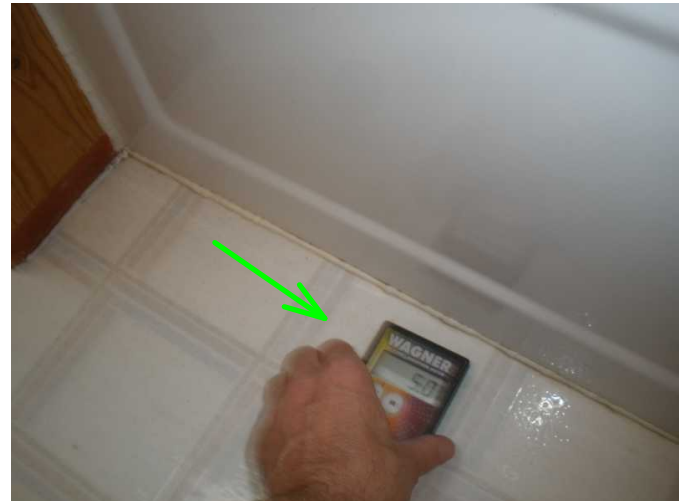
tub area is noted low in moisture at floor...

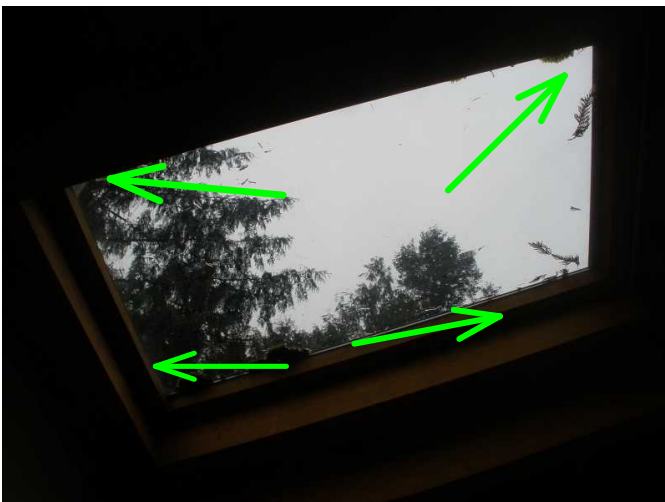
skylight is noted fine..no staining or drips noted...
