Home Inspection Report

27192 East Welches Road

Inspection date 11/09/2010

Photo Attachments

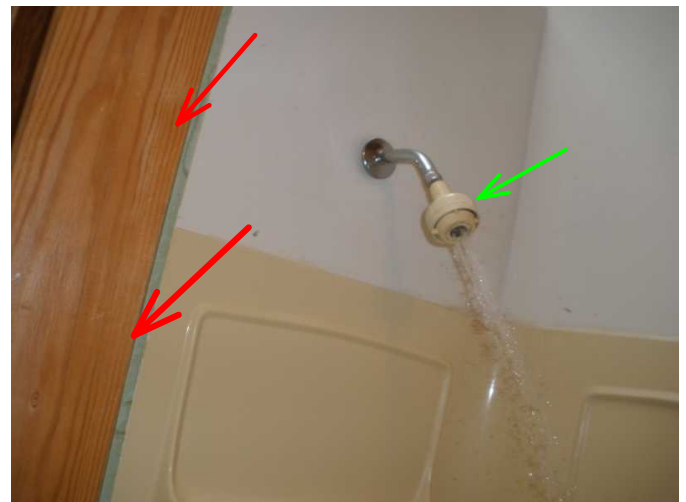
shower head is noted operable...recommend removal of added wall with no water proof finish...

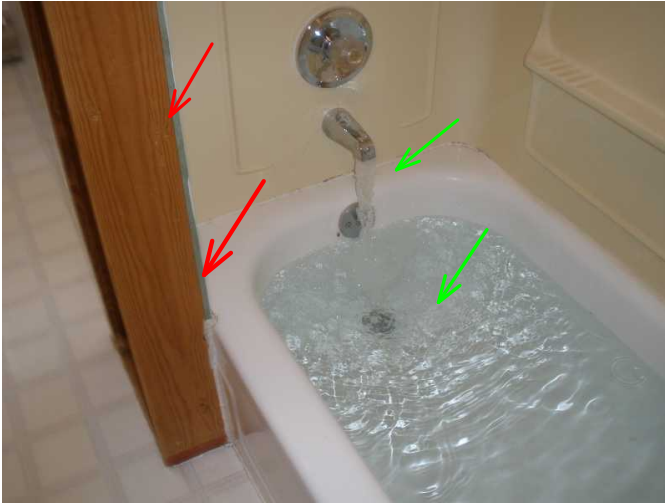
upper bath tub faucet and overflow and drain are noted operable...recommend removal of untreated wall area..

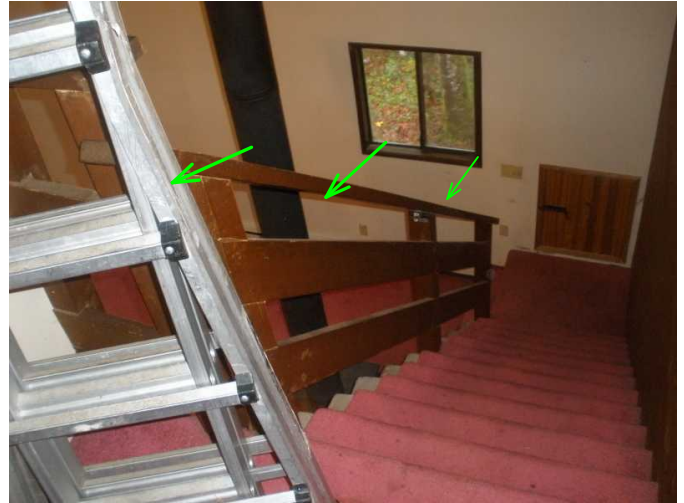
stairs and handrails noted operable...good..

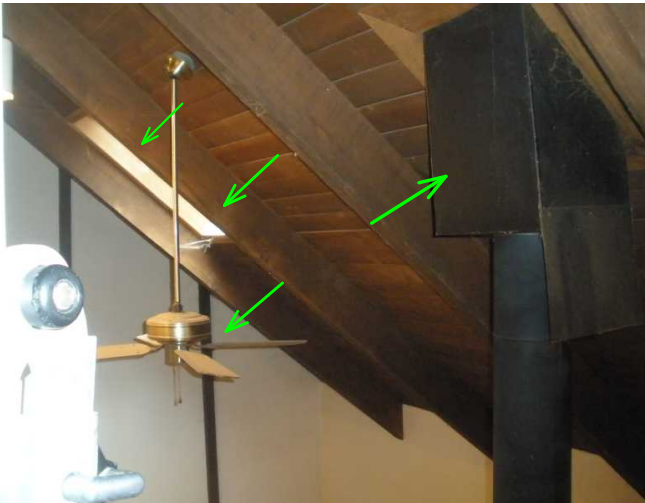
skylight and ceiling fan and flue box mount are noted solid and operable...living room upper ceiling area...

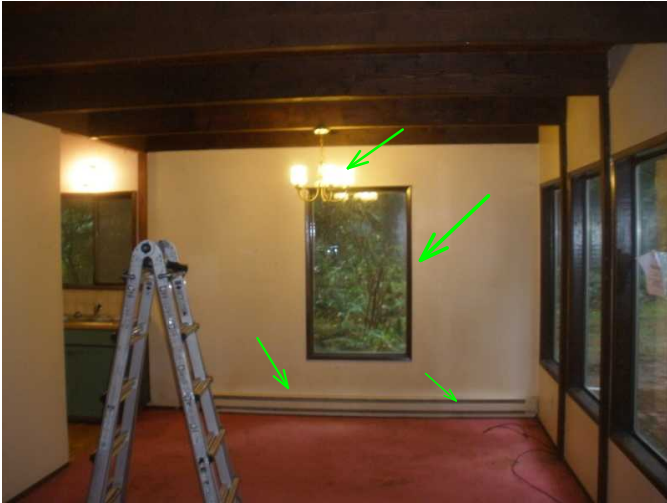
dining area fixture and windows and all baseboard heaters in home are noted operable...

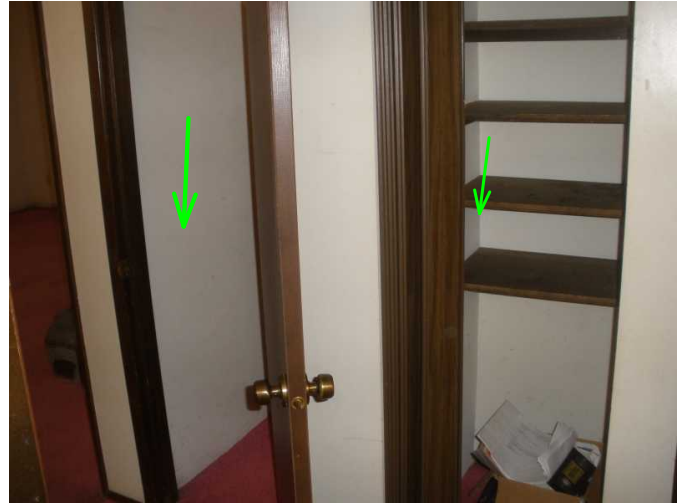
two hall closets are noted operable...good..

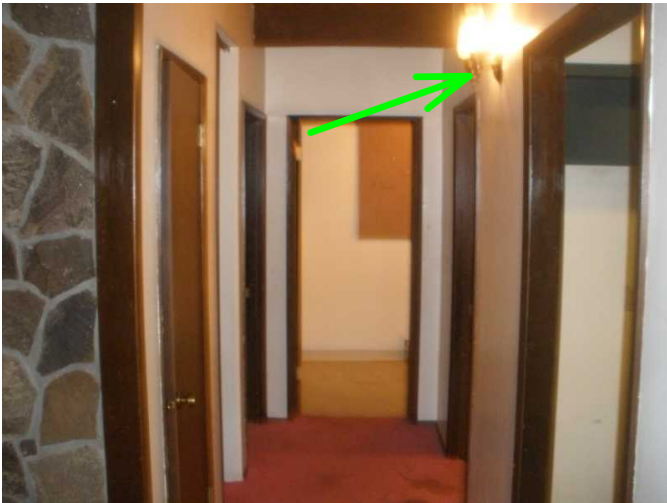
hall is noted fine..fixtures are noted operable...

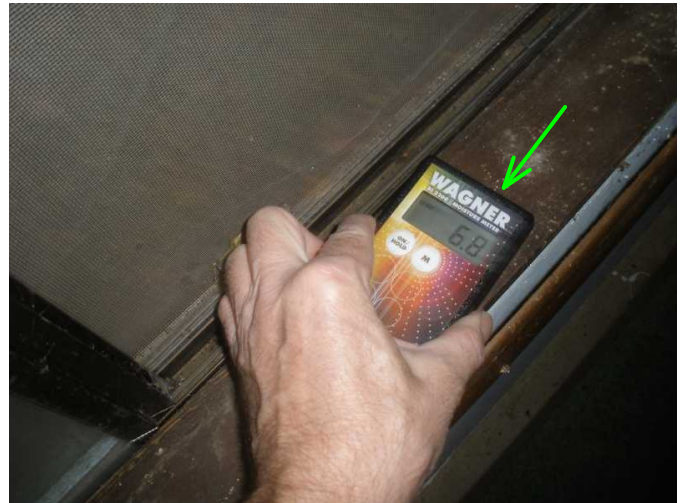
window in first floor bedroom sill is noted low in moisture...

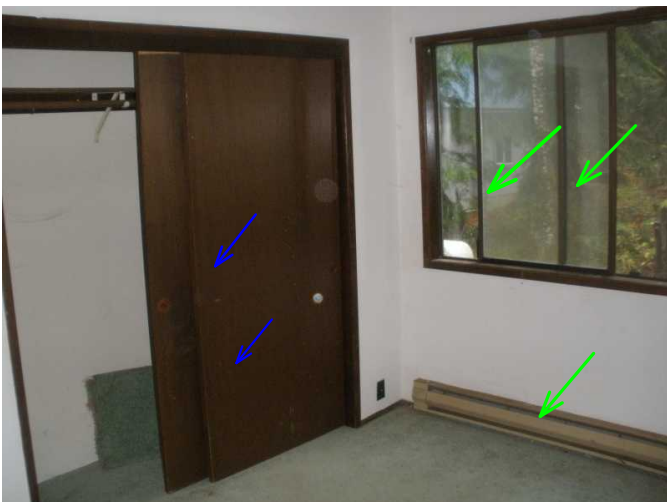
closet doors need repairs...window and baseboard heat are noted fine...

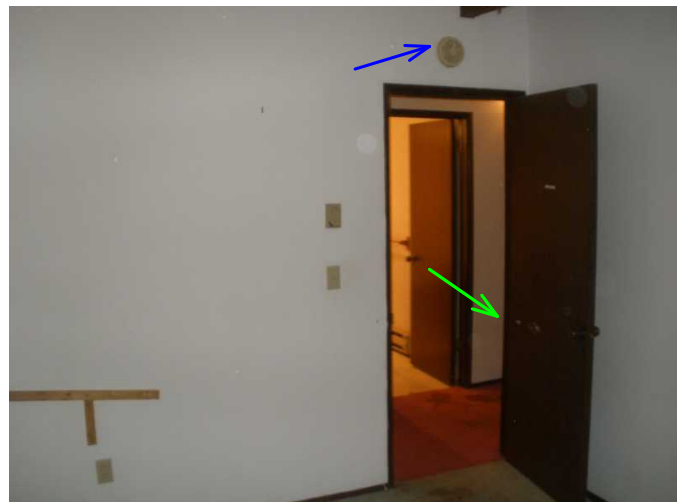
entry door noted operable..smoke detectors need updated and raised to ceiling areas...

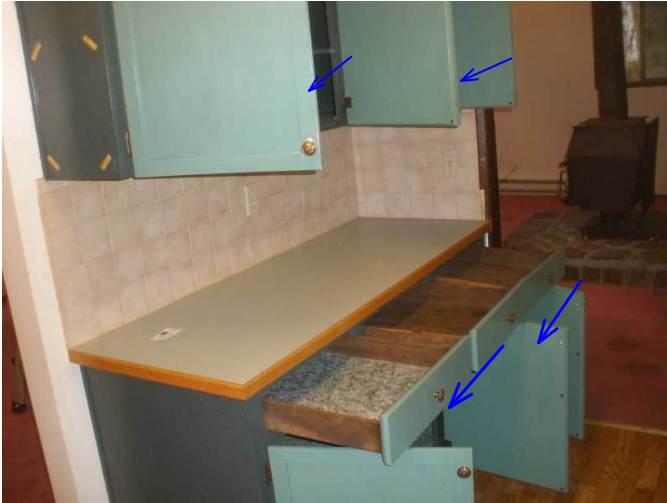
cabinets will need repairs and drawer tracks repaired as well...kitchen area...

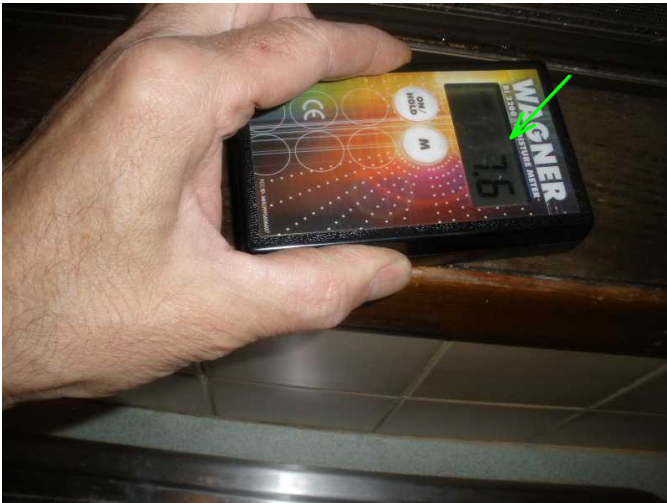
low moisture noted at window sills at sink area...

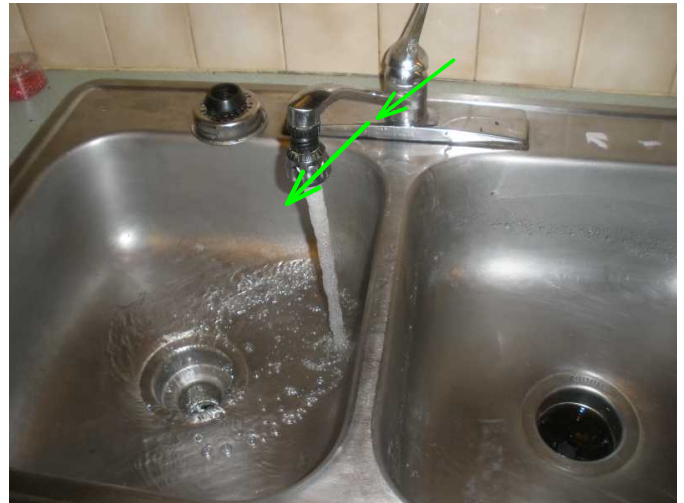
faucet and drains noted operable..

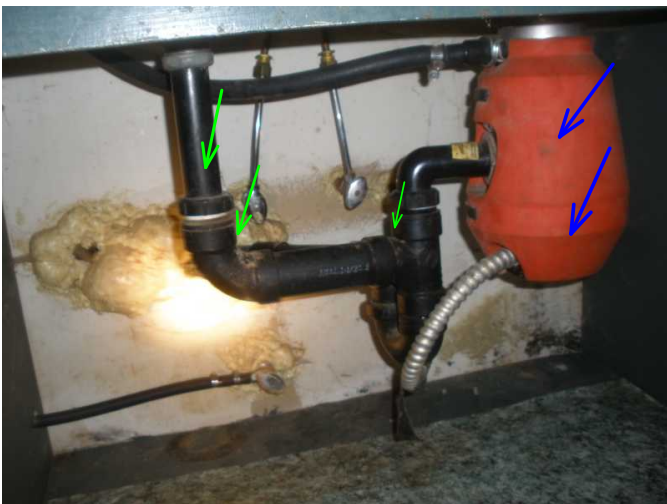
no leaks noted under sink...garbage disposal not recommended with septic system...

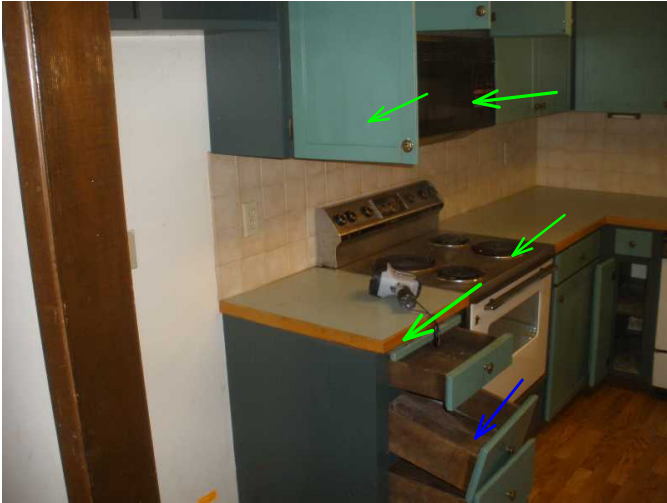
upper cabinets noted operable...lower cabinets noted loose at drawers...

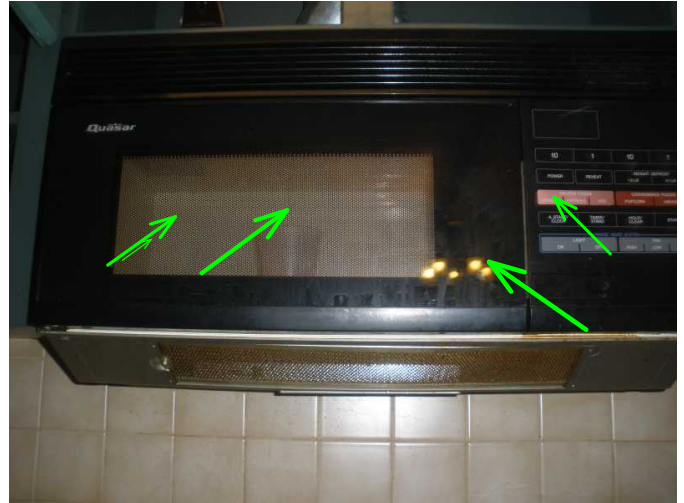
microwave and exit fan noted operable over stove...

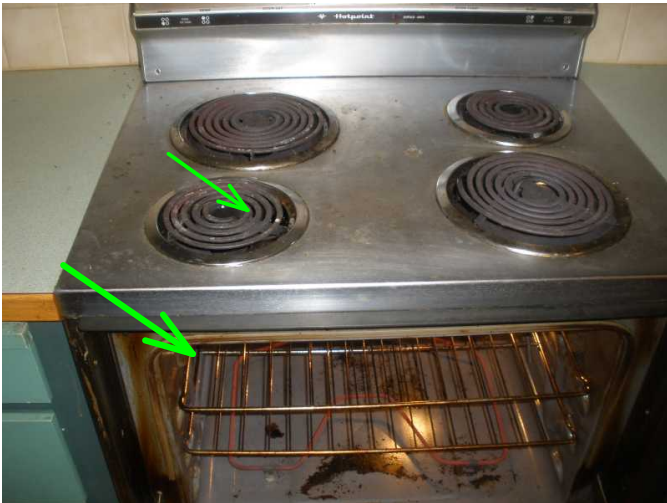
stove and oven noted operable..

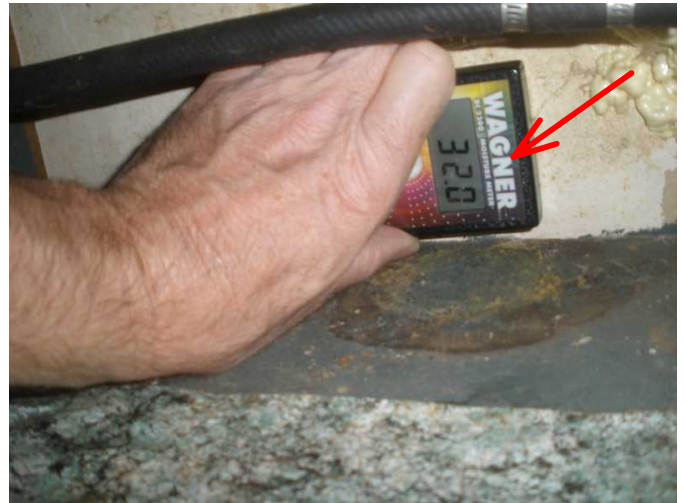
noted black mold at lower walls under cabinets...and moisture reading of 32 %

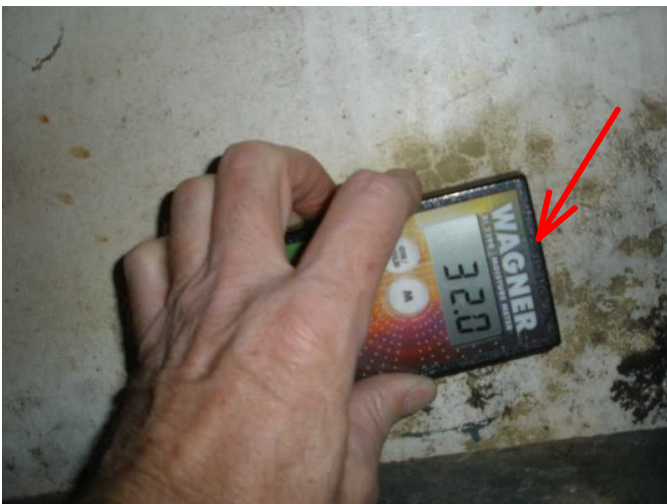
noted more black mold and moisture reading at 32% at lower drywall walls of kitchen area...

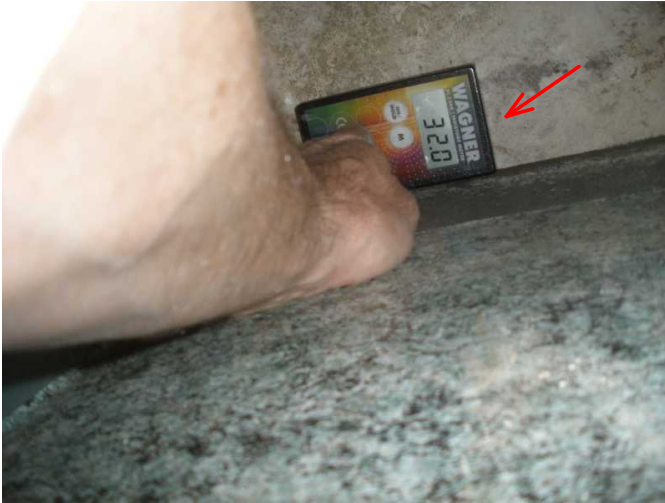
back in lower cabinet walls all noted saturated and reading as wet as can get at 32 %...is drenched...

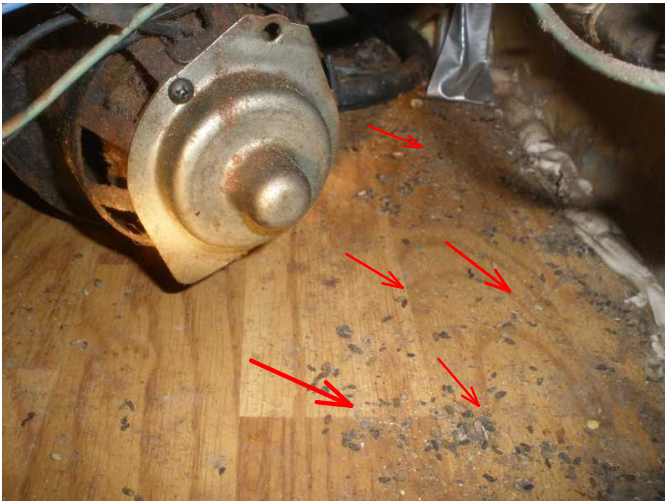
here is close up of vermin fecal droppings...

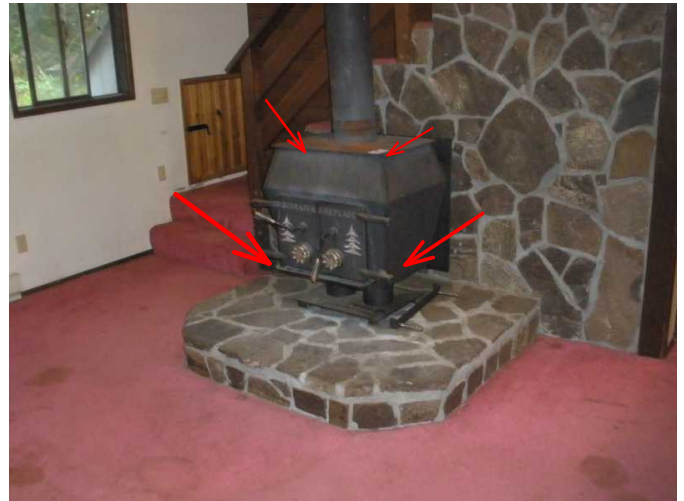
wood stove will need removal...is not EPA approved and as of August 1st 2010 is required to be removed...

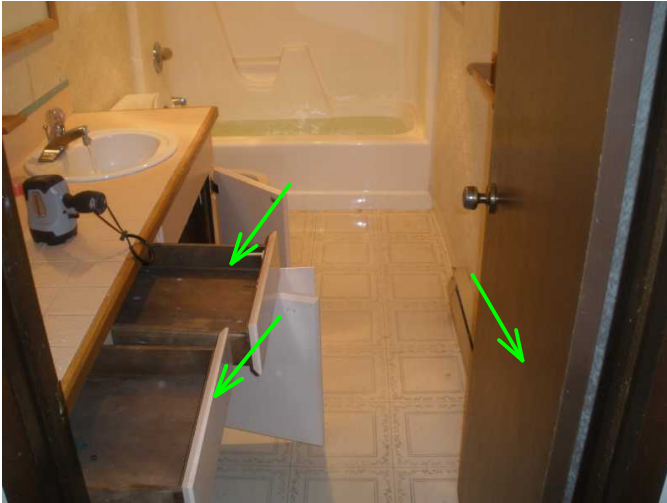
first floor bath entry door and cabinets are noted operable..

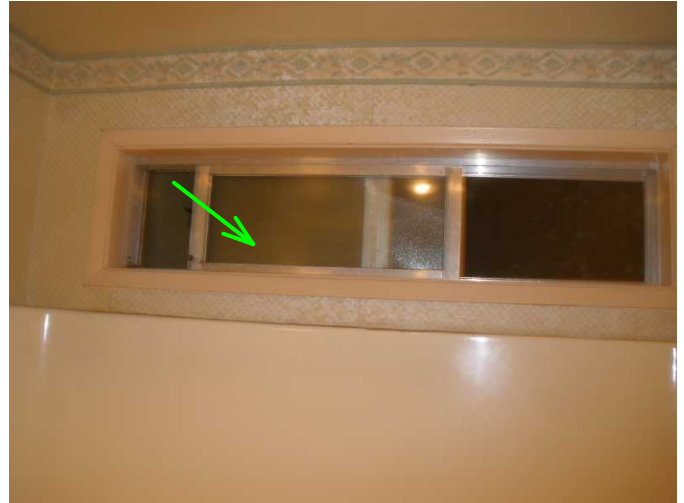
window is noted operable...over tub area...

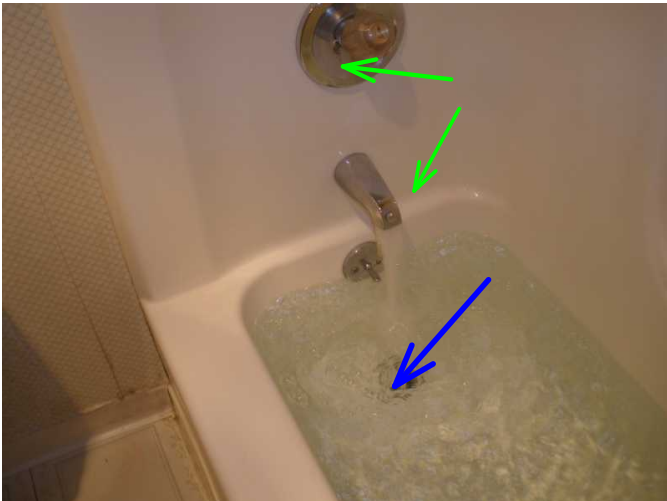
tub faucet and drain and drain stop are found operable..drain stop need repaired..does not drain well...drains slow....

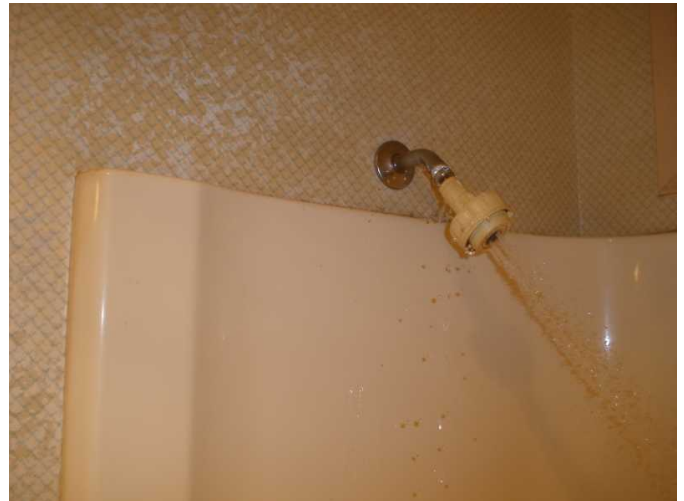
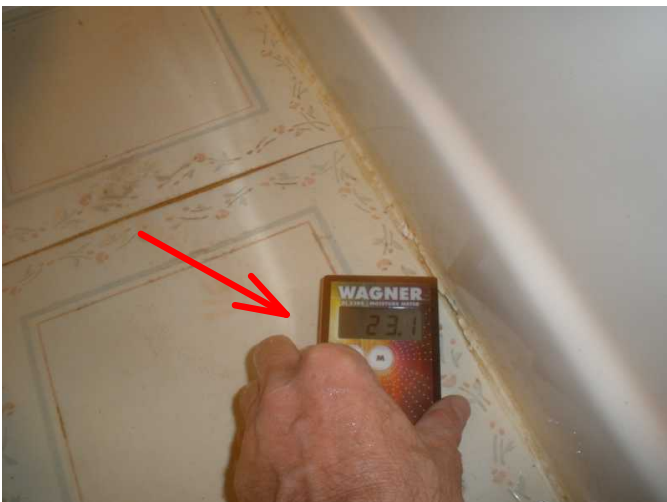
high moisture noted at tub floor...may be from tub or from siding issues...

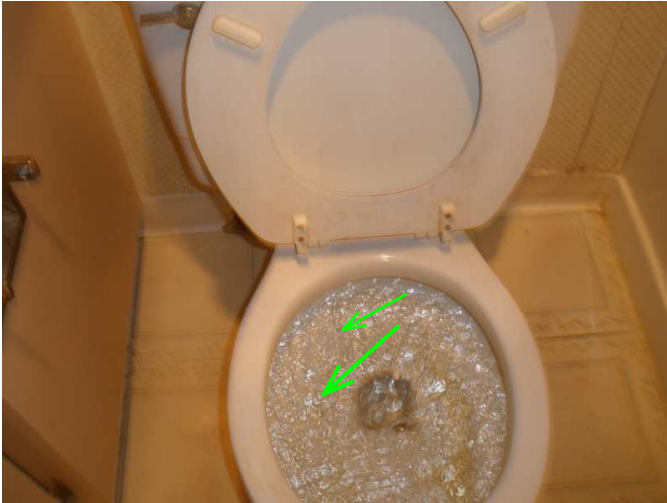
toilet is noted solid to floor and is noted operable..

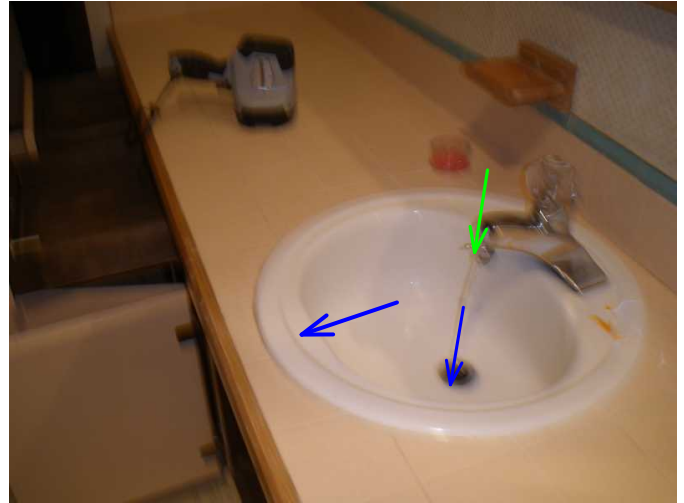
sink faucet is noted operable..but no drain stop noted
and overflow not tested....

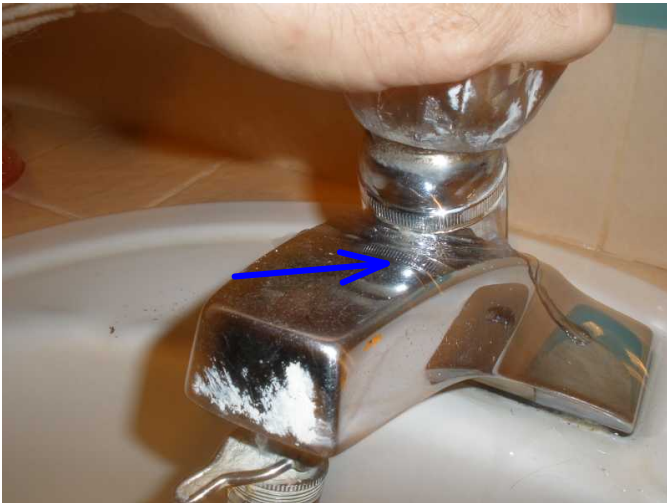
faucet leaks at base..correct or replace...

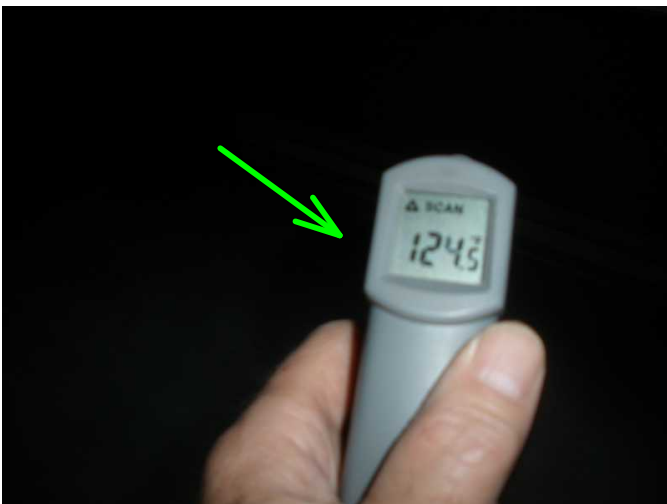
tested all baseboard heaters and found all are
operable..

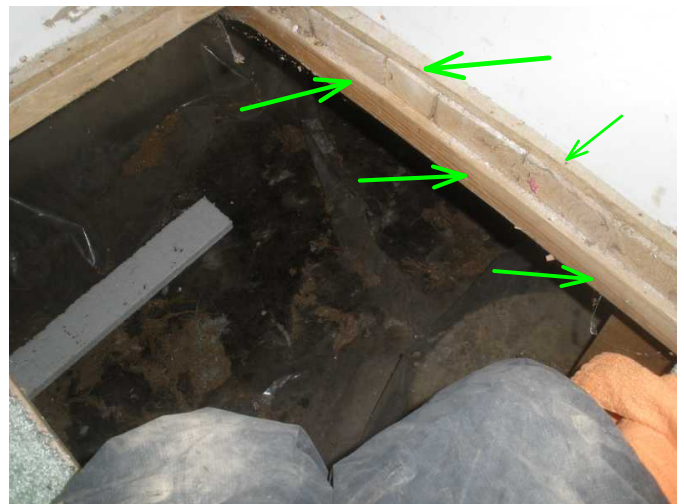
access to crawl space is noted in first floor bedroom
area...is post and beam floor with plank sub
flooring..solid...

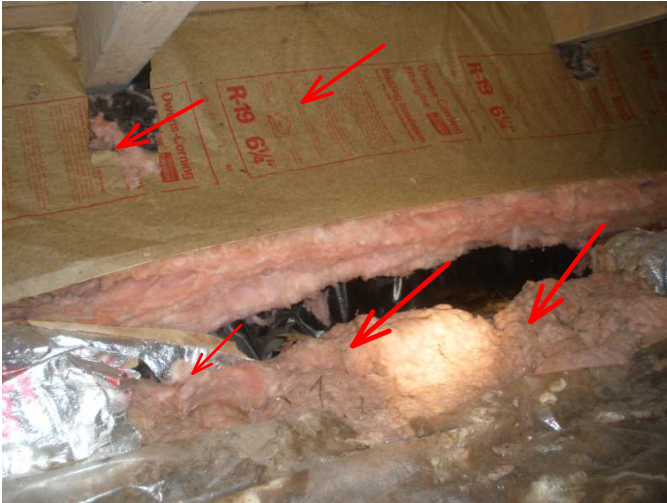
this is north side of home and noted all perimeter insulation is acting as nesting critters..most likely rats...remove

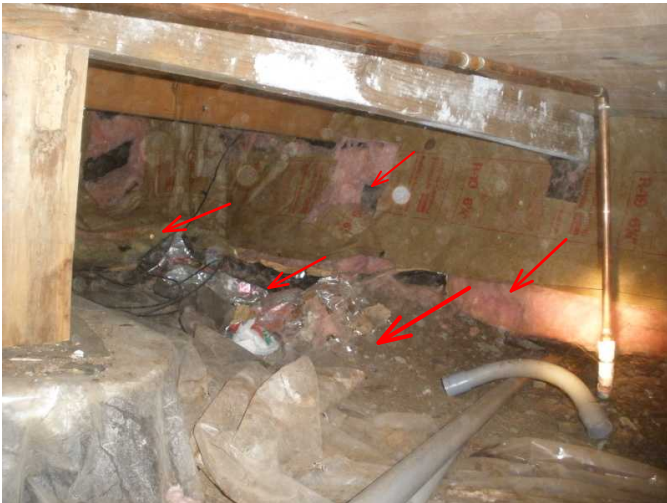
you can see nesting all around perimeter of base of insulation...appears vermin live under corners...

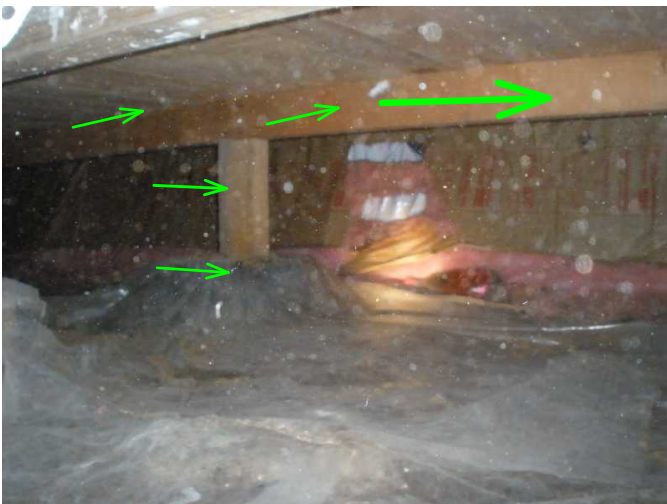
appears most all the post and beam systems are solid and sound...recommend under floor insulation....

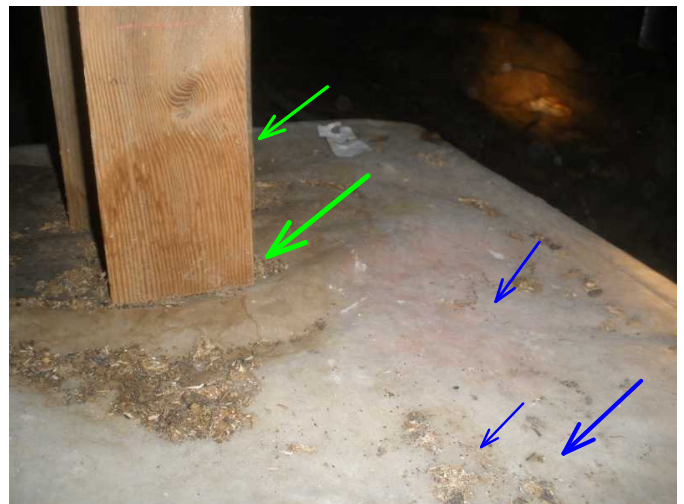
posts are solid..noted vermin droppings all over crawl area...appears to be infested...

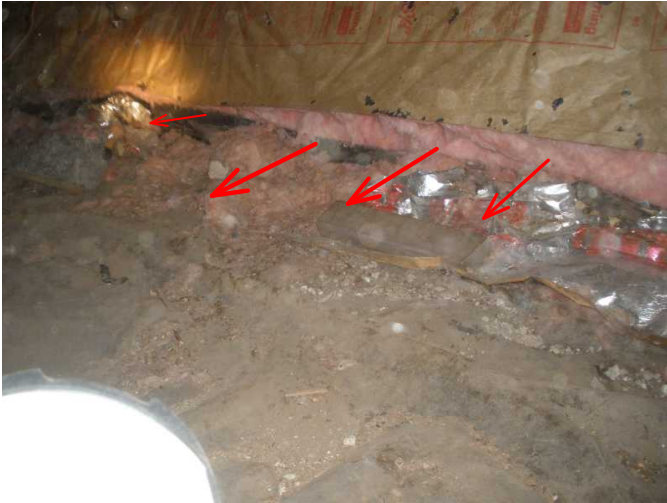
the bunched up insulation acts as nesting for rats and mice...remove and keep off the floor...

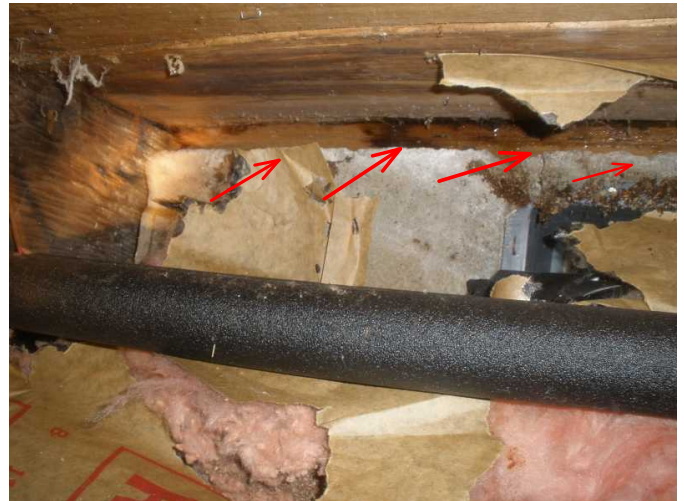
pulled back the insulation at south area and can see wet planks here...

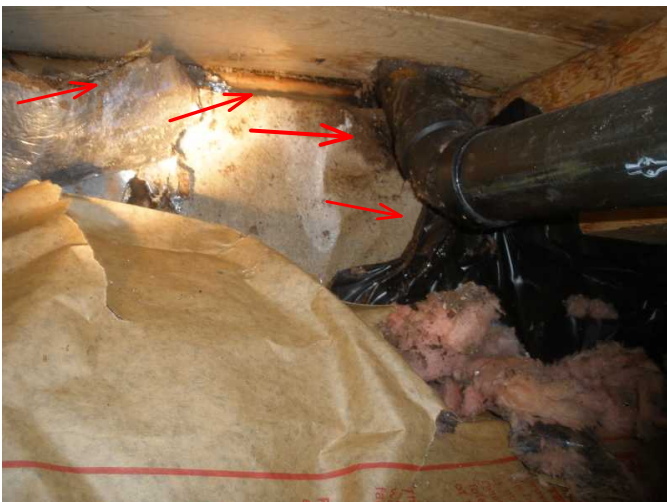
the foundation around kitchen sink drain at wood is noted wet...and foundation is stained...noted water damage...

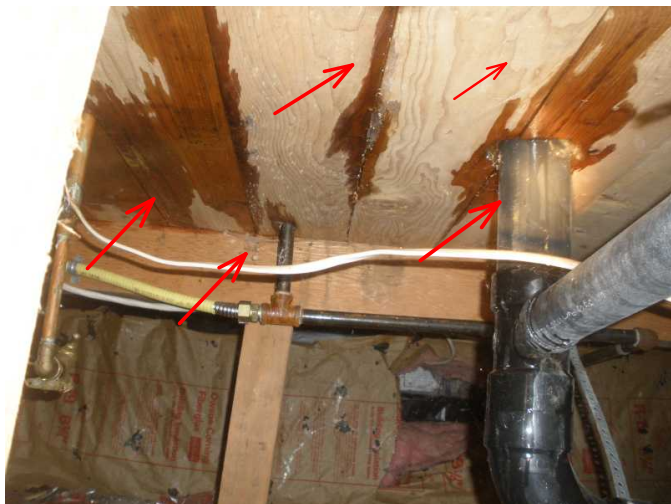
the planks under bath area at toilet and sink and tub are noted here....

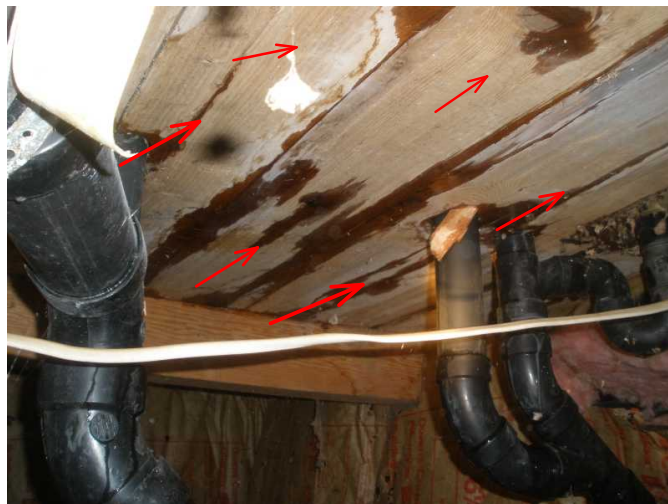
this is under bath and laundry room area....the sub flooring is noted damaged and wet and mold has started...

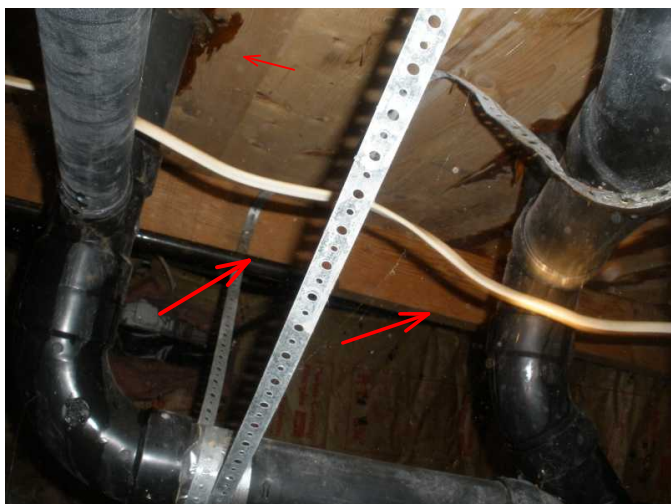
the area at foundation is noted wet at sub floor....

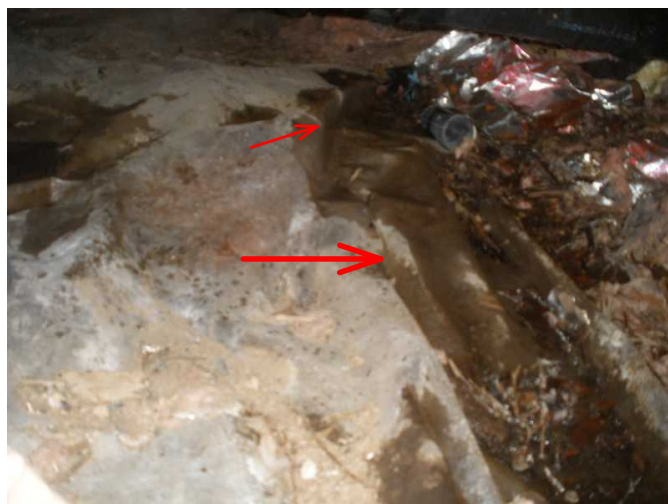
vapor barrier is noted with standing water at leaks under floor at bath and at foundation areas...

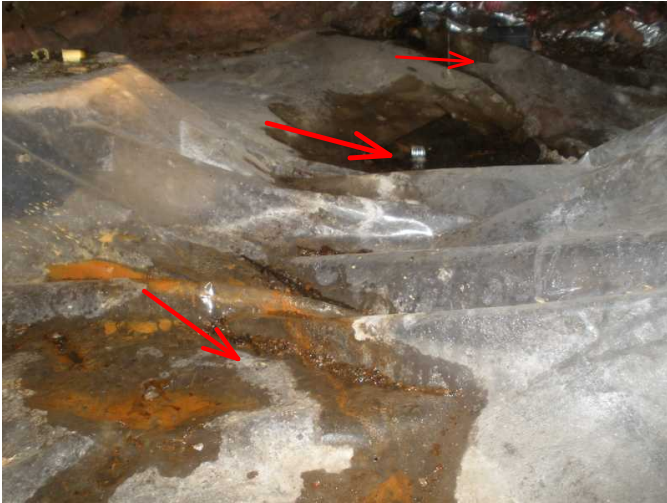
vapor barrier is noted wet....

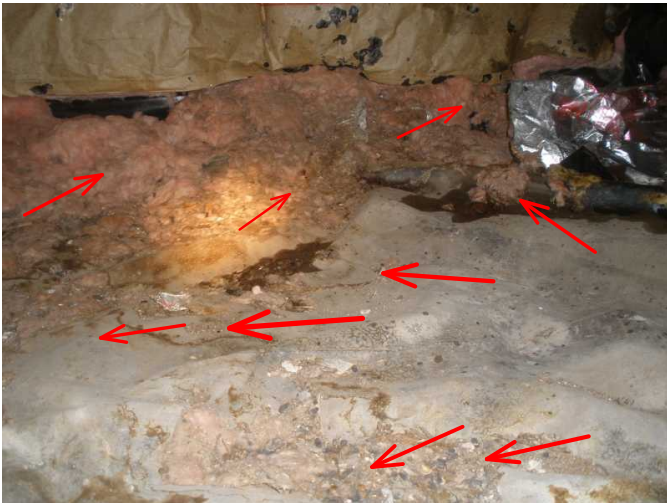
soaked insulation is breeding ground here for vermin and contamination...fecal droppings noted around flooring...

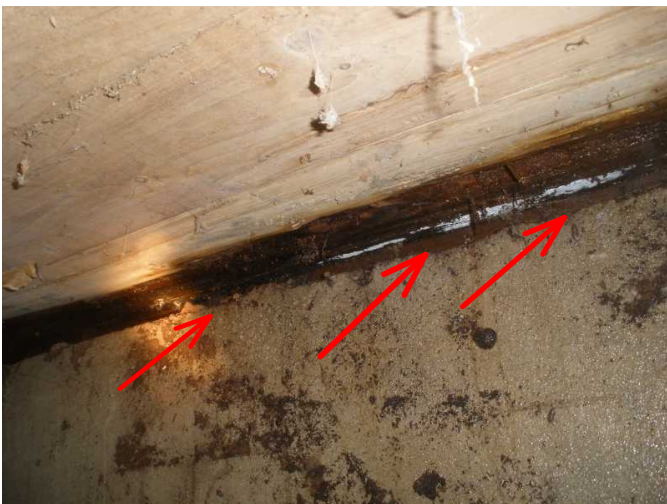
this took some work to pry off the foundation...but here is the wood plank flooring along foundation rotted and soaked...

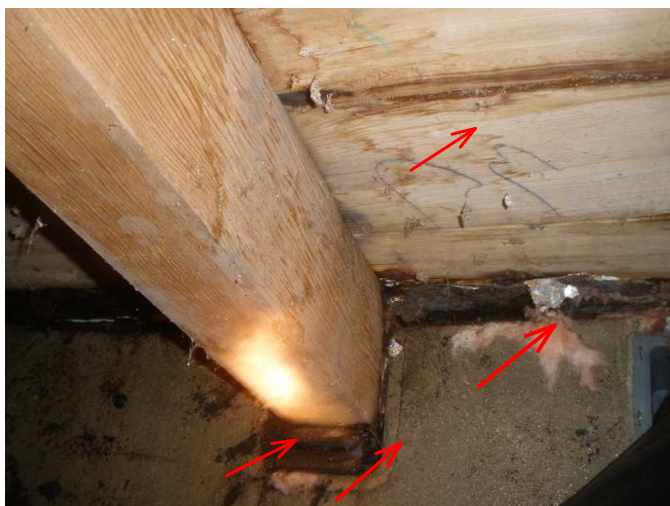
here is second view from distance...

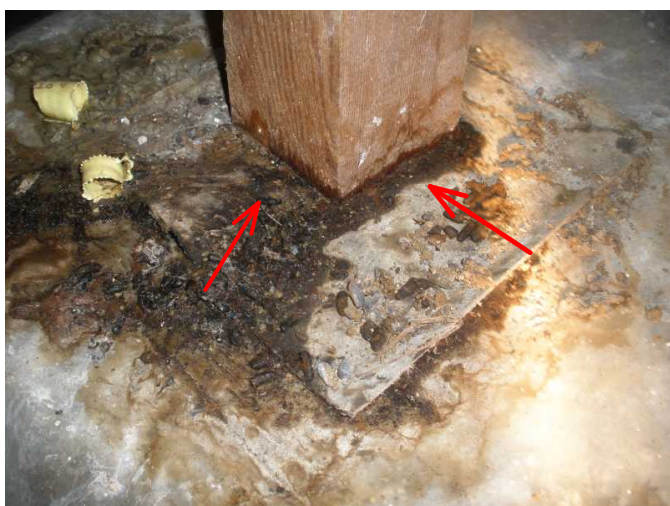
this is standing water at area below affected area with rat fecal matter in water at post...replace post and remove

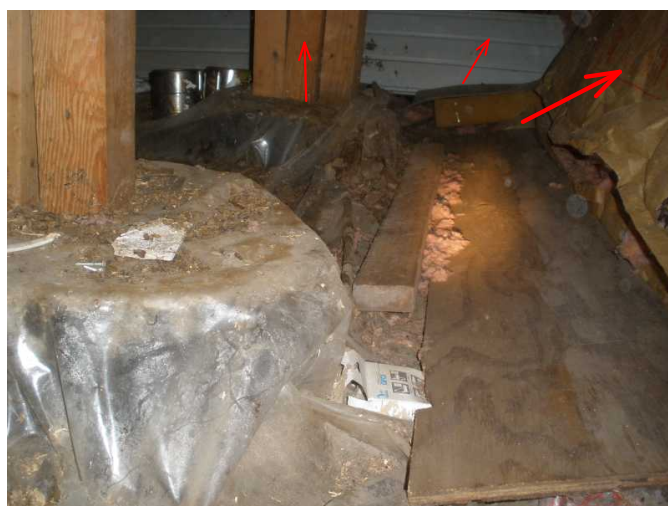
the perimeter flooring and walls at south area will need assessed and replaced to remove all damaged structure

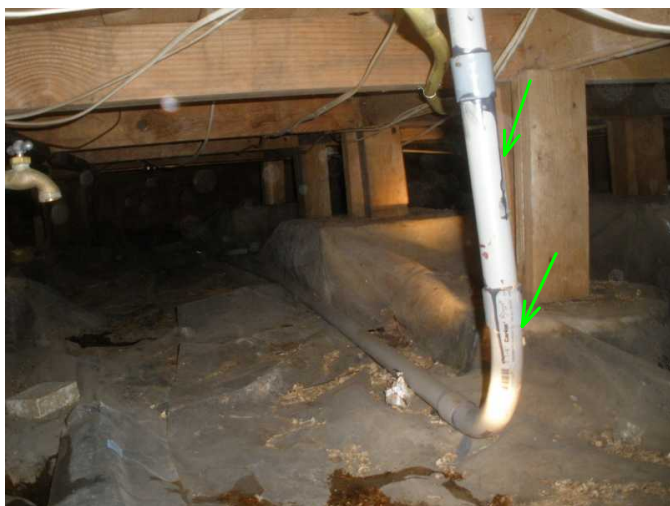
this is electric feed to garage...fine...

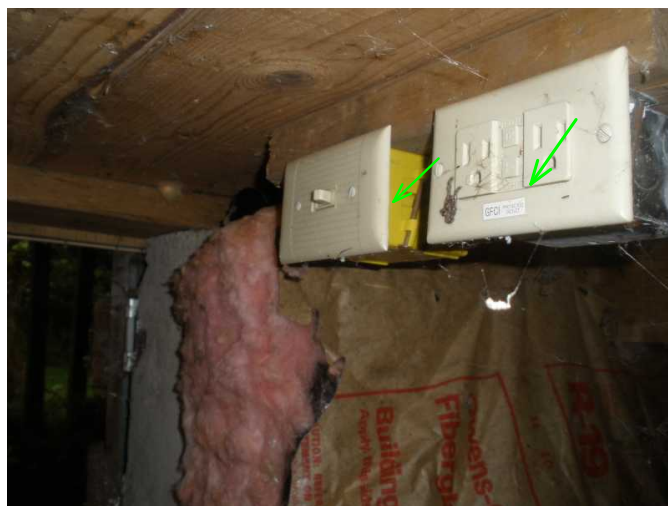
noted outlet in crawl...good..

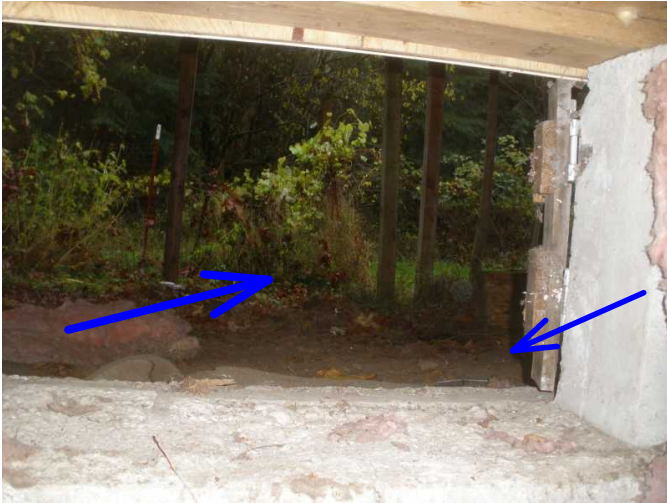
the foundation access hatch has major gaps to allow in vermin and critters...seal off...

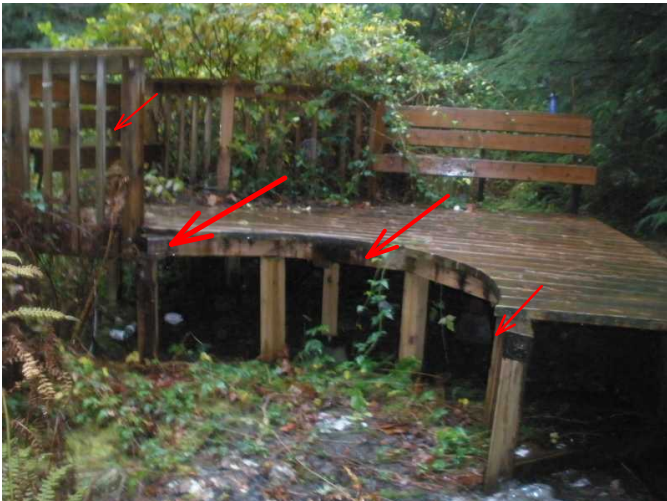
most of deck in this area is noted rotted and recommend complete assessment and replace all affected areas...

Deck: wood - rotted main beams noted at south area under structure...and random planks need replaced...have complete assessment by licensed professional for bids and repairs...

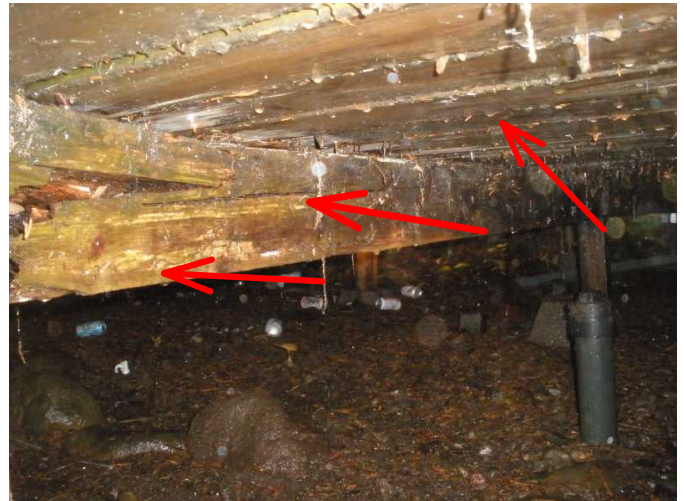
this is under deck along are where siding is rotted...is all due to no gutters along roof lines of home...replace

whole house - Exterior Surface - Type: wood/T-111 siding - entire siding needs paint/ rot noted at south area of siding and will need removal to evaluate complexity of damage

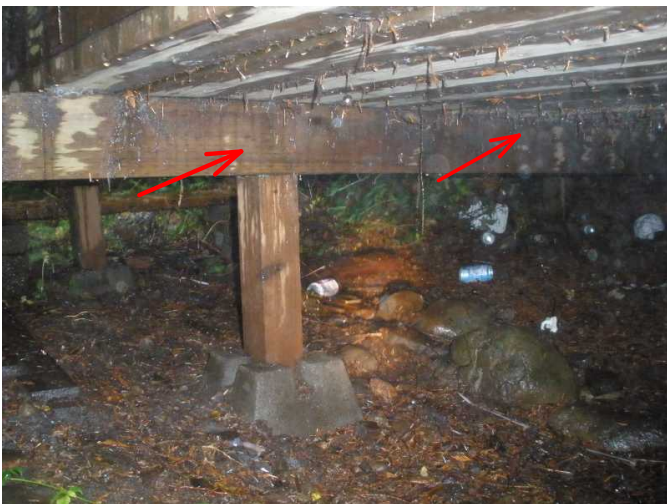
most of deck is noted rotted...assess and replace as needed...may need complete replacement...

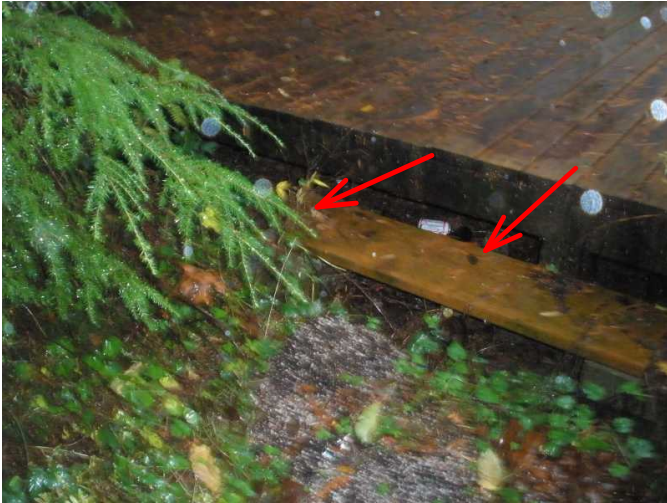
stairs at side to yard are rotted..replace...

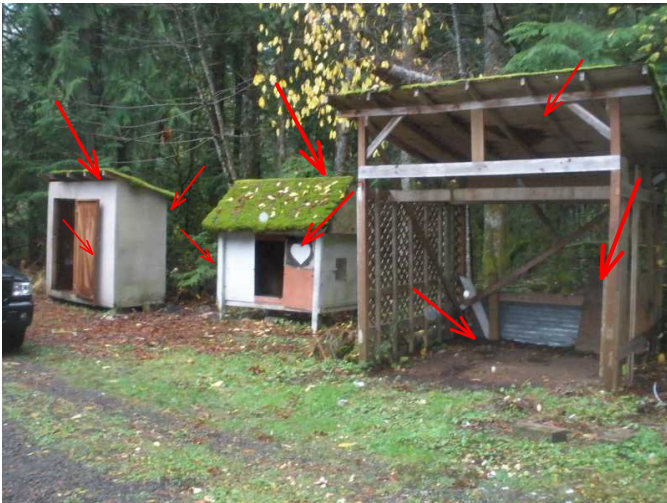
random outbuildings are noted with roof issues and will need regular repairs..is common to find in disrepair...

four random building on lot... - Outbuilding - Roof: Asphalt shingle - A qualified roofing contractor is recommended to evaluate and estimate repairs
