Home Inspection Report

4587 se Bethesda Drive
Gresham, Oregon

Prepared by: The Home Tester

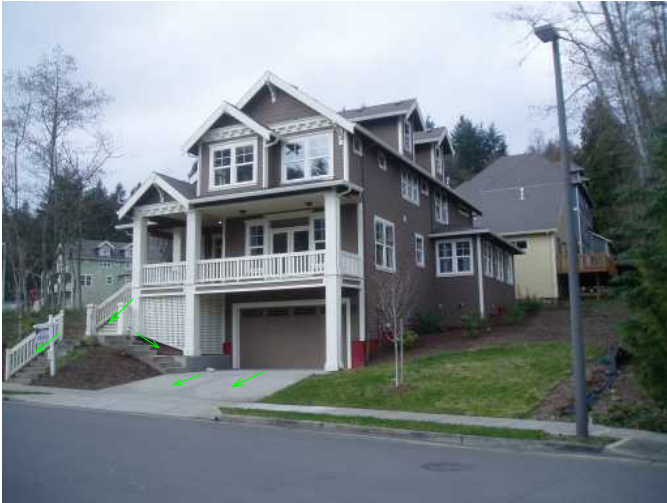
street view of home...driveway and stairs are sloped well for drainage...good..

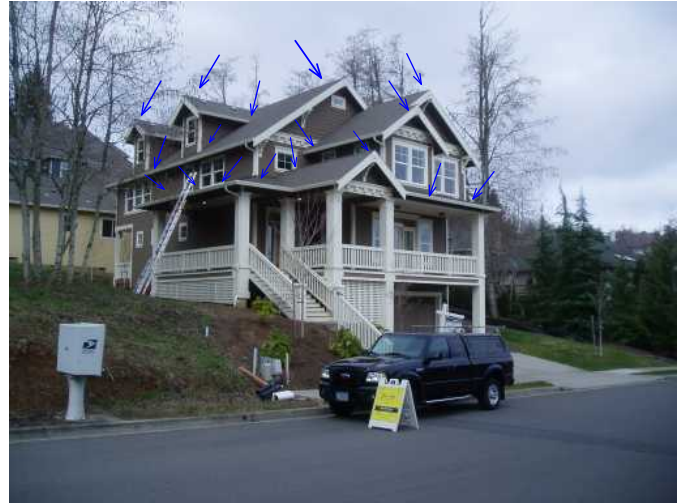
view of home noting multiple roof lines around home that means added cleaning and monitoring flashings...monitor often

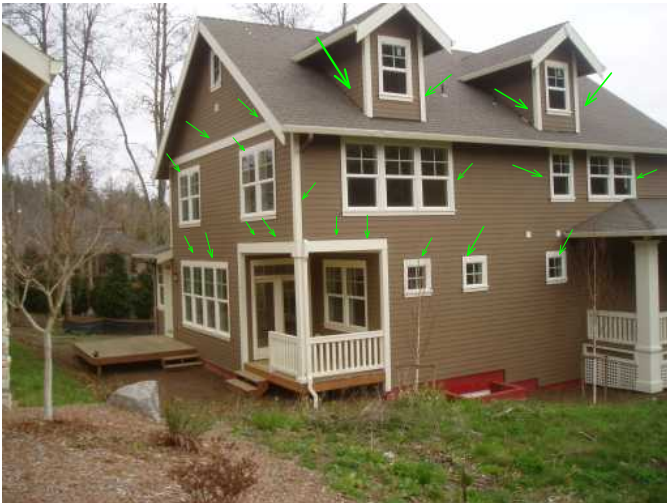
back view of home...noting all windows and trim are z flashed and envelope enclosure are installed well...

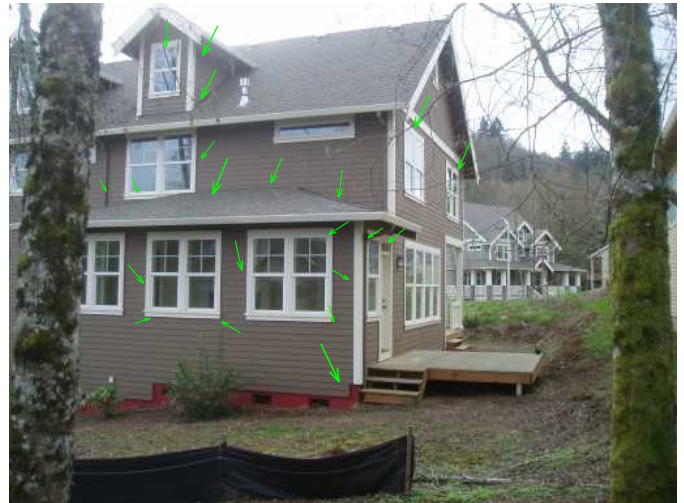
south side of home noting the roof lines and z flashings are installed well all around home...good..

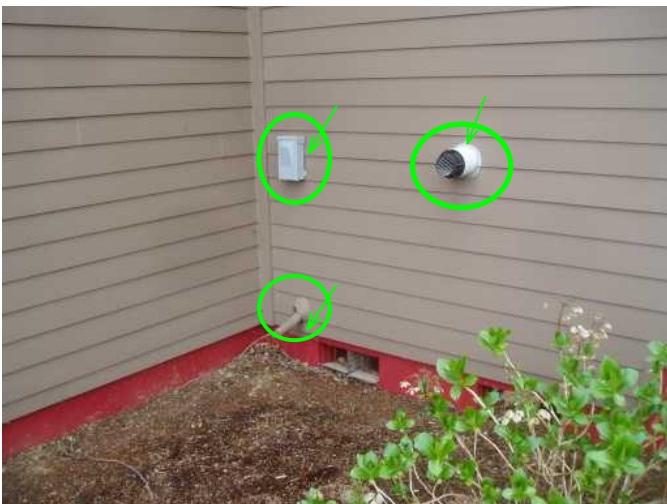
future home for air conditioner..add pad and a/c unit and rest is installed and ready...good..water heater flue is fine..

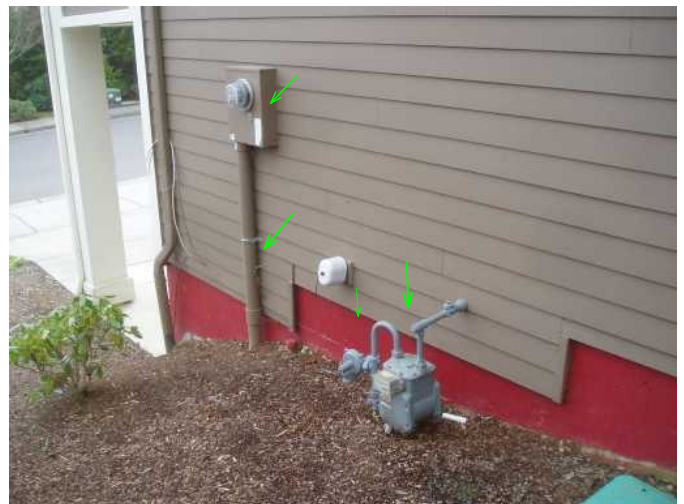
main electric entry is noted fine...gas meter is solid to home and main shut off at meter...fine...

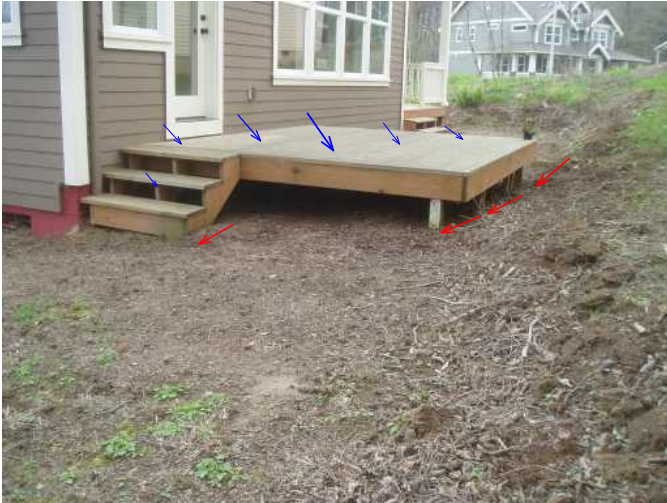
noting earth to wood contact at back deck lower grade to keep wood from rot..also clean and reseal decking...

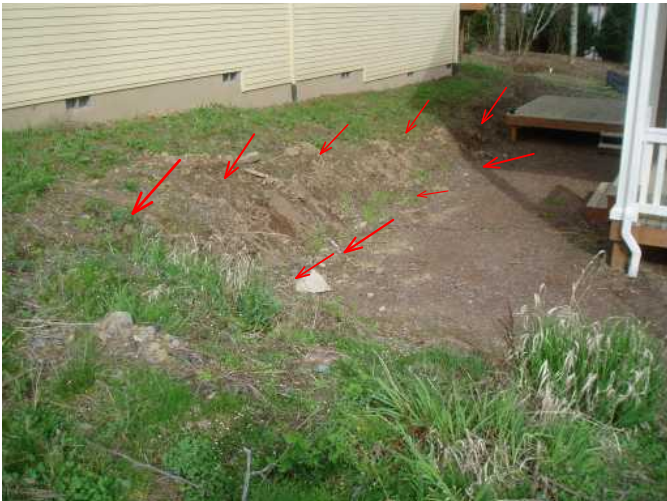
steep slope here needs retaining wall for erosion control...

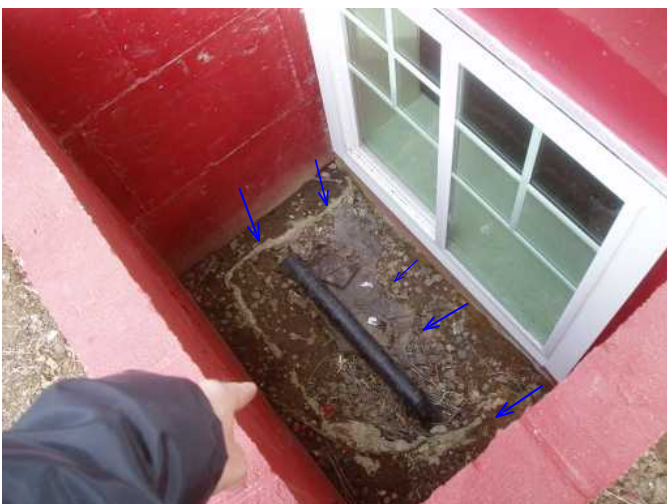
window well needs rock added for drainage...

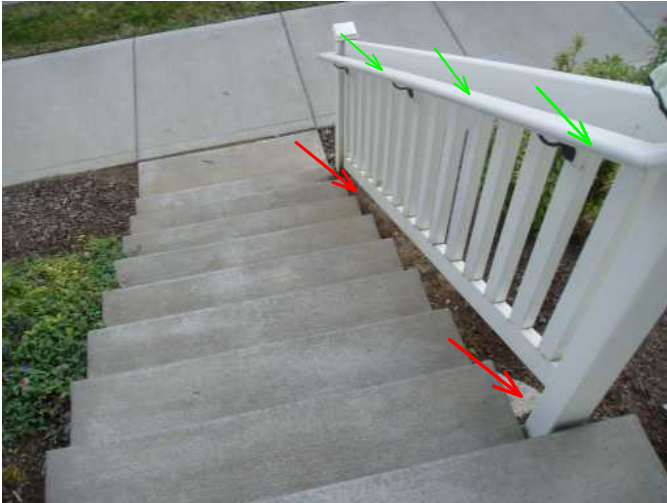
handrail at main stairs to home are solid and sound...but need earth pulled back at posts...

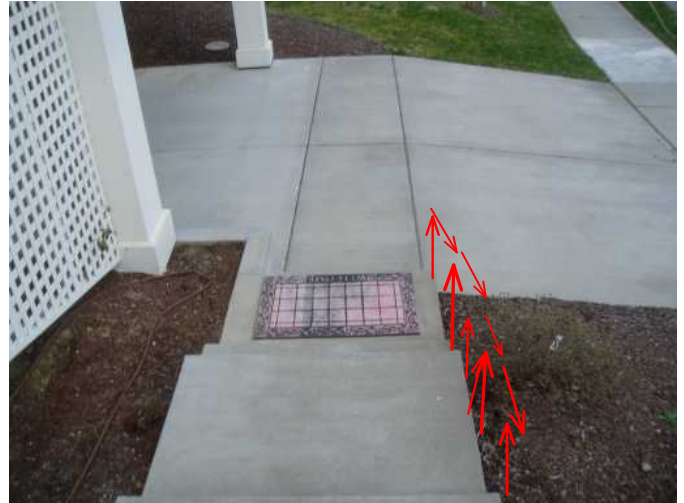
add handrails to second set of steps to avoid trip and fall concerns in winter freeze times...like front stairs..

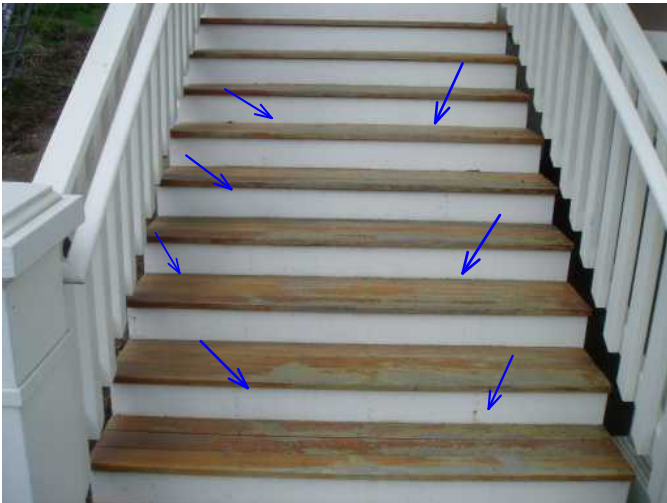
stairs have finish issues, needs to be sealed with weather resistant finish to extend useful life of wood...

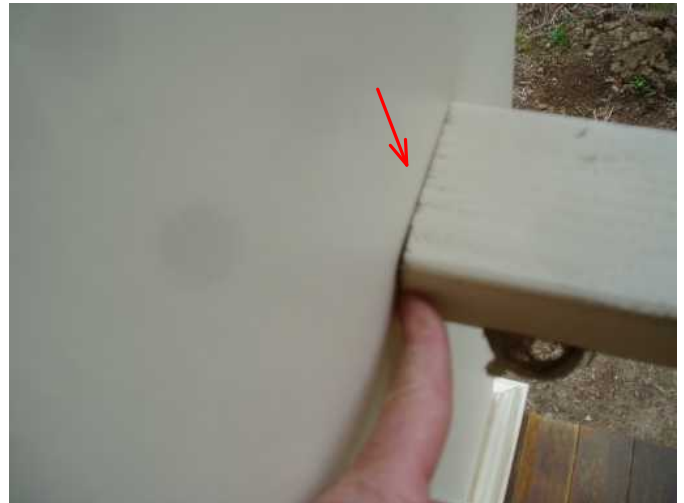
both front and back porch railings have open gaps at random that will need caulked to extend useful life of wood...

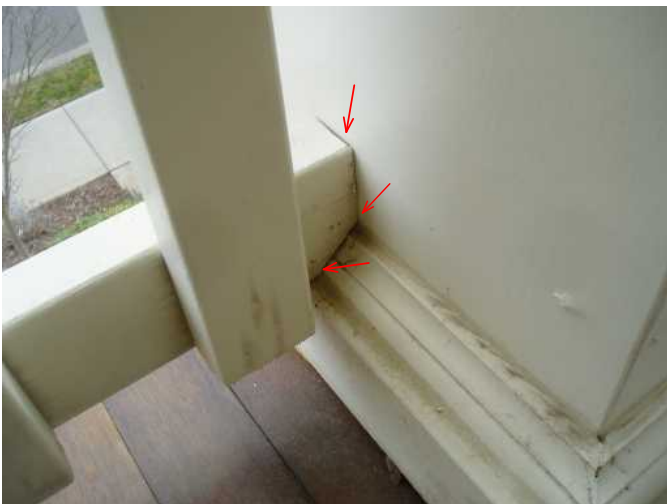
any gaps found at intersections will allow water to stand and rot wood...caulk all open gaps...cracks to extend life

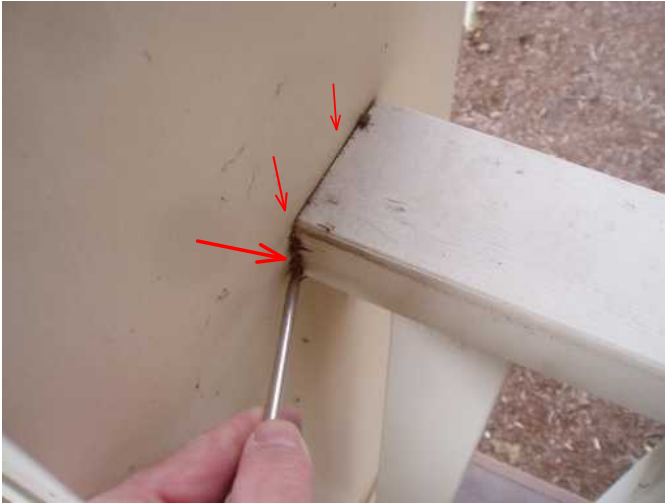
see how wood is dark and needs caulk and paint to extend life of wood by many years...

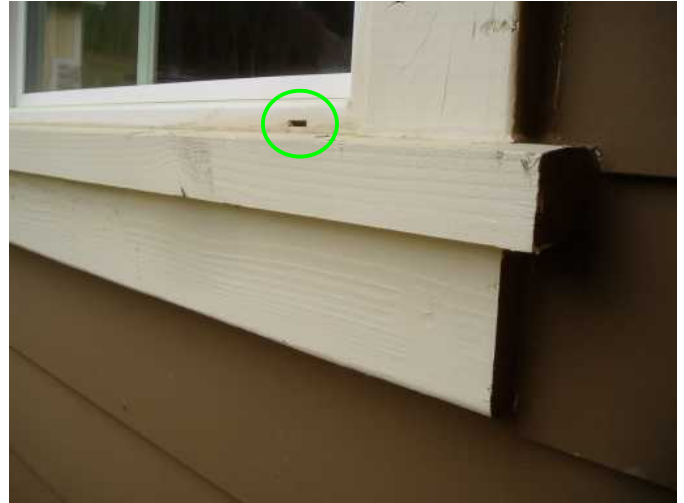
all windows are assessed to see that weep holes are in bottom of windows and not on top or sides...all good

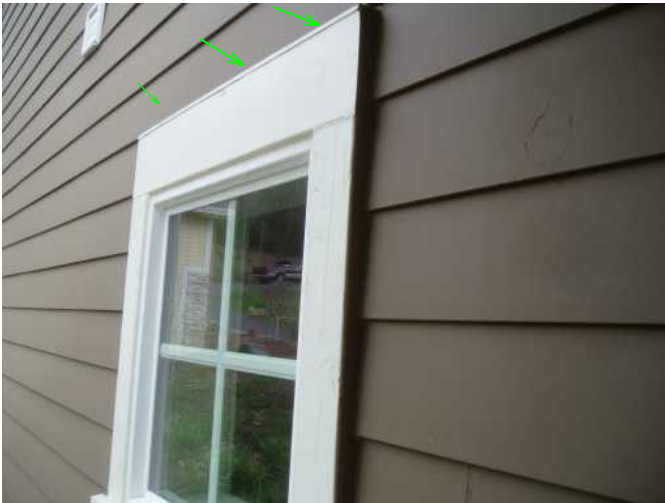
z flashed at all windows and trim around home at upper areas needed...good..

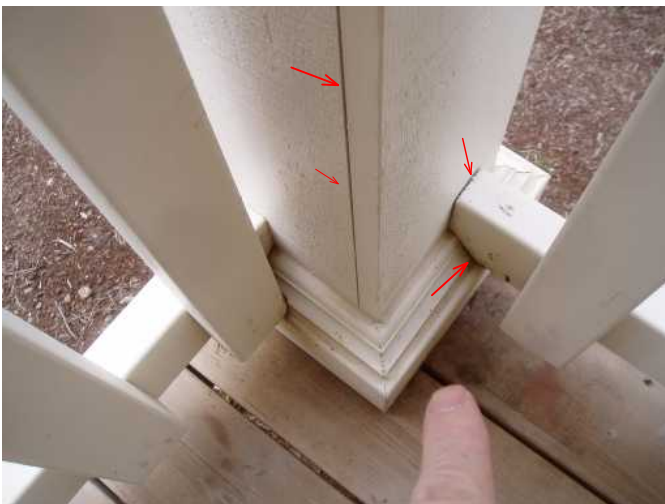
caulk at all open cracks at trim at porches and wood will last many years...will fail in a few years if not...

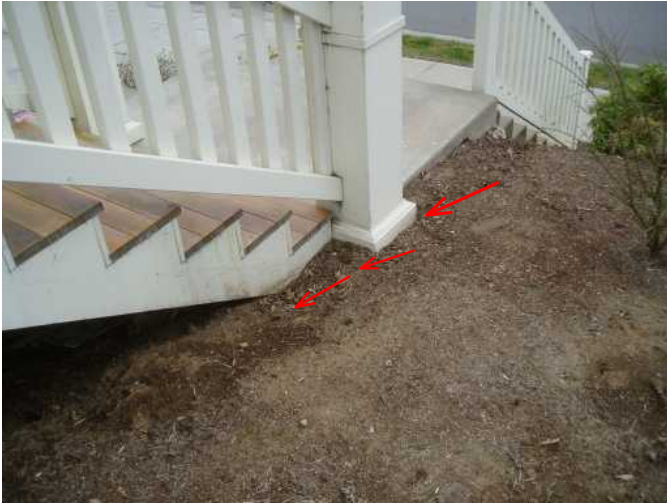
pull back earth and watch the wood last for years...

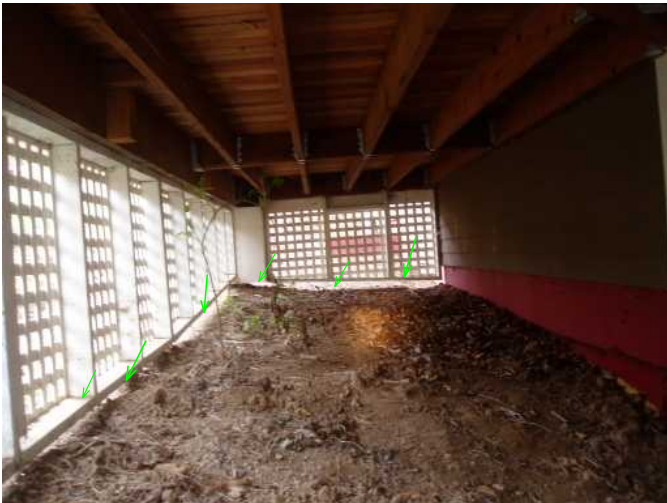
under front porch noting beams are in hangers and attached well to structure...good...no earth to wood contact here...

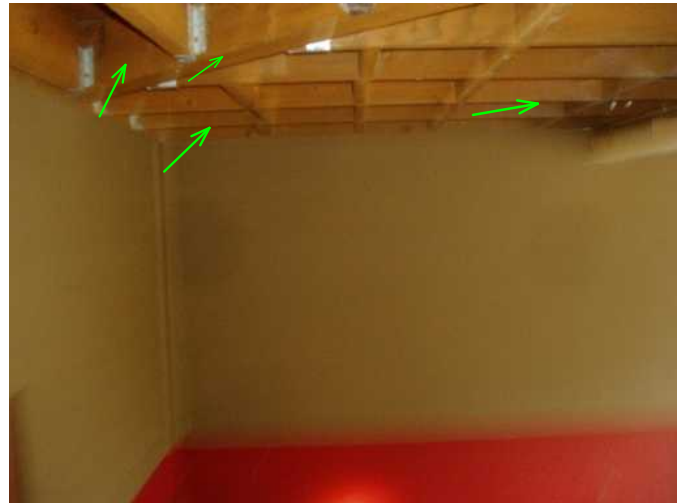
see hangers...very solid and installed well...good..under front porch...

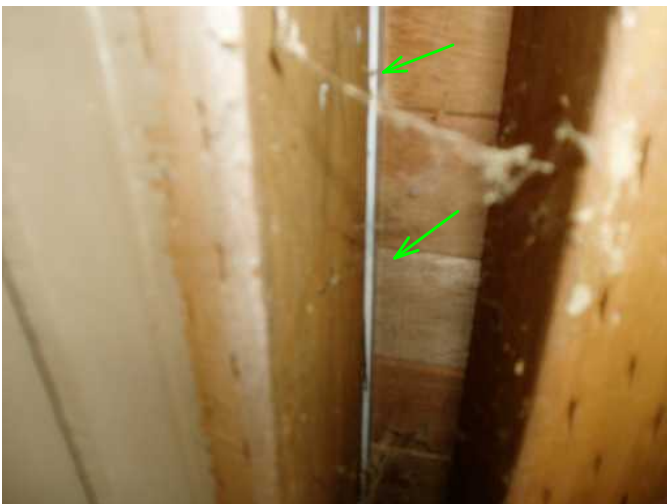
up close to structure and noting the flashing at decking to structure...good..

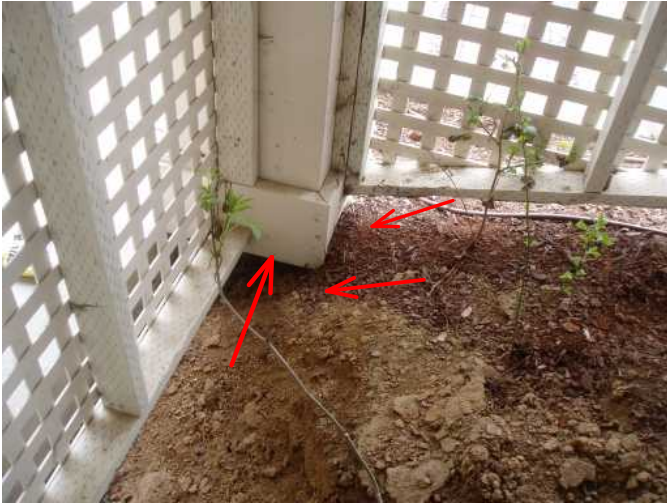
pull back any earth to wood contact found under porch area..and monitor often and coorrect as needed...

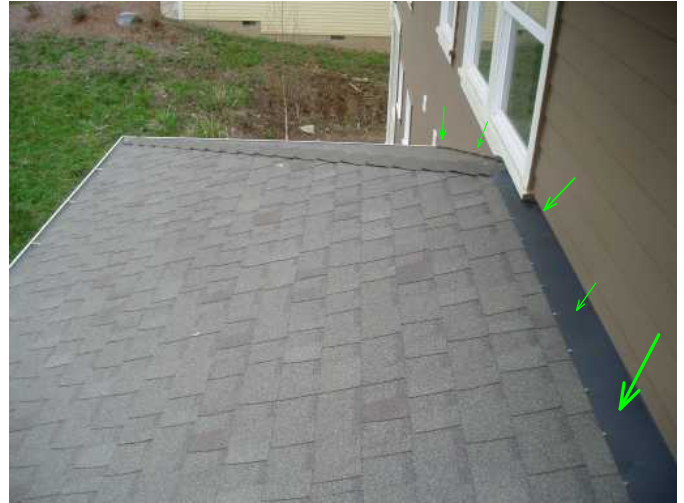
up on roof over front porch noting very good flashing from roof to siding and kickouts into gutters...good..

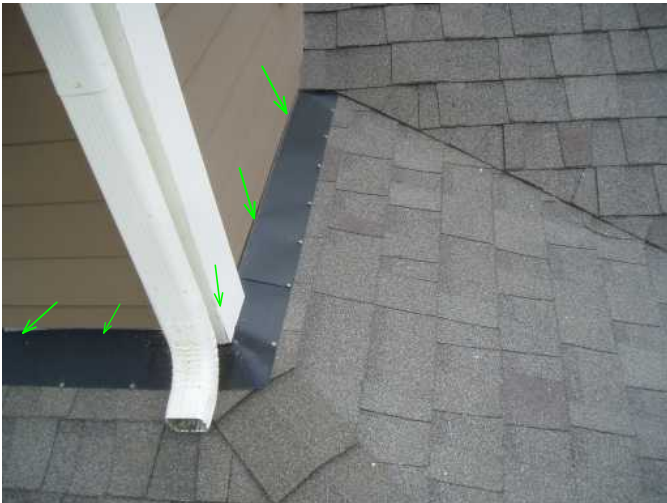
noting very good flash job around home...up over front porch area...

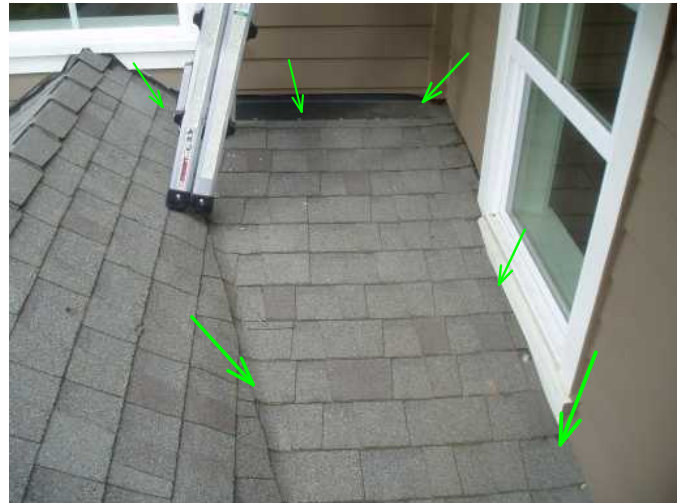
over front porch at master bedroom area...very good flash job...monitor and clean as needed....

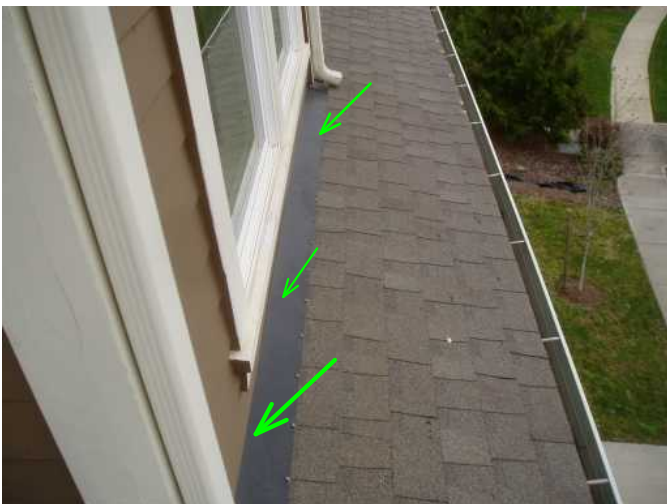
at front of master bedroom and noting great flashing as well..good..

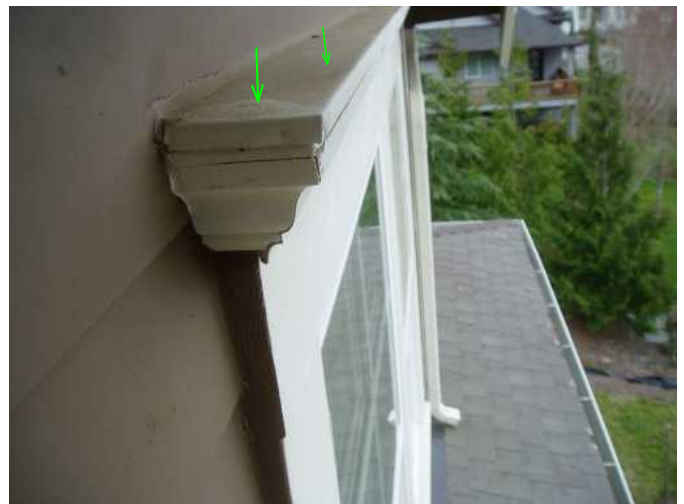
all wood trim around home is flashed well....very good attention to details....better quality home noted here...

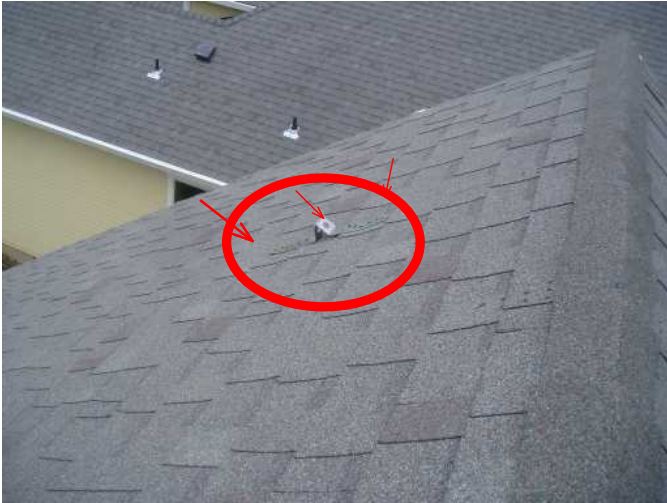
up on roof at back of home over west gable area....remove metal bracket noted here for roofer left behind....patch...

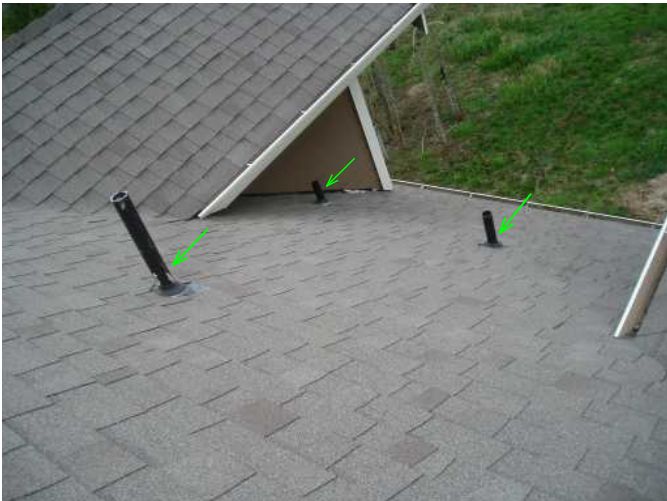
sewer vents are flashed well and step flashings are noted installed well at dormers...good..

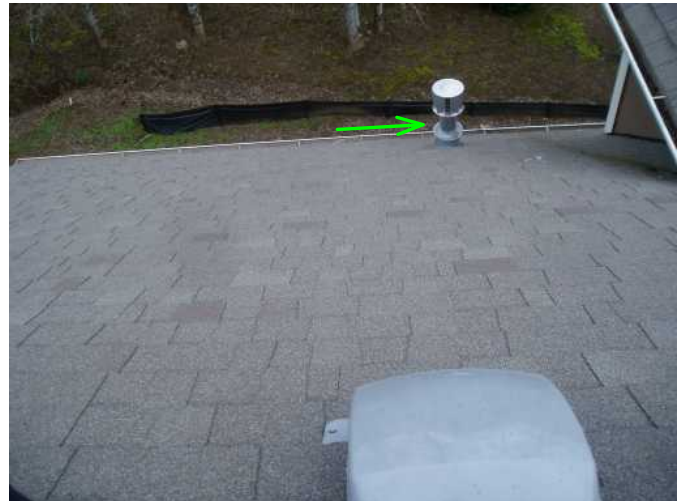
fireplace flue noted here is flashed well at south side of home upper roof...good..

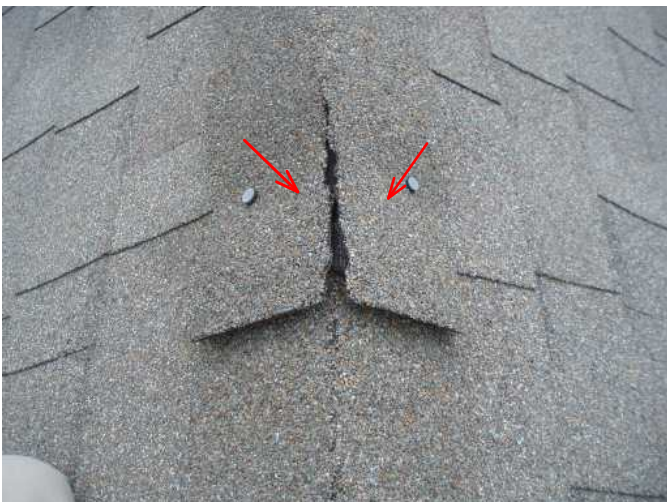
random ridge shingles noted split at many areas of several peaks...replace all damaged like this...example of many...

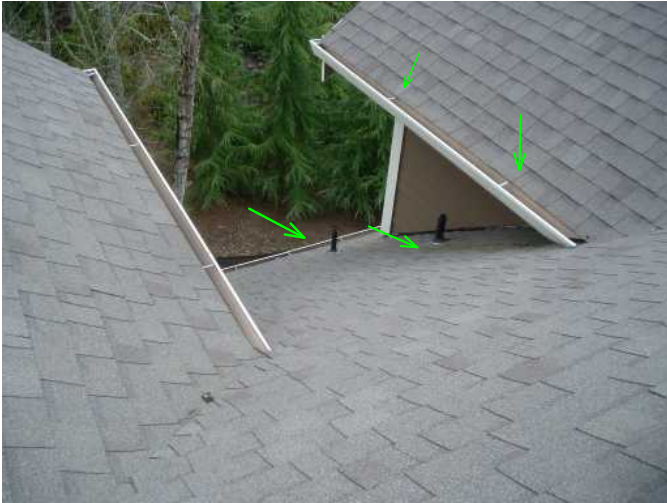
sewer vents are noted at east side are fine...flushed well...gutters up here are fine...

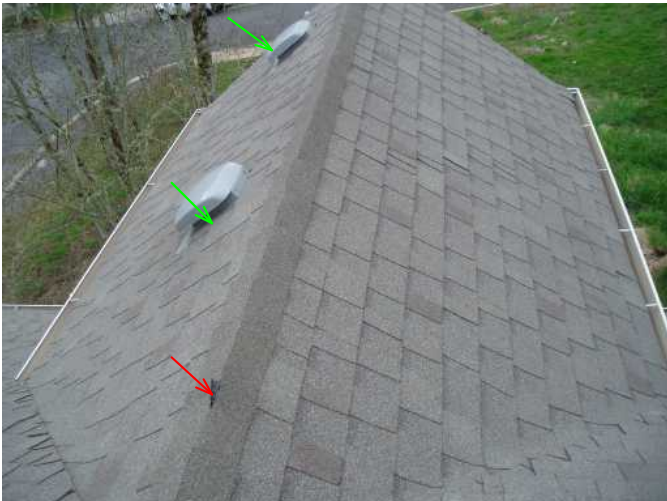
front dormer at west side of home is noted with vents...good..ridge shingle is noted split..replace..

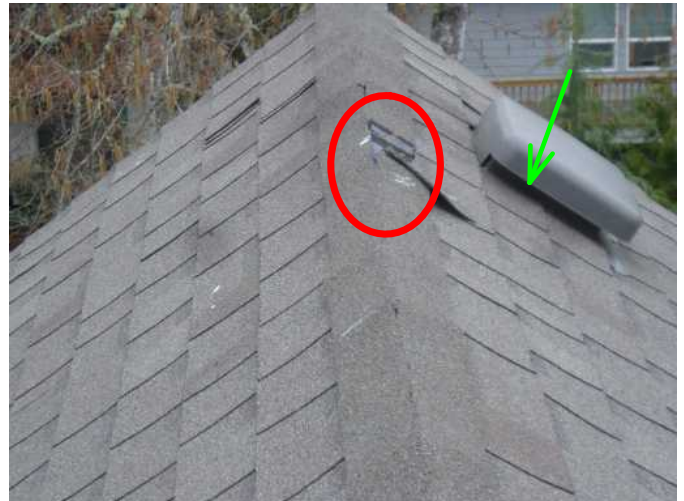
ridge shingle at east front dormer is noted here almost fallen off roof...replace as well..vents are noted fine...

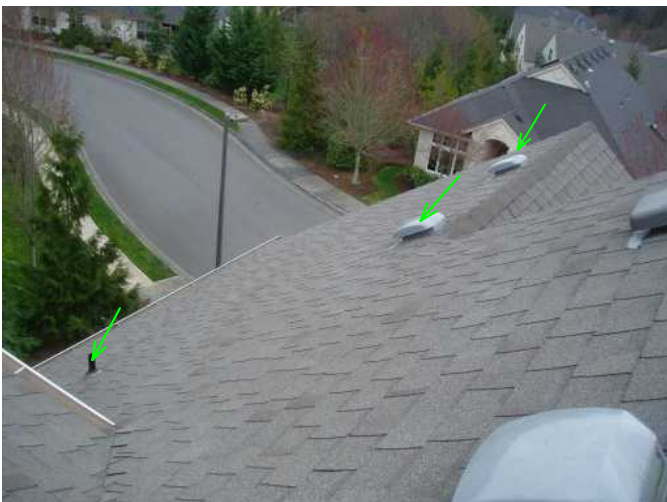
front and east side of roof is noted here...and vents are fine...

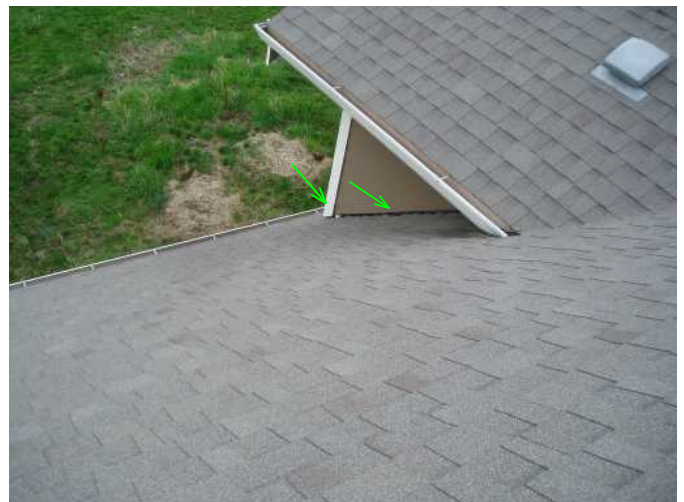
west side of front dormer as all dormers are noted step flashed well...good..

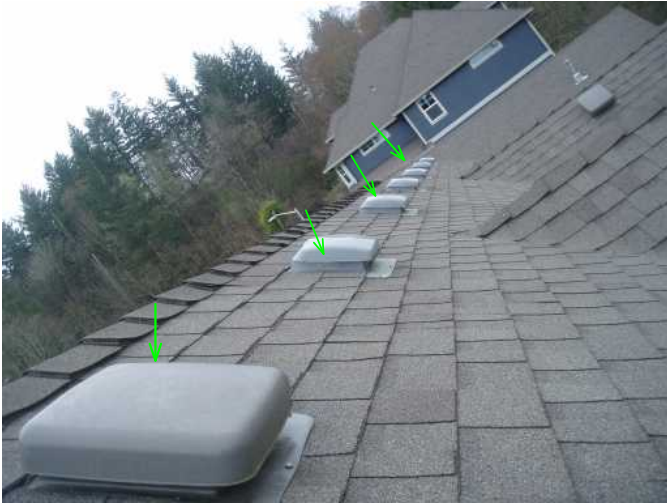
all vents at upper roof area are noted solid to roof..good..

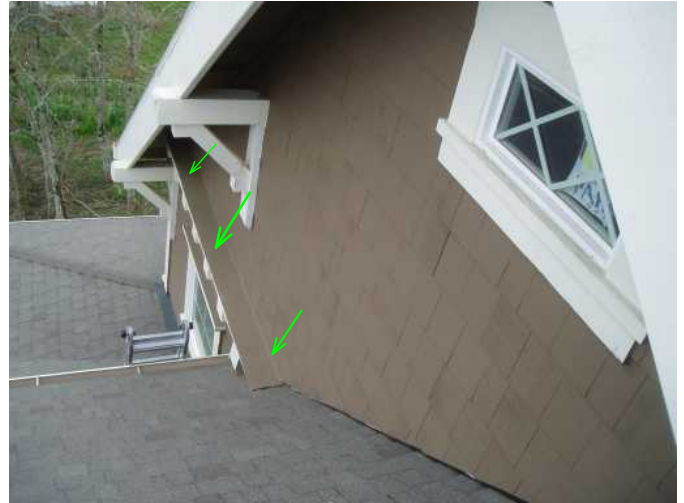
over windows are flashed very well..flashings over deep wood trims are custom made....and is sign of well detail home

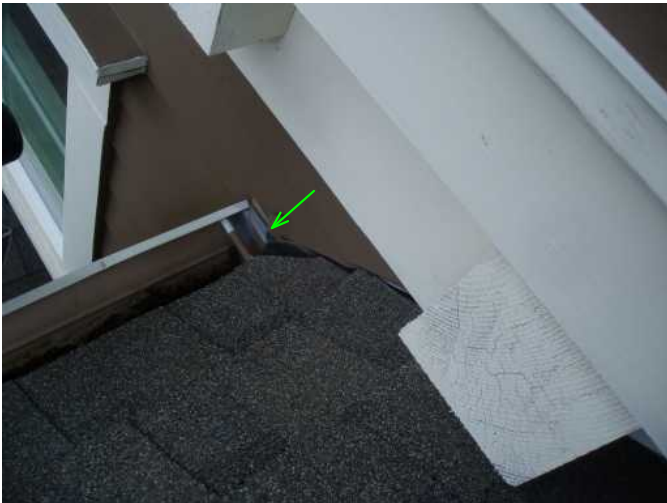
kickouts are noted at all needed areas as well...good...

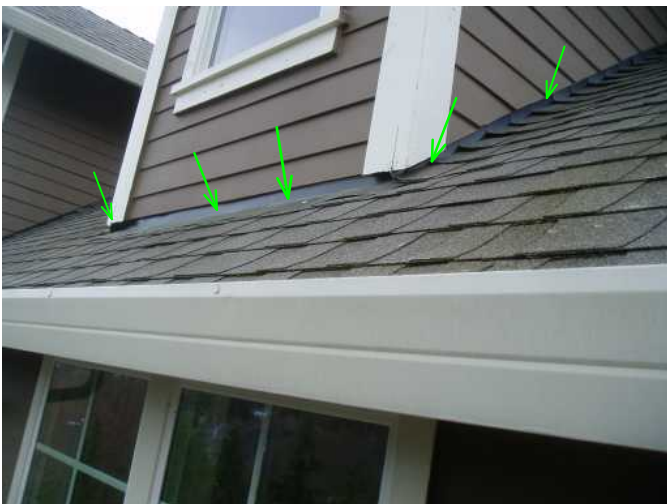
all dormers are decorative...but details are noted with excellent flashing jobs all around...very good...

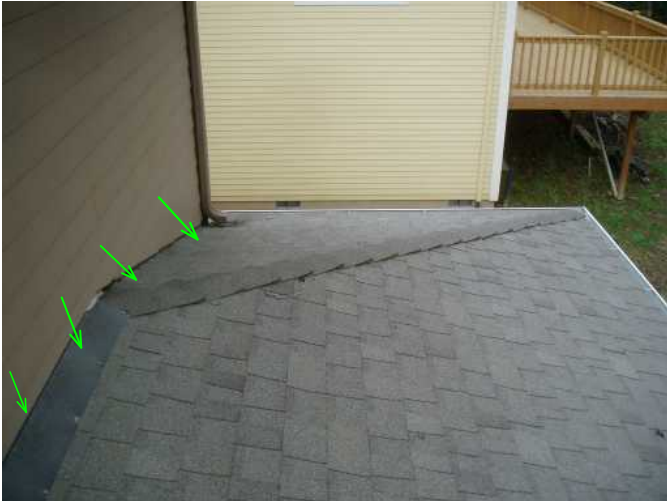
on roof over sun room ...flashed well...good..

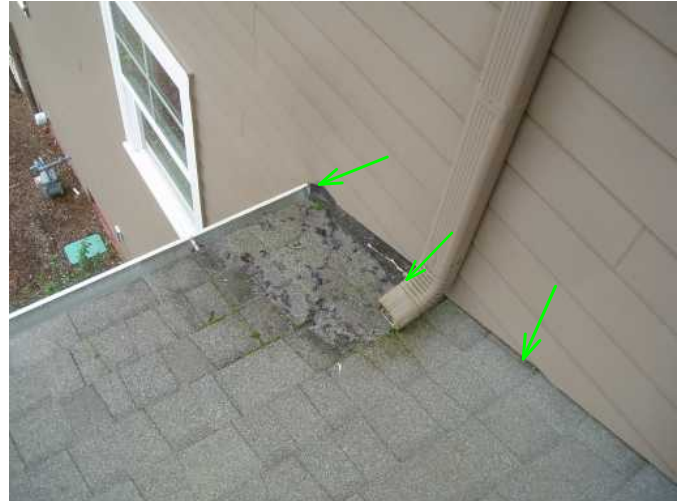
flashed well and kickout is designed to control flow from downspout and is working well...good...

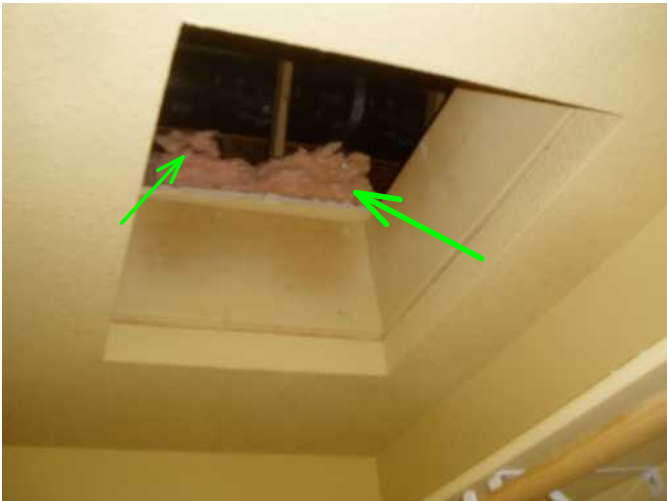
attic access hatch is in master bedroom walk in closet ceiling area...

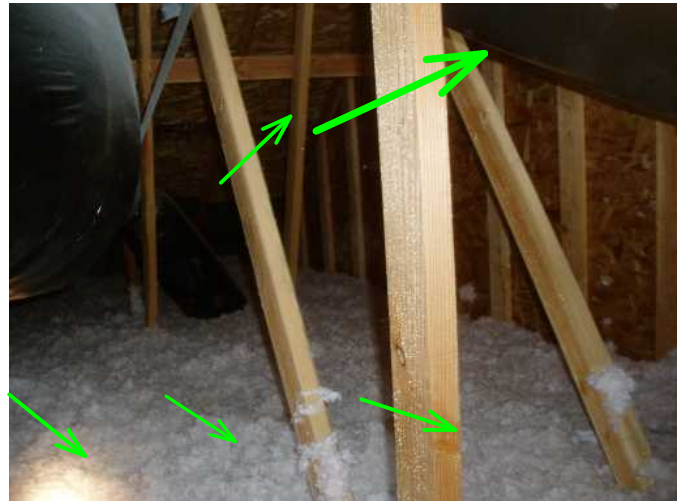
up in attic facing forward and noting solid truss system and insulation is installed even and well...good...

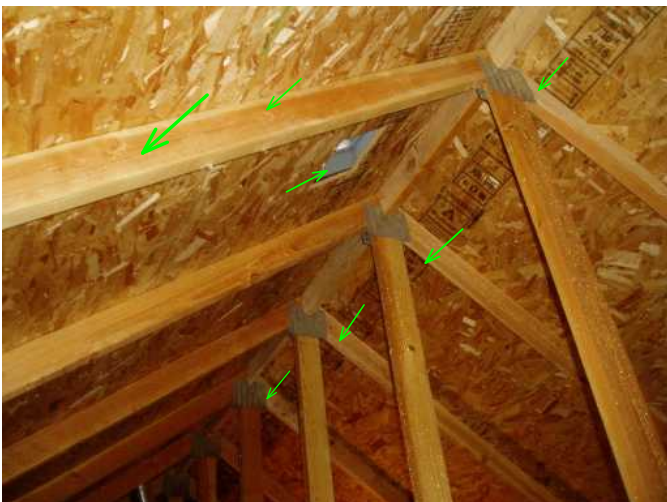
looking up at peak of main attic and noting the roof vents are without staining...good...trusses are evenly spaced...

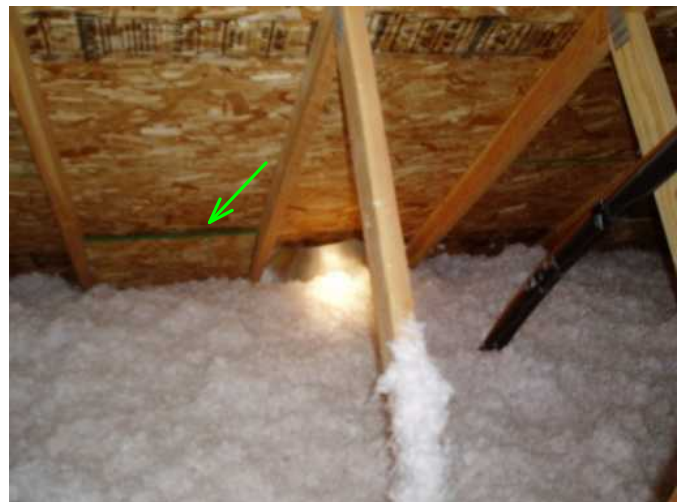
soffit baffles are noted spaced evenly and allow air to flow from lower to upper vents...good..

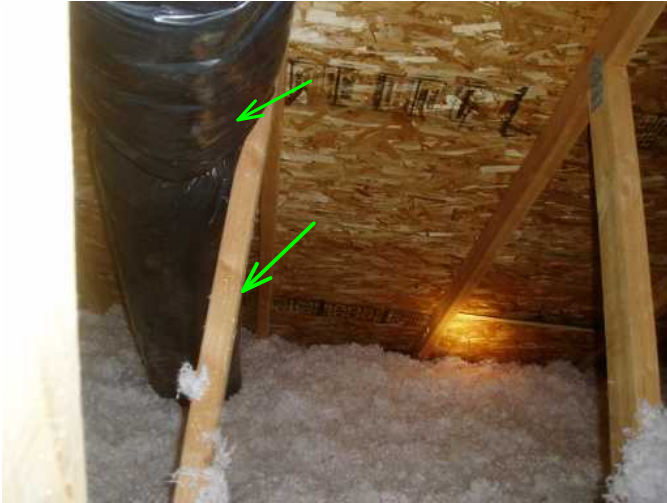
ducts are noted all insulated flex ducts...good...

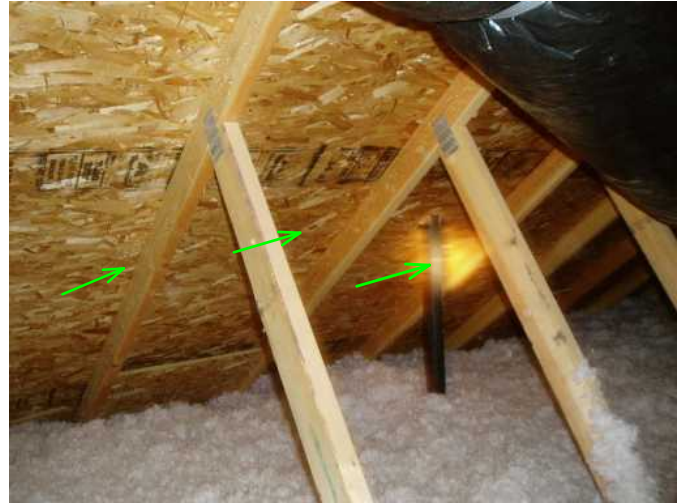
OSB sheathing is noted in attic for decking under roof and sheathing at sides...plywood is at exterior areas of soffits

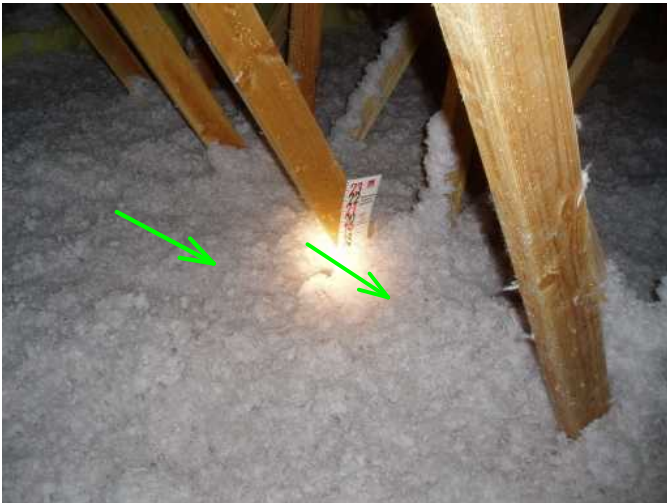
attic is installed with blown in insulation...good....deep and acceptable..will reduce energy bills...good..

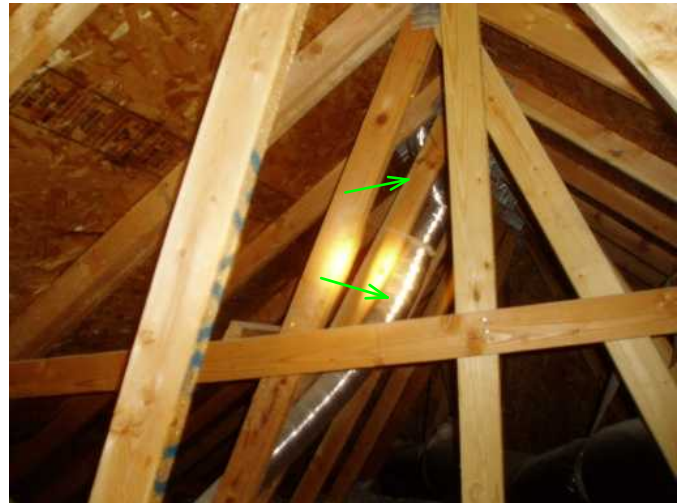
noting both 2 x 4 truss systems that are solid and sound...and bath vents to roof are operable..good..

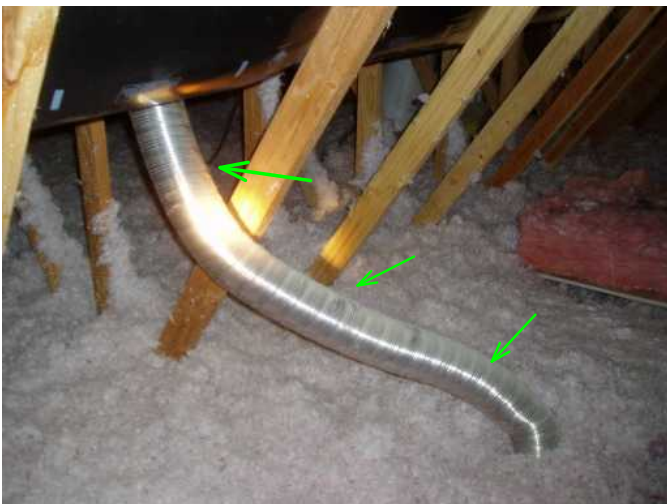
all bath and laundry vents to roof are installed solid and hung to stay...good..

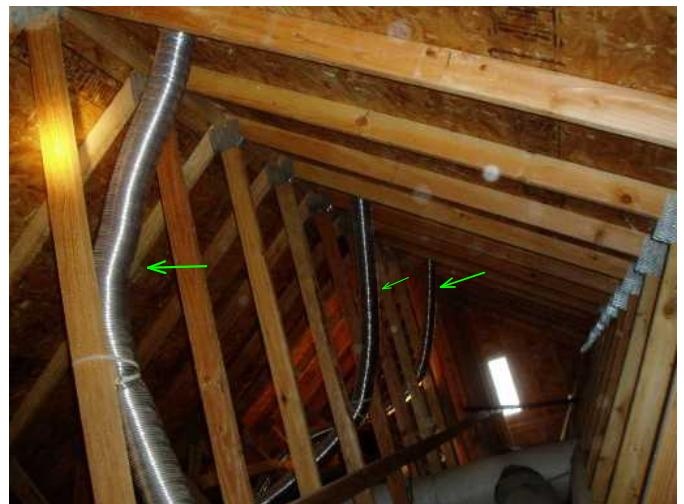
here is view of all three vent tubes to roof vents...srapped solid and attached well..good...

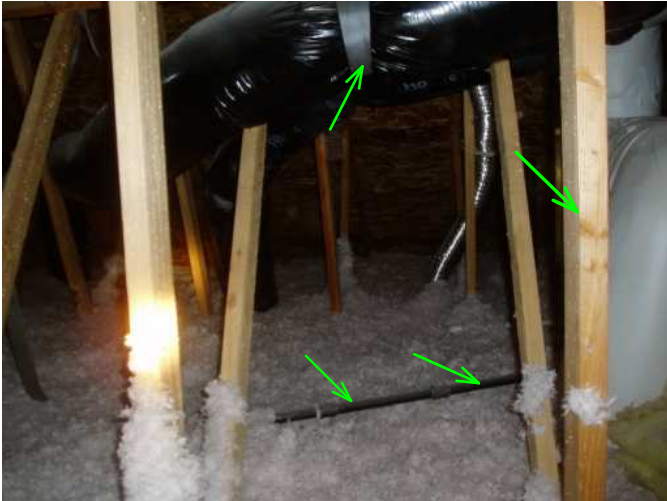
gas line to furnace is solid and dcuts are all insulated...good..

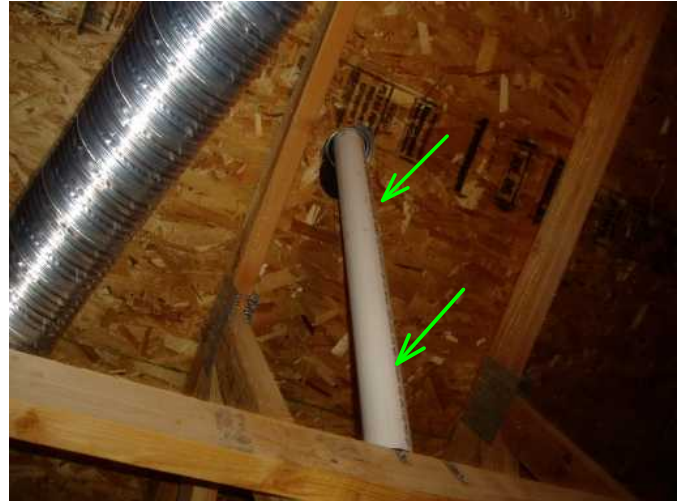
furnace flue to roof is noted here and is stain free.....good..

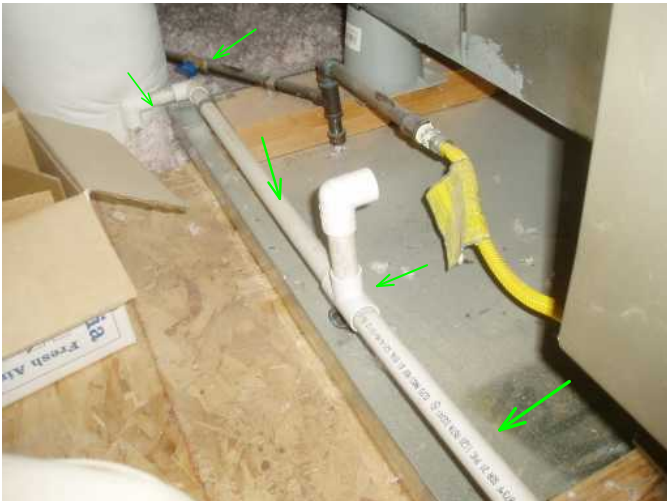
furnace is in drip pan and condensation drain and drip pan are plumbed to drain to lower and out area...good..

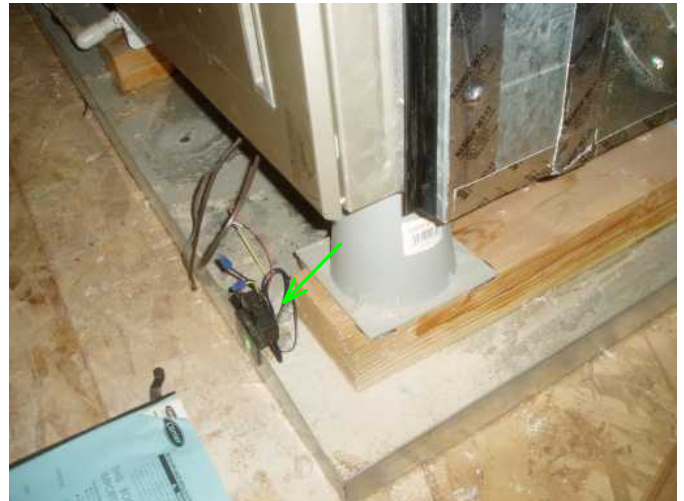
overflow shut off is noted in drip pan...if detected to be full of water, will shut off furnace/ a/c units...

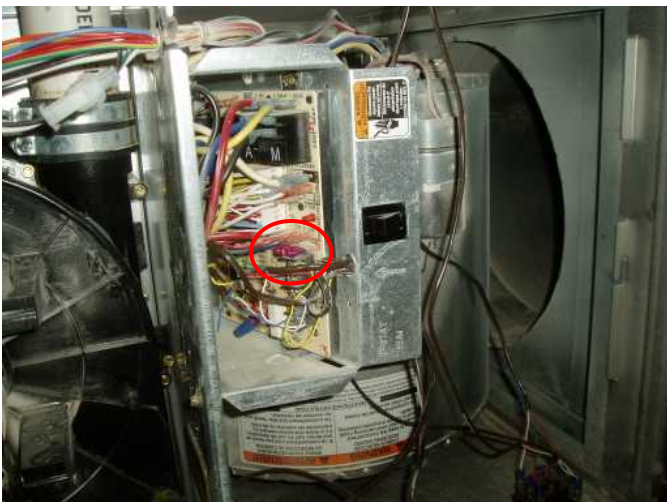
this little fuse is the culprit that appears to have failed and there is a second one on furnace as well..repair unit

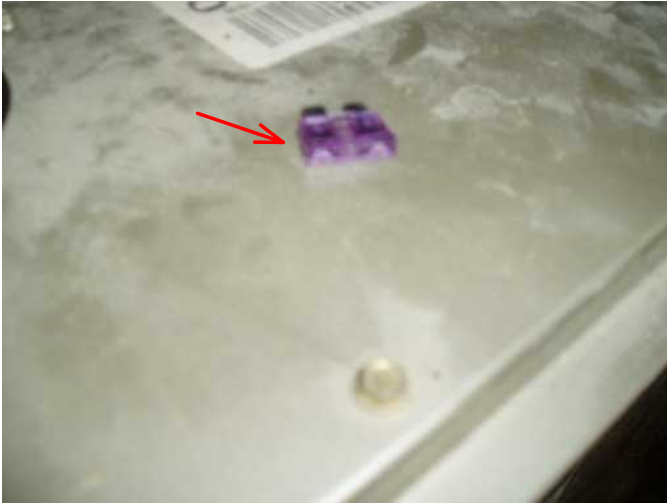
second fuse noted here on furnace that is failed as well..must be some other issue causing fuse failure...correct...

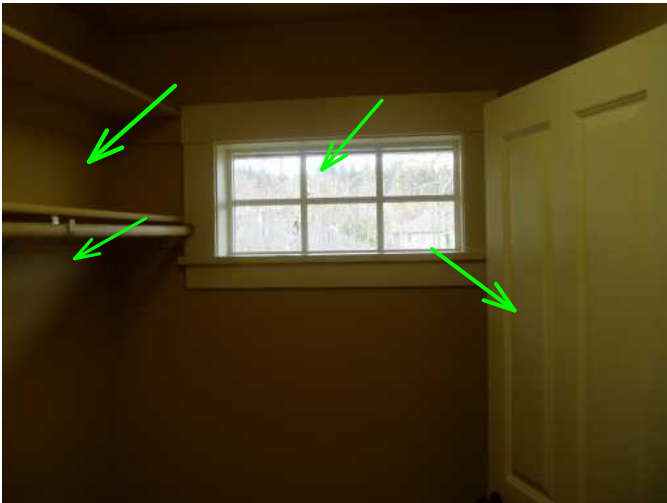
master walk in closet entry door and window are fine..shelves are noted solid to walls...

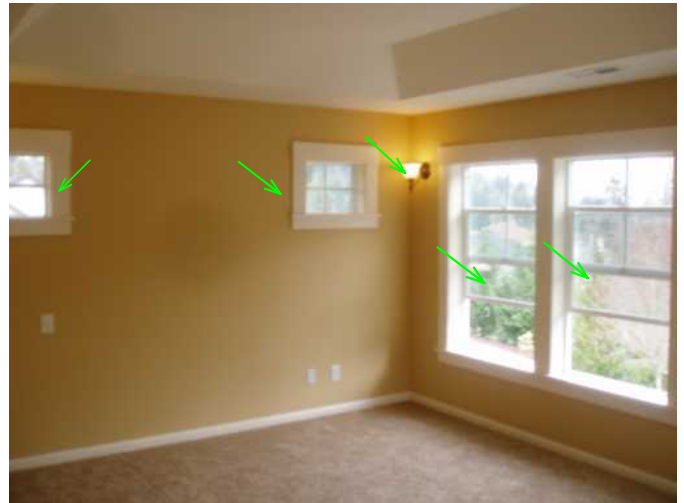
master fixtures and window are noted fine..operable..good..small windows are fixed...

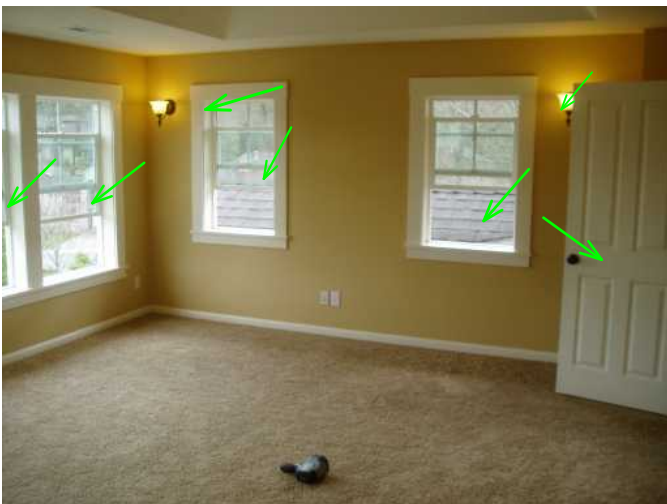
master entry door and windows are noted operable, as are fixtures...good..

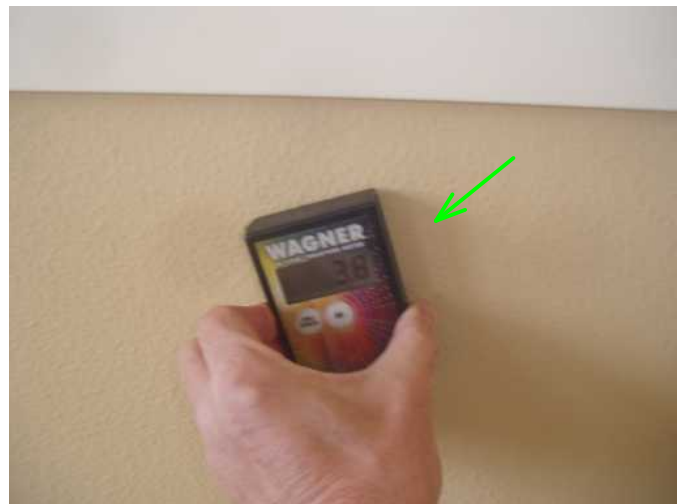
no high moisture found at exterior walls in master bedroom area...good..
