Home Inspection Report

4587 se Bethesda Drive
Gresham, Oregon

Prepared by: The Home Tester

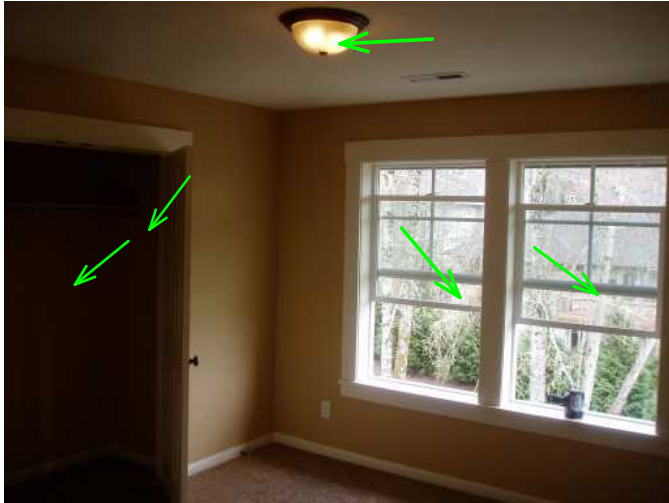
bed 2 windows and closet doors and fixture are noted operable..good..

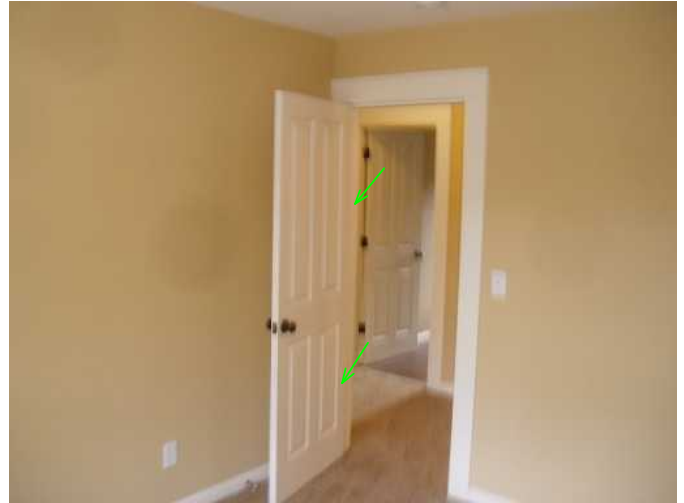
bed 2 entry door is noted operable..good...

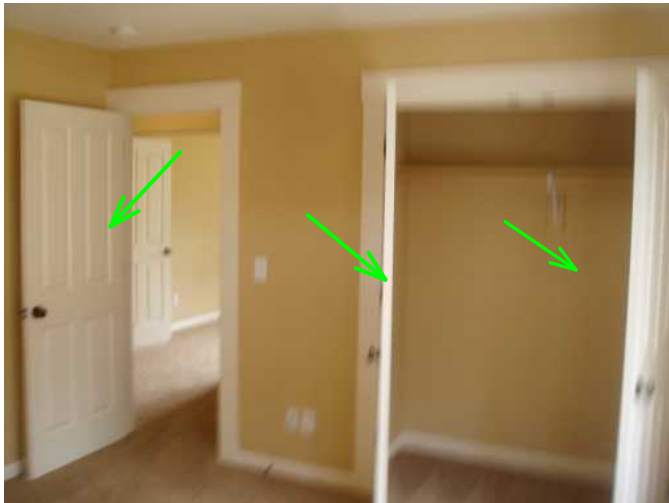
bed 3 entry and closet doors are noted operable..good..

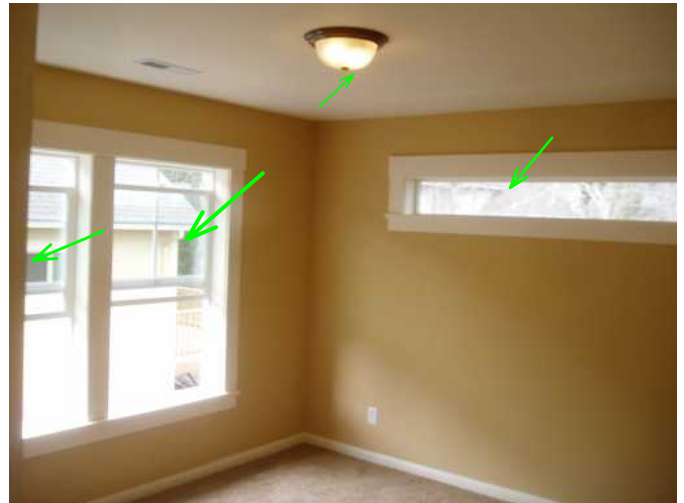
bed 3 windows and fixture are noted operable..good..

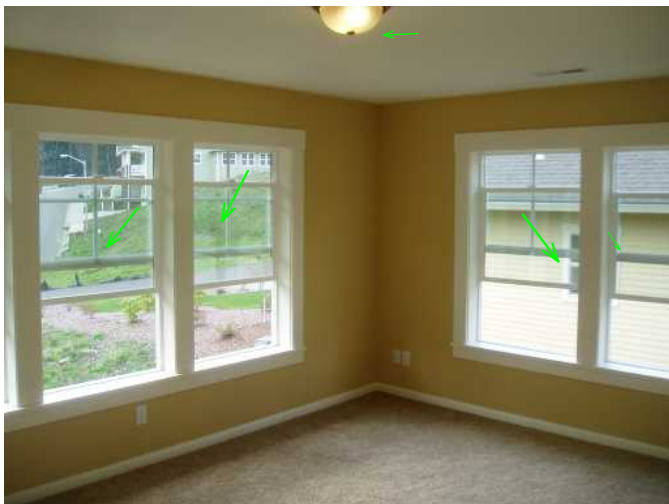
bed 4 windows and fixture are noted operable..good..

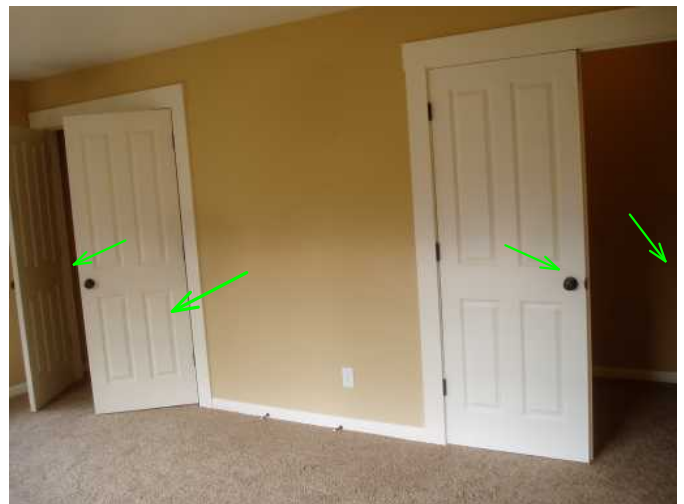
closet and entry French doors to bed 4 are noted operable..good..

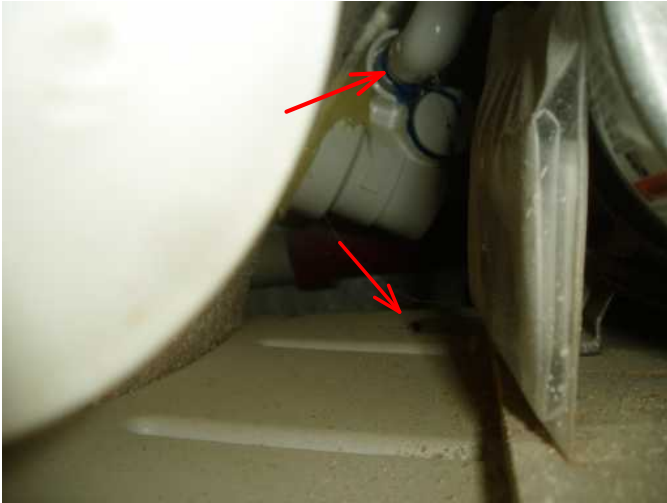
this is master bath spa tub and noted leaks at fittings under tub in enclosed area...correct....

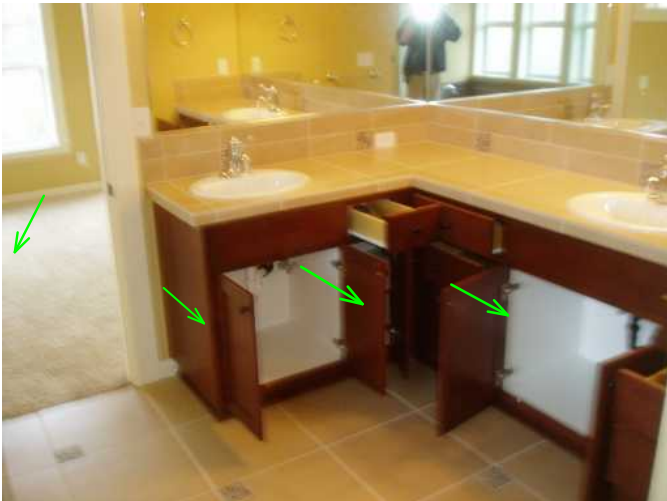
master bath entry door and cabinets are noted operable...good..

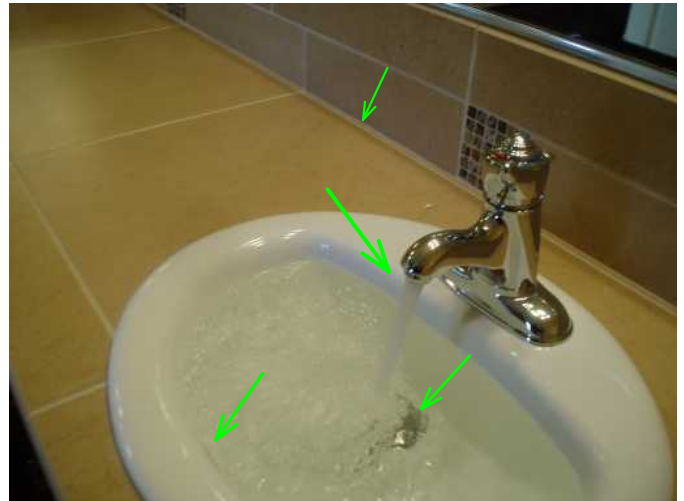
sink faucet and drain and overflow are noted operable at right area...good..

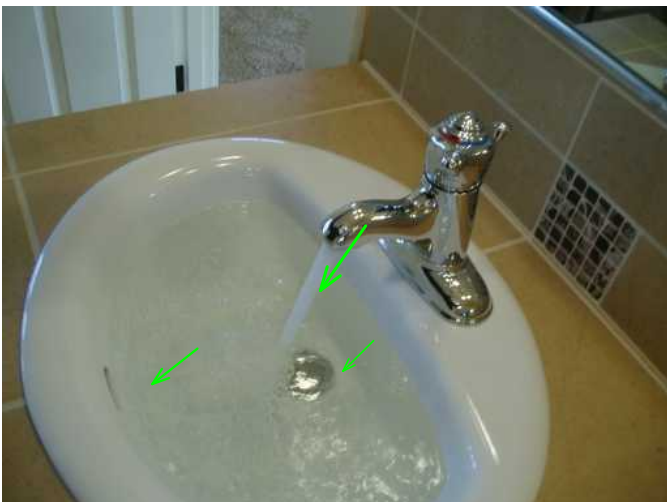
sink and faucet and overflow and drain are noted operable at left area...good..

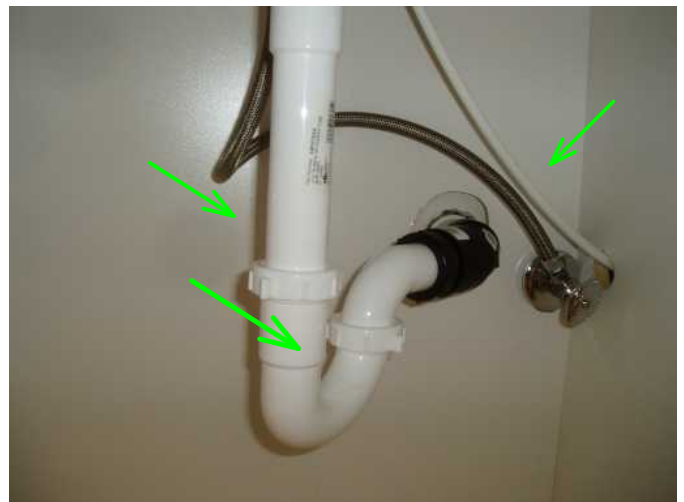
no drips or leaks noted under left sink...

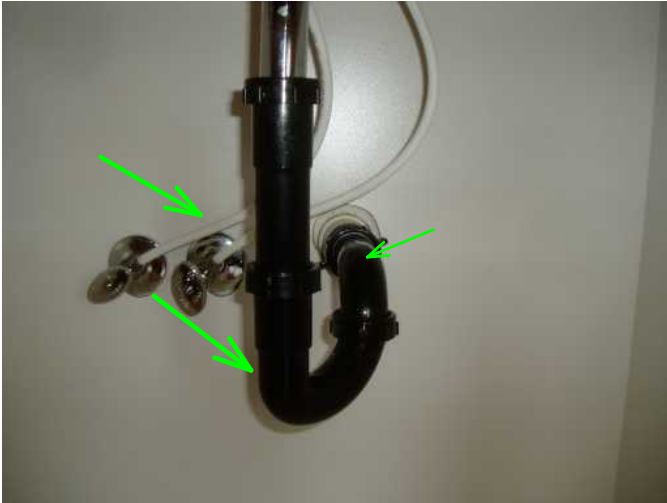
no drips or leaks noted under right sink as well..good..

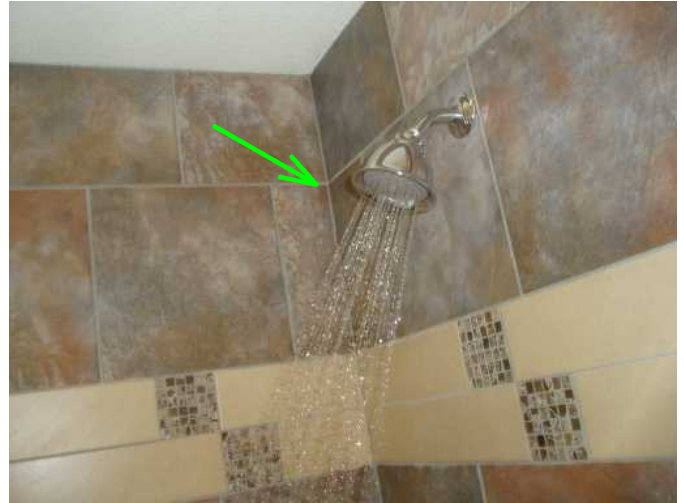
master shower head is noted operable....good..

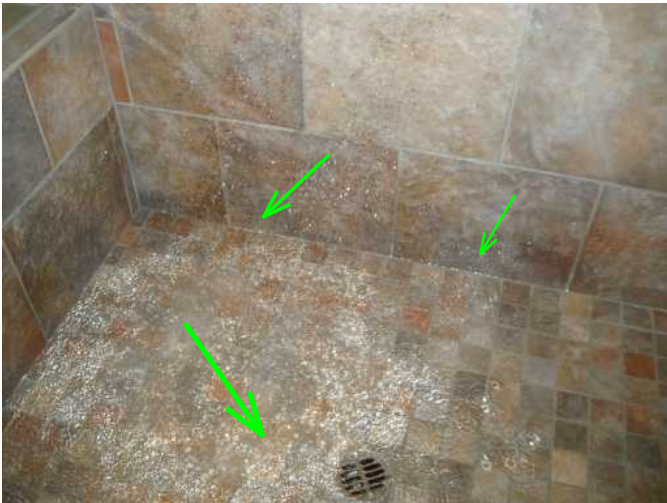
master shower floor and door are noted operable..no drips or leaks noted...good..

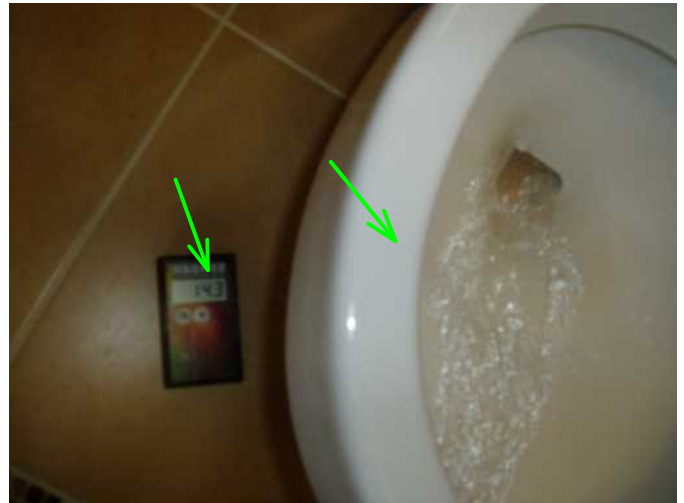
master toilet is solid to floor and no high moisture found at floor area..good..

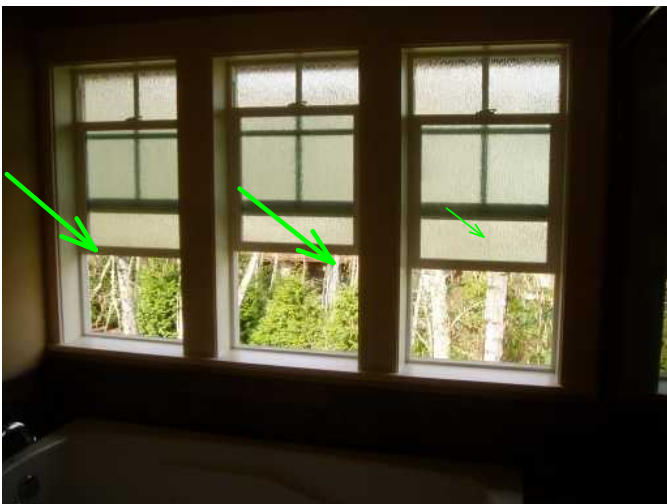
master bath windows are noted operable..good..

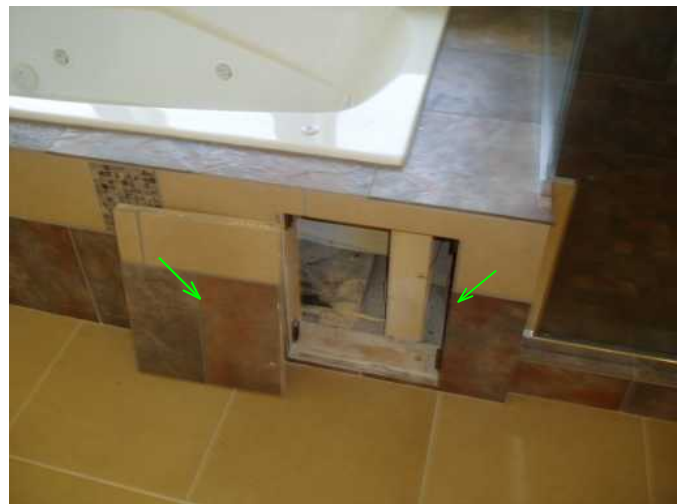
access to spa tub area is noted here...suggest all flooring around bath be caulked to avoid water wicking into MDF

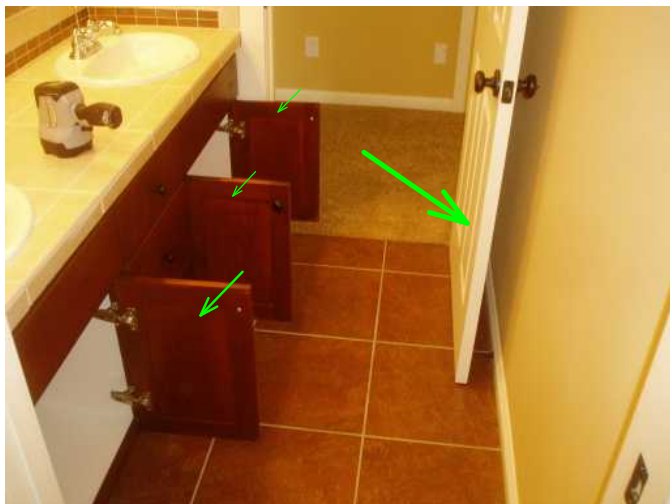
main bath at second floor entry door and cabinets are noted operable..good..

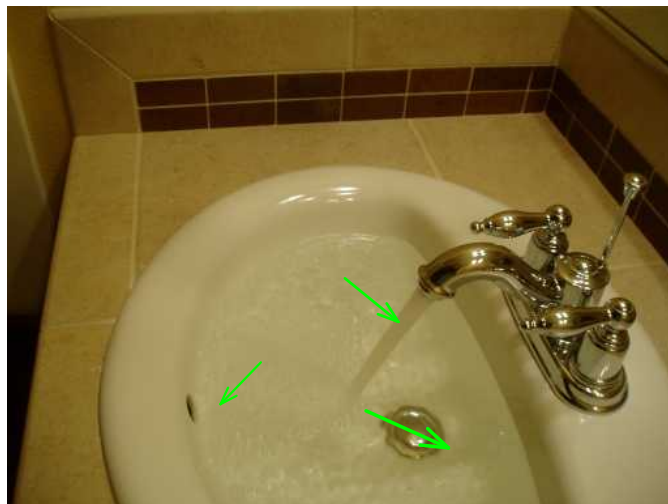
left sink faucet and drain and overflow are noted operable..good..

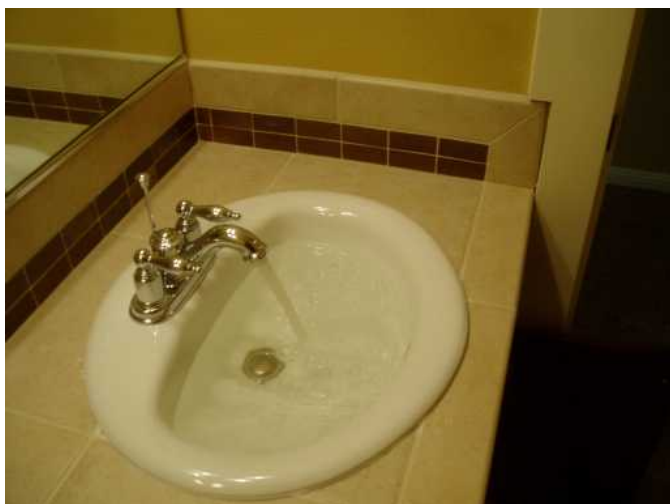
right sink faucet and drain and overflow are noted operable...good..

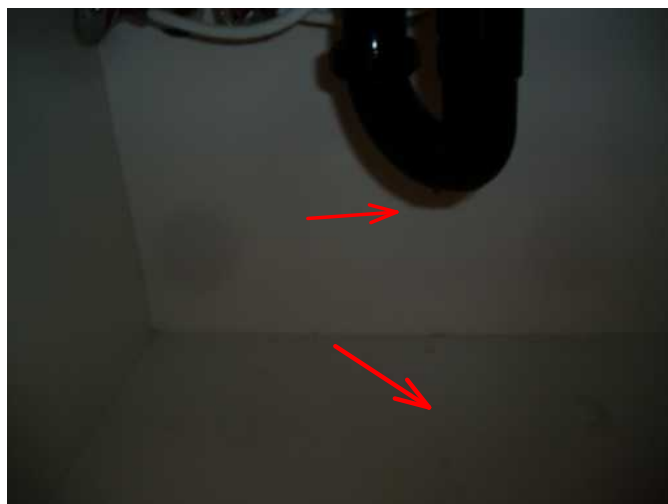
leak detected at left trap area...correct...

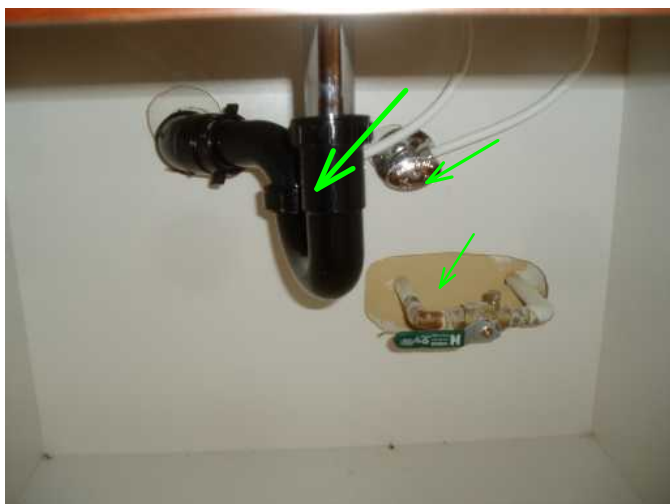
no drips or leaks detected at right sink area...good..

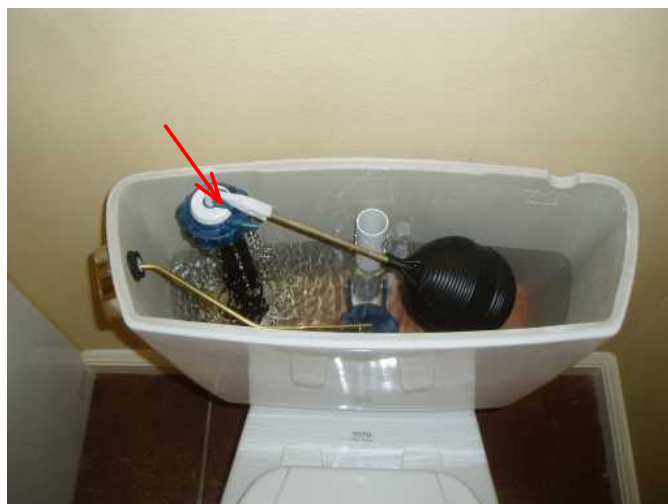
main toilet feed line is blocked and needs repair...did not fill tank as needed....correct....

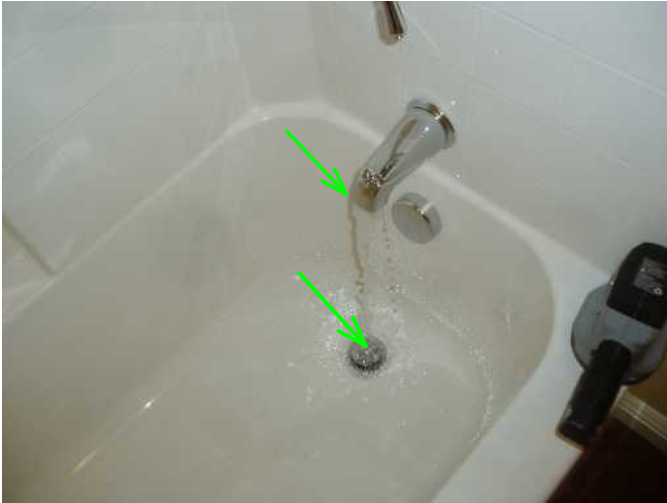
main bath tub faucet and drain are noted operable..good..

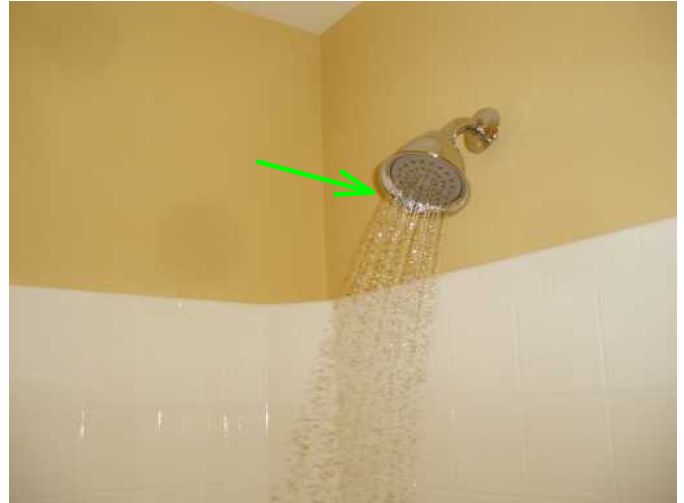
shower head is noted operable..good...

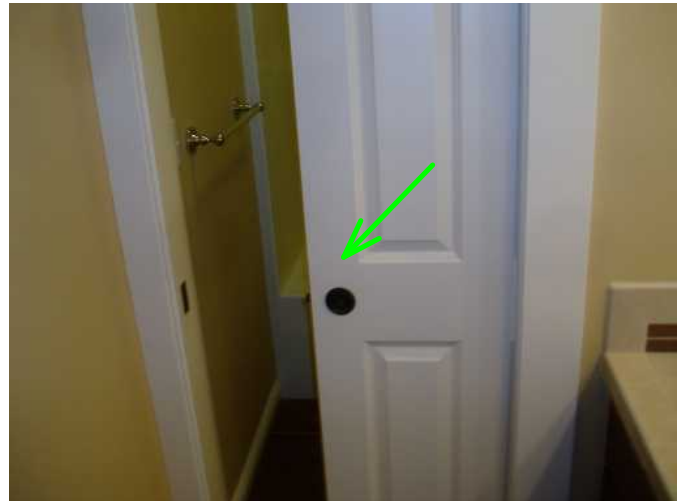
pocket door to toilet and shower area is noted operable..good..

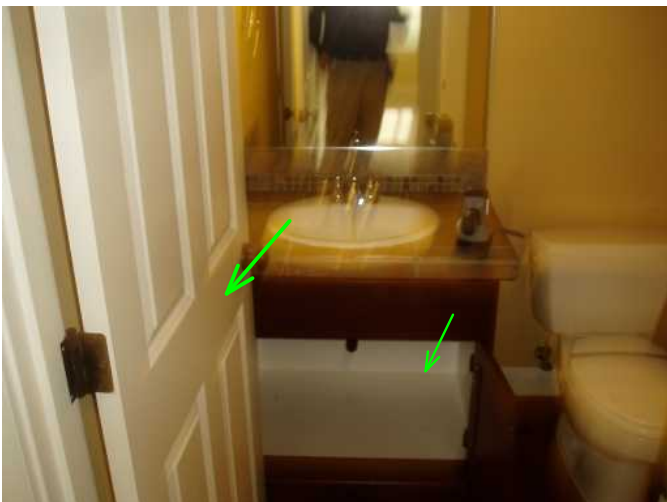
entry door to first floor bath and cabinets are noted operable..good..

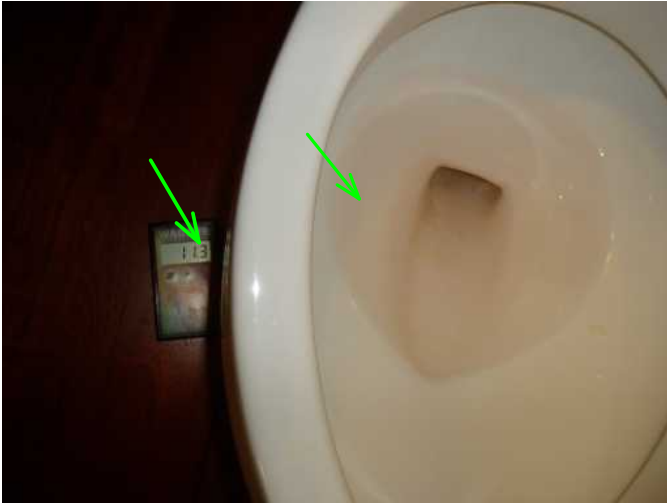
toilet is noted solid to floor...toilet has same issue as main bath...feed tube is noted not operable..and needs repair...

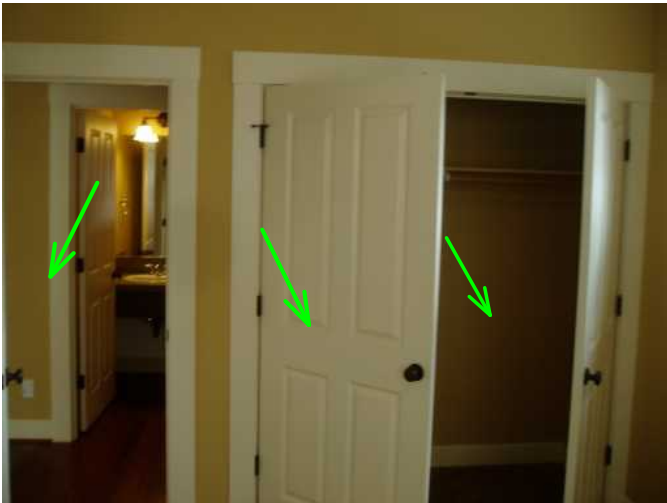
first floor bed 5 entry and closet doors are noted operable..good..

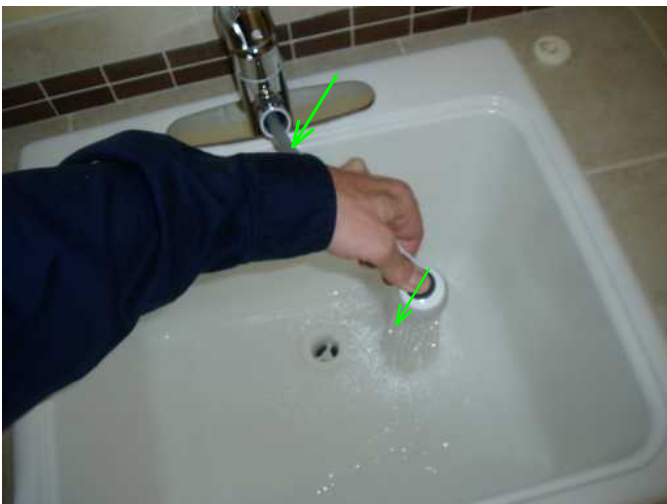
laundry tub faucet and drain are noted operable..good..

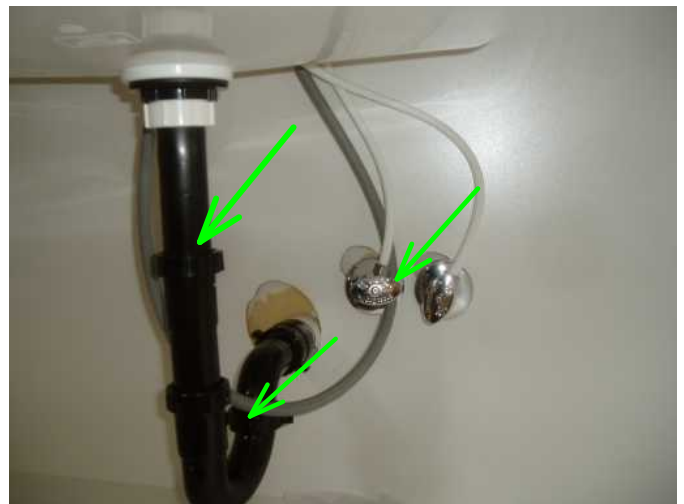
no leaks detected under sink at laundry tub area...good..

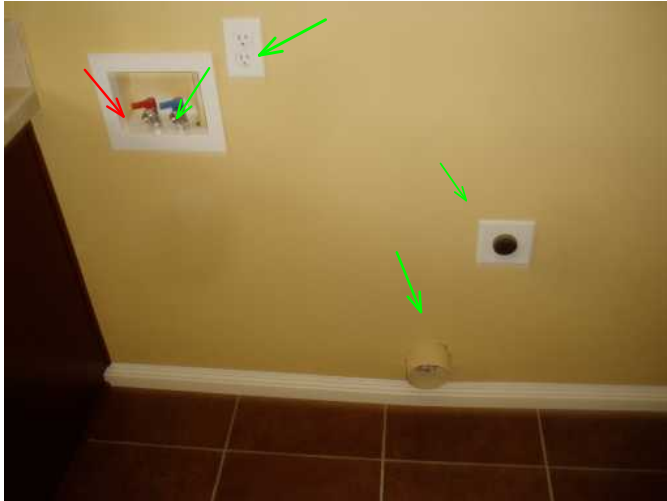
washer hook ups are noted fine except for drain...needs to be opened at red arrow...dryer connections are noted fine..

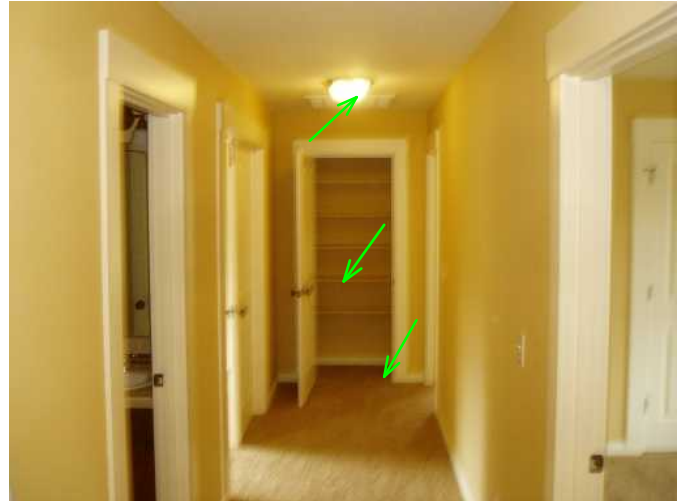
main upper hall fixtures are noted operable..as is door to closet at end of hall...good..

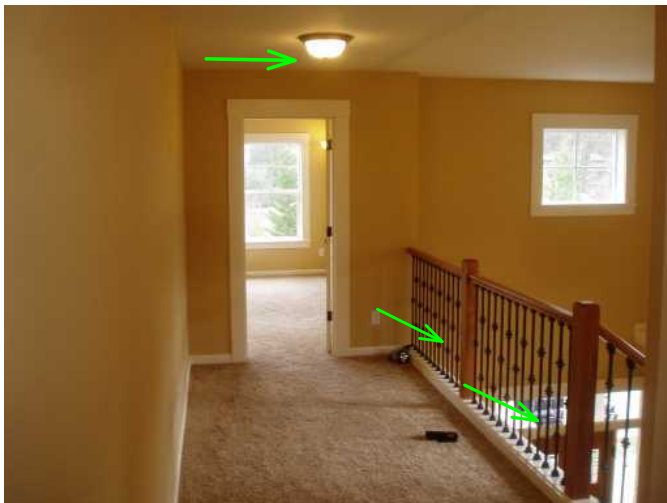
fixture at master entry and handrails are noted solid here at top of stairs area...good..

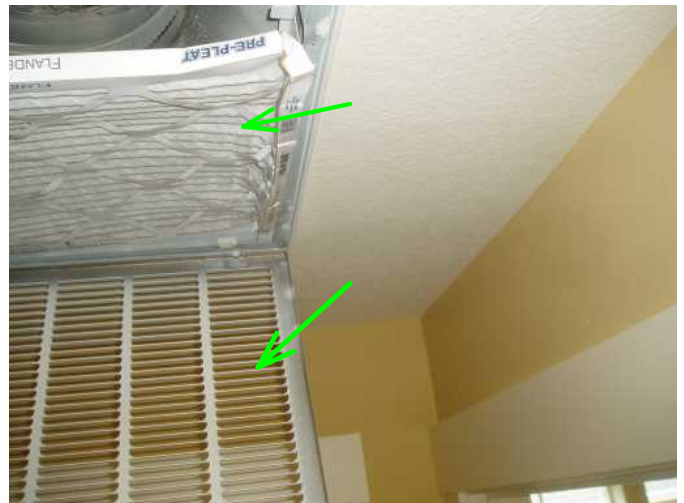
filter for furnace is noted at end of hall in return air in ceiling...good...change filter every 30-60 days..

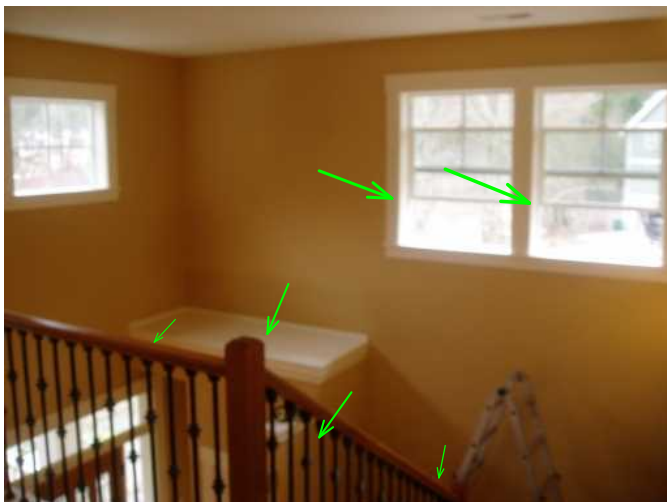
upper hall handrails and windows are noted operable..good..solid to floors...

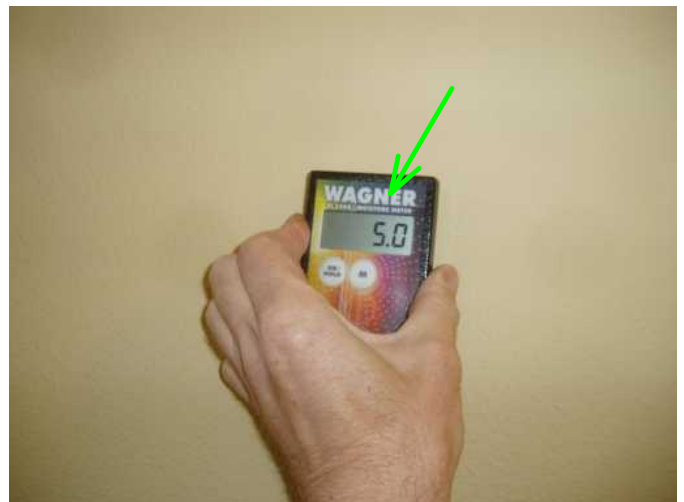
area under windows is noted low moisture...good..

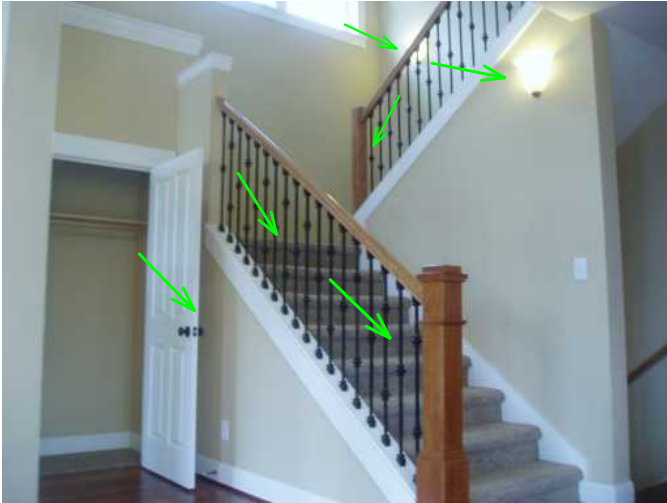
main entry handrails and fixtures and entry closet door are noted solid and operable...good...

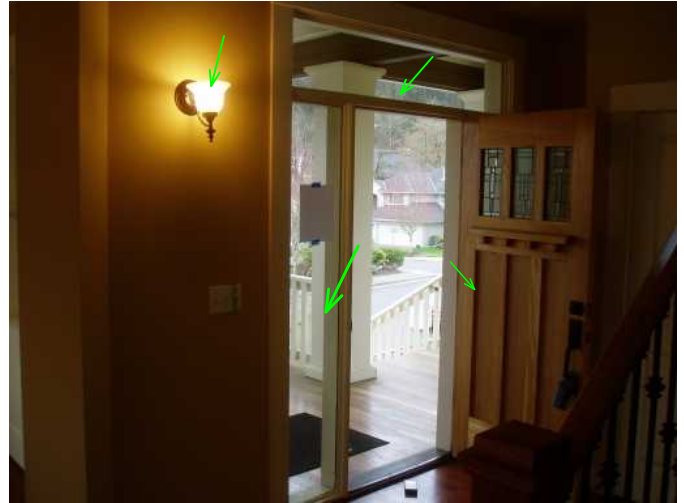
entry stair tower main door and wall fixtures are noted solid and operable..good..

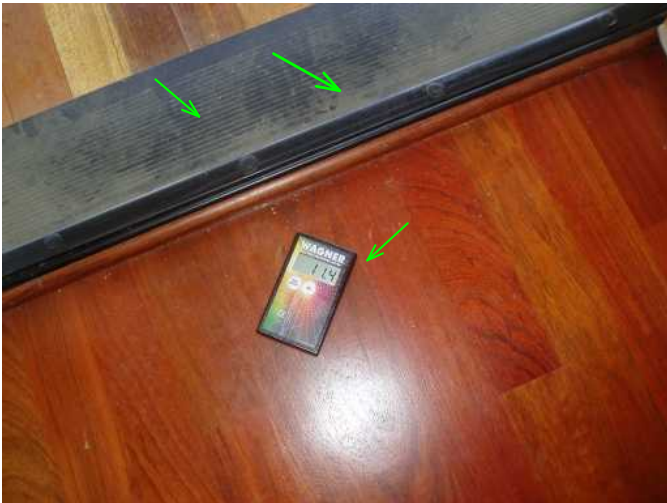
threshold and weather stripping around door are noted fine..no high moisture at floor noted at entry door..

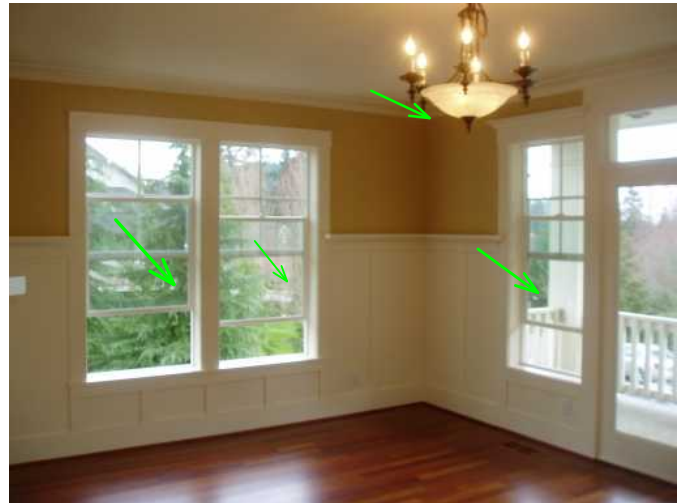
fixture and windows are noted operable in living room area...good..

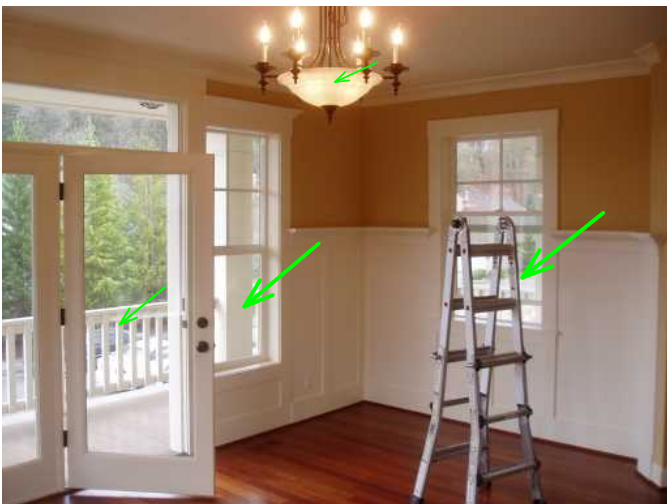
entry door to porch and fixture and windows are noted operable here as well...no high moisture noted at exterior walls..

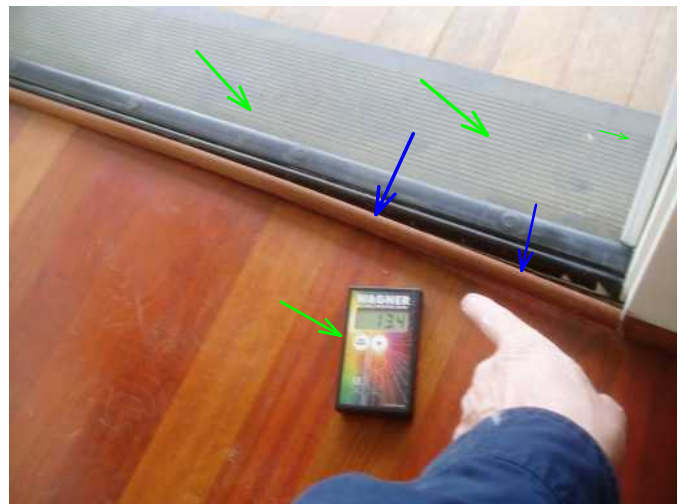
porch exit door threshold and weather stripping are fine..no high moisture noted..trim needs attached...

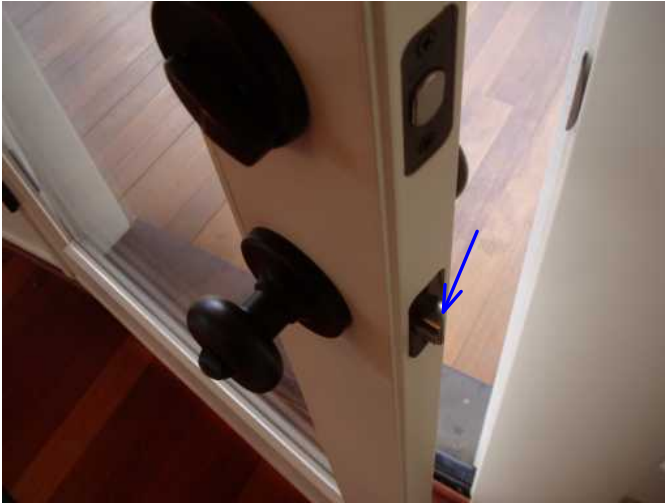
door handle latch is noted here to not latch...correct...

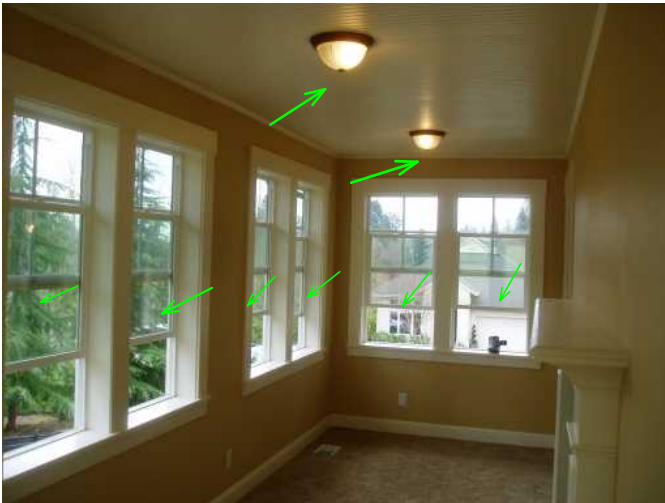
Sun room windows are noted operable as are fixtures...good..

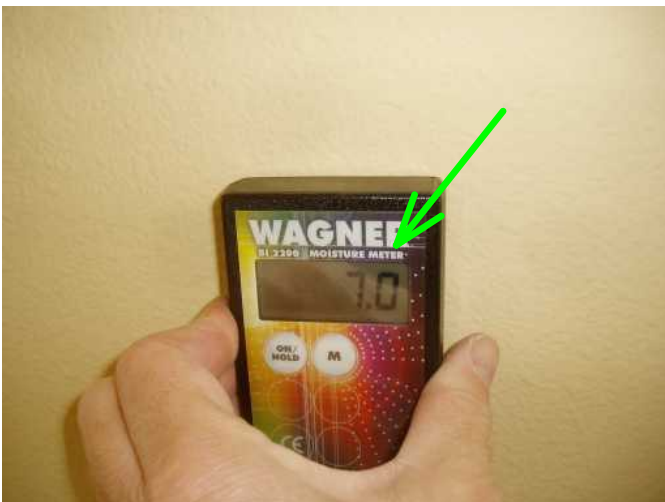
checked walls in sun room and found no high moisture at exterior walls...good..

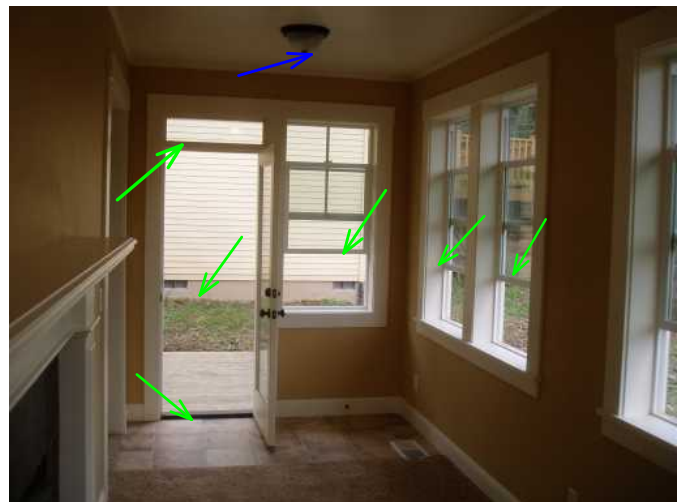
fixture at ceiling needs bulb...windows are noted operable..as is side door to deck...

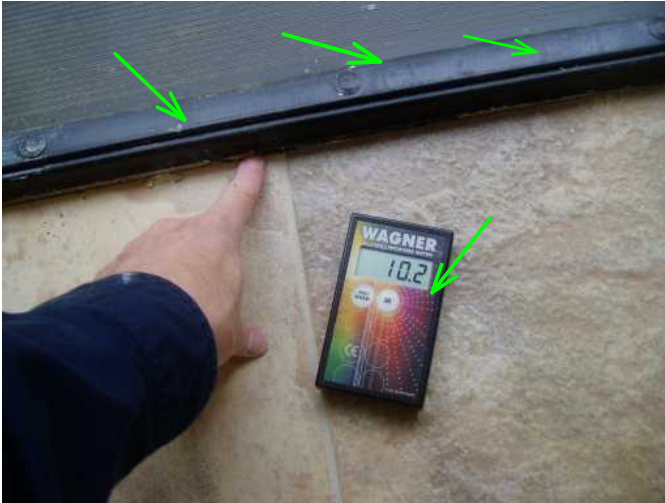
threshold and weather stripping around exit door are solid..needs grout at edge...no high moisture found...

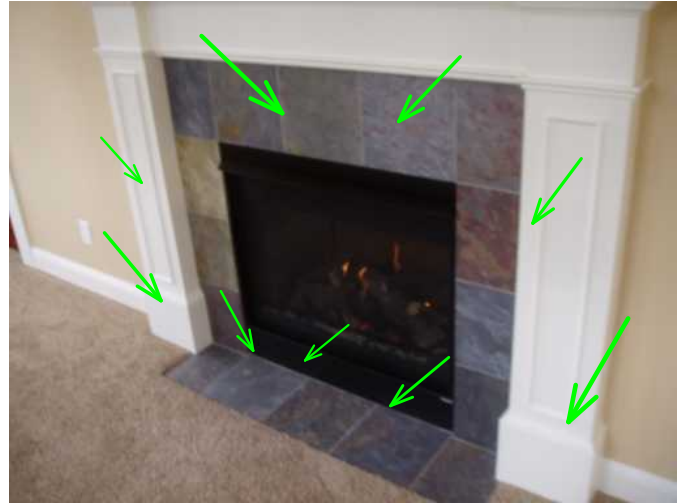
fireplace is see through into family room and is operable...shut off is in sun roomgood..

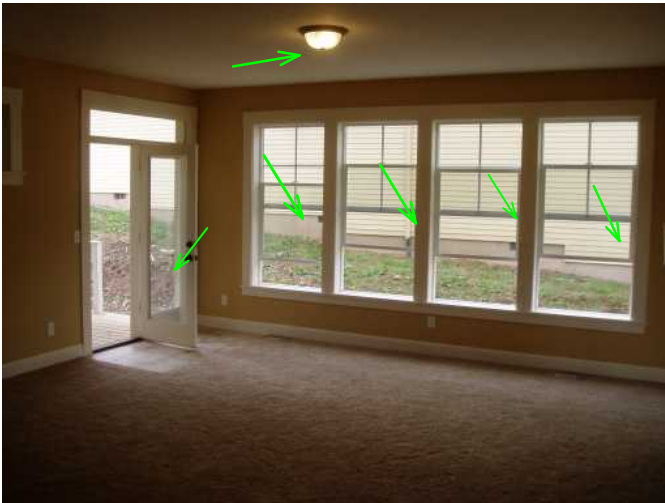
family room windows and fixture are noted operable as is door to side deck area...

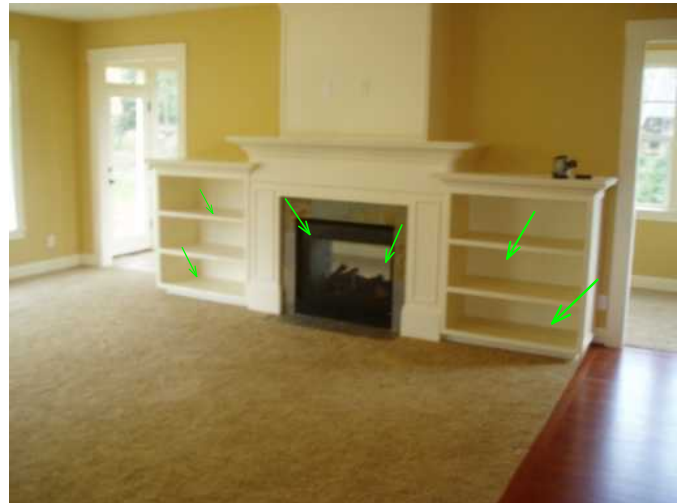
center of family room shelves are solid to walls and fireplace is see through to sun room and is switched in sun room...

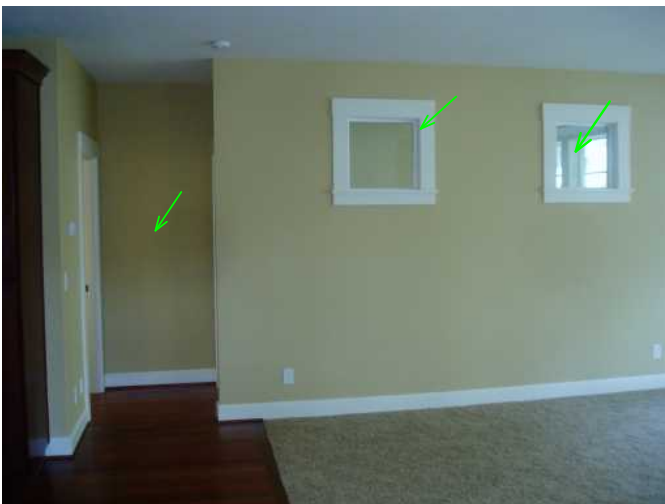
windows in this area are through into bed 5 area to let in light...good..

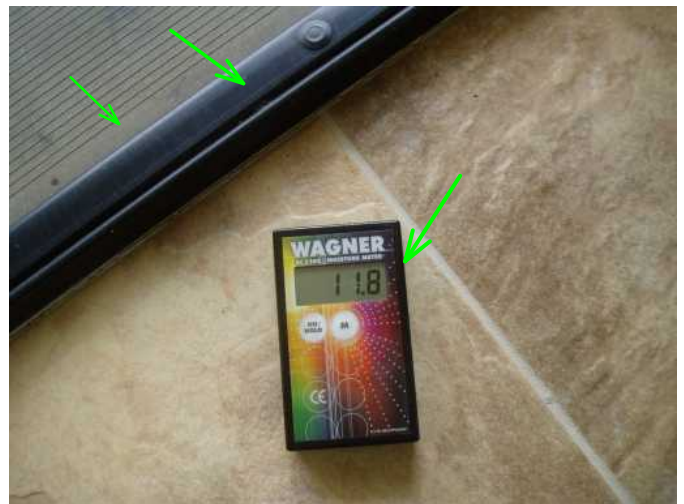
threshold to deck door in family room and weather stripping are fine...no high moisture found at floor area...good..

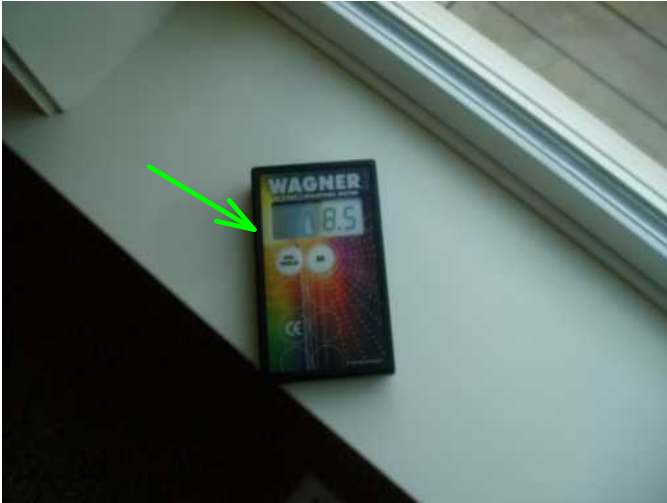
checked walls and window sills and all fine in exterior walls in all of home...good..

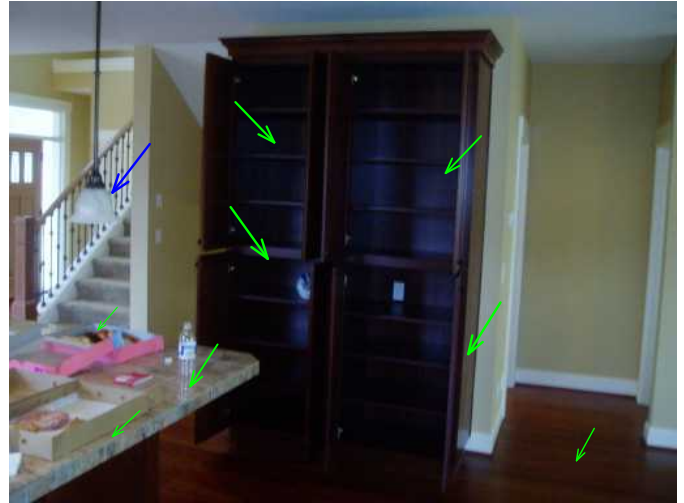
dining area has large pantry off to center wall area..and large island bar for stools around to eat at...fine..

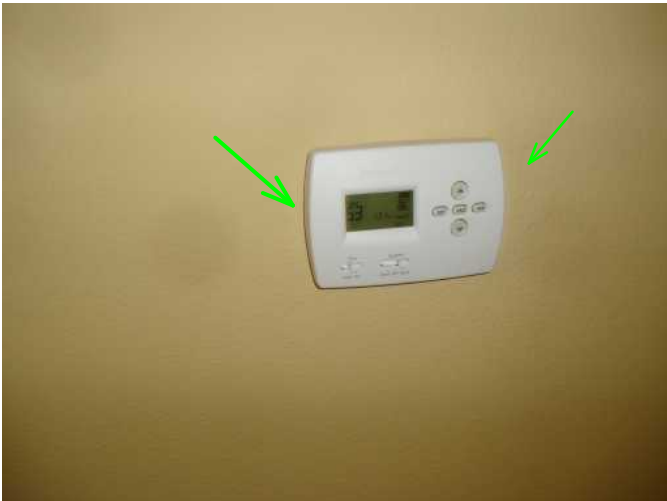
programable thermostat is noted in center of home...and appears to respond to requests...furnace not operable..

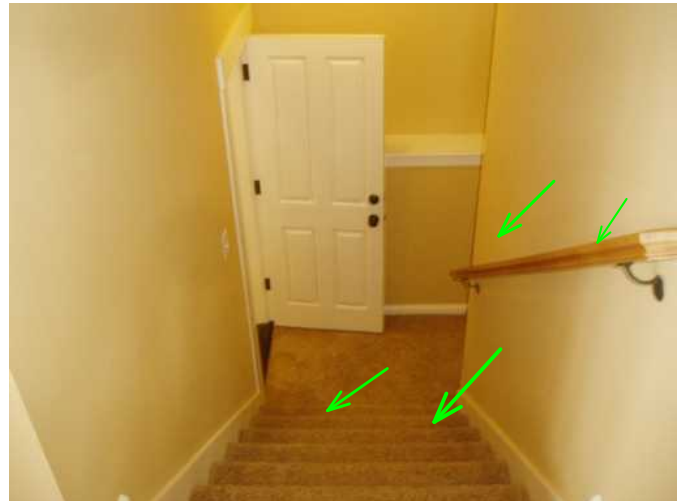
handrails to lower area basement are solid and sound....

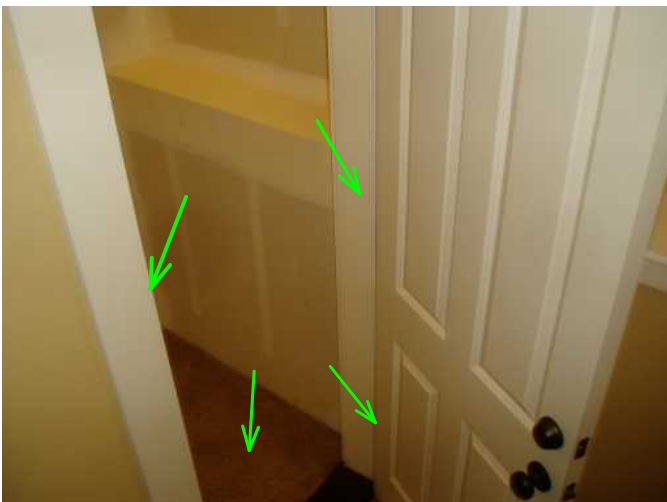
left door at landing to garage is weather stripped and threshold is noted solid and sound...good..

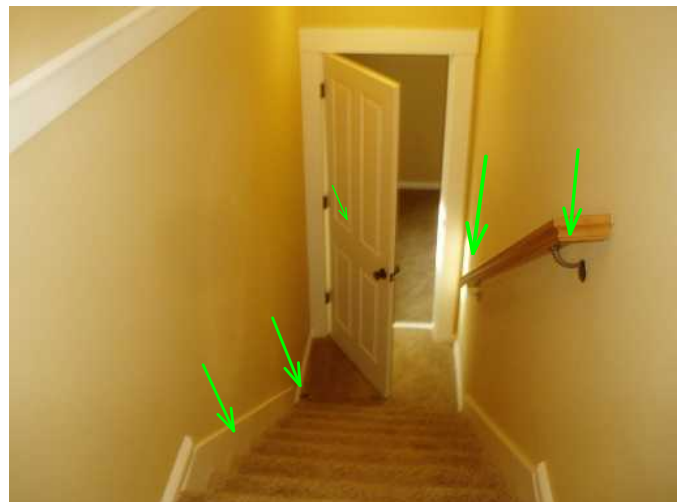
handrails to lower area of living space in home are solid and stairs are even...good...

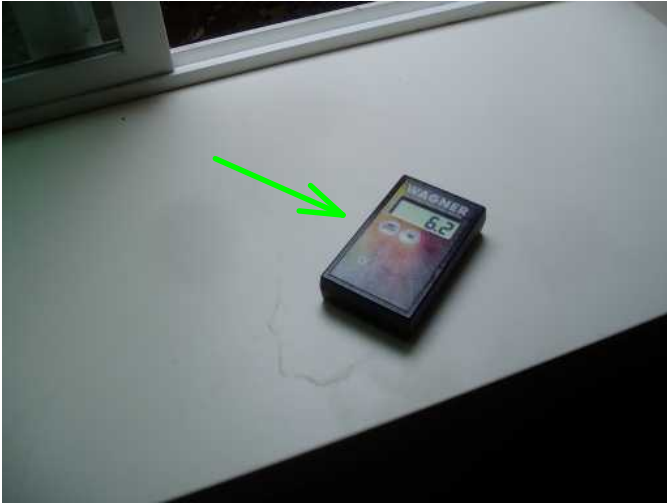
large window sill is noted in basement family room and
no high moisture is noted in wood sill area...

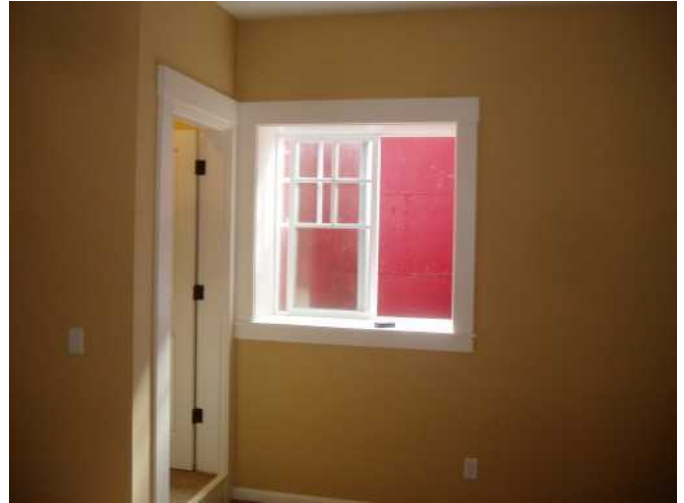
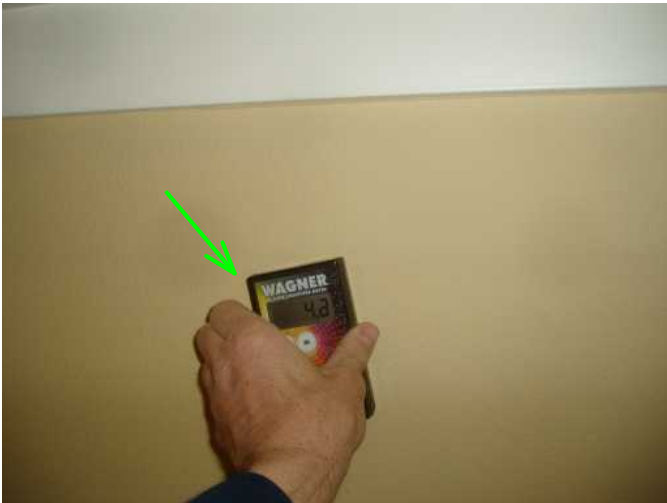
no high moisture noted under window as well.....

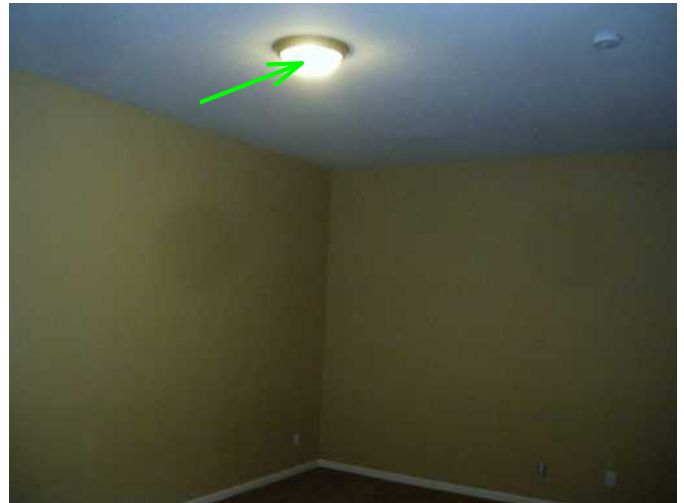
family room fixture is noted operable..walls are
fine..no high moisture detected...

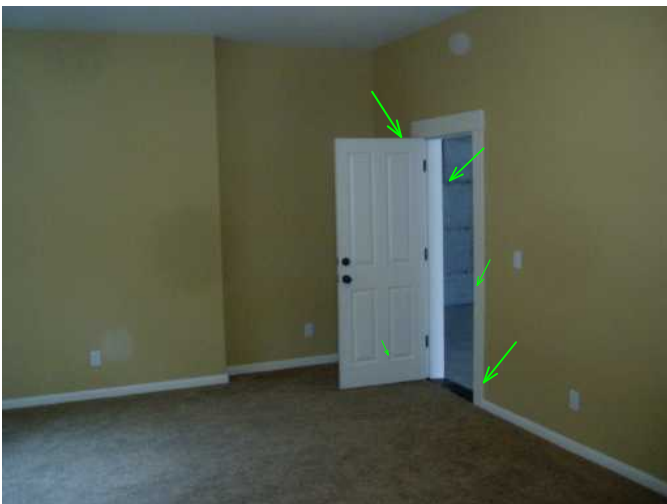
door to garage in family room is weather stripped and
threshold is found solid and sound..good...
