Home Inspection Report

4587 se Bethesda Drive
Gresham, Oregon

Prepared by: The Home Tester

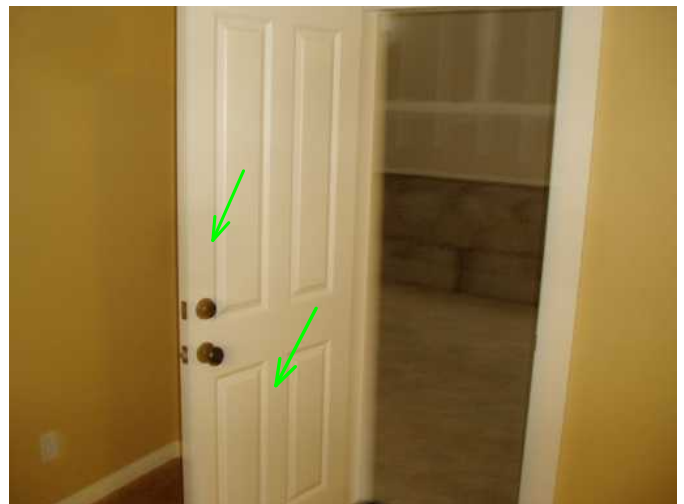
hardware to door is noted operable..good..

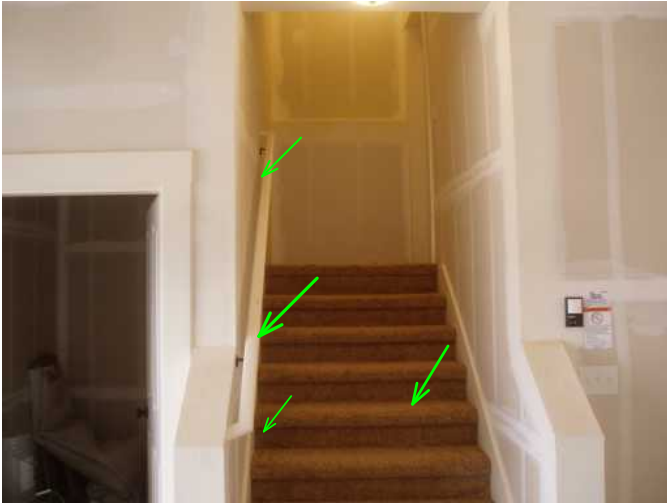
handrail to lower area of garage by second set of stairs into garage are found solid and sound...good..

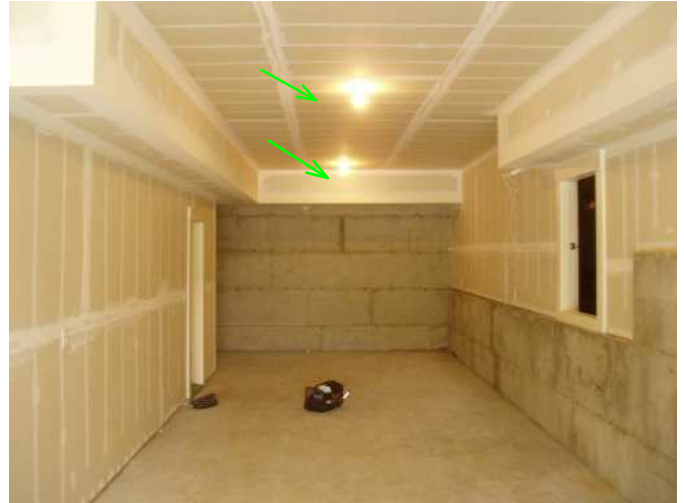
fixtures in back area of garage are found operable..door opener control responded well...

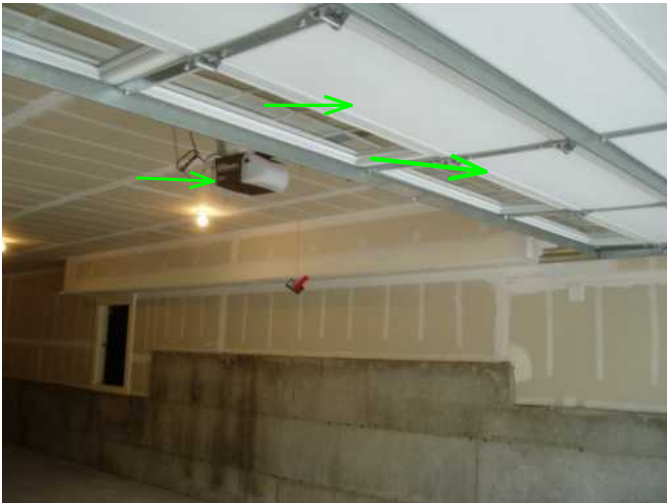
garage door is operable...and opener has auto reverse operational...good..

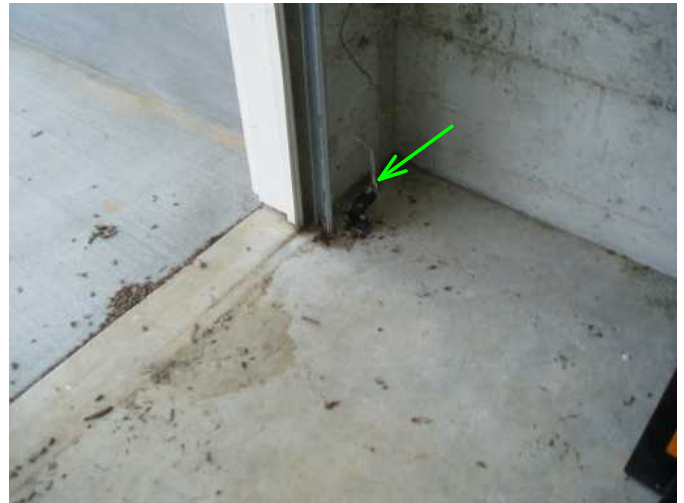
lazer detected interruption and reversed quickly....good..

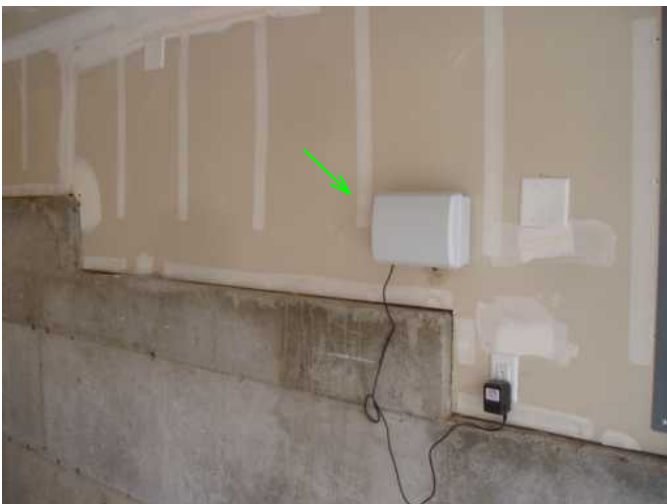
did not test sprinkler system...is beyond scope of home inspection..have assessed by system professional

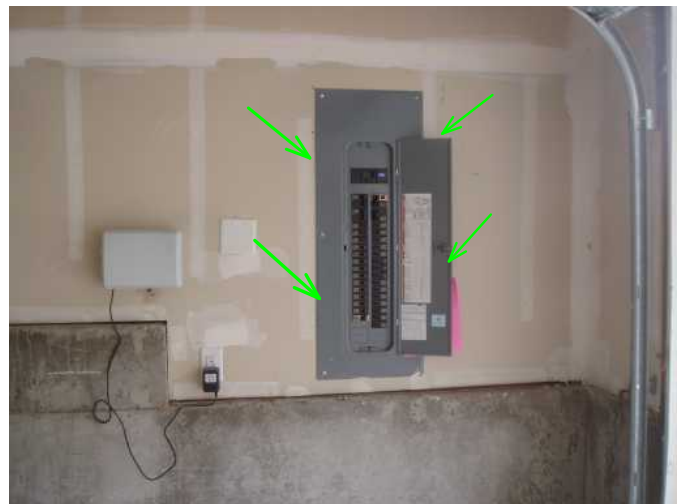
200 amp system is found in front of garage and is noted installed well, all clean and professional work found...good..

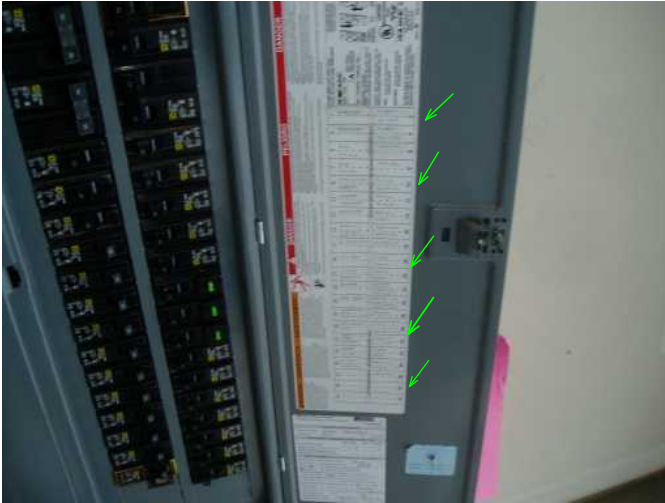
system is clearly marked and has additional breaker opening for future..

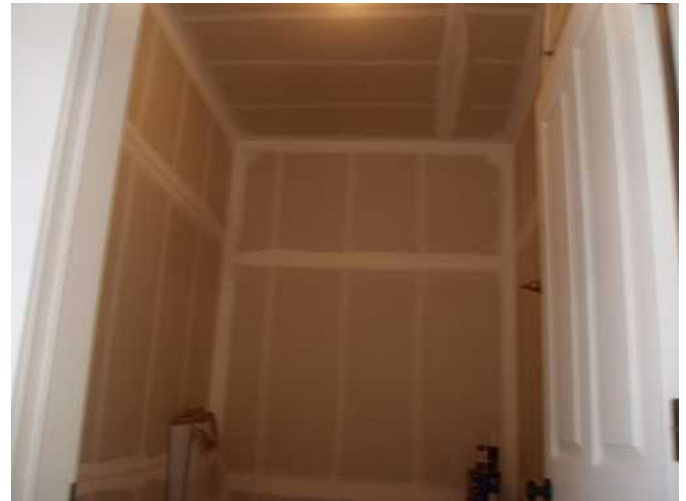
small utility room off garage is noted with paint and flooring and main water shut off

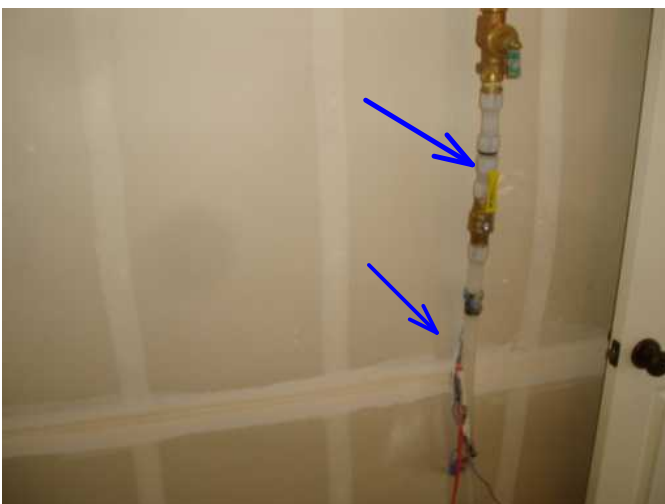
main water entry and shut off noted here, suggest insulation added to protect from freeze in winter....

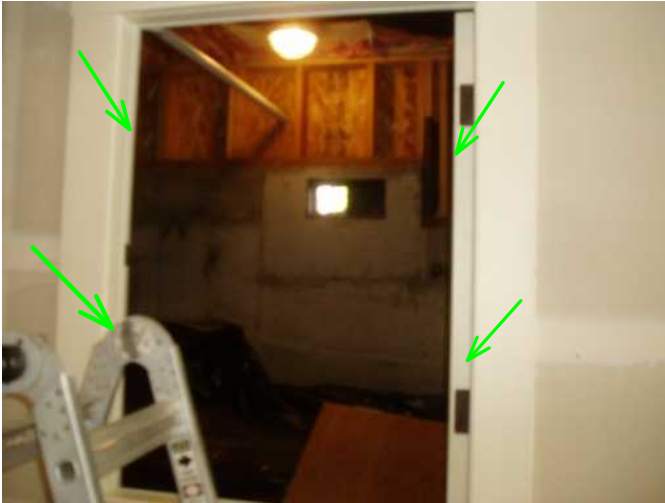
access door to crawl space is noted here in garage and is weathe stripped well...good..

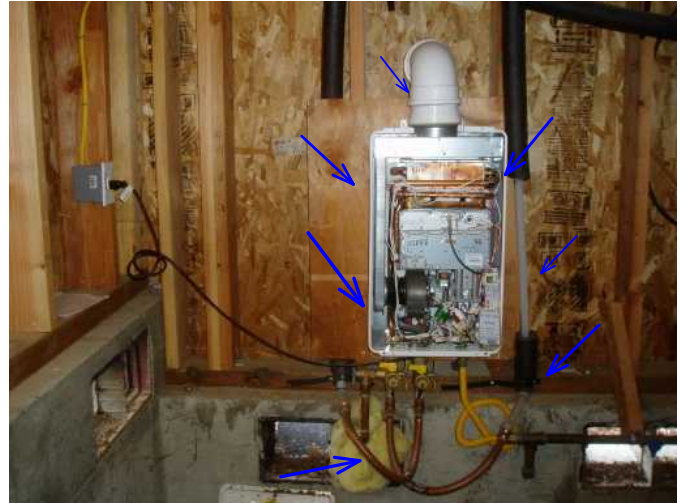
water heater is found not user ready...cover plate is off and gas is shut off and needs serviced to make user ready...

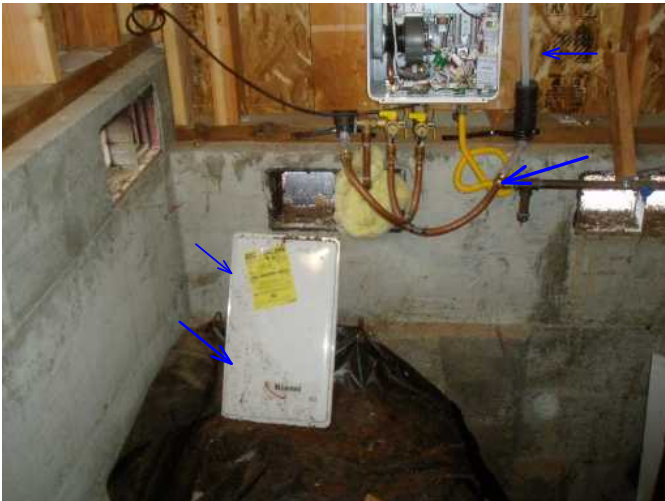
cover found on crawl floor and no screws found to attach...some PEX pipes need insulated...

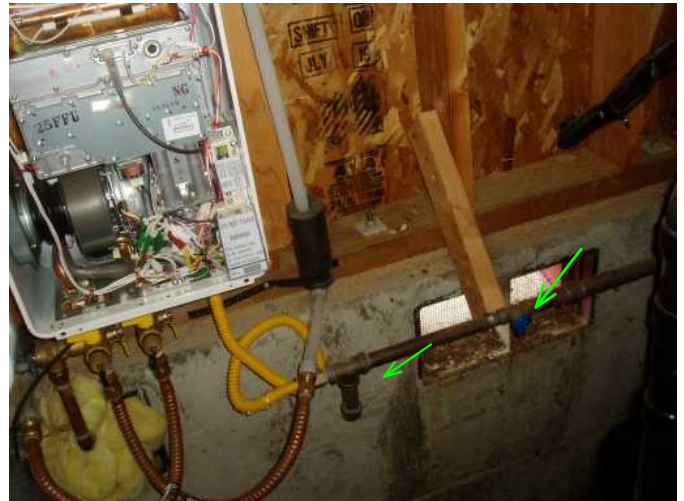
drip leg is found and main shut off was found off and was left off when found in state of condition here....

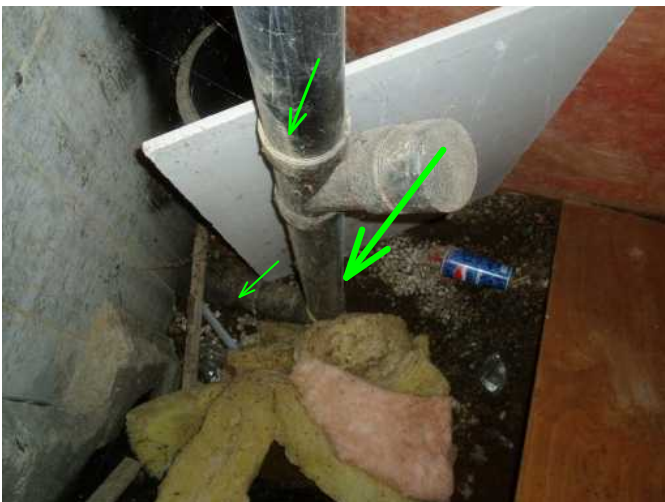
main sewer exit line is noted here and is accessible for clean out if needed...

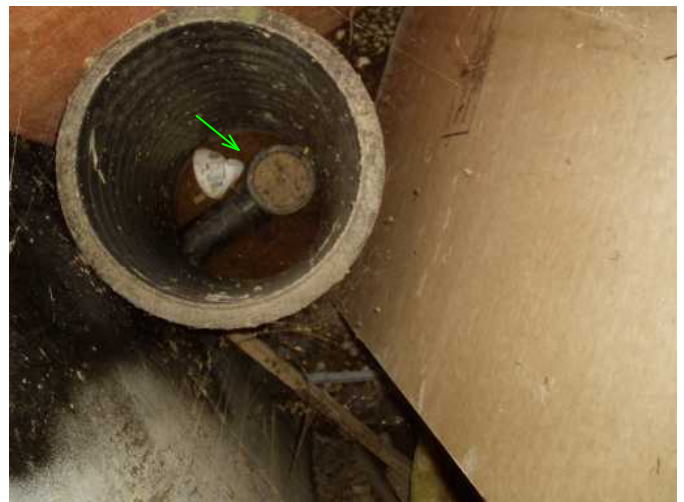
gate at base of crawl space is noted if any water issues occur and need to drain ...

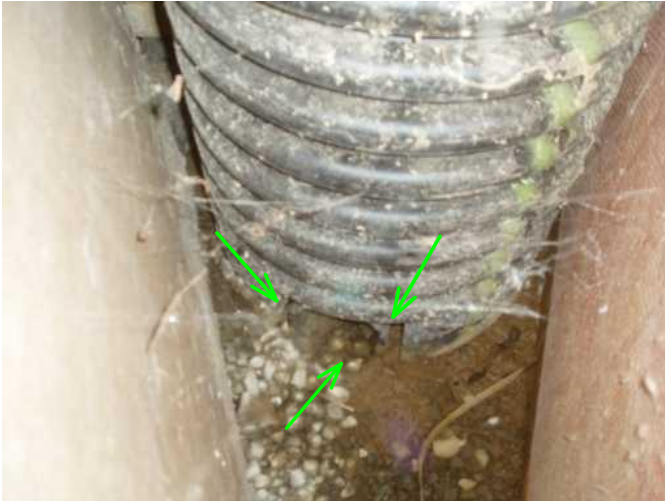
drain is noted here for exit gate....good..

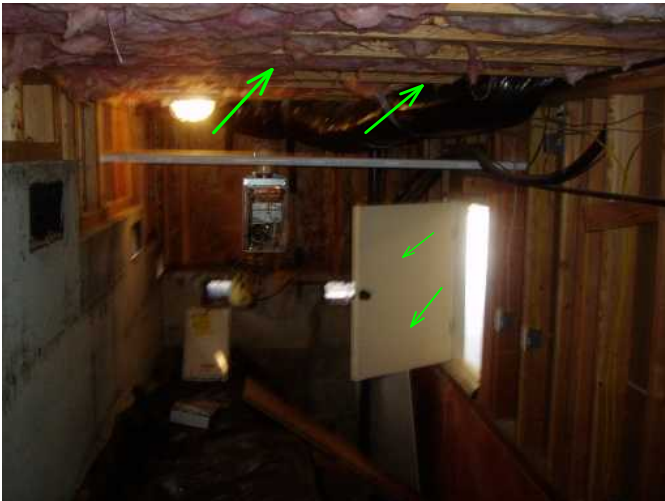
overall view of crawl space is noted here with under floor insulation found installed well...good..

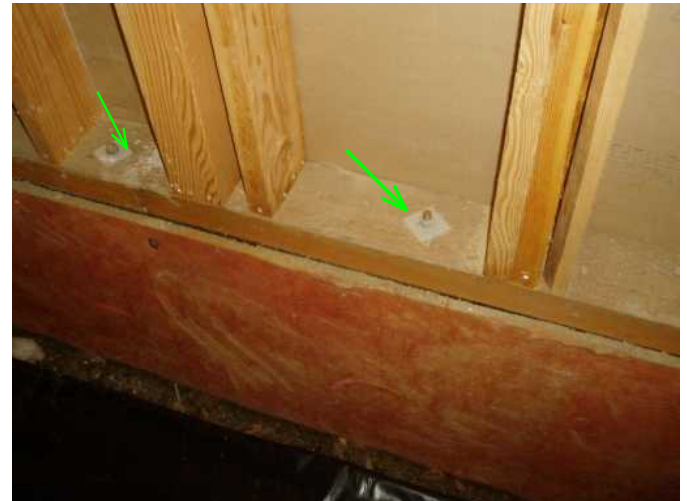
earth quake protection found at foundation and mud sills...good..

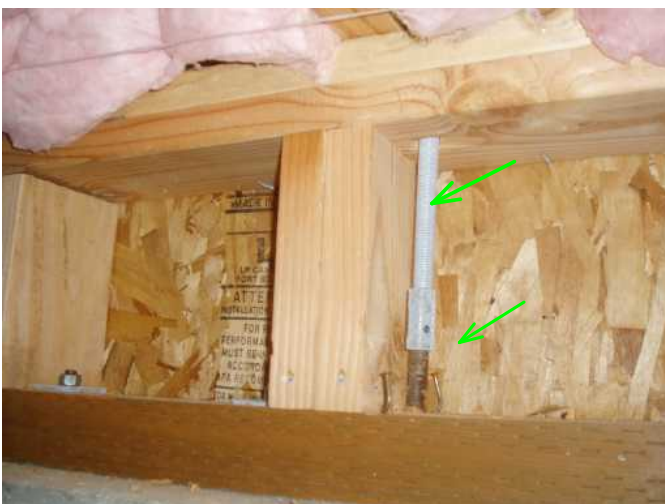
extra support bolts found as well...good..

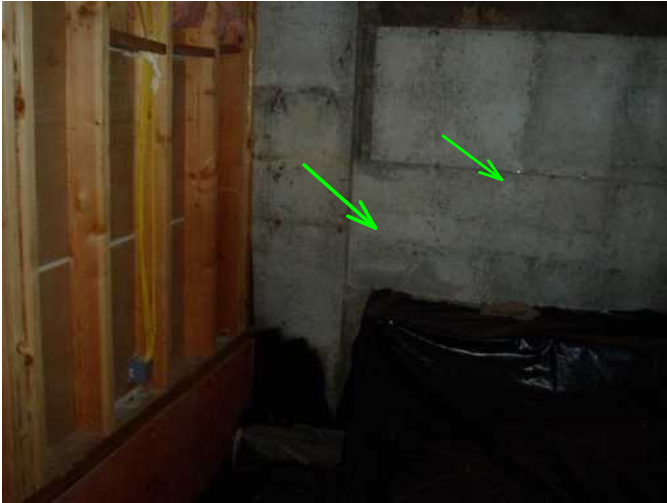
no staining noted at crawl space area concrete walls...good..

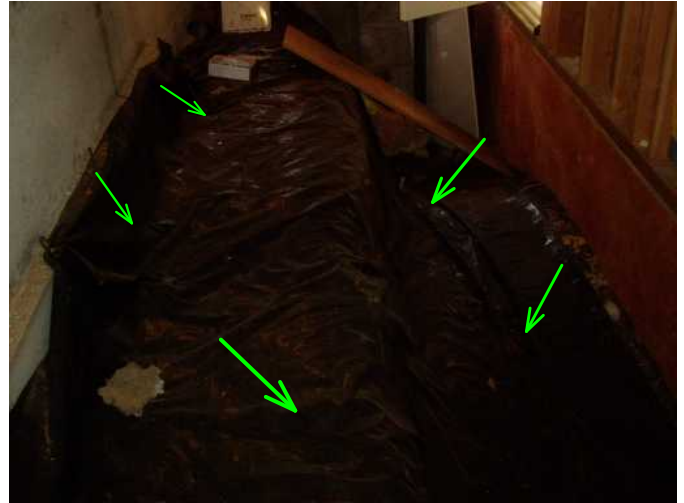
vapor barrier found all along floor of crawl space.....good..

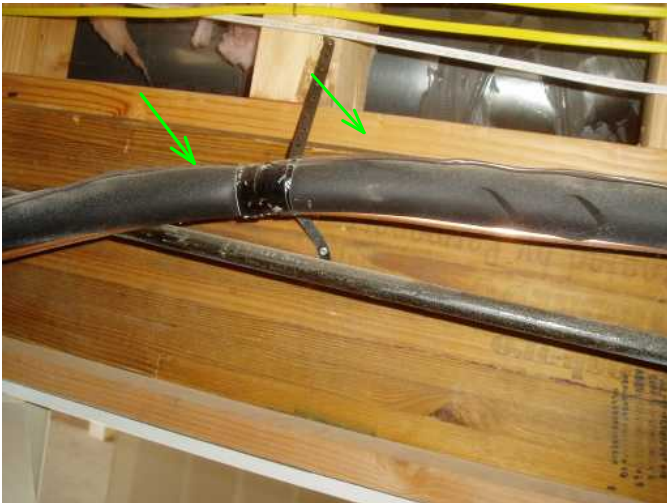
a/c lines noted installed and a/c ready...just add pad and unit at outdoors...and connect to furnace in attic area...

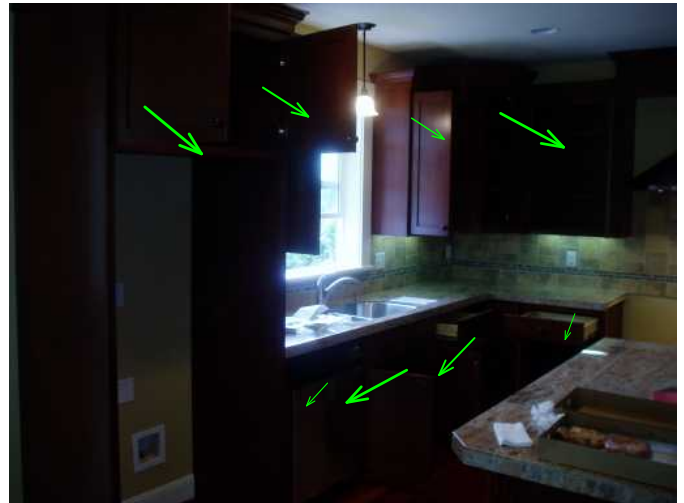
cabinets at exterior wall of kitchen wall are solid to walls and operable..good...

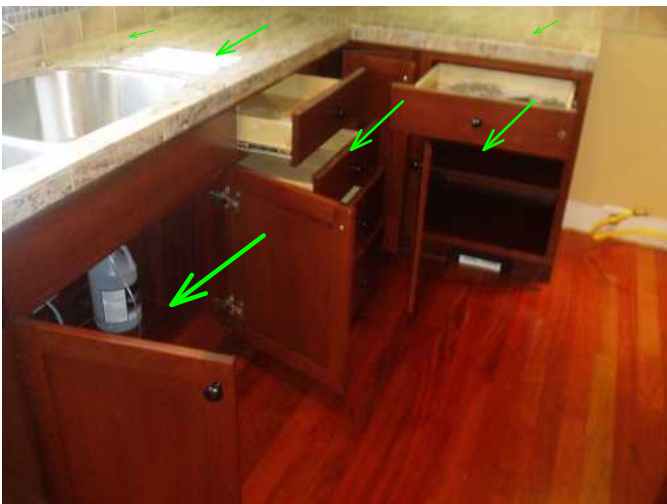
lower cabinets are noted operable..and counter tile work is found in good shape...

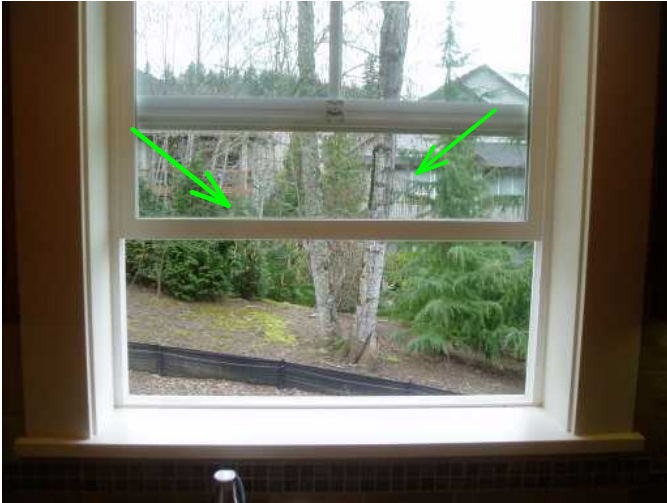
kitchen window and fixtures are noted operable in kitchen...good..

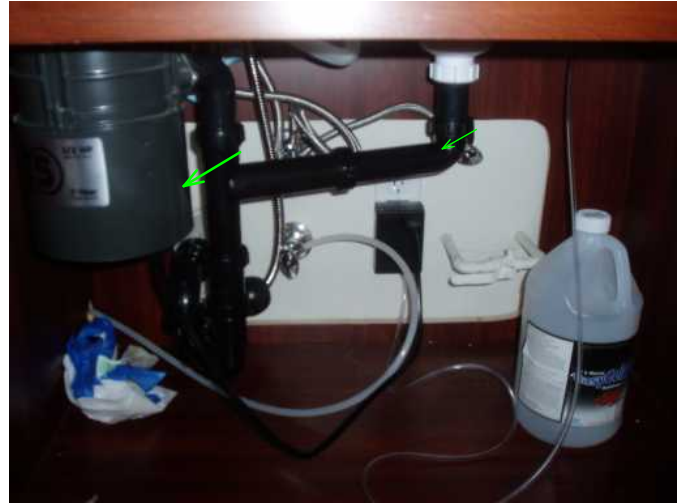
garbage disposal is noted operable..has pneumatic switch and is noted better quality install...good..no drips noted traps...

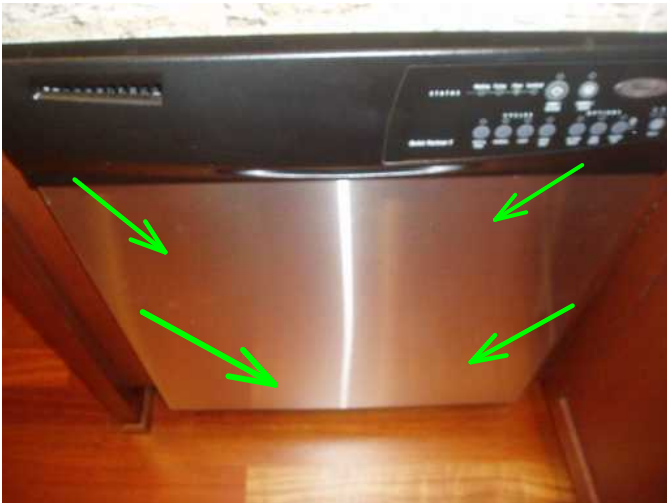
dishwasher is noted operable..

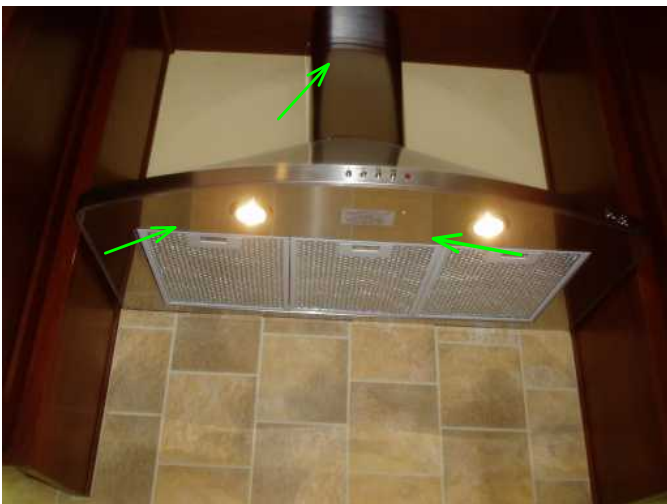
over stove hood is noted operable..good..

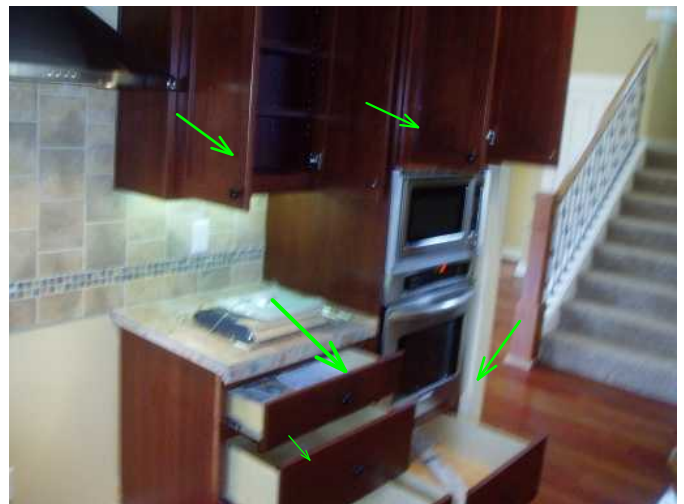
cabinet here at edge of kitchen counter and cabinet are noted solid and operable..

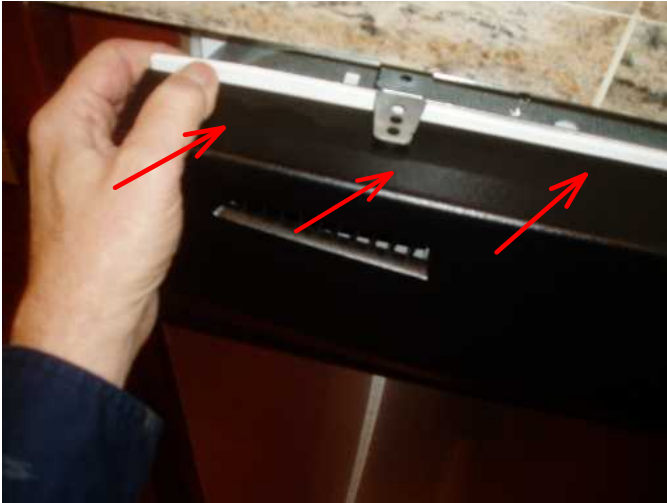
dishwasher is noted not secured to counter of kitchen and is dangerous around children....correct..attach...

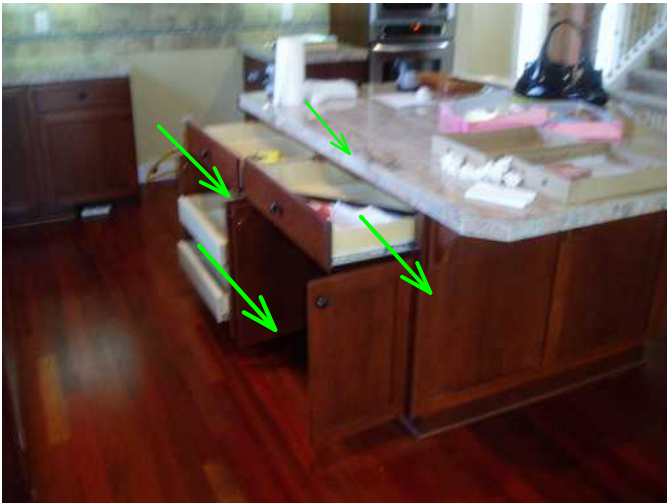
island cabinet is solid to floor and cabinet doors and drawers are noted operable as well...good..
