# Home Inspection Report

6603 se 31st ave  
Portland, Oregon

Prepared by: The Home Tester  
10555 SW Tigard St. #57  
Tigard, OR 97223  
Ben Tester  
503-515-1833 CCB# 164921 OCHI # 912

## Photo Attachments

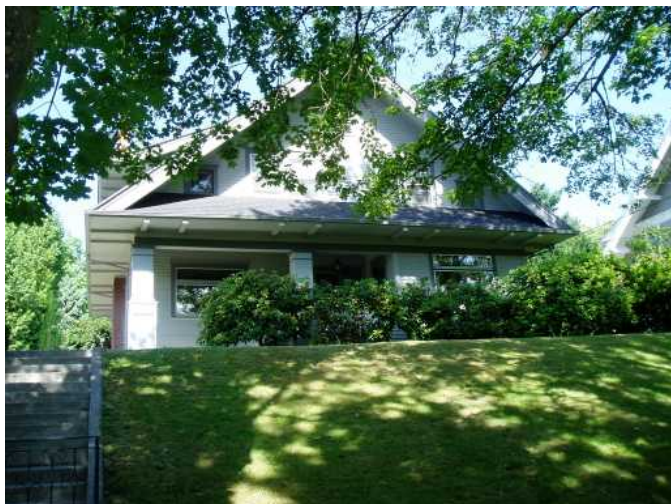
front of home

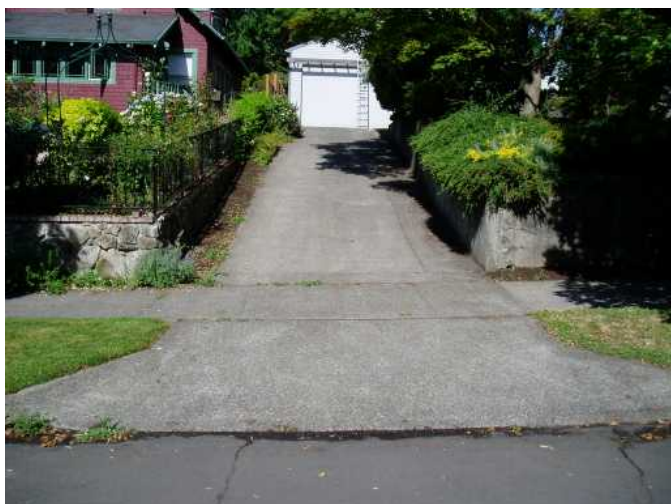
driveway ..good..

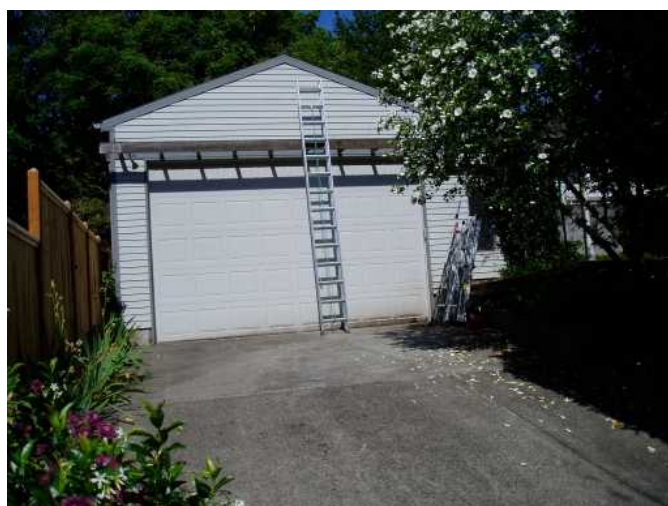
garage is detached....

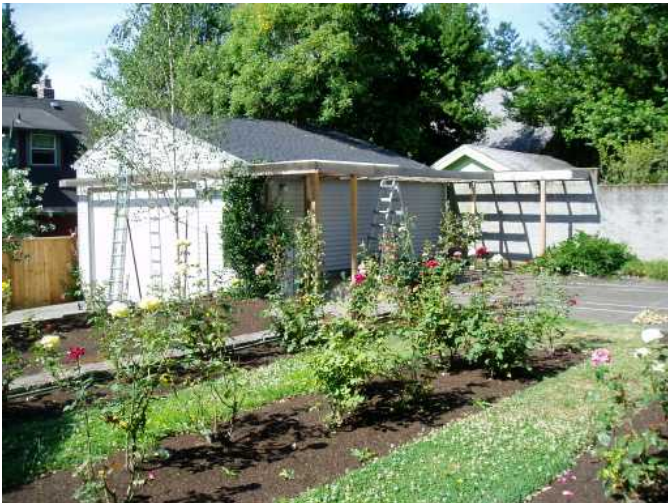
garage and patio area..

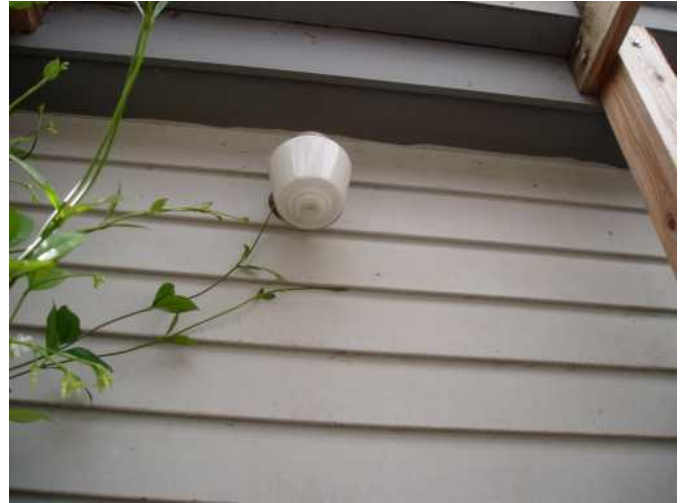
light over garage door appears to be on sensor...didi not turn on..confirm with seller it works...

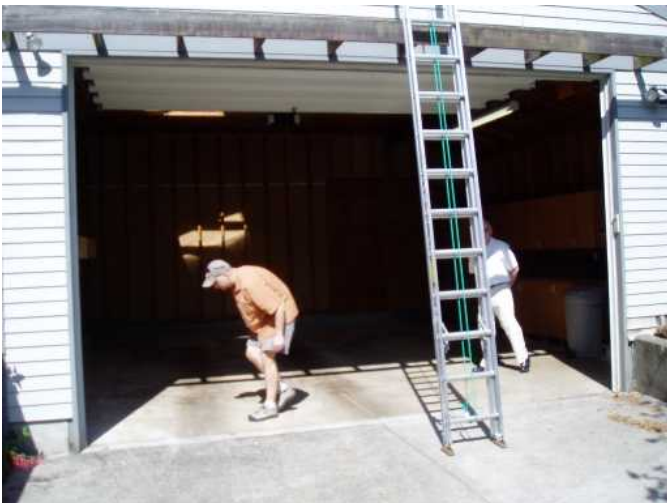
looking at ants/apper to be pest type only...

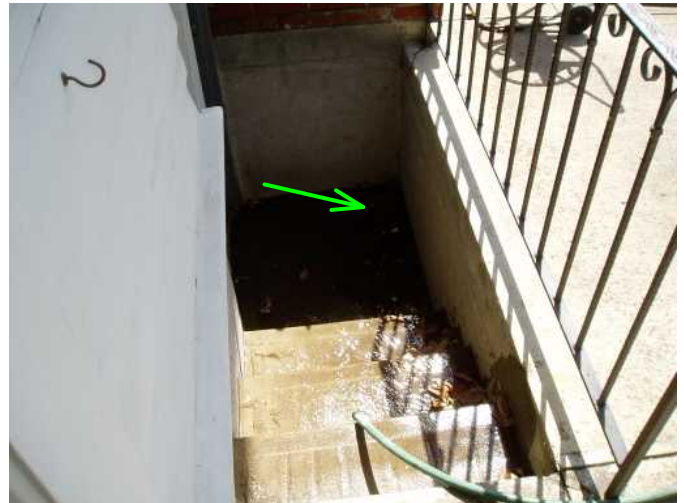
surface drain works fine...

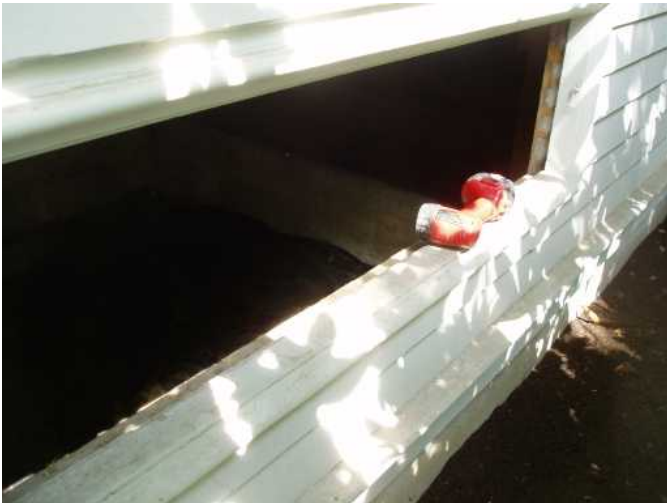
scuttlehome entry to under porch...very good...

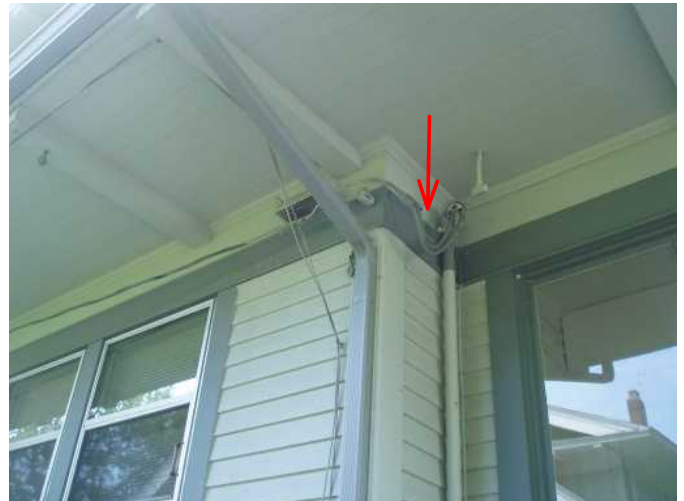
electric drip loop good....

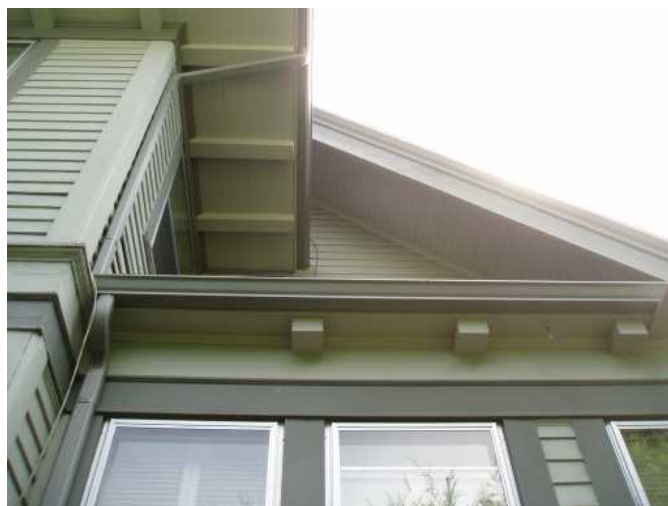
another view of well maintained siding and trim...

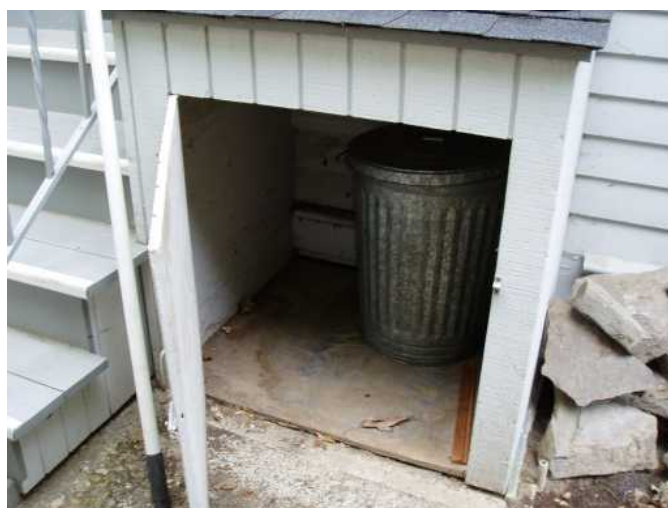
garbage storage is fine...

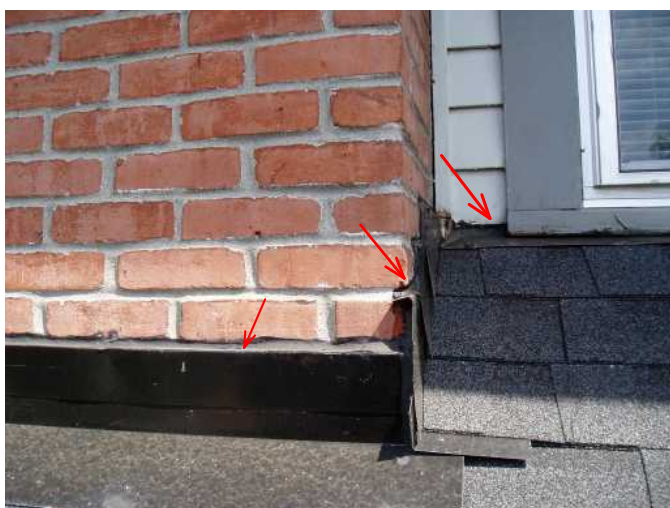
great new flashing system...by the book...

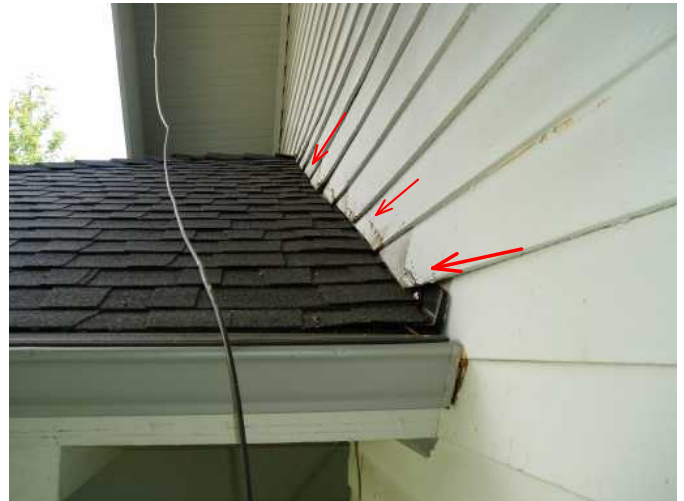
same here..great new flash..needs pant at old flashing areas...

**whole house - Exterior Surface - Type:** Wood - generally in good condition, will need paint around areas where old flashing were removed when new roof was installed..see photos...

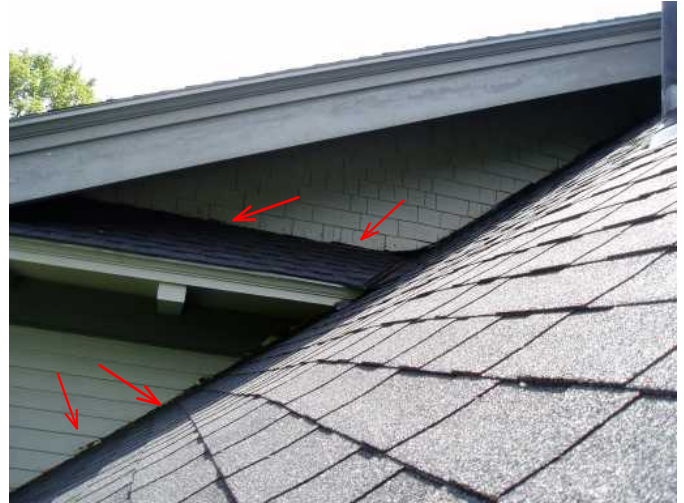
trim paint is needed..as stated before...

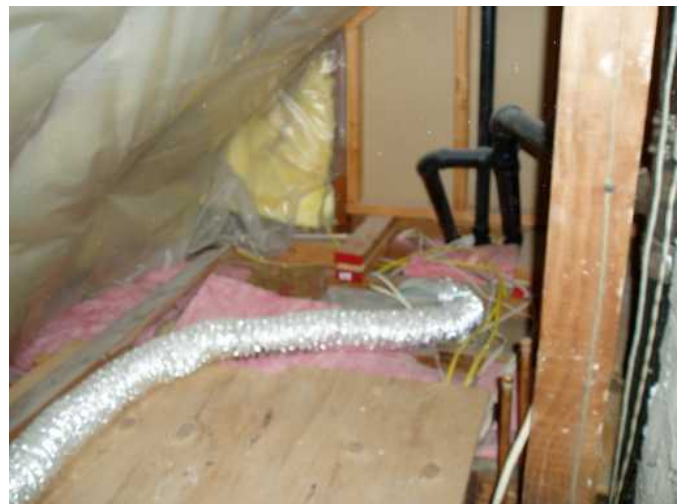
master bath vented right...

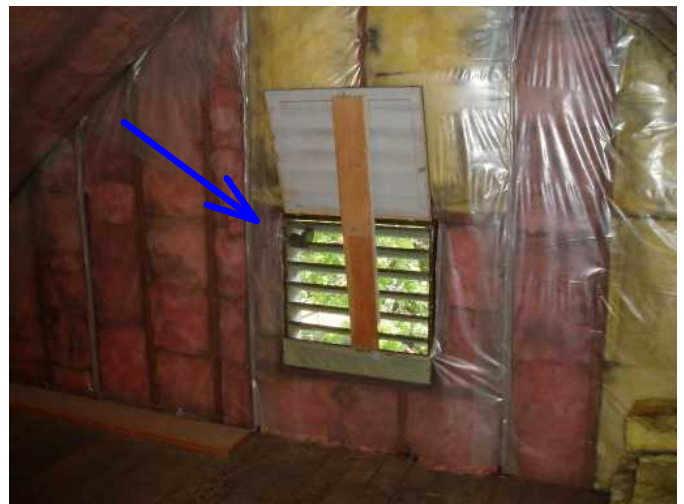
great vent in front of home and in original shape..very good...

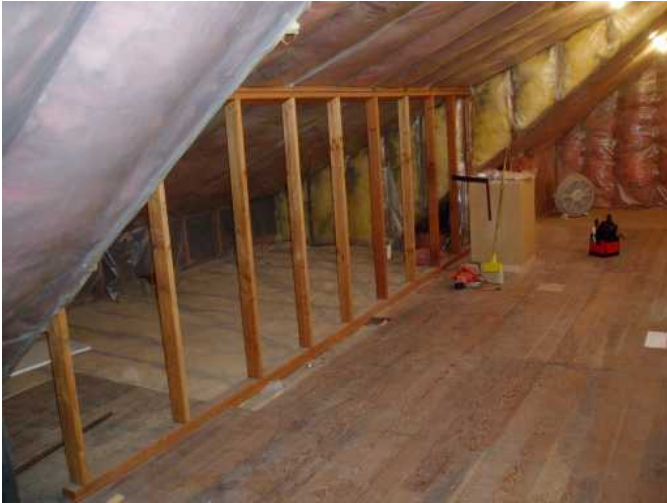
attic appears to be ready for finishing...I sent basic guide in mail from city as to what is needed to convert....

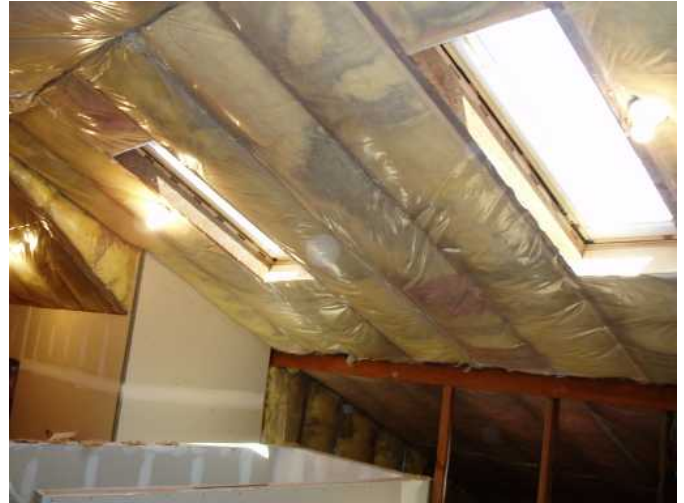
well insulated and skylights work fine...

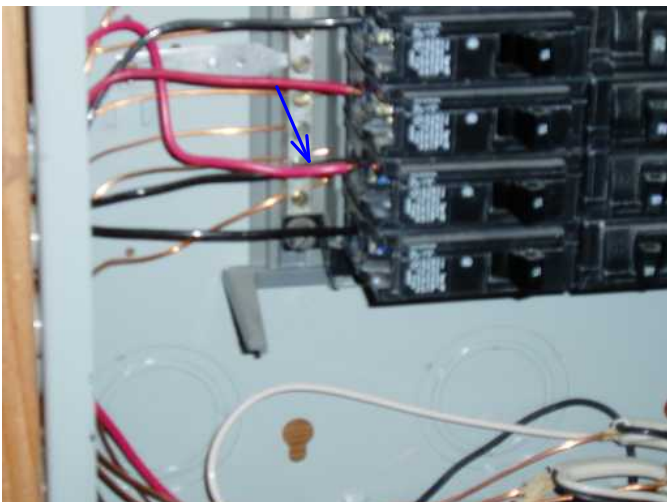
slight concern here about a double tap(two wires one breaker) this is ususally frowned upon..have checked by electrician

**attic - Electric Panel - Breakers:** CU - one double tap noted..have assessed by electrician...(2 wires/one breaker) is ususally frowned upon....see photo...

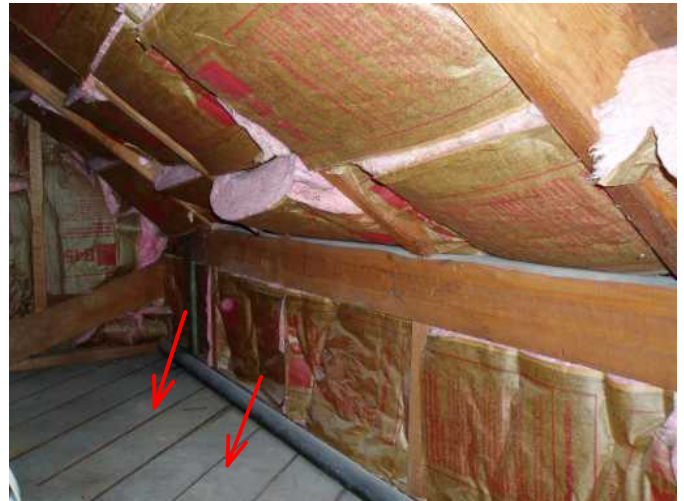
storage area in bath behind tub...well insulated..see plank sub floors...

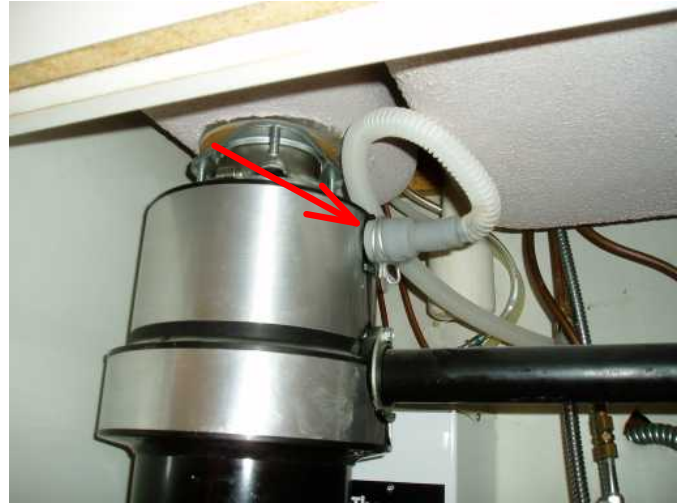
air gap for dishwasher is good...garbage disposer not responsive....

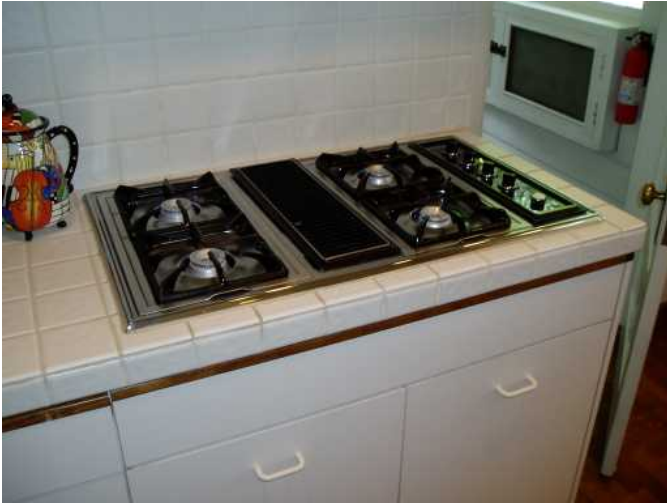
stove is older/but works fine...

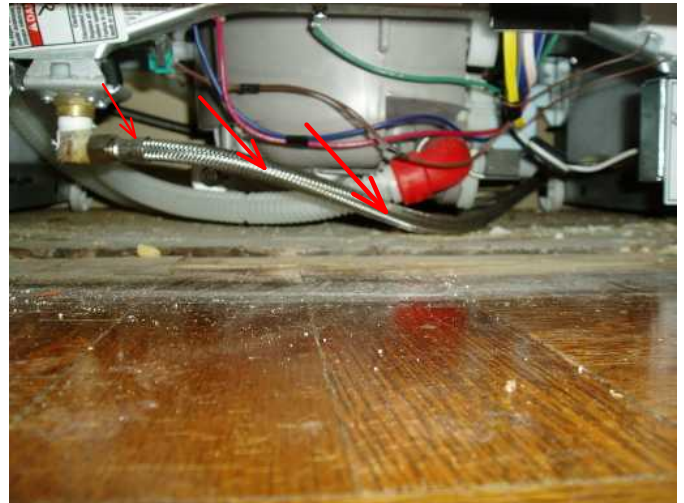
under dishwasher is dry..and metal mesh hoses are my favorite...

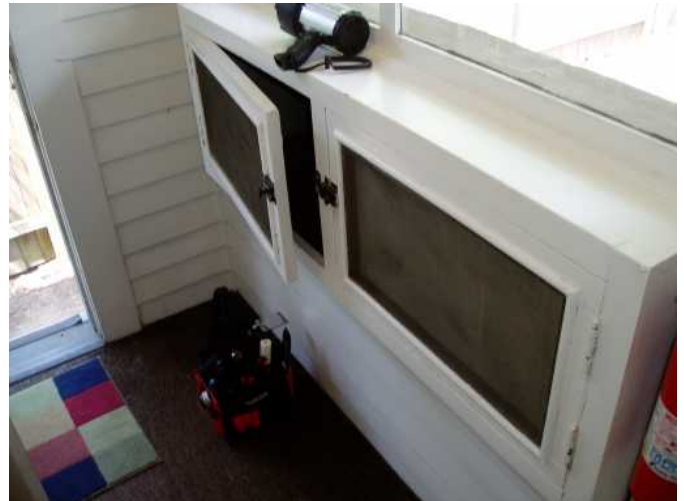
old pie case...

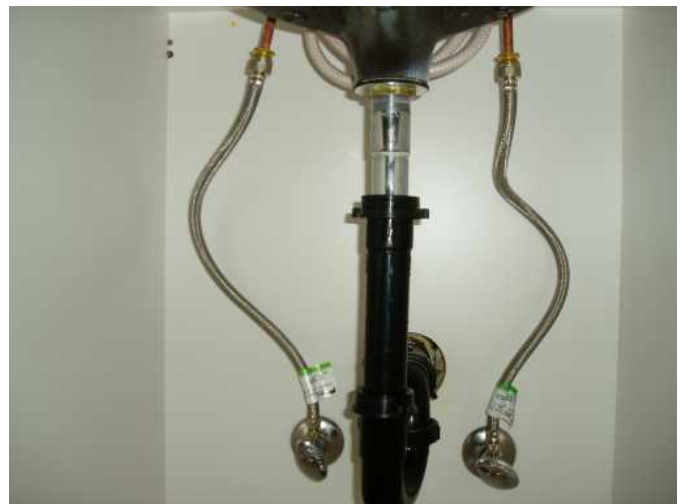
no drips here...

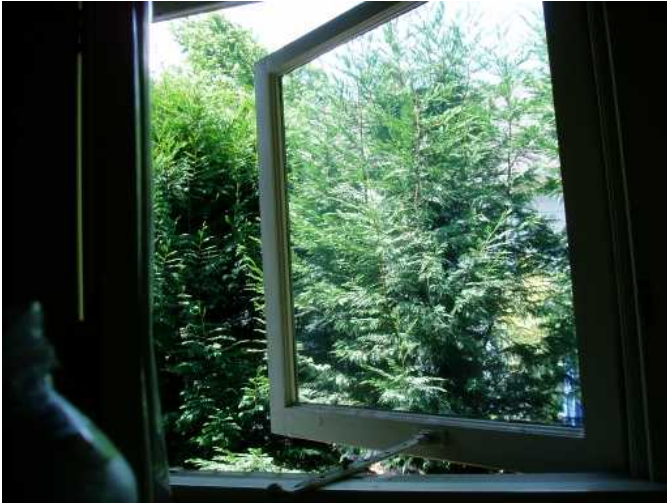
window works fine...

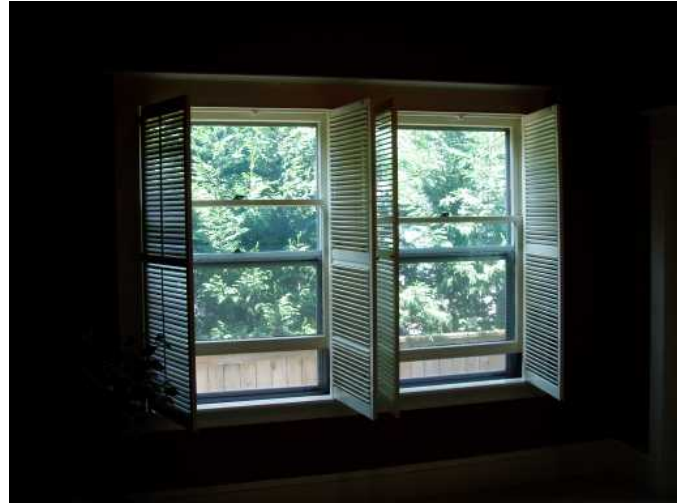
library windows work fine...

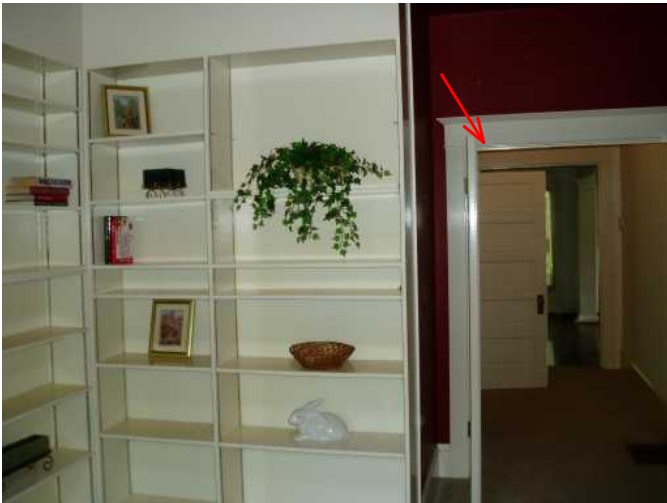
door to library are good...

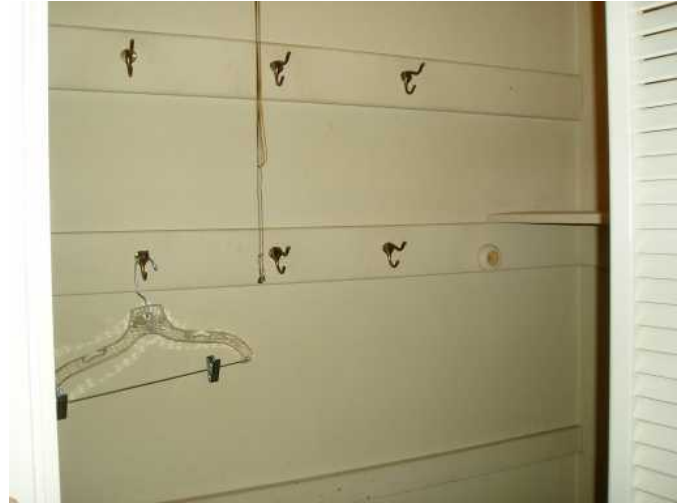
closet one doors are fine...

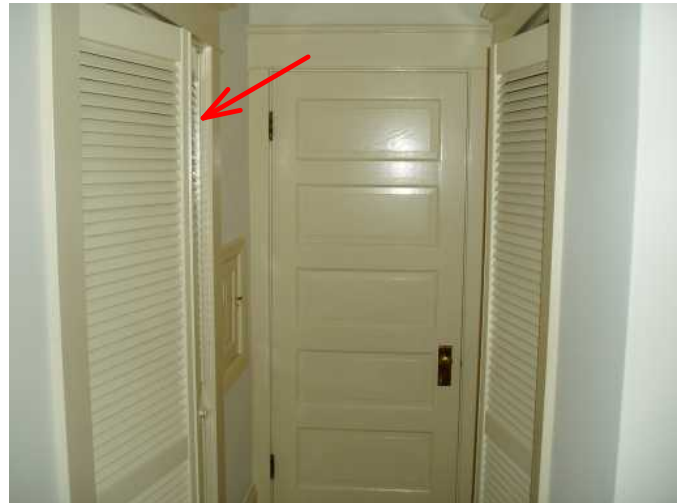
doors a bit hard to open....all others fine...

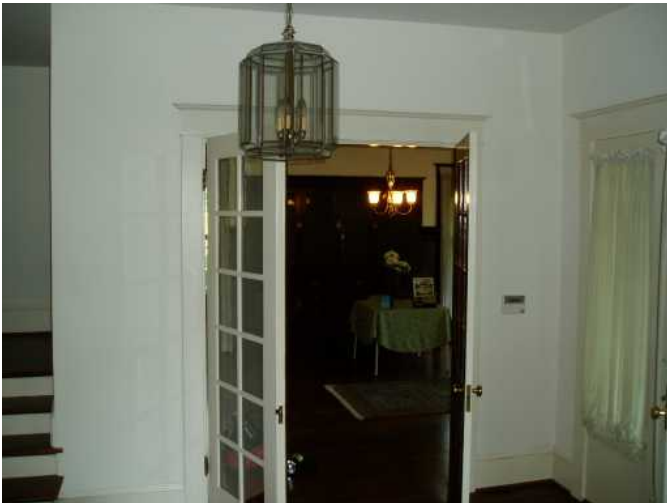
doors to dining room are good....

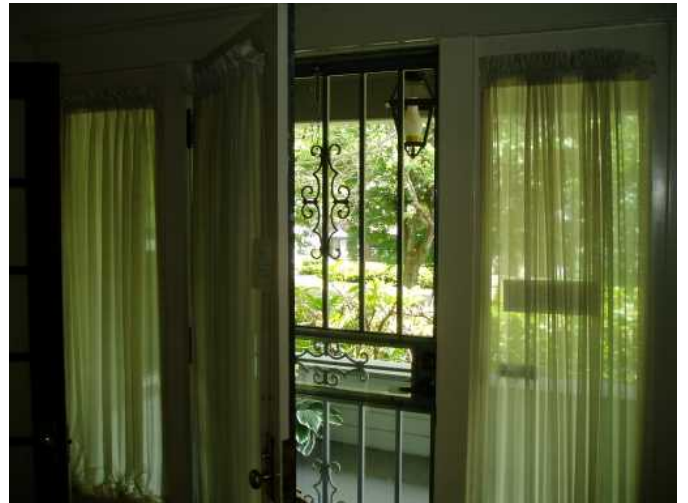
entry door and windows are good....locks are fine...

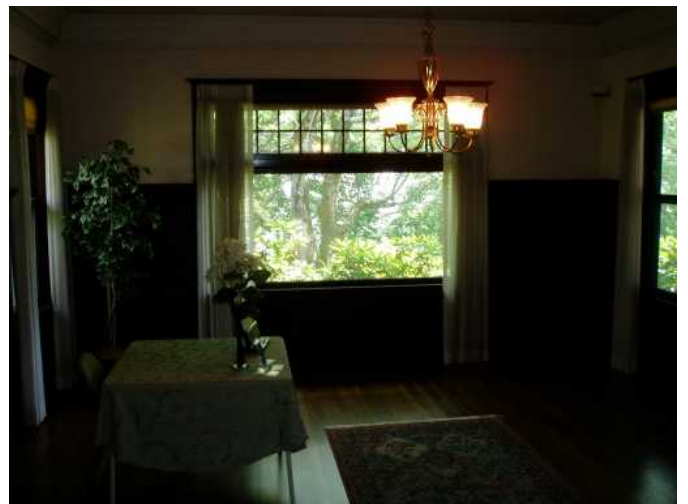
dining room windows work fine...

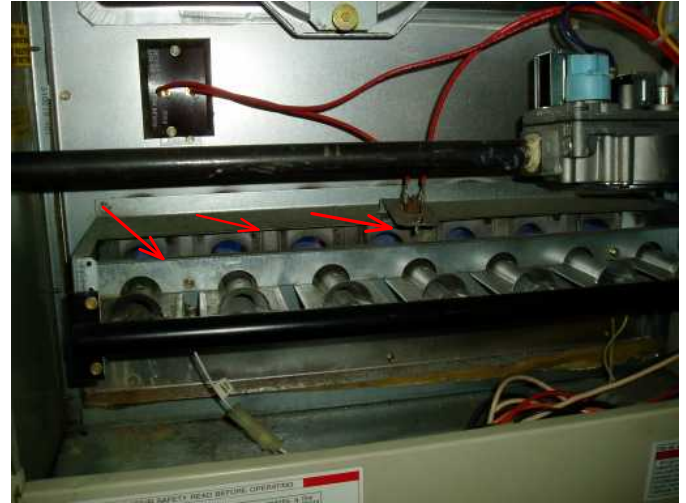
burners are bery good....

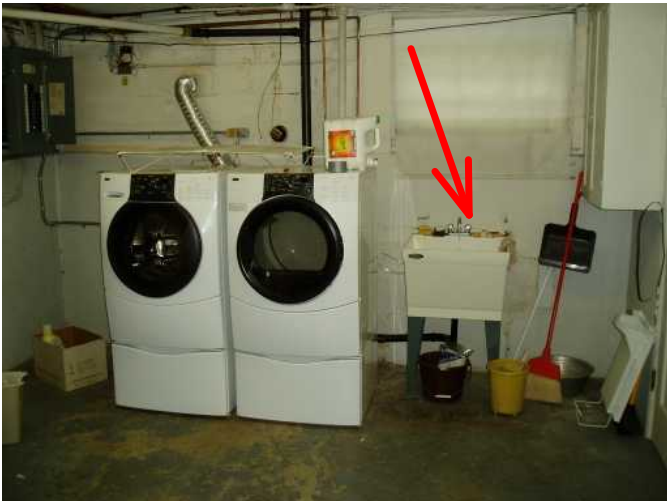
washer and dryer are working great..laundry tub works fine...

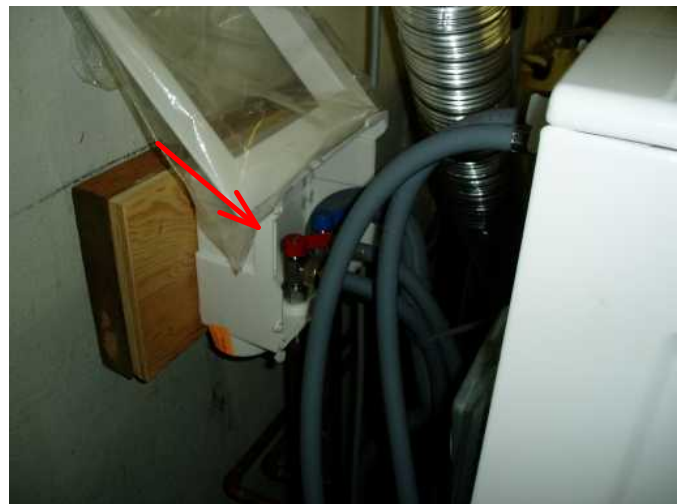
washer hook ups are fine...

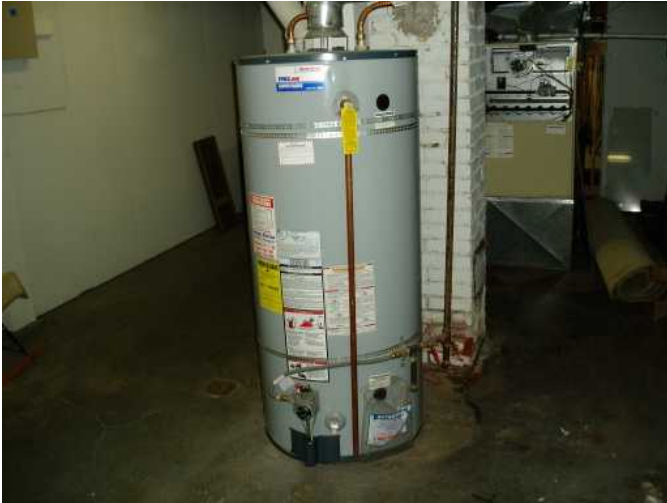
water heater is new..and 75 gallon..great for high usage....

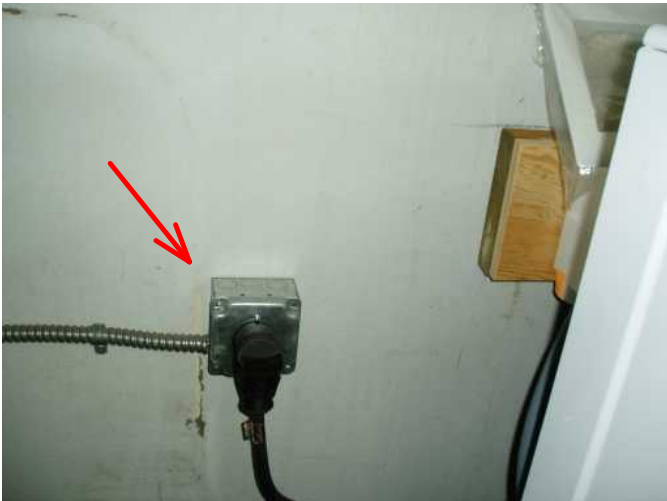
dryer electric hook up is good...

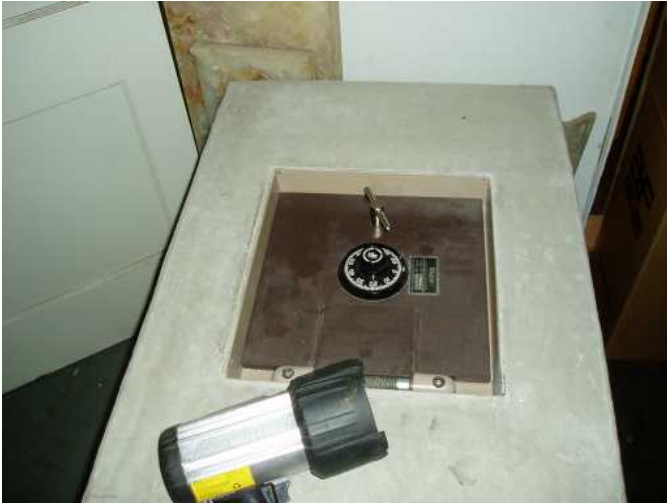
safe is awesome....not going anywhere...

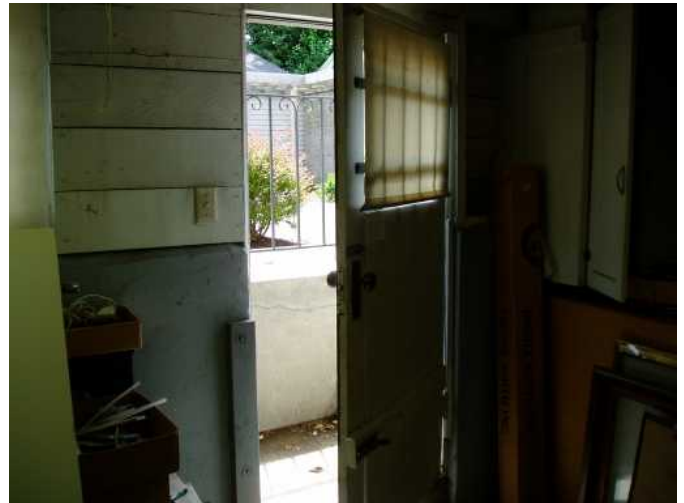
basement door exit to outdoors....solid and sound...

**Main - Basement - Moisture Location:** at entry door to stairway at base of door - thresh hold plate will need to be re-sealed...is letting in water...

basement door threshold needs to be removed and sealed  
up well to eliminate leaks...
