# Home Inspection Report

72310 E Faubion Loop-Road 9 lot 11  
Rhododendron, Oregon  
Inspection date 12/24/2010  
Broker/ Sandi Strader @ Oregon Realty

Prepared by: The Home Tester  
10555 SW Tigard St. #57  
Tigard, OR 97223  
Ben Tester  
503-515-1833 CCB# 164921 OCHI # 912

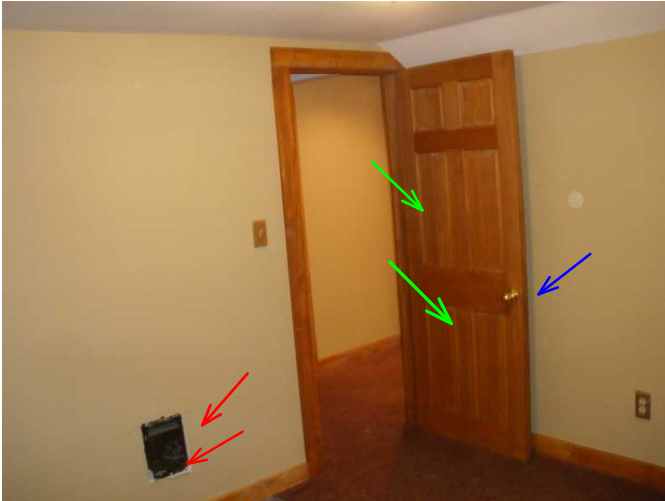
bed 3 entry door and wall heater...wall heater needs cover plate and entry door needs door stop...operable...but swollen

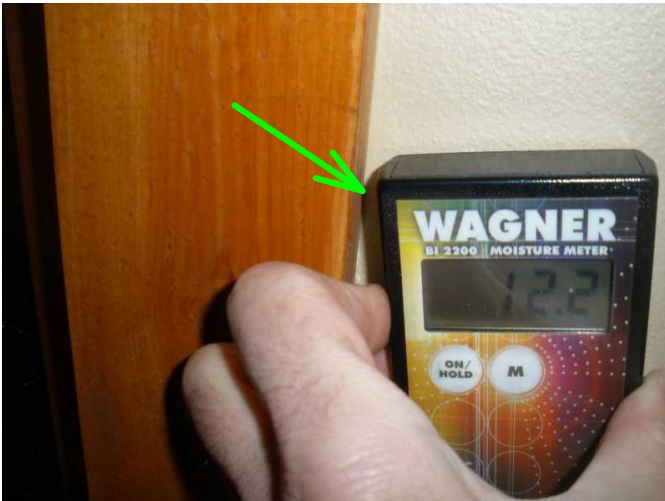
wall moisture is noted fine at right window wall area...bed 2 area..entry door operable...window painted shut...

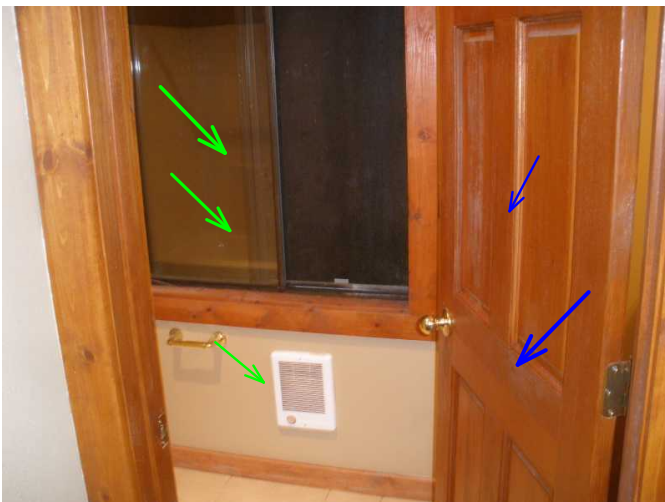
second floor entry to bath door is noted operable..but swollen as noted all doors...heater and window noted operable...

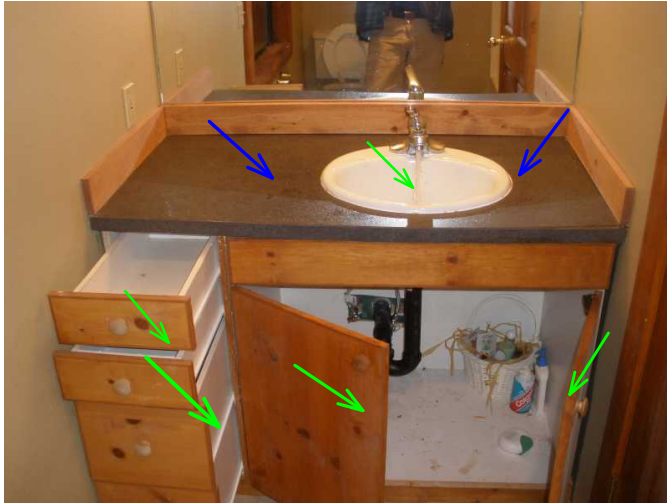
cabinets noted operable...sink is fine...counter is damaged and will need replaced...

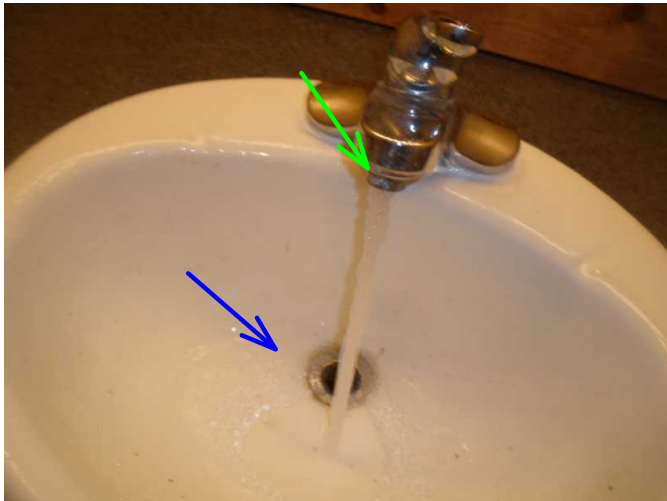
faucet is noted operable..drain is noted operable...no drain trap noted...correct...

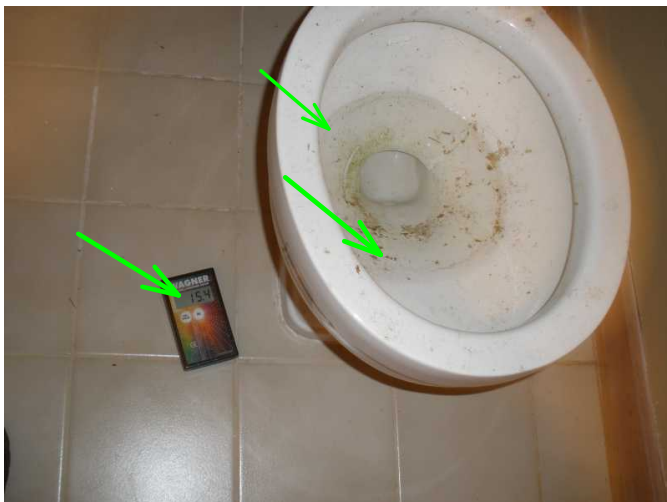
toilet is noted solid to floor and operable...does run after flushed...correct...floor moisture is fine...

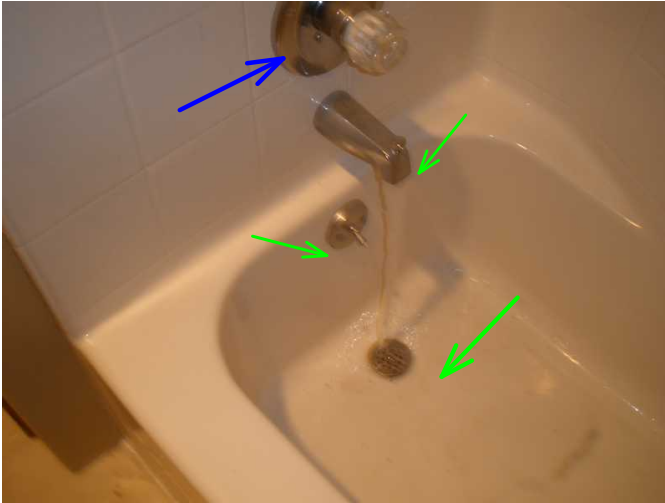
tub faucet is noted loose...operates....drain and drain stop noted operable...

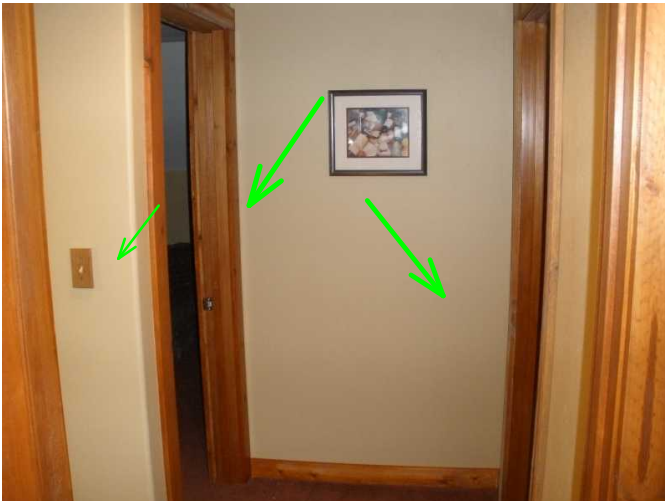
upper hall is noted with no issues...fixture is noted operable...and 3 way switch is noted operable..

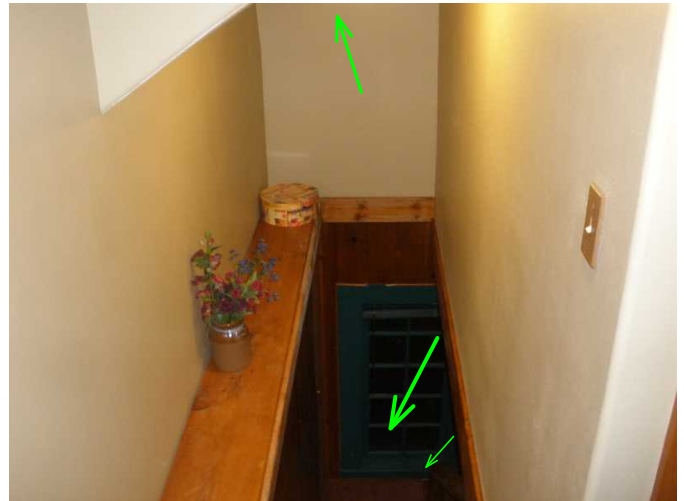
stairs are noted solid...a bit narrow...but for cabin...fine...

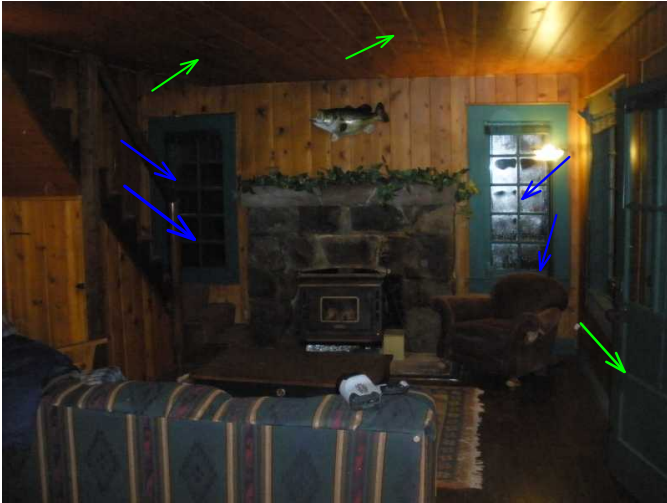
general view of living room and noting windows are painted shut and walls and ceiling are fine...

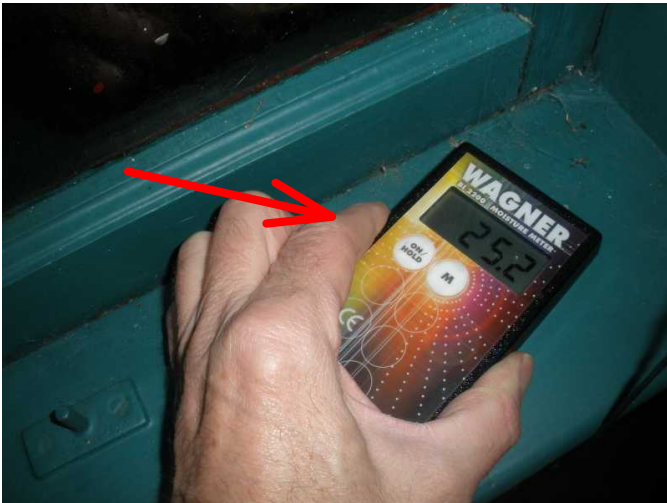
high moisture noted at exterior window sills at main level of home...appears to be too damp...leave heat on...

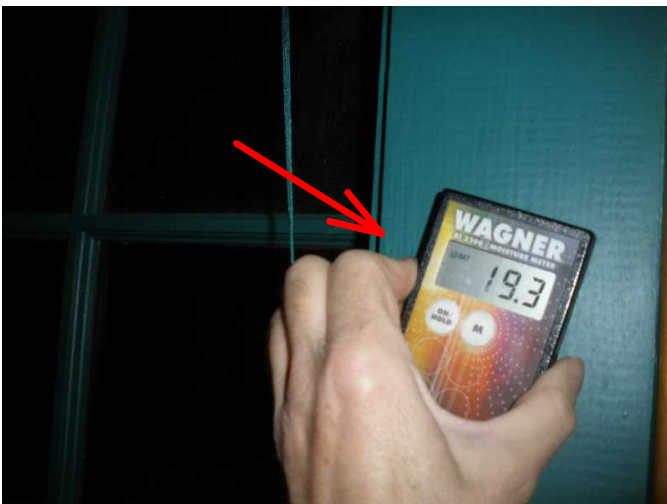
all throughout home is noted with higher moisture content of exterior wood trim...is due to no heat and damp areas..

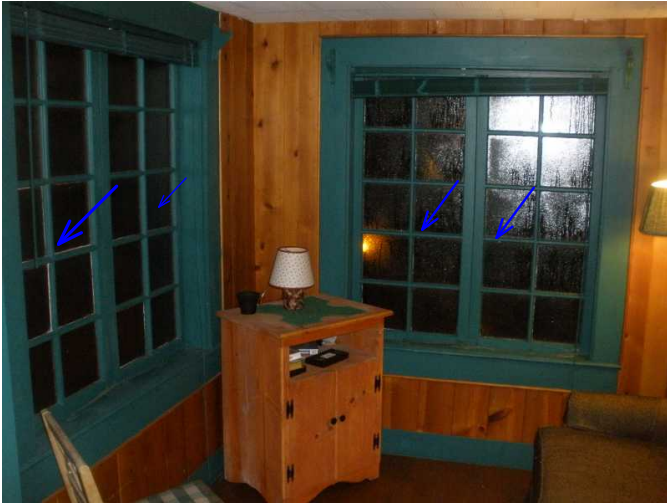
study area noted here with windows not operable...condensation noted...

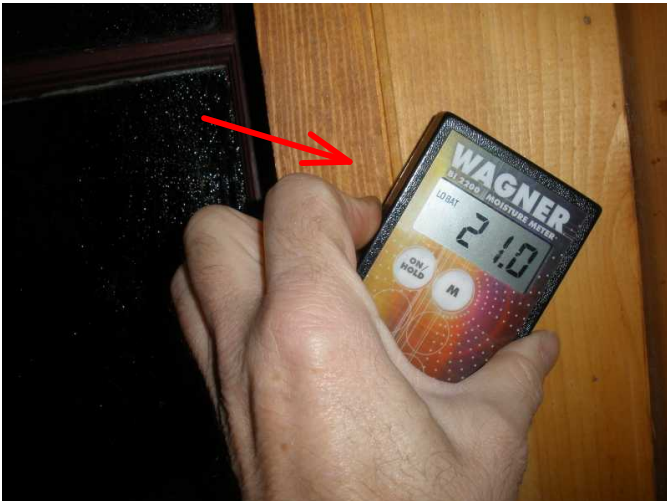
higher moisture noted at trim at study area windows...appears all exterior wall areas have higher moisture...

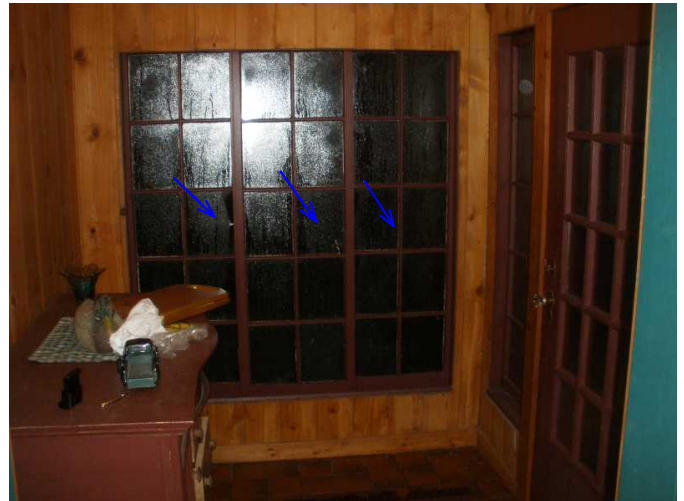
entry noted here with windows not operable..and condensation noted ...

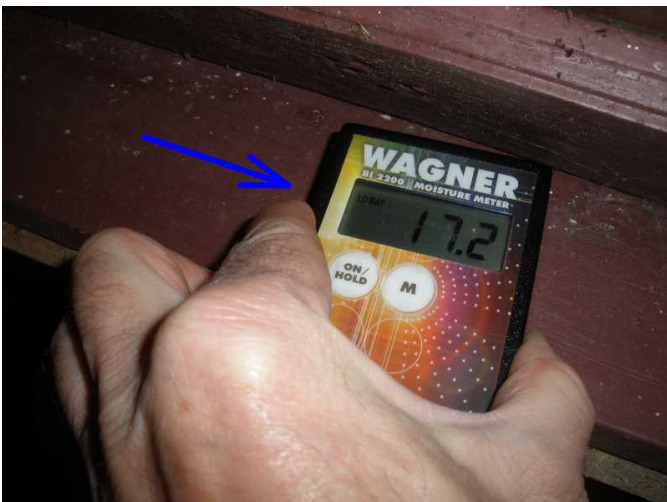
higher moisture noted at window areas...at sills...noted at all exterior wall sills...run all heaters to keep home dry...

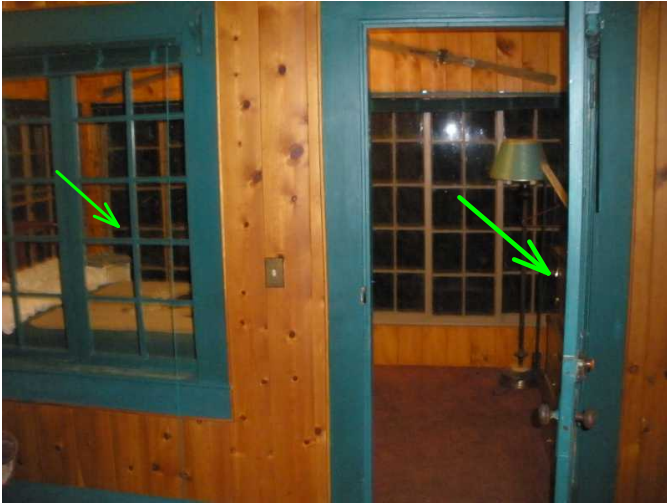
door to master first floor bedroom area is noted operable...swollen as is all interior doors...to much moisture...

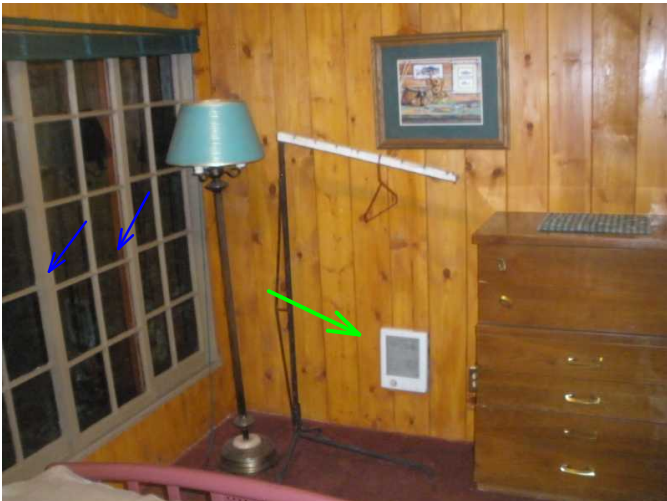
cadet heater is noted operable...exterior windows are noted with condensation on them...

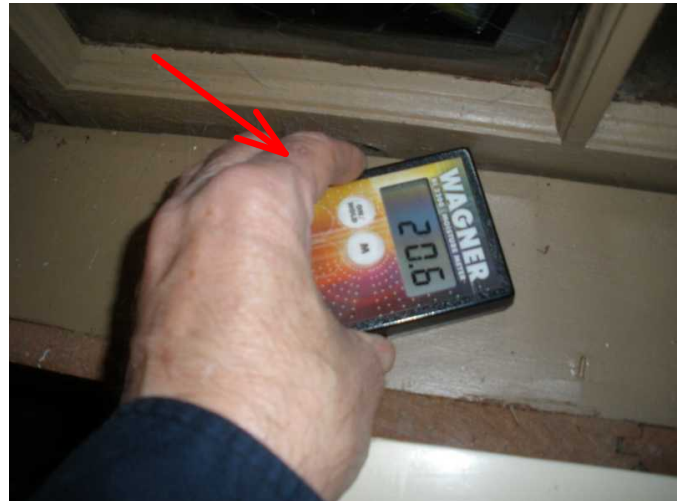
window sills are noted with high moisture...recommend double pane windows for best moisture control...

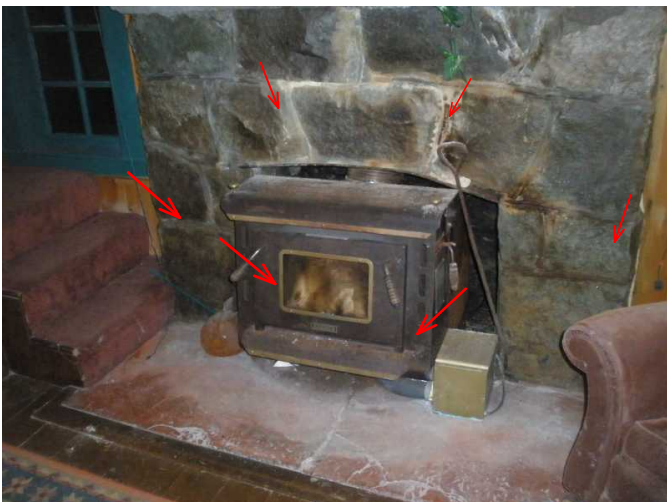
fireplace has a obsolete wood insert...is noted with spalling and efflorescence at mortar joints...high moisture

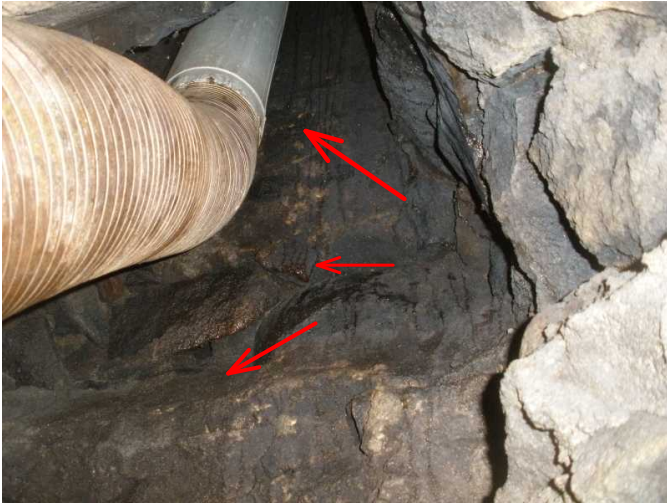
the wood stove insert is noted with single wall flue installed up the original chimney... no damper noted...

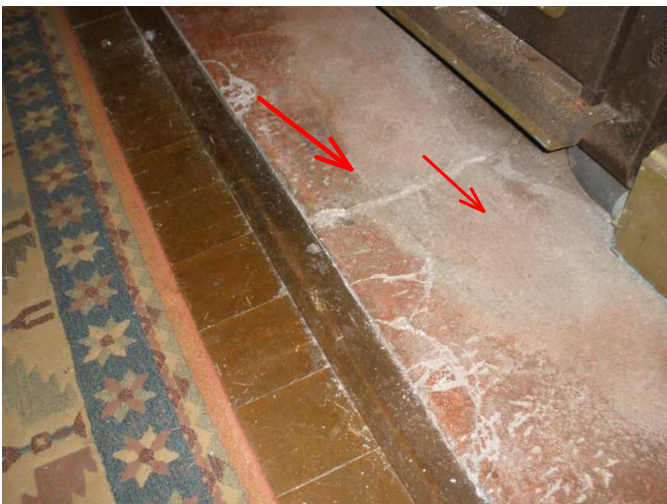
hearth is noted cracked...

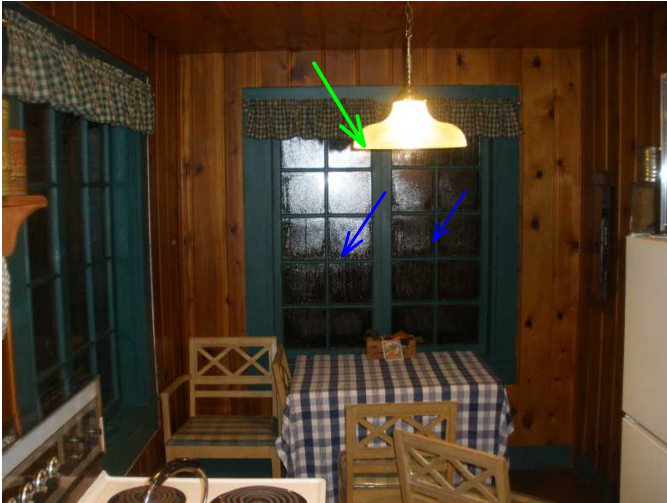
dining area is noted here with fixture operable...west windows are noted not operable...and have condensation...

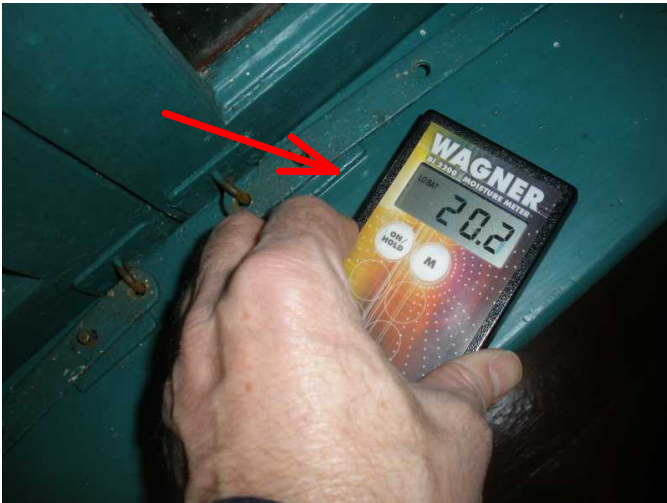
high moisture noted at east window sills as well...

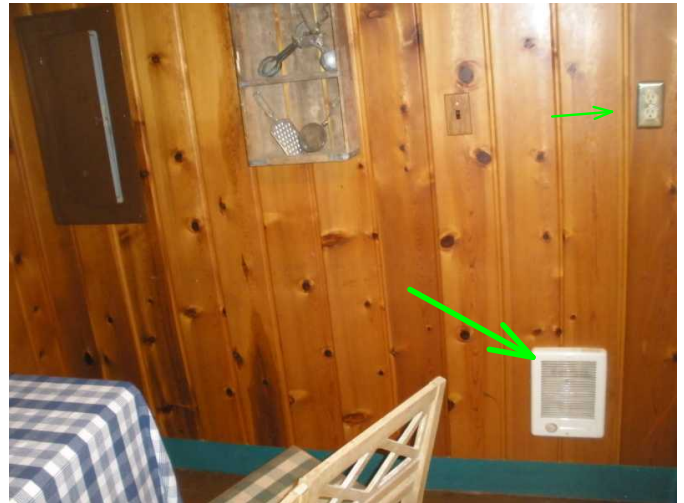
dining area Cadet heater is noted operable...all Cadet heaters need to be cleaned 2 x per year...

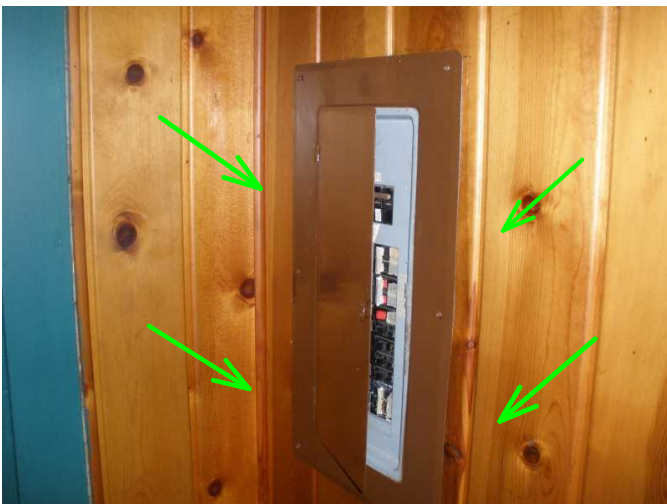
dining area has main breaker panel noted in dining area...

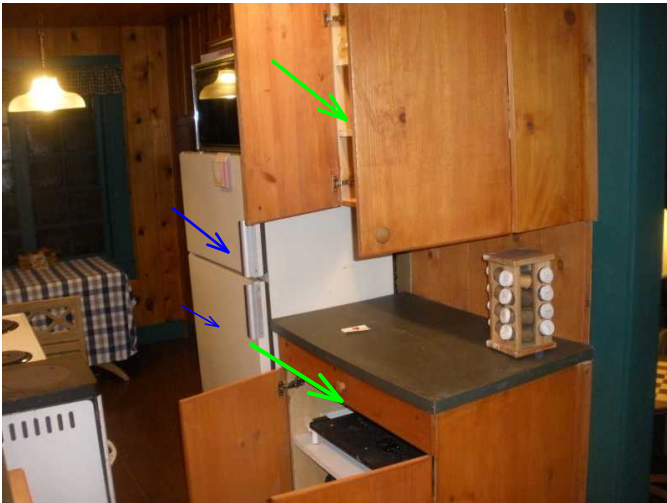
center wall cabinets are noted operable and solid to walls..refrigerator was not plugged in...not tested...

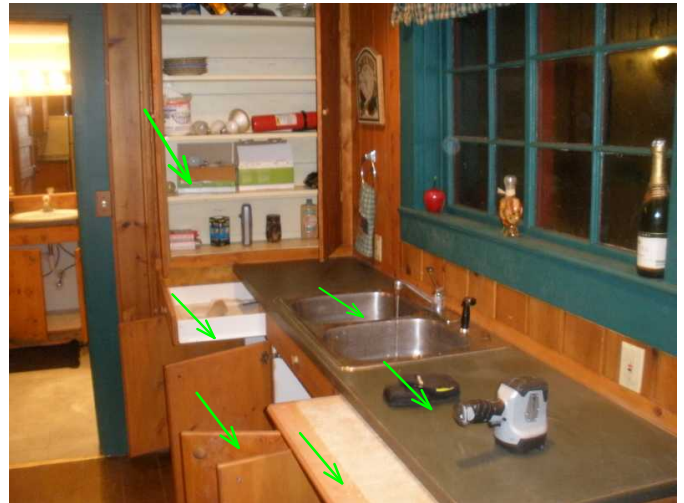
exterior wall cabinets and counet are noted solid to wall and operable...

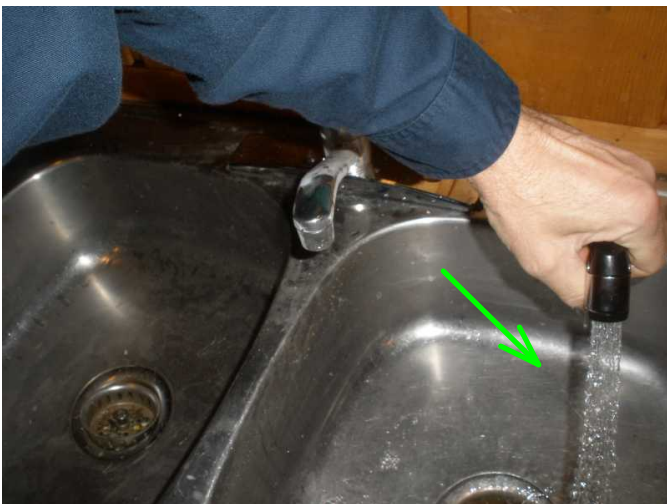
facuet is noted with sprayer arm and is operable..

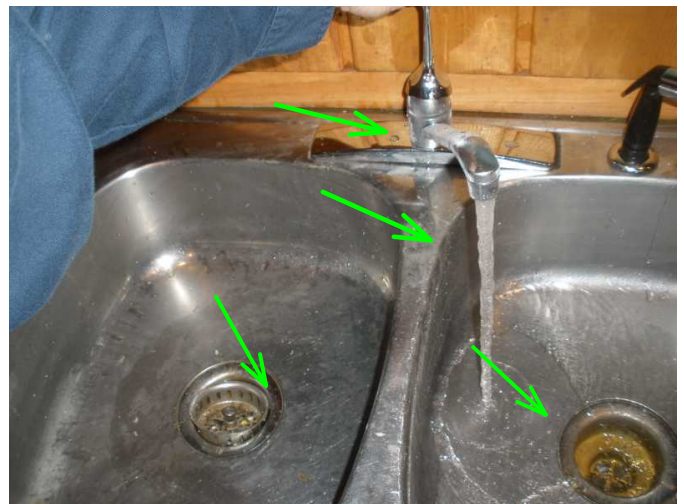
facuet is tested and operable...did run hot water and ran O.K. but not much noted...

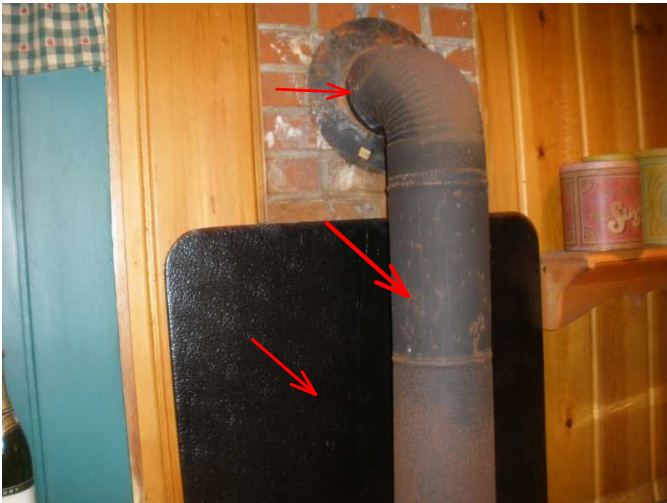
the single wall flue is noted here and is noted to close to wall...has simple wall protection,. but needs secure brick..

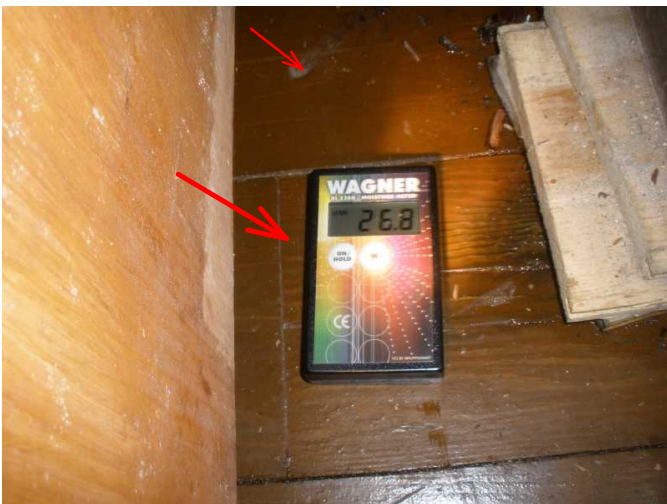
noted high moisture at floor area by wood stove..appears is coming from wall of sink area...

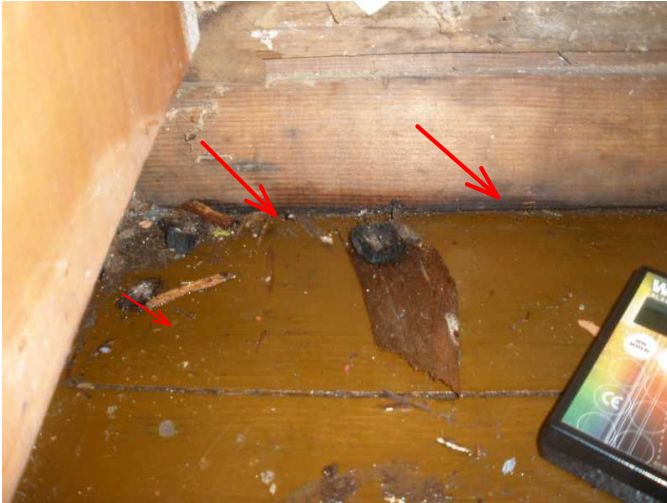
appears may be leaking from wall area at sink? but can not determine....just can see wet and staining at trim...

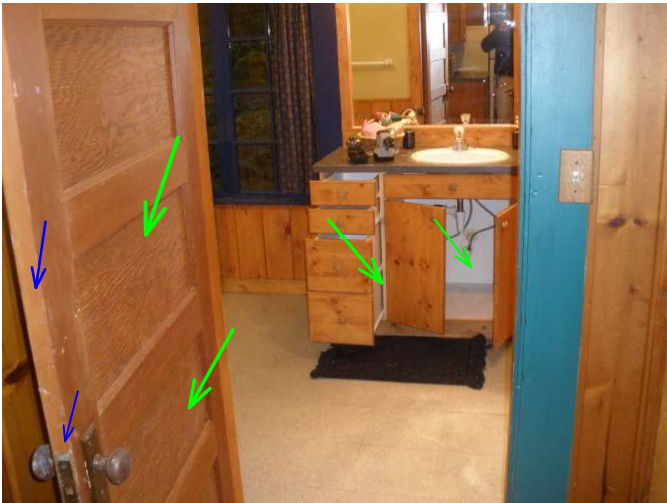
first floor bath entry door is noted operable..but sticks to door frame and cabinet at sink is noted operable...

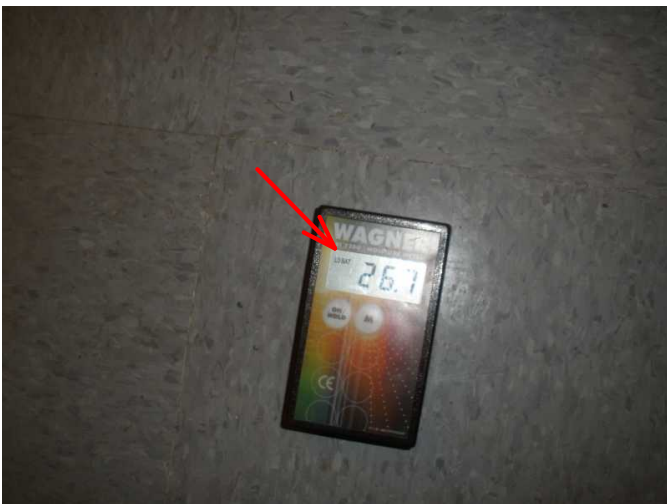
the floor is noted high in moisture to laundry area...and in rest of bath area...leave heat on to see if dries out...

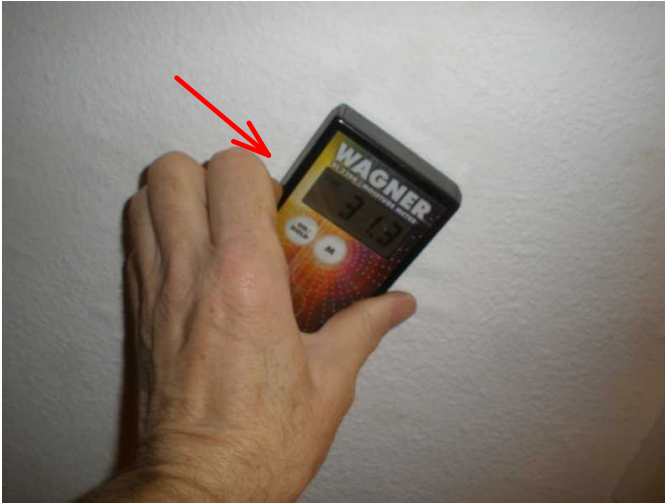
ceiling at main bath is noted with high moisture...at wall by entry door...appears the roof to siding is not sealed well...

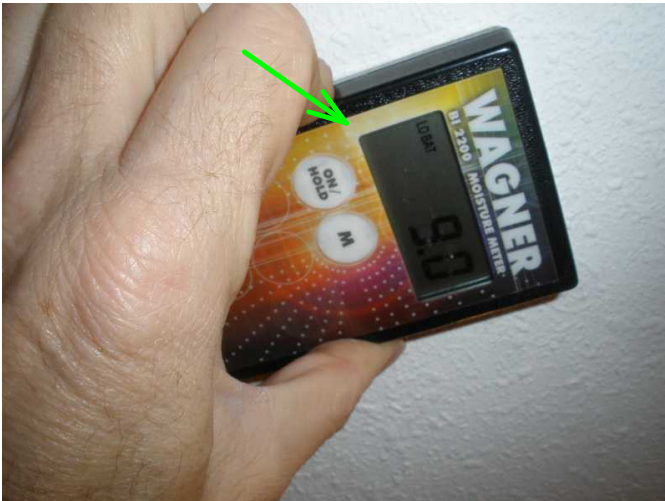
center ceiling area of bath is noted low in moisture...expect is has to do with the roof and siding not sealed...

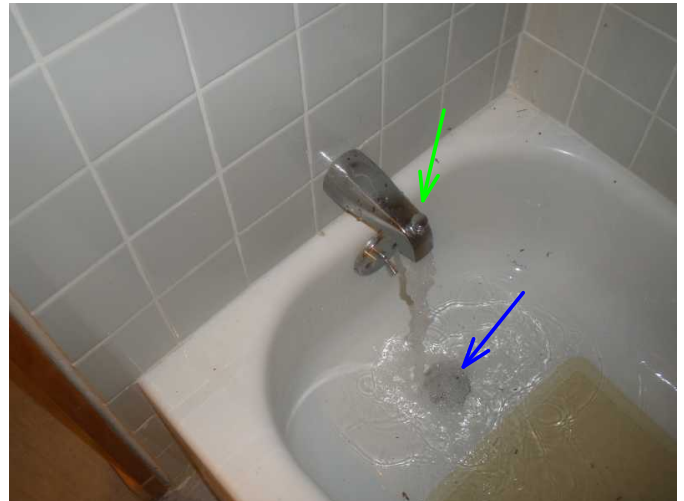
first floor bath faucet is noted operable...drain stop is noted not operable...and drain is very slow..correct...

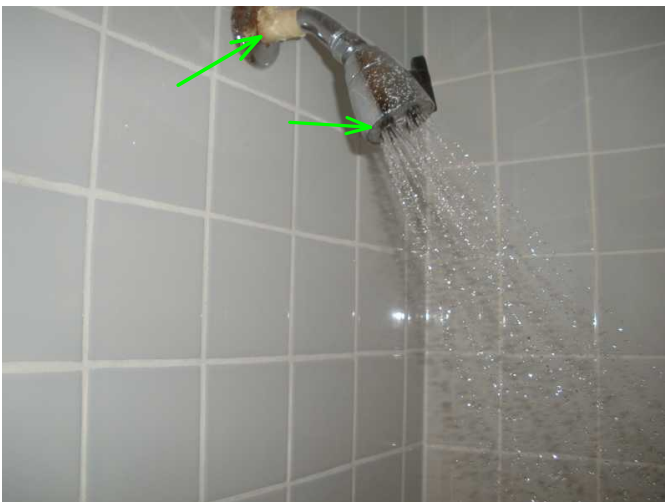
shower head is noted solid to wall and operable...

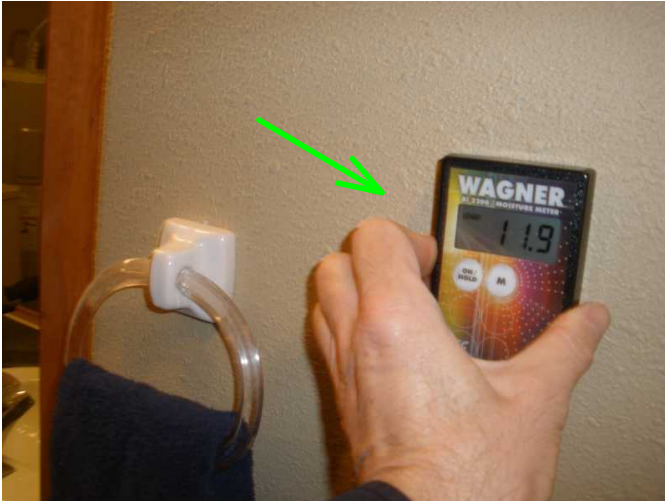
upper walls are noted fine...moisture is in good range...

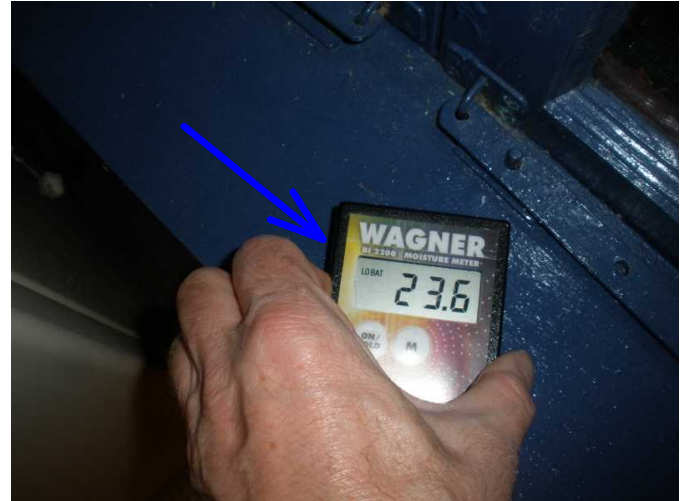
first floor bath window sill is noted to high...should not be above 20 % and the whole home is very damp....

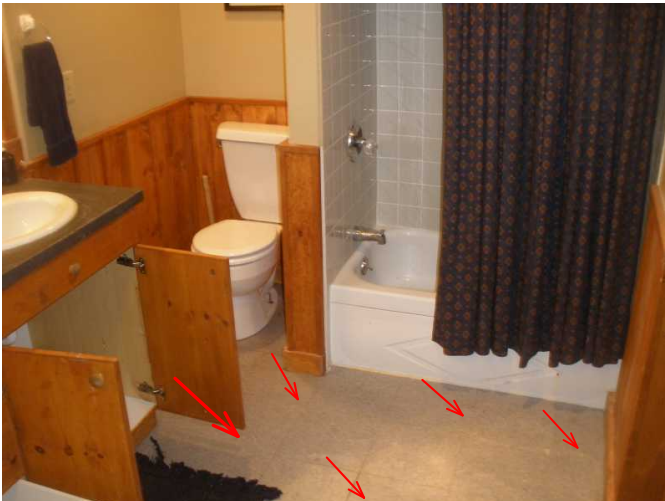
overall view of bath is noted here...the floor is high in moisture...from past water line break...

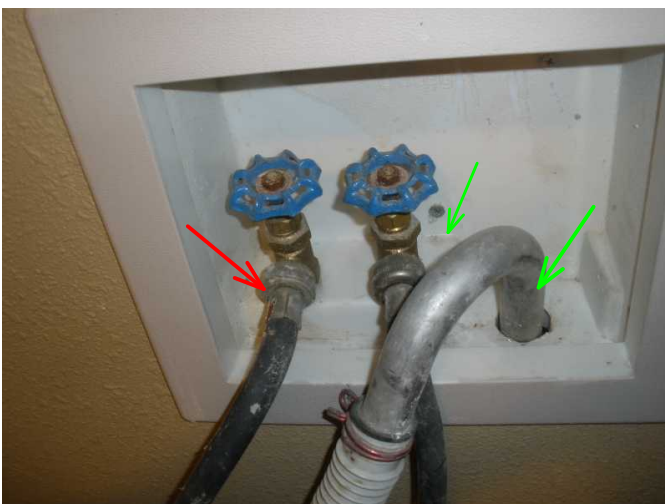
main hook ups for washer are noted here and are operable...left valve is noted leaking...correct...

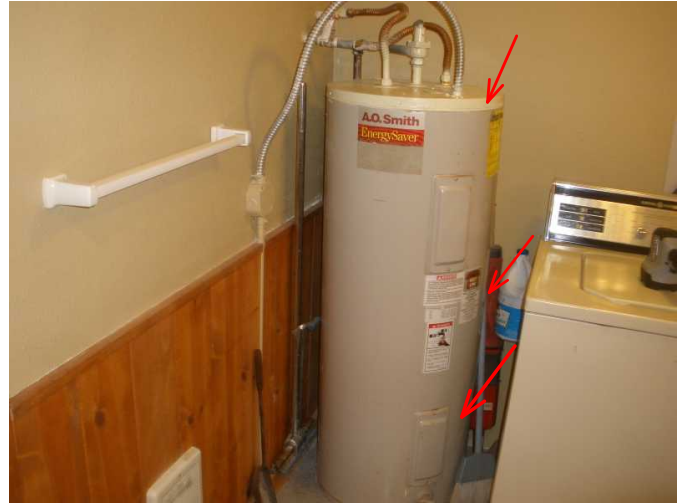
water heater is noted here with no earth quake strapping and was not very hot water noted...is older unit...

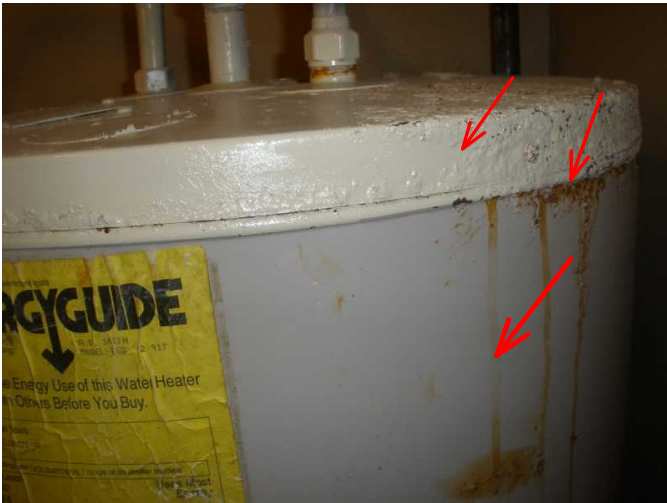
noted rusting at upper tank areas...

as well as along the base...recommend a new water heater....

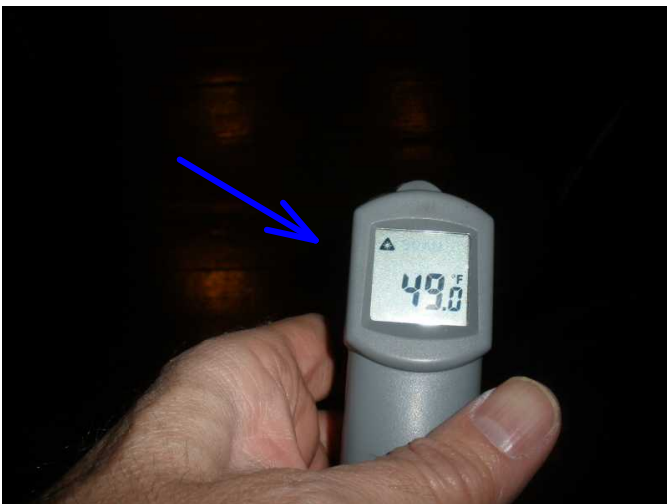
temperature of floor of home...is very cold...no insulation noted at under floor crawl area...

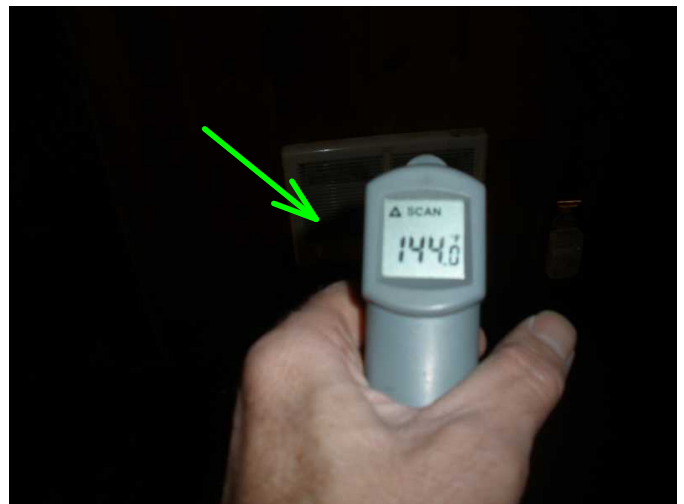
all Cadet wall heaters are noted operable..recommend they be cleaned often for safety...

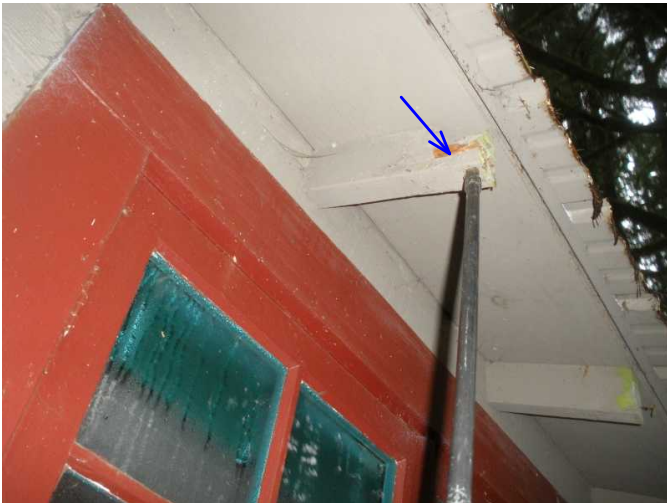
rake has some minor rot noted...at front of structure...

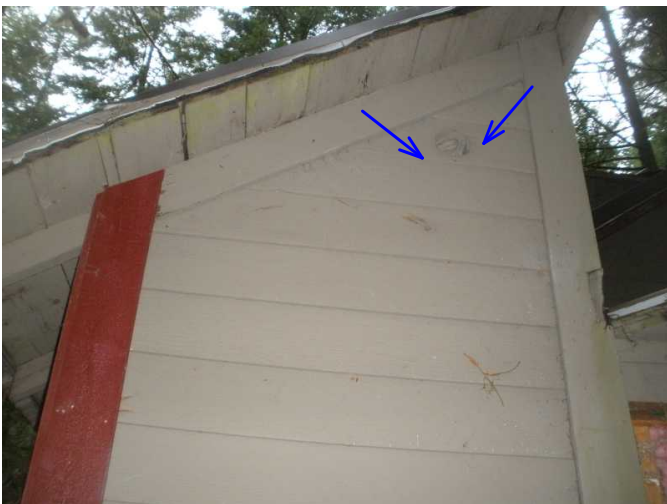
exterior fixture box needs cover plate noted here...

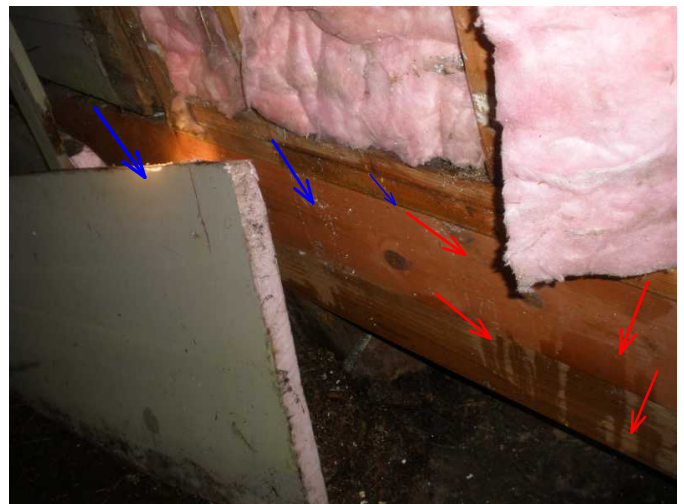
the addition is noted here with newer beams...and water is noted here at right...again...leaks...

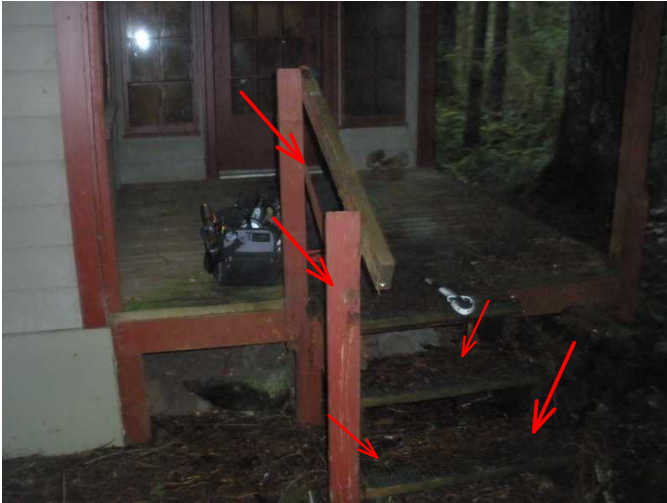
handrail and steps need repairs...wood touching earth and handrails are loose...

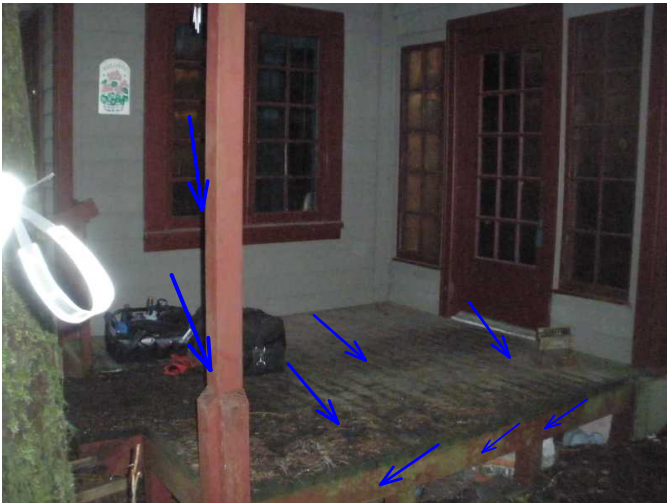
general view of porch is noted solid...just needs some cleaning and sealant on wood...paint to trim needed...

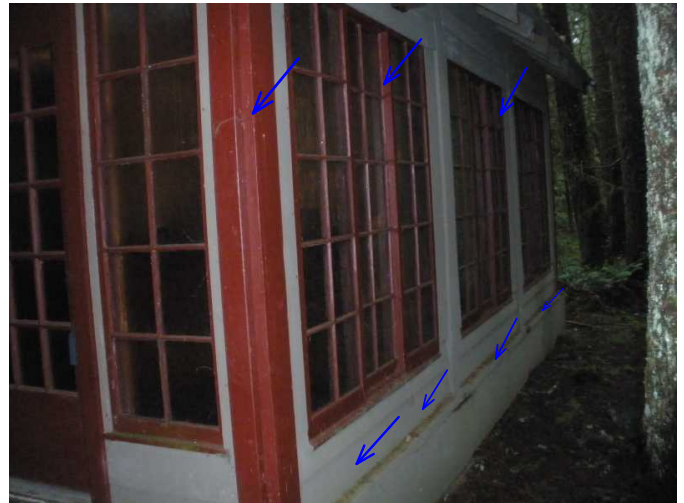
north view of home...trim and siding need paint...

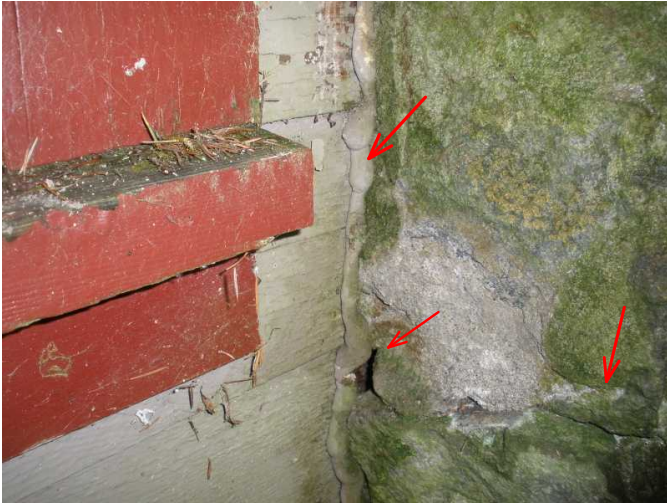
fireplace is old and has issues with seal to siding..is letting in water to home...have assessed and repaired/replaced

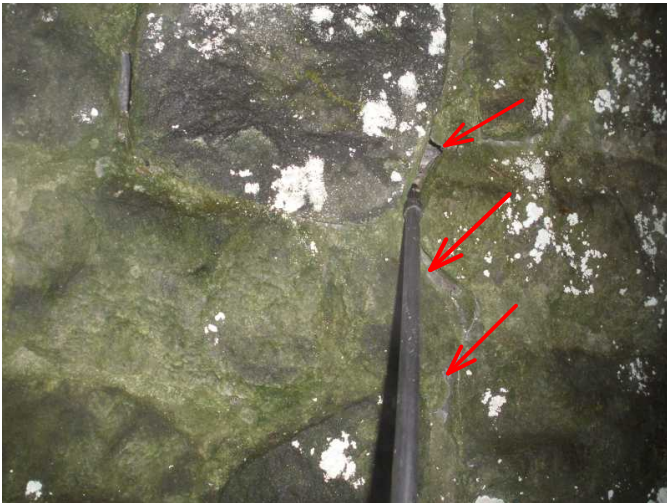
many gaps noted in fireplace to allow in water and leaks...correct...may need re-build...

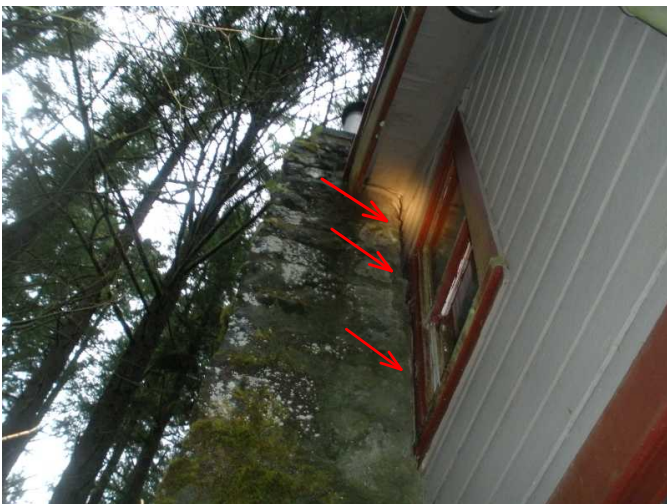
large open gaps are not good...have assessed and corrected by licensed mason...

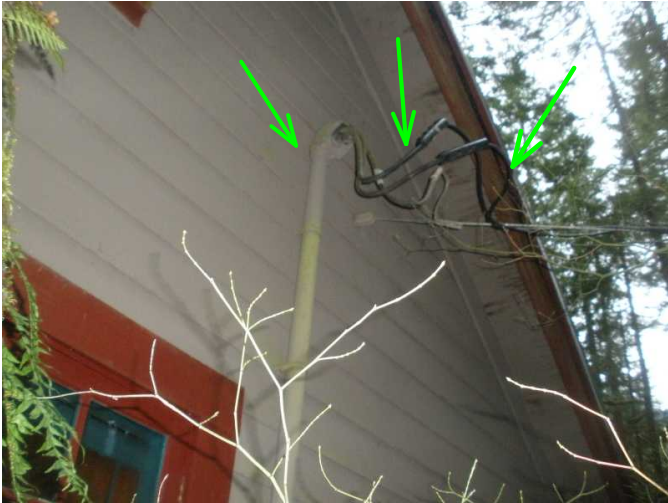
main electric entry is noted here at west side of home...drip loops are noted fine...

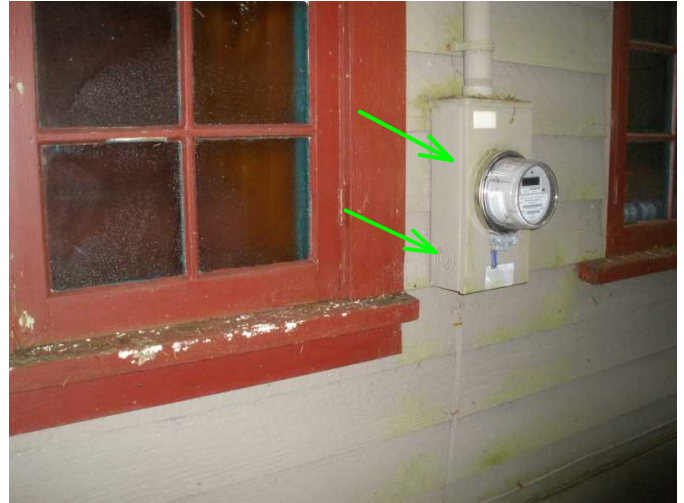
meter is noted fine and is solid to siding...

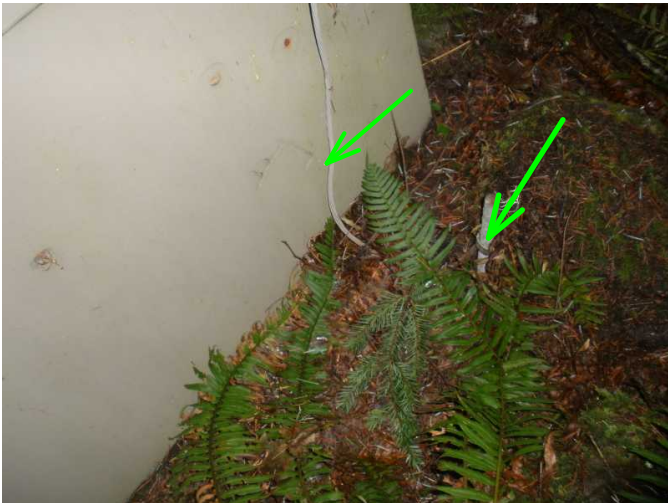
grounding wire is noted here at earth below meter at corner of home...

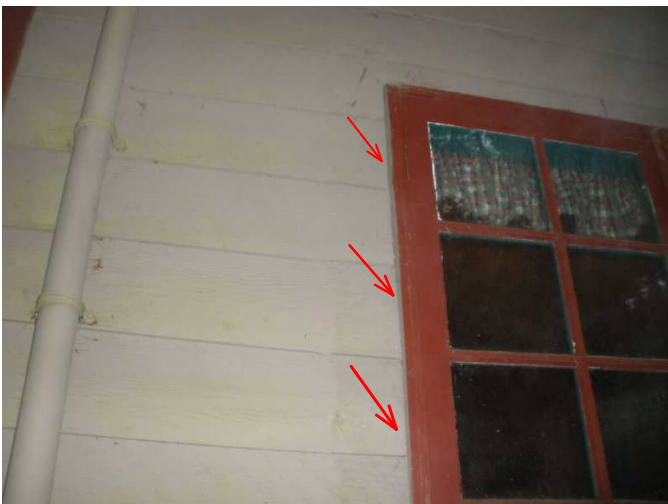
open gaps noted at dining area window at west side...seal with caulk...

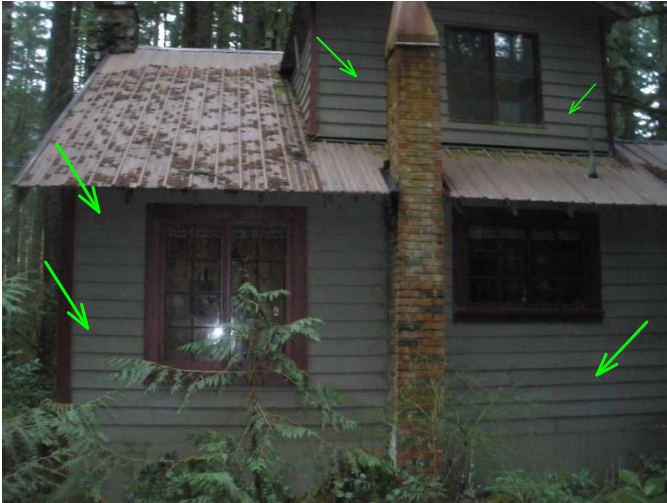
east area of home is noted here with siding appearing solid...

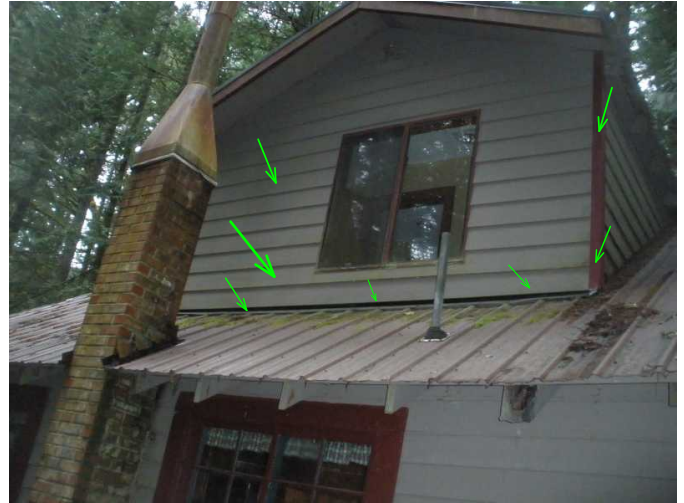
dormer is noted here and appears fine...flushed at base....good..

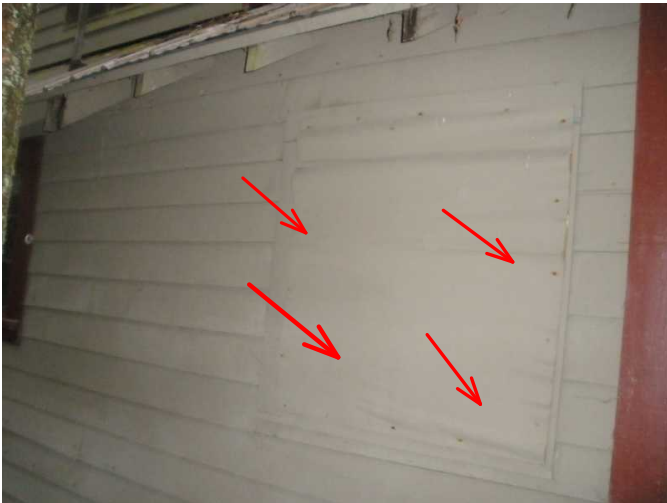
wood area here at old window does not appear to be exterior grade and will need replaced...warping from wet...
