# Home Inspection Report

72310 E Faubion Loop-Road 9 lot 11  
Rhododendron, Oregon  
Inspection date 12/24/2010  
Broker/ Sandi Strader @ Oregon Realty

Prepared by: The Home Tester  
10555 SW Tigard St. #57  
Tigard, OR 97223  
Ben Tester  
503-515-1833 CCB# 164921 OCHI # 912

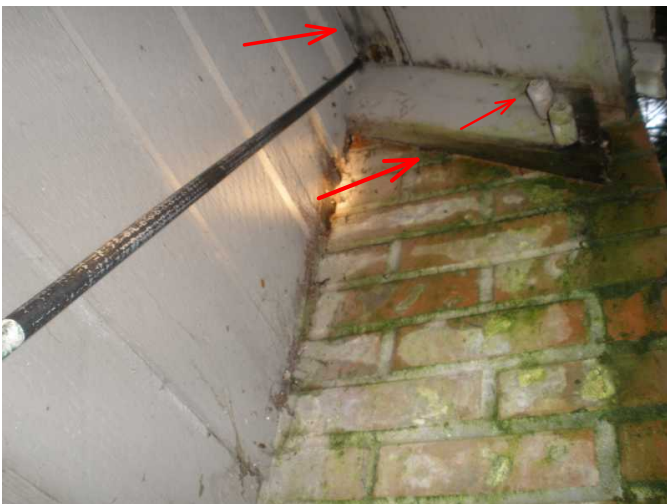
same issue noted at other side of chimney and open gaps noted at chimney to siding..seal off and correct flashing...

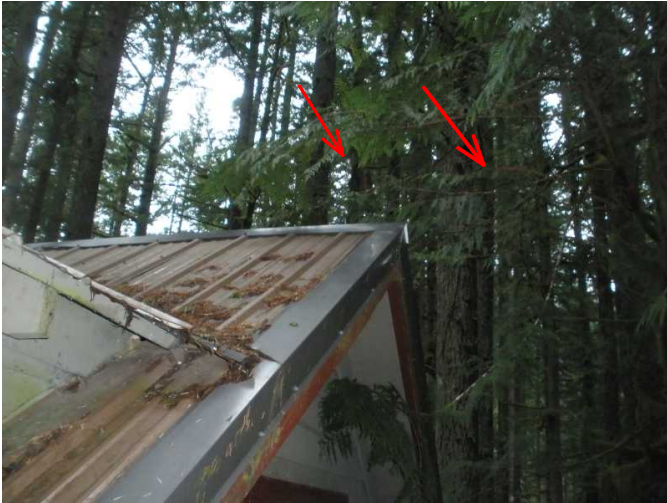
cut back tree overhangs at roof area...east side upper gable...

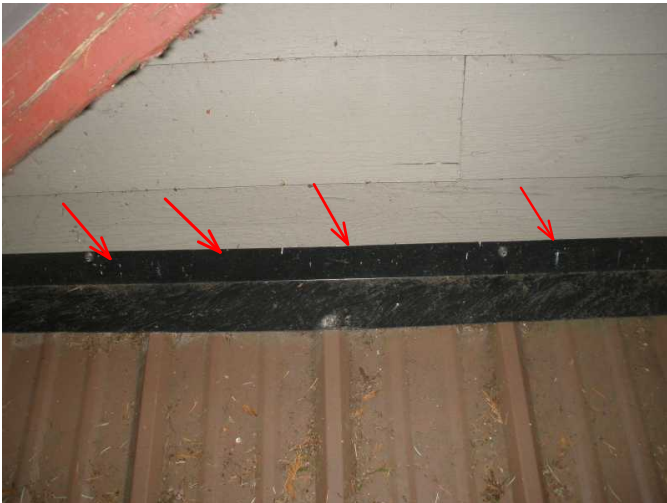
this flashing at roof to siding will need repaired to have counter flashing or plenty of caulk to seal...appears leaking

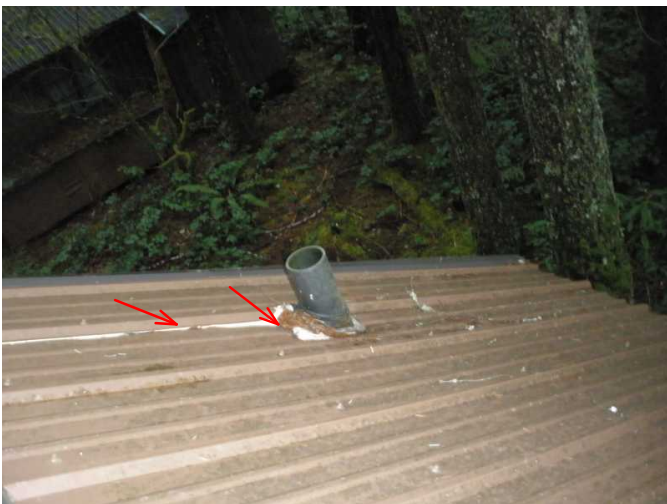
noted main sewer vent is noted with caulk at flashing and will need new caulk in spring...to ensure sealed...

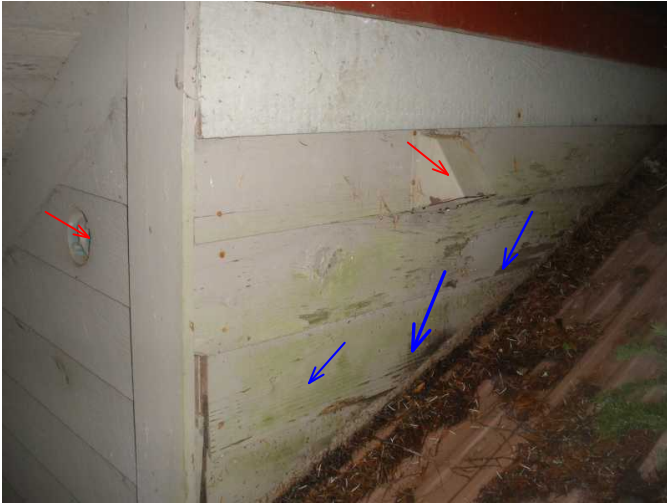
siding needs paint...step flashing at roof here is fine...bath exit fan vent is not operable..fixture needs covered

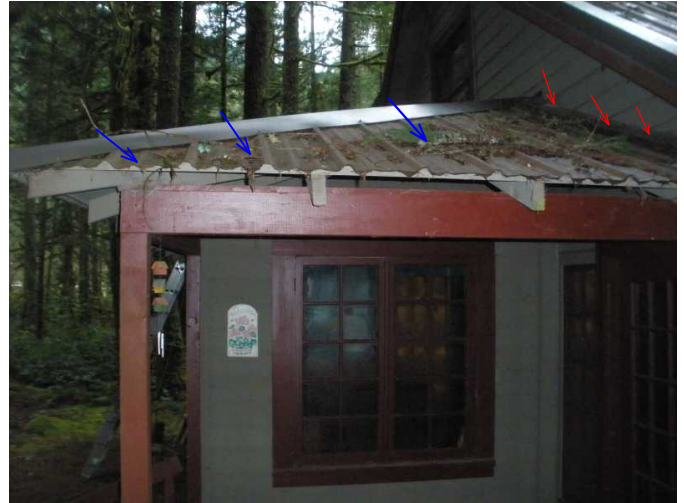
porch roof area is noted needing cleaned...add flashing to roof to siding area...

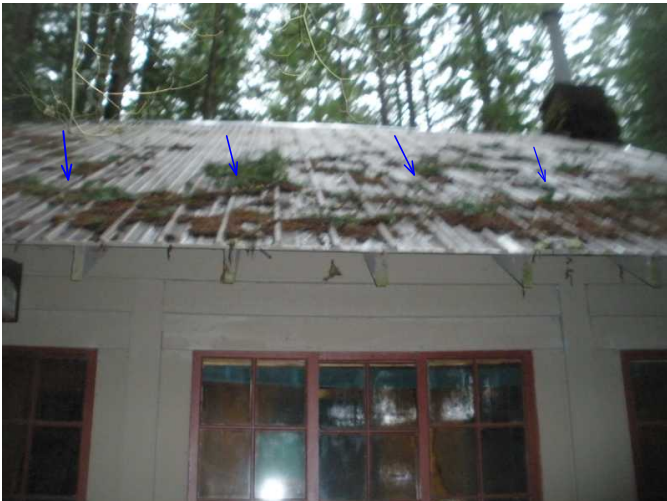
north roof appears fine...just needs cleaned...

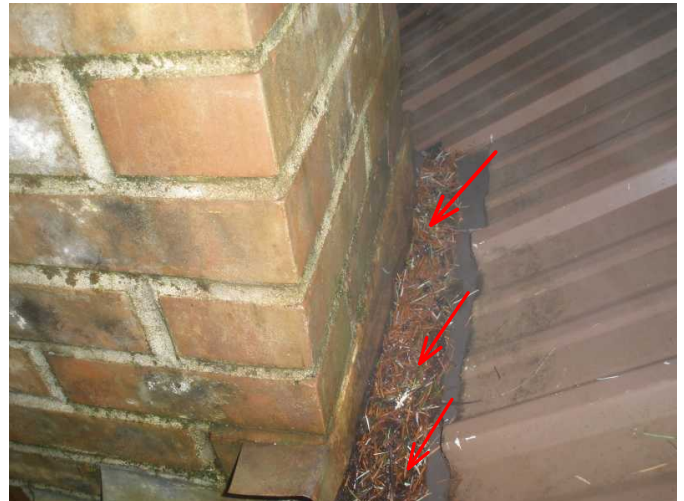
flashing at south chimney appears not installed properly...correct...also clean often to assess and monitor...

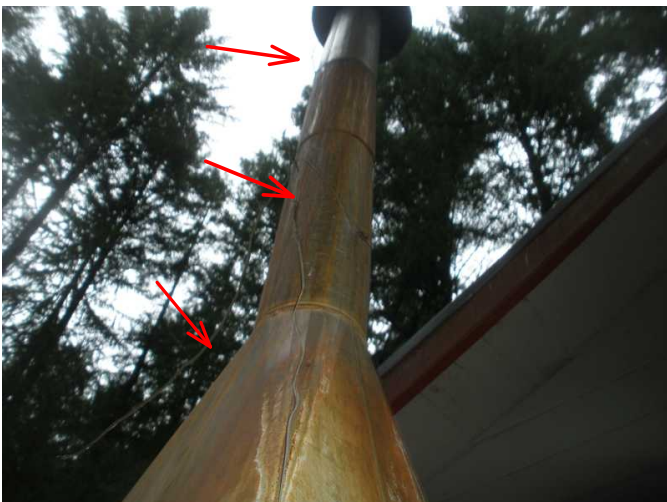
the single wall flue extension is not allowed by today's standards...correct...

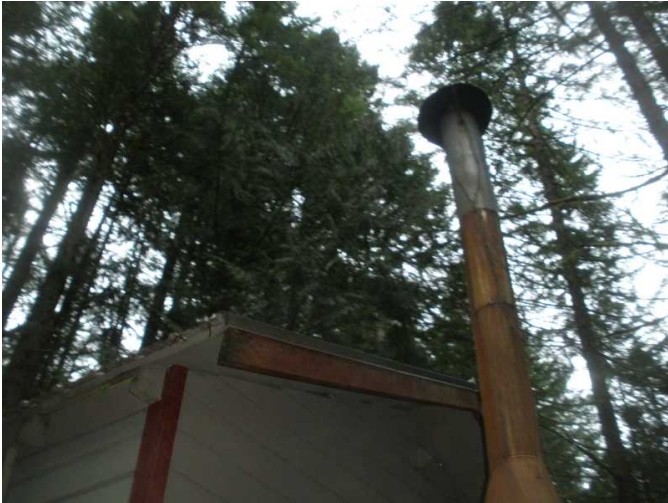
sewer vent noted here needs to be above upper roof line..is required...and appears step flashing is fine...clean roof...

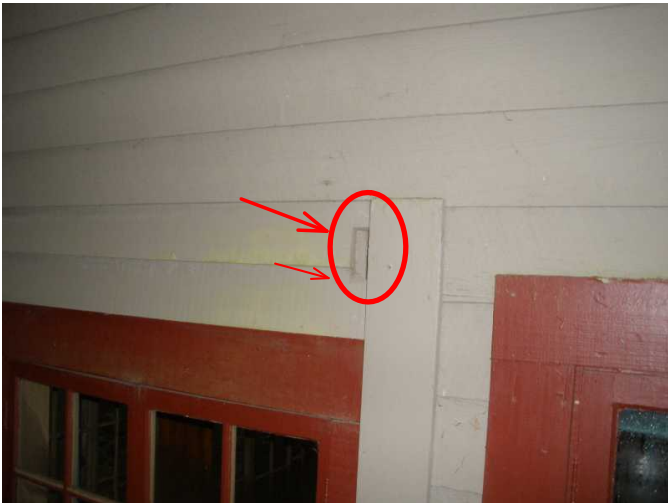
more open gaps noted at siding by master bedroom area...close all noted gaps at siding around home...

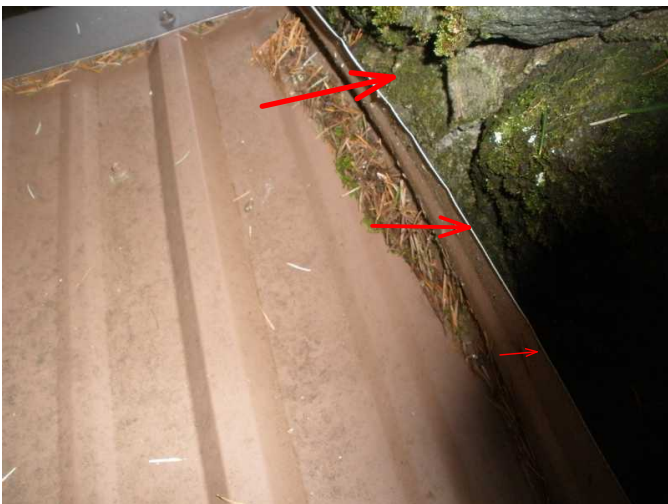
no flashing noted at roof line as well ...correct...

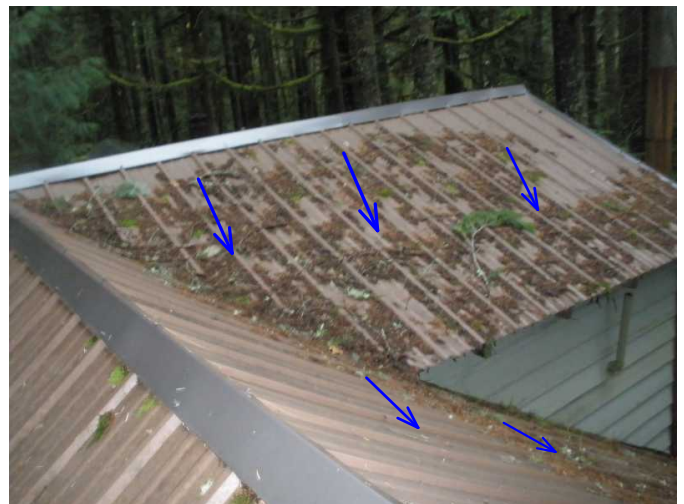
roof area over second floor bath valleys appear fine...roof needs cleaned...

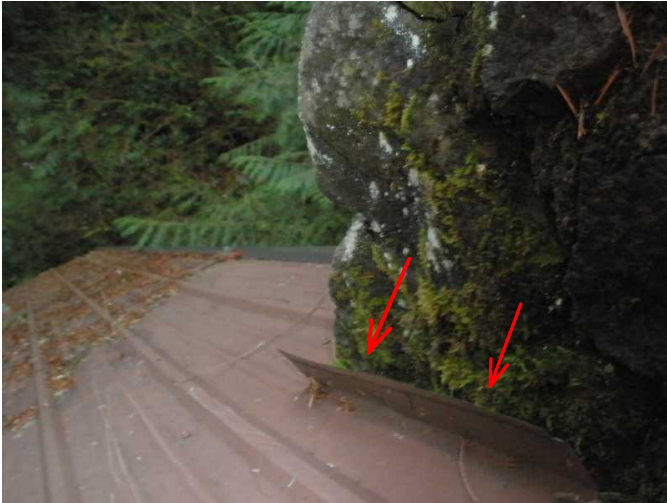
no flashing noted all around fireplace at all sides...correct...may be reason for high moisture in home as well...

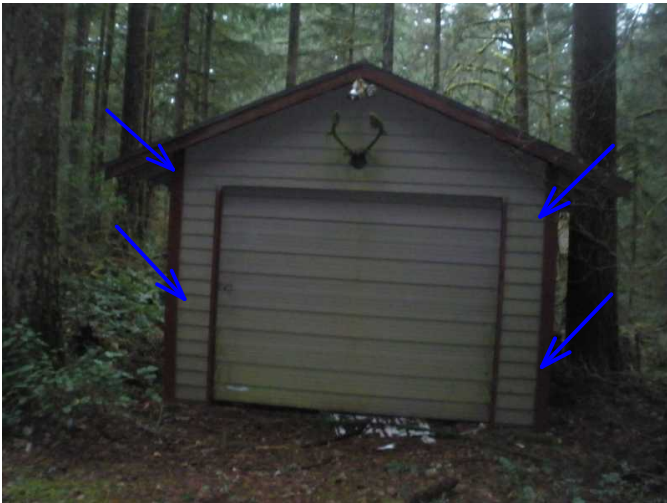
front of garage is noted here...siding and trim will need paint...overall appears solid...

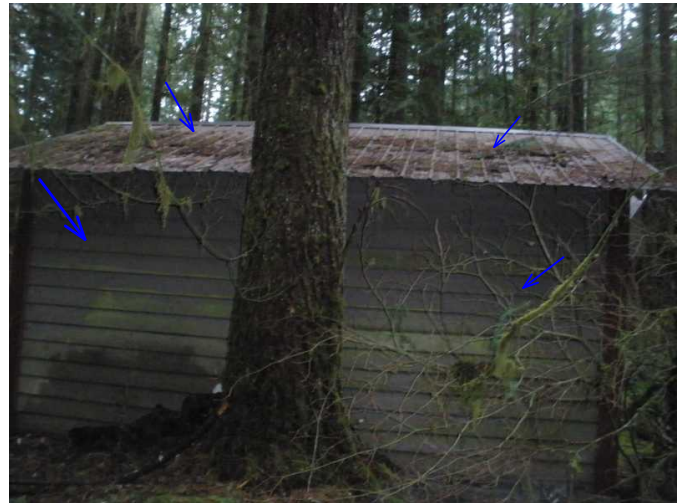
north side of garage appears fine...will need paint..roof needs cleaned and de mossed..

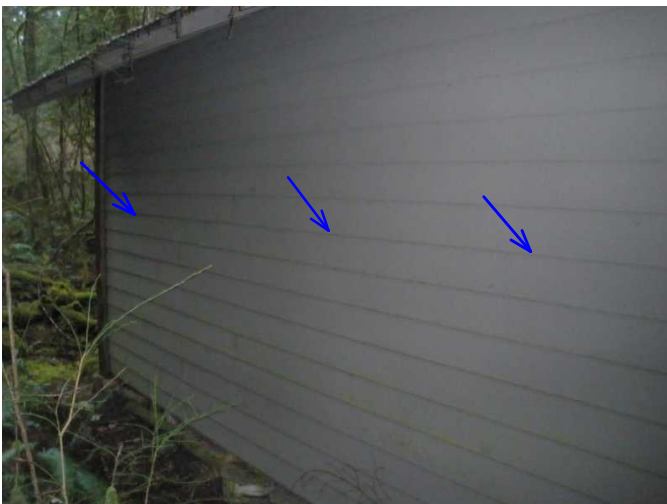
east side of garage will need paint as well...

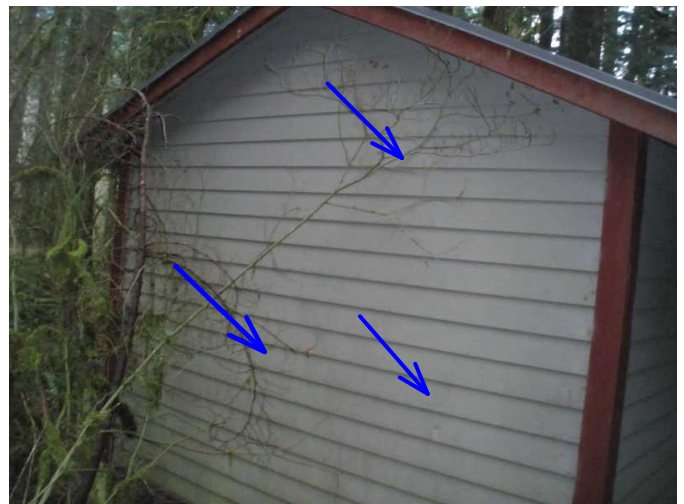
west side of garage and trim will also need paint...

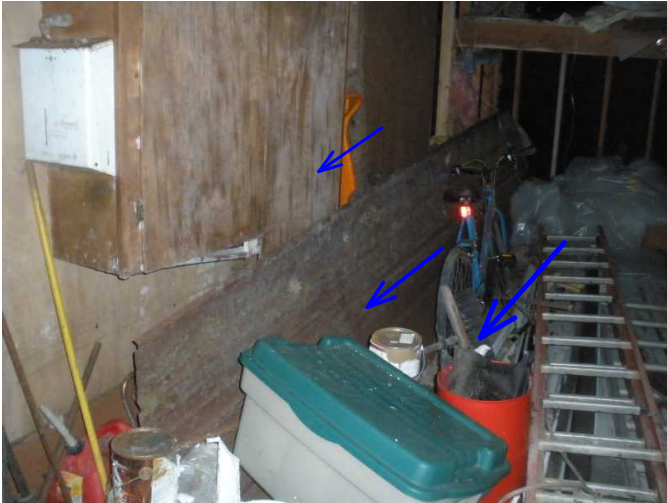
could not access and inspect walls of garage..is full of debris...

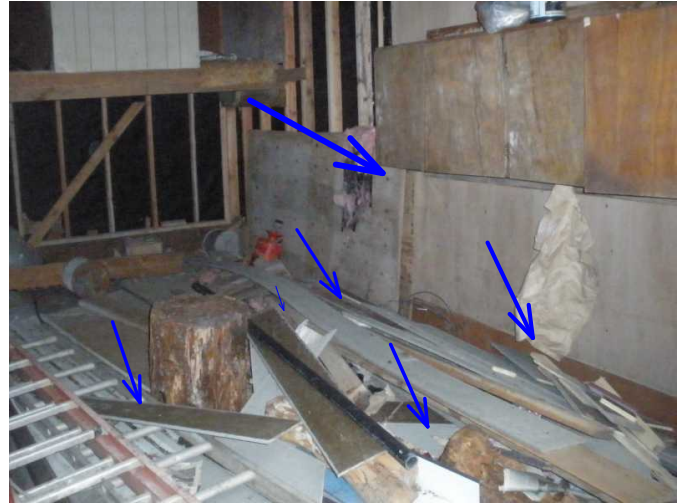
recommnd removal of all debris and assess for any issues behind stored items...

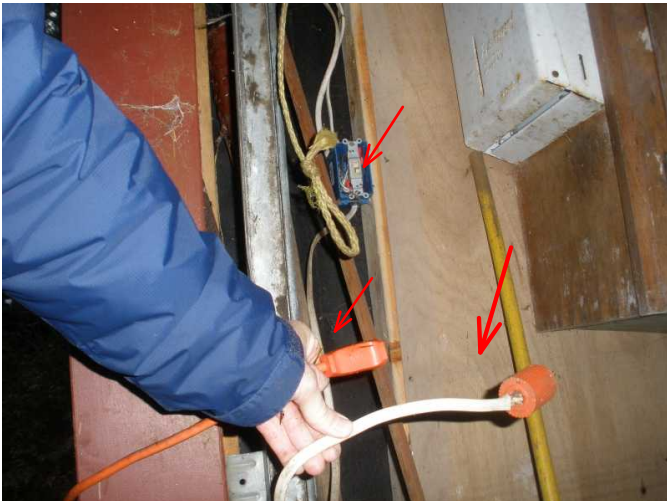
appears the electric supply is an extension cord...correct...is not acceptable..will require underground exterior grade

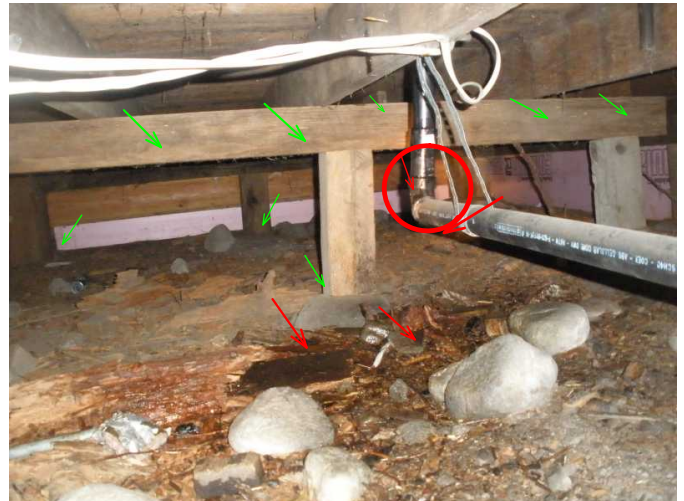
access under home is noted here...this is facing north side at front porch...all posts are on pads...leak noted at drain...

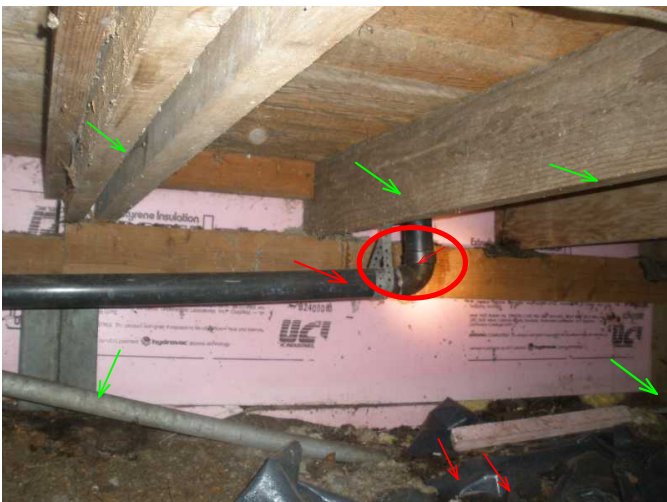
also noted leak area at sewer exit under kitchen drain area...posts are all noted raised and solid...

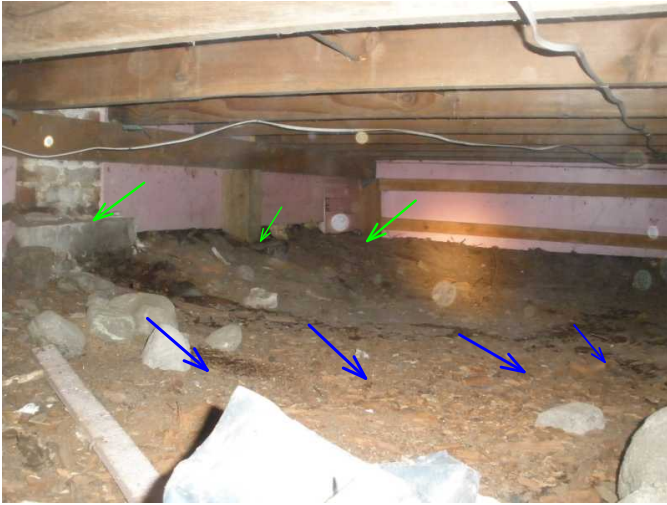
all post under dining area are noted raised on rocks/recommend pads...no vapor barrier noted for most of crawl..correct...

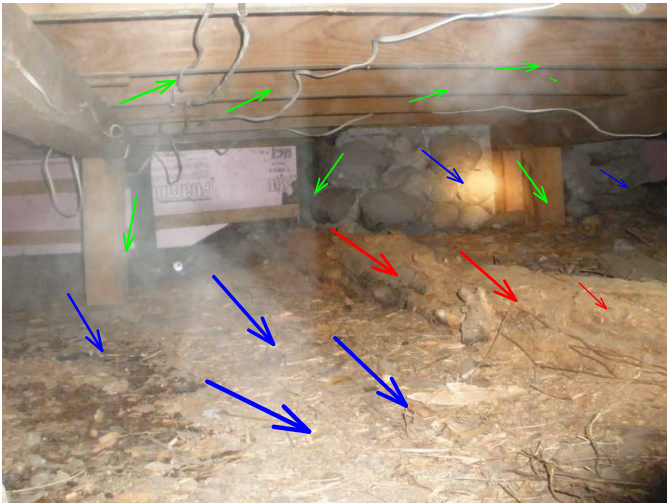
remove rotted wood...add vapor barrier and noted the base of fireplace is here...assess mortar joints...posts are solid...

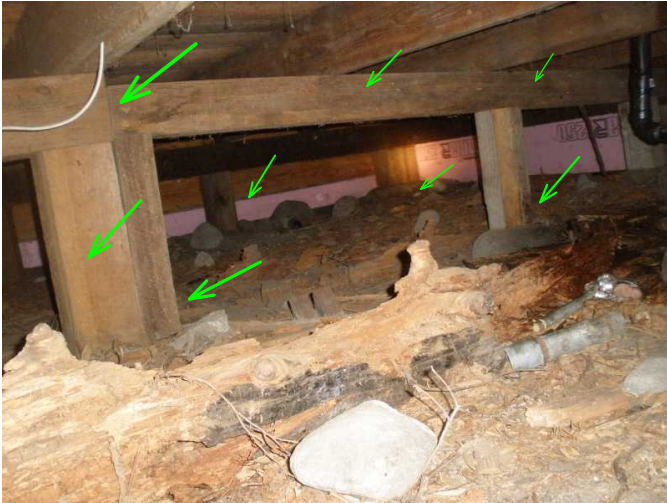
we have now done a complete circle under home from center area...all posts and beams and joists are solid...good...

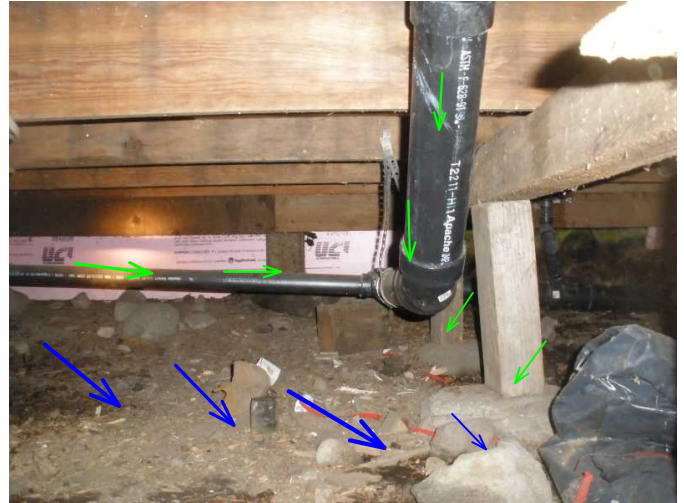
main sewer line from upper bath is noted here and leak free...posts are solid as well and raised...add vapor barrier

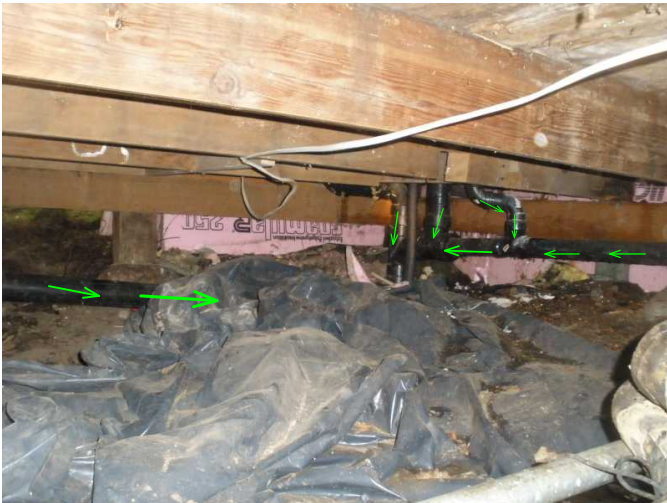
main sewer lines intersect here under first floor bath area...and are drip free this area...only area with vapor barrier

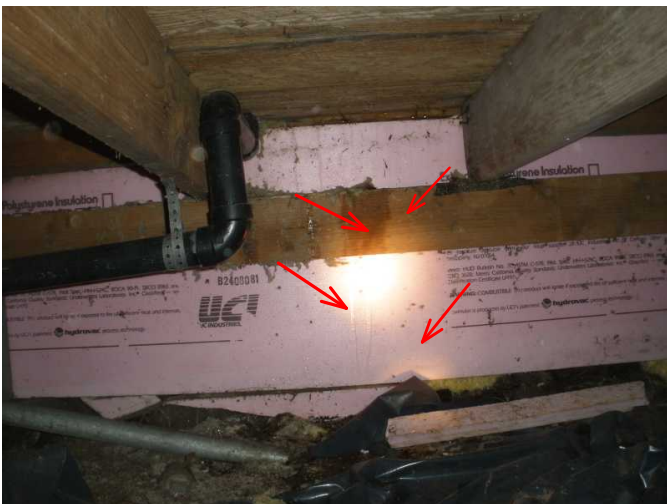
the area under kitchen is noted with leaks...and can be same issue as found outdoors at siding under sink area...
