Home Inspection Report

1503 #52 Hayden Island Drive
Portland, Oregon

Prepared for: Manufactured Home Sample / Actual Report

Prepared by: The Home Tester

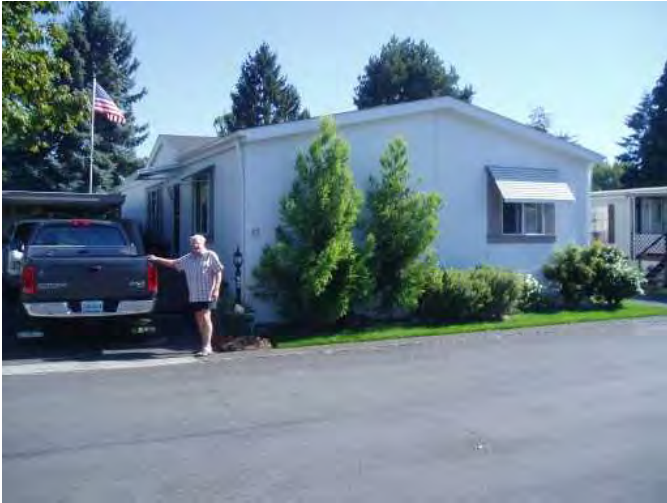
street view of home...good...

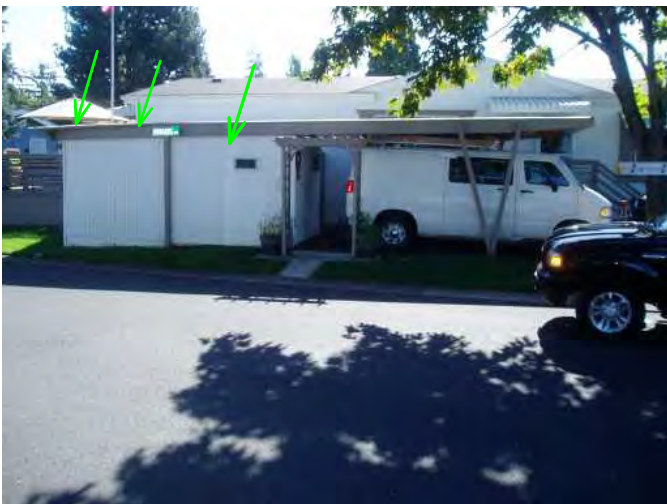
carport has and addition for tools and storage...good..

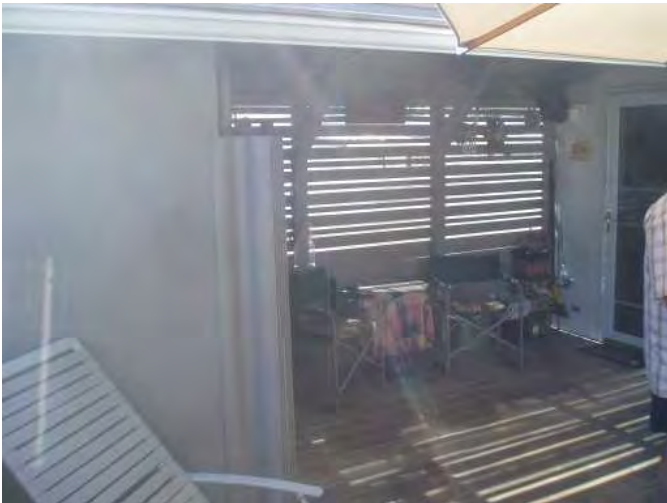
back view of covered deck area...good...solid...well built....

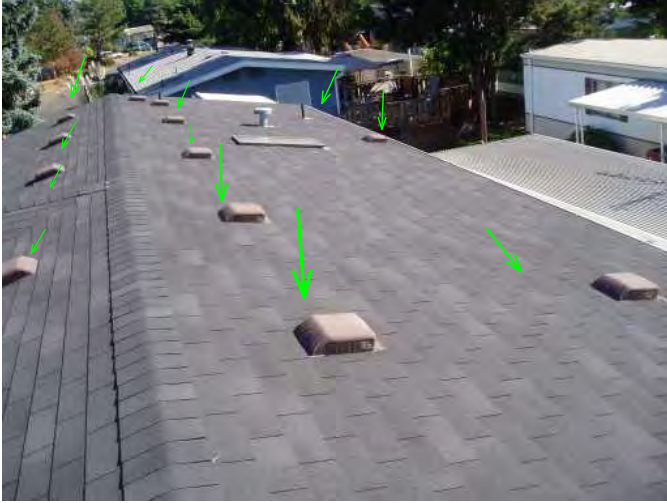
noting all of roof at south side and vents are all solid and sound....skylight flashing is fine...all good...

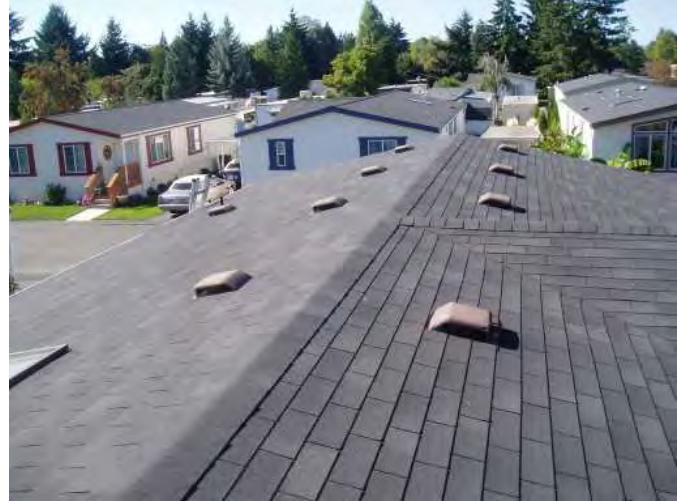
facing front of home and noting all is well as well...roof has been well maintained and cleaned regular...good...

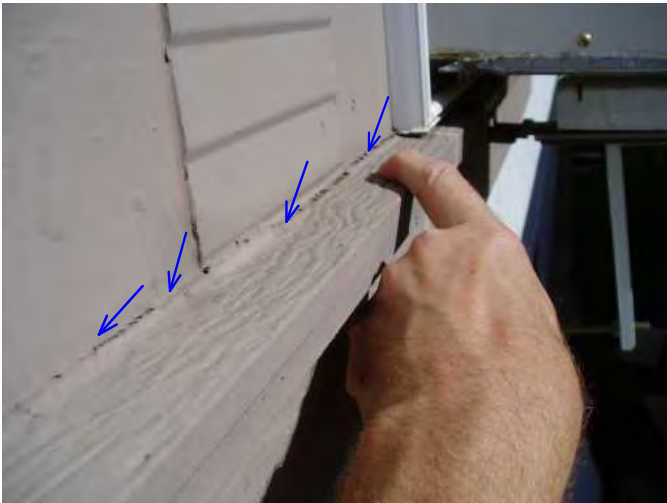
minor issues here at south side with need for caulk to seal at window trim....

Trim: Wood - caulk at open gaps at trim/noted at south side lower windows...

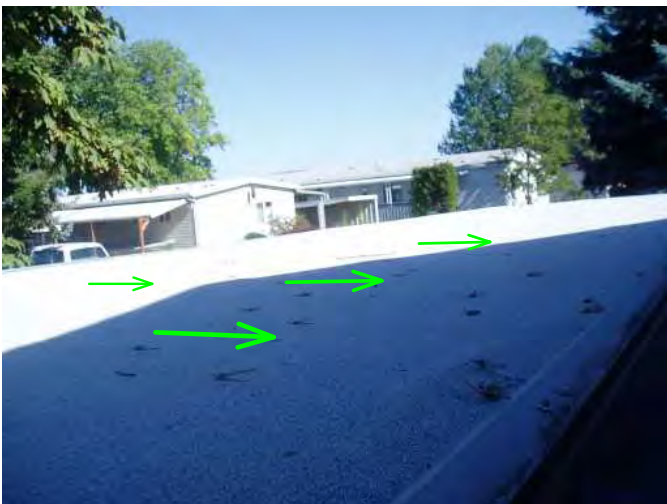
rolled roof over carport appears to be part of land owner and ask who maintains and repairs...

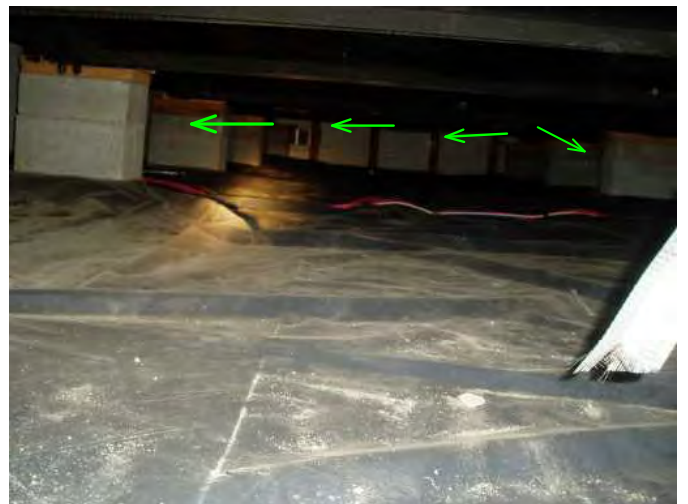
clean and dry again...good...

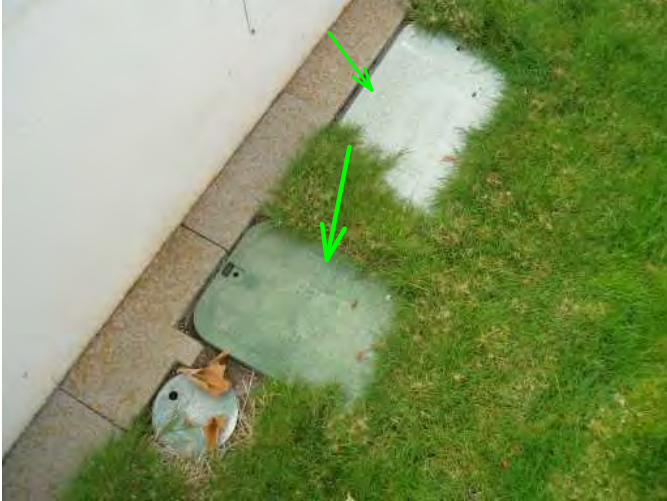
irrigation control valves....also...see brick pavers along skirting? Great! less of an issue to mow....

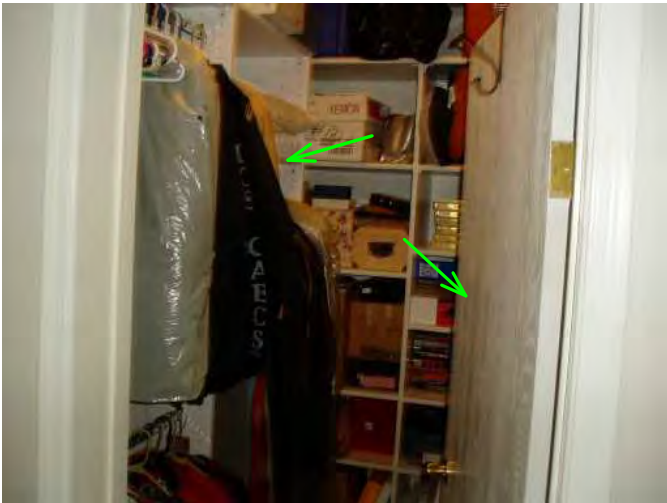
bed 3 walk in closet and door and shelves are solid and sound....good...

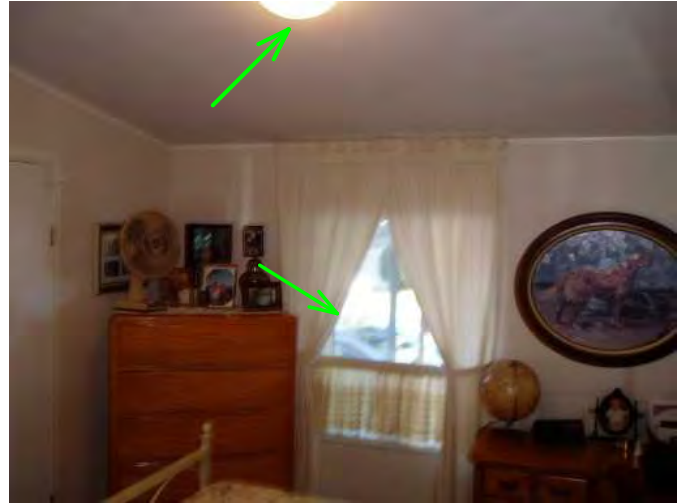
bed 3 fixture and window are operable...good..

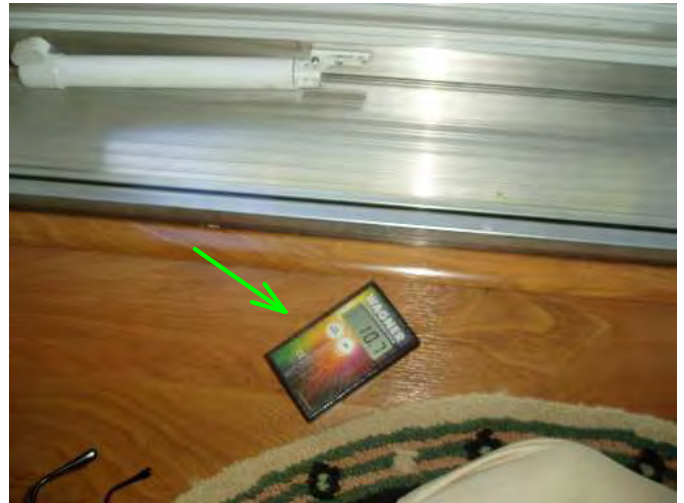
front door is noted with low moisture content...good...threshold and weather stripping is good...at door....

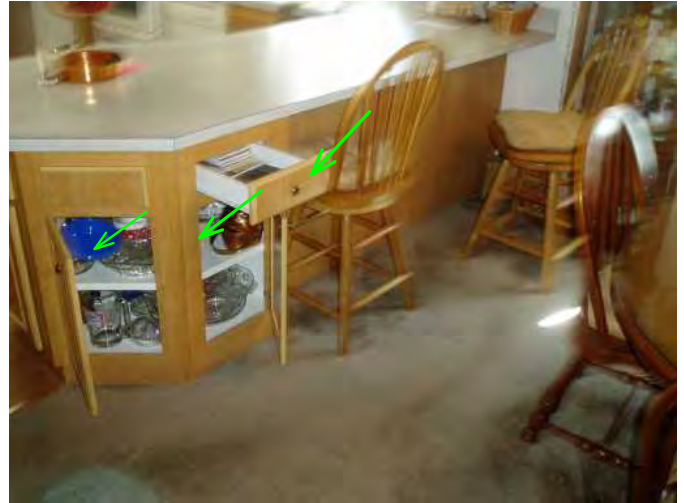
dining room cabinets are operable..and counter is solid to cabinets....good...

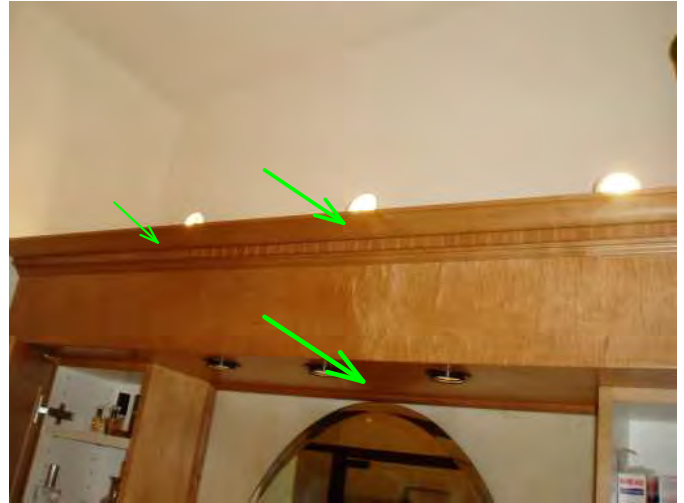
custom cabinets and lighting are amazing here....very nice!! Solid to walls and operable...good...

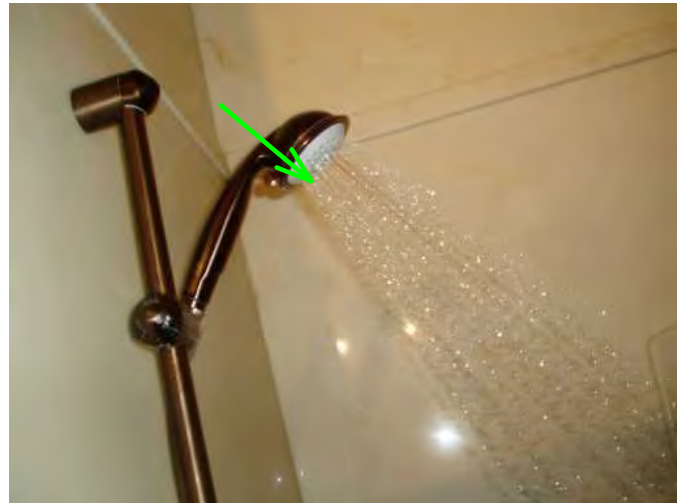
shower and shower door are operable....good...

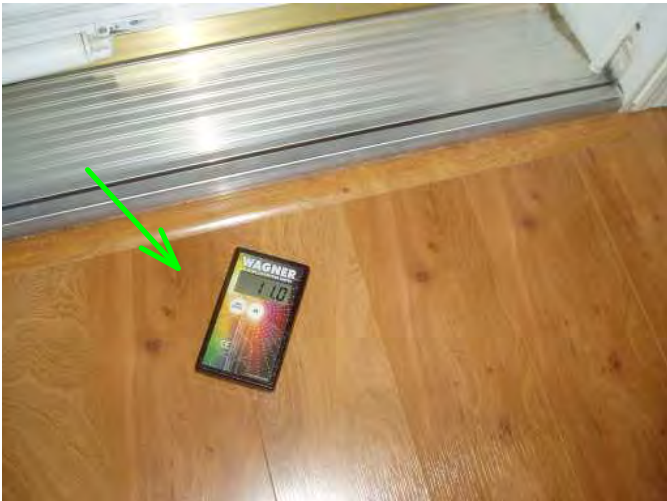
no high moisture noted at back door area flooring....good...

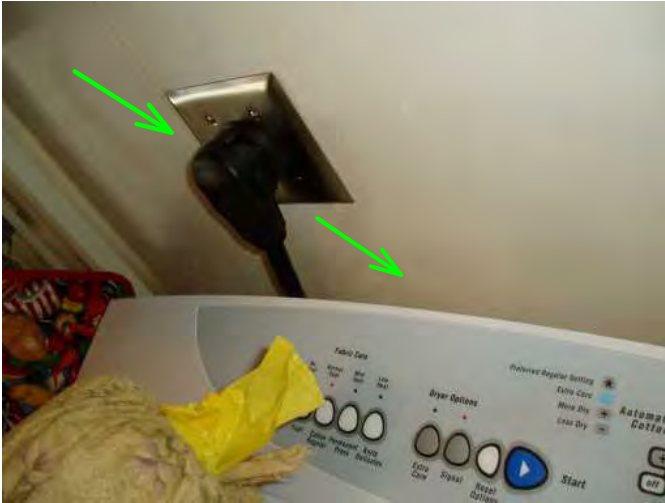
dryer hook ups are fine as well...good...

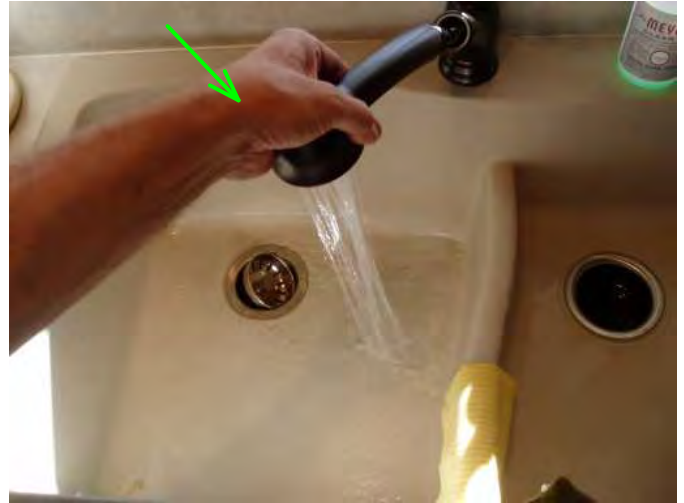
sprayer arm is operable...good...

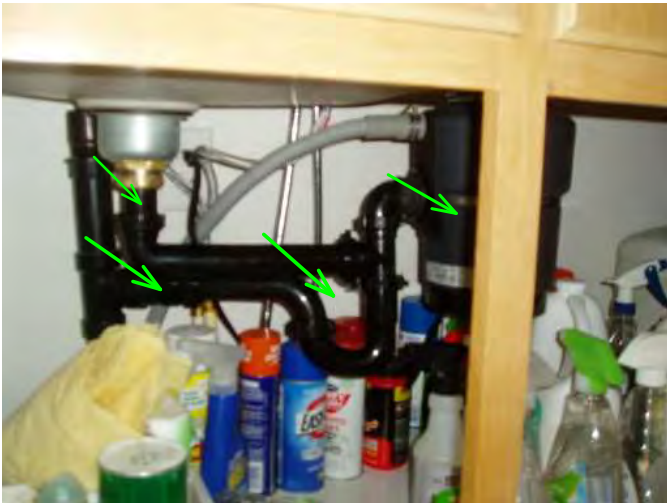
garbage disposal and drains are fine...no drips or leaks noted...good..

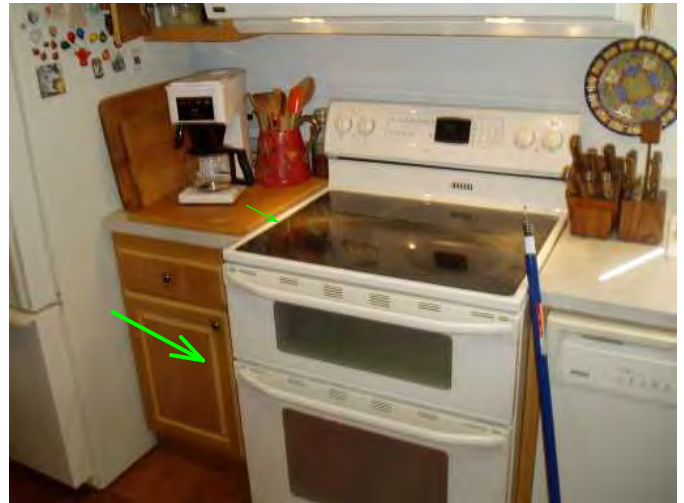
stove is operable...good...

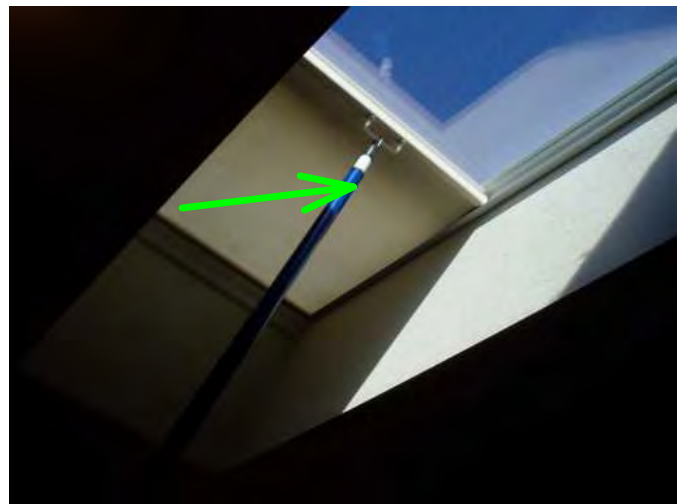
noting skylight is operable..good...
