Home Inspection Report

18623 NW Reeder Road
Sauvies Island, Oregon

Prepared for: Sample Report

Prepared by: The Home Tester
10555 SW Tigard St. #57
Tigard, OR 97223

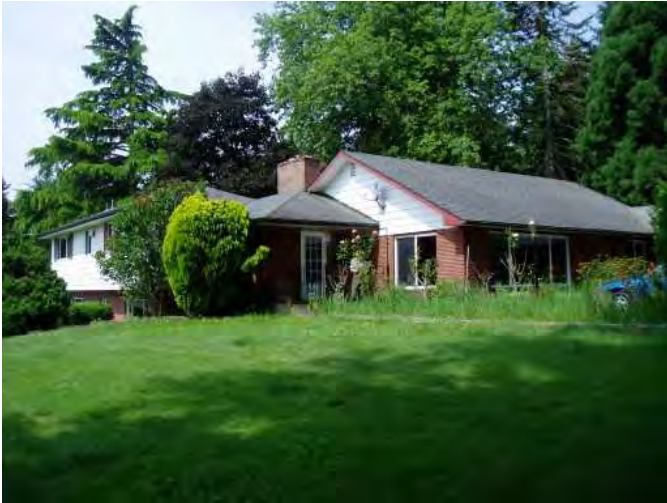
front view of home....

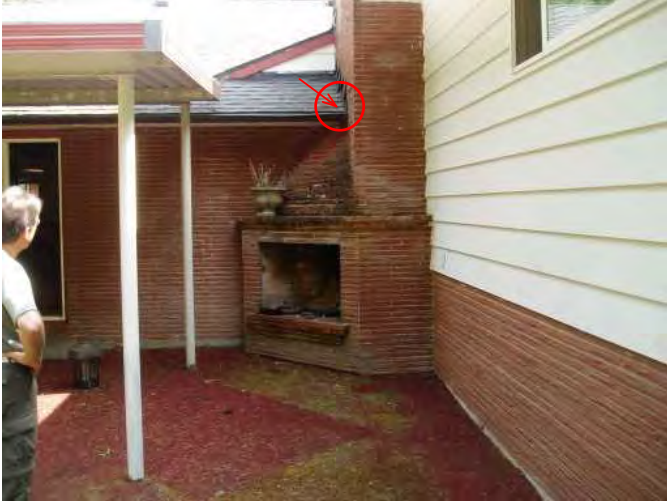
fireplace is noted here, and roof appears to be flashed well above...could use better kickouts at base to gutters..

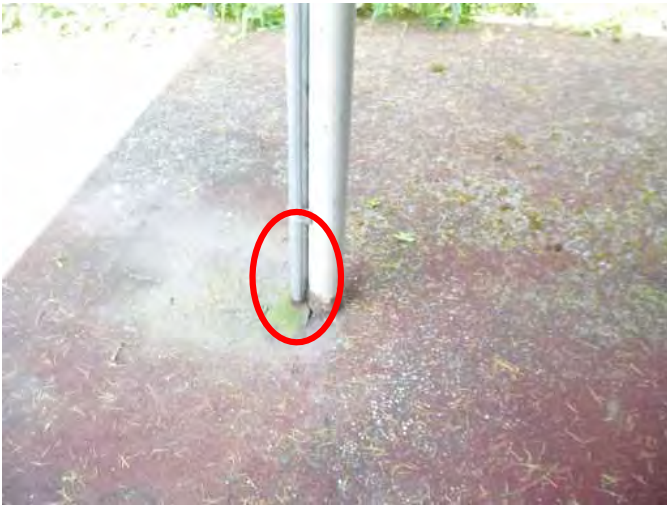
mini metal ro over patio has downspout that dumps here and feeds into sloped area..re-think this...

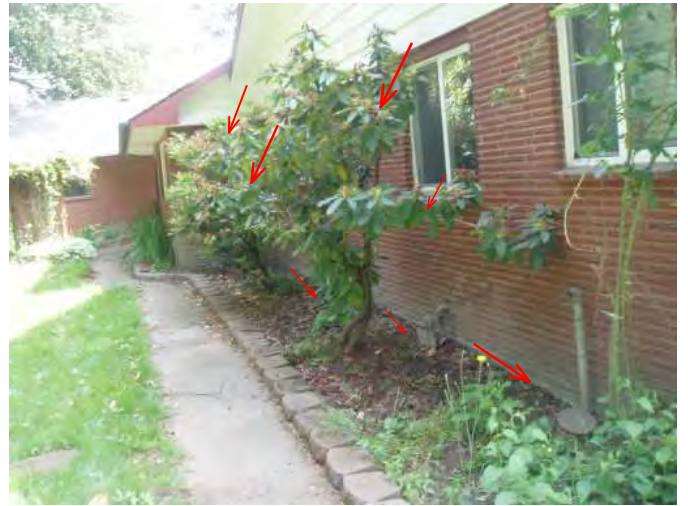
backside of kitchen area brick is below grade and needs to have earth lowered...trim back vegetation...

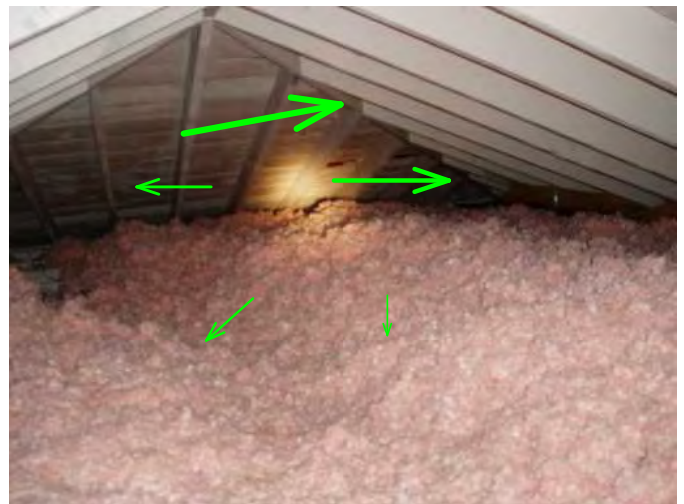
roo fover bedrooms is hip type...rafters are solid and sound....good...painted after fire in past...

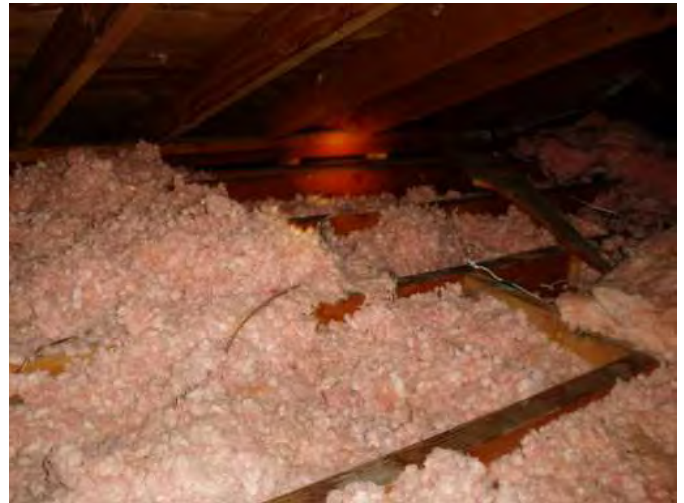
upper attic over kitchen area, has double wide ceiling joists noted for extra strength...good..

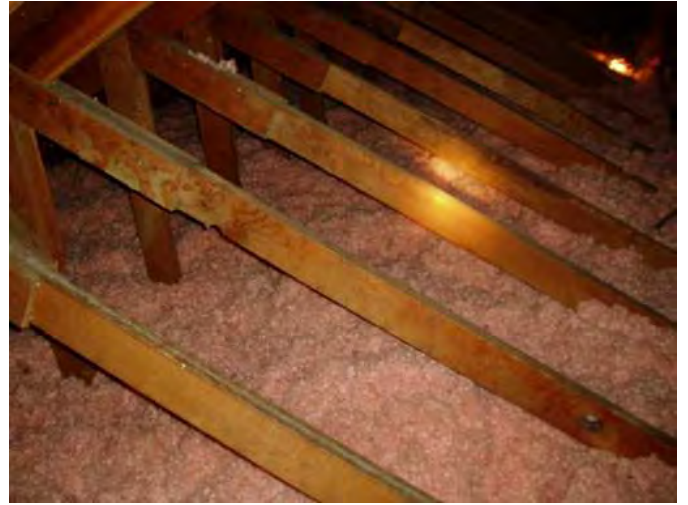
rafters are built in truss style with extra strong junctions...very good...

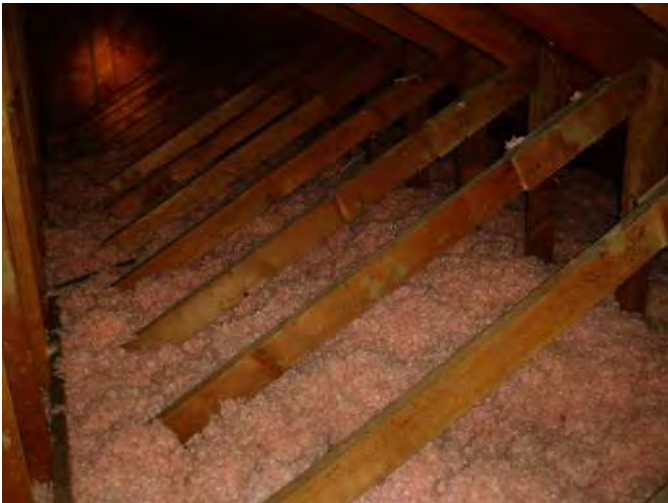
looking toward back of lot...above kitchen area...

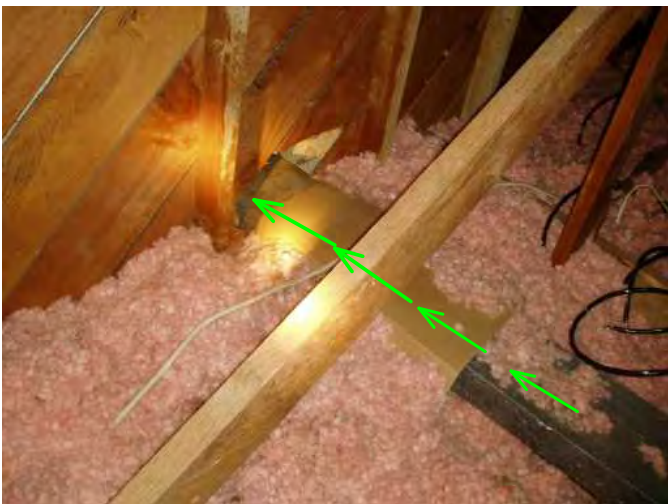
kitchen hood vent exits side of home...good..

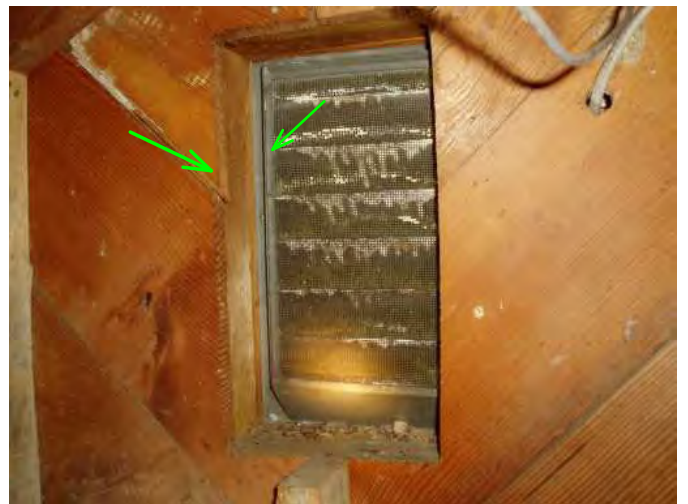
double thick walls in upepr gable area...good..

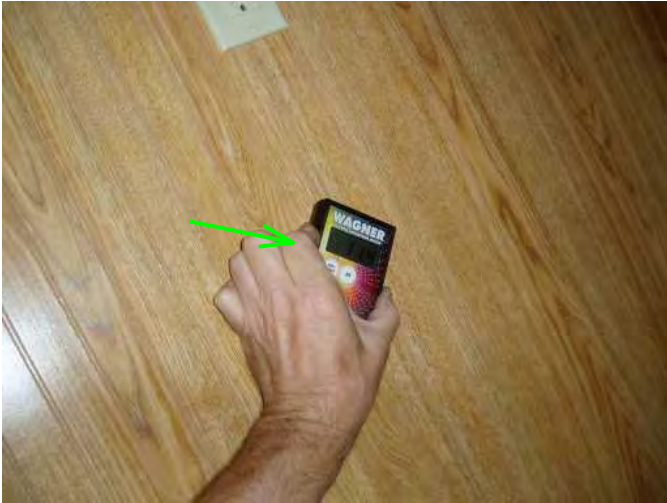
moisture at bed 3 walls are good...exterior walls are fine....good..

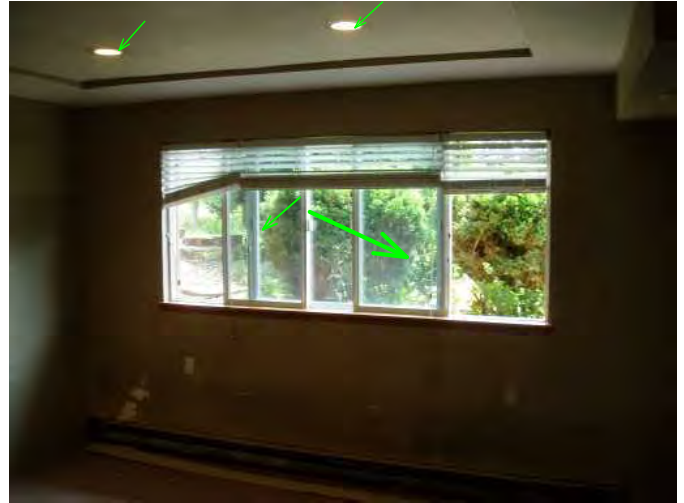
windows in family room are operable...good..as are fixtures....

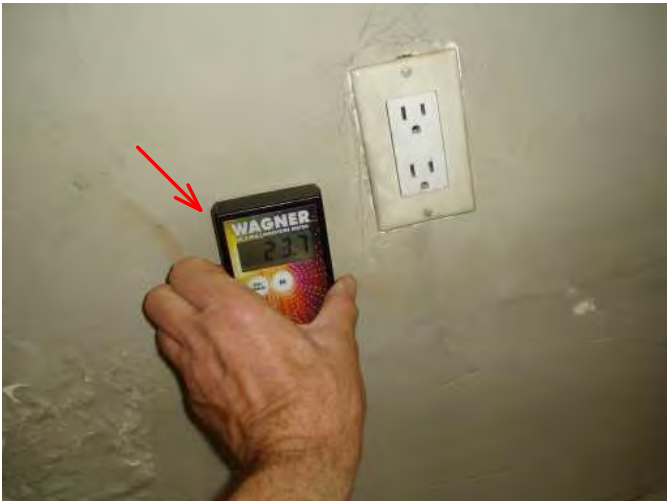
here is issue with family room walls...lower area and at corner is noted with very high moisture content, will need work

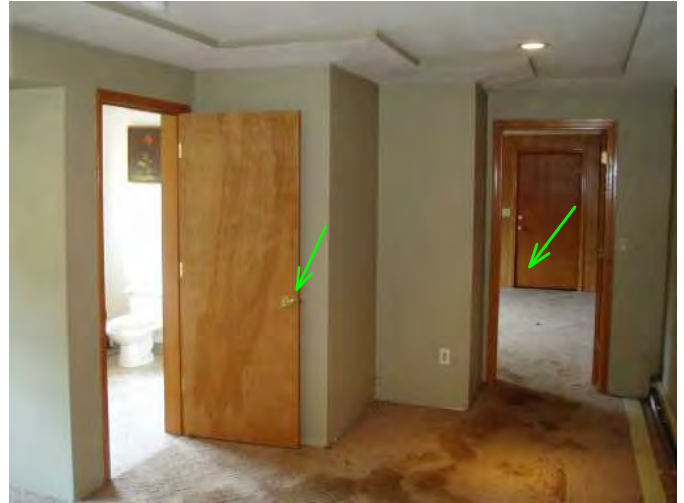
doors to family room area operable....good...

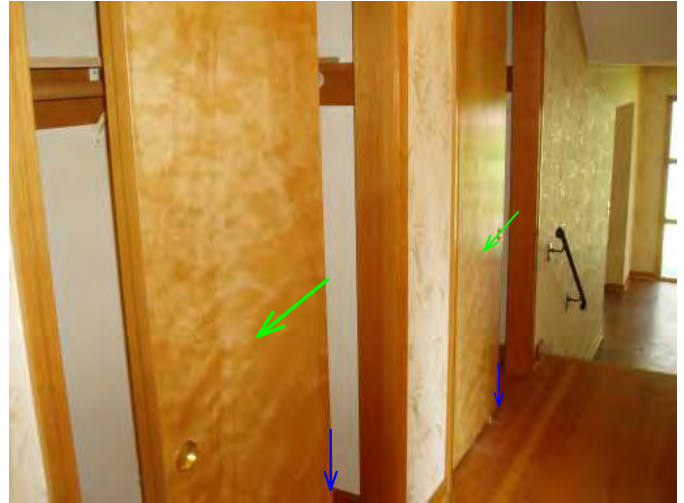
left closet doors need tracks like right one has...

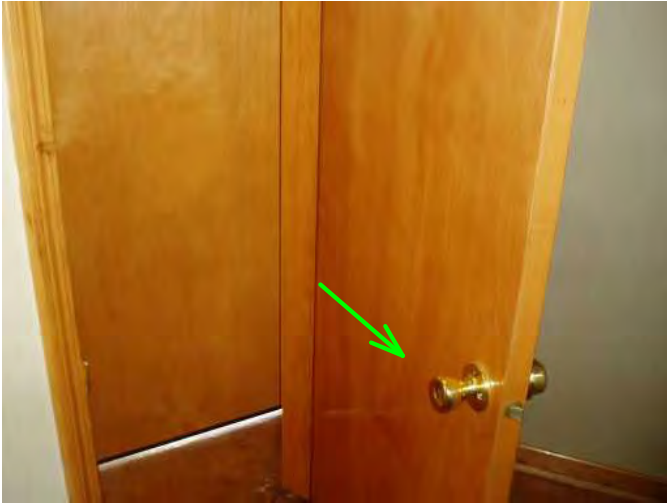
door to basement is operable...

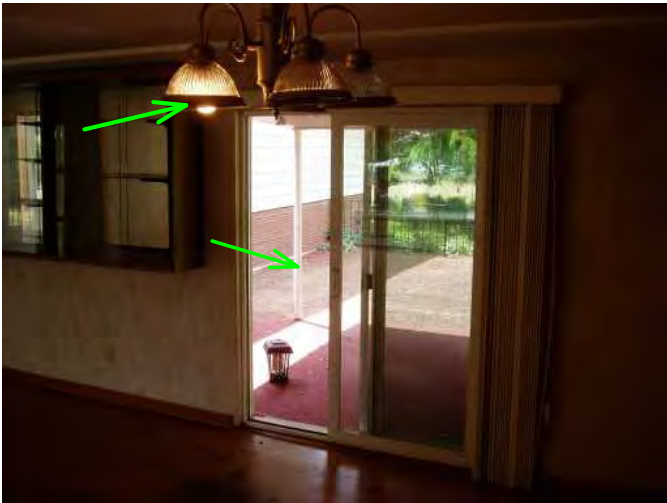
fixture over dining room and slider are noted here as operable...

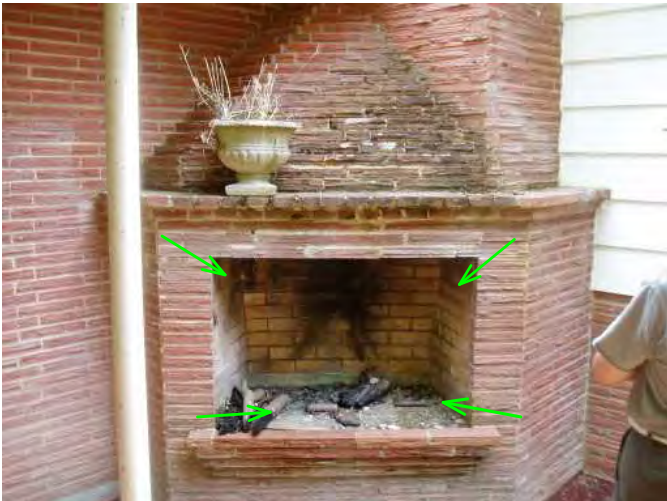
outdoor fireplace is operable...pretty clean for age...

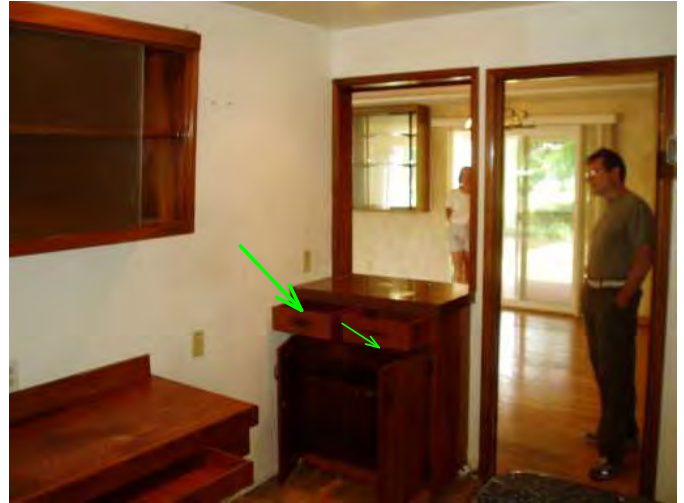
small area here is operable...good.

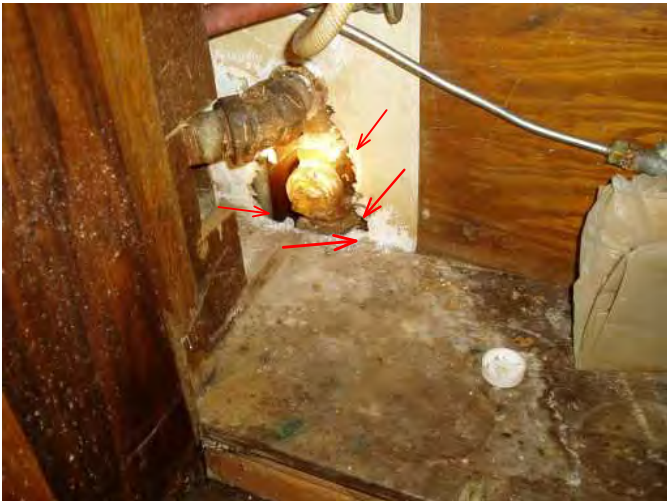
most likely vermin access entry area...seal up asap...

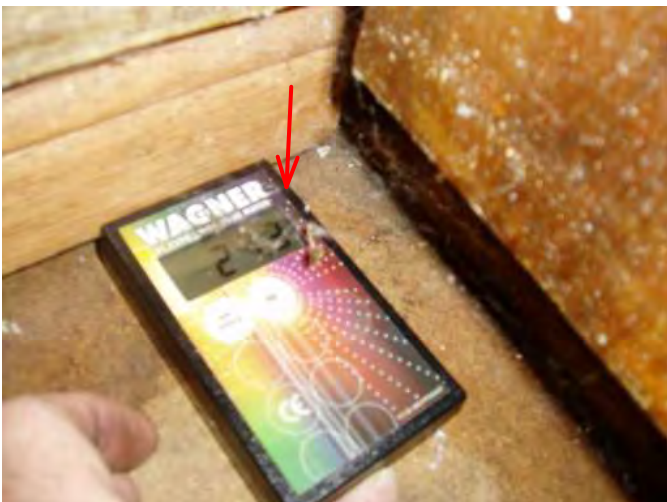
very high here as well in left area...by sink wall area...

1st Floor - Kitchen - Floor: Vinyl floor covering - Water damage, needs flooring

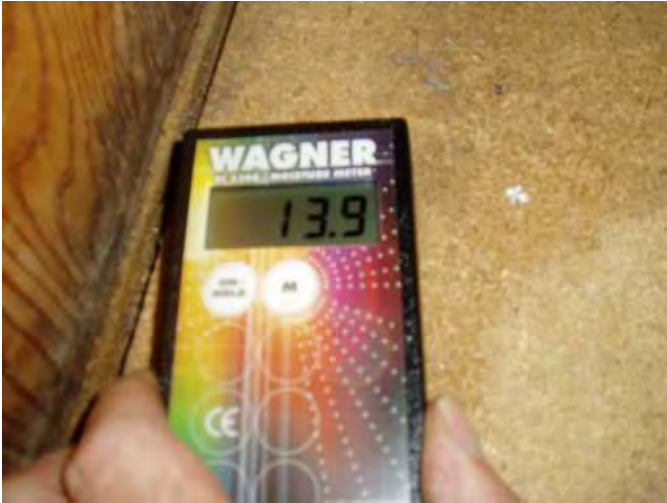
lower her at far left at coner of cabinets..good..

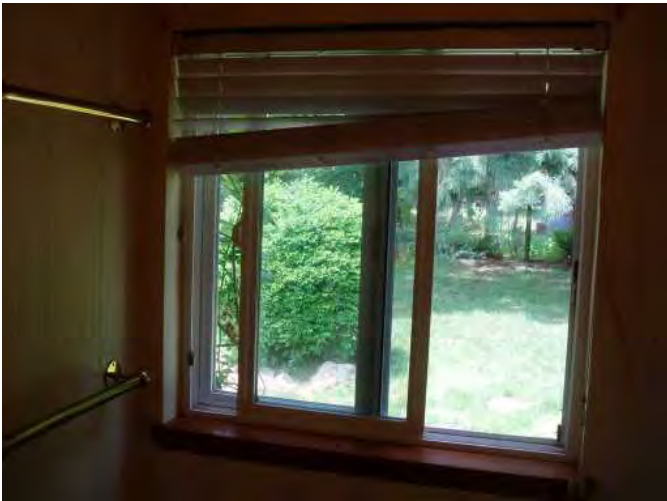
window is operable at back of bathroom...good..

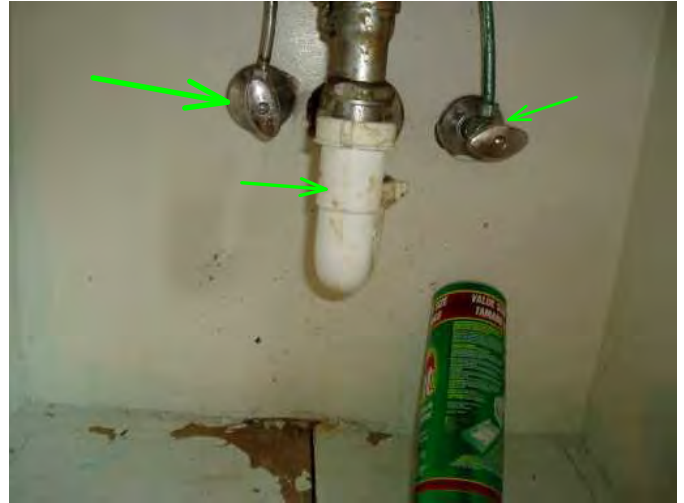
no drips or leaks under sink noted....

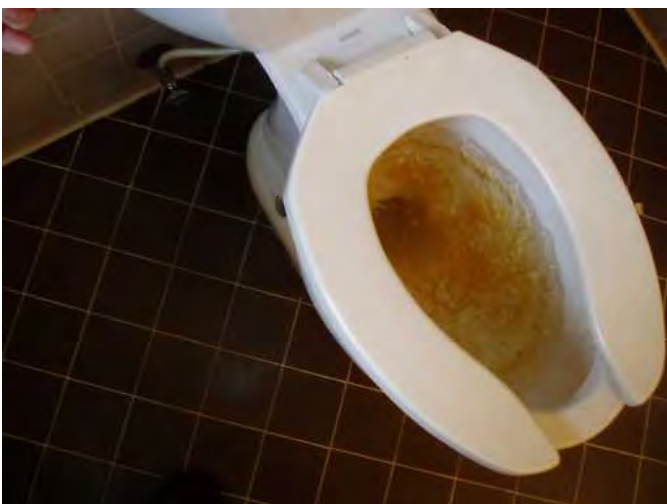
toilet is operable....

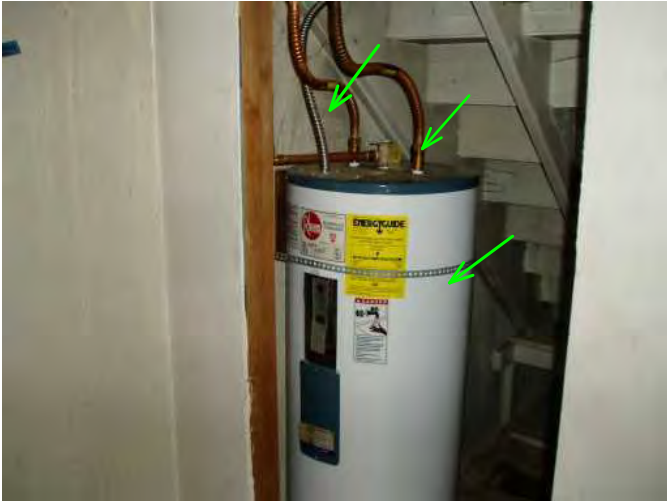
water heater in basement utility room area is noted here as operable...strapped well to wall...about 10 years old...

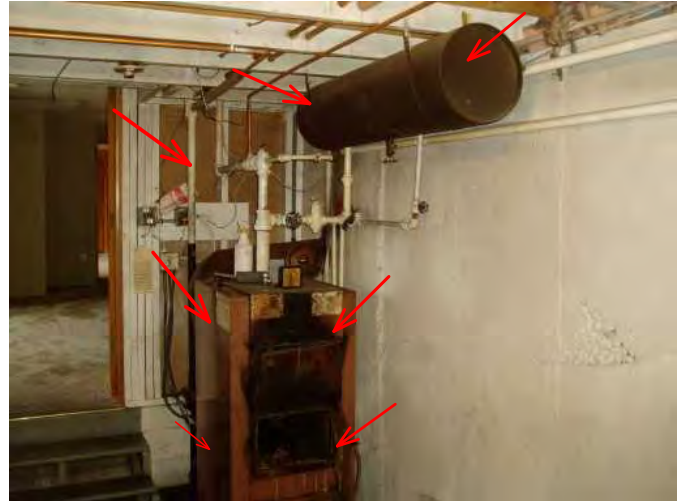
none of furnace was inspected....appears to be in process of repalcing to gas unit....good..

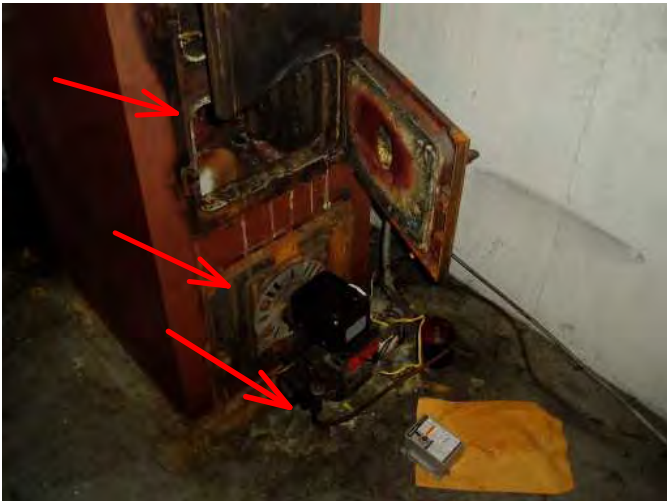
appears to be really ready for change...

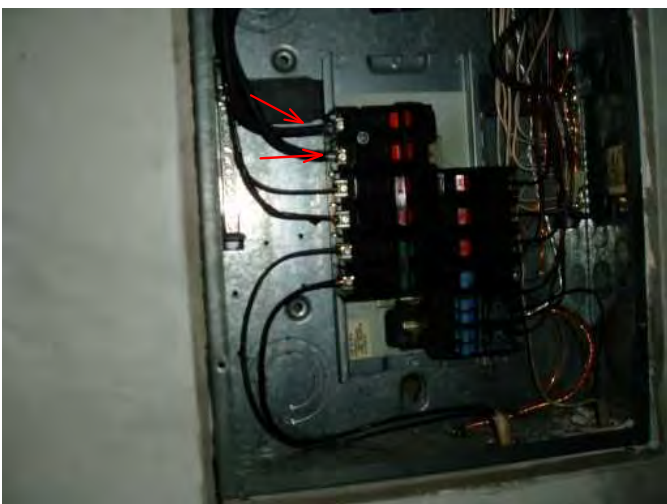
open view of panel shows a conflict of breaker sizes..this one is 60 amp...and breaker in main panel is 50 amp...assess...

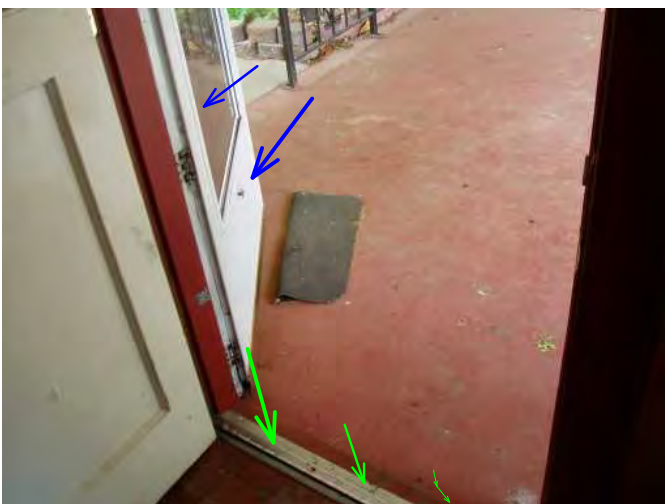
storm door is needing a bit of work to latch...threshold for mud room door is solid....good..

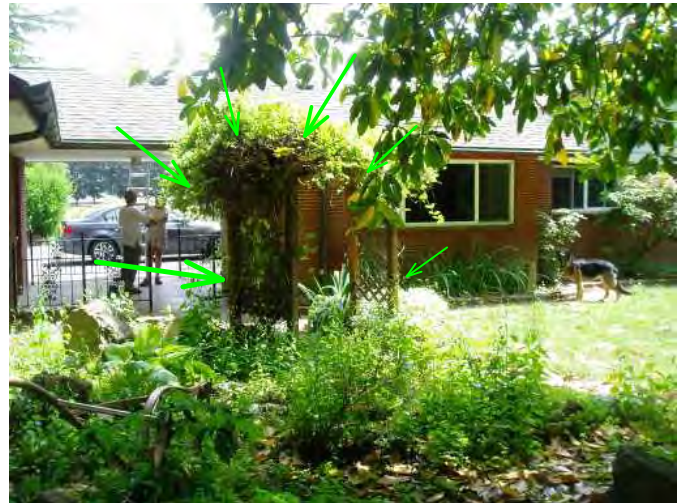
arbors are a great way to enjoy vines and vegetation without contact of living area structures...great!
