Home Inspection Report

8170 SouthWest Maxine Lane #65
Wilsonville, Oregon

Prepared for: Sample Report/ Actual Report / Condo

Prepared by: The Home Tester

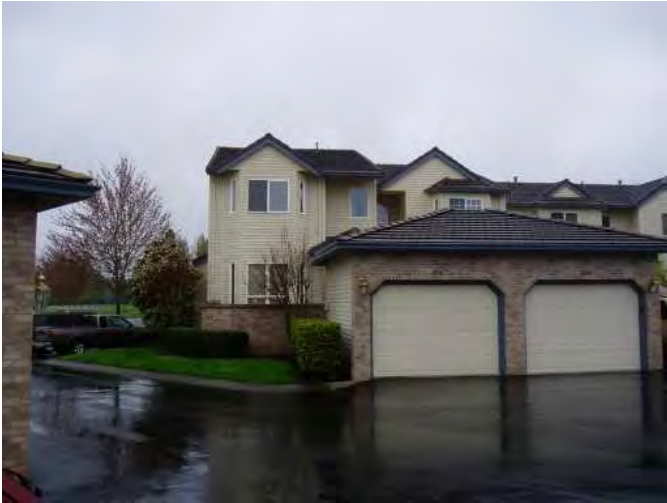
front view of unit and garage....

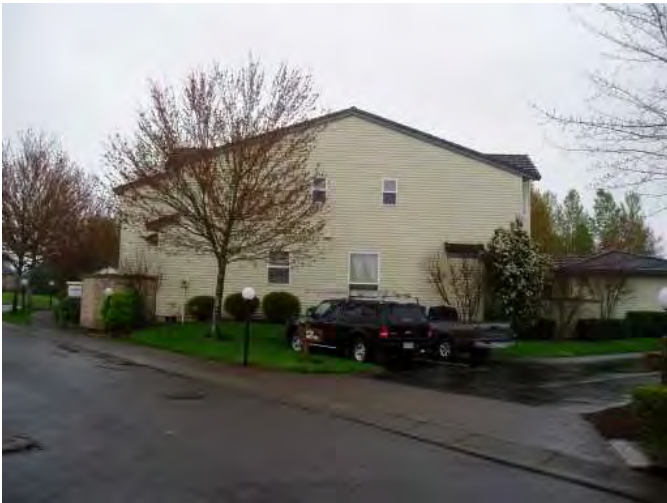
side of unit...entire outside of unit appears well maintained...as does complex...

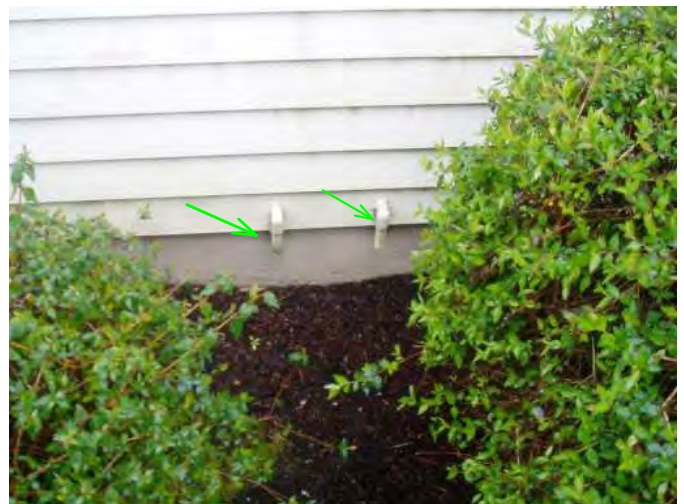
these are for drainage from attic furnace...good..side of exterior of home...

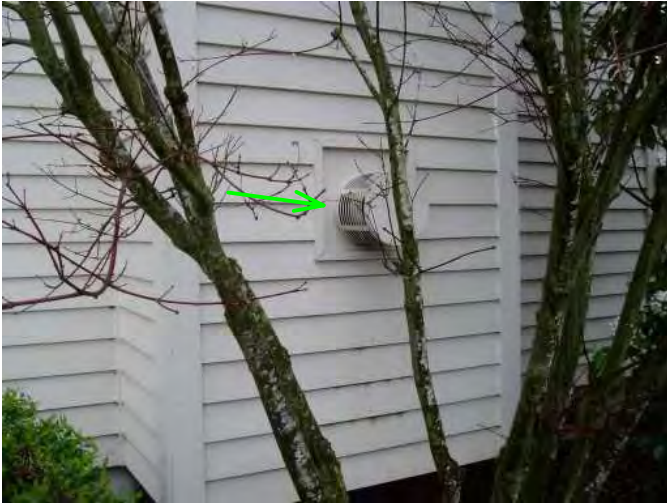
direct vent gas fireplace is operable....

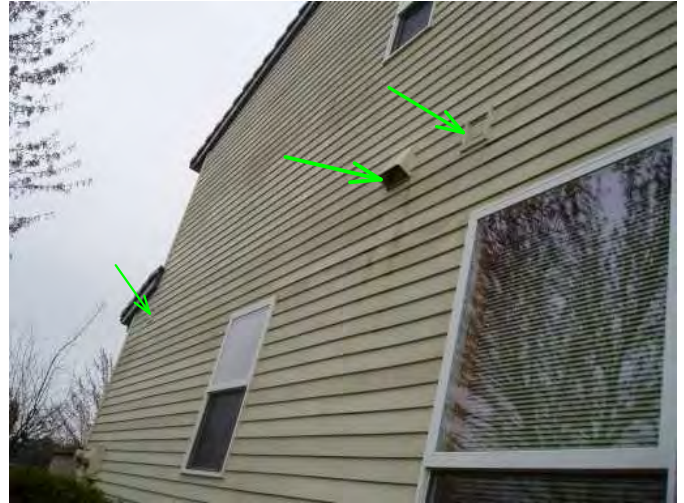
venting or kitchen, bath on first floor and laundry are noted here....good...

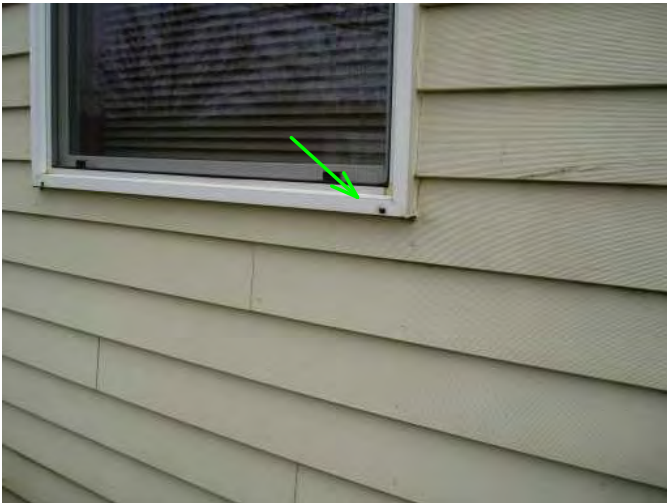
all windows have weep holes in proper place...good...just be sure and clean windows sills inside once a year...

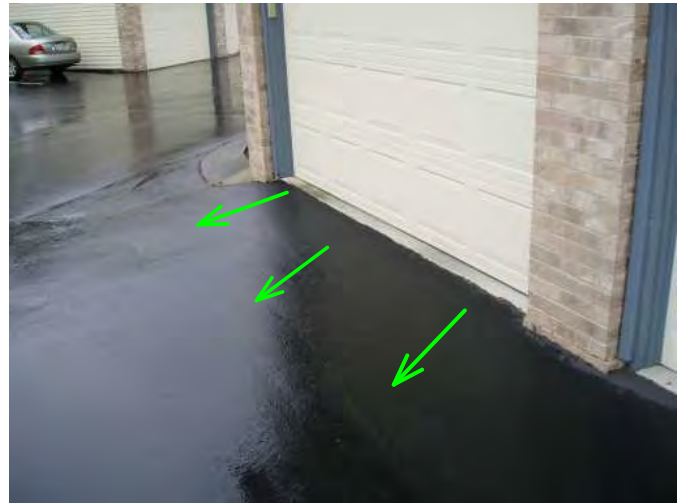
garage has good slope at door for water drainage...

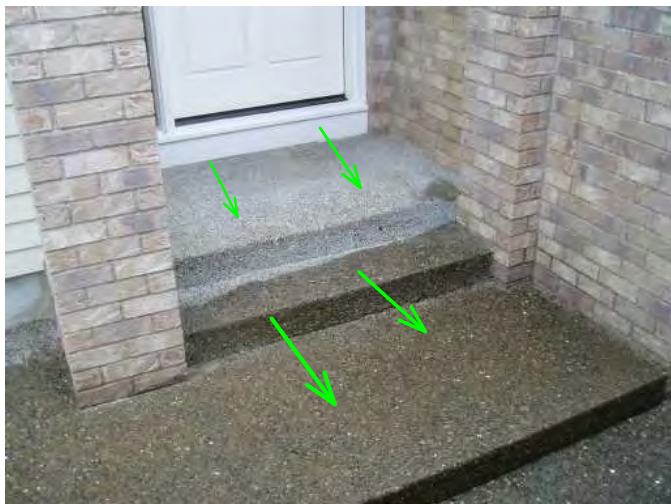
entry stoop is sloped well for drainage...good..

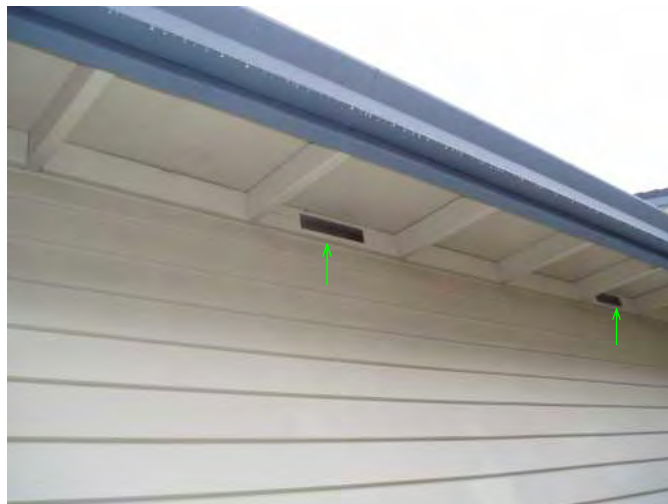
all of units are noted with good ventilation...good..

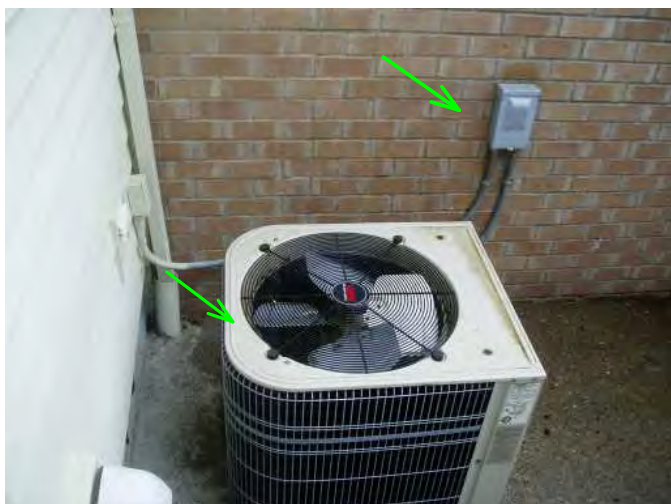
air conditioner is noted here ...did not test...to cold...appears operable...breaker disconnect is noted here...

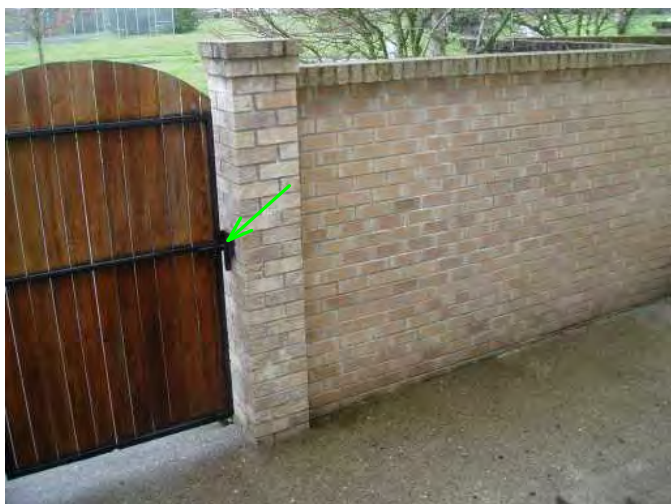
very secure lock at back gate for private and secure area...

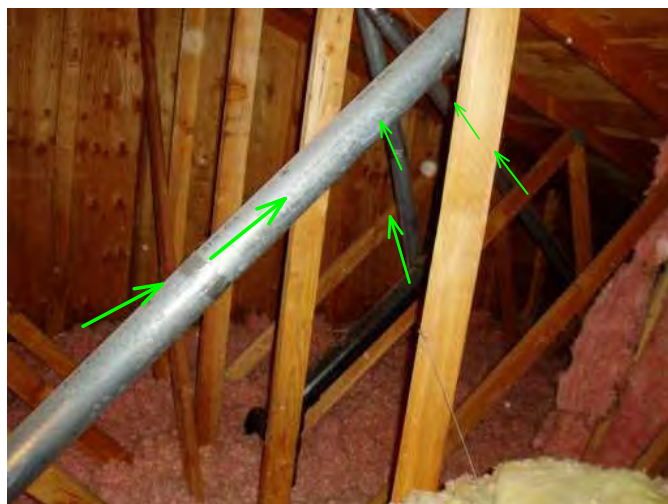
up in attic showing venting to roof from bathrooms...good..

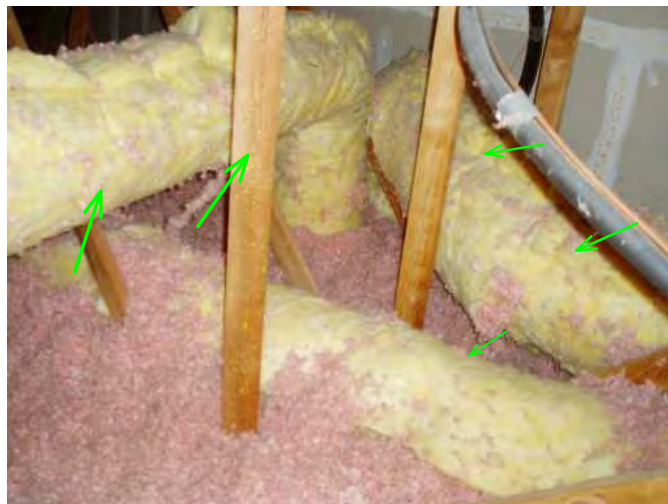
all ducts are insulated in attic....good...

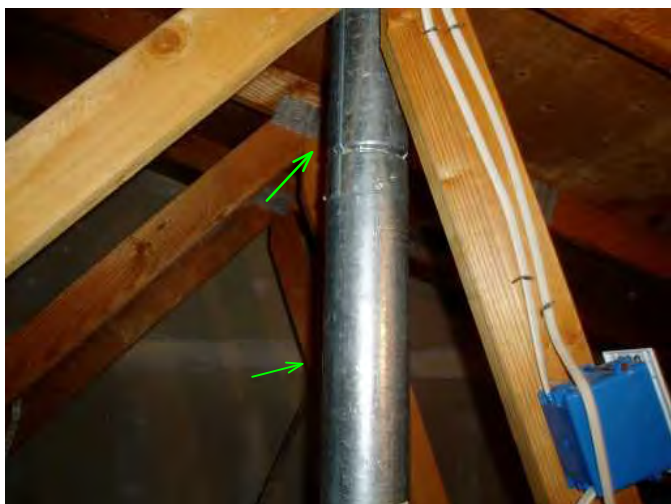
furnace flu in attic is solid and no staining is noted at roof line...good..

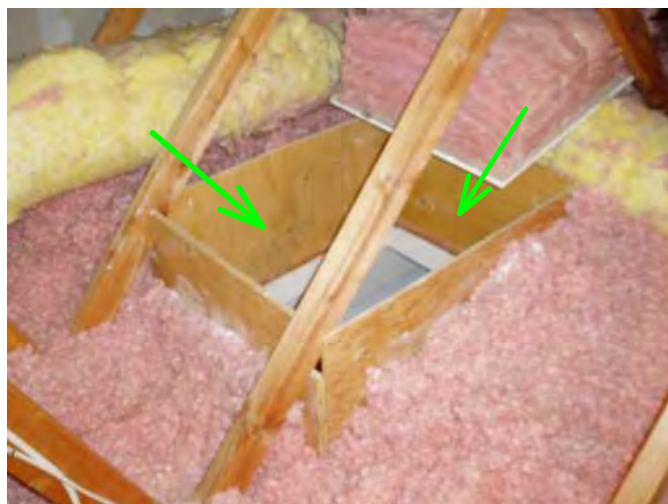
attic access from attic view...

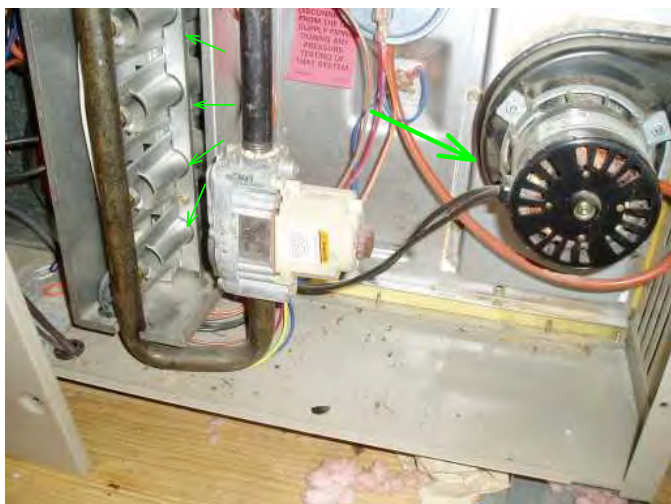
4 burner system is operational...in furnace...good...has draft inducer...good..

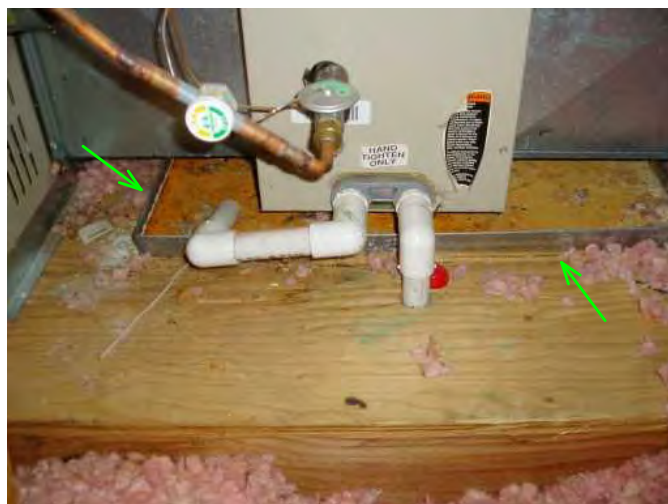
this is drip pan that feeds to outdoors...good...

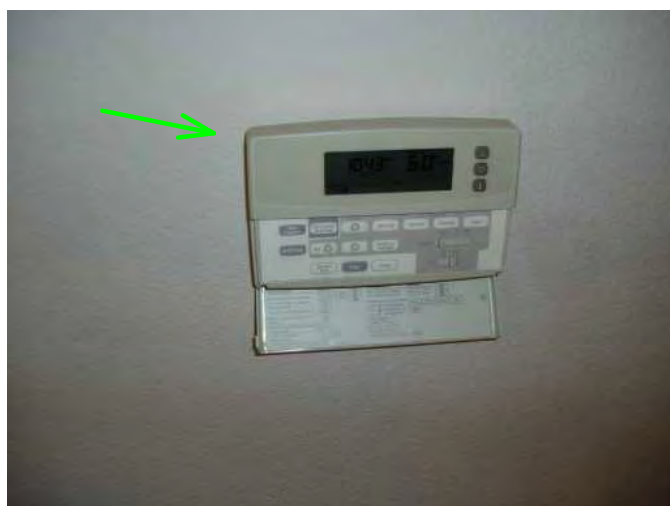
thermostat is operable..on first floor by bathroom...

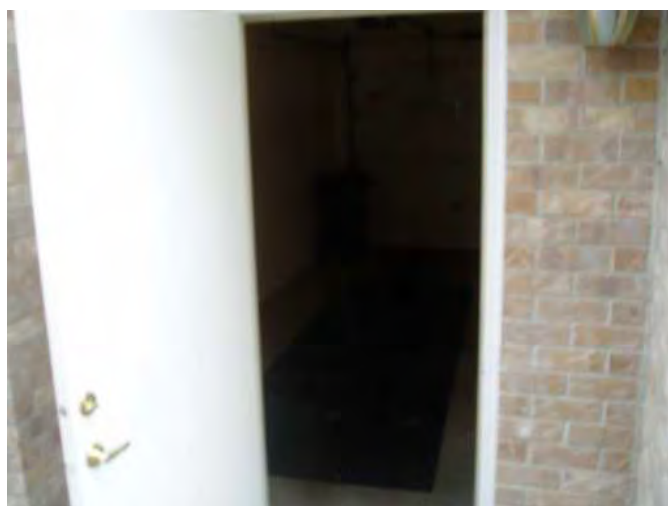
going into garage...

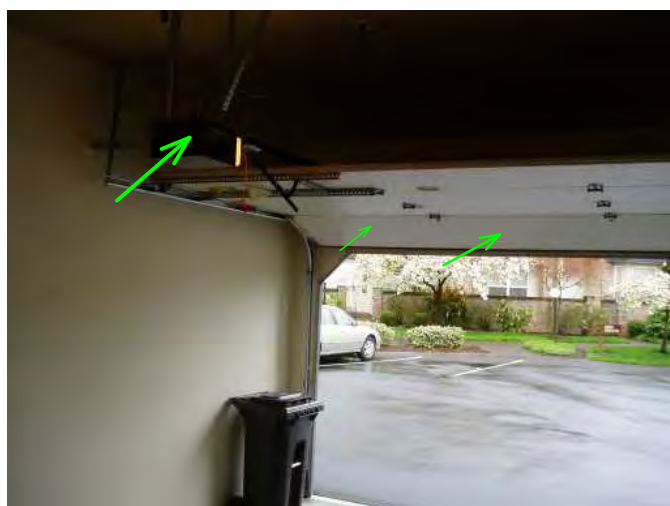
both garage door and opener are operable...good...

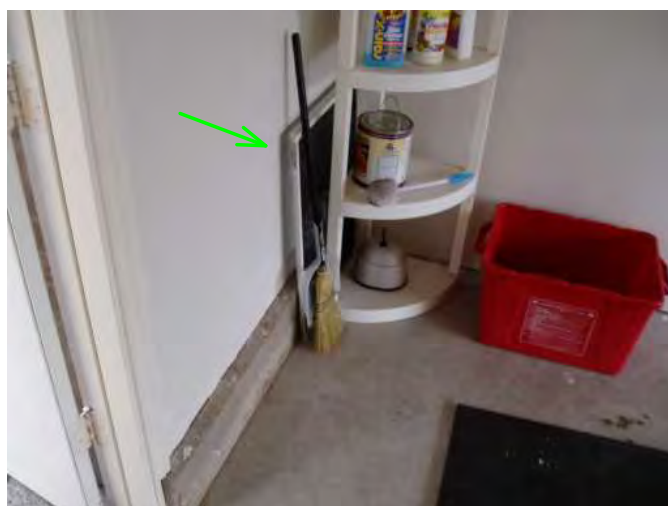
screens noted here in garage....may be for front windows...

Living Room - Living Space - Windows: all vinyl - missing screens...noted screens in garage...may be the ones...

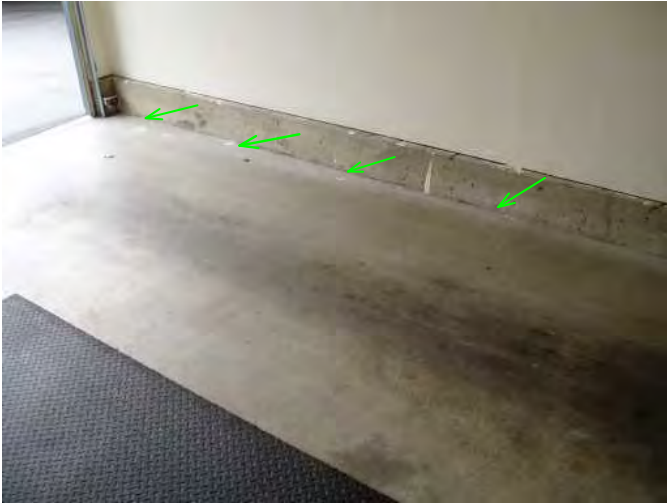
garage has good slope for drainage to outside...good..

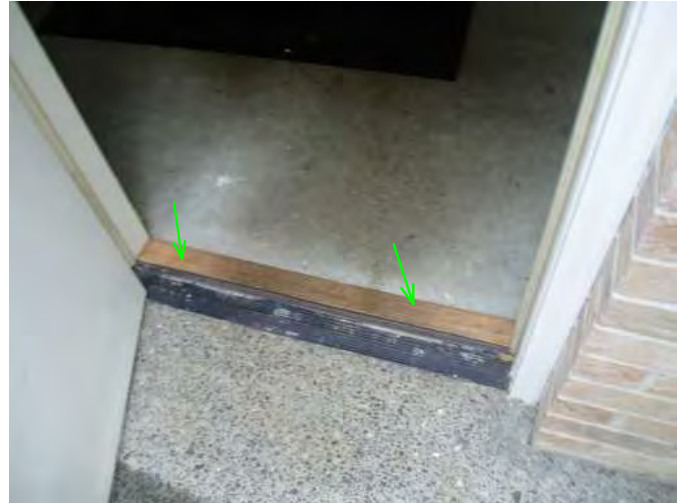
garage entry door is weather stripped and threshold is solid...good..

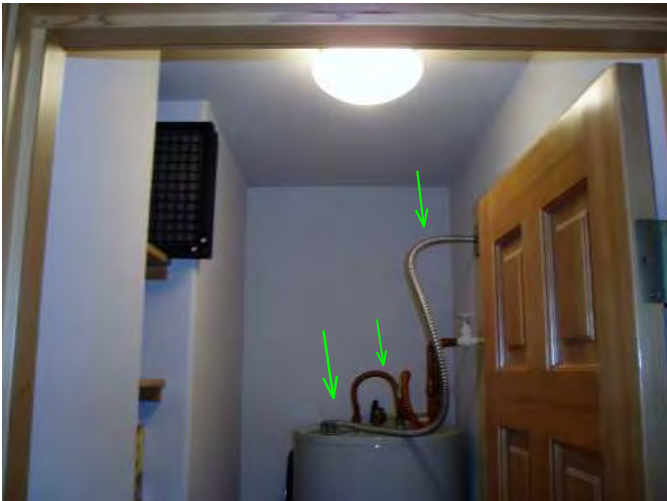
upstairs utility room entry door and fixture are operable...water heater is connected well...

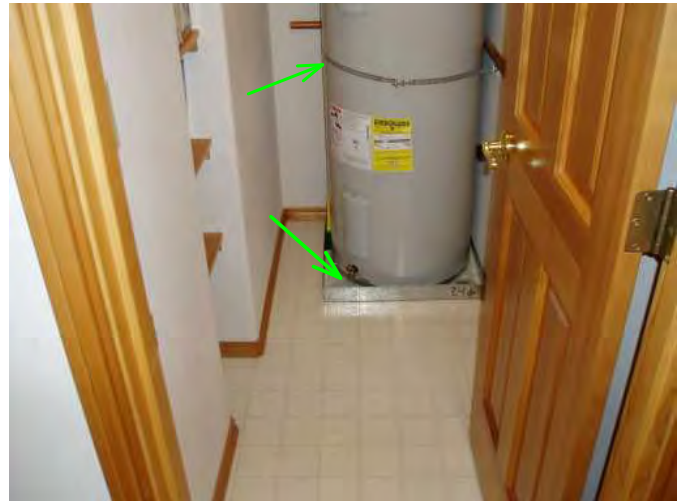
water heater is strapped and in drip pan...good...

Utility Room - Water Heater - Water Heater Operation: Adequate - Water heater is nearing the end of it's design life, monitor at base for any leaks...then replace

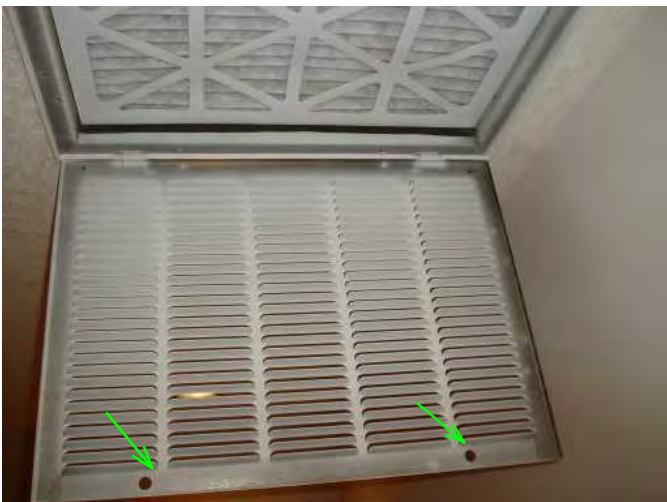
upper furnace filter and return air vent cover...two easy twist screws to open and change...

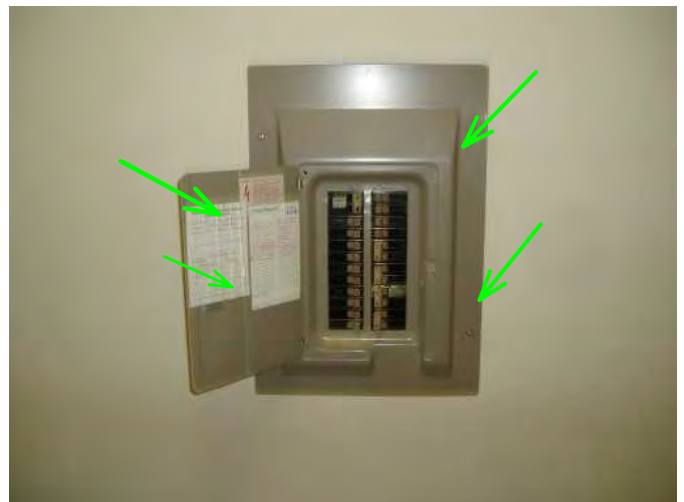
main electric panel is in laundry room off of kitchen area...well marked...

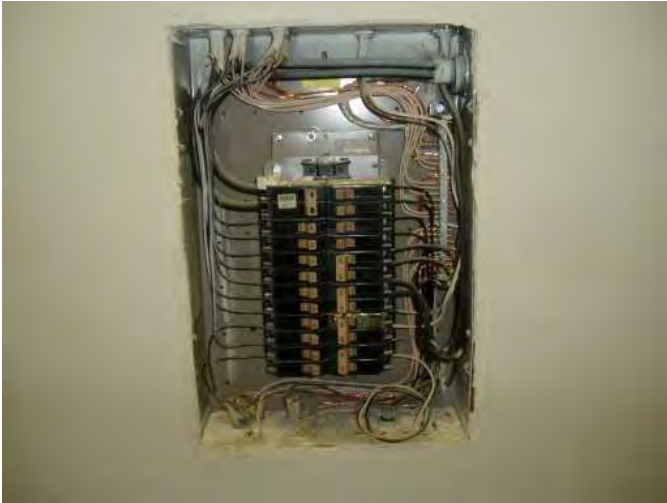
open view of panel is showing all is well...professionally installed..

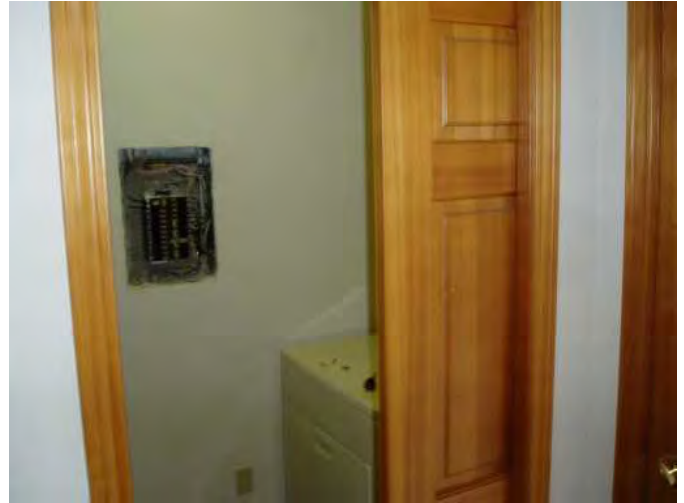
laundry room has pocket door that is operable..

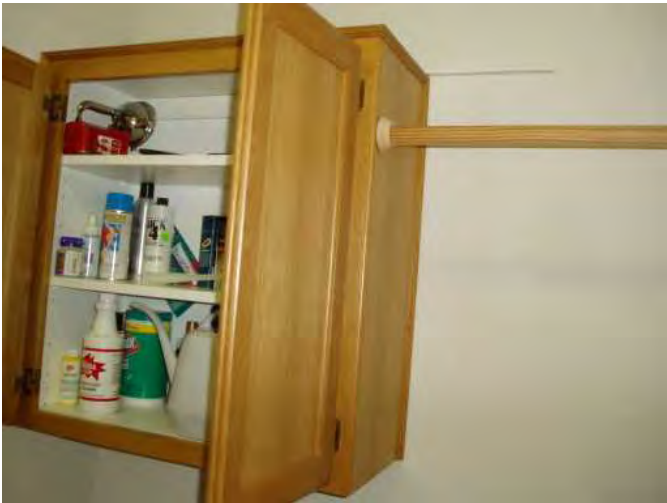
over dryer has cabinets that are operable...

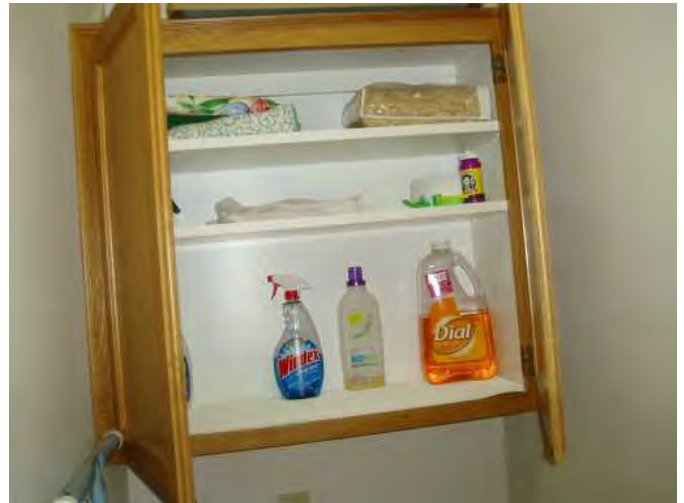
over washer cabinet is operable...both cabinets are attached to wall well...

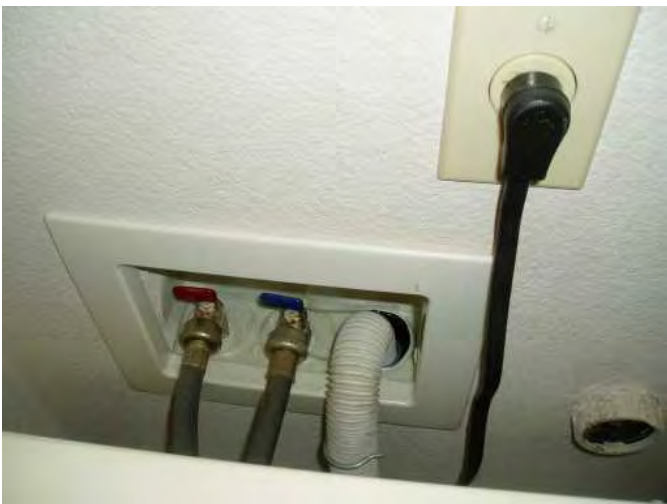
washer hook ups are good...

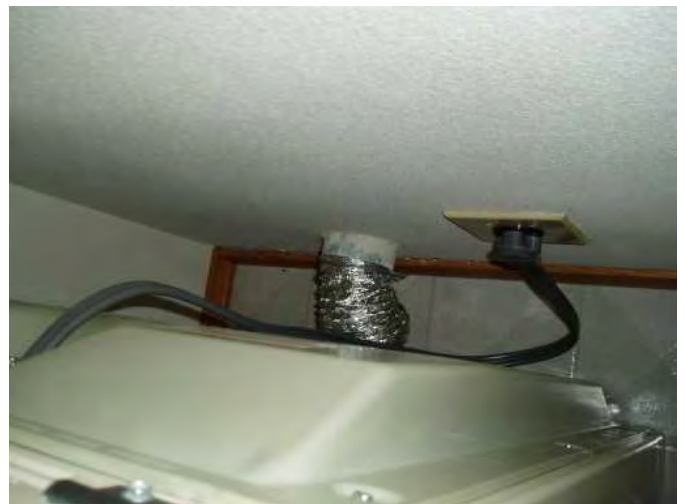
dryer hook ups are good...

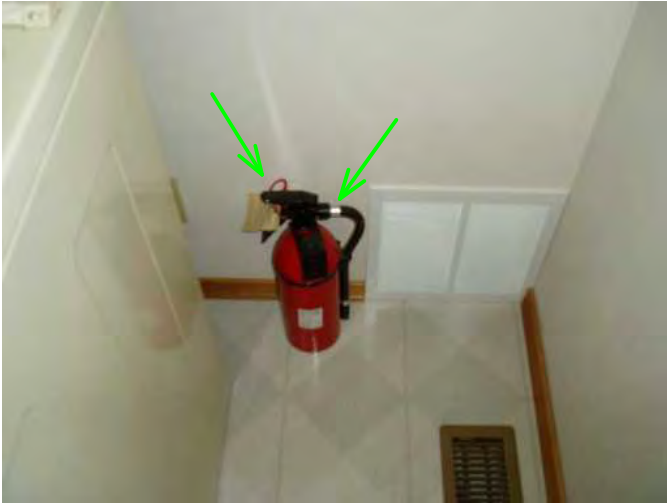
a good sign of well maintained home is to find a fire extinguisher in home....very good!

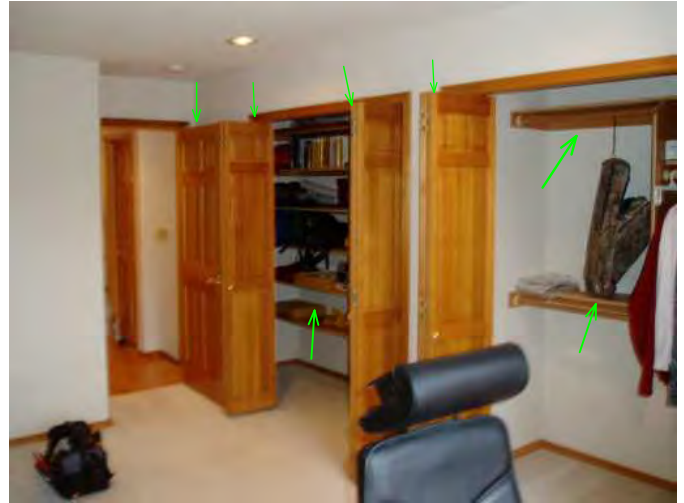
front master bedroom entry and closet doors and fixtures are operable...shelves in closets are solid...

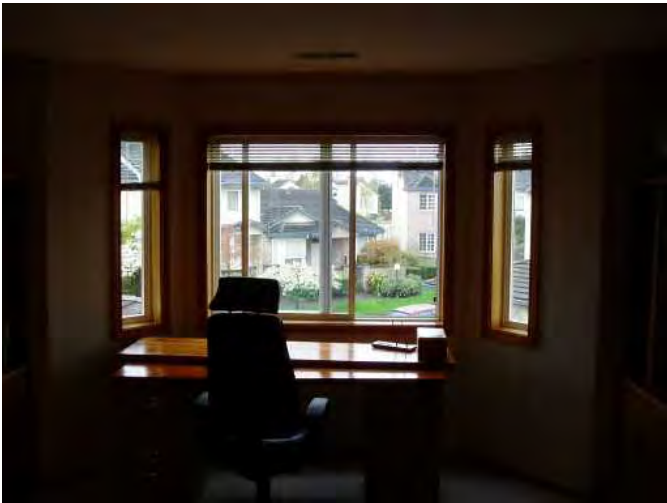
front master bedroom windows are operable...

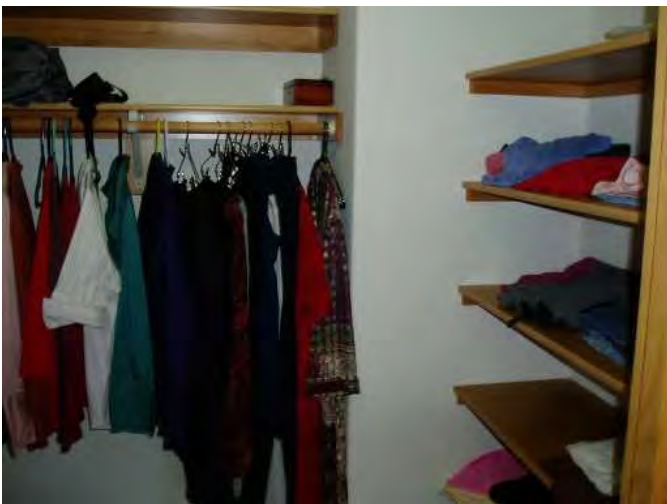
master closet shelves are solid....fixture is operable..

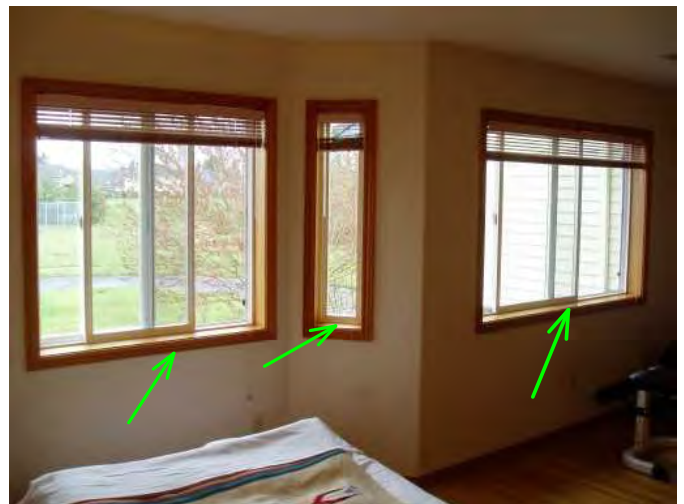
back bedroom windows are operable...

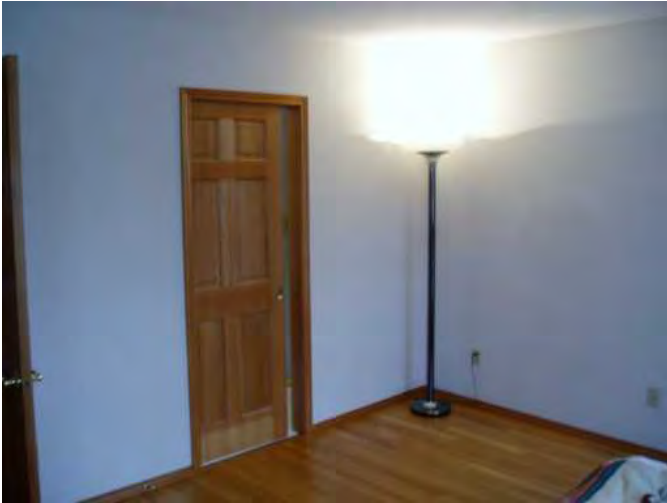
pocket to back bath is operable...

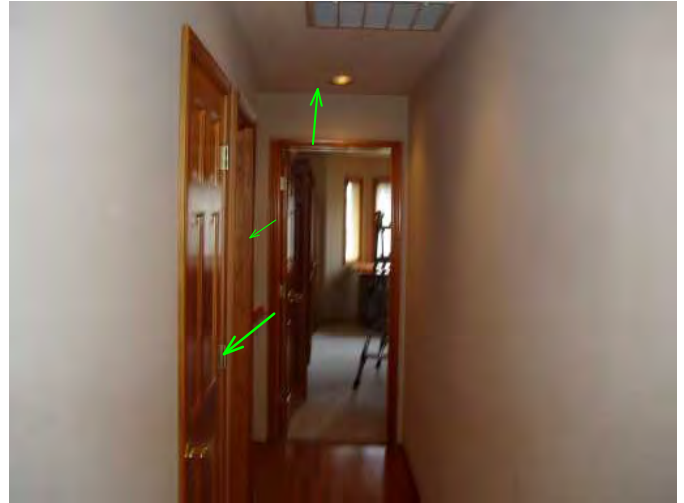
hallway doors and fixtures are operable...

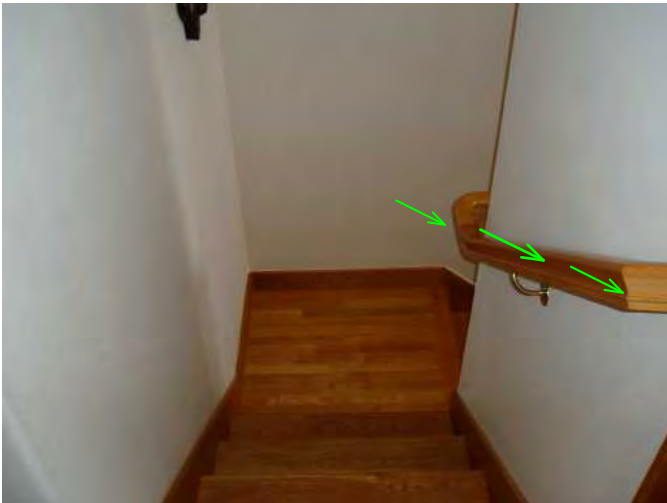
stairwy handrails are solid and steps are even...good...upper area...

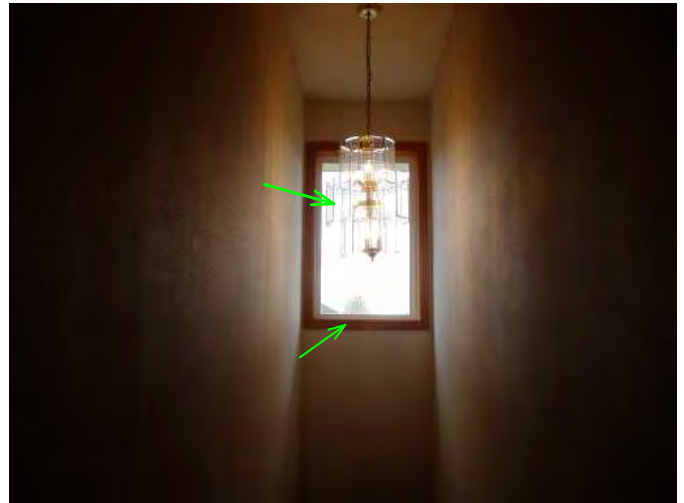
fixture and window are operable at main entry up high...

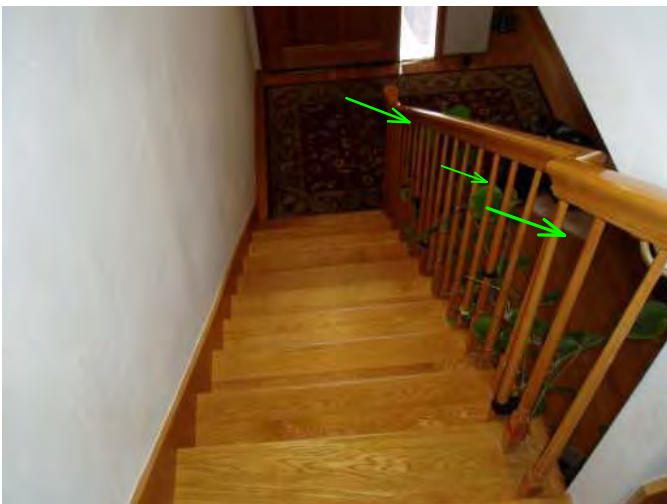
lower handrails are solid and steps are even to first floor...

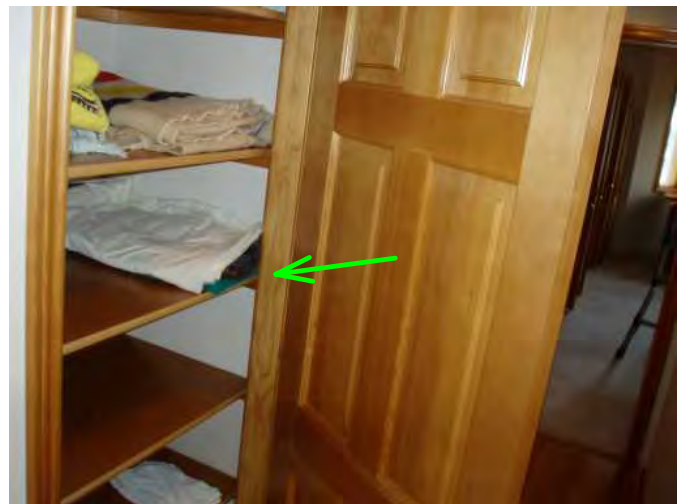
upper hallway closet door is operable..shelves are solid...

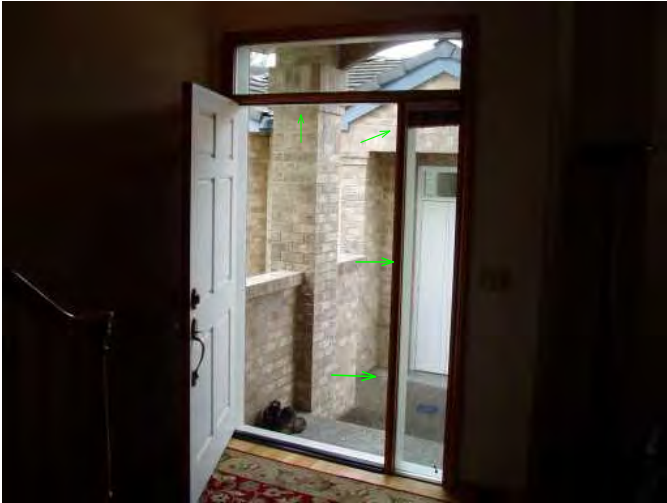
main entry door and windows are solid..good weather stripping noted...

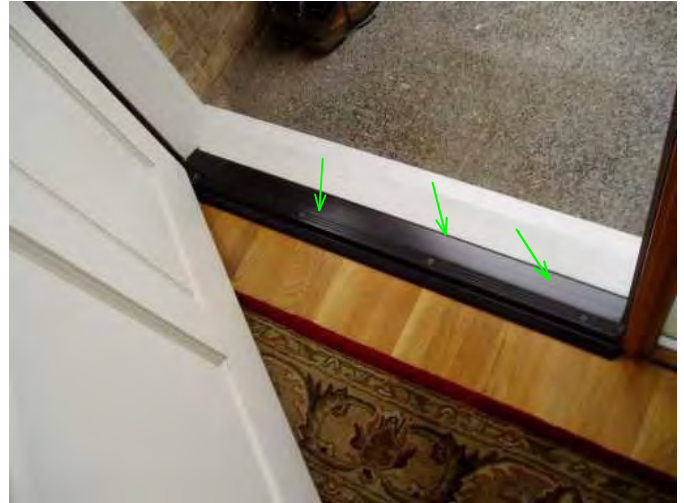
threshold is solid and sound...at main entry door...

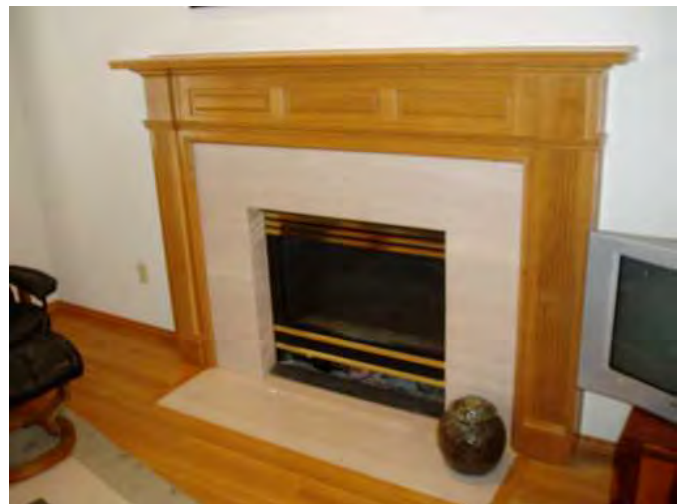
fireplace is operable..is on remote control...

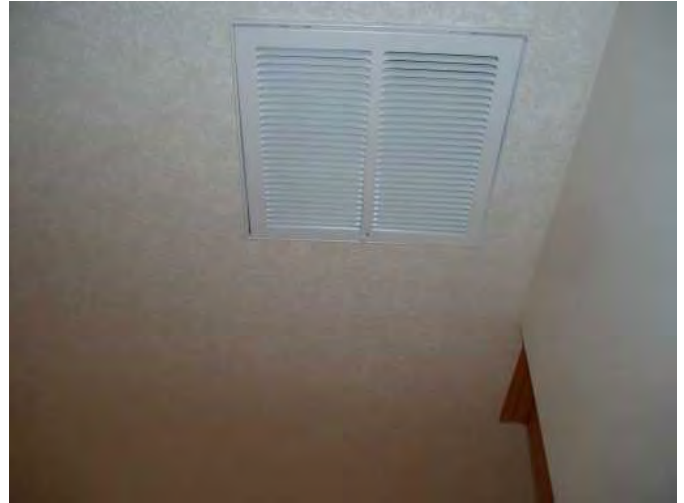
lower return air is filtered as well...

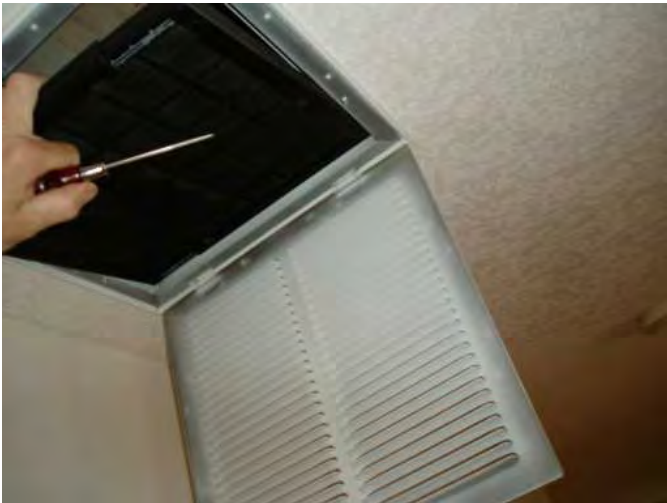
this retrun air has re-usable filter...good..

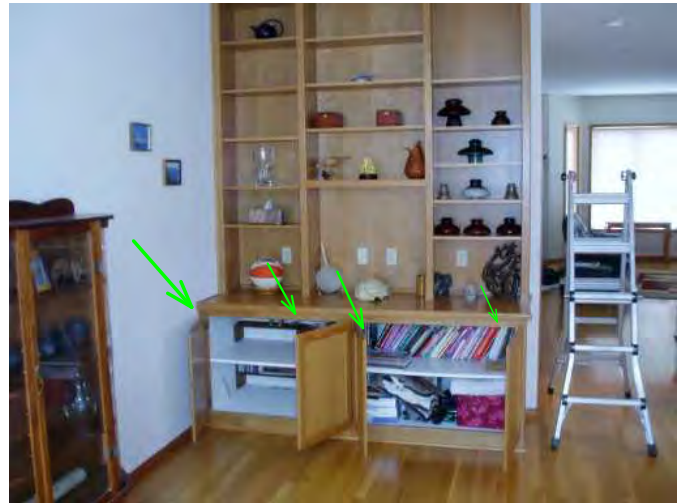
great room cabinets are operable...adjust hinges as needed...

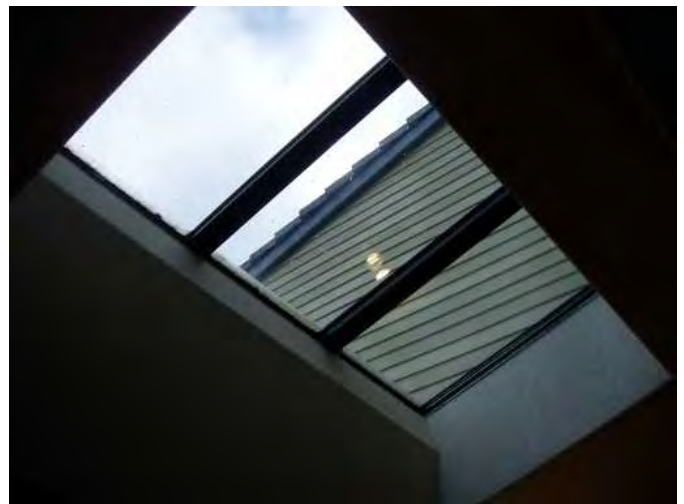
skylight is operable...no staining noted at walls...

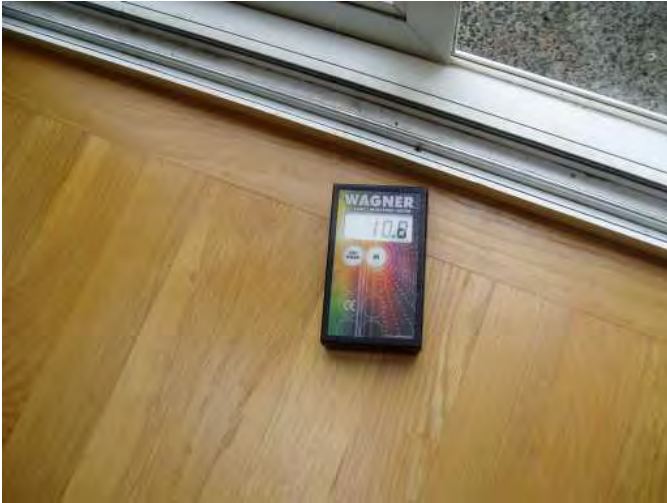
moisture at patio slider is good...

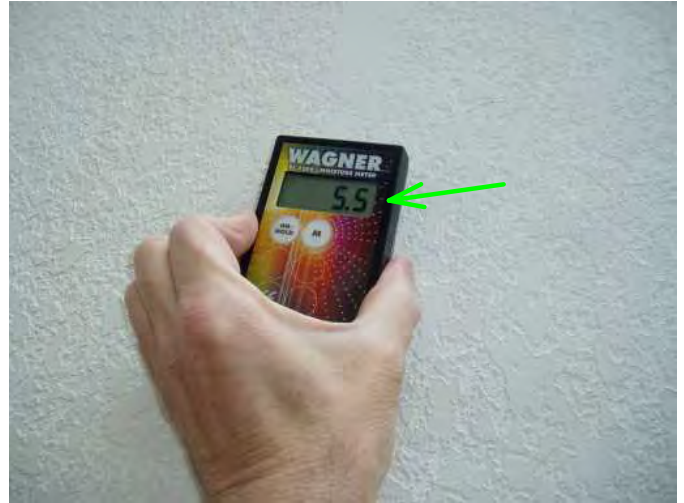
moisture at skylight walls are good...

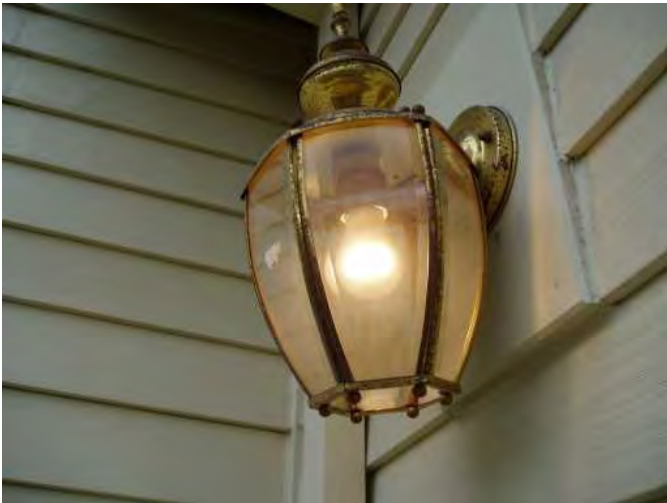
fixtures outdoors are operable..

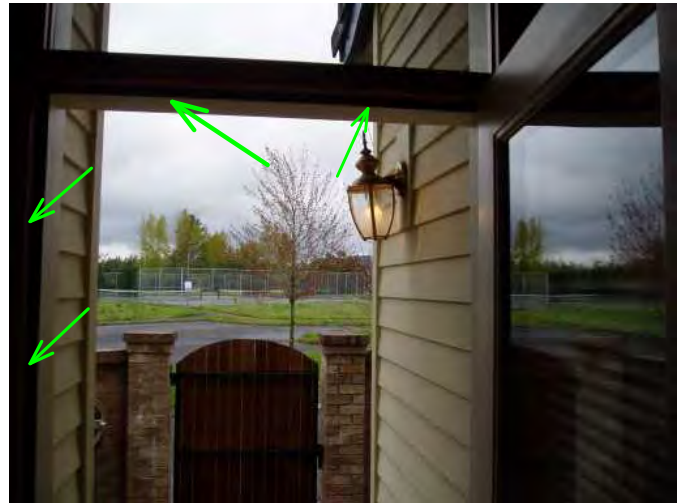
back door has good weather stripping at door frame...fixture here works as well..

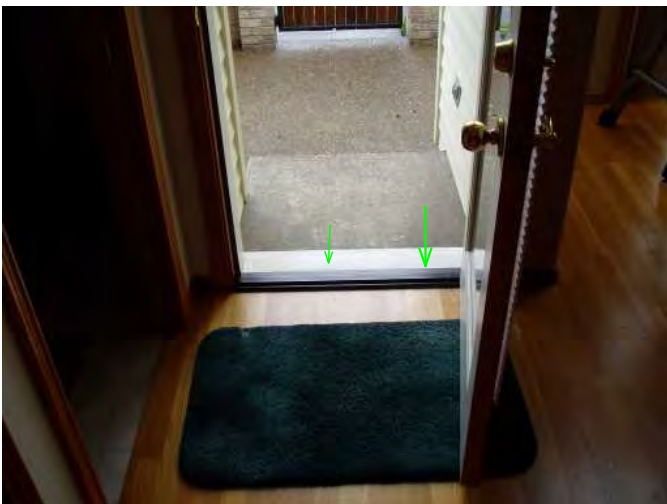
threshold is solid and no moisture issues noted...

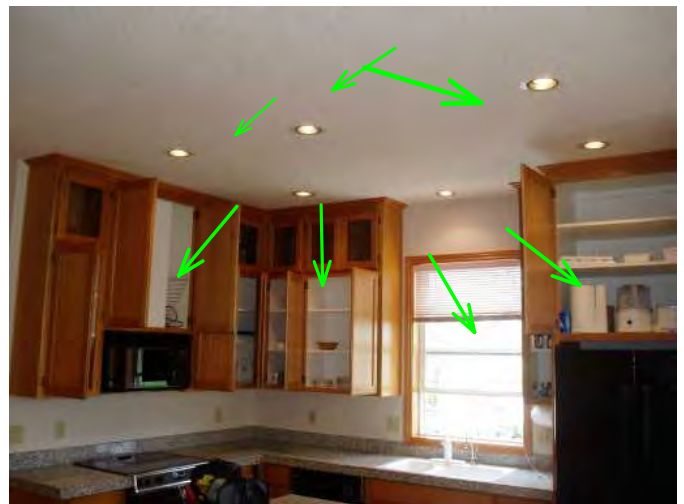
all upper cabinets are operable as are fixtures and window...

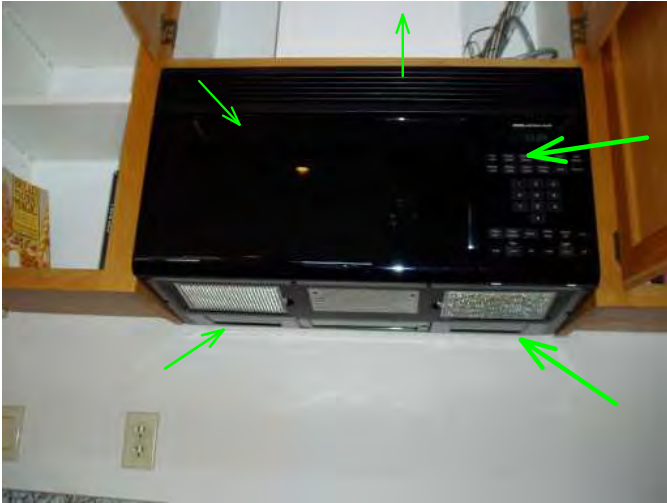
microwave and over stove exit fan are operable...and vented to outdoors...good...

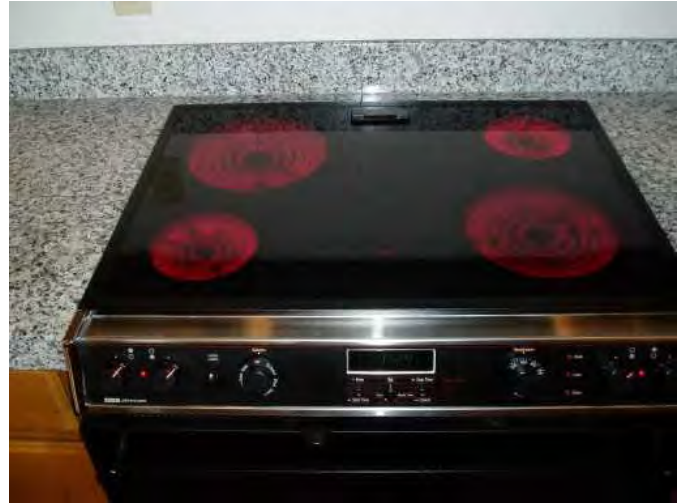
stove is operable as is oven...

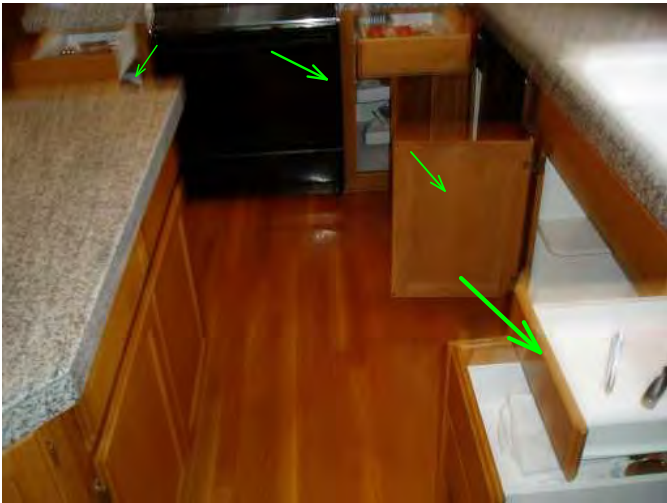
lower cabinets are operable..

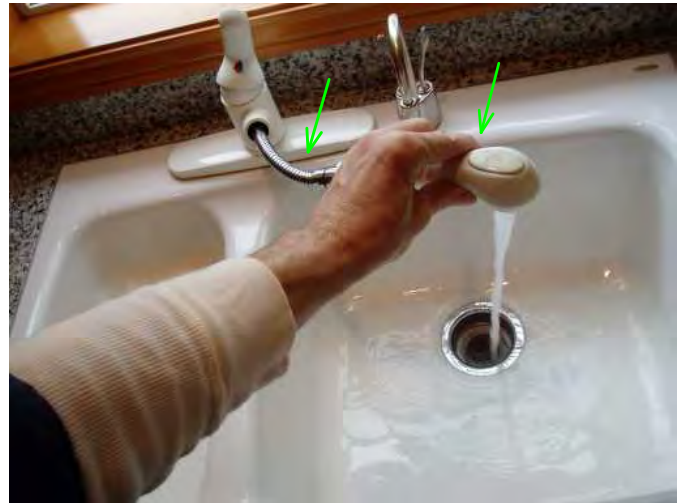
sink faucet is sprayer arm as well...operable...

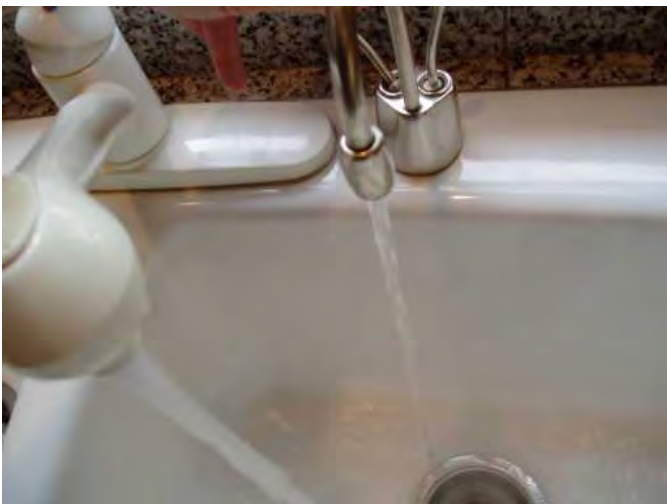
hot water dispenser is operable...

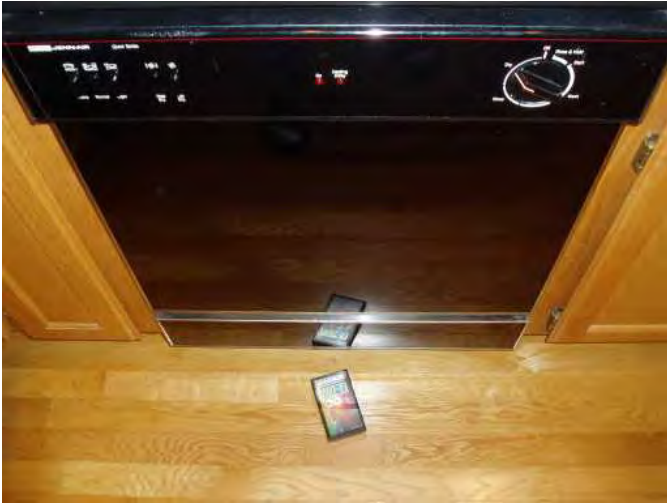
dishwasher is operable..ran through complete cycle...good..

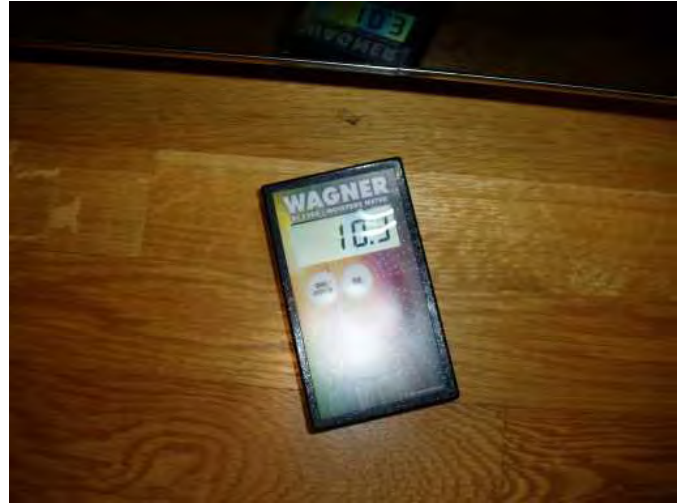
no drips or leaks at front of unit...good...

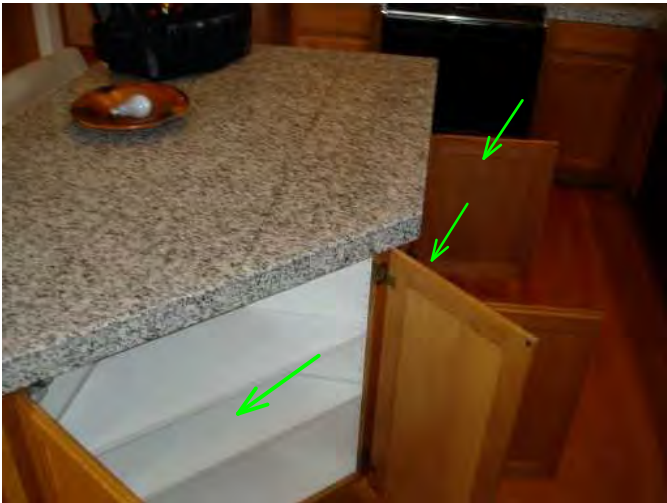
island cabinet doors are operable..
