Home Inspection Report

8170 SouthWest Maxine Lane #65
Wilsonville, Oregon

Prepared for: Sample Report/ Actual Report / Condo

Prepared by: The Home Tester

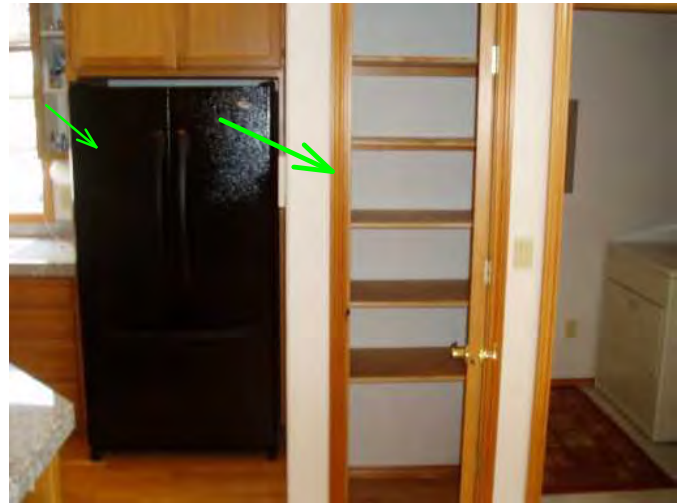
pantry closet and refrigerator are operable...

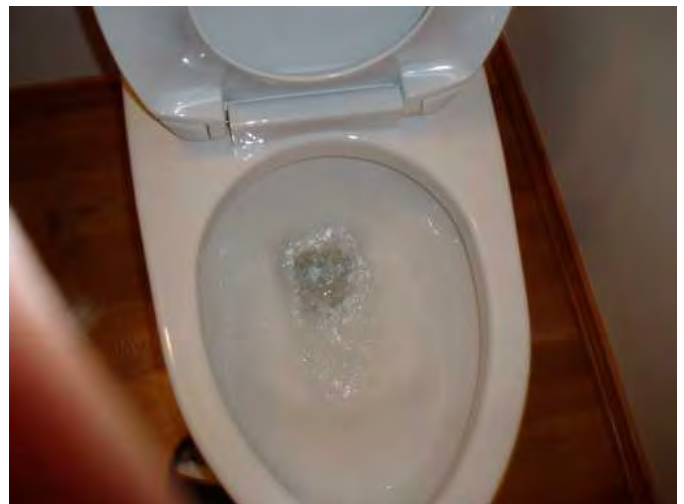
toilet is operable...

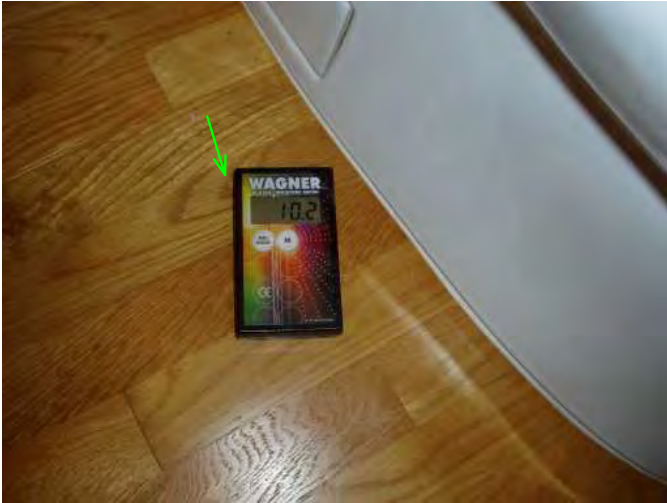
no high moisture at toilet is good....

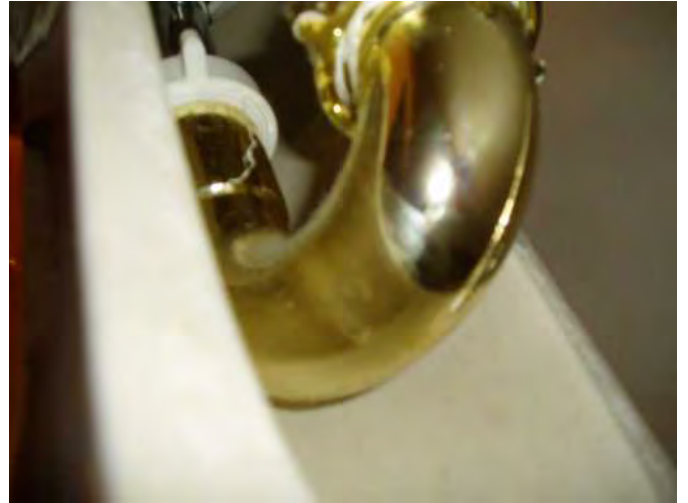
no drips at trap under pedestal sink is noted...good..

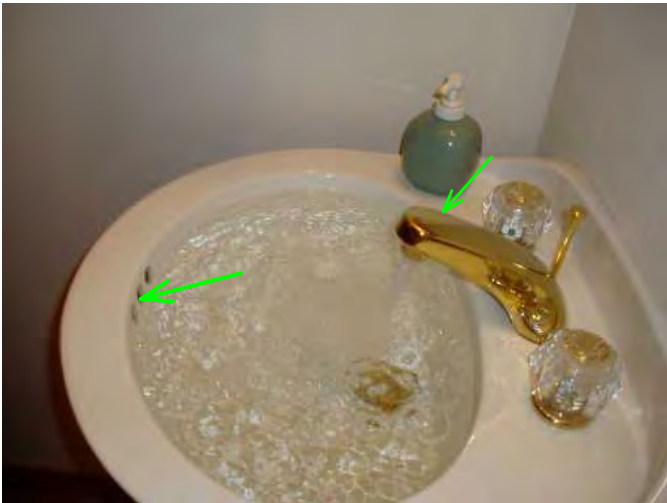
faucet and overflow are operable..

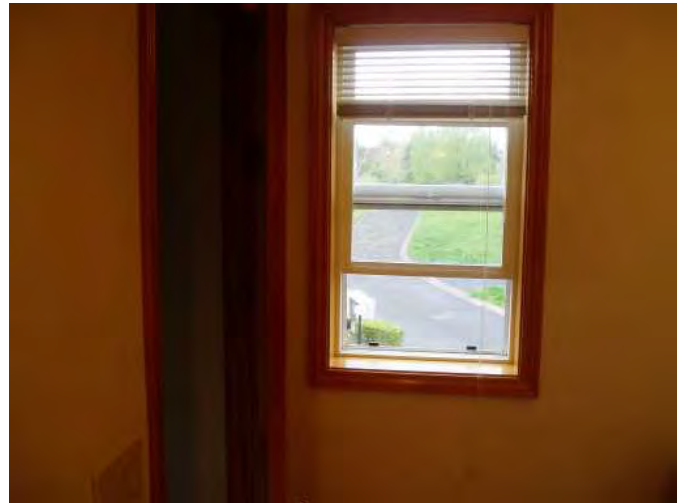
front master entry door and window are operable...

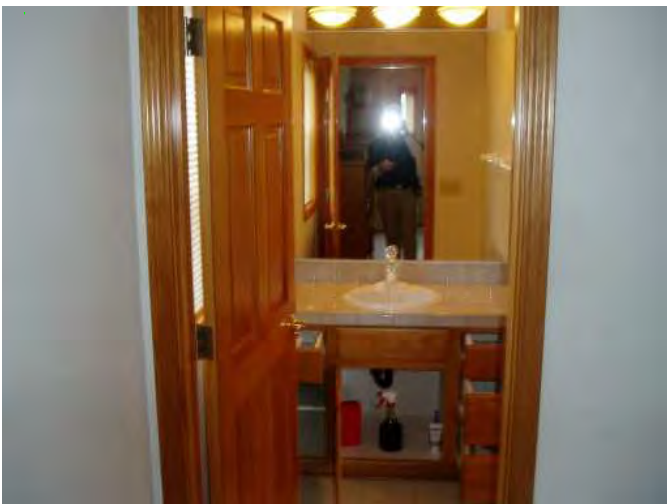
cabinets and fixtures are operable...

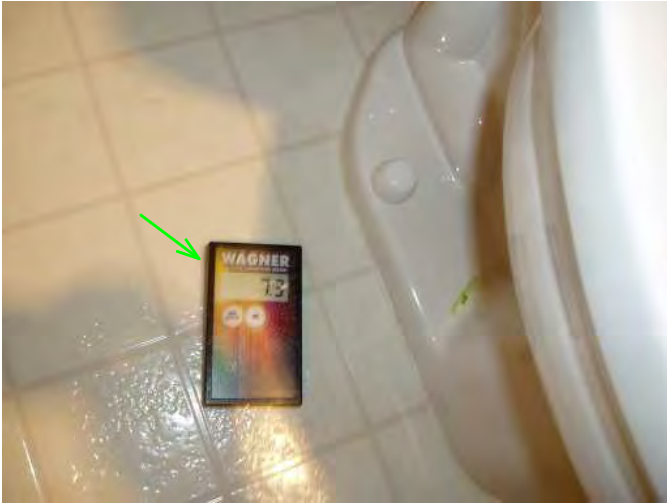
no moisture issues noted here at toilet area...

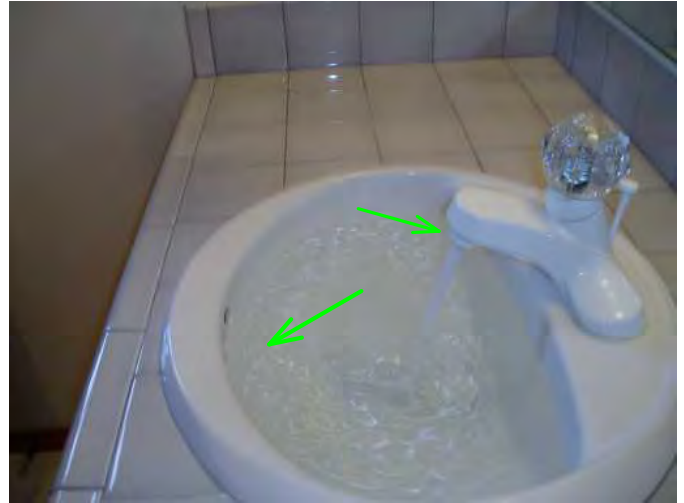
sink overflow and faucet are operable...

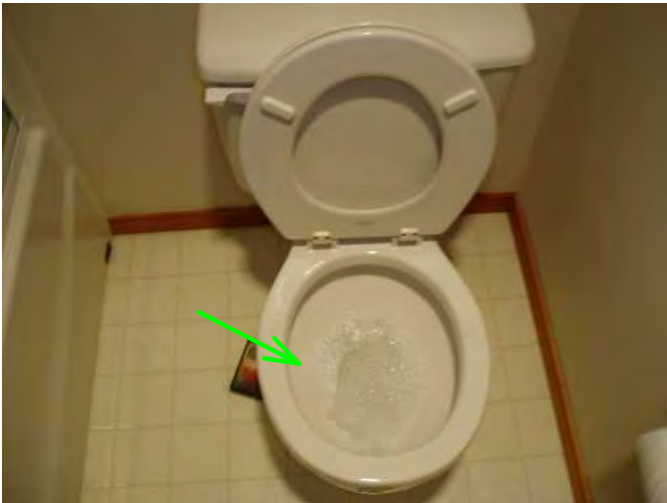
toilet flushed well...no flow changes in shower were noted when flushed...

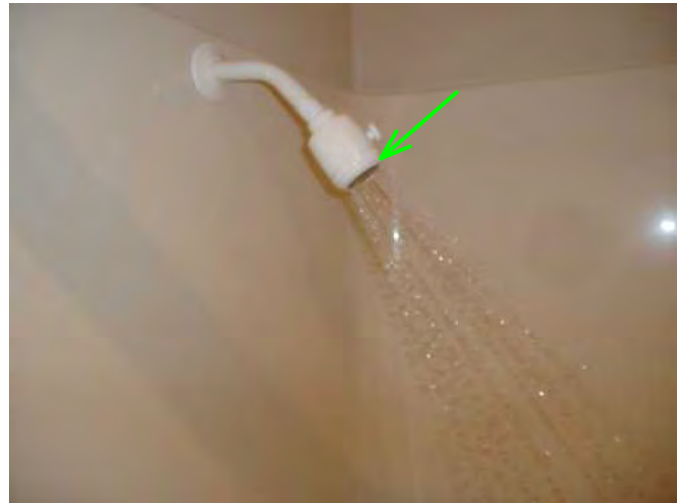
shower is operable..

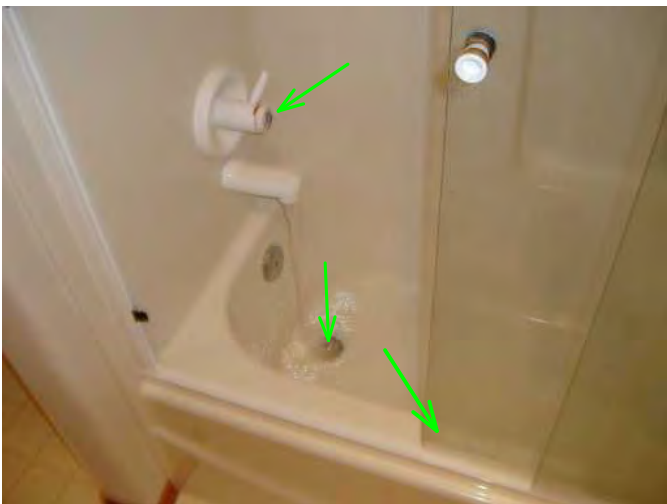
glass doors, faucet and drain are operable..good..

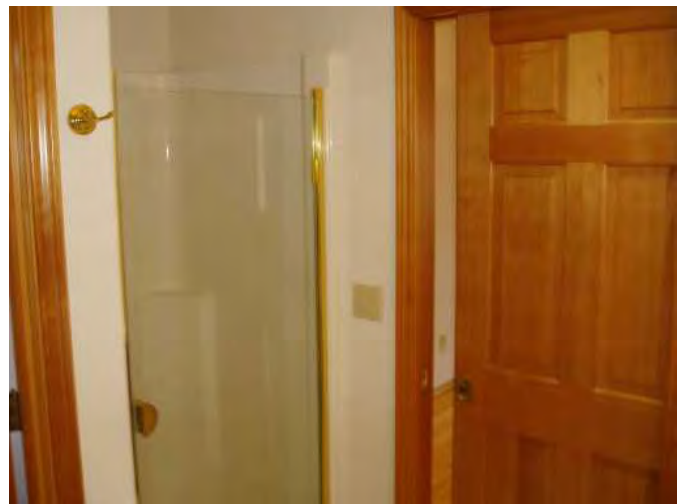
back master bath entry pocket and shower door are operable...

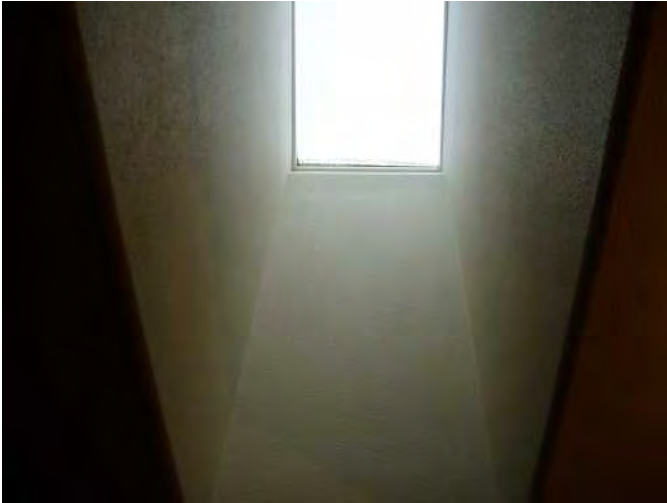
skylight is dry..no staining noted at walls...

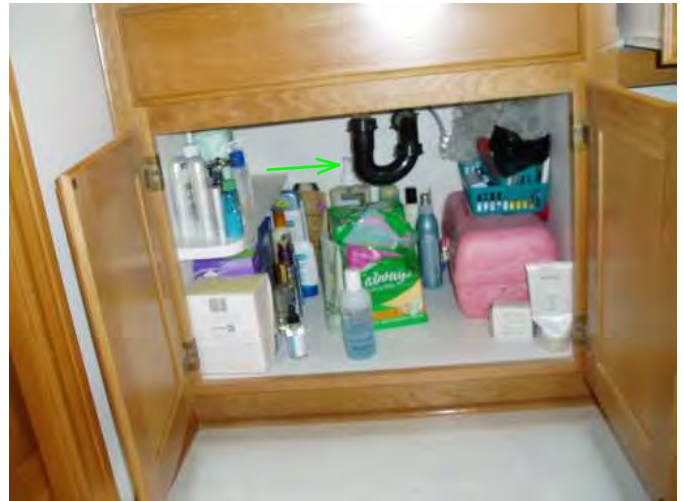
no drips under left sink..cabinets are operable..

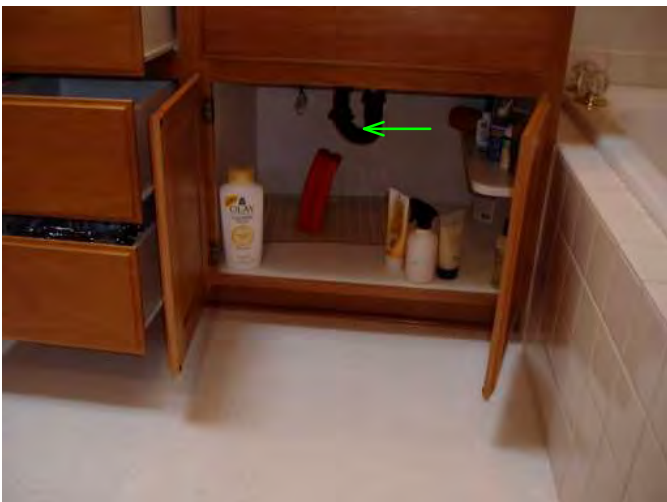
no drips under right sink..cabinets are operable...

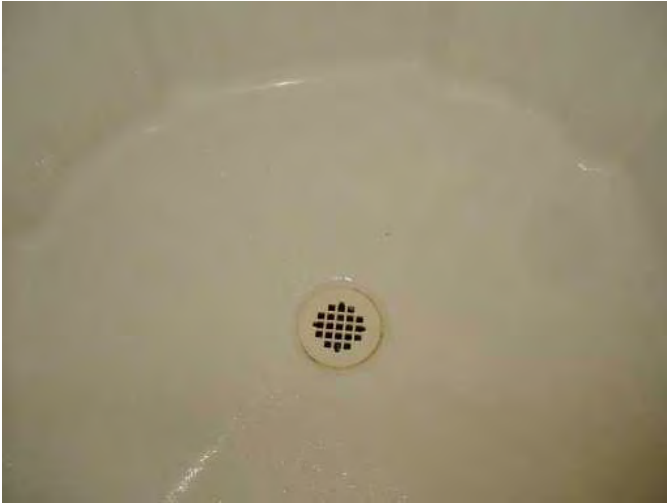
shower drain is operable...

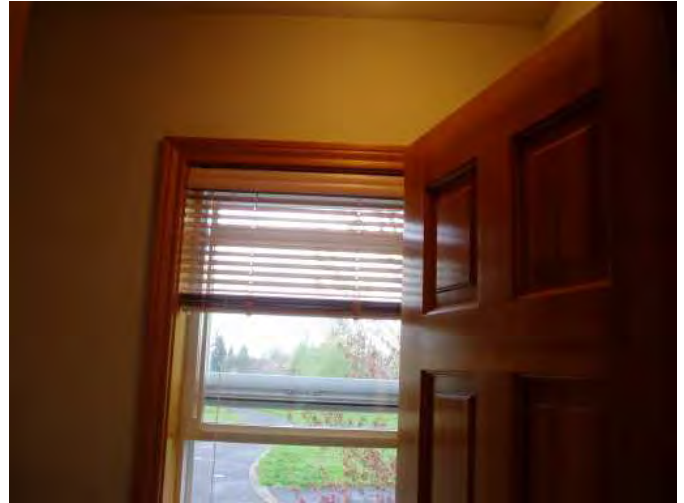
entry door and window to toilet room are operable...as is fixture

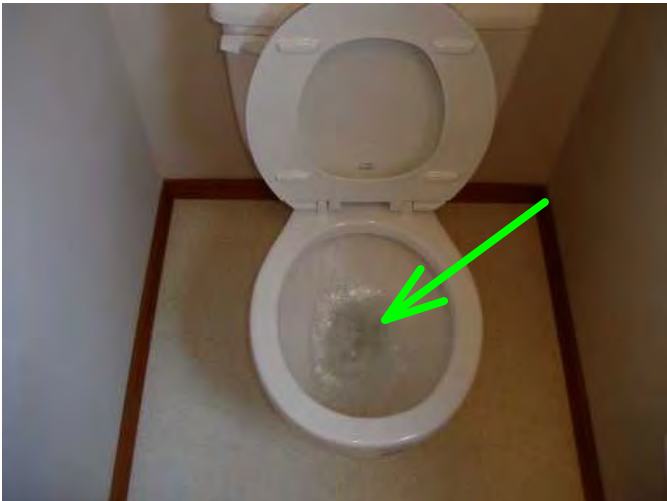
toilet is operable...no flow change noted at shower when flushed...

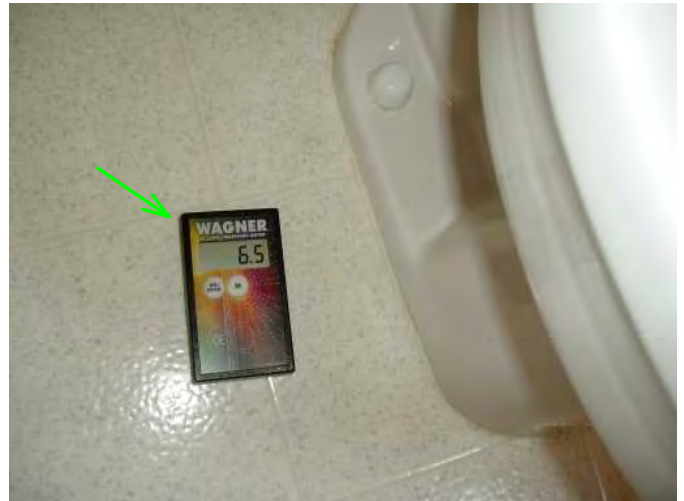
no high moisture is noted at toilet at floor....good..

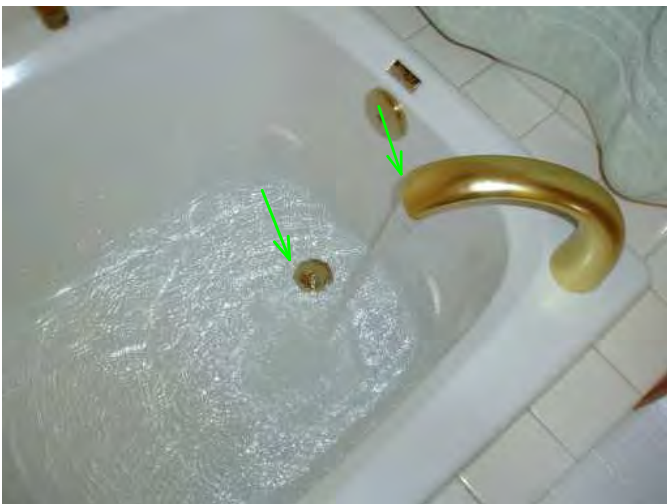
tub faucet is operable as is drain...good...

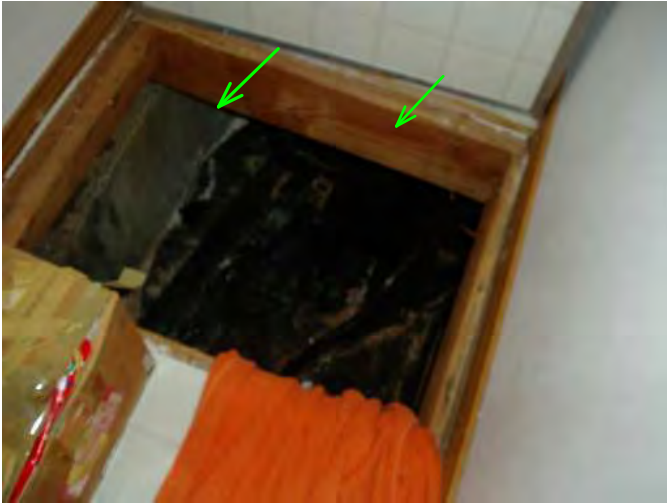
going into crawl space under stairs closet...

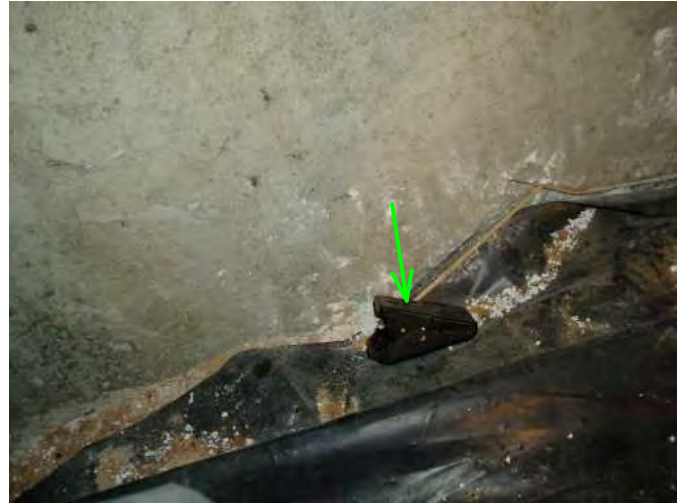
mini traps are set for nay vermin issues..none seen...whole crawl has been treated to prevent rodents...good..

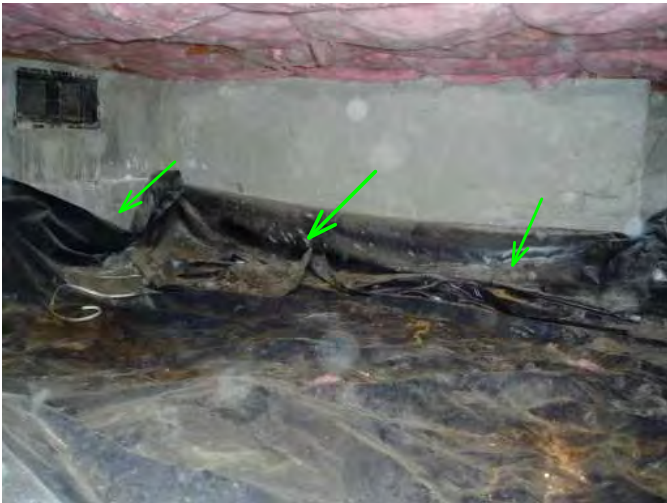
vapor barrier is on all areas of crawl space...good...

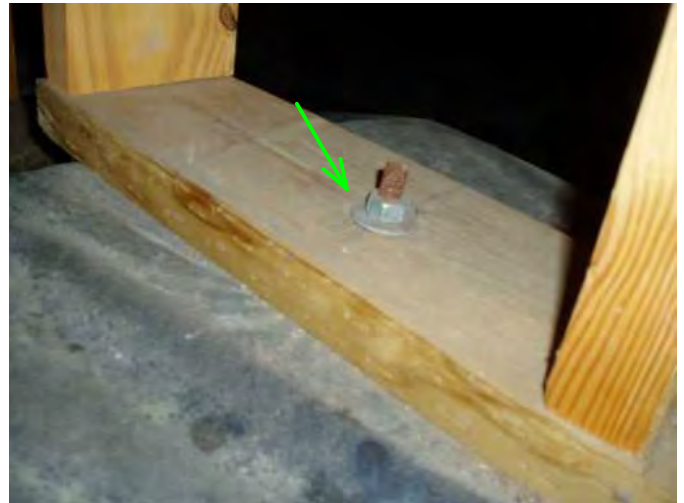
whole unit is earth quake proofed....

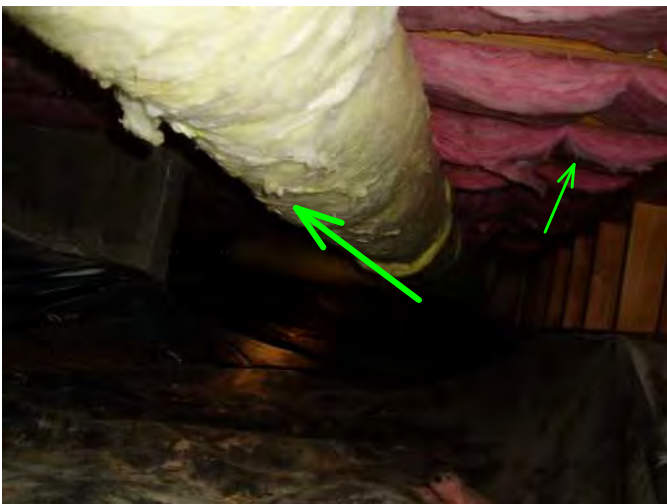
insulated floors and heat ducts are noted here...

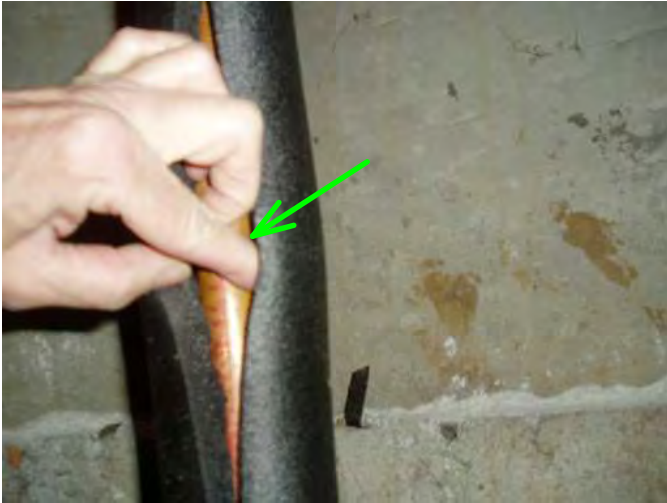
water pipes are copper...good...(all homes at farm field areas need to be protected from vermin...is common...not issue)

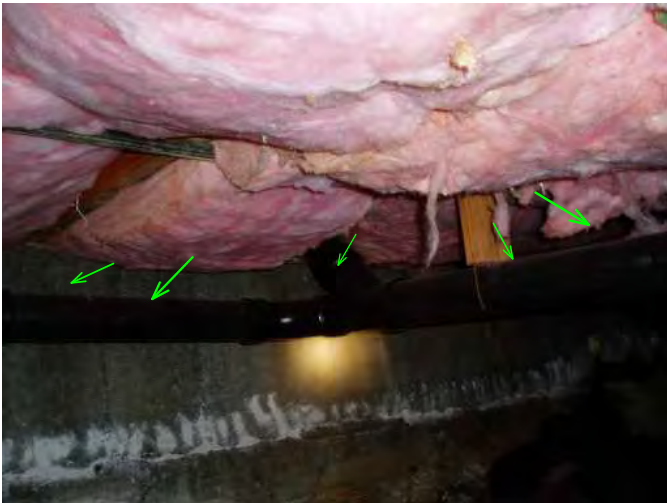
mai sewer eixt pipe has no drips or leaks detected....good...ran all faucets for 2 hours...

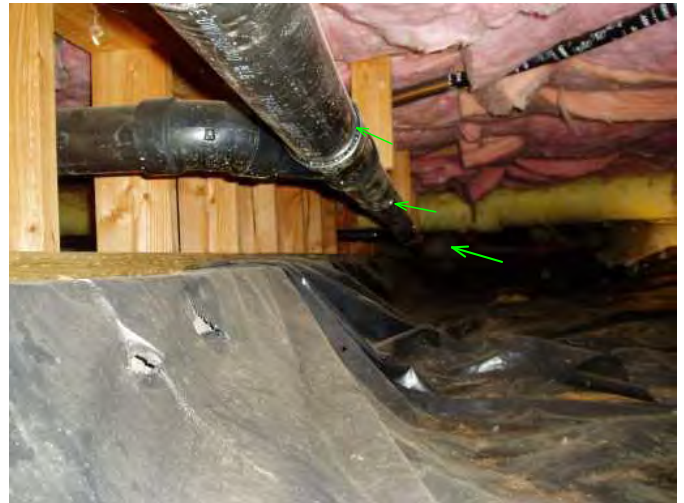
no drips or leaks noted here to exit of sewer pipes as well...good....crawl area...
