Home Inspection Report

Actual Inspection

Prepared by: The Home Tester
10555 SW Tigard St. #57
Tigard, OR 97223
Ben Tester
503-515-1833

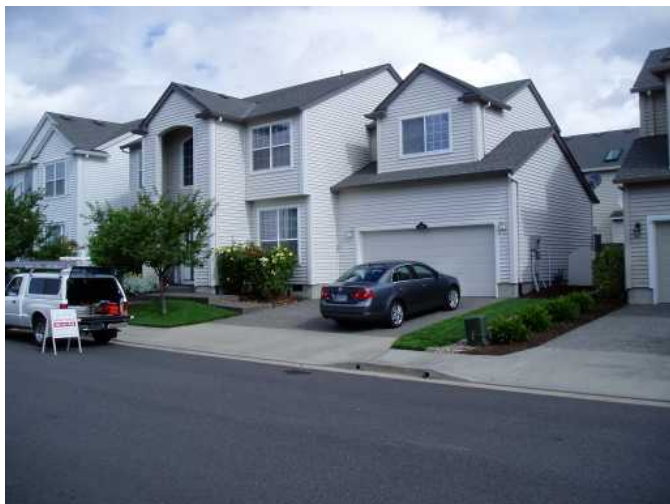
Front of home...

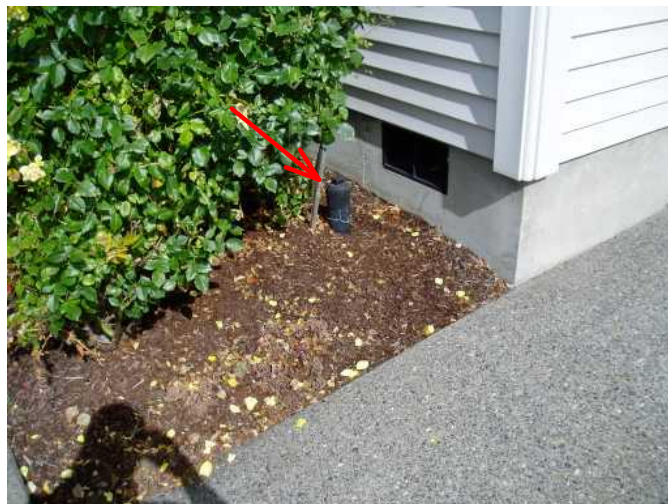
main sewer cleanout..good..

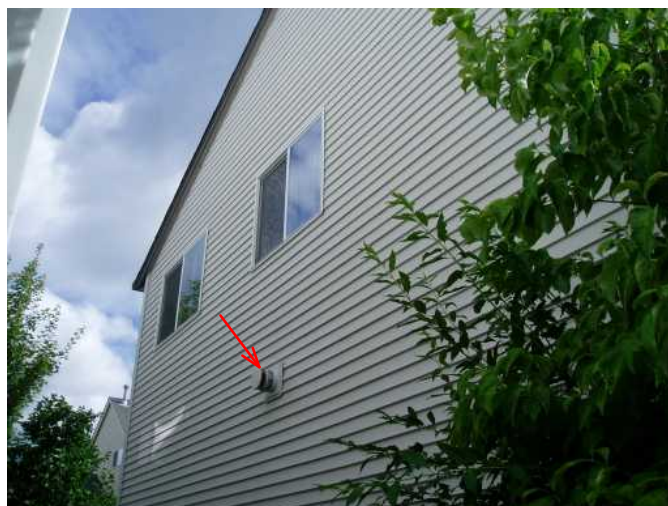
fireplace exit duct...good..siding in great shape...left side of home....

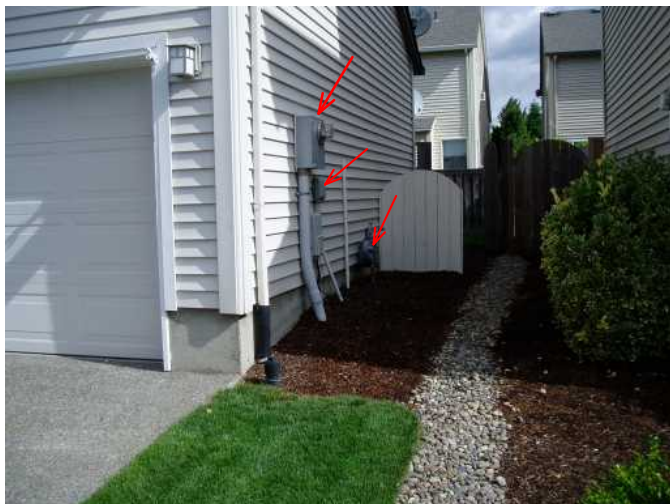
electrical/gas and phone entry at side of garage..all good...

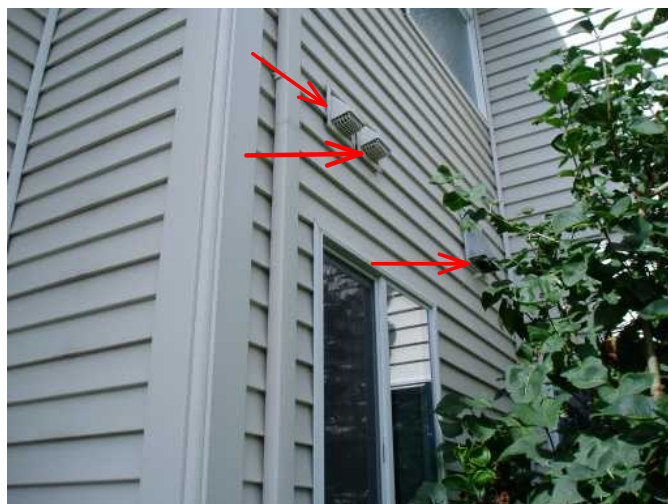
left two vents are laundry vent and bath vent/ right vent is over stove exit vent..all working fine...

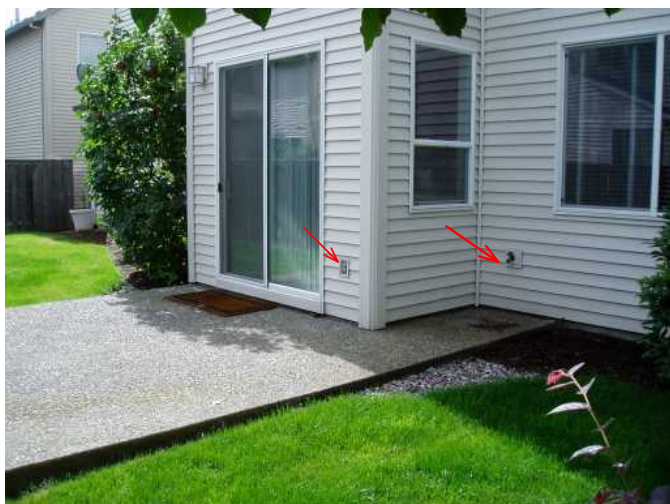
back patio has good slope/ electical outlet works fine/ hose bib works fine as well....has backflow protection...

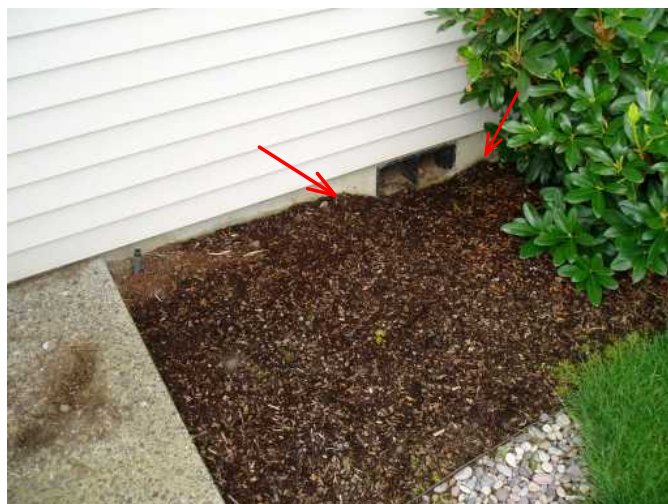
this is vent with too much barkdust and will allow rain water entry to crawl space...keep even or below vent opening

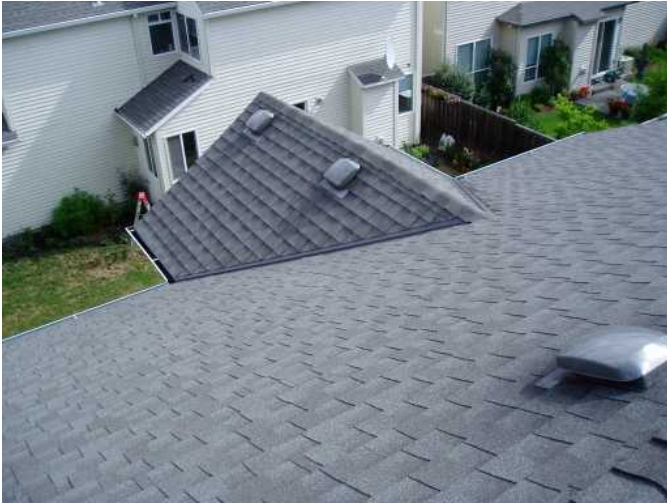
back of roof is vented well...valleys are good...

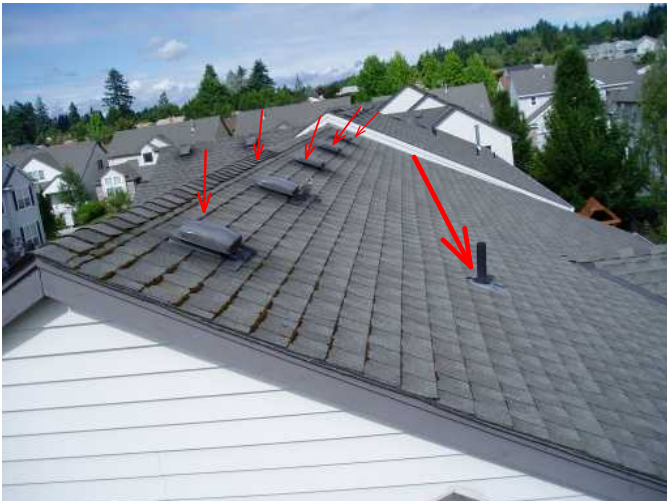
peak of main roof is well ventilated...one of three sewer exit vents to keep sewer pipes flowing...good...

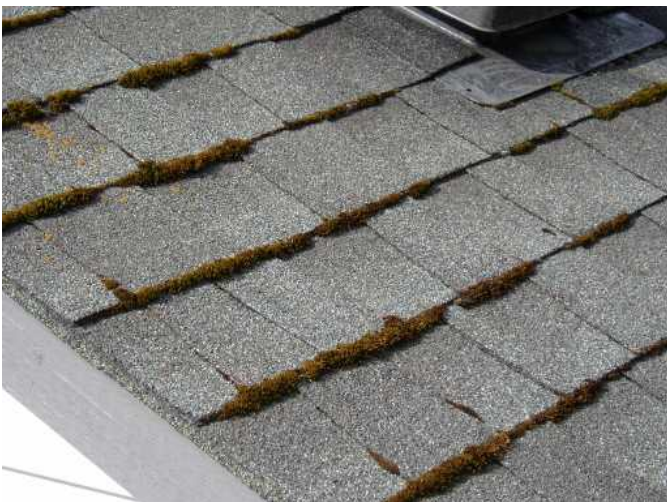
this is moss on upper rear side of roof..appears to be treated..will need treatment every year..is normal...just monitor

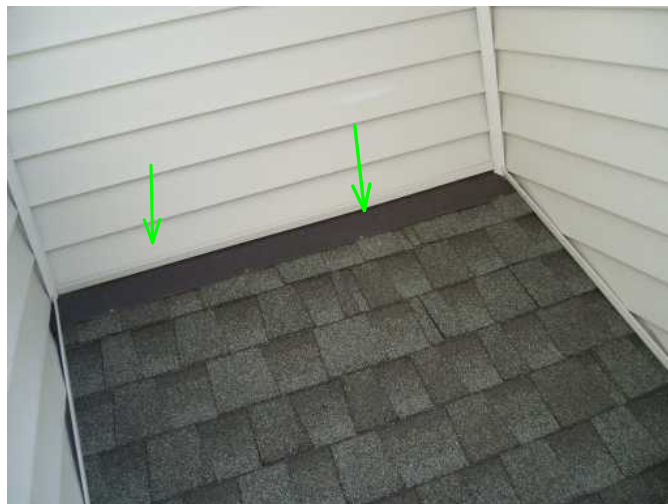
very good flashing here as well in front of main bathroom...

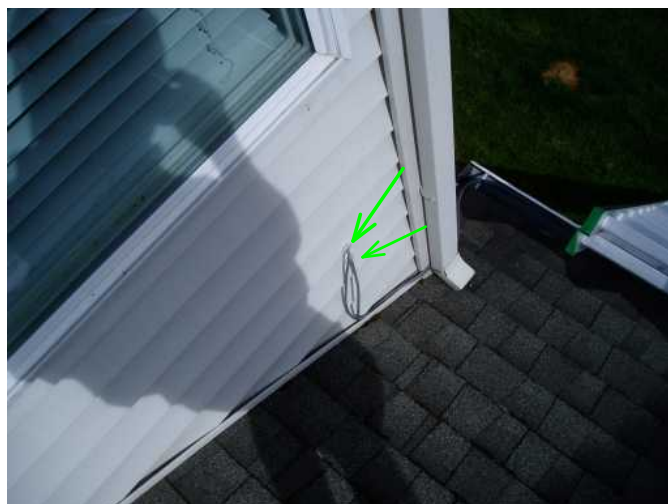
dish type television cables are installed well with grommetts to keep out water....

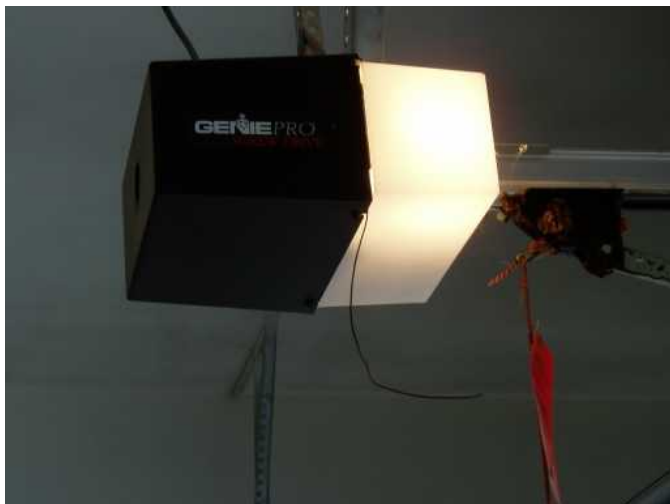
garage door operation is fine....

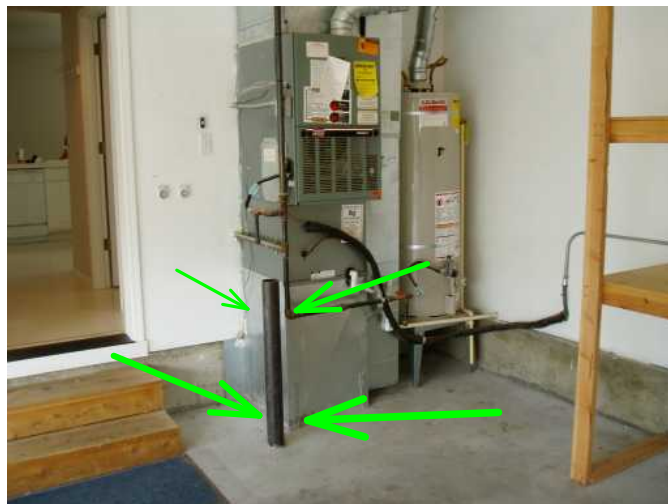
furnace and water heater have post protector in place...very good...

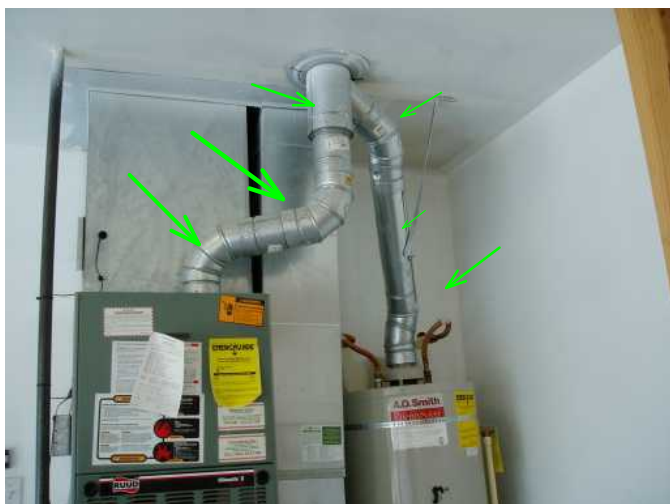
exit flus are installed well and solid....

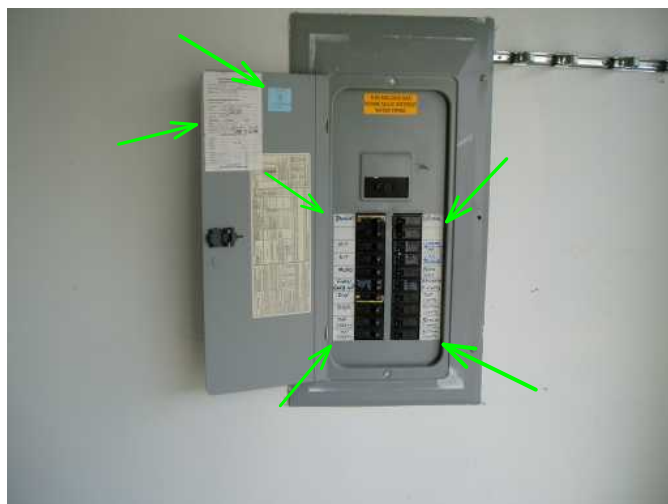
electric panel open showing well marked for zones and has permit sign off and blue tag for a/c installed later....good

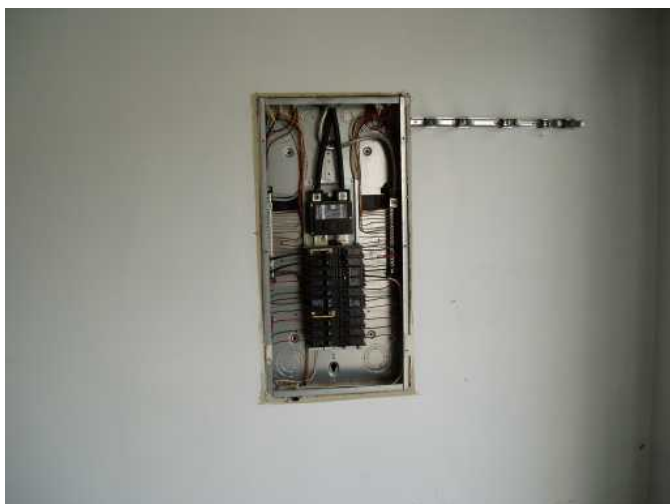
this is clean and well done...all good here....

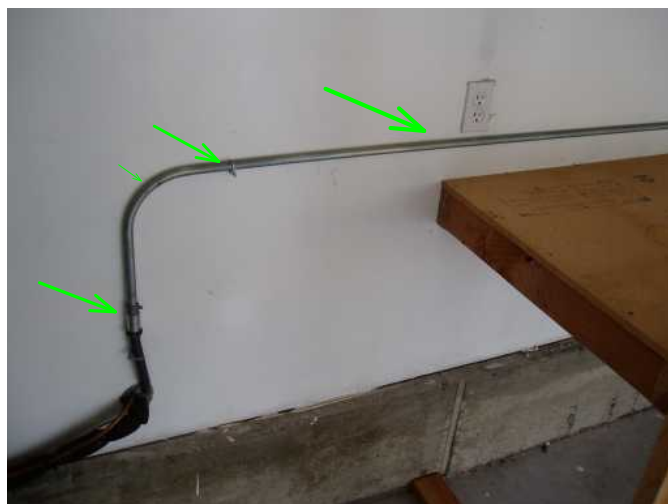
newer a/c electrical service is in conduit ..very good...

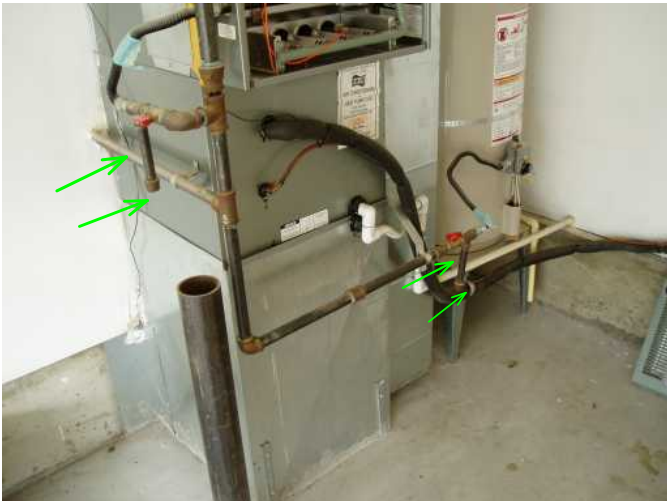
gas service to furnace and water heater are installed well and solid..have two drip legs to catch impurities in the line

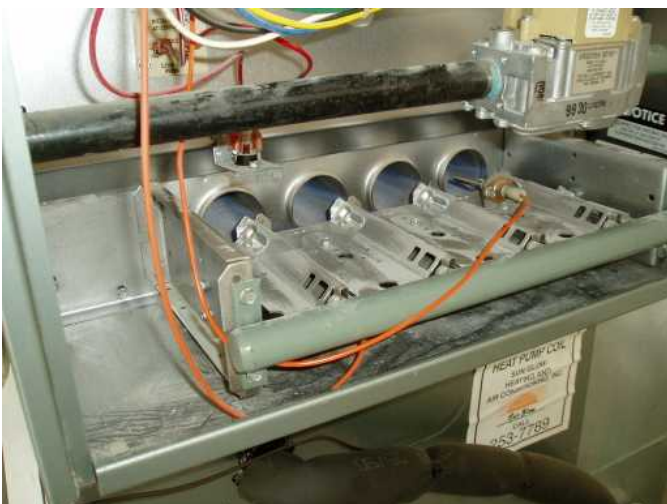
furnace in action..worked jsut fine..got the home really toasty fast..ran a/c as well did very good job cooling....good

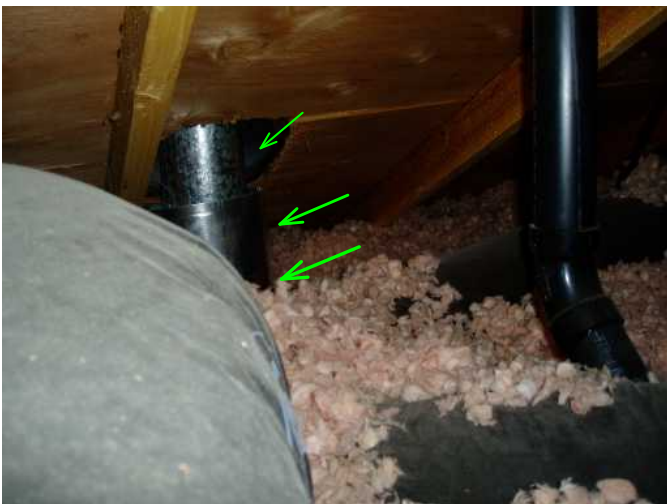
this is furnace and water heater exit flu with attic shield to protect pipe from insulation..by the book...good...

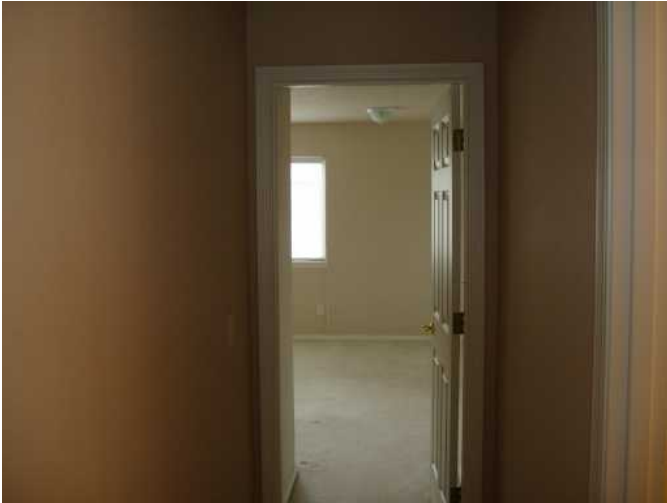
door to great room works fine...outlets are all good here as well...

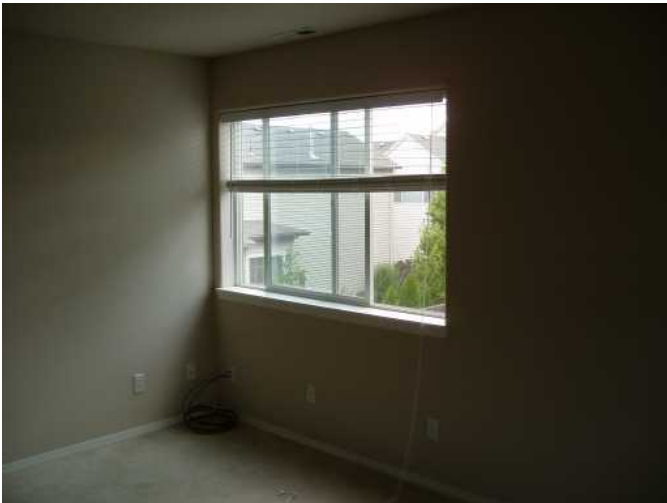
side window if great room is good...

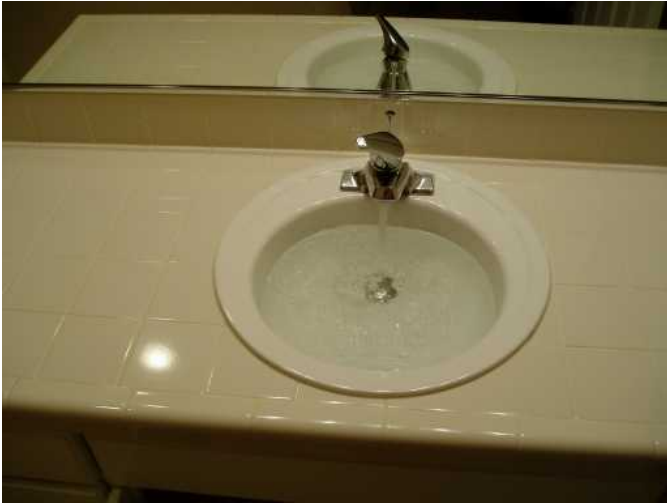
sink overflow is fine...drained fine as well...

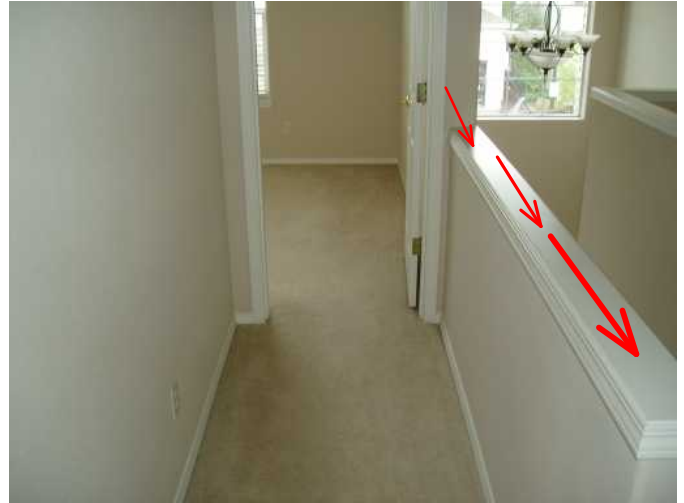
hallway to bed 2 railing is solid and sound....

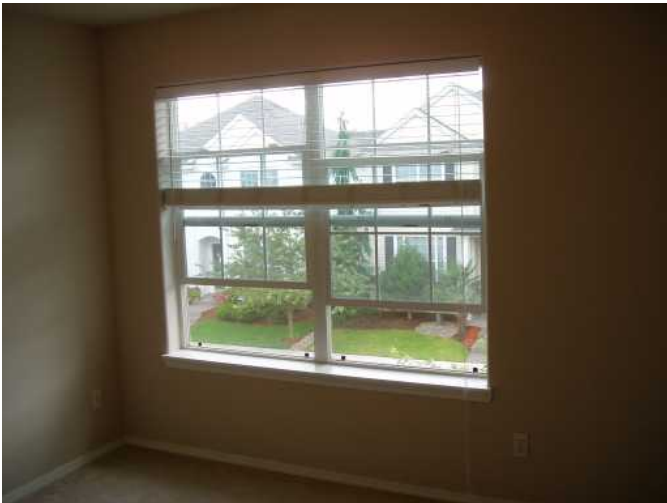
bed 2 windows work fine...

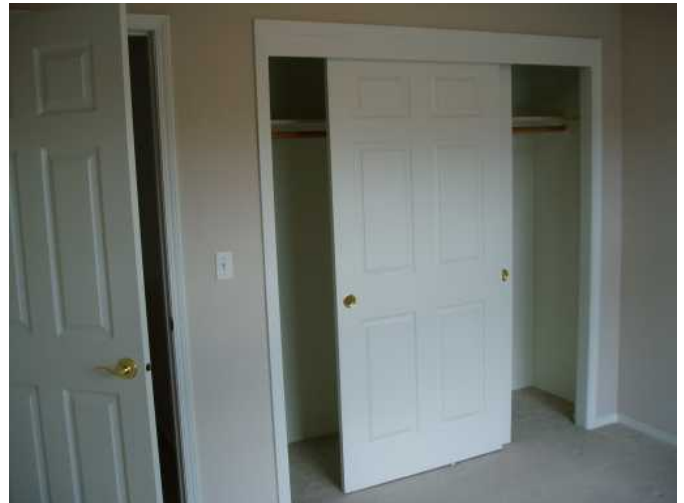
bed 2 doors operate well, both closet and exit....

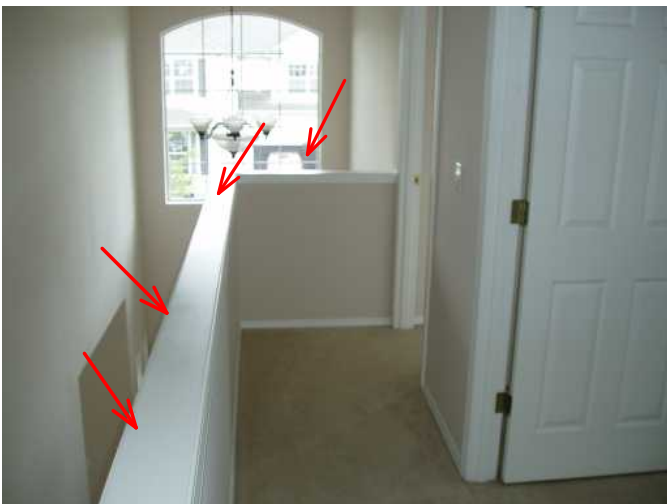
hallway railing to bed 3 is solid and sound...

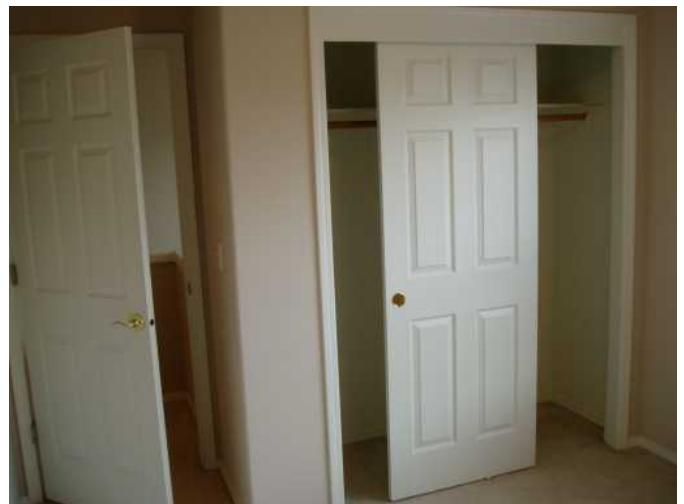
bed 3 exit door and closet doors are in good order...

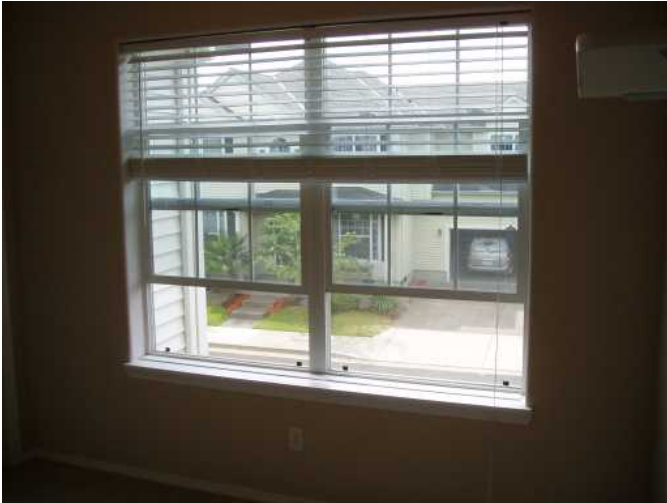
bed 3 windows are operating well...

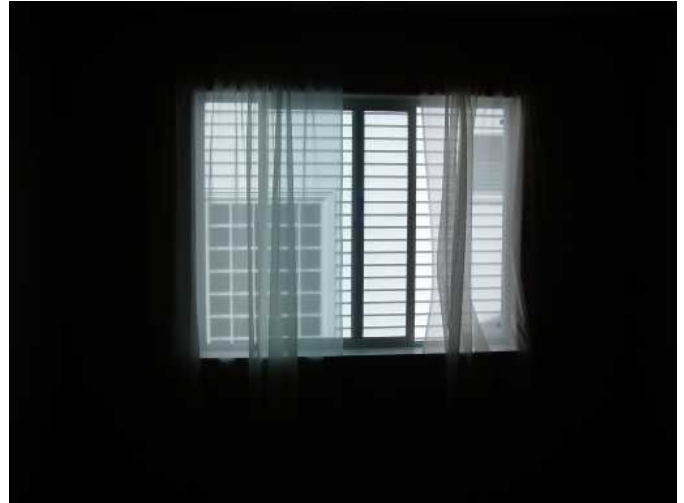
den (next to bed 3) window is operable...

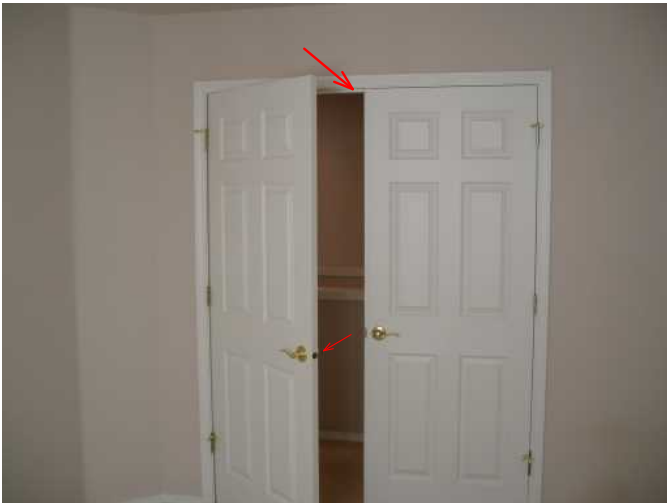
exit doors to hallway are operable and attach to frame fine...latch properly...

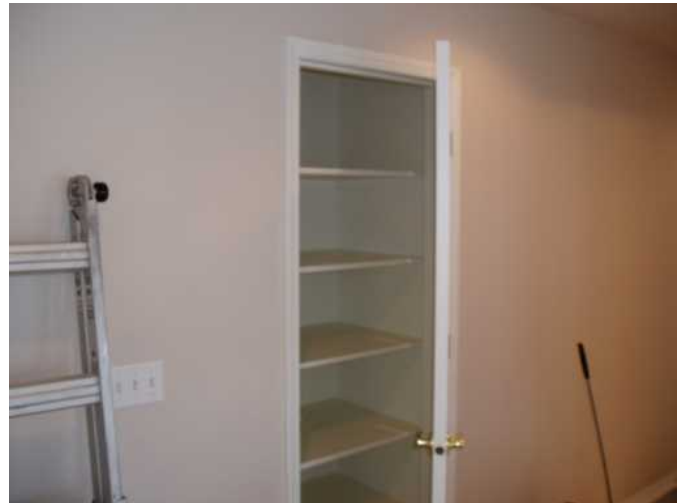
hall linen closet door is operable...

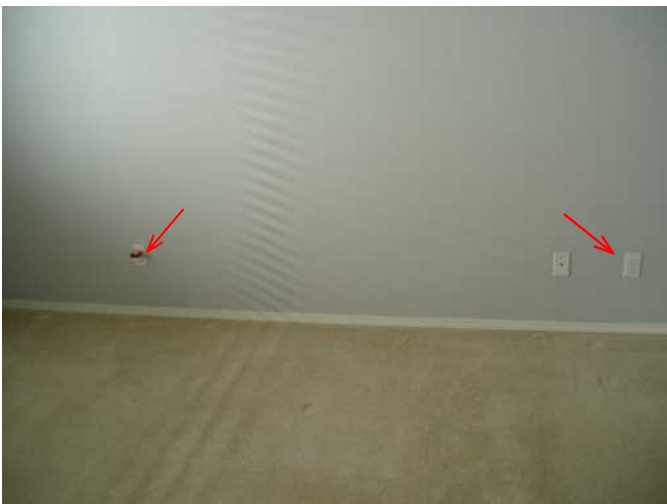
master wall outlets are switched for lamps..good...

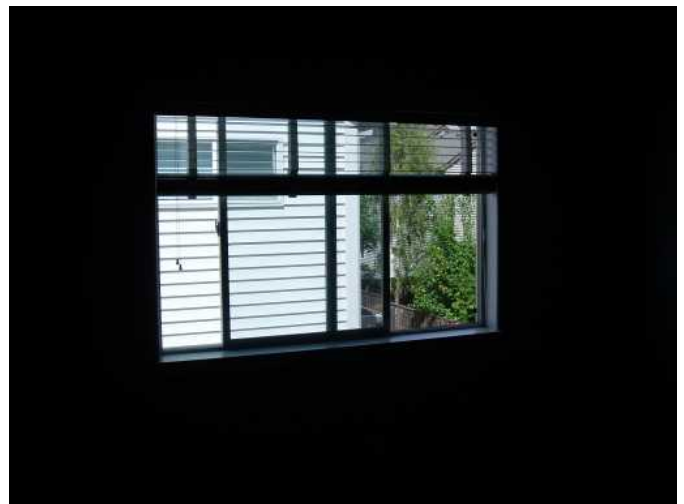
master window is operable...

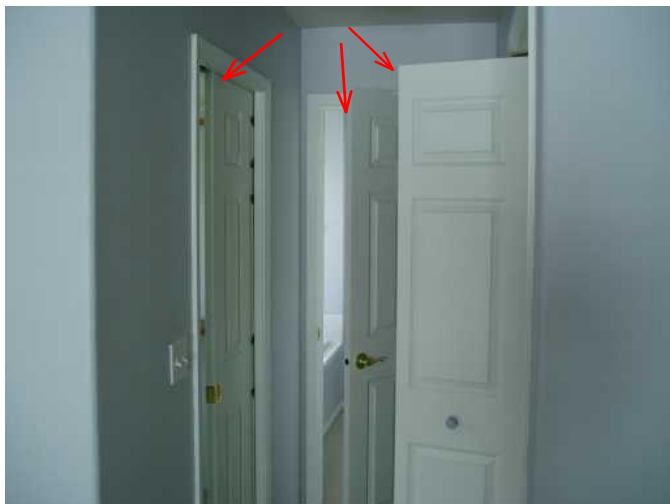
all doors to master side closet to right...master walk
in closet pocket to left and bath to center are
working fine...

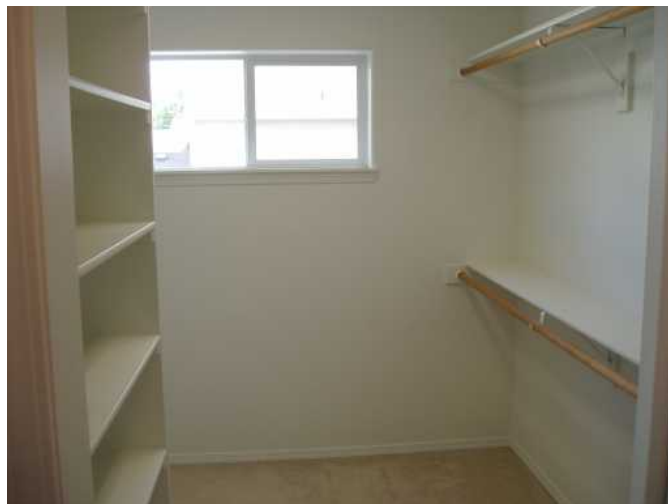
master closet is in very good condition...

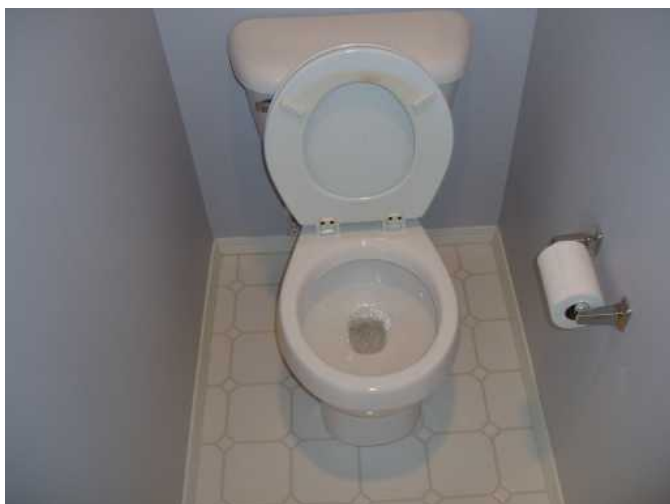
did rate of flow test...when all utilities were in
operation..noticed a bit of slowing of flow..use only
tub or shower...

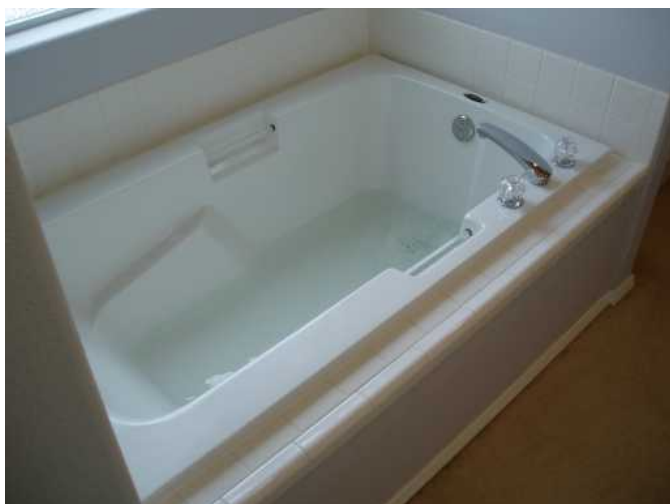
tub filled and drained well...ran slower with shower
and both sinks ..only run tub or shower, not
together....

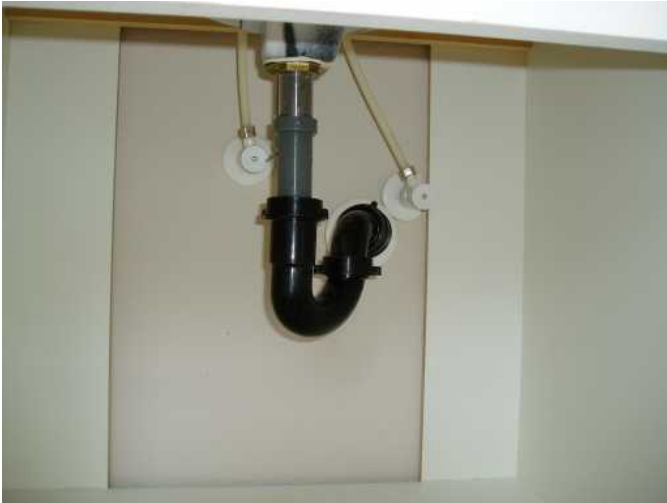
under sink had no leaks ...right master

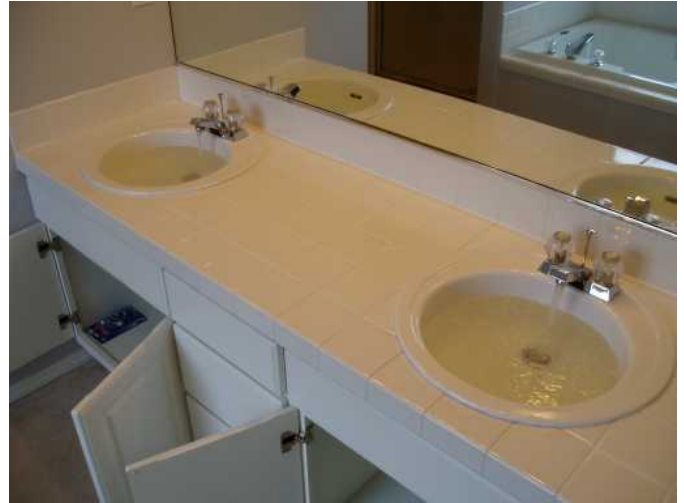
did overflow test on both sinks..did fine...

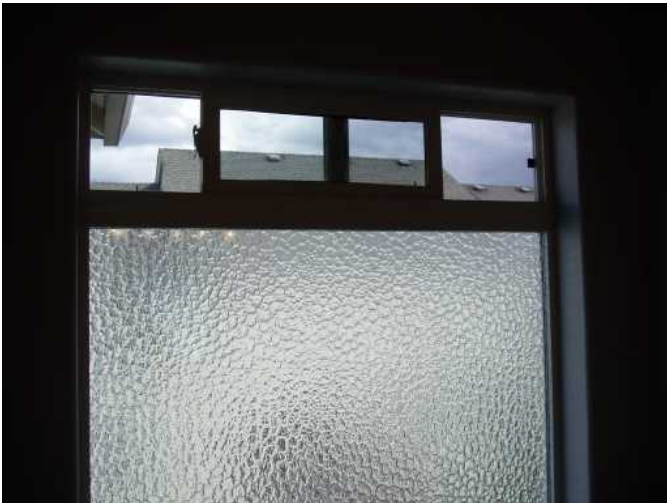
upper window worked fine above tub..master...

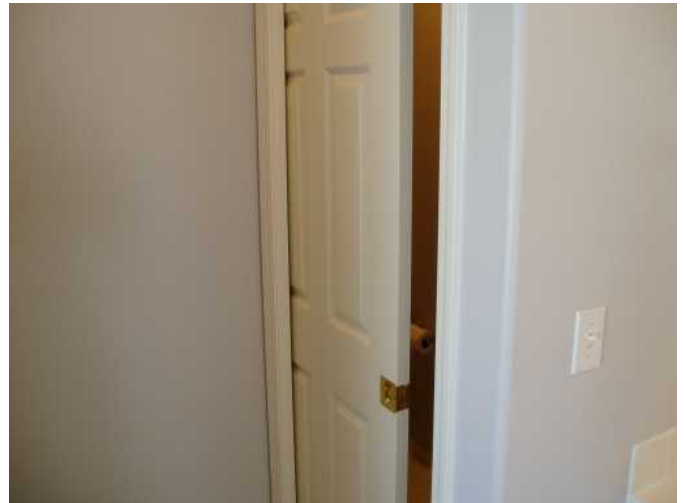
pocket door to toilet master worked fine as well...

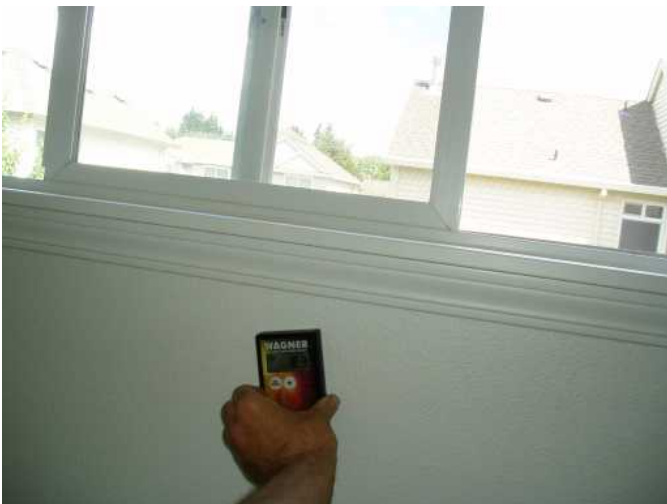
master closet window worked fine...did moisture check
of walls around windows and at random, 5.5% - 7.7%
good...

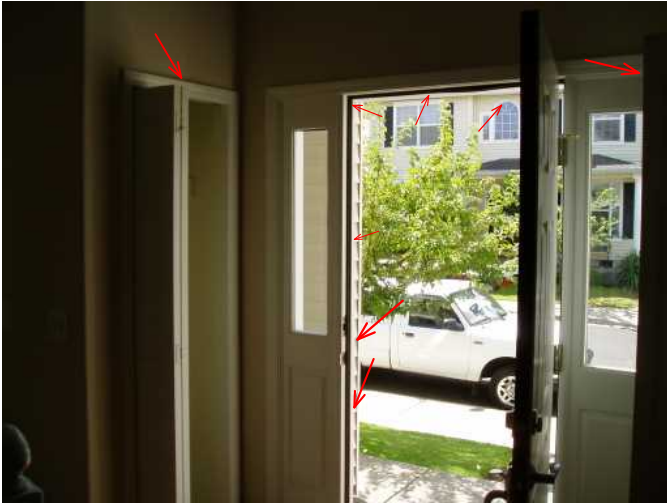
front door weather stripping is good..closet doors on both closets are operable...

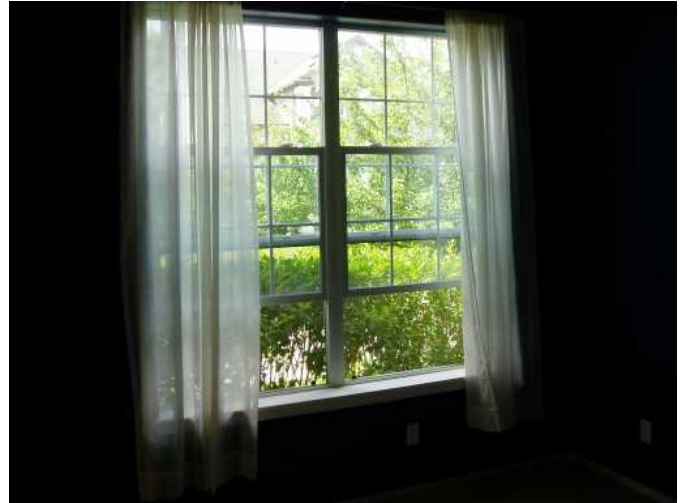
livng room windows are operable...

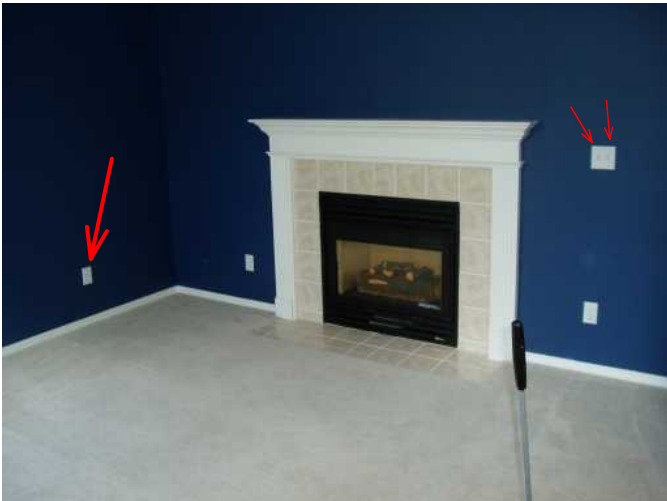
see through fireplace is operable...works fine...is wired for fan, but doesn't have one installed..outlets are switched

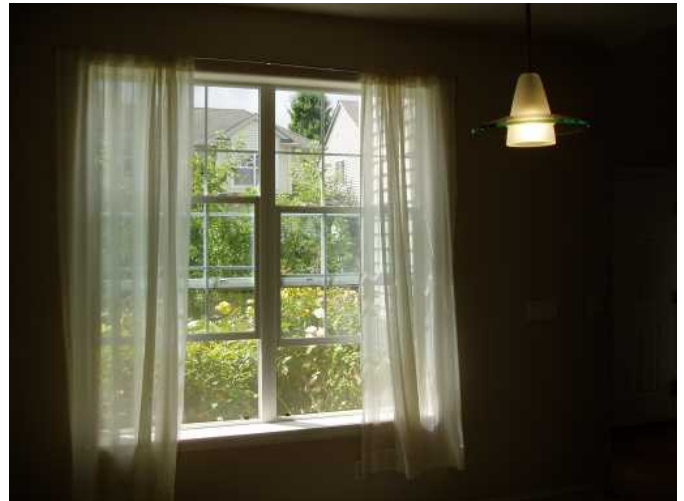
dining room windows work fine...

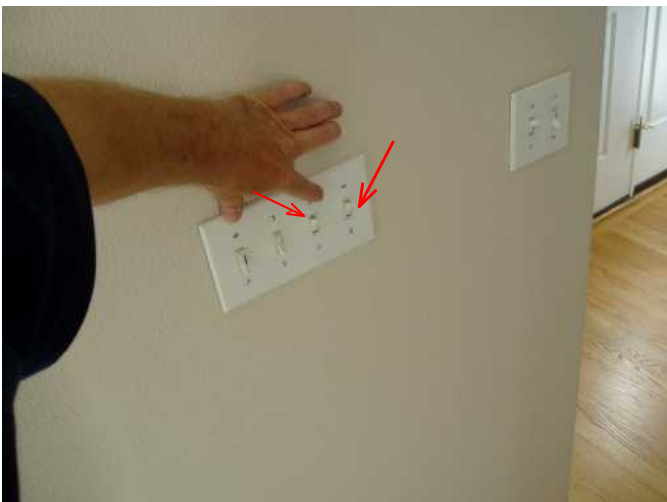
could not determine what the two right light switches in dining room operate...please have seller disclose...

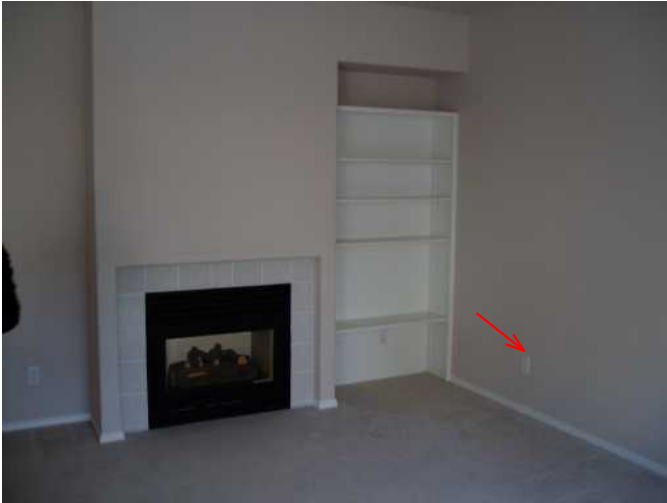
family room fireplace and shelving unit...outlets are switched for lamps...(2)

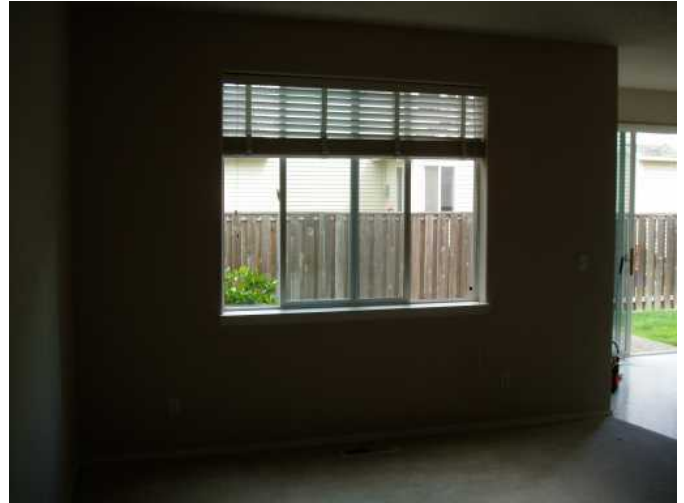
family room window is operable...

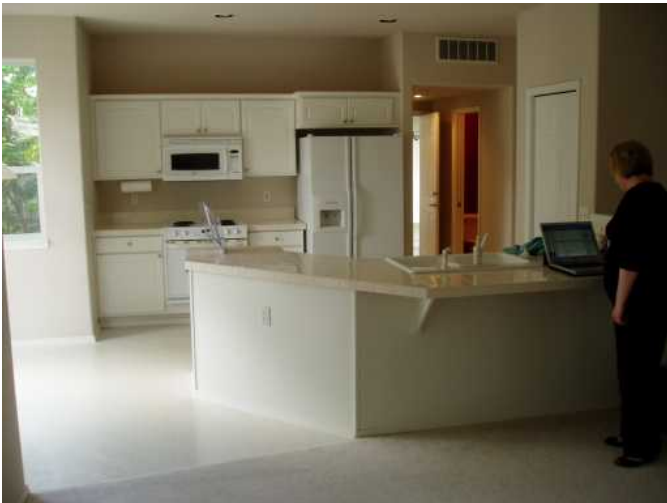
overall view of kitchen...cabinetts are in very good condition...counter tops are well maintained...

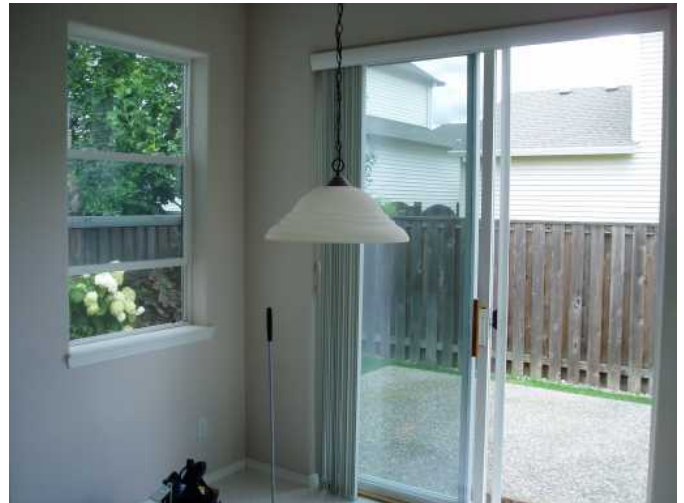
dining area windows (2) and slider are operable....

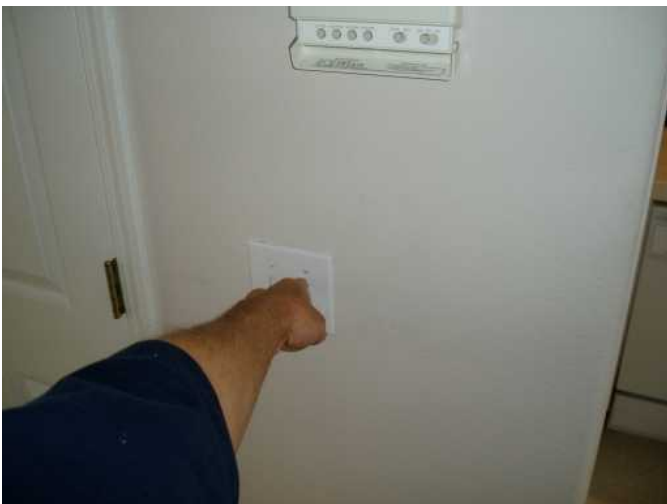
this is to remind me to tell you that when you have dimmers on three way systems they have to be on to run the other one

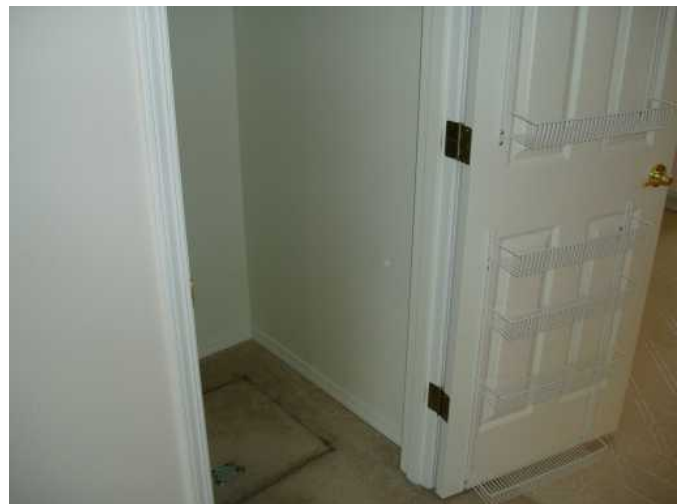
access to under stairs closet and scuttlehole to crawl space....

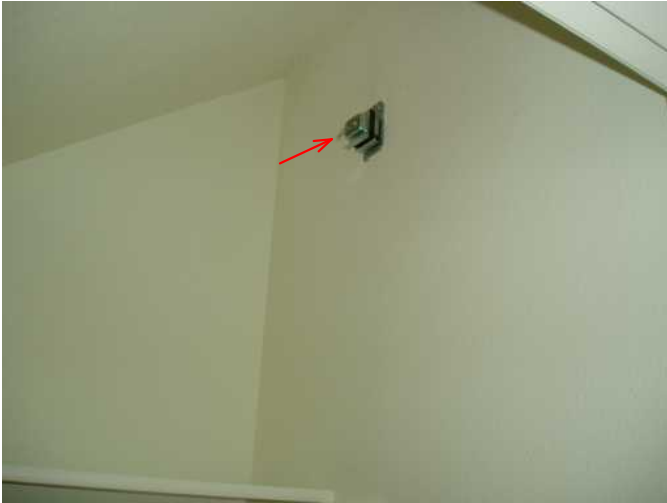
low voltage coverter to operate door bell button in front of home..without shock issues...

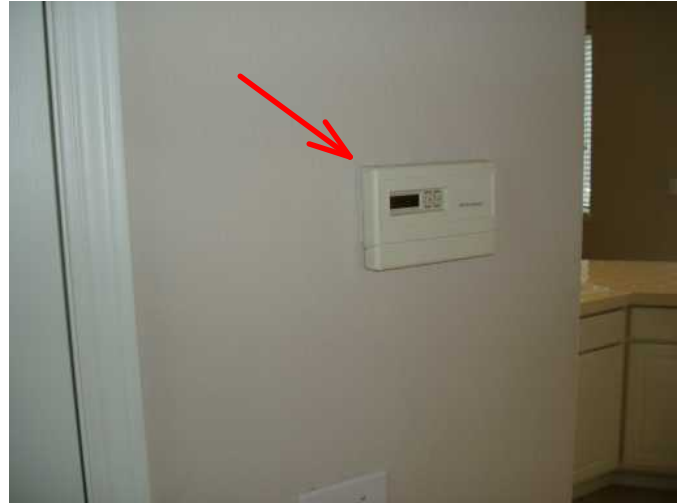
programable thermostat ran everything just fine...

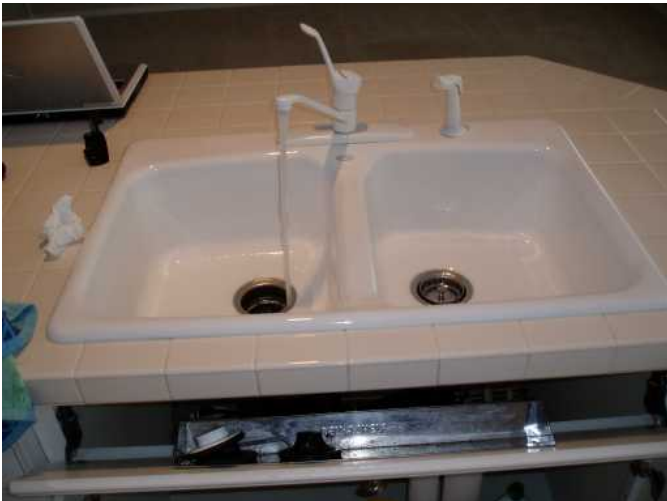
did flow test at kitchen sink and ran dishwasher through complete long cycle..all good no leaks noted...faucet is good.

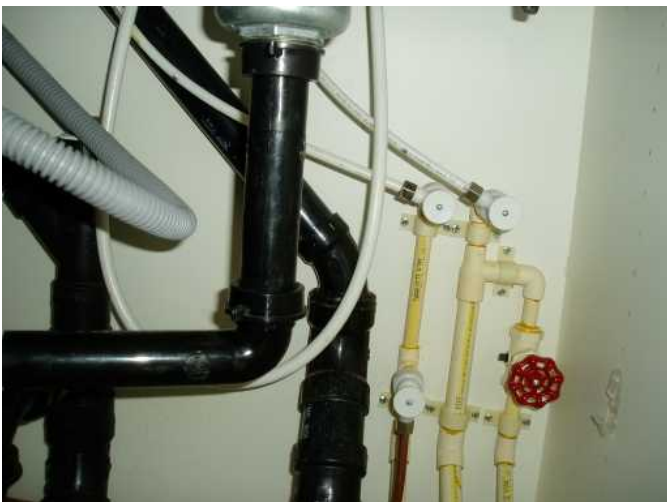
water connedtions are all solid and no drips noted...

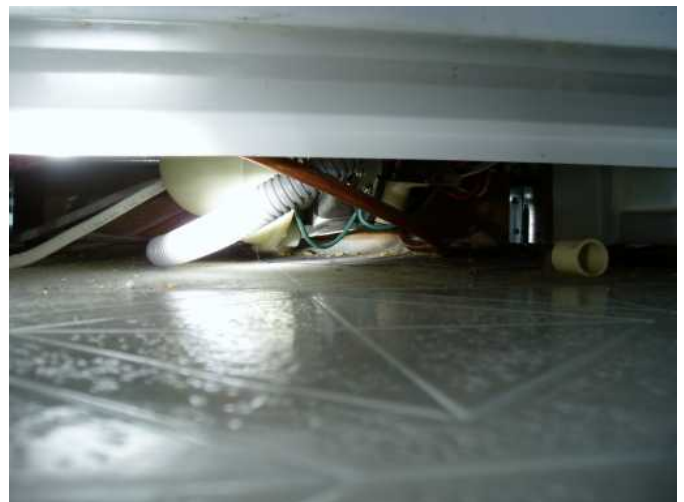
under dishwasher is dry and tight...

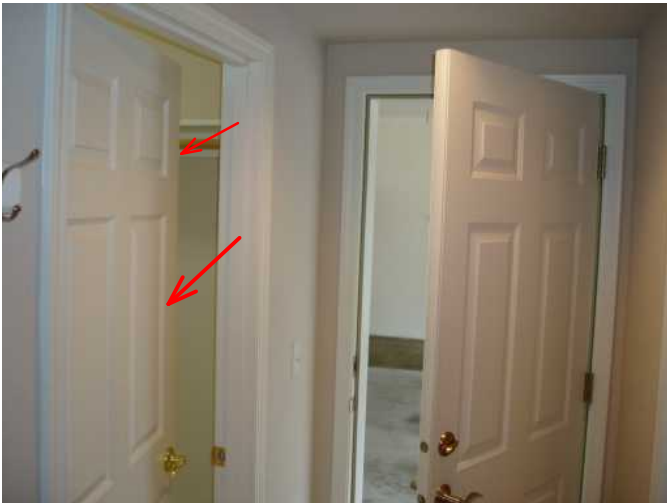
laundry room door is in good order...

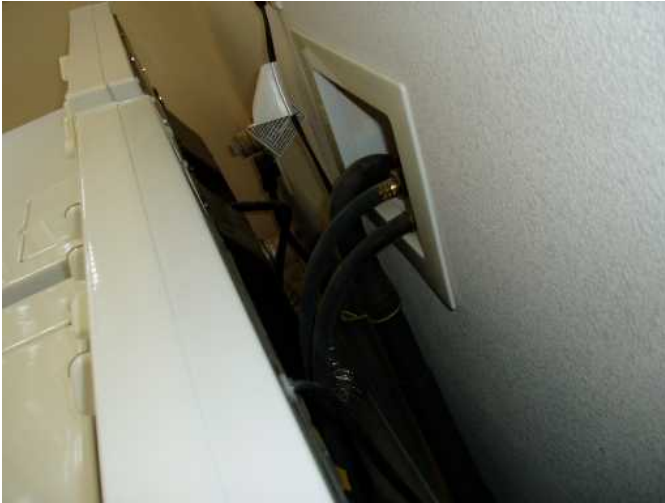
laundry hookups a-o.k.

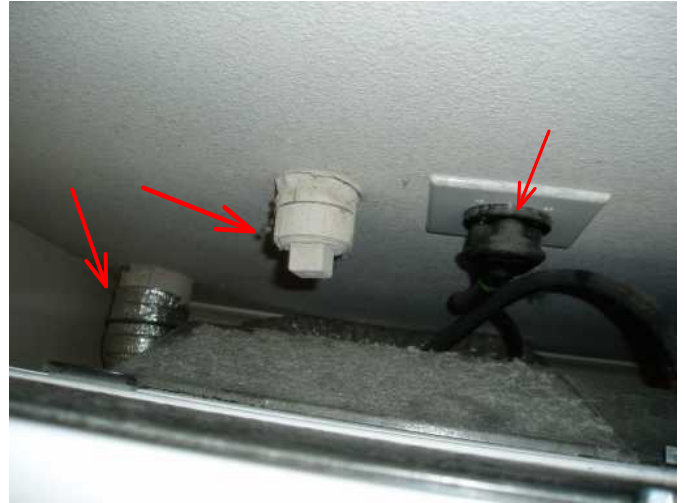
cleanout for drain...dryer hook up and exit duct for outdoors..good...

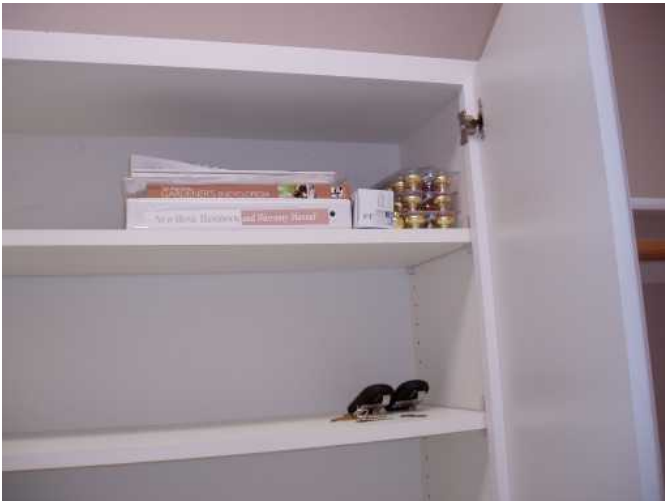
everything is in order...its amazing....garage door openers..extra keys old knobs from kitchen in boxes...wow!!

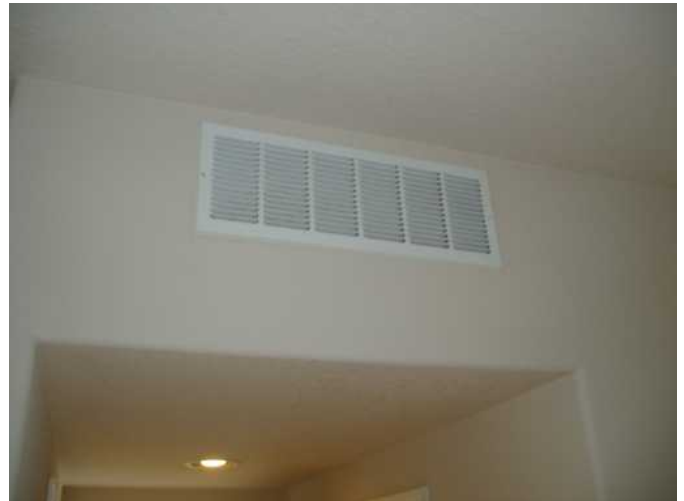
second return air for furnace system in kitchen area..lower level...good...
