Home Inspection Report

Actual Inspection

Prepared by: The Home Tester
10555 SW Tigard St. #57
Tigard, OR 97223
Ben Tester
503-515-1833

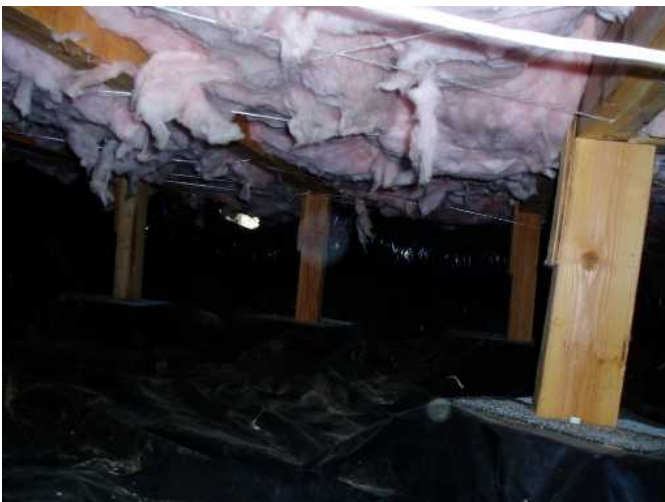
post and beam system in crawl space means a very well built home...sub floors are plank diagonal tongue and groove...

| 2. Acceptable | Foundation: poured and post and beam |

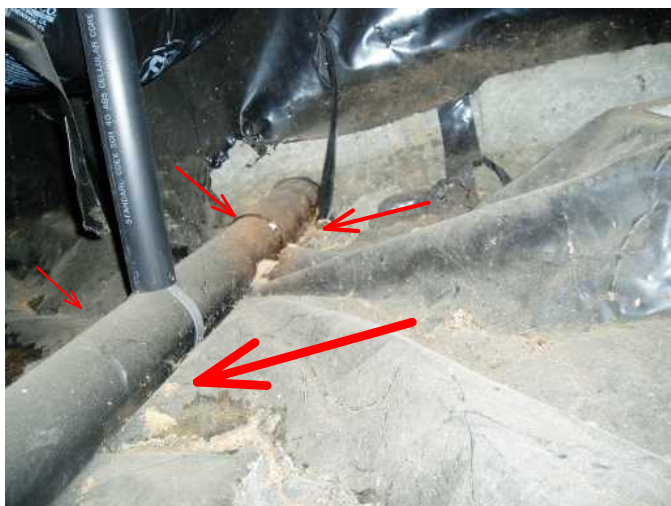
main sewer exit pipe goes out the front of home under dining room...

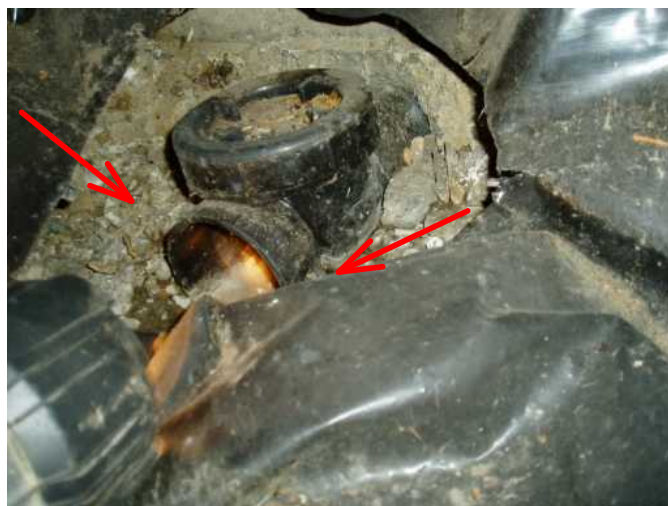
this is exit gate at low corner of crawl floor to let out any water that may enter crawl space..very good...

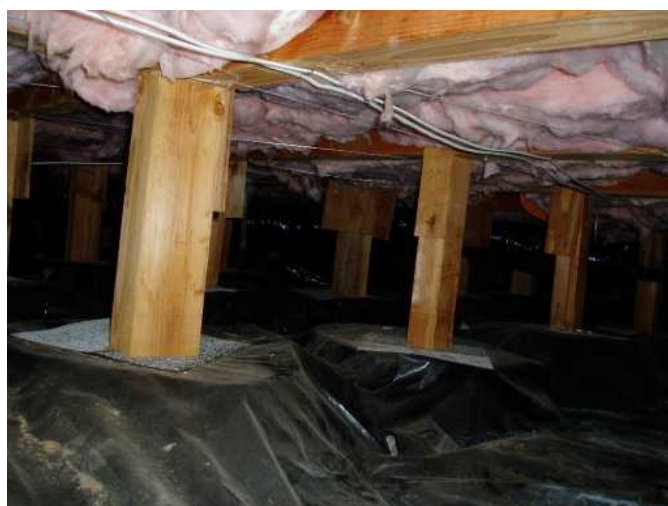
another great view of lots of post and beam under your home...

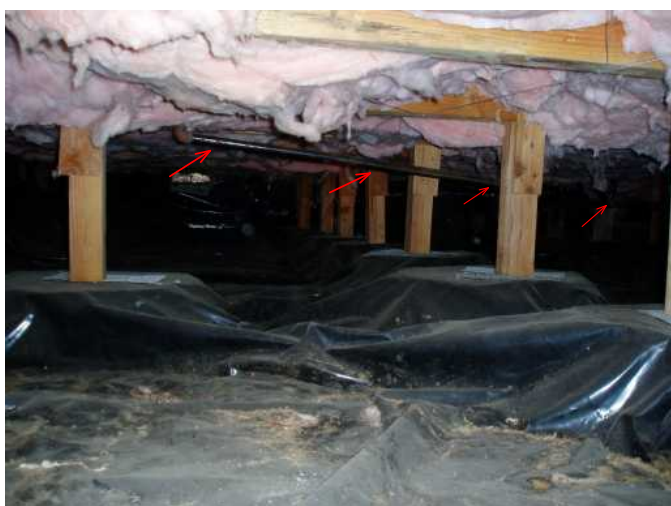
gas service to fireplace is hard piped...

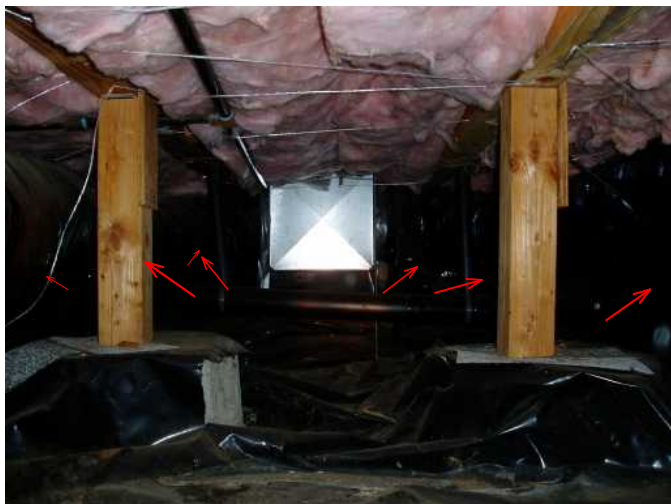
main distribution of furnace/a.c system at garage side with insulated duct running throughout crawl space....good...

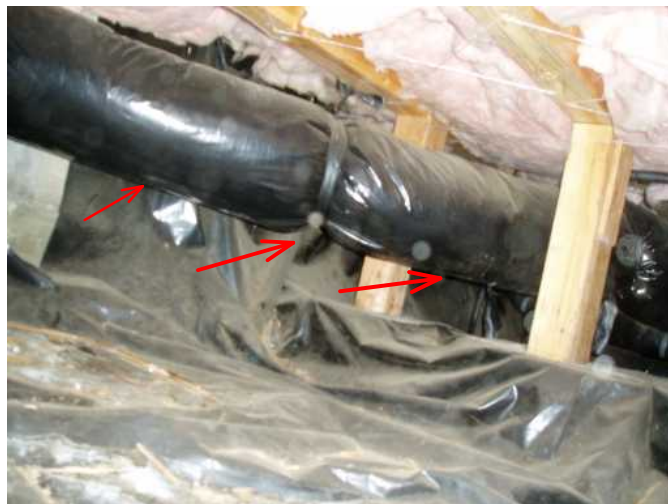
all insulated duct work is in tact and connected and performing well....

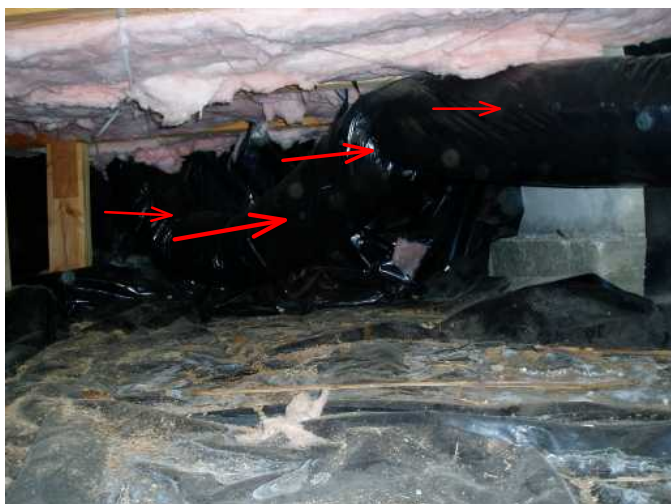
more duct work going to family room..area...good...

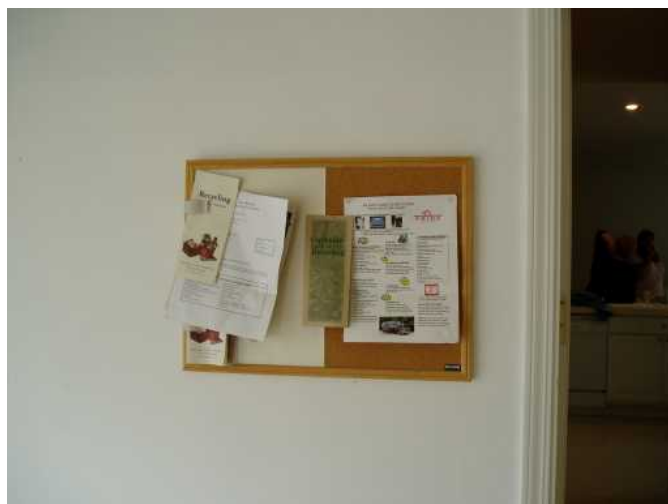
lots of information for garbage and recycling..very good...
