Home Inspection Report

1936 Sunburst Terrace
West Linn, Oregon

Prepared by: The Home Tester

18:09PM March 14, 2010

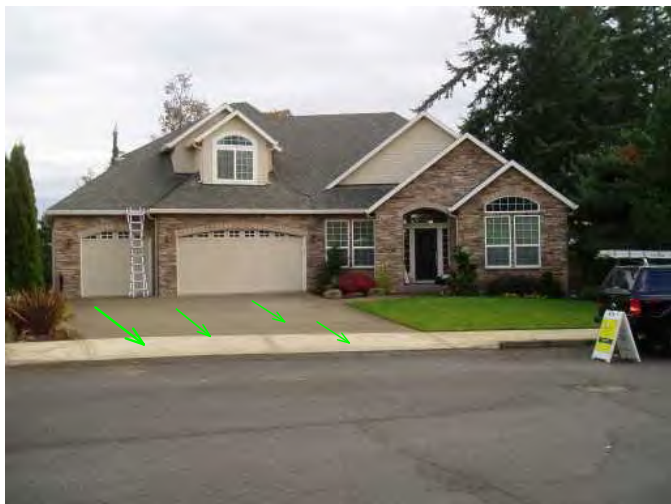
street view of home...driveway is sloped well for drainage...good..

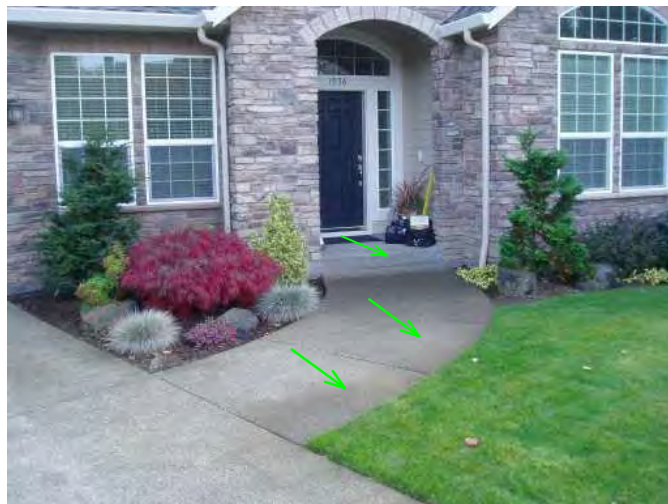
front porch and walks to porch are noted sloped well for drainage...good..

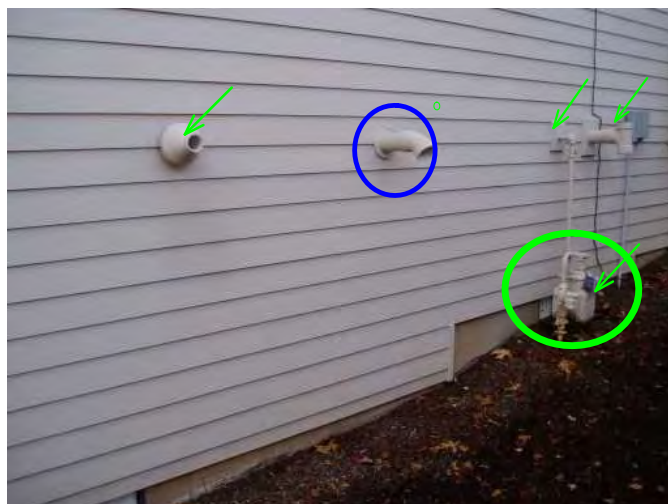
main gas meter is solid to home...PVC flues are noted for both furnaces and water heater...one needs to be re-sealed...

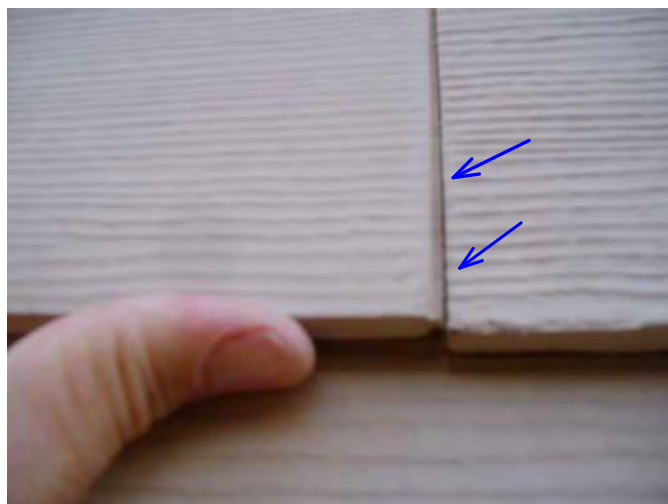
noted at random siding butt joints are loose and small gaps are forming to let in water, re-caulk as needed,ongoing item

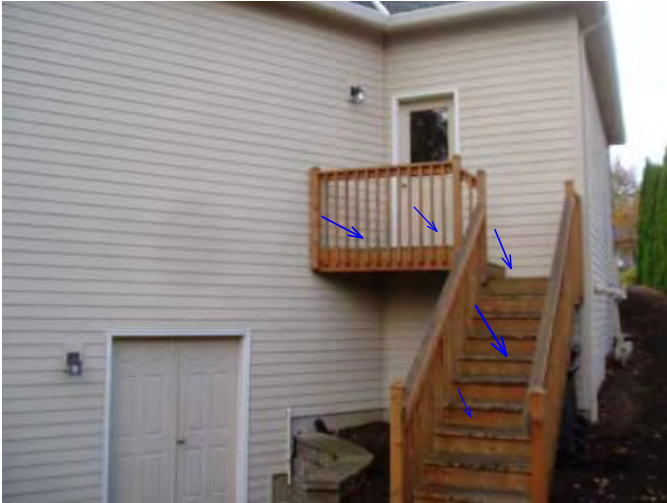
back mini deck is well built, but needs to be cleaned and treated to avoid very slippery steps...

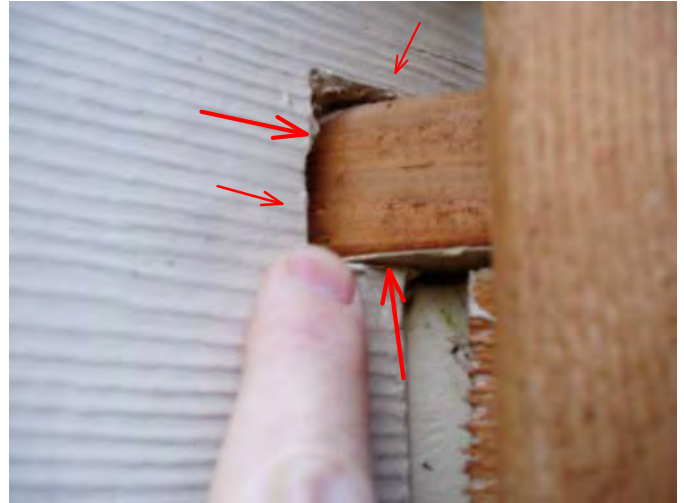
seal at siding here at deck joint into area here...is open gap for water entry...

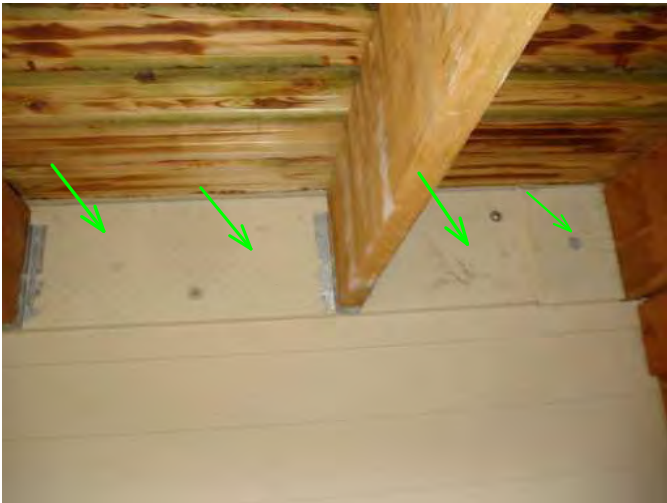
deck joist are installed well....good..

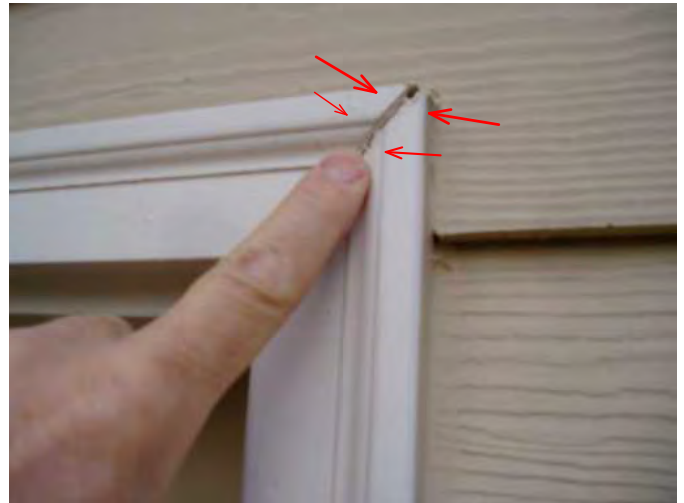
any gaps noted around home that are working their way open are common and need to be caulked to extend life...

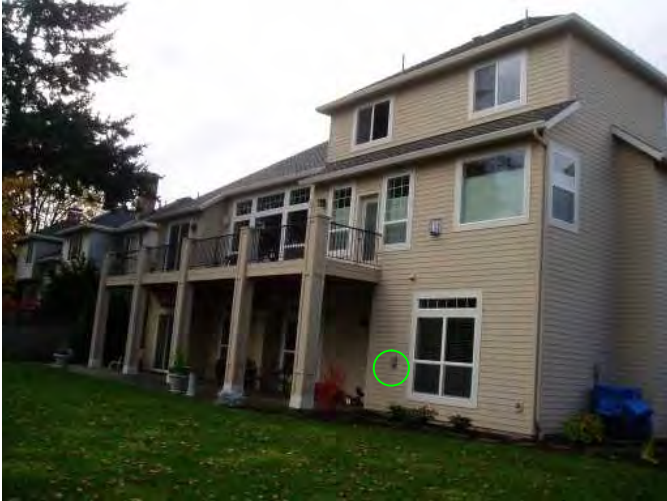
main back view of home is noted here....lower patio has good slope for drainage...good...breaker box is for future spa...

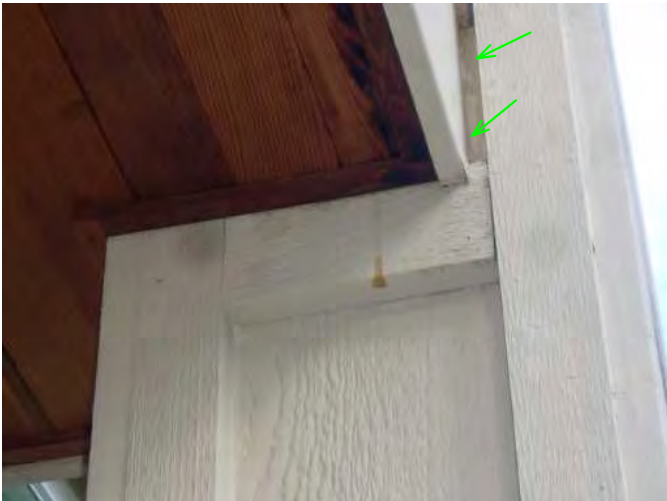
trim here is filled well...and sealed water tight...good...

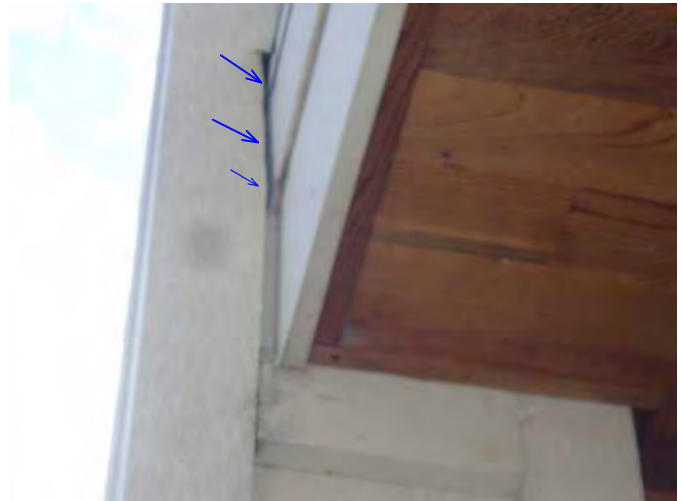
needs to be sealed here like photo before...

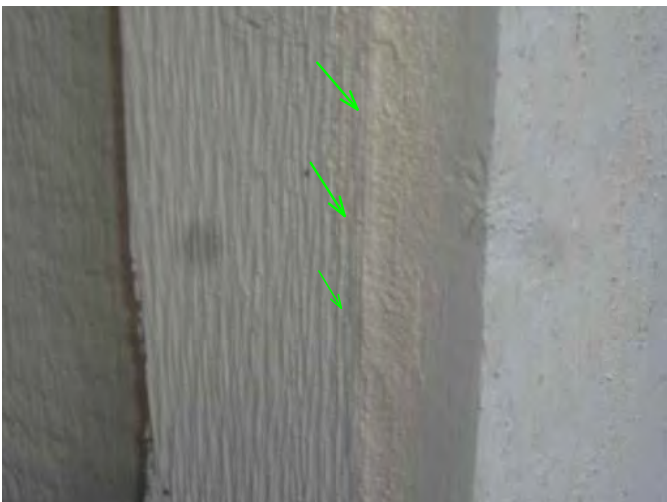
joint here at balcony column trim is noted caulked...good..

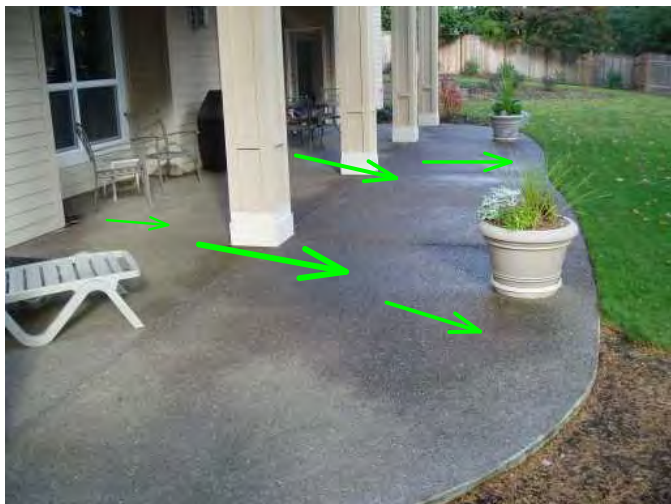
good slope of patio noted here at lower area of back yard...good..

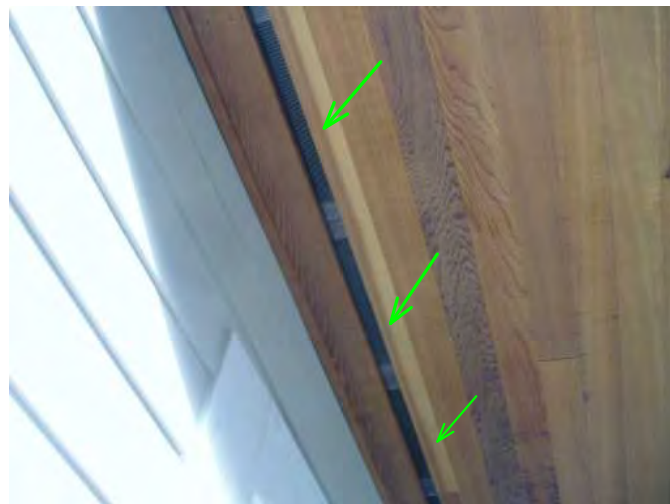
gap under balcony is noted as venting to allow any potential water that is in area can dry out...good..

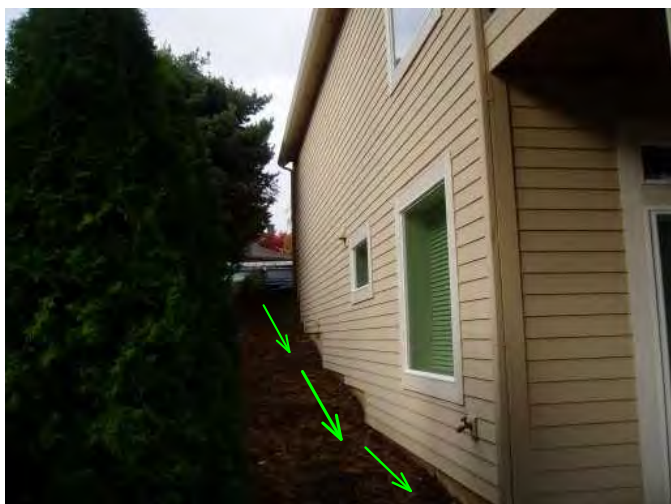
right side of home is sloped well for drainage...good..siding is noted solid to structure...monitor joints for caulking...

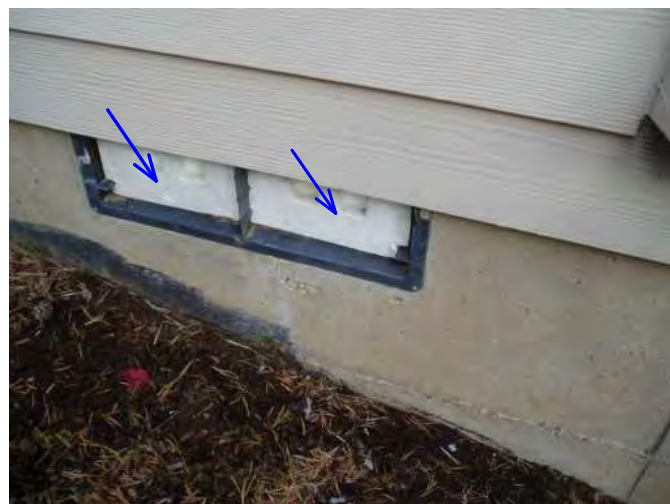
crawl vents should be left open to allow crawl area to breathe and air flow through...

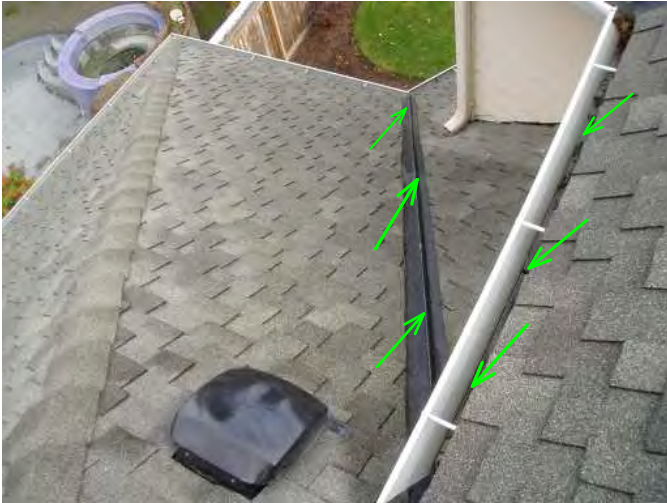
on roof at front of home noting the valleys/gutters are solid and clean here, but need to be monitored in fall regular

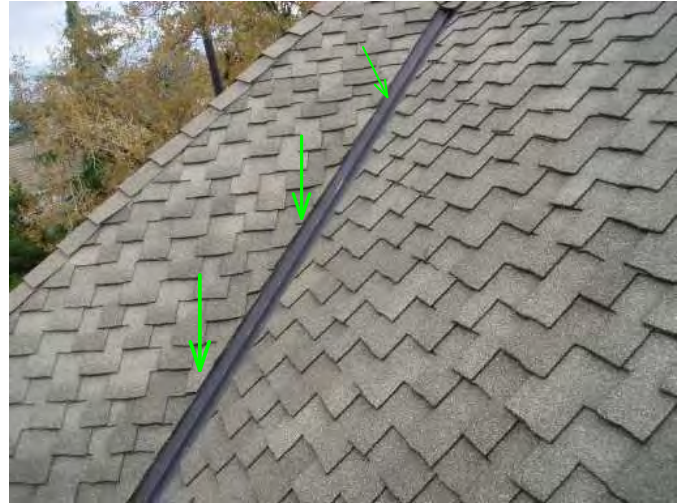
valley here at upper area over garage and bed 2 is clean...roof is clean as well...good..

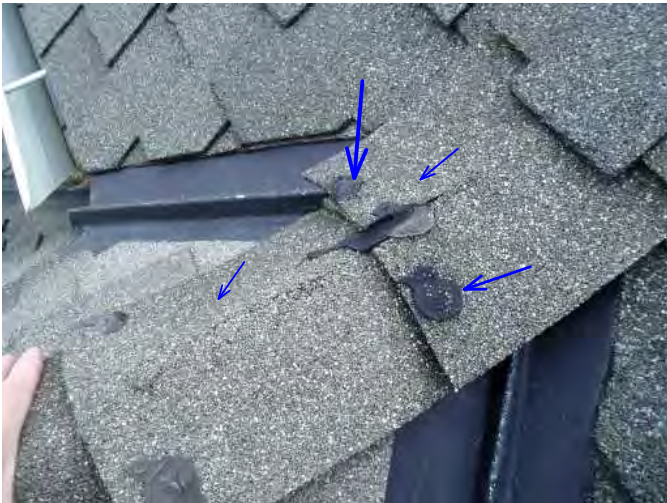
monitor ridge caps at random as noted here...some patching is noted and will need to be replaced...

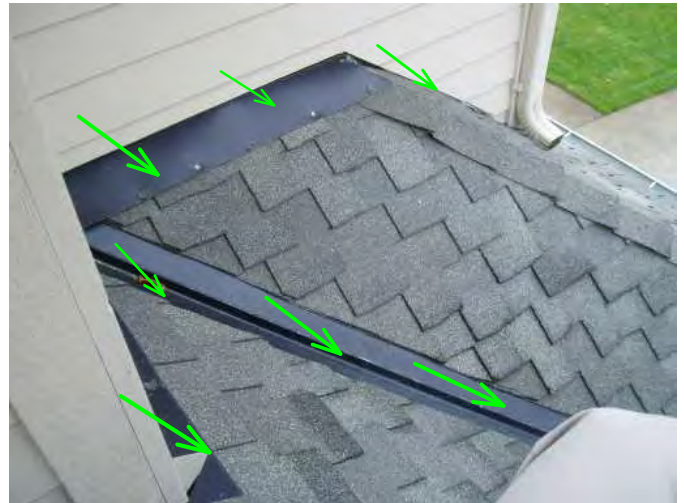
great flashing here and valleys are clean at front of home...good..

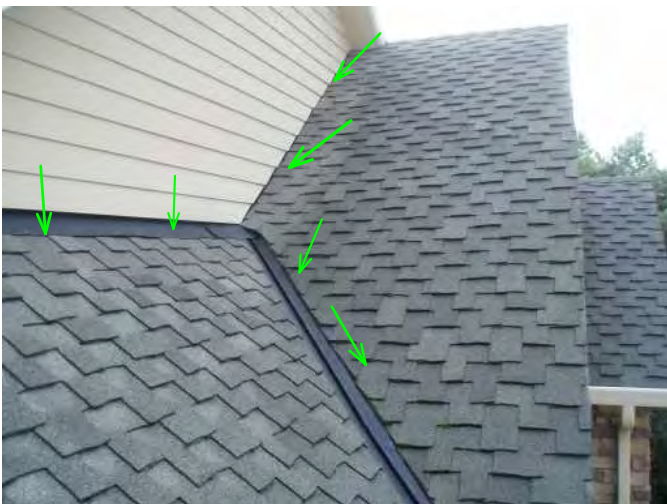
this area at front of home over front porch is noted here and is flashed well...good..valley is clean...good..

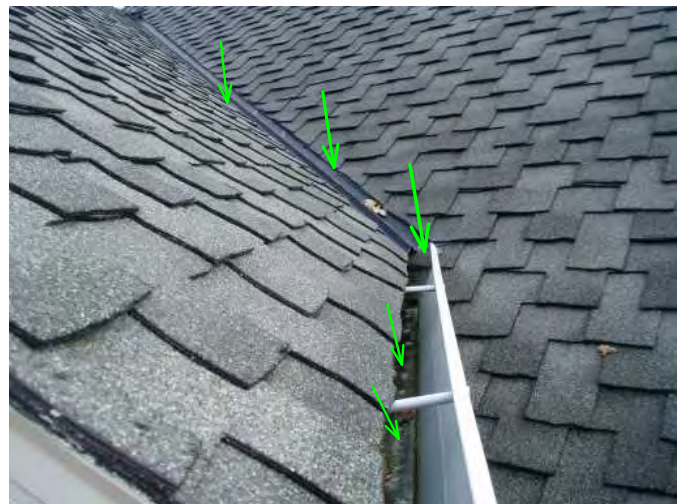
upper valley at front of home over bed 2 is noted clean, gutter is clean here, but needs monitored in fall every 2 weeks

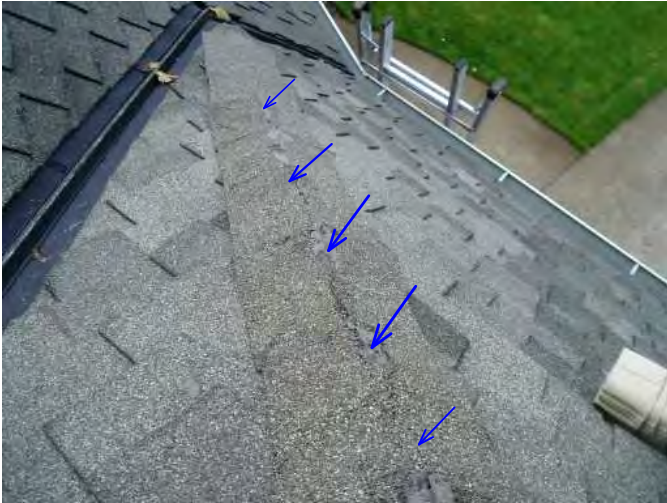
more ridge caps at this area are failing and have been caulked...replace to ensure no water entry occurs...

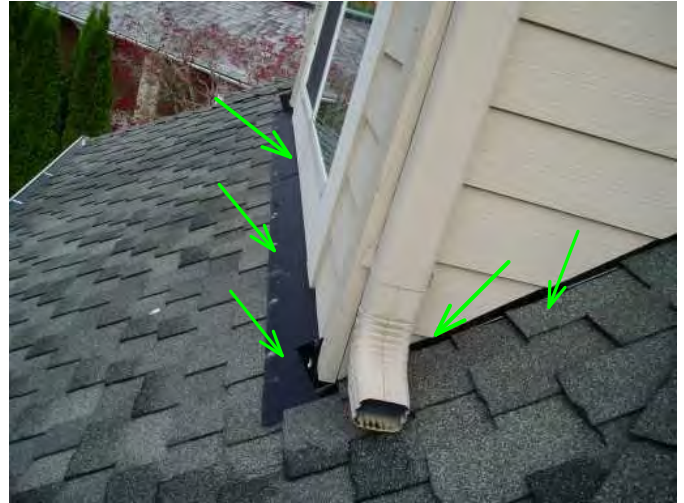
great flashing here noted at front of home...good..

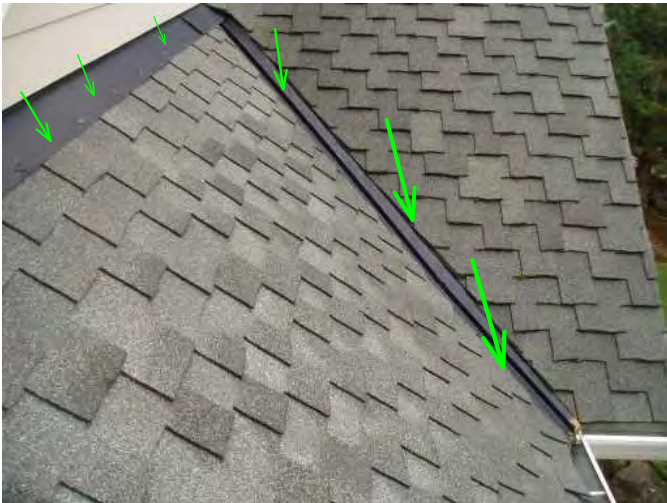
great flashing noted here at front of home as well...good valley noted as well...

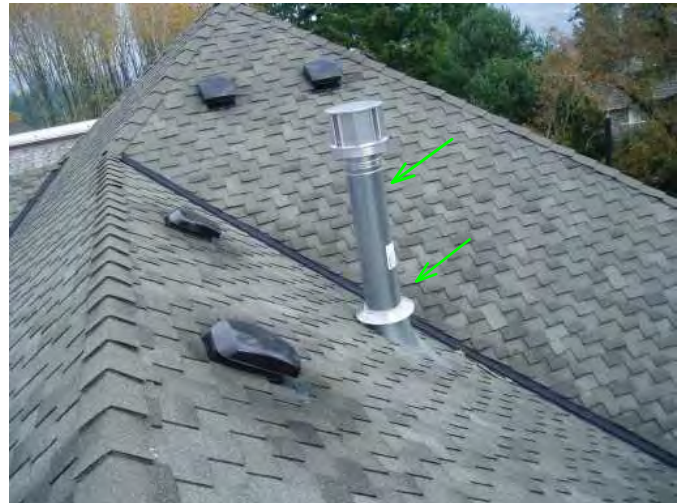
fireplace flue is noted here and is operable...good..this is for the living room unit..the other two are side vented...

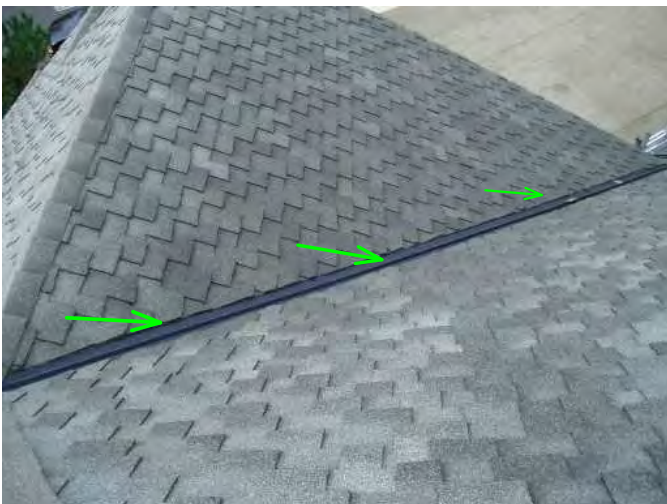
valley at the front of home above dining room is noted clean here...good..

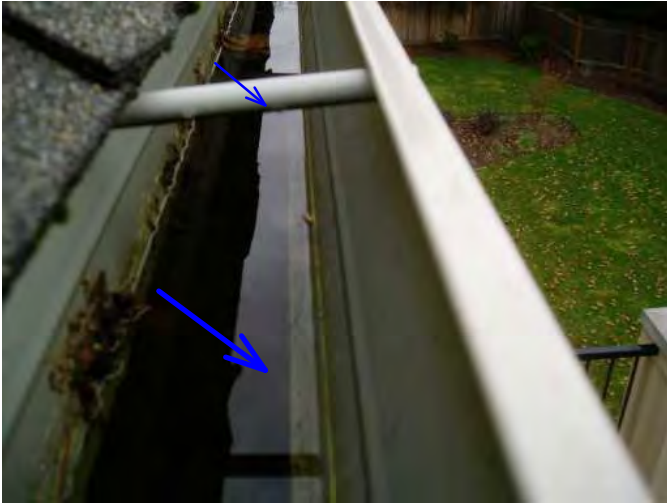
back gutter is noted full of sludge and has standing water....clean all gutters..

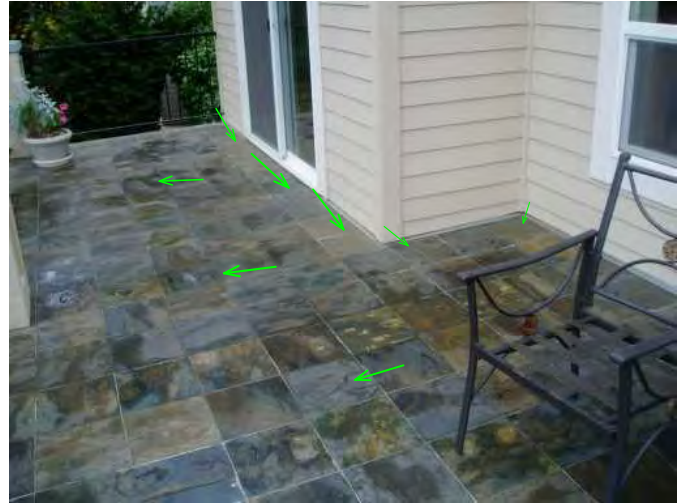
on balcony area noting the slte tiles and grout are fine at this time...flashing is noted at siding areas...very good...

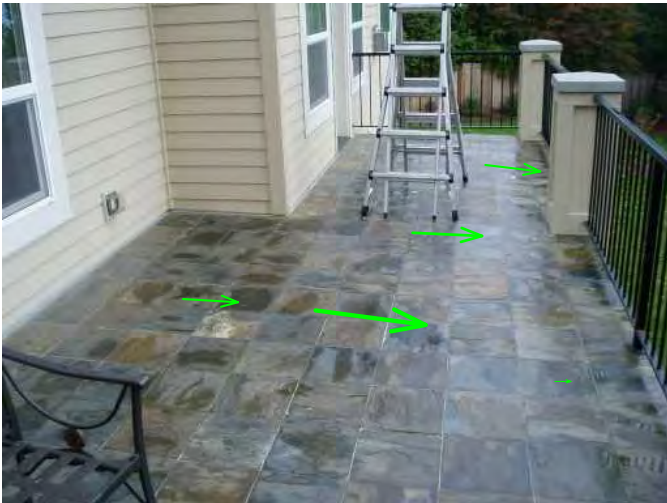
balcony is sloped well for drainage...monitor grouting and re-grout as needed...re-seal balcony every spring...

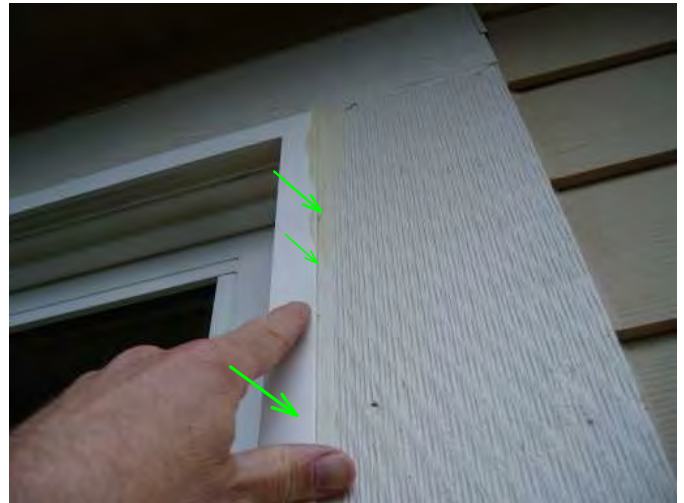
there are areas noted that gaps between trim and windows has been caulked...monitor and caulk any gaps found...

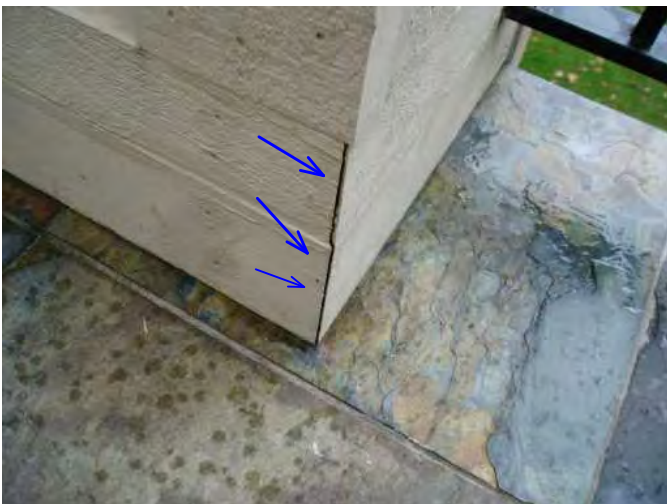
here is gap noted at column at balcony area..the wood cures and shrinks in time...monitor and seal all gaps...

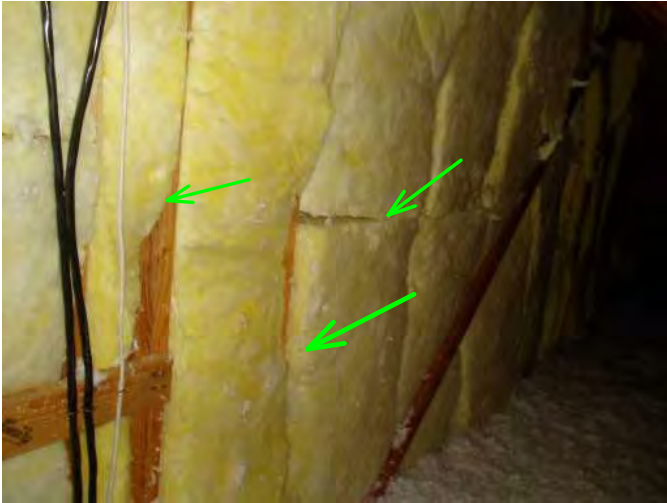
upper walls are batting insulationgood..

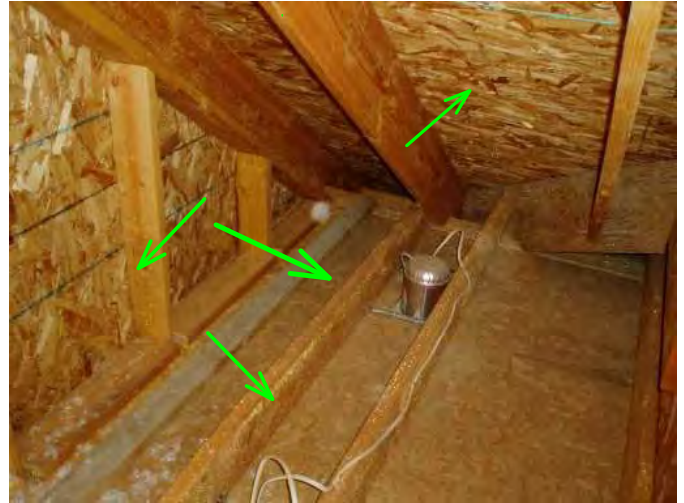
area over porch is not insulated as it is not needed...you can see recessed lights here....fine..

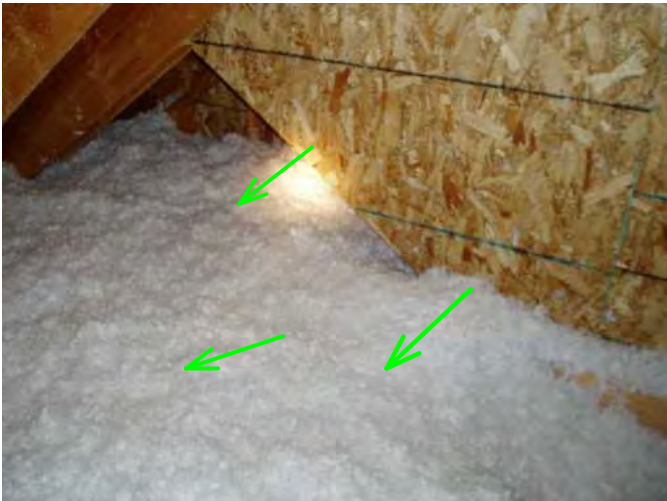
front area over dining room is noted here well insulated...good..

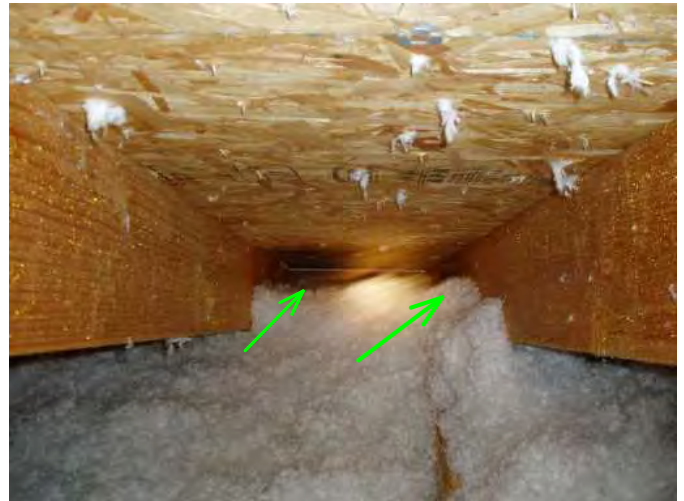
baffles are installed to keep insulation from filling in at vents at soffits...good..

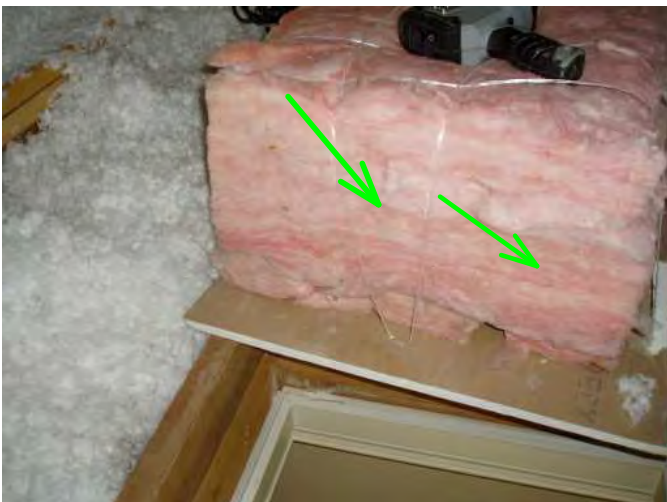
access hatch is noted with batting insulation at about 12 inches....good...

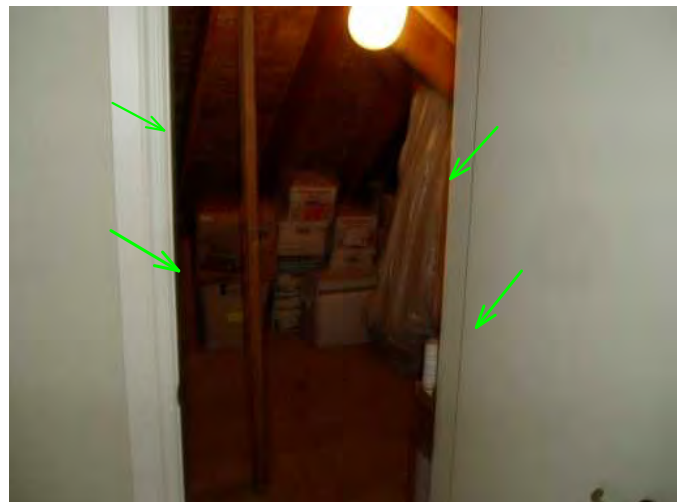
bedroom 2 attic access is noted here and is used for storage area...with lights...good..

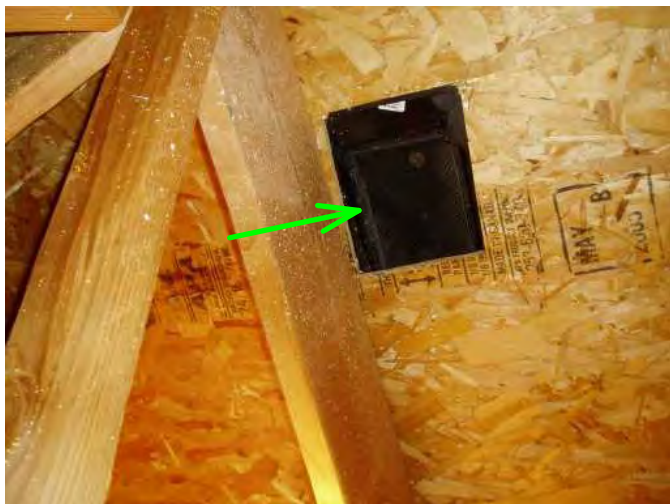
area is vented....good...

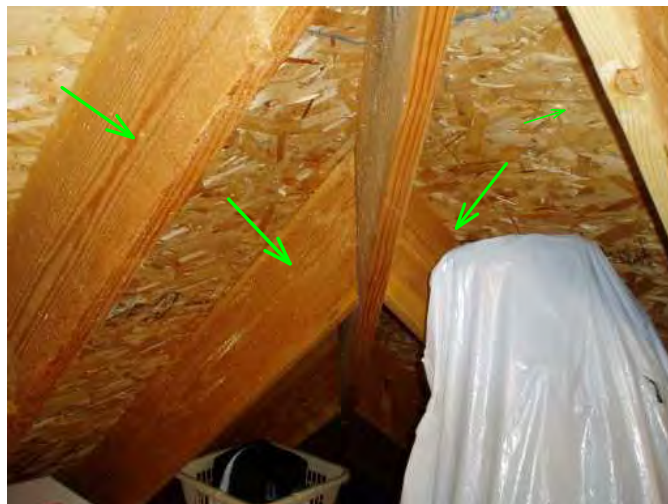
all attic rafters are 2 x 12 and are solid and sound....good..

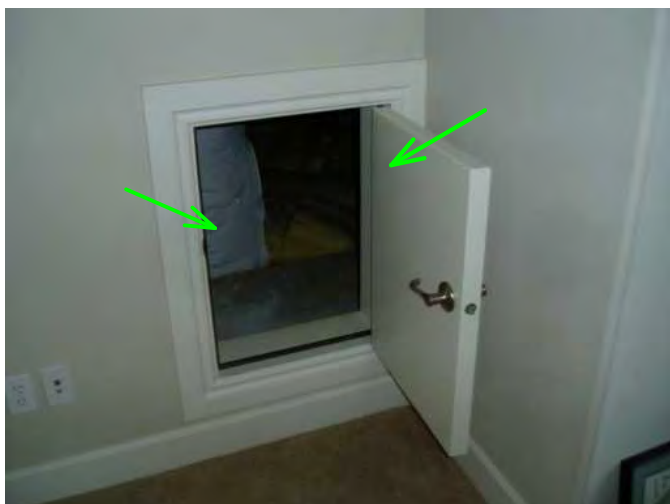
smaller attic access is noted in bed 2 area opposite side....doors are weather strippedgood..

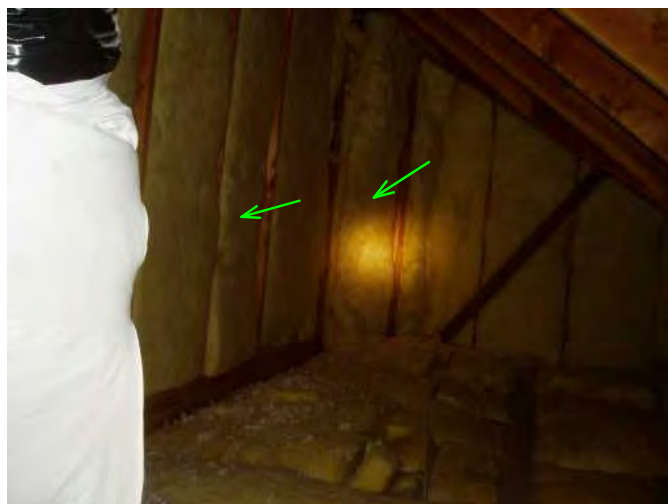
walls in attic here at noted insulated as well..good..

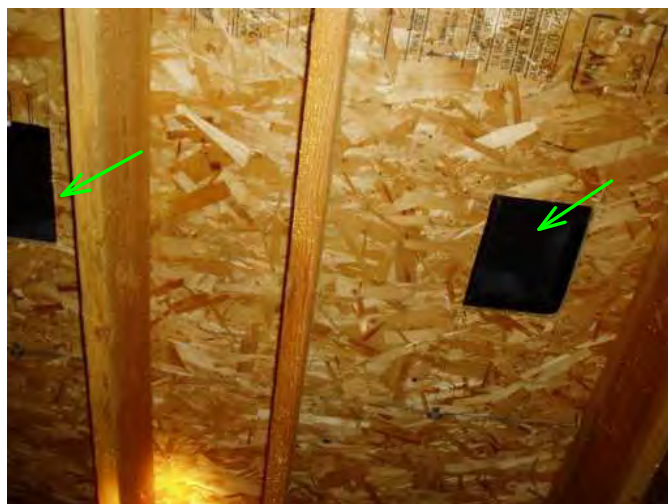
vents are noted here and are fine...good...this is upper attic area over main home area...

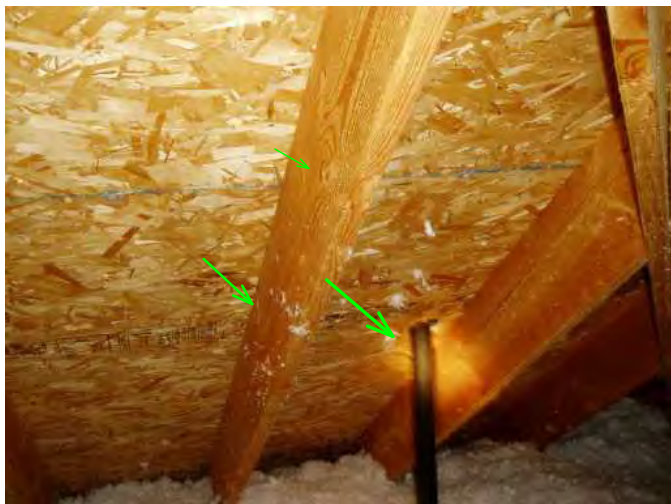
sewer vents are noted here and no staining is noted at intersections...rafters are solid and sound....

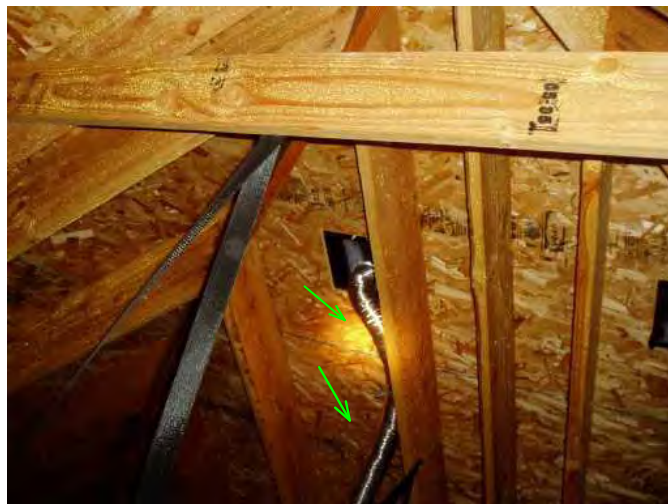
bath vents are vented to outdoors...good..

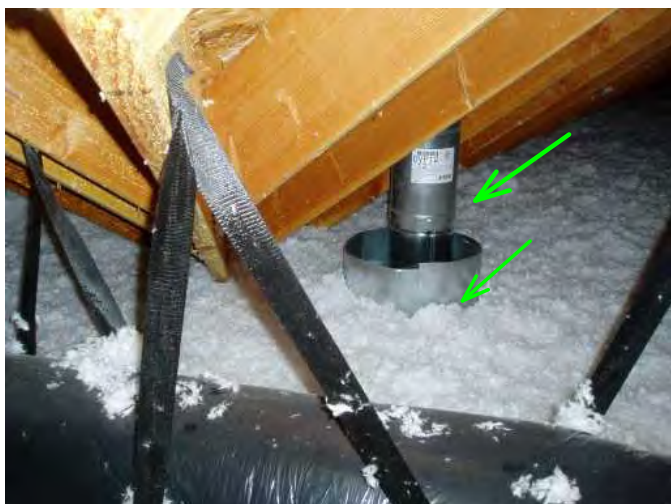
fireplace flue has attic shield to protect insulation...good..

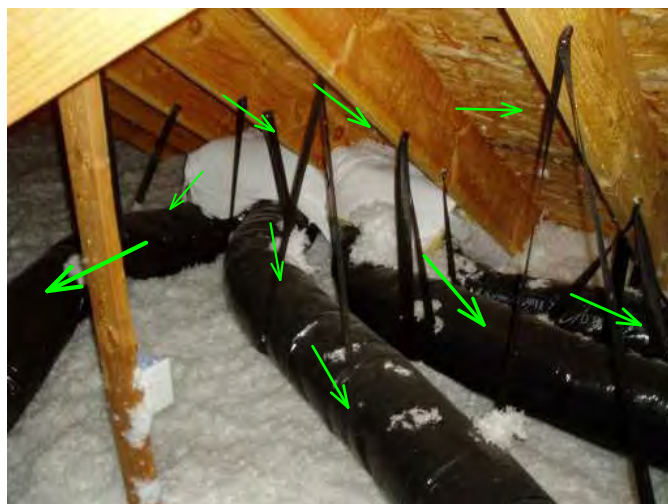
heating distribution ducts are noted here and are insulated flex dcut work....good..see strapping at rafters...is good...

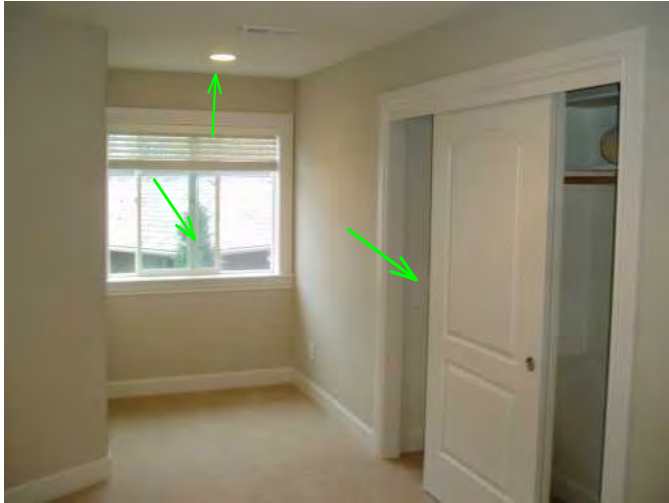
second window and closet doors and recessed fixture are noted operable...good..

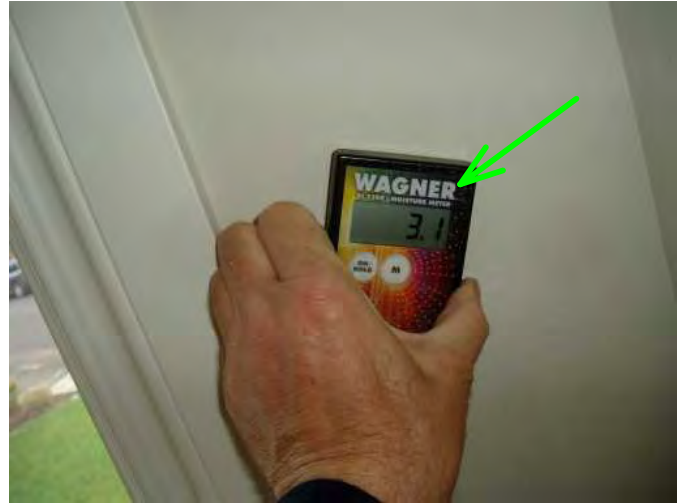
check all exteriors walls around windows and doors and noted moisture is low...very good...20% or higher is issue...

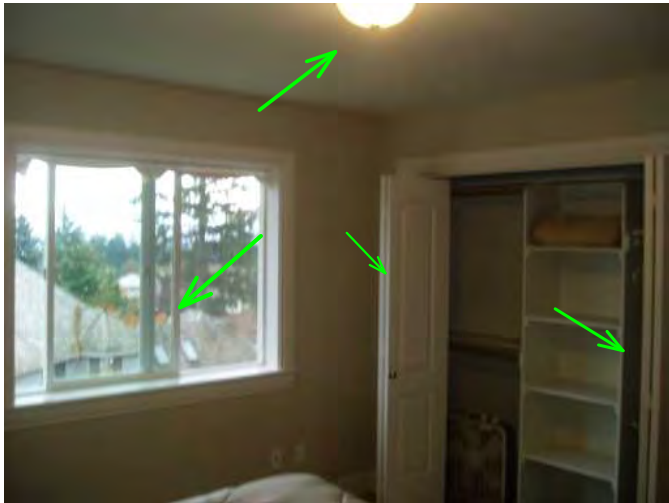
bed 3 window and fixture and closet doors and shelves are operable and solid to walls...

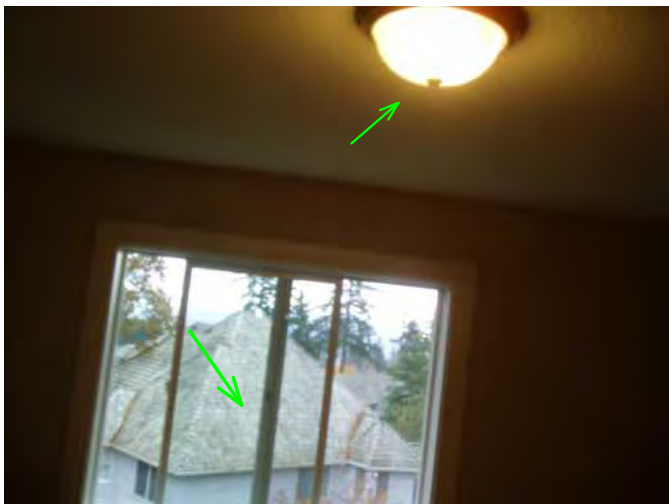
bed 4 window and fixtrue are noted operable...good..

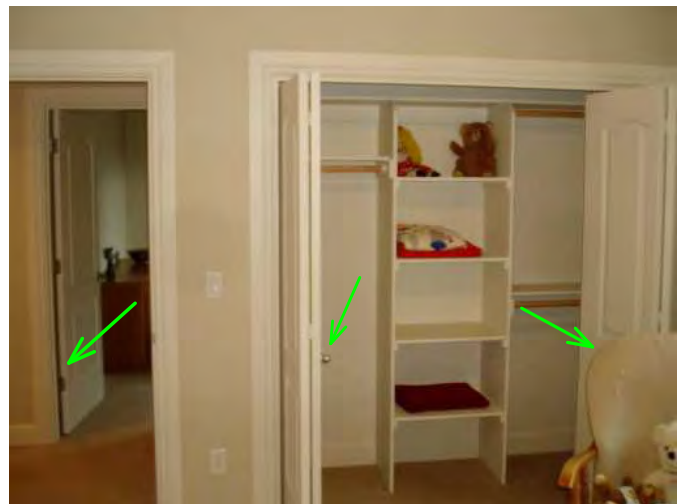
bed 4 entry and closet doors are noted operable...shelves in closet are solid to walls...good..

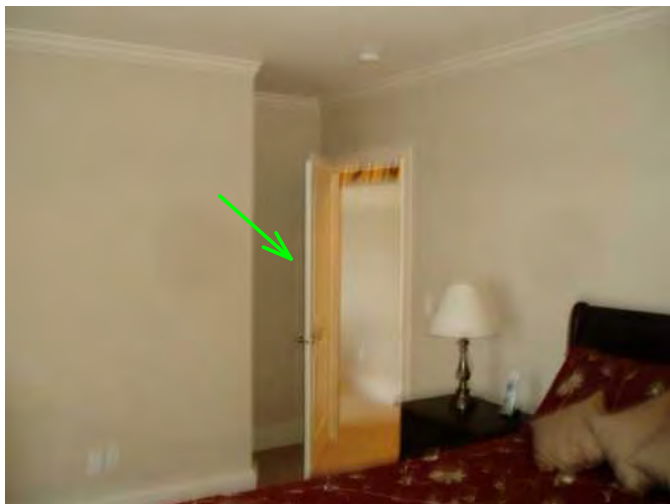
master bedroom entry door is noted operable here...good..

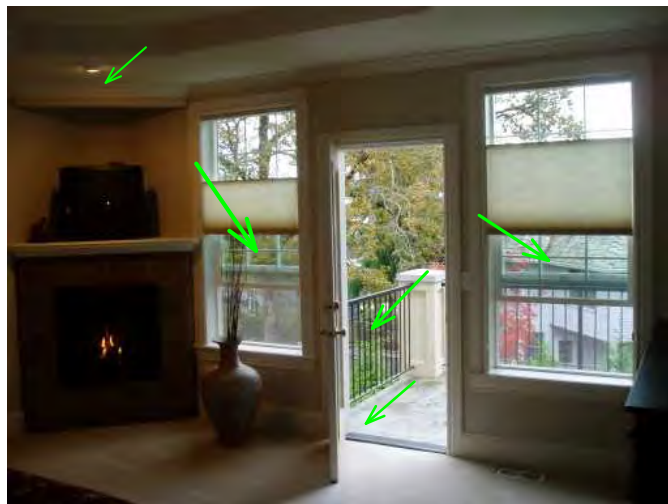
master bedroom exterior door and windows and fixture are noted operable...good...

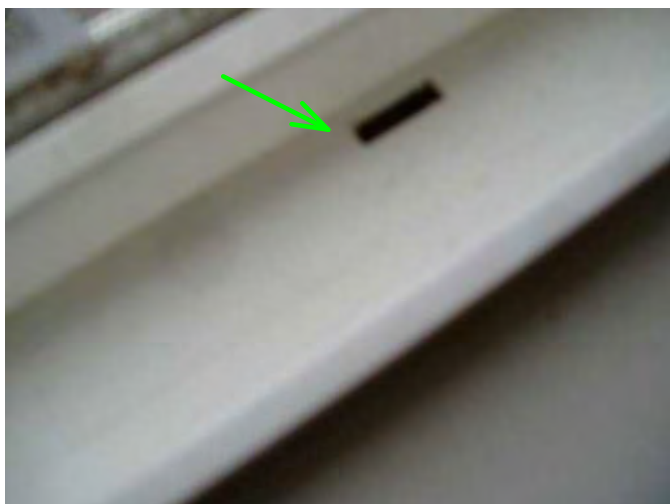
checked all windows to ensure they are installed properly....weep holes at front bottom...good..

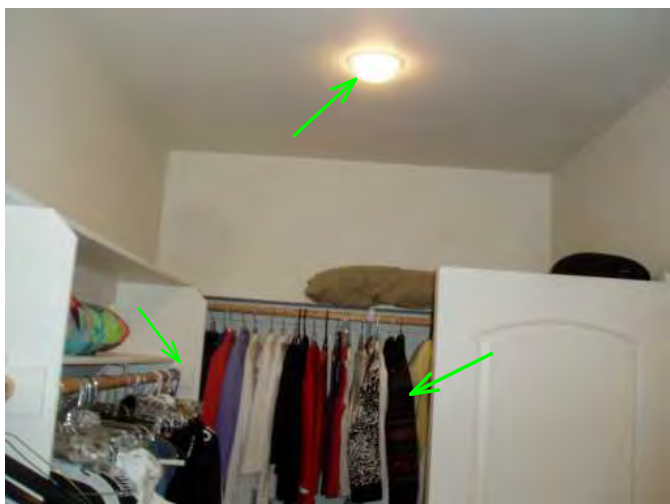
fixtures and closet shelves are operable and solid to walls...

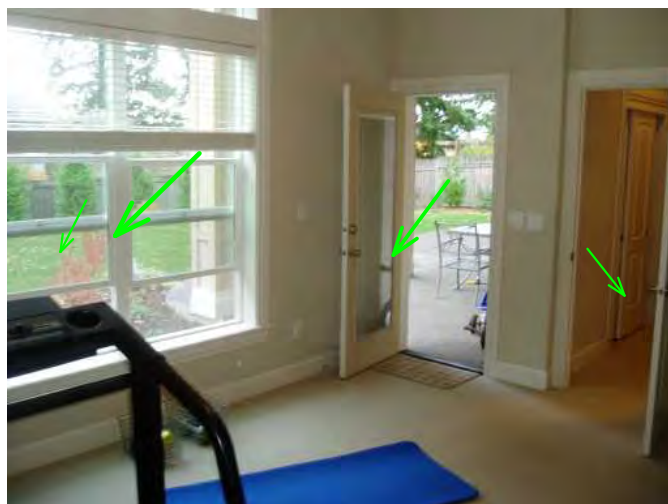
berdroom 5 /den windows and exit door and entry door are operable...good..

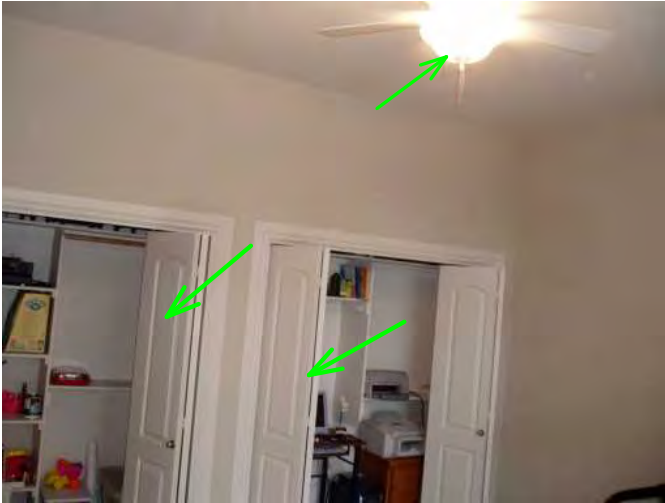
bed 5/ den closet doors and fixture and fan are noted operable..good..

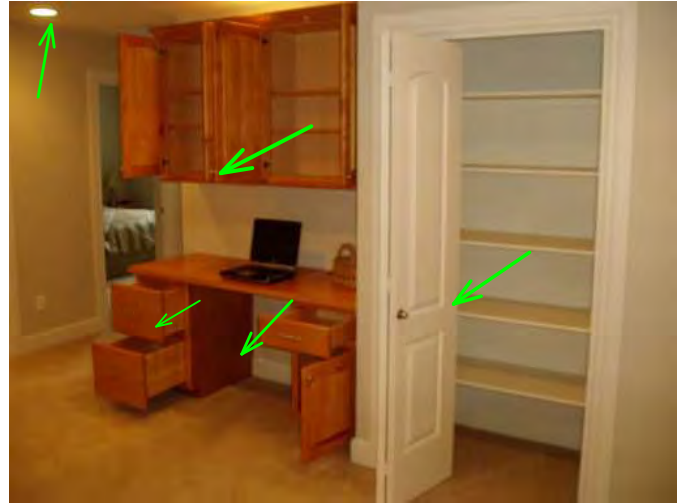
upper hallway study area and closet doors are noted operable as are recessed fixtures...good..

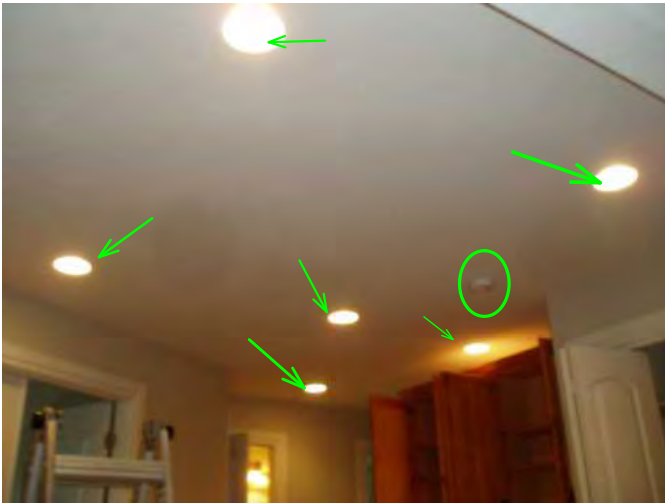
all fixtures are noted operable as are smoke detectors in bedrooms and in hall areas....check batteries often...

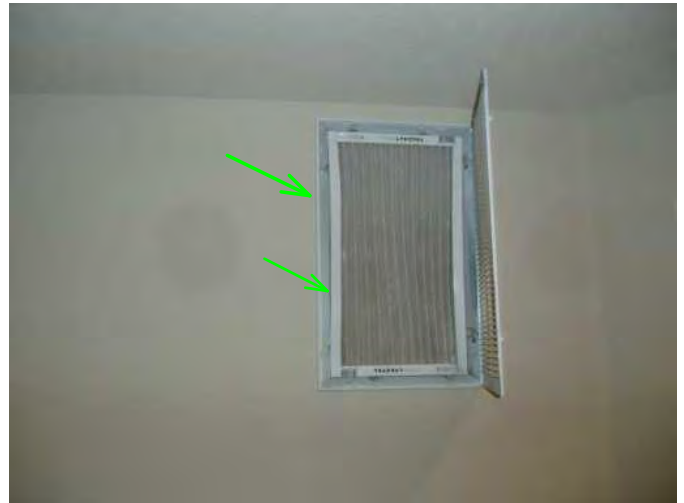
one of two furnace air returns are noted in upper hallway area...change filters every 3-60 days...14 x 24 x 1

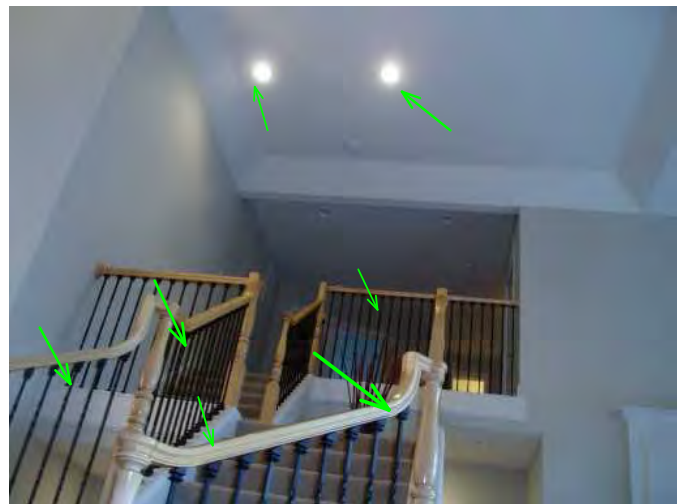
stairway to lower floor main area are noted solid and sound...fixtures above are operable..good.

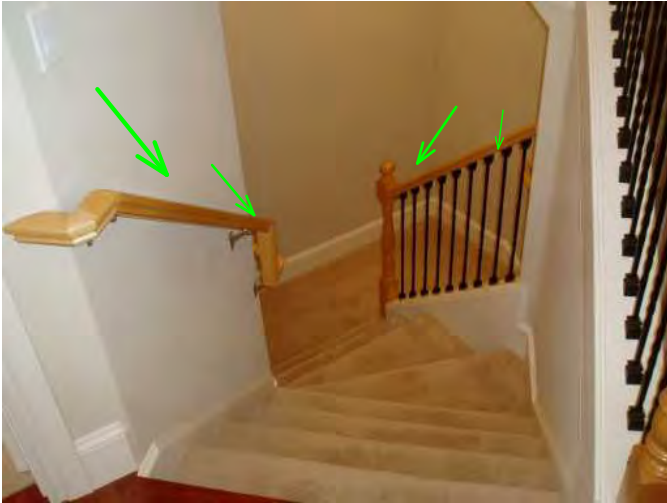
handrails to basement stairtower are noted solid to wall and in center area...good..

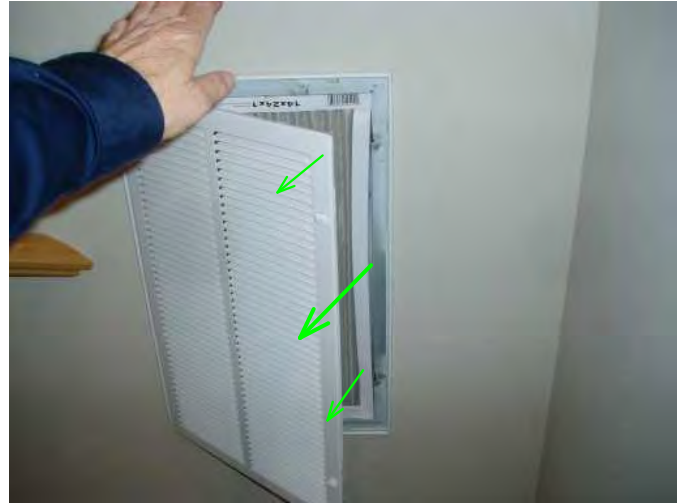
second air return is noted at lower landing to basement area, is 14 x 24 x 1 as well...check and change as needed...
