Home Inspection Report

1936 Sunburst Terrace
West Linn, Oregon

Prepared by: The Home Tester

18:09PM March 14, 2010

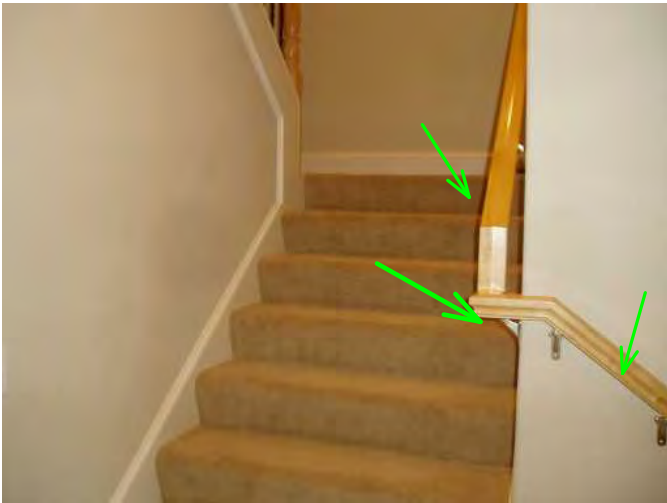
bottom of stairs noted handrails are solid as well...good..

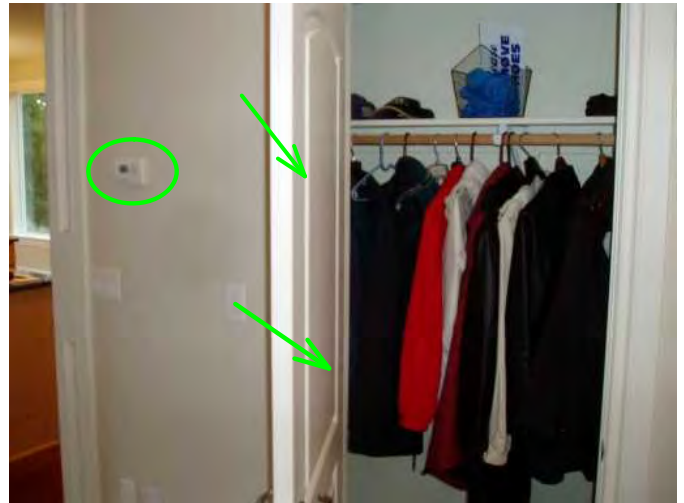
main entry hall closet door is operable...noted main furnace for first and second floor is noted in entry...operable...

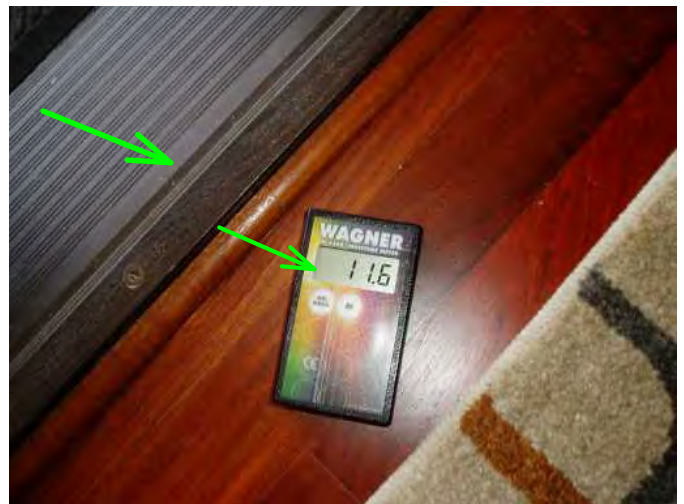
threshold is solid at entry door and floor has good moisture reading....good..

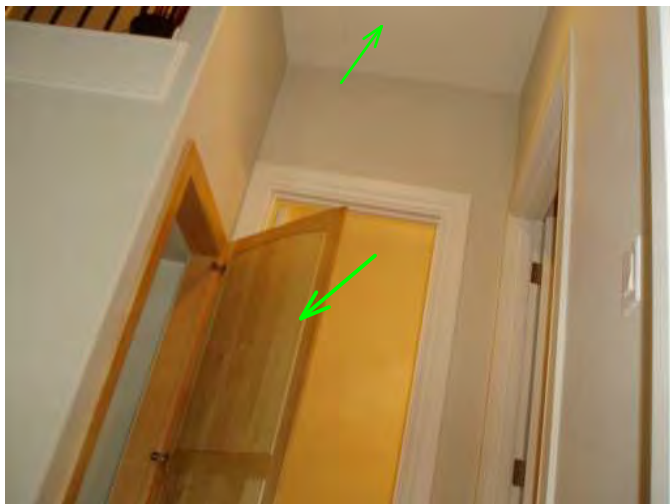
mini hall under stairs closet is noted operable...fixture above is noted operable as well...good..

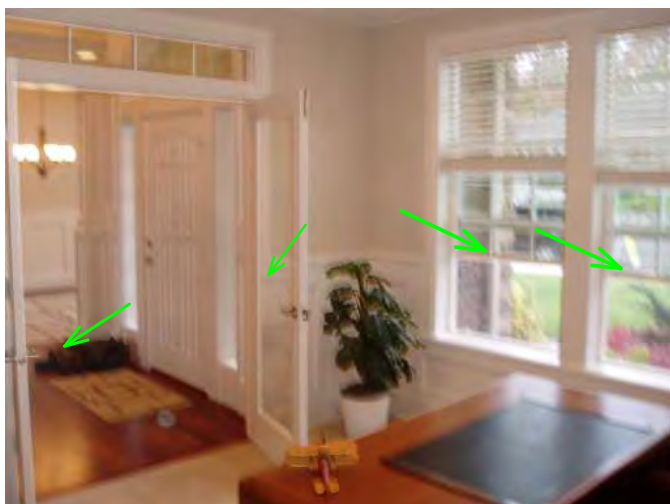
first floor office French doors are operable...and windows are as well...good..

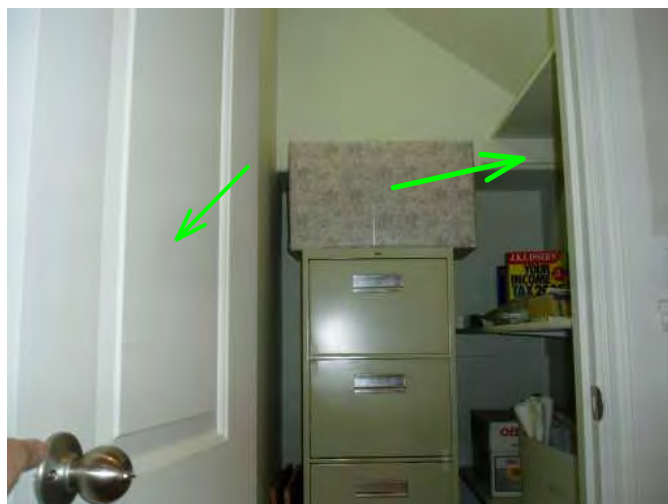
walk in closet in office door and shelves are operable as well...good..

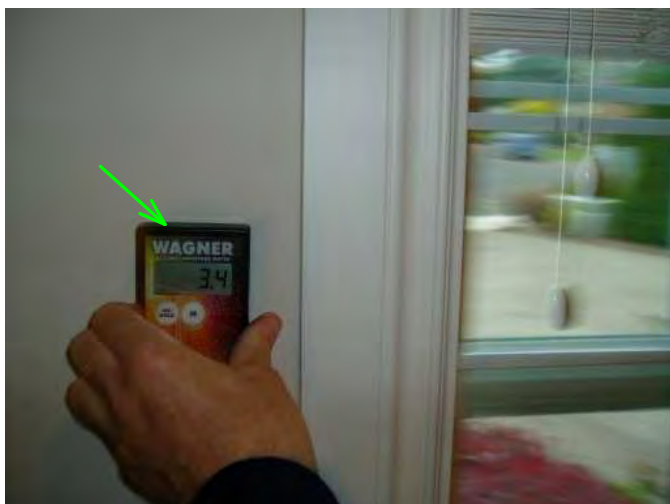
no high moisture noted at exterior wall areas...good..

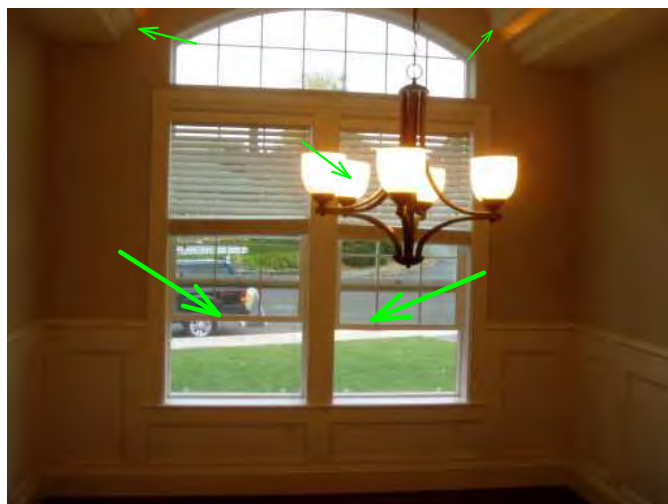
dining room fixture and windows and recessed lighting is noted operable in dining room area...good..

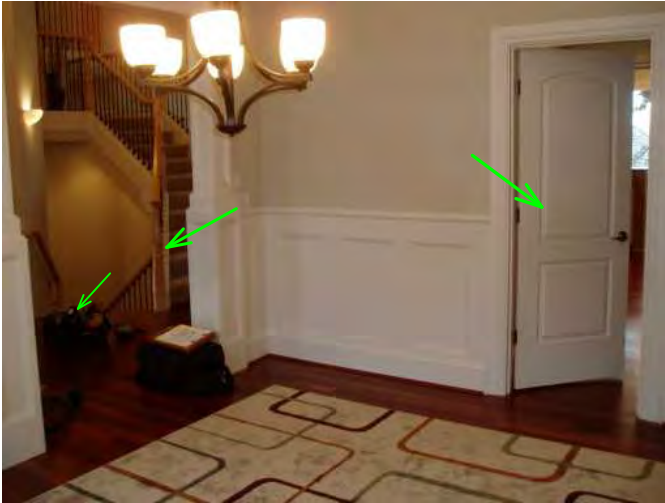
doorway to butlers pantry area is operable..and doorway to entry hall has solid trim noted...good..outets in walls fine...

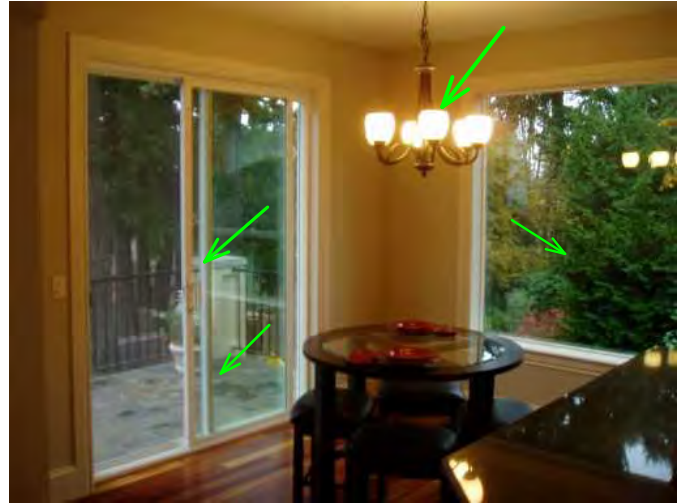
fixture over dining area 1 table is operable...slider to balcony is operable and has screen door...good..

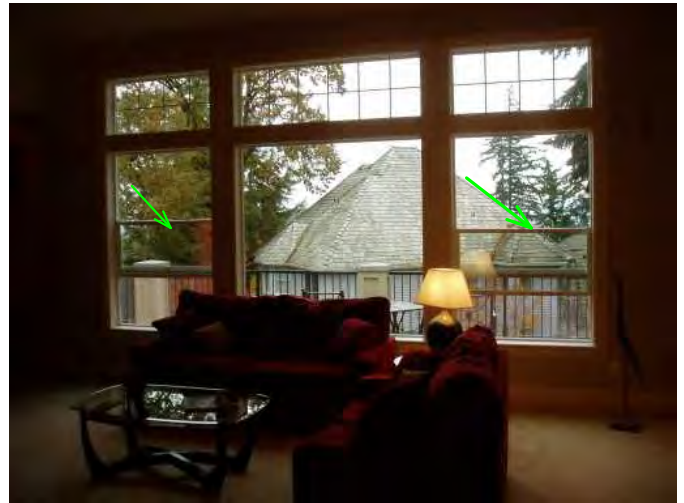
living room windows are noted operable here...good...

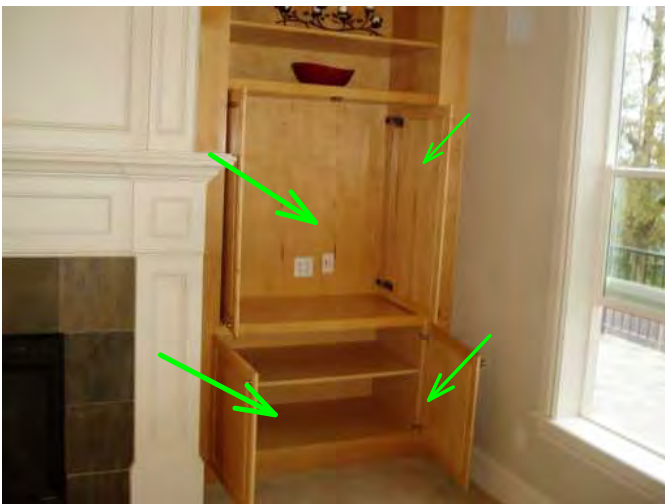
side cabinets in living room are noted operable...good...

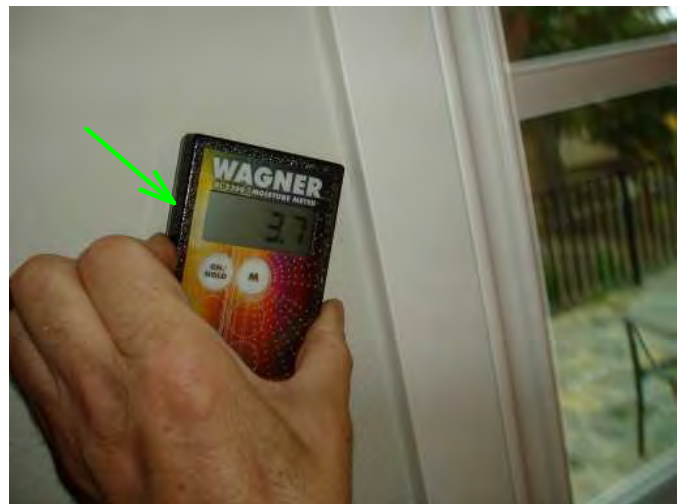
no high moisture noted at back exterior walls noted...good..

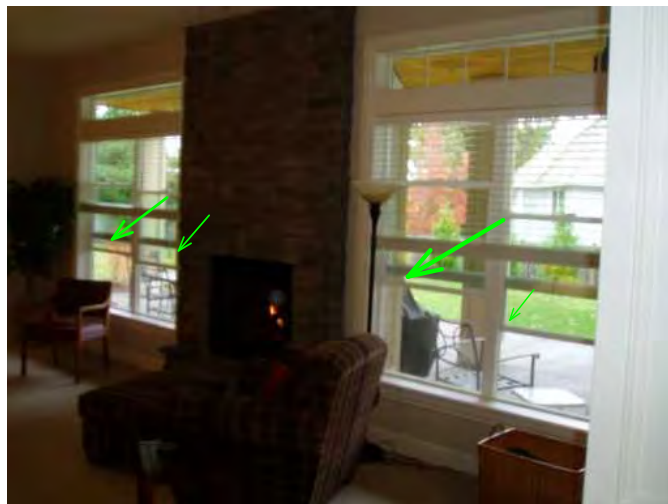
family room windows are noted operable here as well...good..

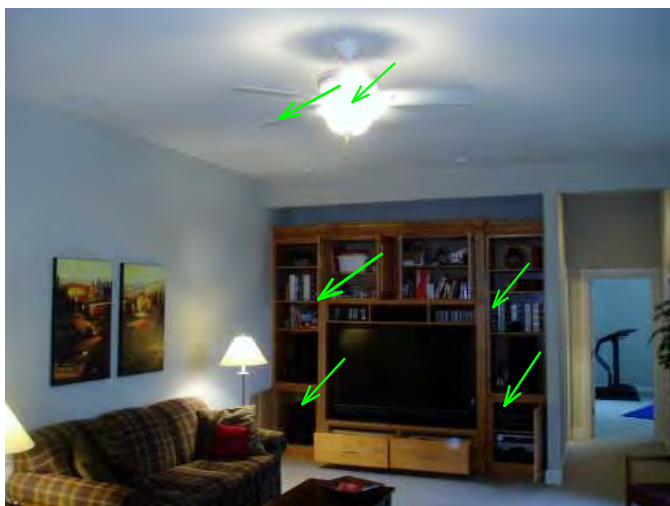
ceiling fixture and fan and wall storage cabinets are noted operable in family room area...good..

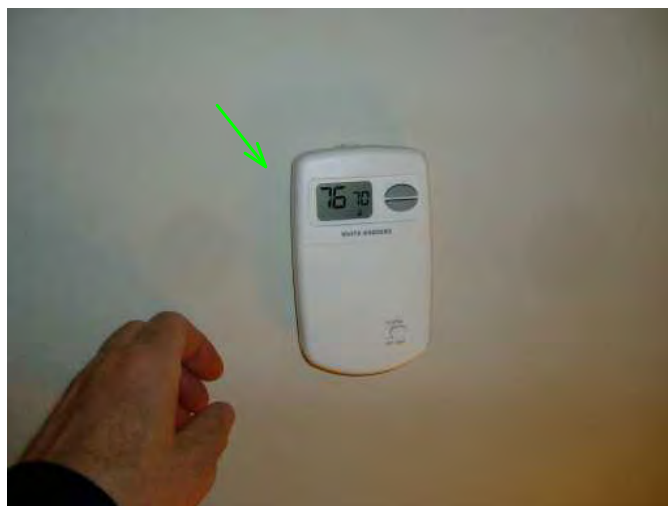
thermostat for hydronic floor heating is noted here in family room ..is operable...good..

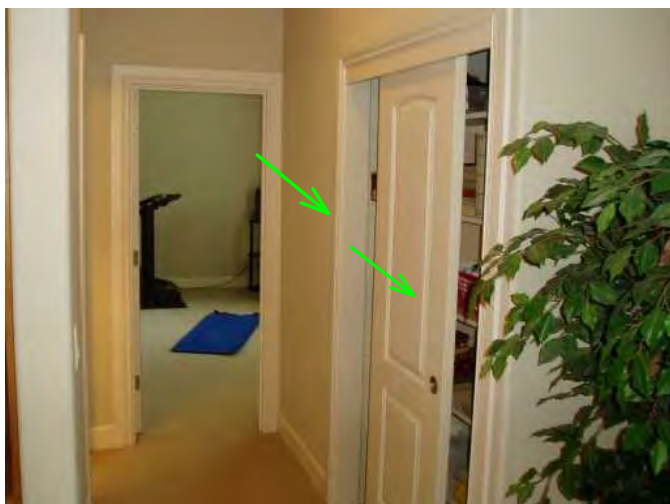
mini closet in family room to bath area doors are operable...good..

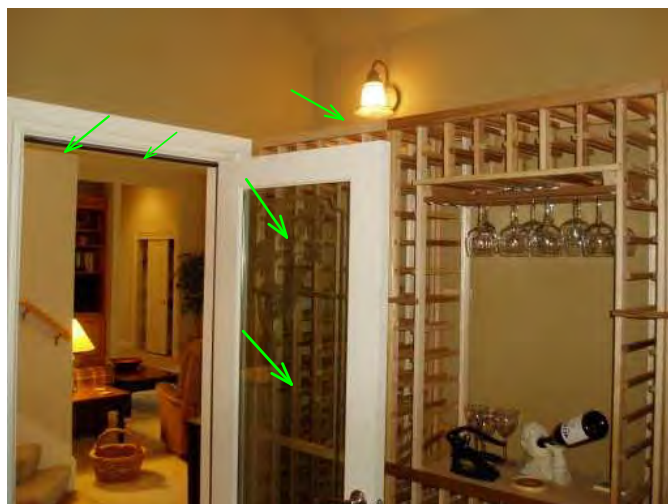
wine room entry door is noted operable and has weather stripping to seal door from rest of home...good..

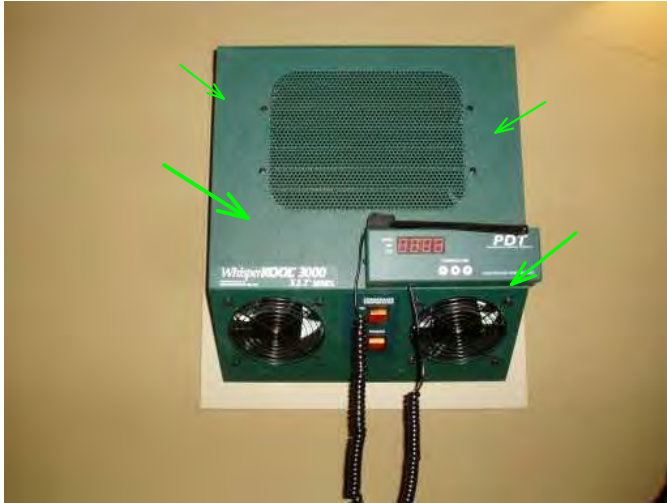
ask for operating instructions for wine room air control system..is vented into crawl space area..fine...keep vents open

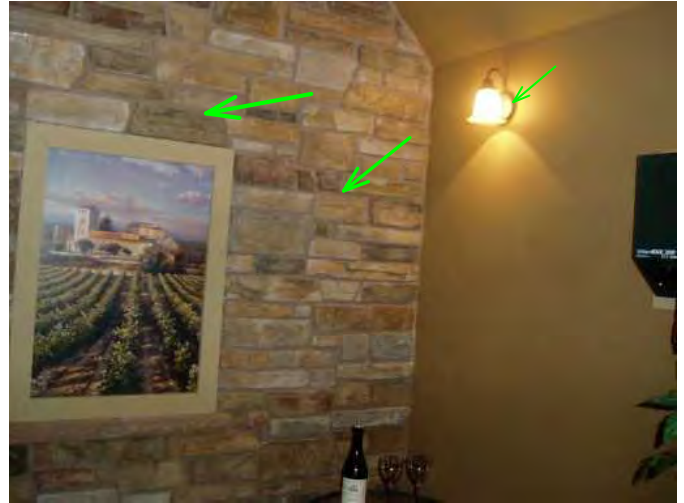
stove veneer and fixtures are operable...and solid to walls...

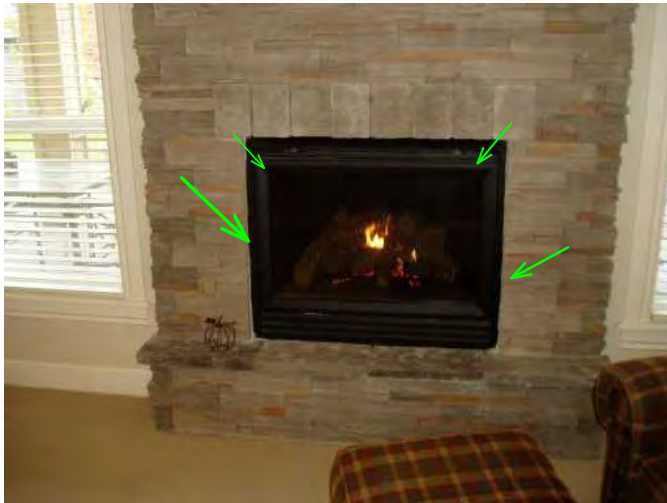
family room fireplace is operable....is fan ready if wanted...no fan noted...

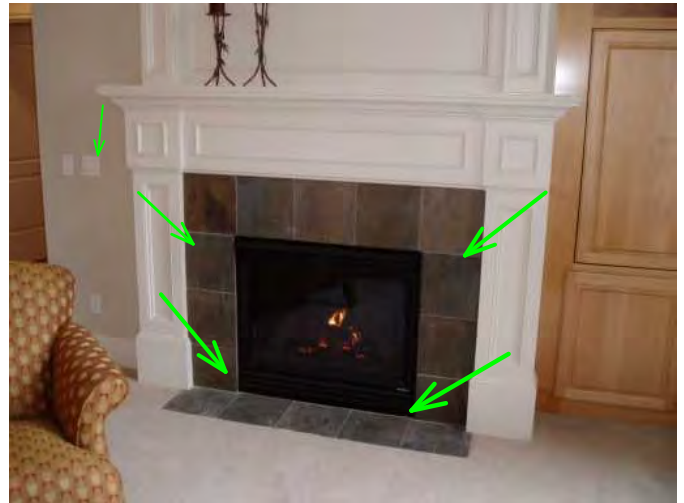
living room fireplace is noted operable...is fan ready... most homes do not have fans in units...can install if wanted...

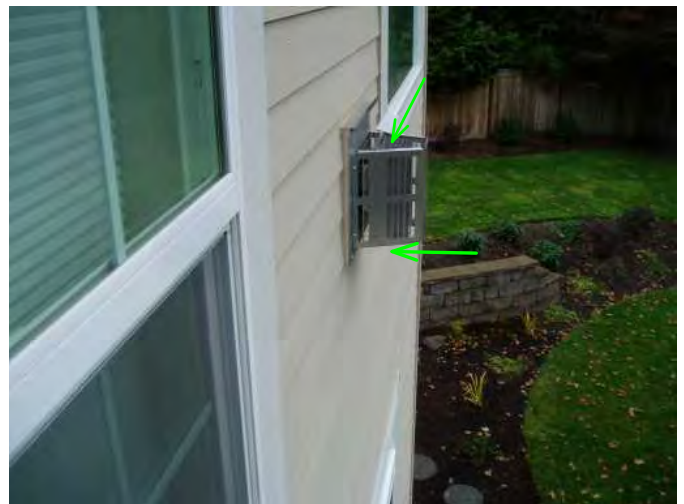
this is direct vent that is for master and family room fireplaces and the living room is roof vented...fine...

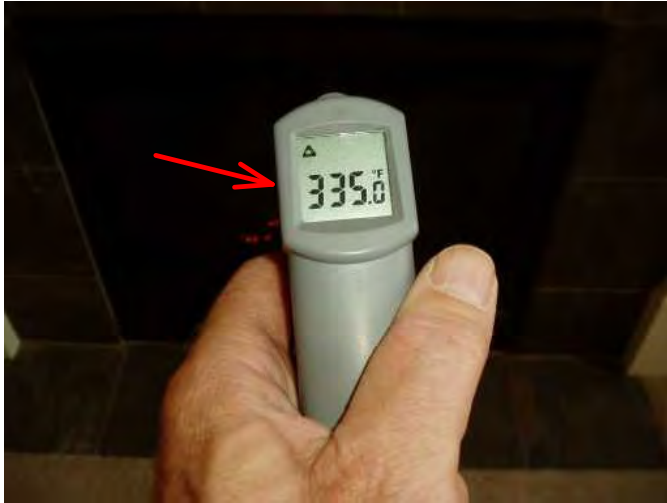
glass on fireplaces gets very hot...be careful...do not touch and clean only when cool...or will break glass....

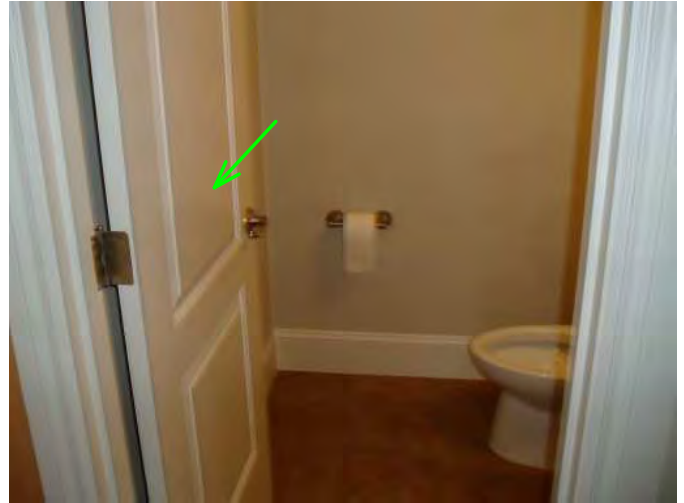
main floor powder bath entry door is operable..good..

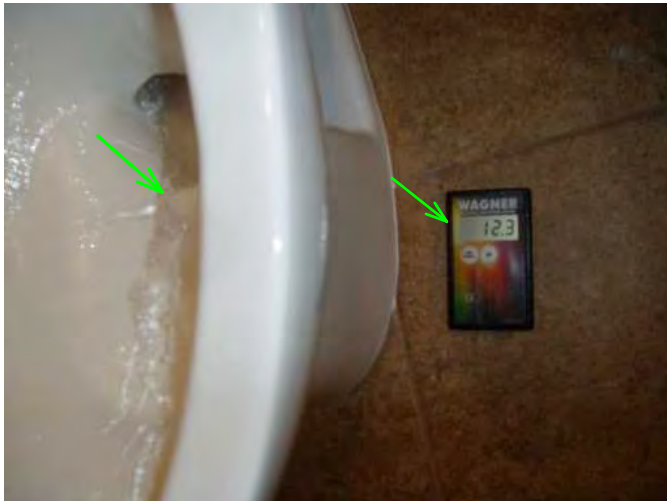
toilet is operable and floor shows no high moisture issues...good..

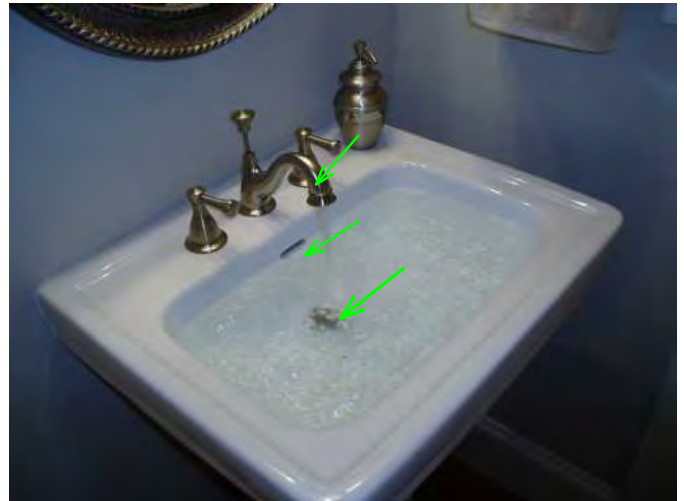
pedistall sink is noted with overflow and drain and faucet operable..good...

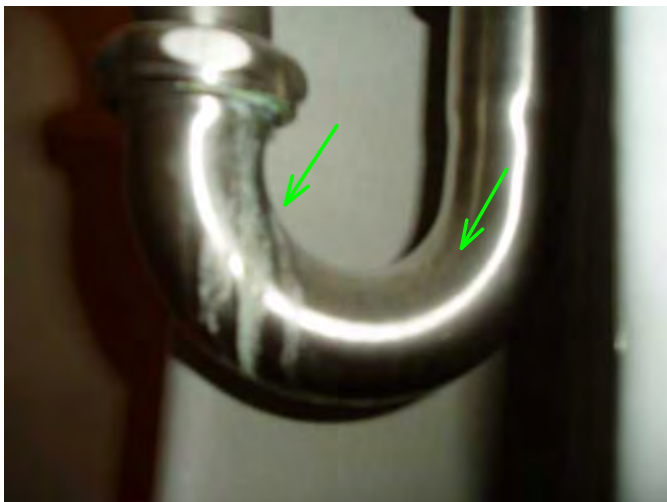
no drips or leaks at trap under sink...good..

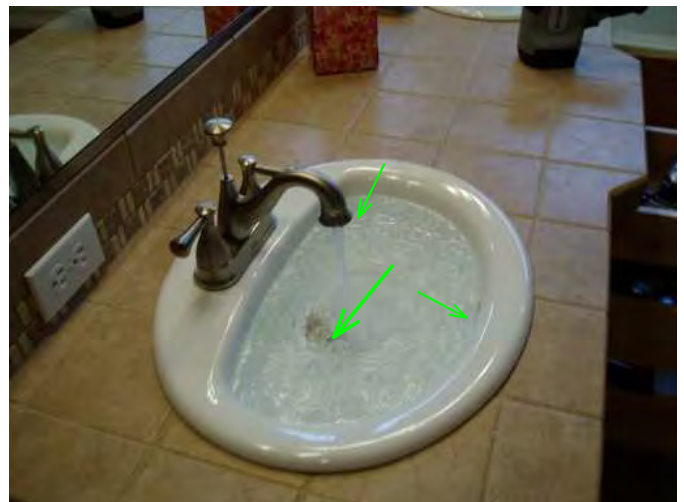
master bath left sink overflow and drain and faucet are operable..good..

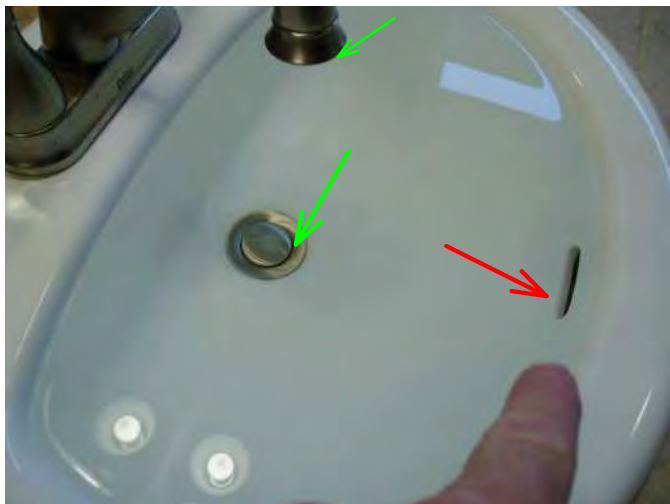
right sink at master bath overflow does not work and will overflow if left..correct drain and faucet are operable....

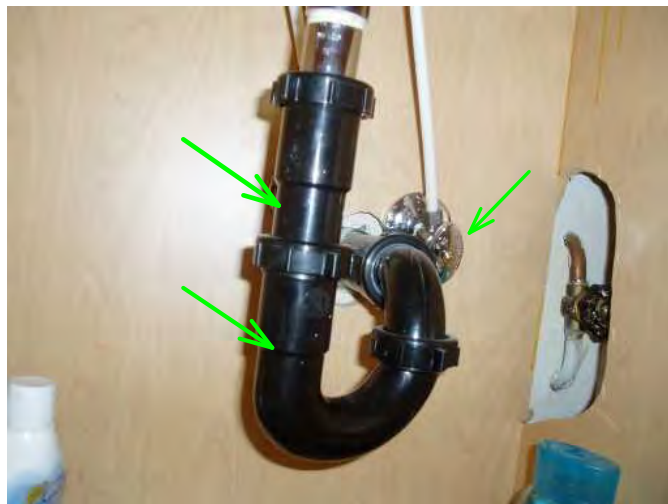
left sink trap is noted with no drips or leaks...fine...

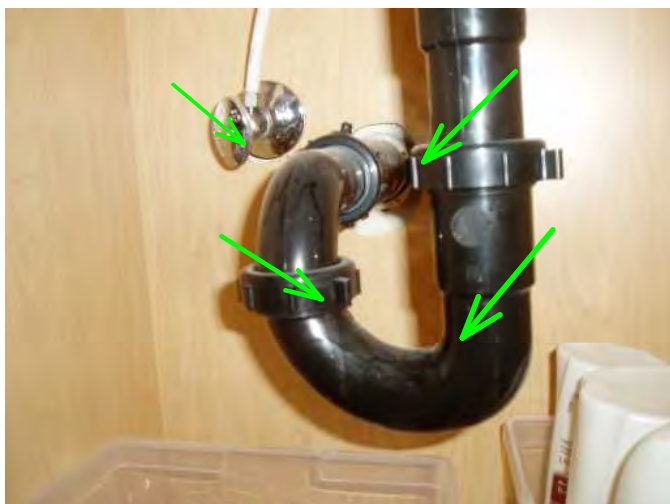
right sink is noted with no drips or leaks...good..

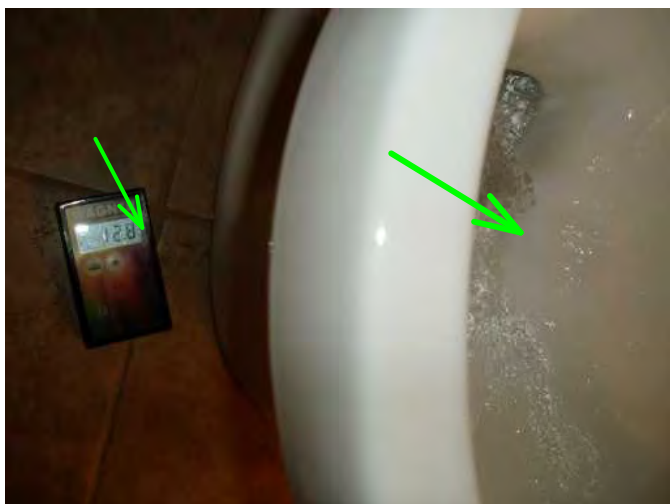
toilet is operable and no high moisture noted at floor area...good..

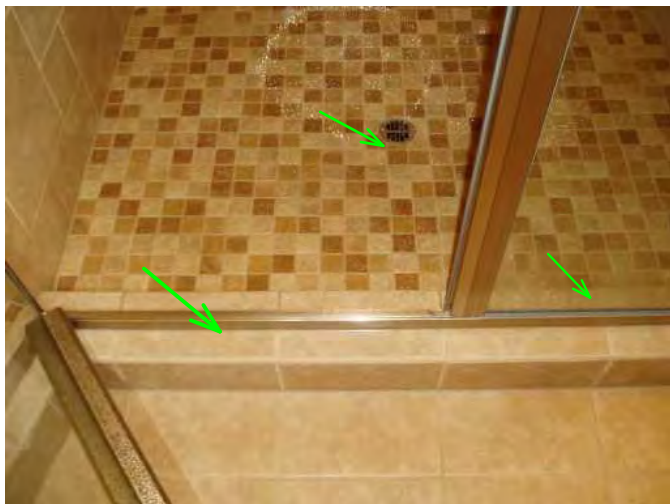
drain to shower is noted operable...ran all faucets in entire home for 2 hours..

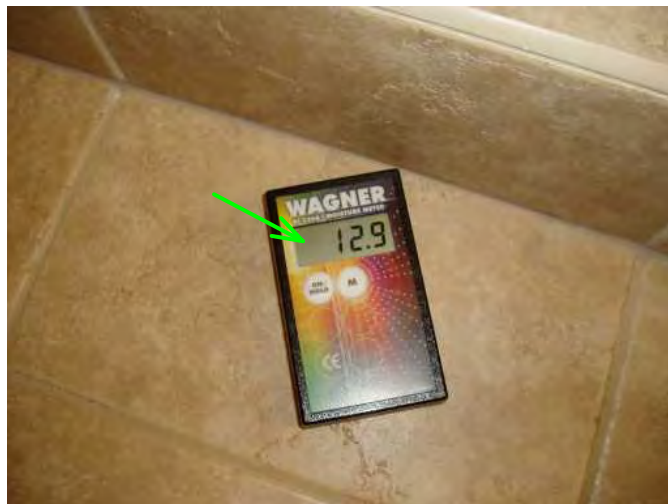
floor at shower area is noted with no high moisture issues at this time...good..

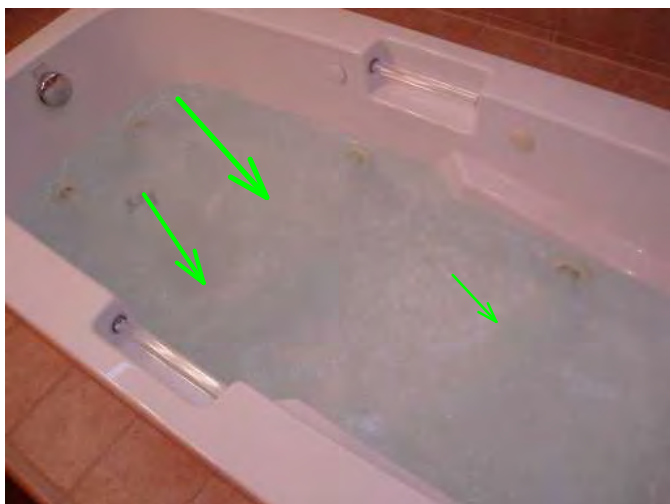
ran spa tub for one hour and all good....

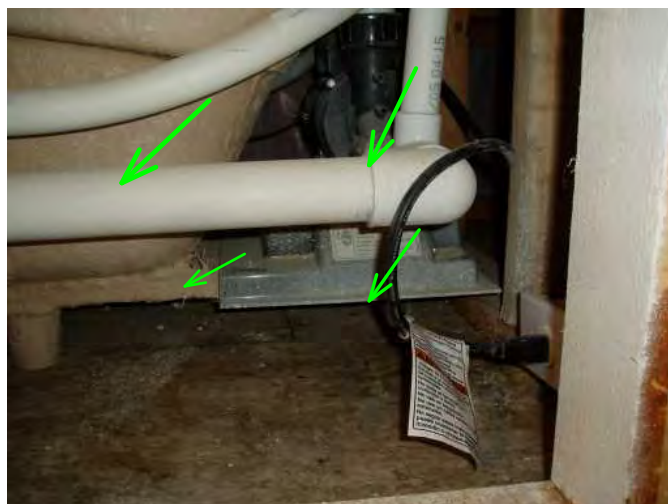
no drips or leaks noted under spa tub noted...good...

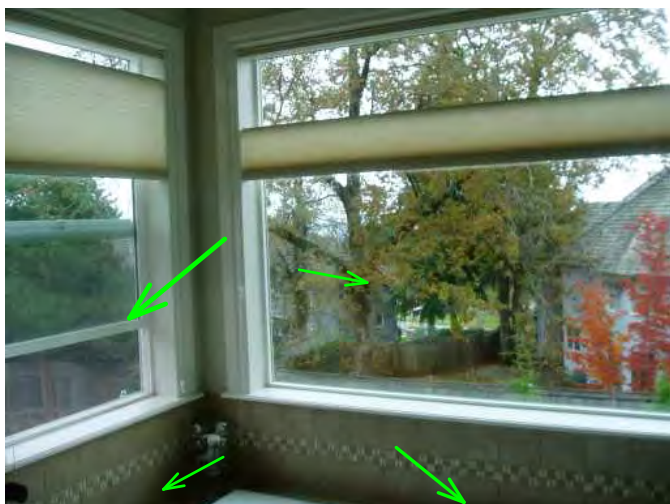
spa tub window area is noted operable...good...grouting around tub is noted fine...good...

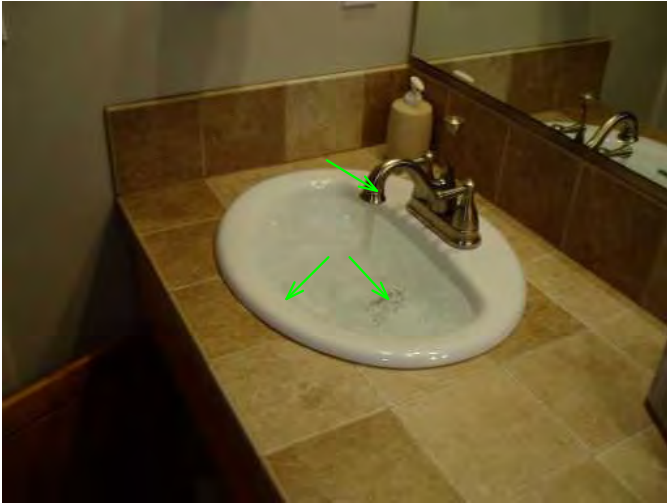
lefts sink faucet and drain and overflow are checked and found operable...good..

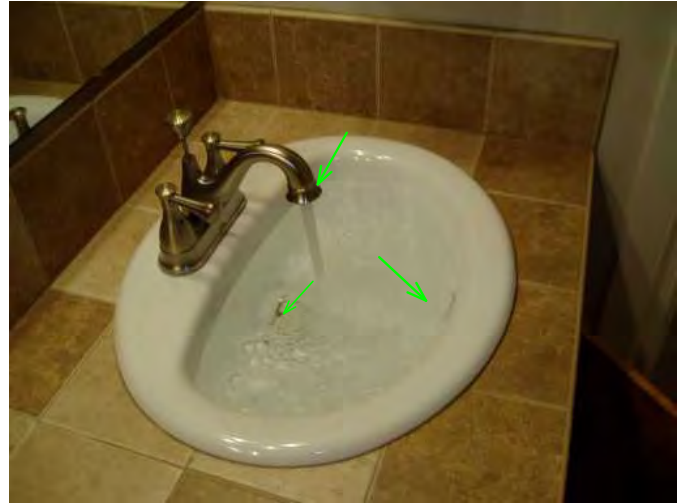
right sink faucet and drain and overflow are noted operable...good..

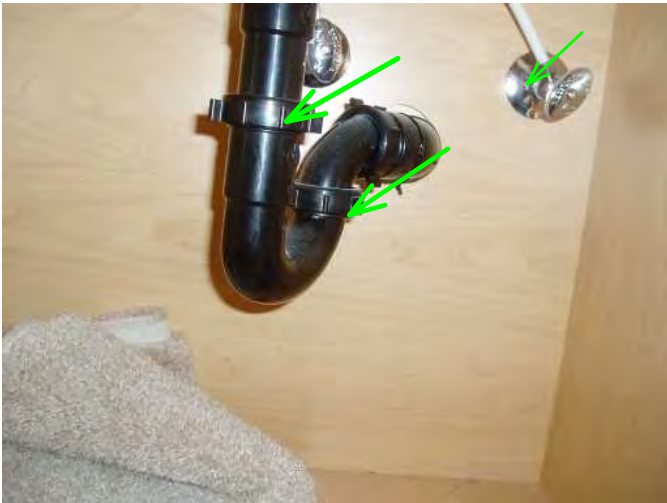
left drain trap is noted operable...good....

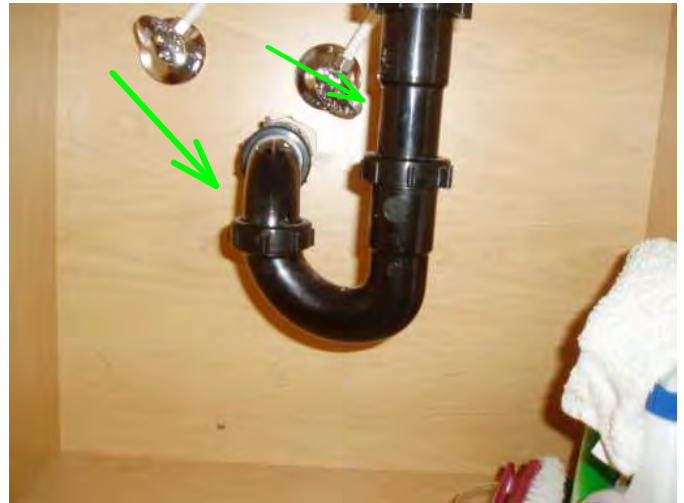
right sink drain trap is noted operable as well...good..

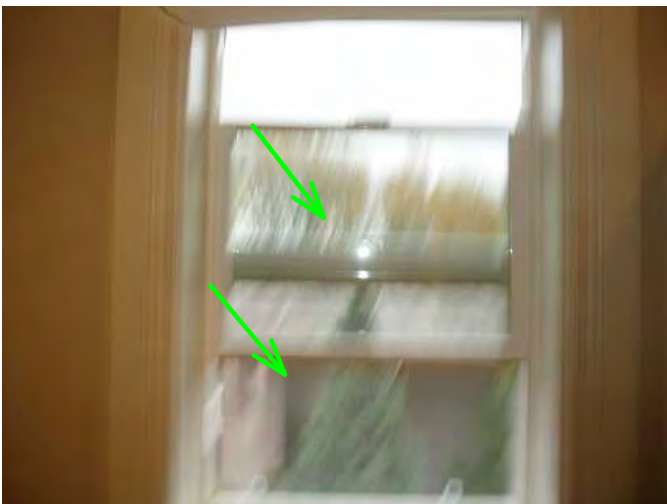
bath window is noted operablegood..

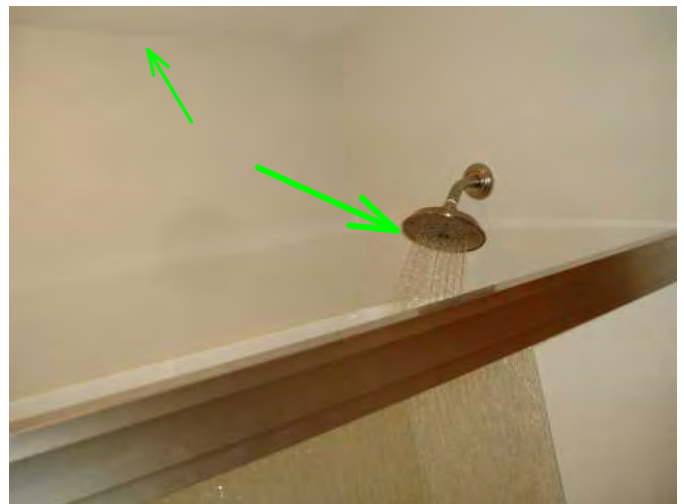
shower head and overhead fixture are noted operable...good..

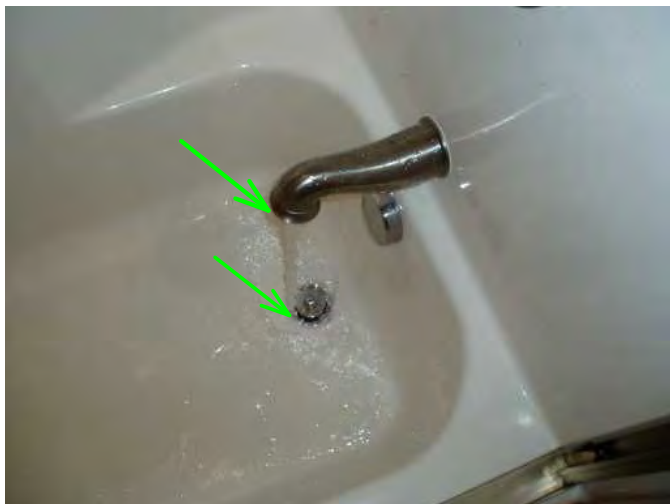
tub faucet handle and faucet and drain are noted operable..good..

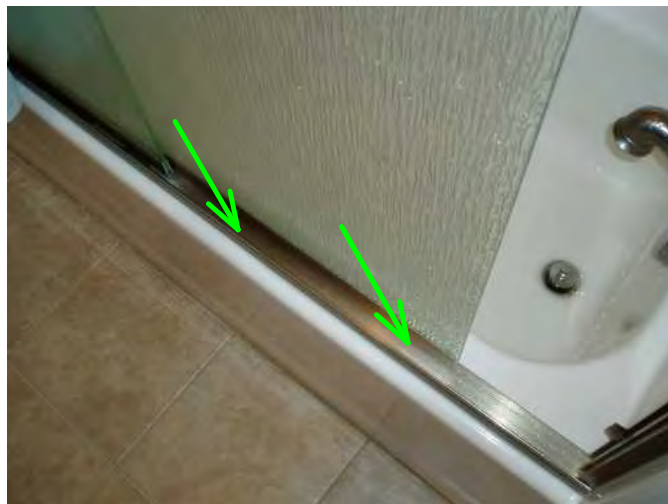
shower enclosure is noted operable..good...

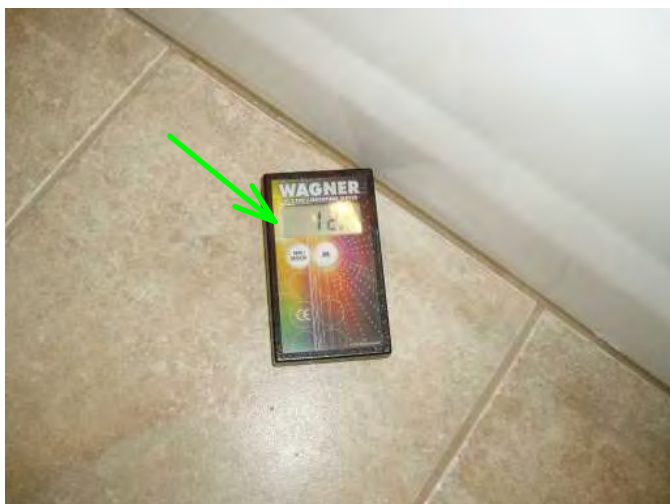
no high moisture at floor at tub area noted....good...

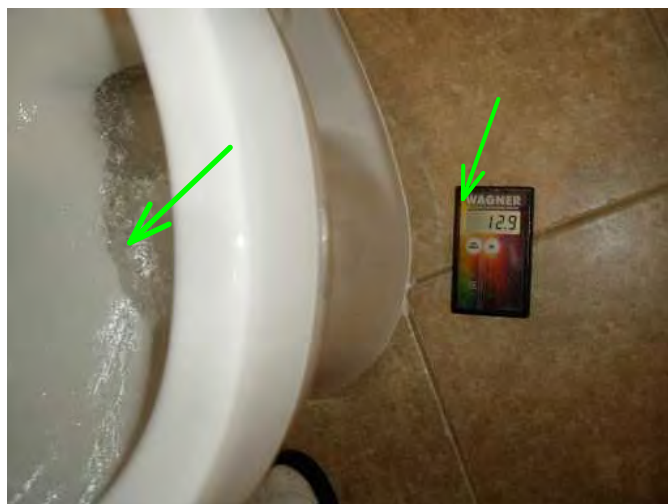
toilet floor area has no high moisture content noted...and toilet is operable...good..

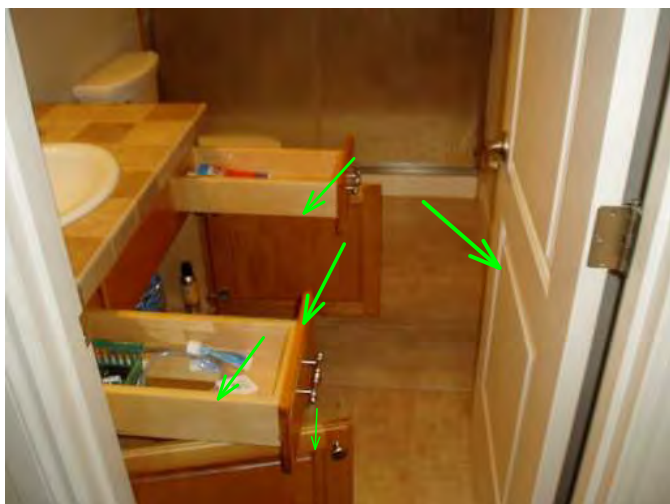
basement fourth bathroom entry door and cabinets are noted operable ...good...

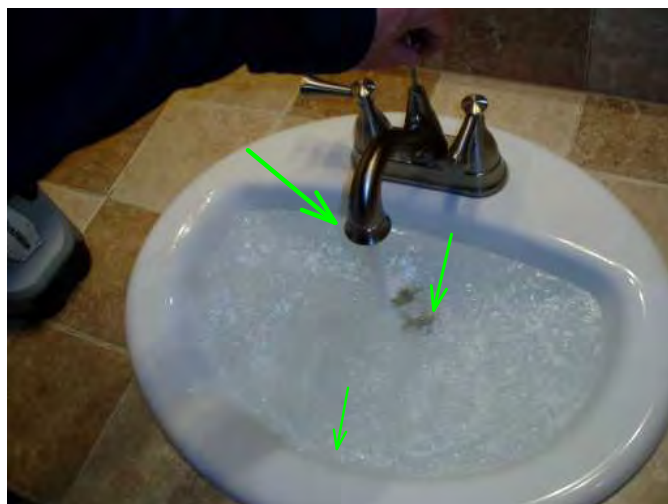
sink faucet and drain and overflow are noted operablegood...

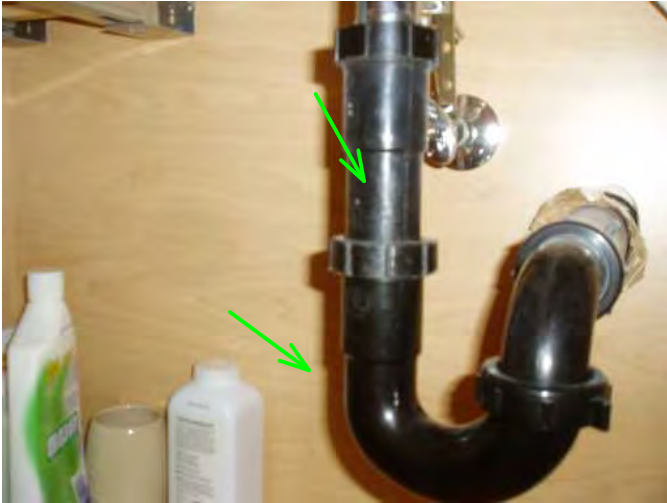
drain trap under sink is noted with no drips or leaks
...good..

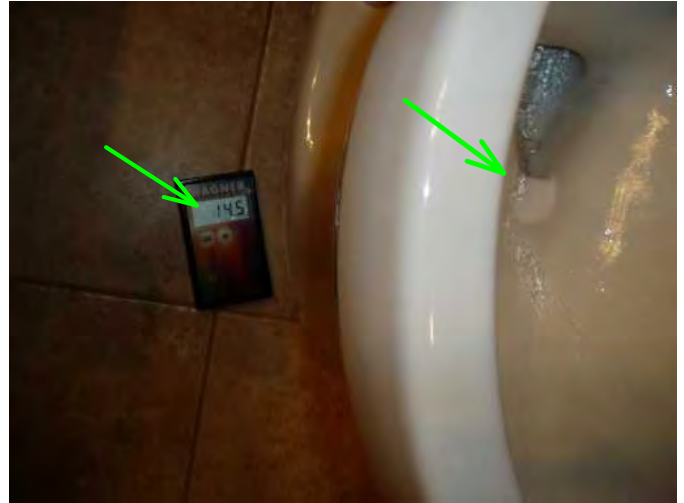
toilet floor area is noted with no high moisture
issues...and toilet is operable..good...

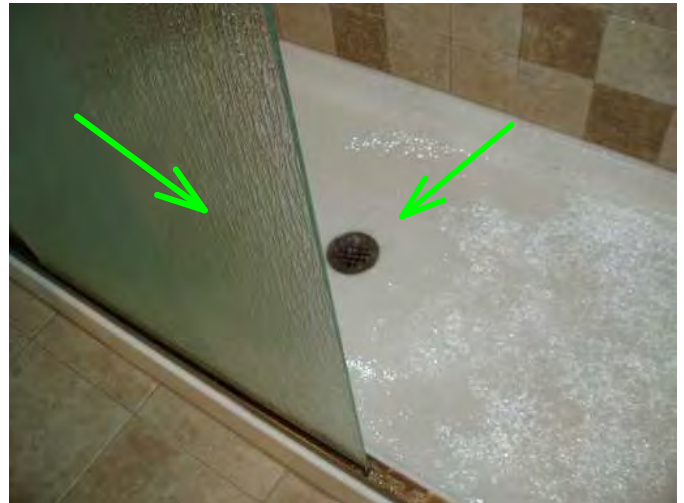
shower drain and pan are noted operable and
solid...slider doors are noted operable..good..

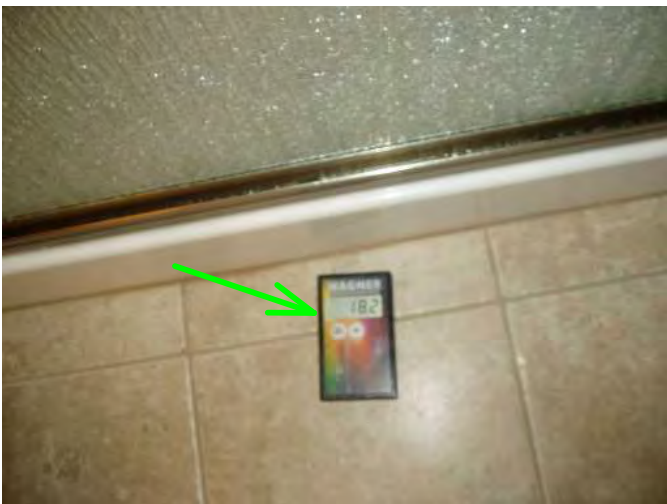
moisture here is fine...reads a bit higher due to
concrete floor under it....fine...

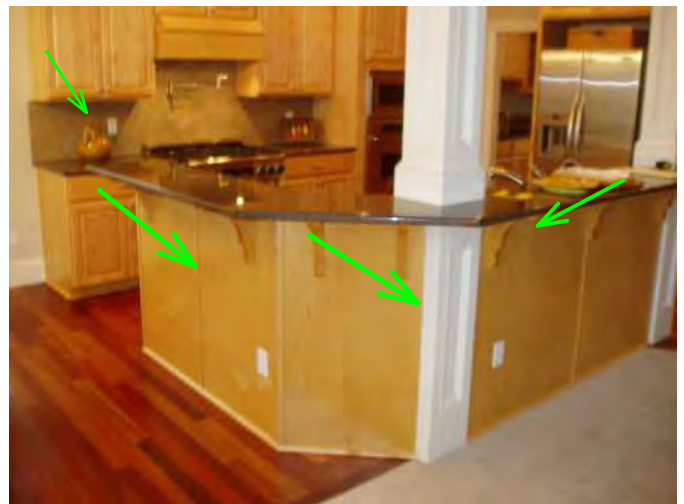
main kitchen area cabinets and bar area are noted
solid and sound...good...

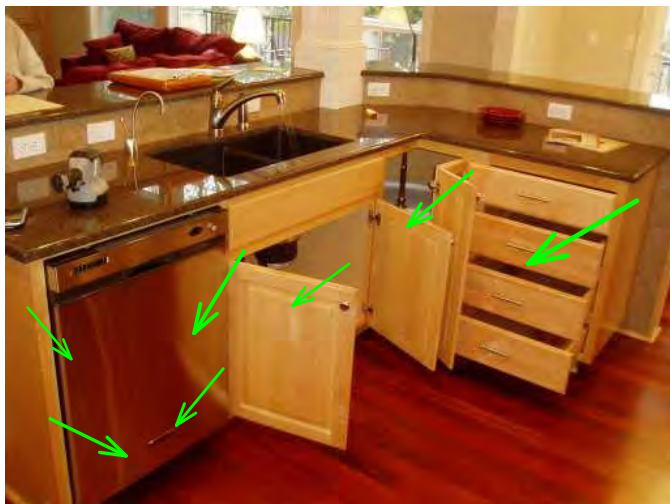
cabinets here at sink area are noted operable..good..ran dishwahser through cycle and is operable ...good...

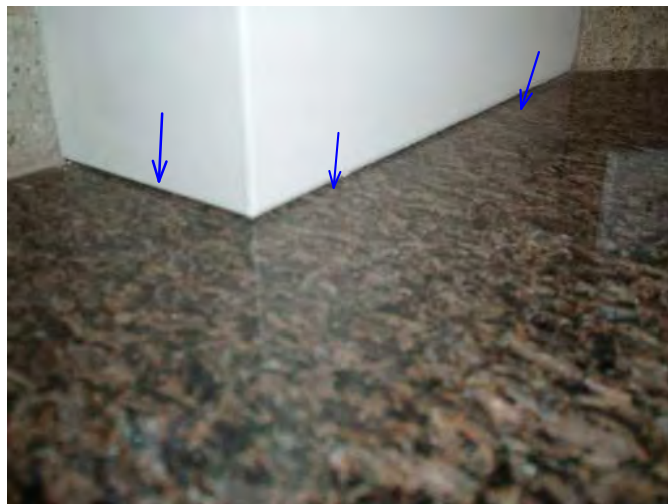
gaps noted around wood trim of columns at counter area and suggest adding grout to avoid build up and trapped water...

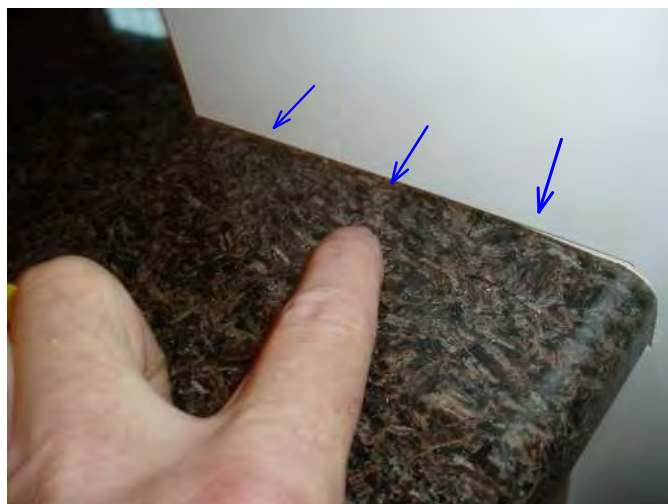
upper areas at bar as well...

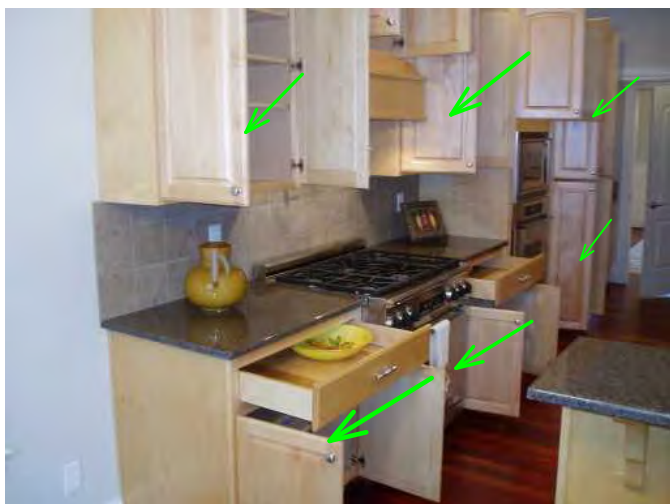
cabinets at outer wall area are solid to walls and counters are solid to cabinets...good...

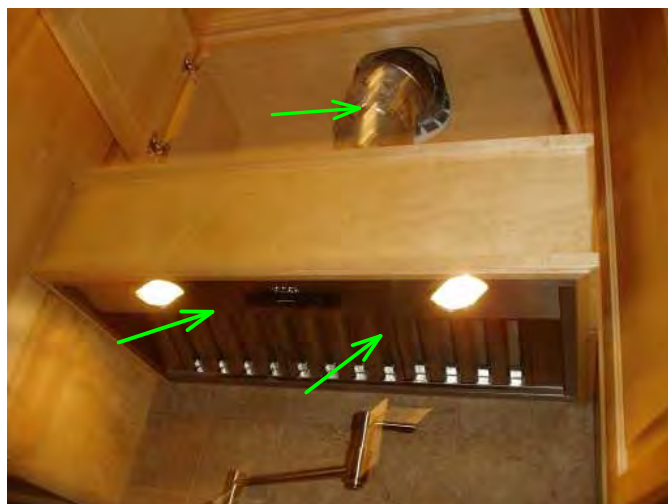
over stove exit vent is operable and vented to outdoors...good...

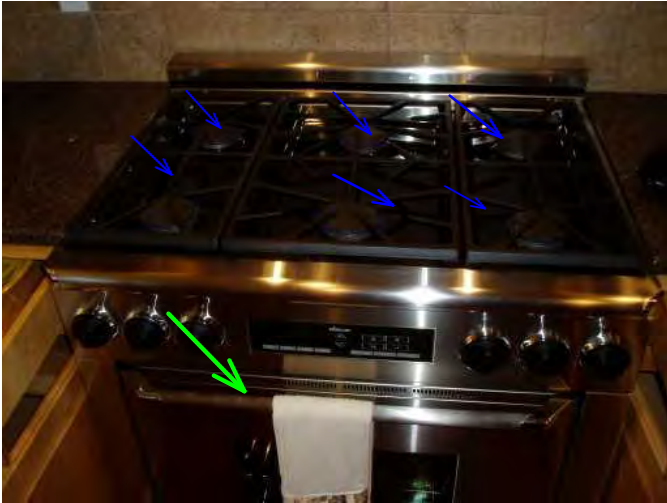
stove and oven are operable...but sparker keeps sparking after all burners are on and in operating positions...correct

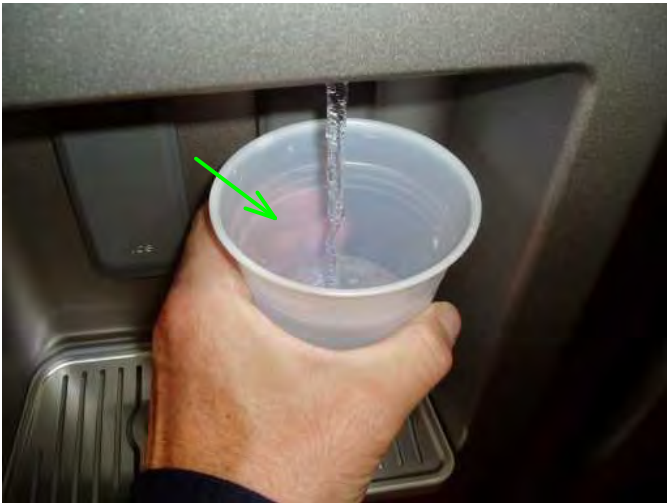
water is operable...but ice maker is not on yet..this kitchen appears not to be in use....

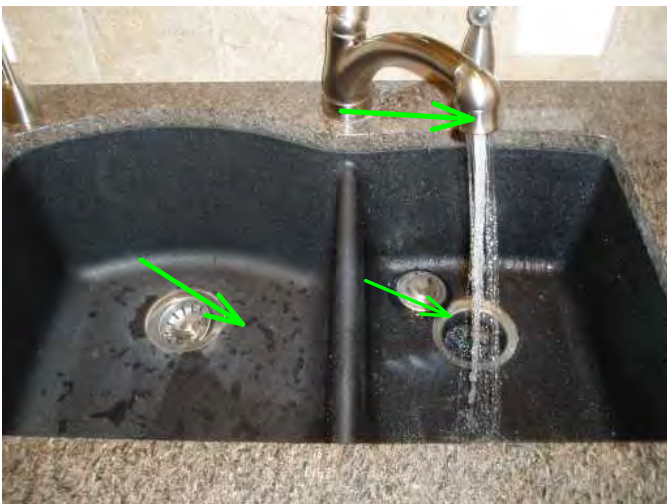
kitchen sink and faucet are operable..good..

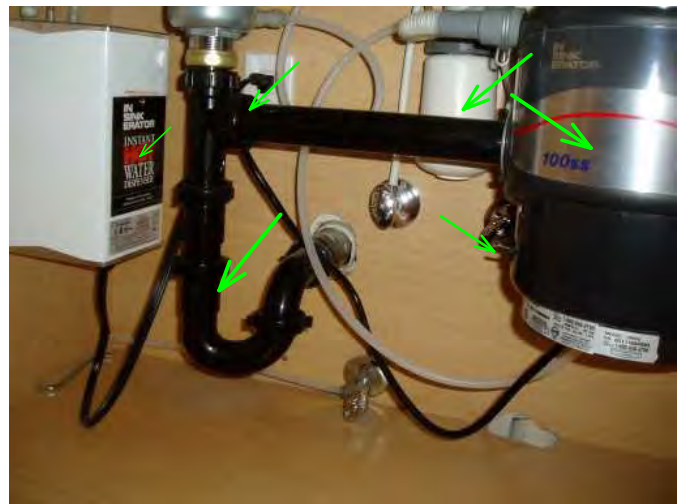
no drips or leaks noted under sink and hot water dispenser is operable and garbage disposer is operable as well..good..
