Home Inspection Report

1936 Sunburst Terrace
West Linn, Oregon

Prepared by: The Home Tester

18:09PM March 14, 2010

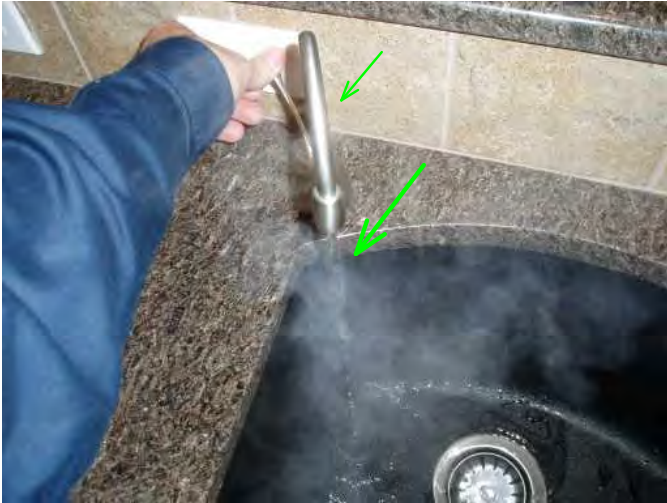
ran hot on demand...good...

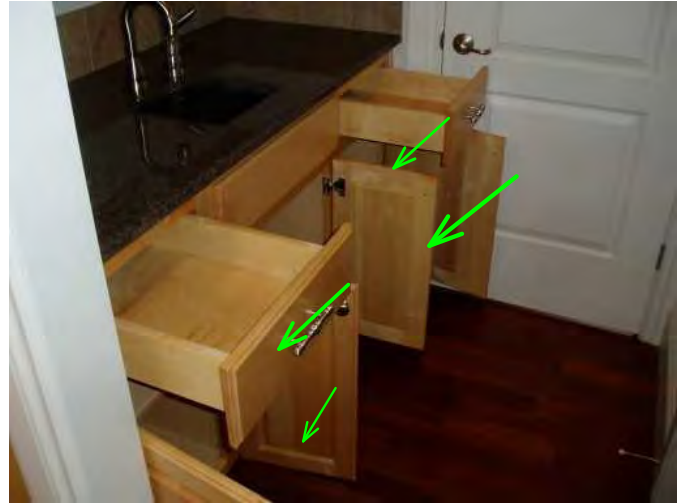
butlers pantry l;ower cabinets are noted operable..good..counter is solid to cabinets...good...

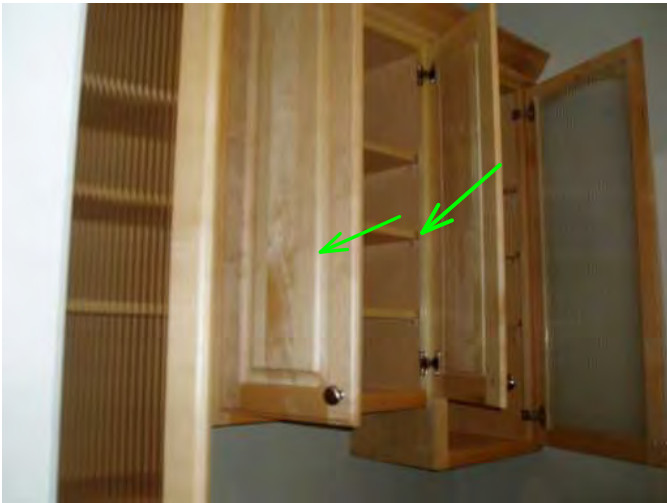
upper cabinets in butlers pantry are noted solid to walls..good...

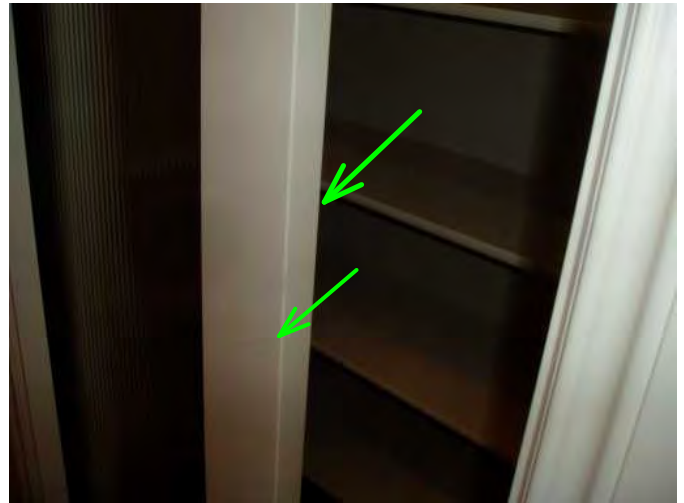
pocket door to main pantry is noted operable....and shelves are solid to walls...good...fixture in area is operable..good..

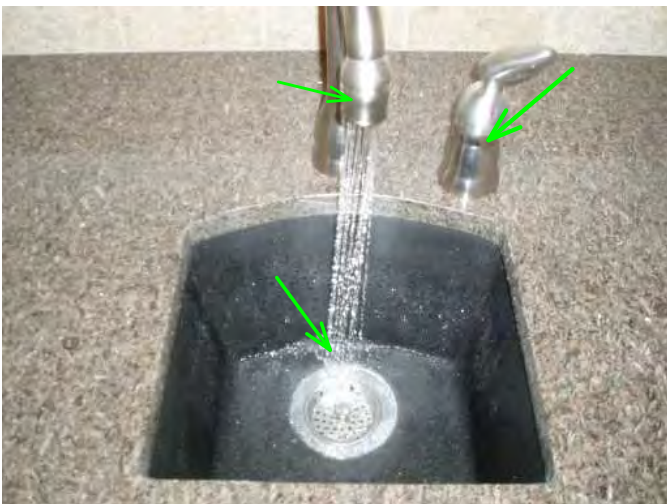
sink at butlers pantry is noted operable...

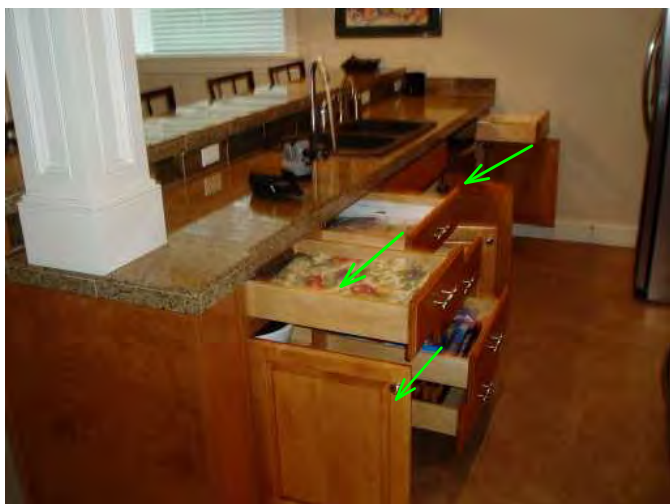
lower kitchen area noted here with cabinets are noted operable at center area...good..counter is solid to cabinets...

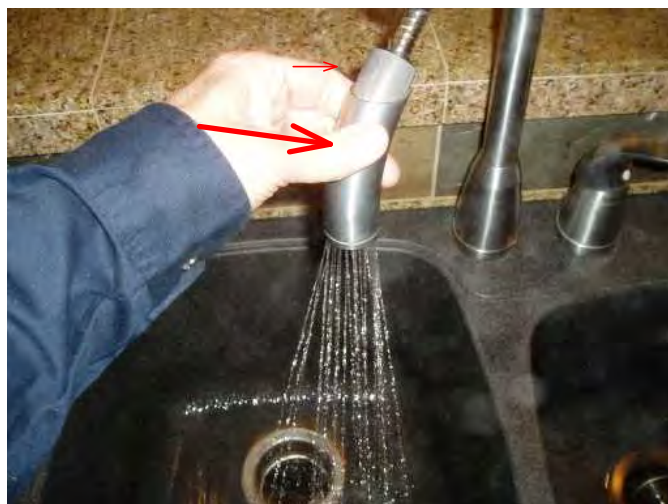
faucet is operable, but sprayer is noted stuck in faucet and needs repair....

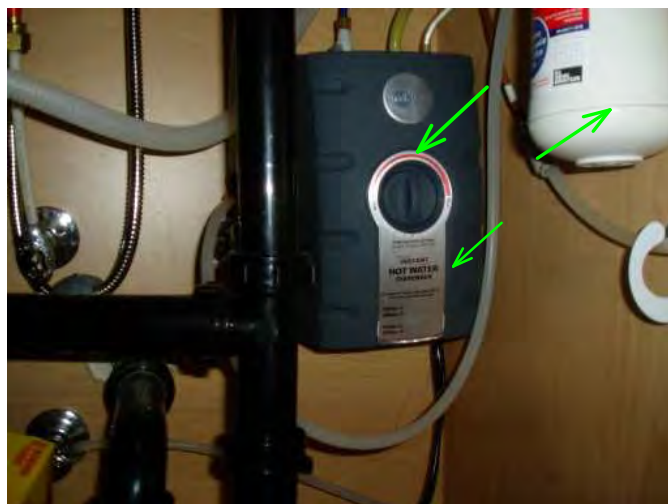
hot water and filter are noted here and are operable...good...

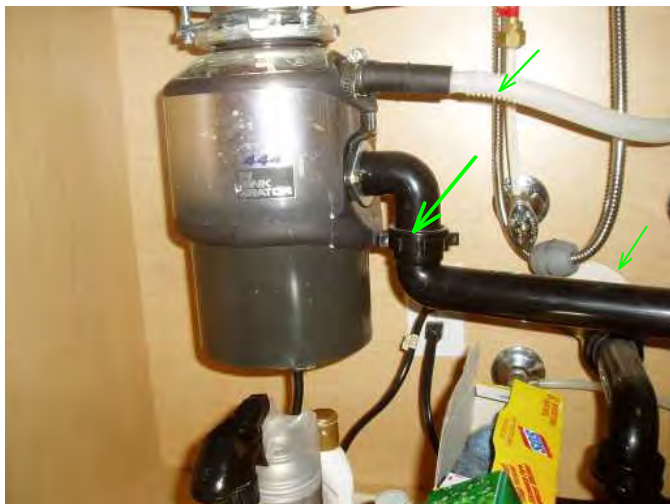
no drips or leaks detected in trap under sink area...and garbage disposer was run and is operable..good..

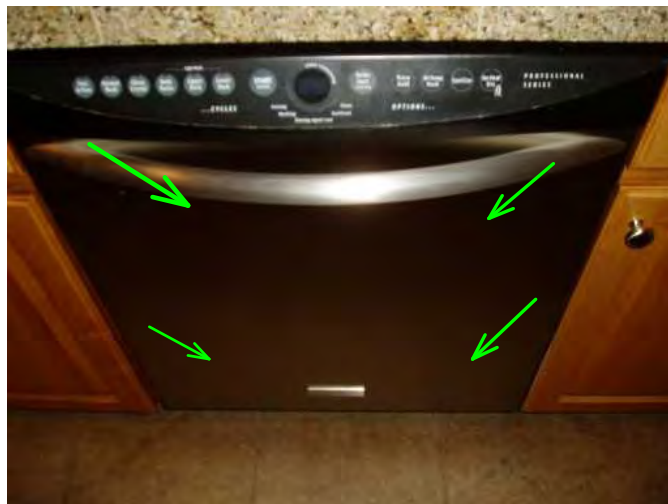
dishwasher was run and is noted operable with no leaks detected under unit...good...

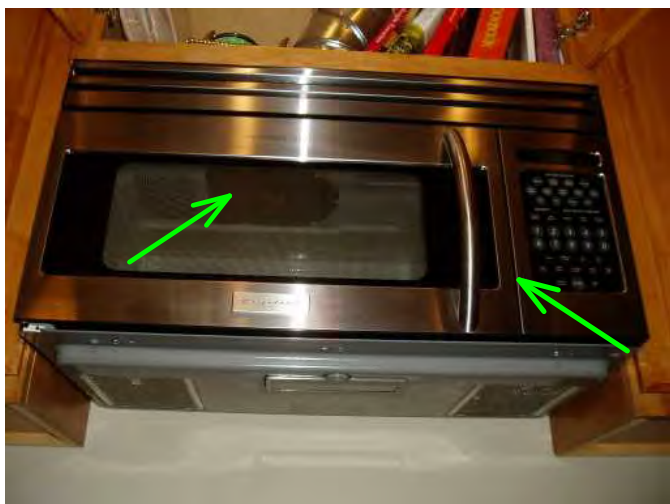
over stove microwave and exit vent are noted operable and vented to outdoors...good...

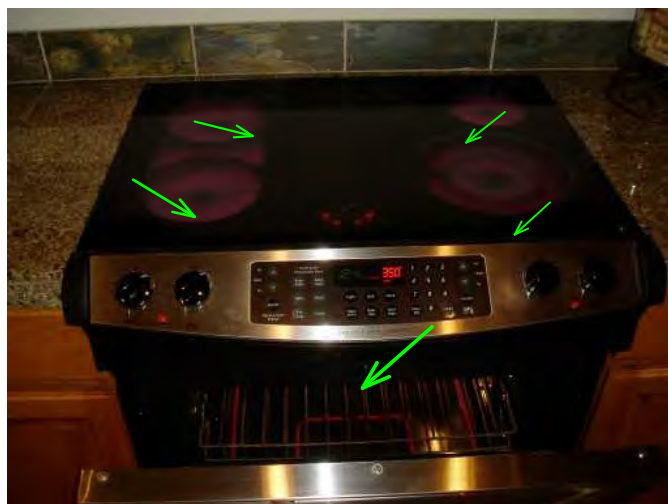
stove and oven are noted operable in lower kitchen area and is electric....fine...

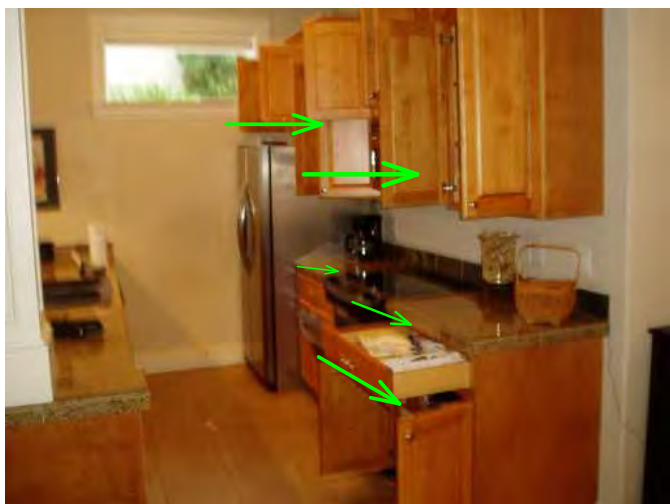
cabinets and counters at back section area noted solid to walls and operable...good...

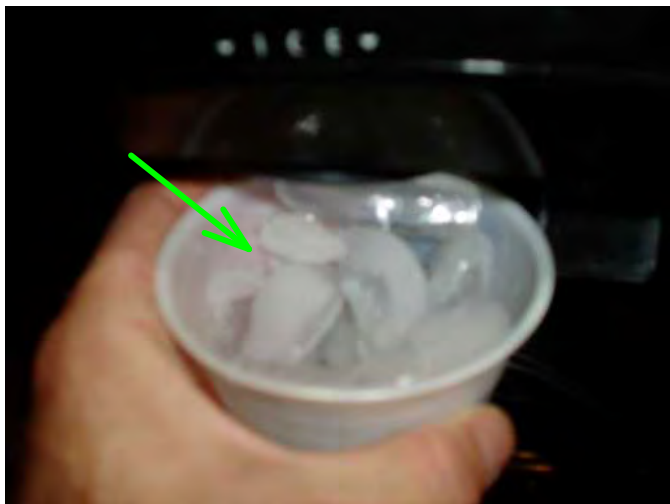
ice maker is on and operable...

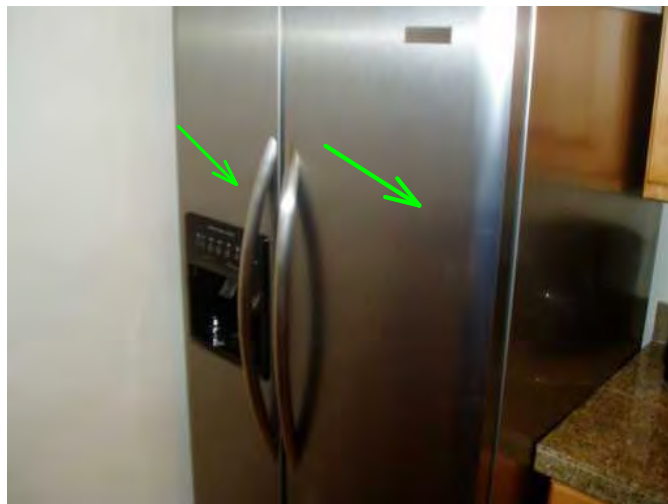
refrigerator is operable and noted here working....good...

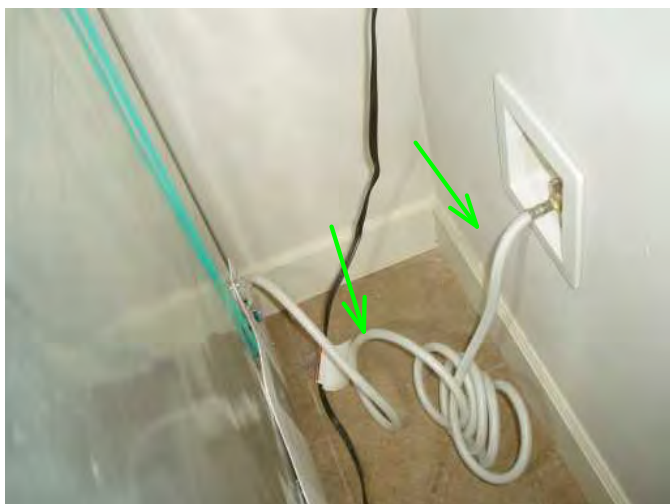
no drips or leaks noted at connections at back of refrigerator...good..

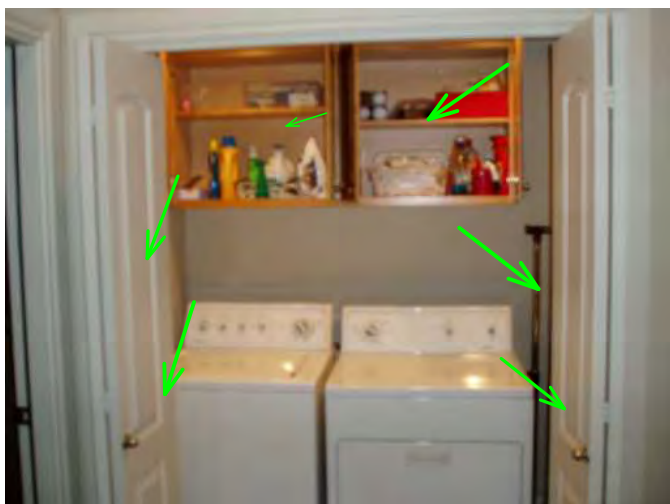
basement laundry area is noted with doors and cabinets are operable...ran machines to check water/electric flow...fine...

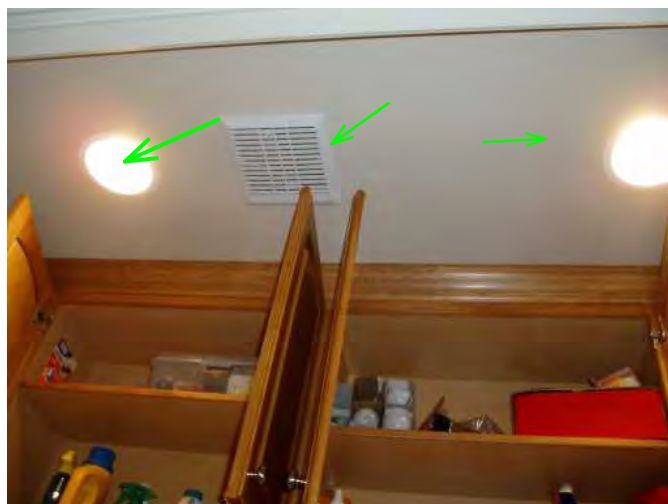
ceiling fixtures and exit fan are operable..good...

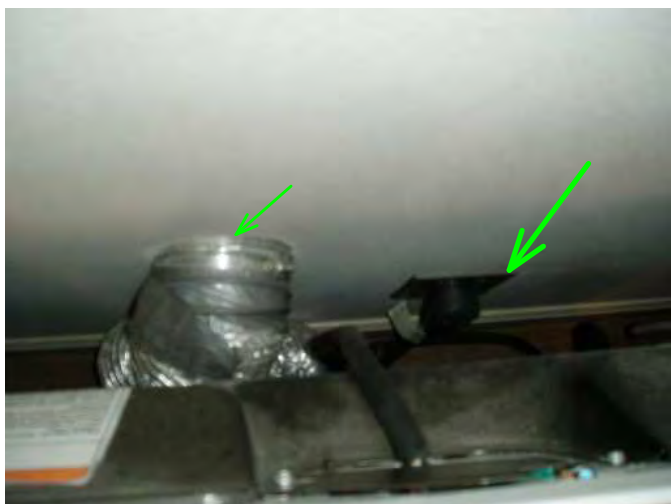
dryer hook ups are noted here and appear fine....

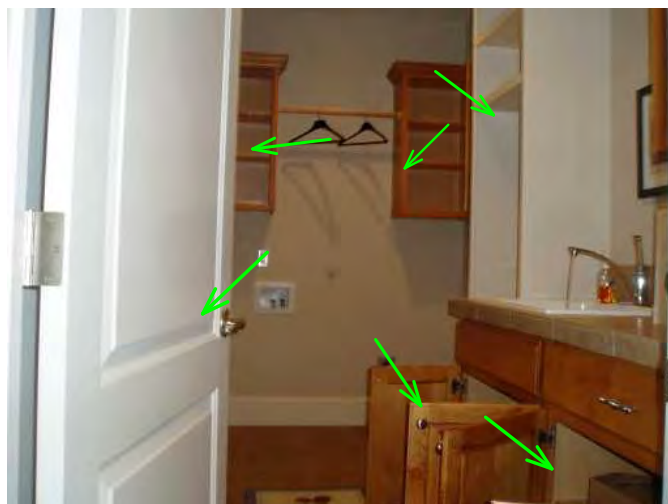
upper laundry area entry door and cabinets are noted operable...good...solid to walls...good...

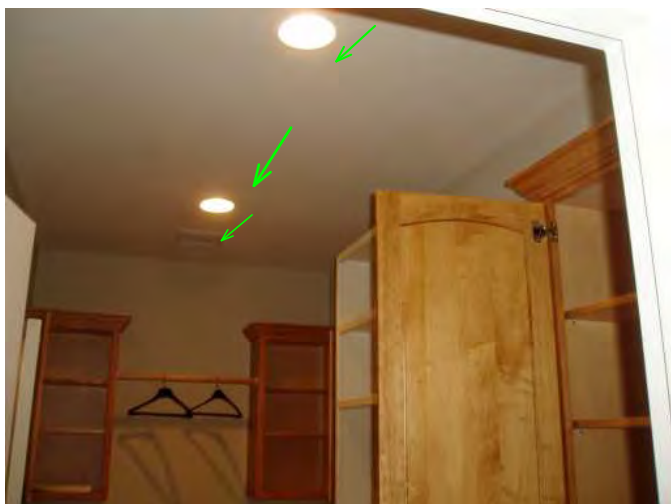
fixtures and exit fan are operable...good...

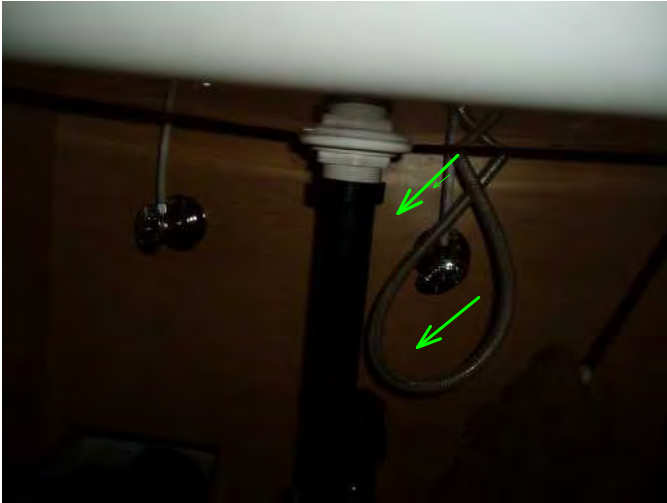
no drips or leaks noted under laundry tub area in main laundry...good...

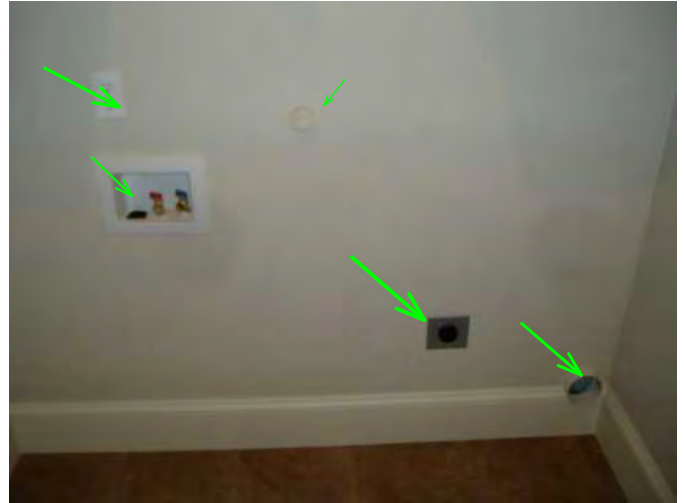
all hook ups appear operable heregood...dryer is shut off at breaker panel...if used, just turn on...

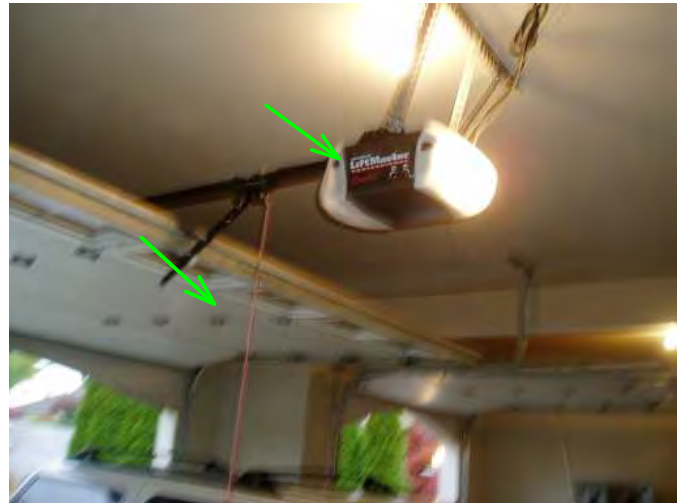
larger garage door is noted operable ...good..has auto reverse installed for safety....good...

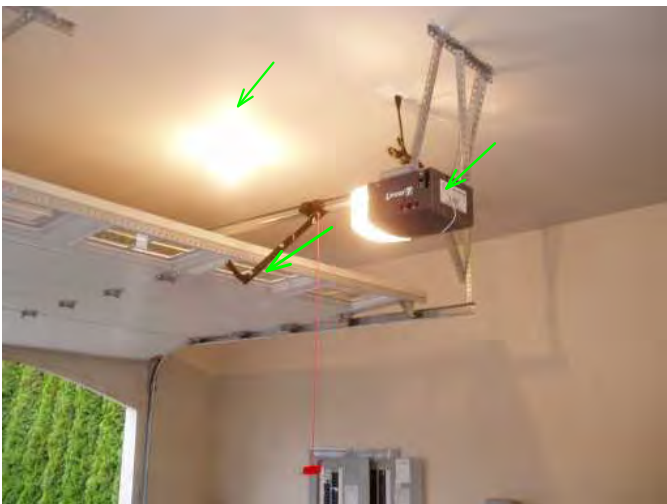
single garage door is noted operable and auto reverse is noted operable as well...good...

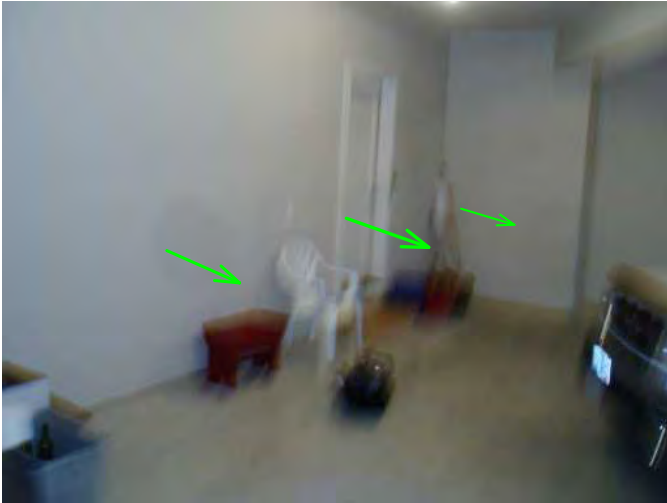
garage is set up for storage shelves at the back wall
if wanted...good...

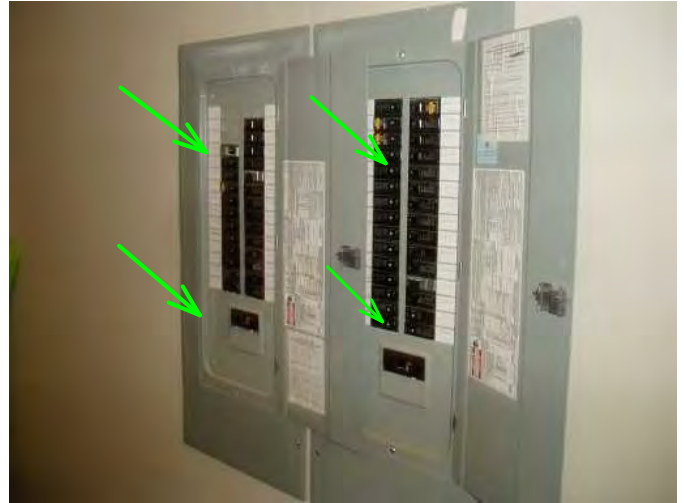
two breaker panels are noted in garage...very
good...200 amps x 2 is very nice...

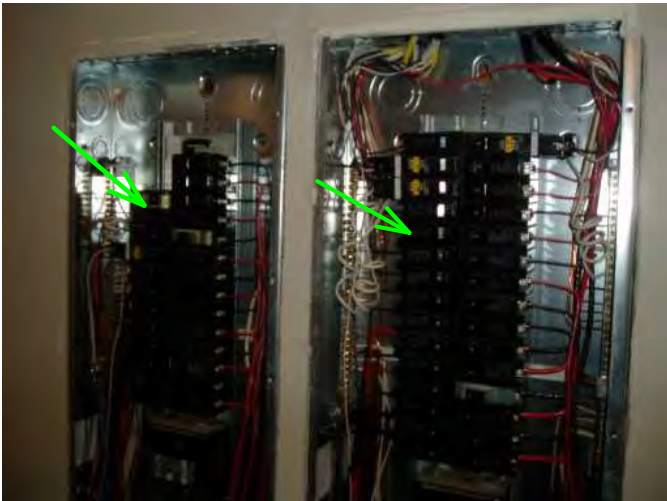
pulled off panel covers and noted all installed
well...good....

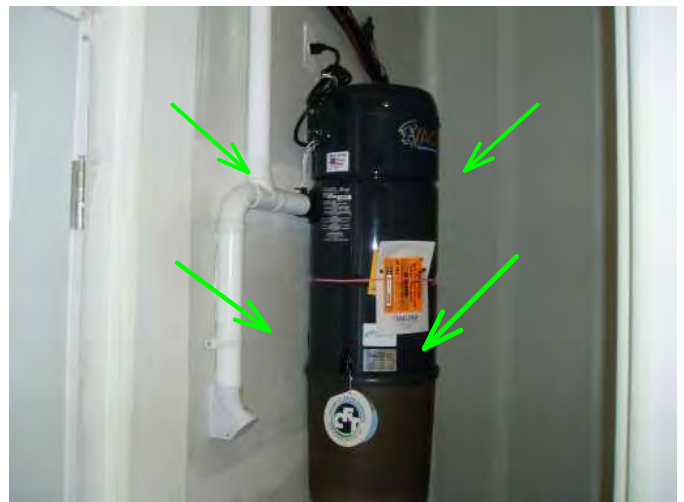
in basement area noting vacuum system is in
place...and is on and operable at outlets throughou
thome..no attachments

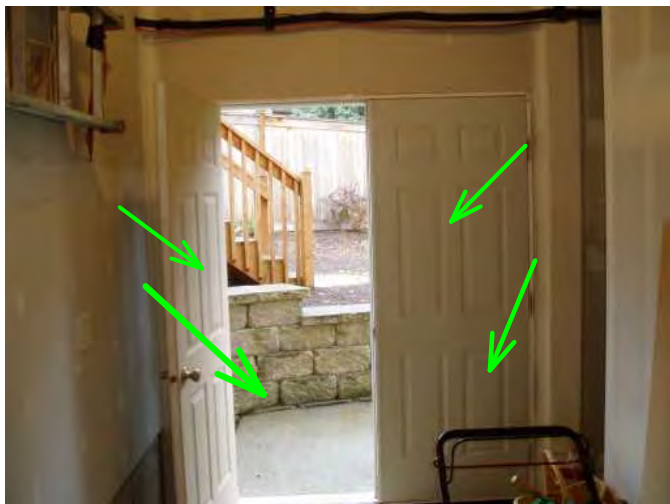
French doors to exterior area from basement area are noted operable here...good...

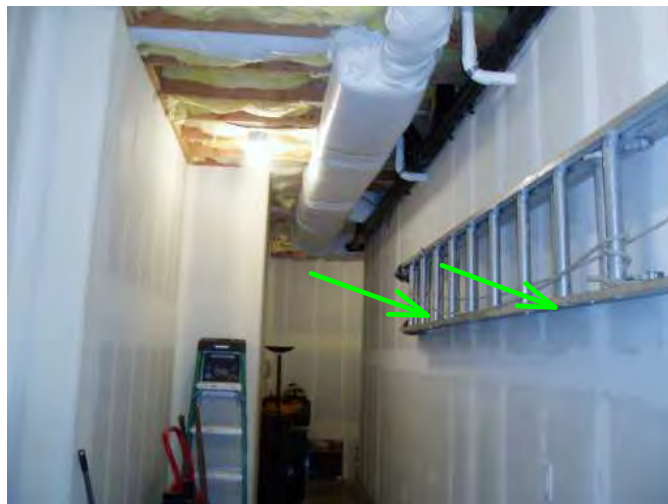
ladder is noted that tells me the home is most likely well maintained...good..ask if leaving ladder...

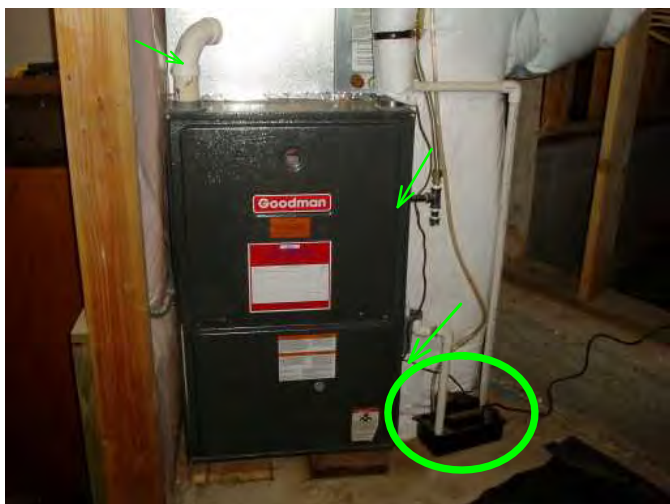
furnace is noted here in basement area and is noted well maintained...and has condensate pump...good...operable...

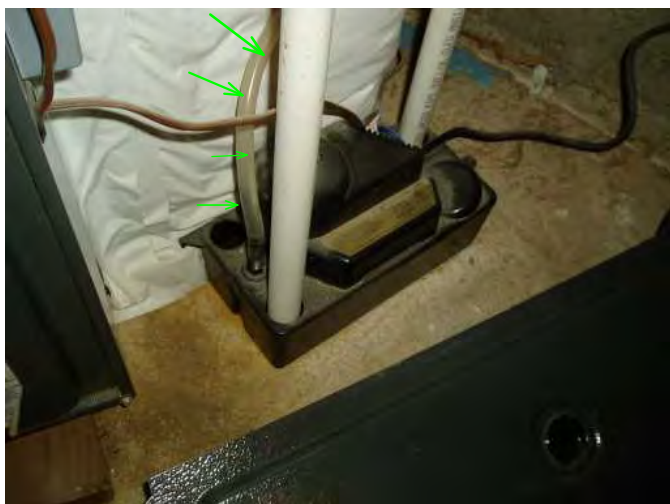
pump is noted as operable..good..check drain tube often....

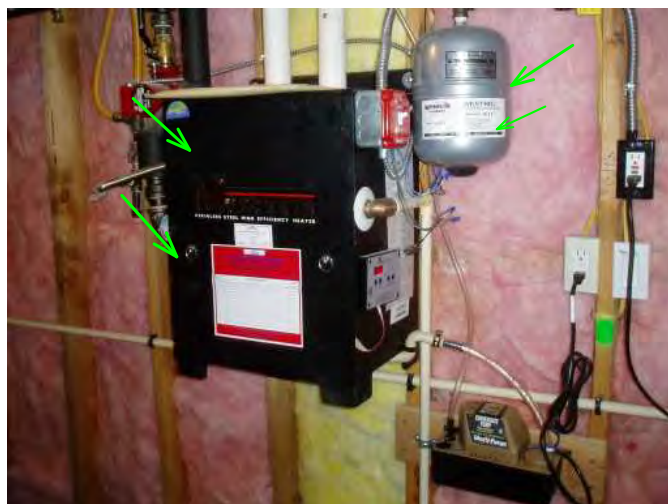
munchkin hydronic heater is noted here and is operable...good...expansion tank is noted to control water noise

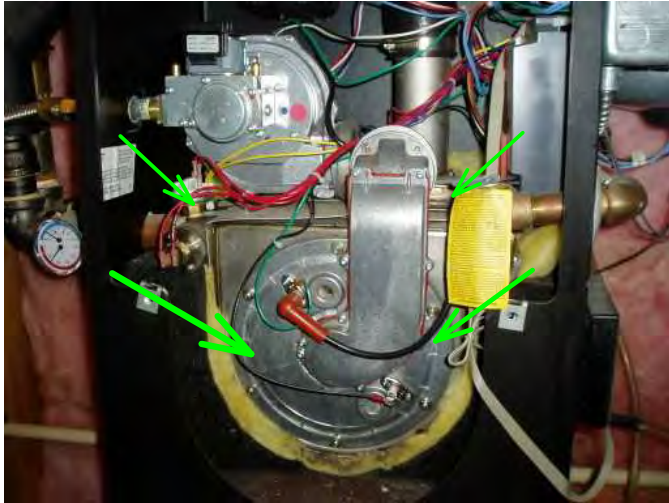
open view of burner and draft control are noted here and operable...have unit serviced every fall....

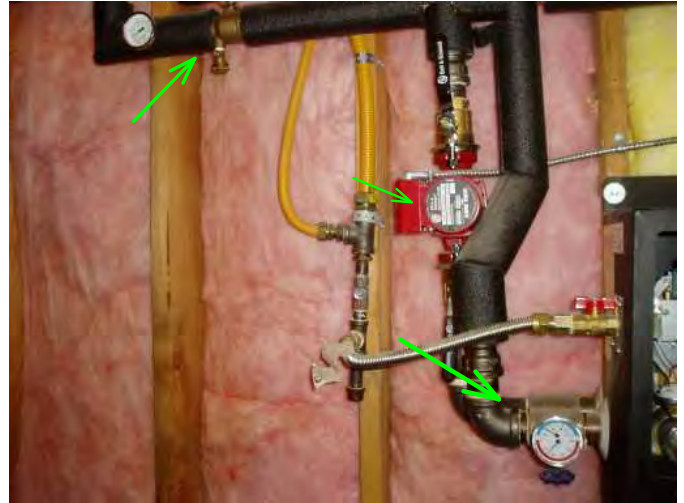
pump and gages are looking good here...ask for operation instructions and read to understand maintenance of unit...

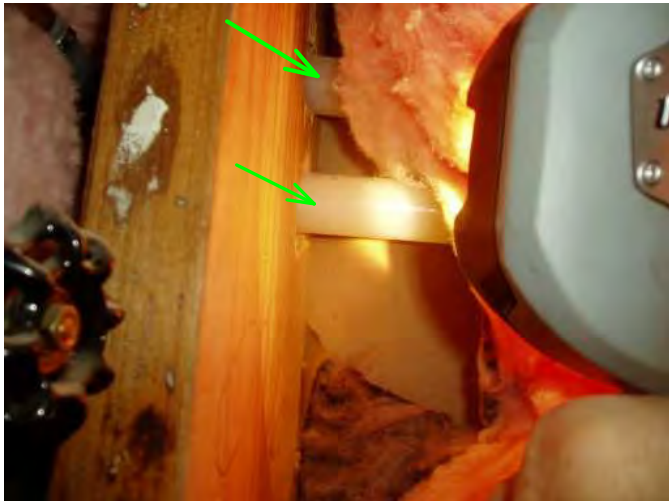
pex water supply system is noted here for pottable (drinking) water is clear color...

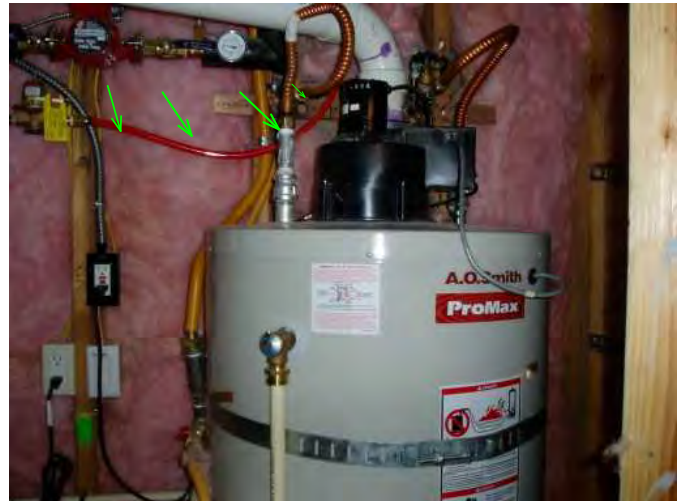
red pex is for munchklin system...water heater is noted here next to munchkin system...is noted operable..good...

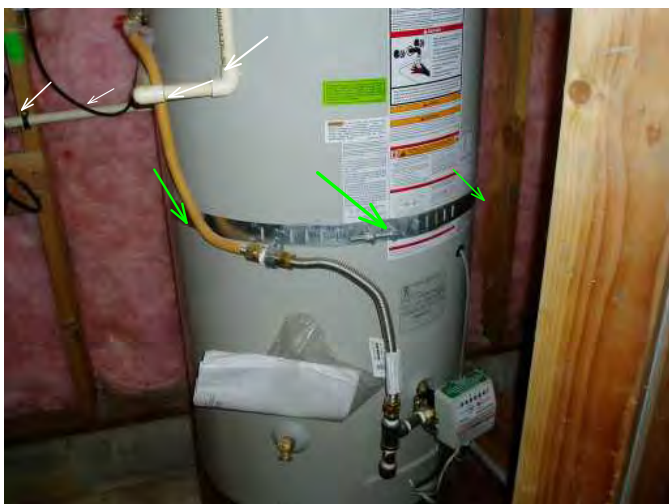
water heater is operable and is strapped to wall is good...TPRV is noted in pvc and drains to outdoors...good..white

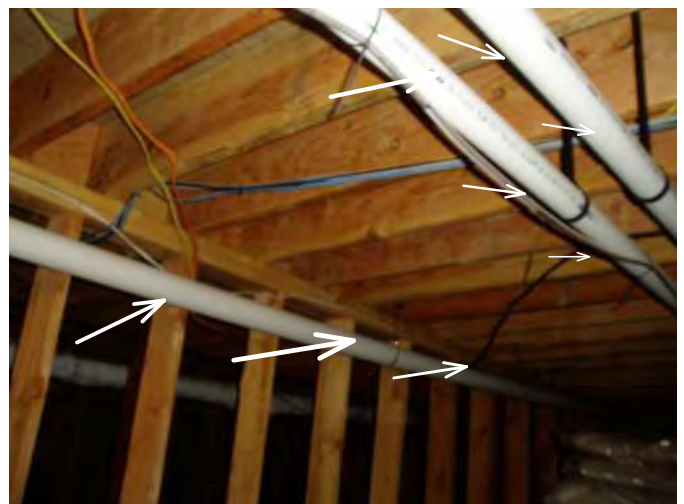
flues for water heater and munchkin are noted here and strapped to joists solid...good...

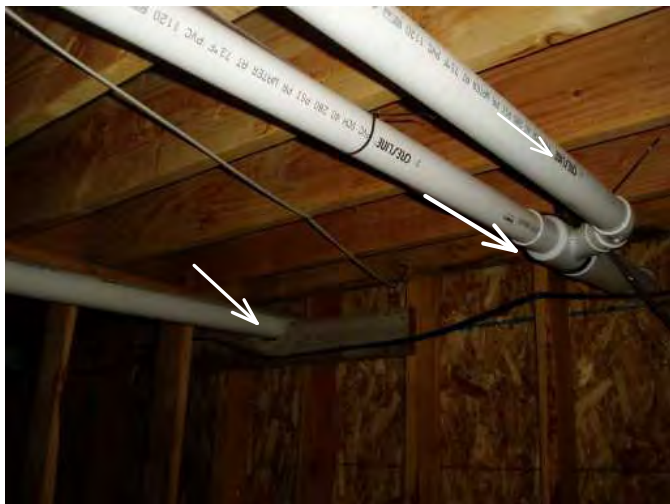
pvc flues are run to side of home and are solid to joists...good...

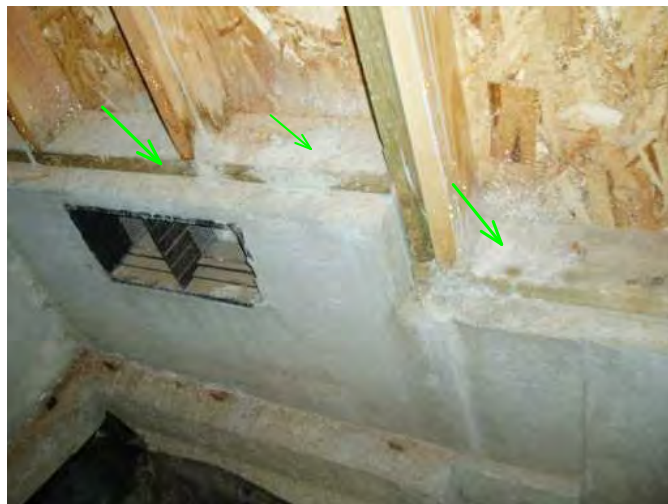
noted all rim mud sill plates are treated wood and are bolted to foundaion for earrth quake protection...very good...

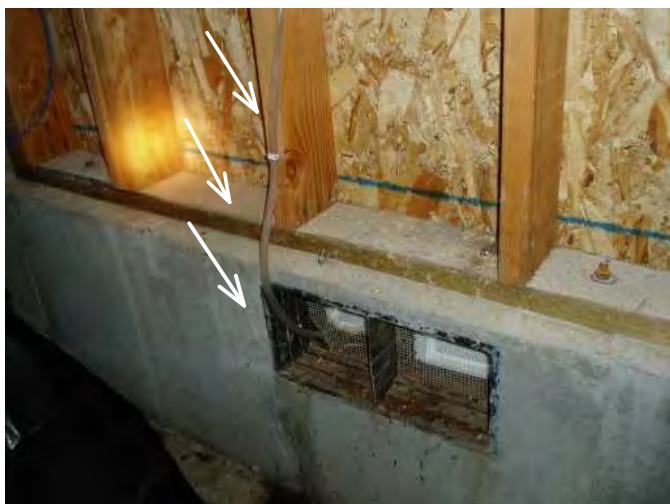
drain tube for furance is noted here....good...

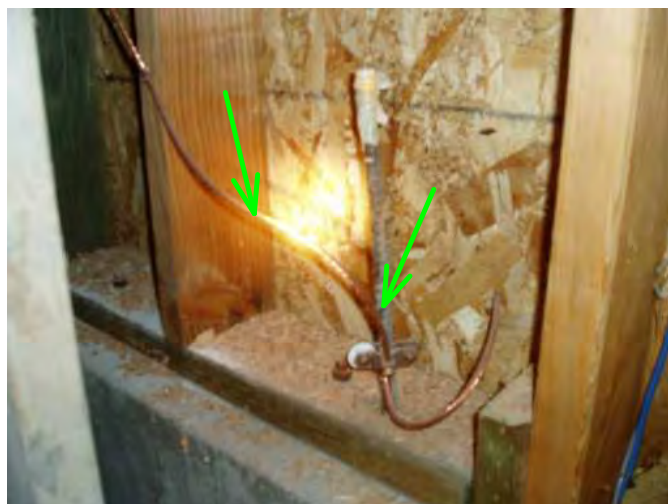
grounding is noted here at re-bar to foundaion for electric system...good is also bonded to gas lines...good...

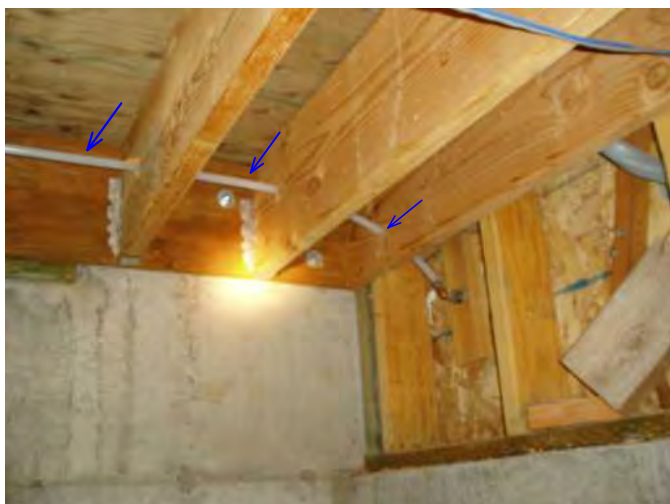
pottable pex system should be insulated....

Water Lines: pex - a few short sections of water lines were noted not insulated in basement and crawl area..suggest insulation them to avoid potential freeze in cold winters...other sections were...see photos

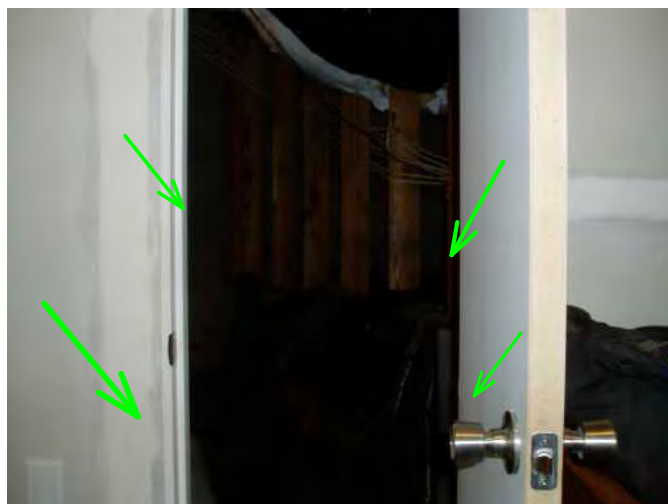
door to main crawl area is noted here in basement area...

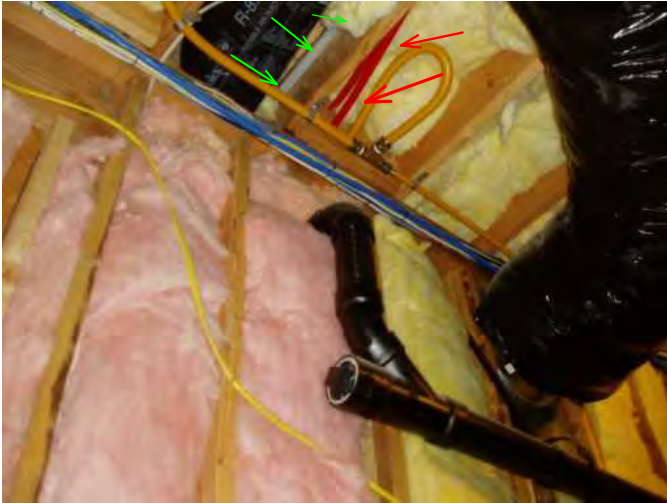
red pex is to in floor heating system in basement area...pex clear is needed to be insulated...see at green arrows...

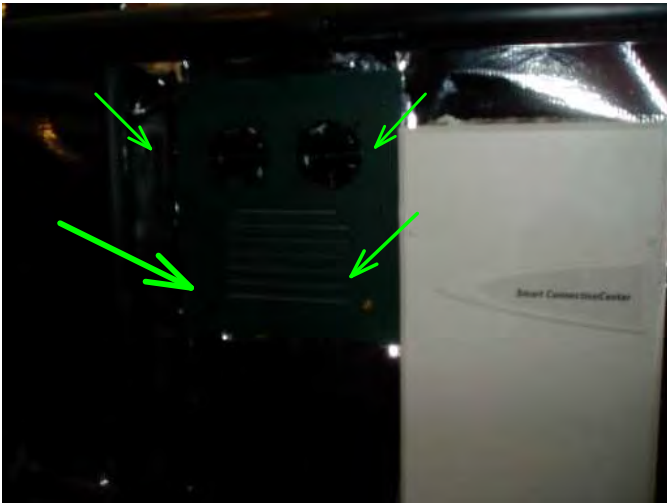
dark photo, but trying to show wine room air control system is venting into crawl area..if used..open crawl vents

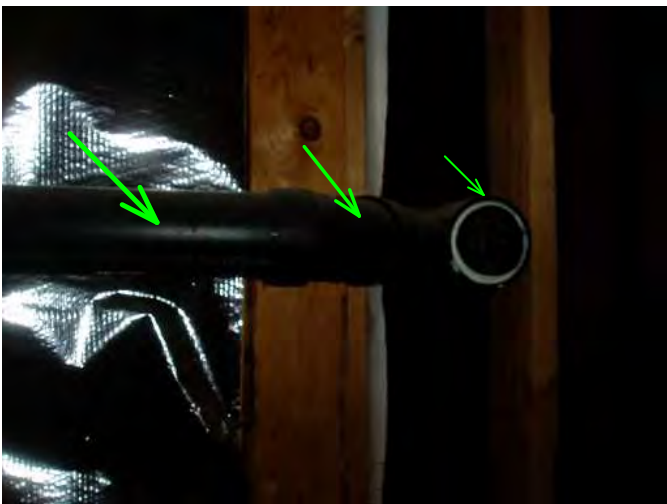
plumbing sewer pipes are noted with good slope to lower area of exit and cleanouts are noted as well...good...

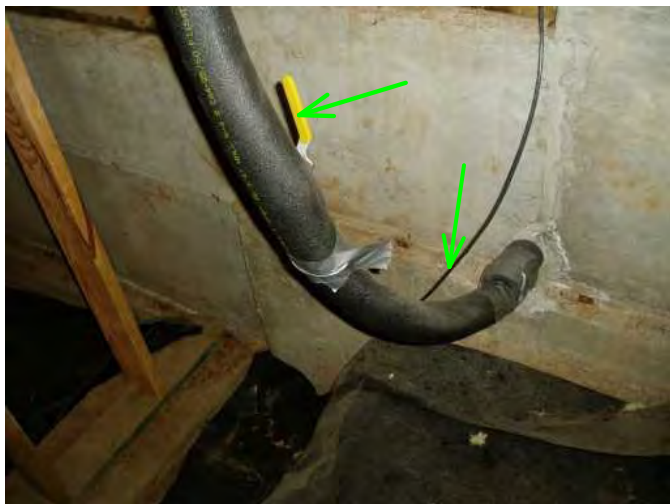
main water entry is noted here and is pex service lines...with shut off noted here...good...

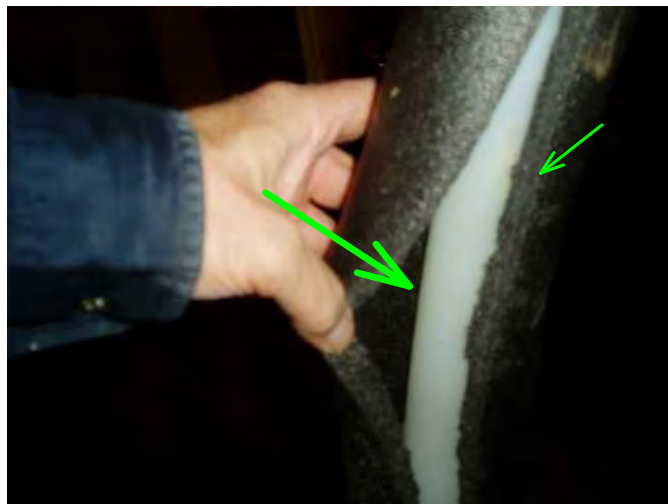
pulled back service line and showing is pex...fine...

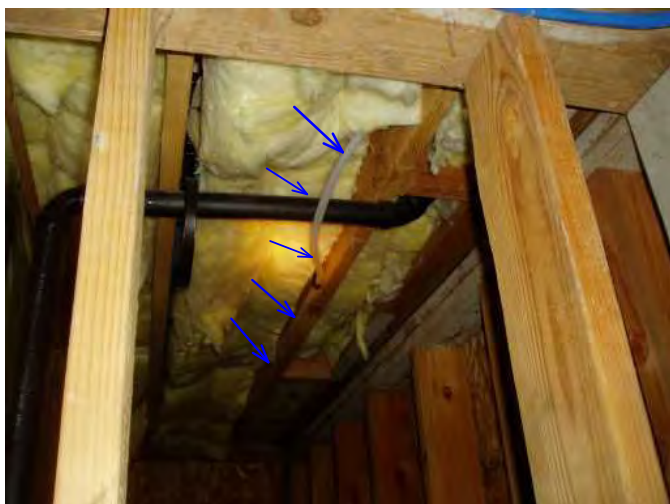
seeing random areas that pex water supply lines need to be insulated....

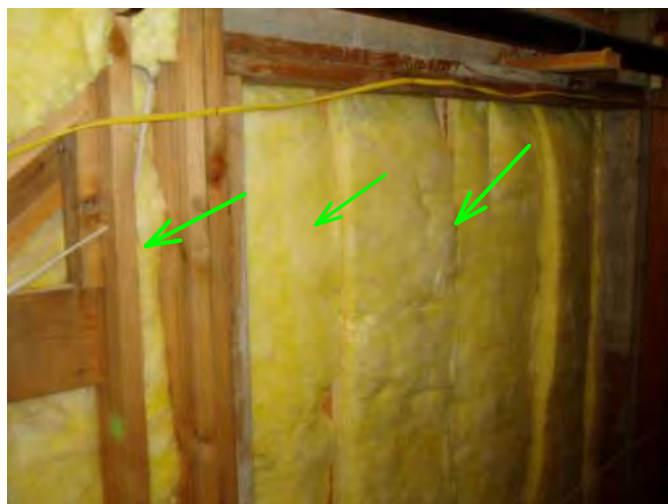
walls to basement area are insulated fine...good...

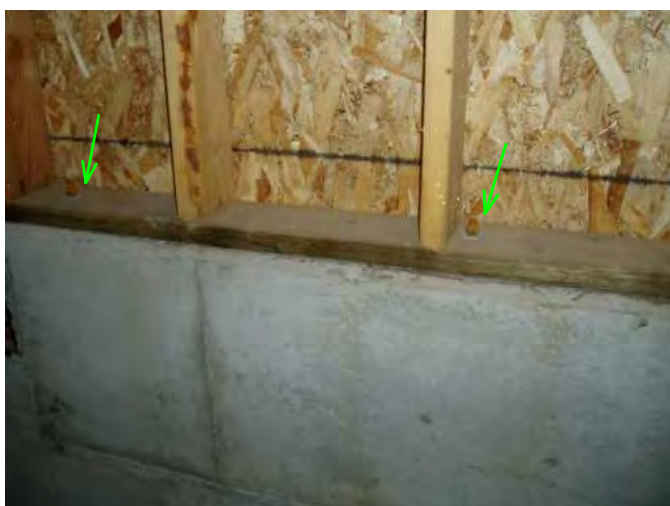
noting mud sill is treated wood under dining room area and is bolted to foundation for earth quake protection...good..

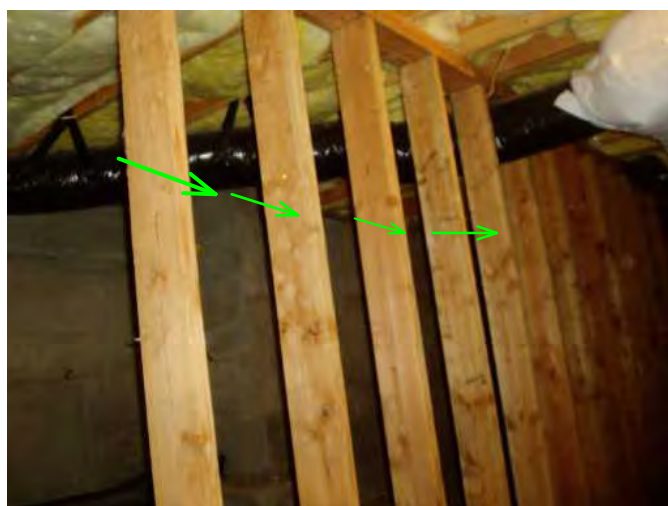
main support wall is noted here and is solid and sound...under entry and dining room and office area....

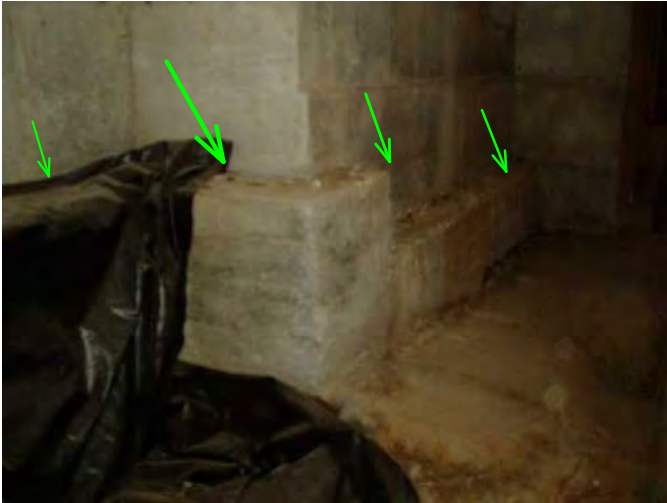
front of home foundation is noted solid here and no staining of water noted...good...

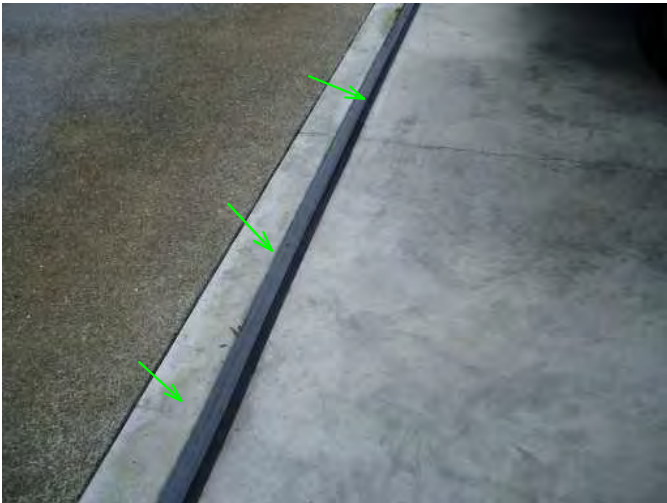
noting garage doors have gasket attached to floor at door area...very good to keep out drafts and vermin...

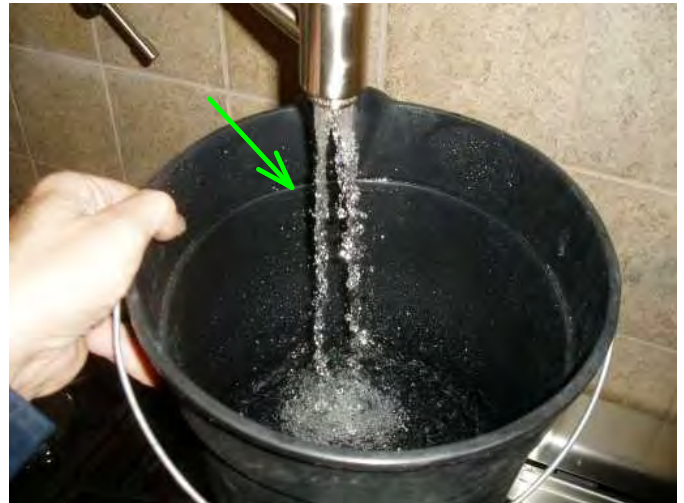
ran the water feed to over stove faucet and found the water became clean after running several buckets...

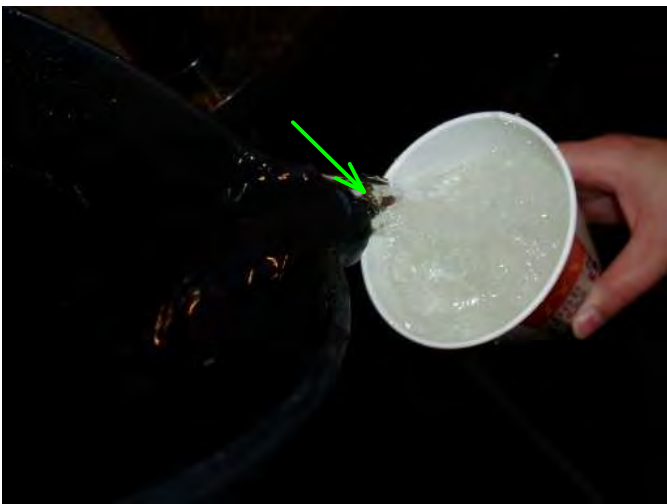
running clean and clear here....good...just appears was old water not used for while ...appears clean now....good...
